Department:  
Water Affairs  
**REPUBLIC OF SOUTH AFRICA**

## **Dam Safety Office**

# **2009-2010 Annual Report**

**ADMINISTRATION OF THE DAM SAFETY  
LEGISLATION IN TERMS OF  
CHAPTER 12 OF THE NATIONAL WATER ACT,  
1998 (ACT № 36 OF 1998)**

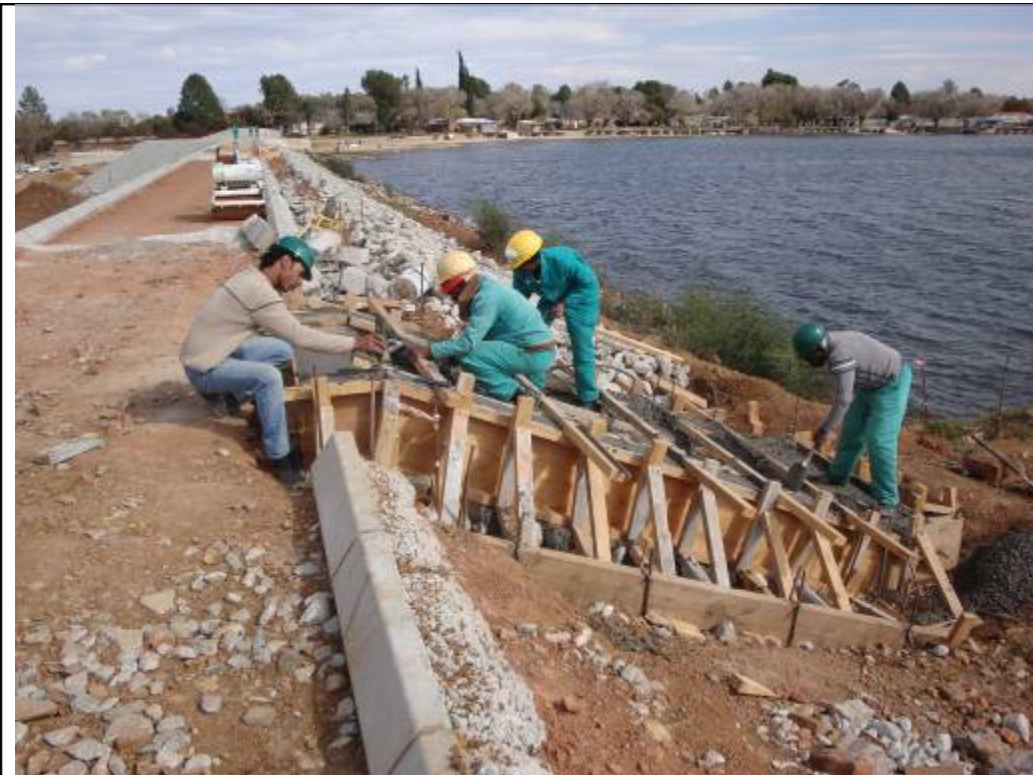
**Lakeside Dam near Potchefstroom in the Northwest Province.**

Dam Safety Rehabilitation Works nearing completion.

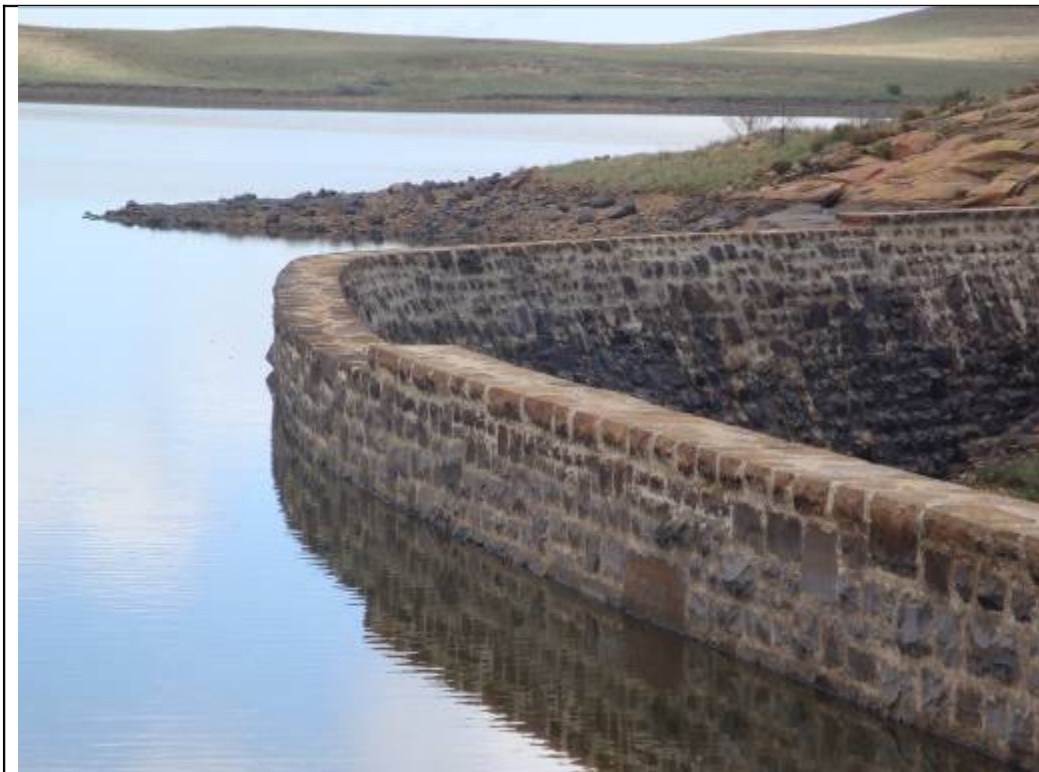
**Gibson Dam on top of the Platberg Mountain near Harrismith.**

Rubble Masonry Concrete Arch Dam constructed in 1906.

Dam leaking but otherwise in good condition.

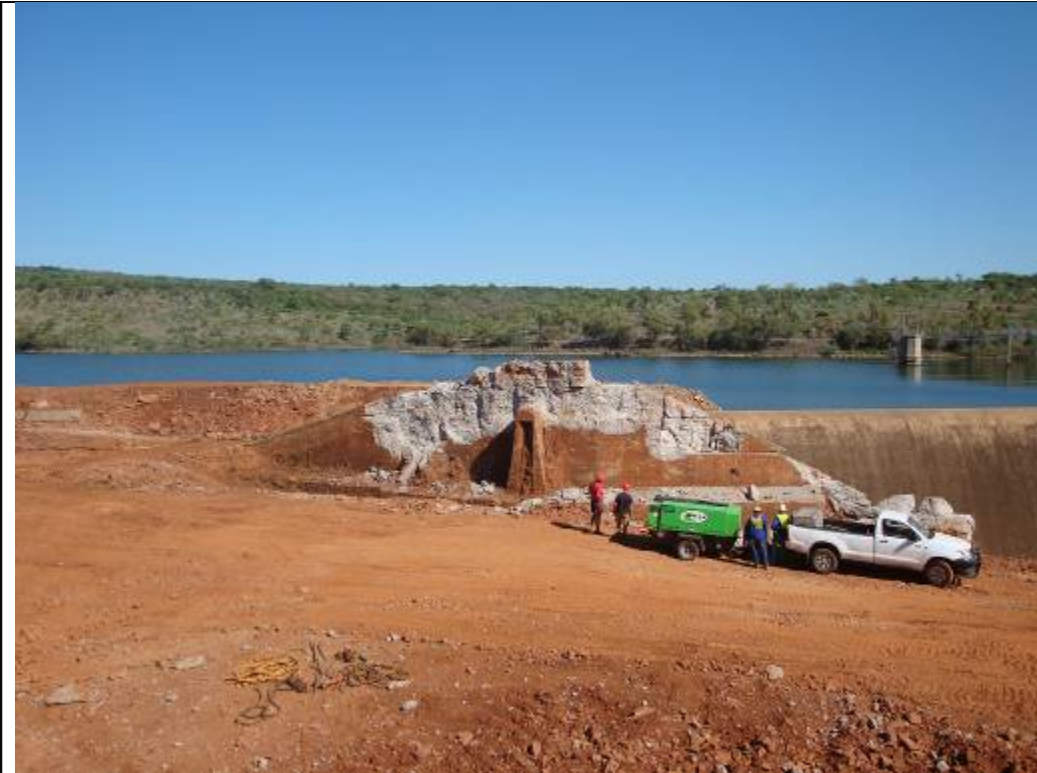
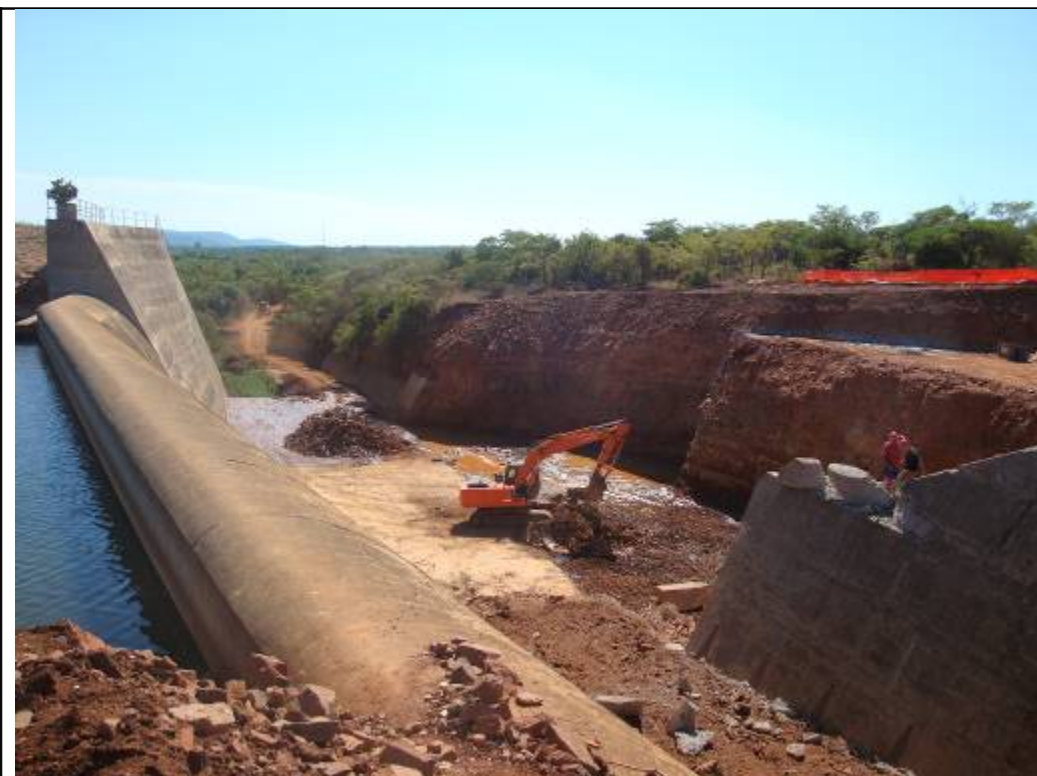
**Klein Maricopoort Dam near Zeerust in North West Province.**

Dam Safety Rehabilitation Works.

Enlargement of Spillway to increase spillway capacity.

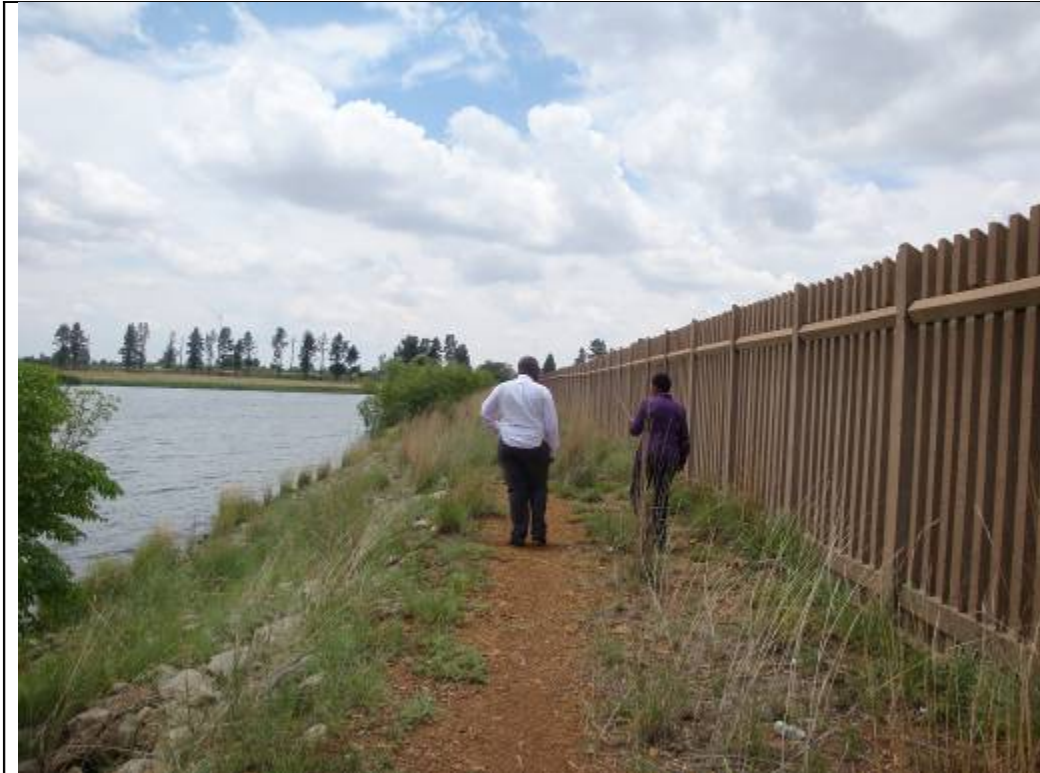
**Donaldson Dam in the Wonderfontein Spruit near Westonaria.**

Dam Safety Inspection by Municipal staff and Dam Safety Office.

Note the vegetation on the dam wall.

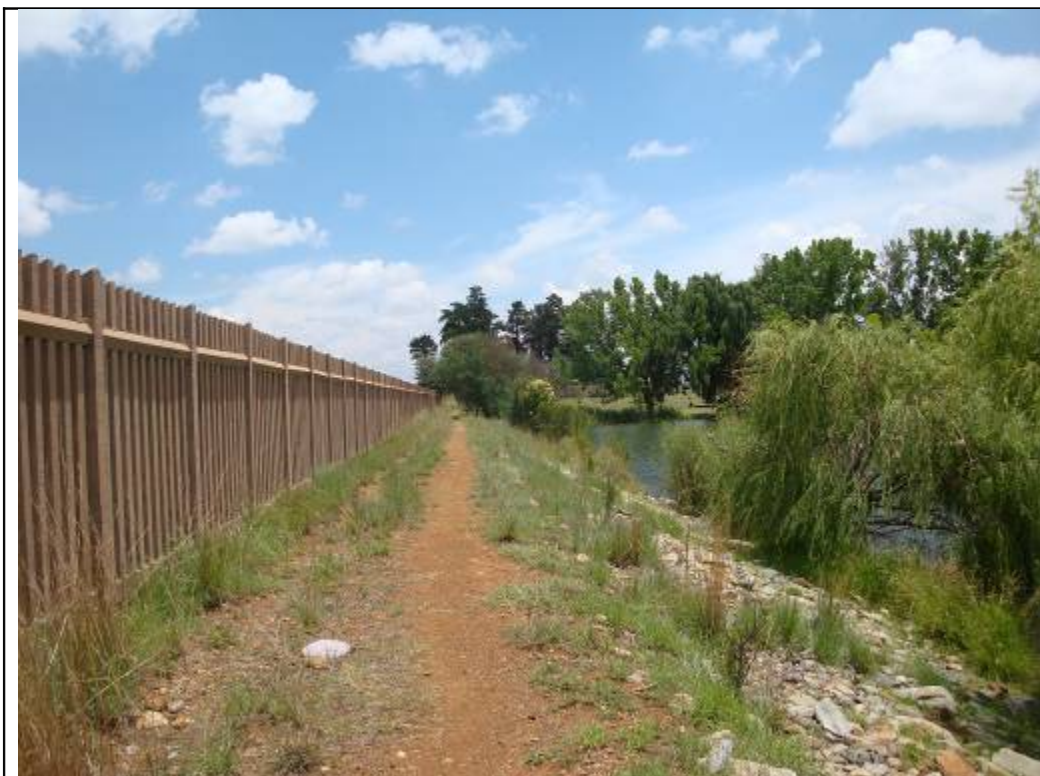
**Donaldson Dam in the Wonderfontein Spruit near Westonaria.**

Note the vegetation on the dam wall.

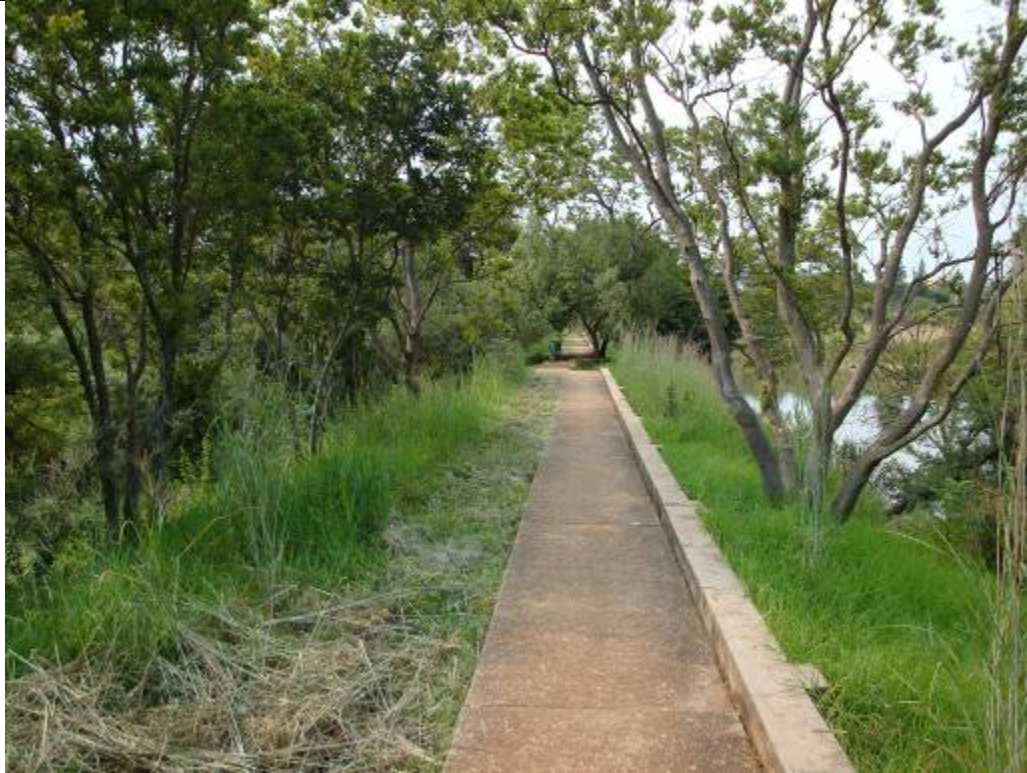
**Struben Dam in Pretoria**

Crest, upstream side and downstream face of dam overgrown with trees.

It is standard practice in dam engineering not to allow any trees on embankment dams because they can fall over during storm events and form holes in the embankment that can lead to dam failure.

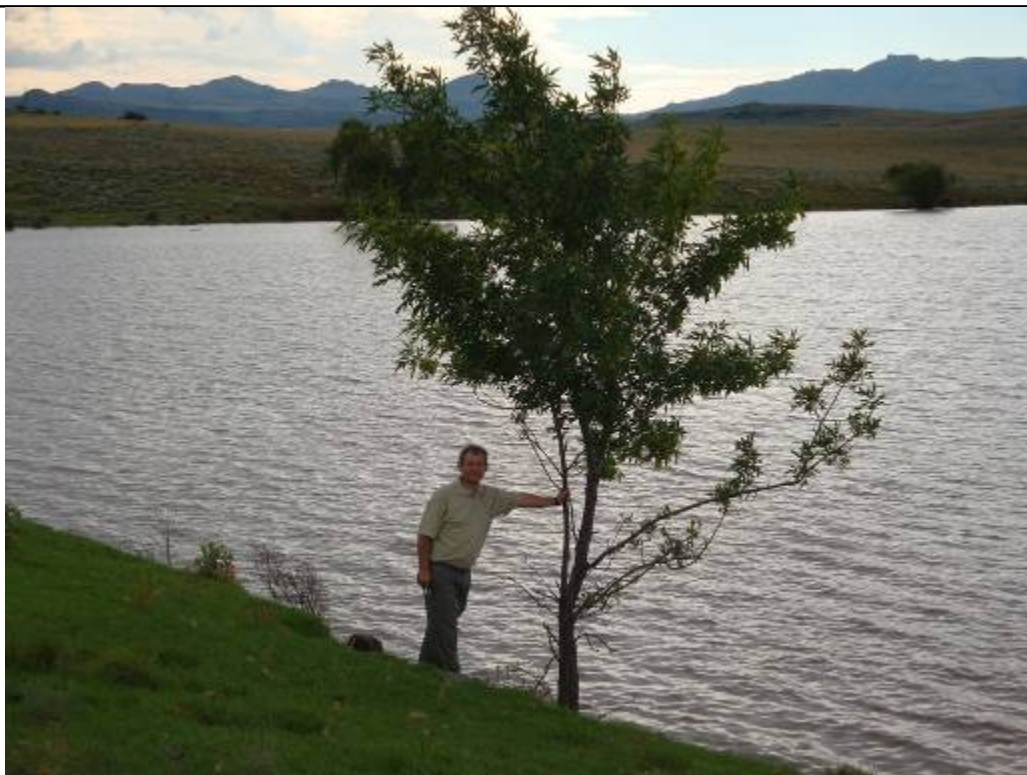
**Montagu Dam near Zastron**

The roots of the trees will eventually die and rot and this can lead to piping failure of the embankment.

Unwanted vegetation on embankment dams also hampers the routine dam safety inspections that must be done regularly by the dam owner.

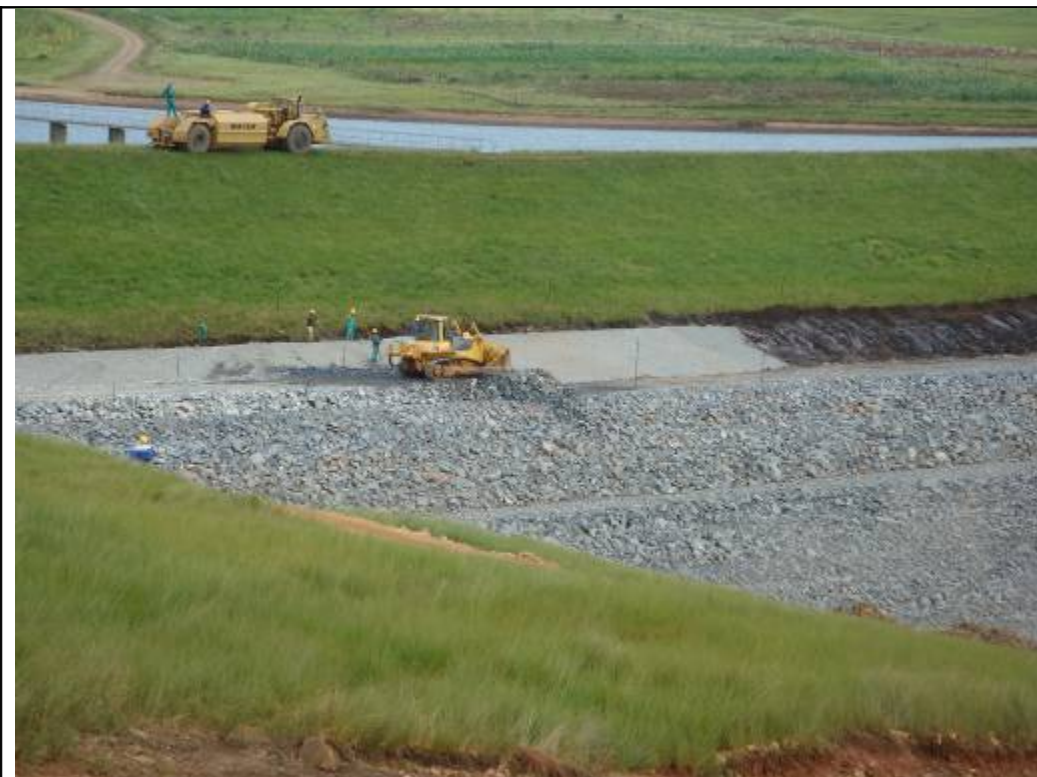
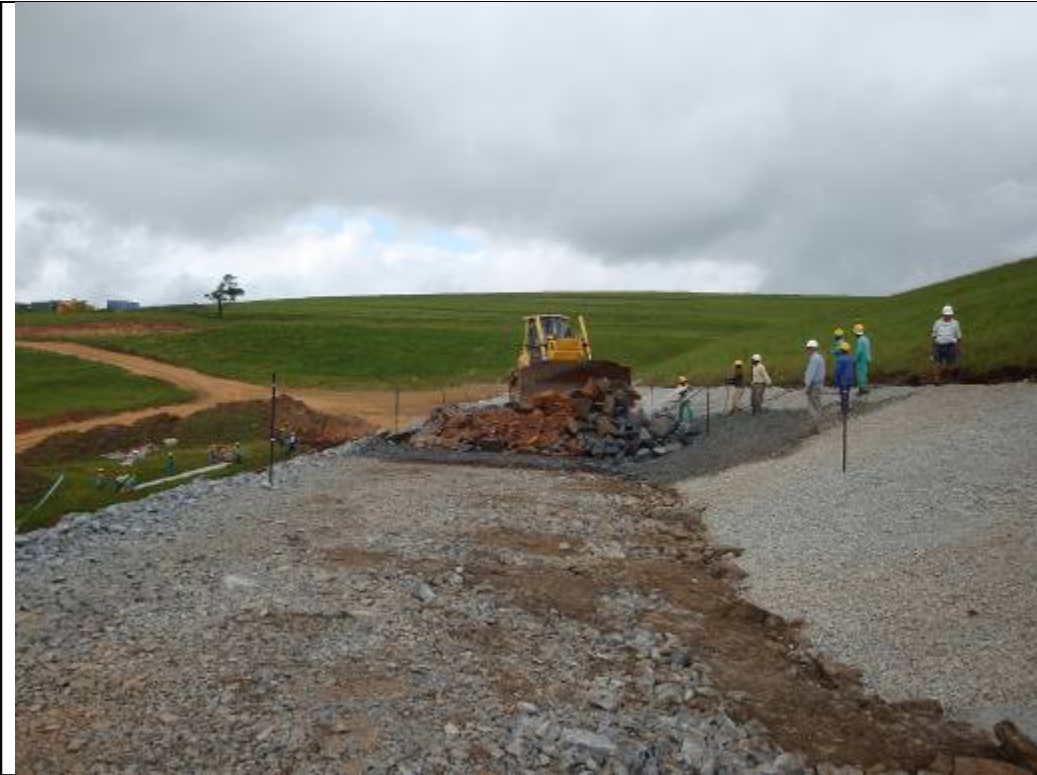
**Magwa Dam in the Eastern Cape.**

Dam Safety Rehabilitation Works.

Construction of a layer on the downstream face to improve drainage and stability.

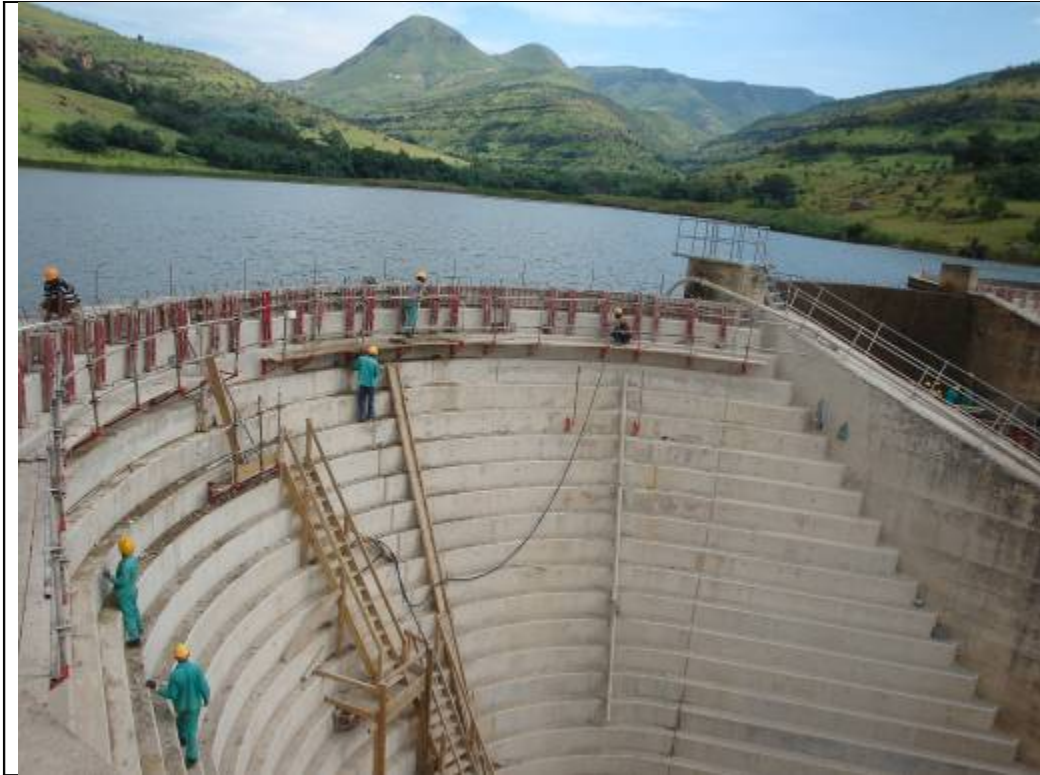
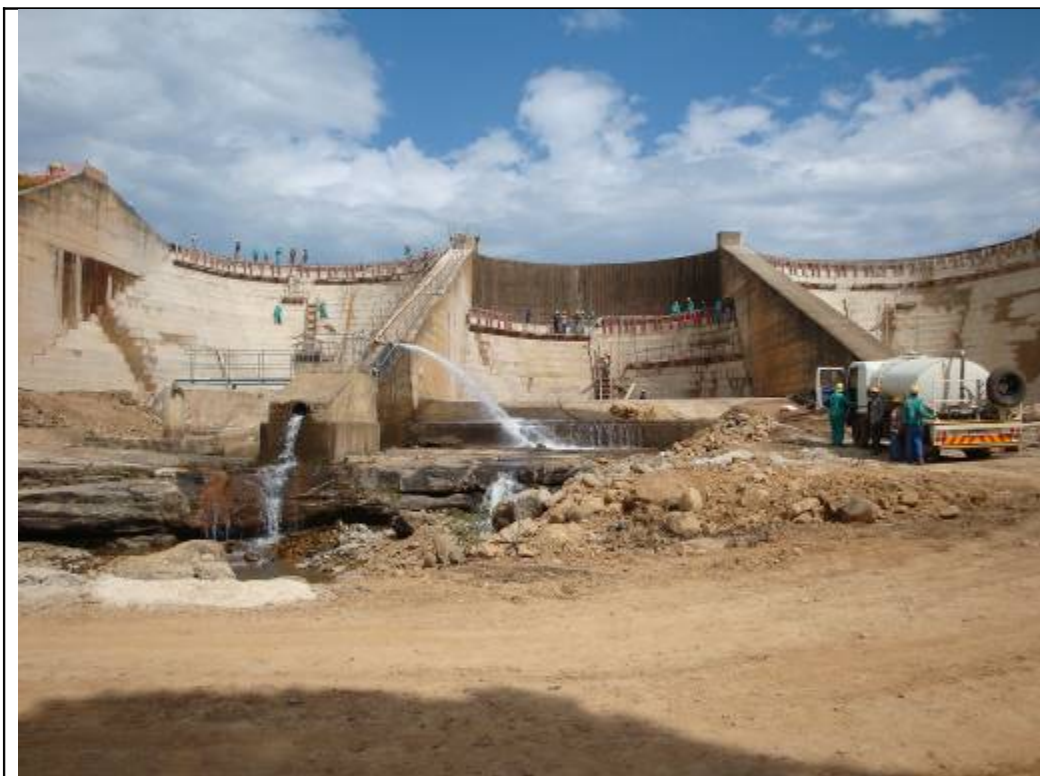
**Belfort Dam  
in the Eastern  
Cape.**

Dam Safety  
Rehabilitation  
Works.

Mass concrete  
is added on  
the  
downstream  
side of the  
three arches to  
improve  
stability.

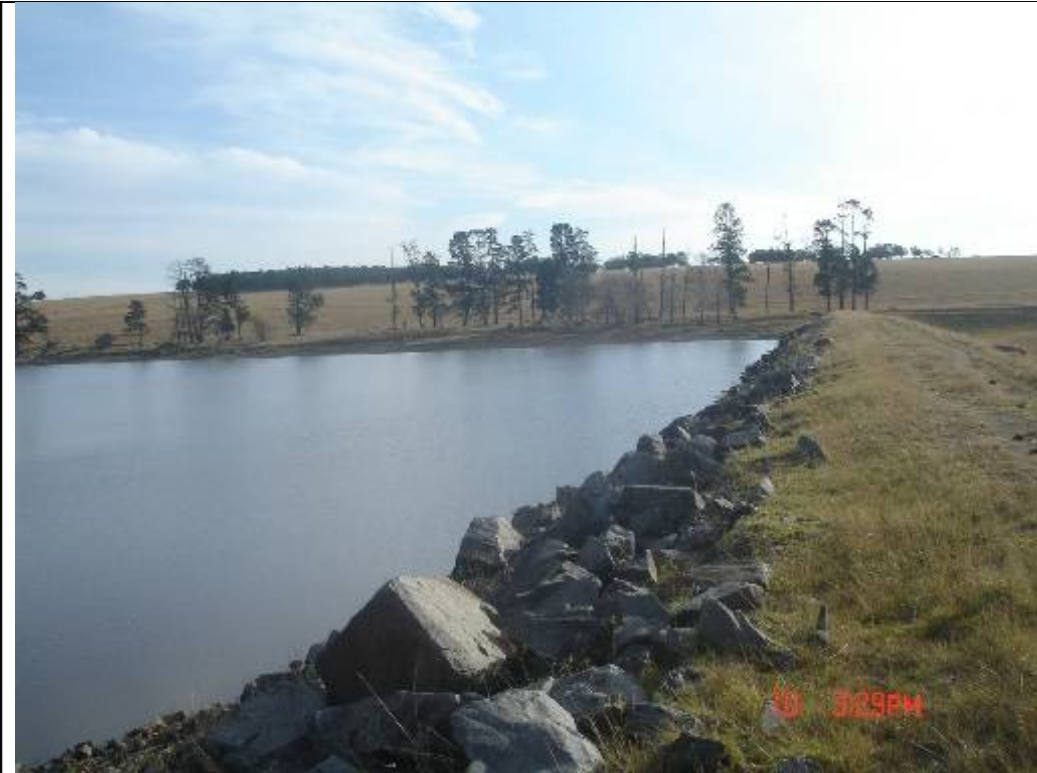
**Amabele Dam  
in Eastern  
Cape.**

View of rip-  
rap on  
upstream side  
of dam wall.

No apparent  
shortcomings

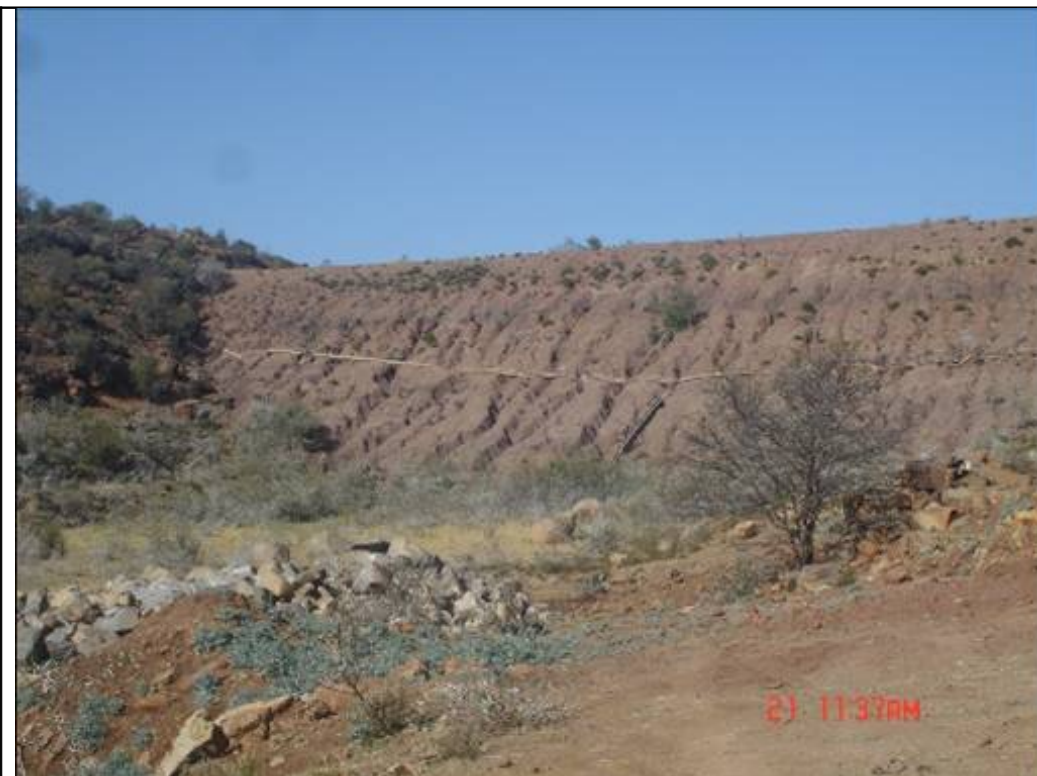
**Glen Brock Dam in the Eastern Cape.**

Picture shows the badly eroded downstream slope of embankment.

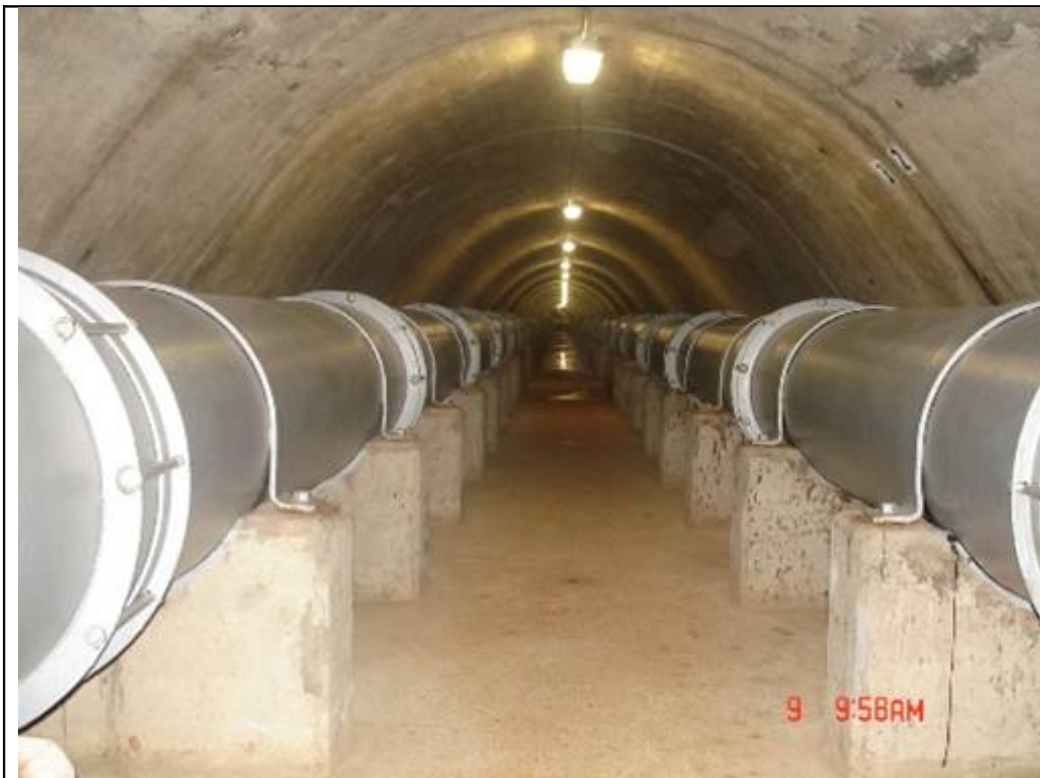
**Gubu Dam in the Eastern Cape.**

View showing good condition of pipes in outlet tunnel.

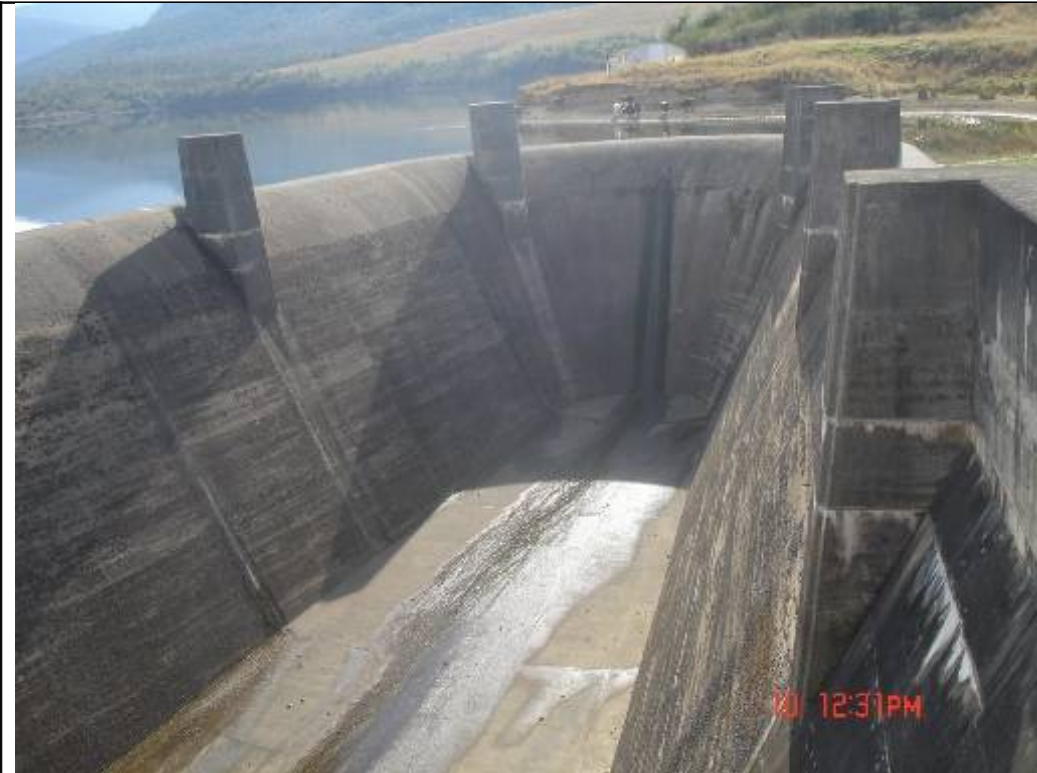
**Rooikrantz Dam in the Eastern Cape.**

Seepage through spillway joints of Spillway Structure.

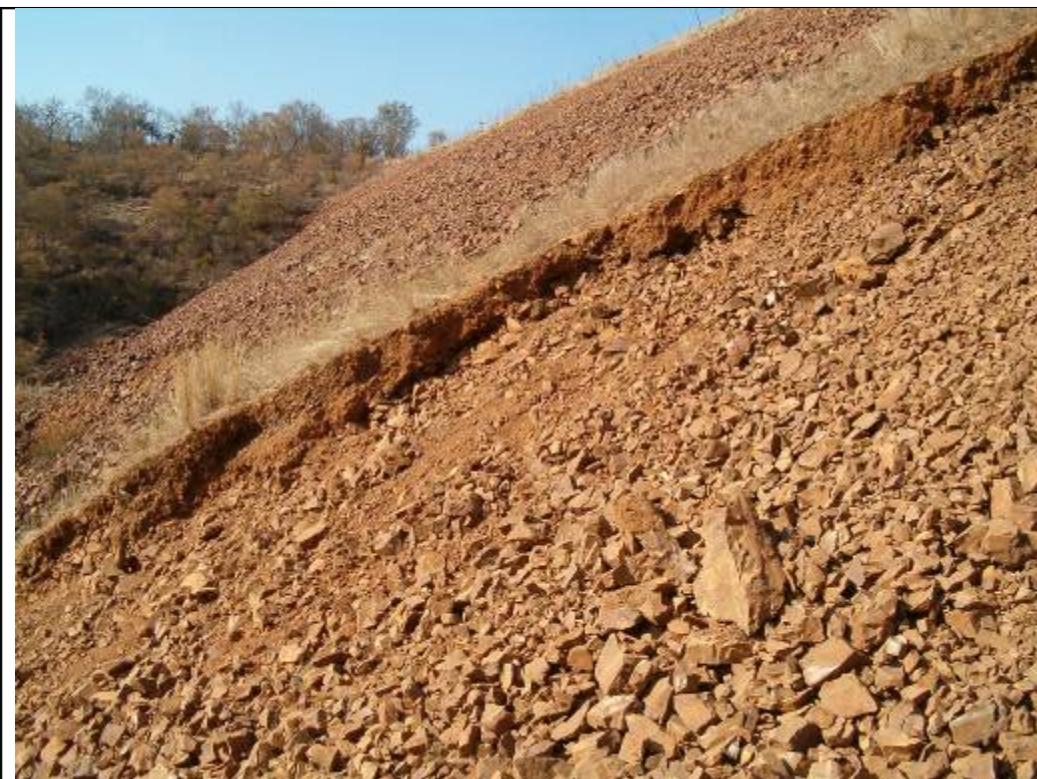
**Rust de Winter Dam**

NAME OF DAM (TYPE)	LOCALITY AND NUMBER OF DAM	HEIGHT (m)	CAPACITY (m <sup>3</sup> )	CAT	INCIDENT OR DAMAGE
Rust de Winter (Rockfill with u/s concrete membrane)	Pienaarsrivier, north of Tshwane. B310/01	31	28 million	3	Superficial downstream slope failure of rockfill dam when contractor undermined toe when constructing temporary access road.

Surficial downstream slope failure occurred during the rehabilitation work when construction of an access road at the toe of the wall slightly undermined the slope, demonstrating marginal stability of the existing slope.

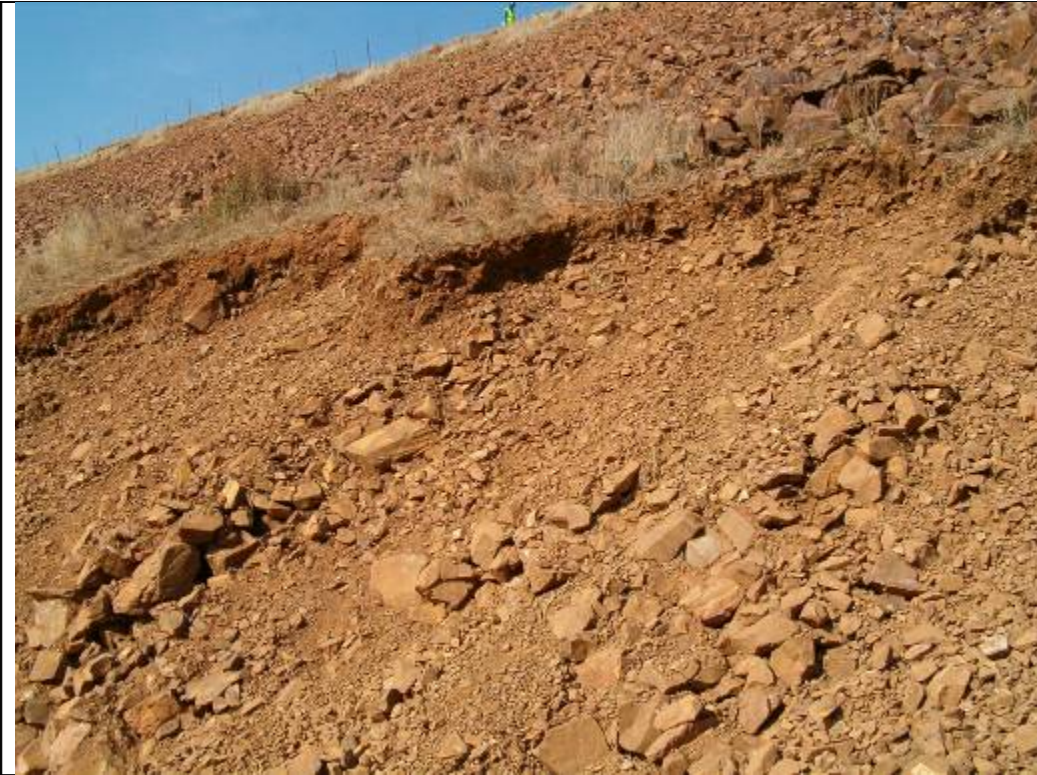
**Rust de Winter Dam**

Another view of downstream slope failure which is on average 1,0 m deep.

The incident occurred during August 2009.

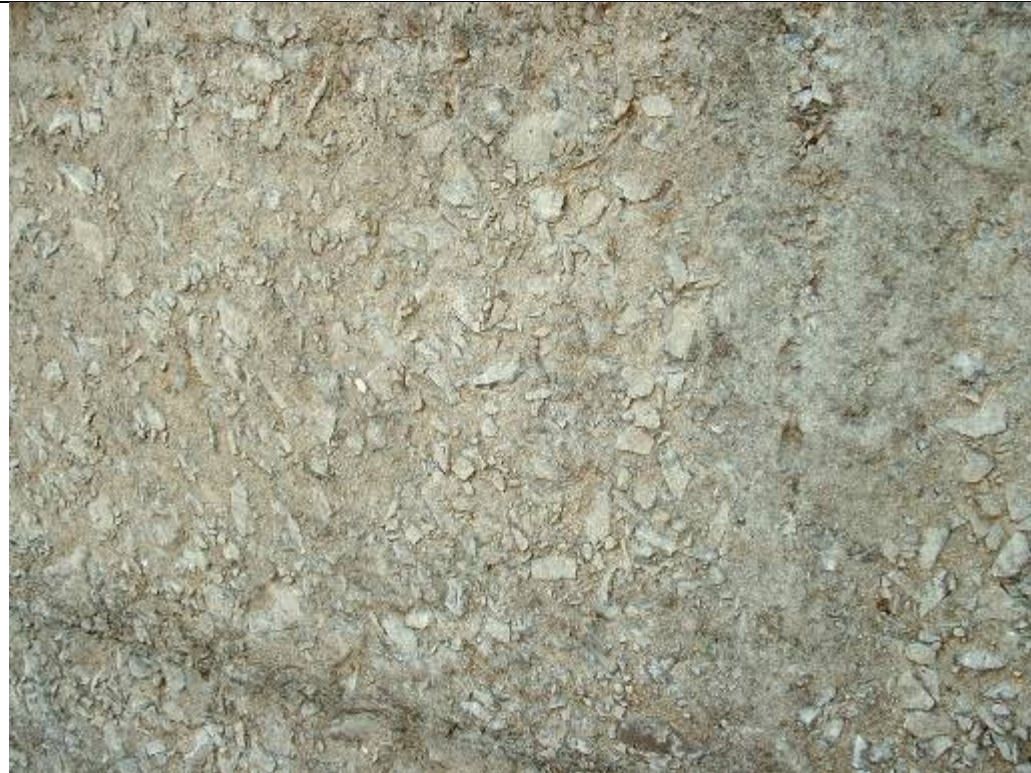
**Witbank Dam near Witbank.**

The water in the dam has a low pH level and a high sulphate level due to extensive opencast coal mining in the catchment of the dam.

The consequence of the poor water quality is significant concrete corrosion with possible corrosion of the steel reinforcement in the buttress heads, which may have an impact on the stability of the dam wall.

0.000							
					0.000							
6B100-04		WITBANK DAM	3	Y						5		
	Spillway		* Investigate and improve (gated spillway)	200	0.394	350	1		177.681		Programmed for...?	
	Structure		Pendulums and cracking should be monitored. Concrete corrosion	1000	0.095	350	1				Programmed for...?	
	Poor O&MM		Improve O&MM	1000	0.095	350	1				Programmed for...?

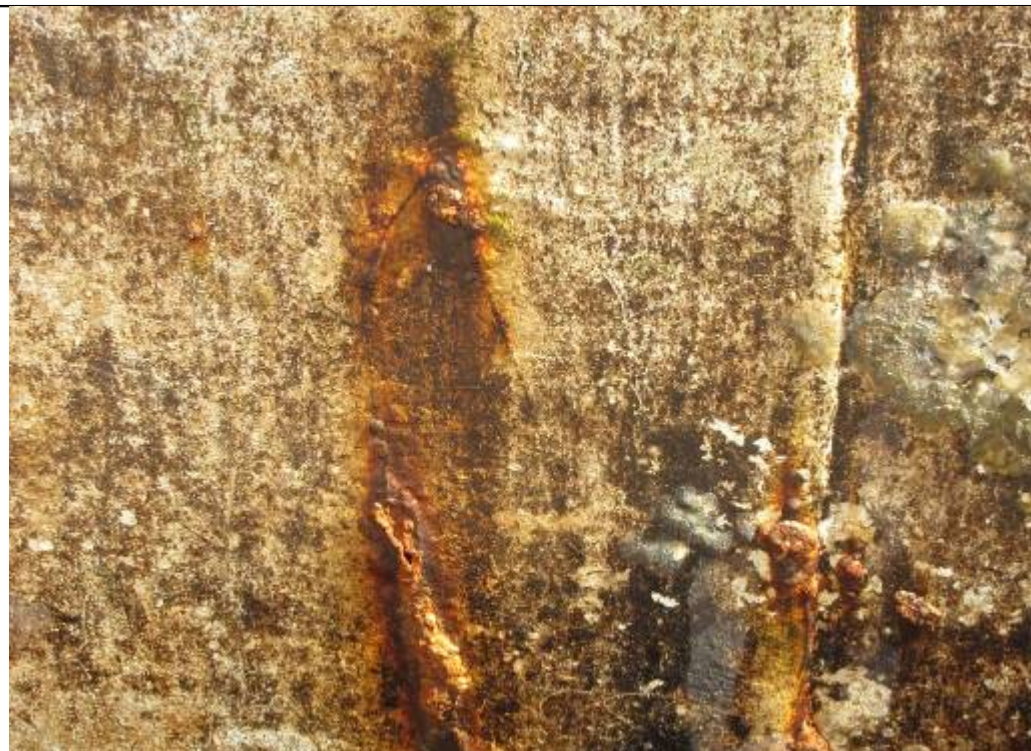
**Witbank Dam near Witbank.**

A further consequence of the poor water quality is significant corrosion of the steel radial gates, raising concerns about the safety of the spillway system. These matters have and are being investigated but it is clear that a long term solution must be found soon.

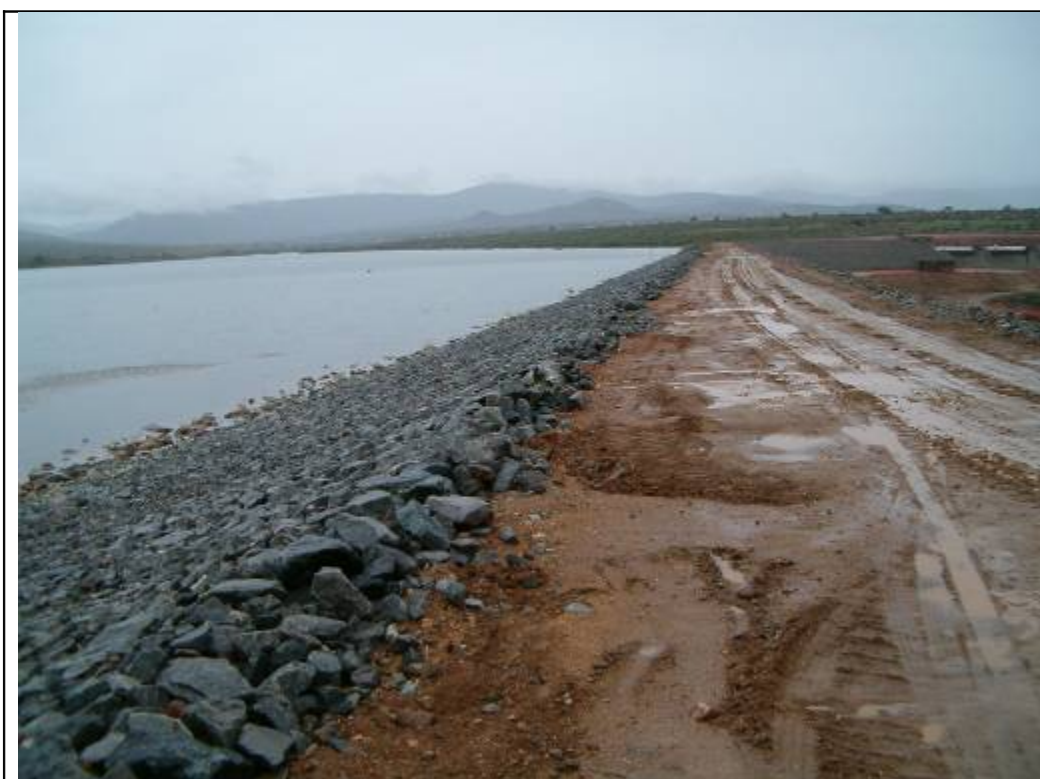
**Molepo Dam near Zion City in Limpopo.**

Major rehabilitation work included raising and stabilising earthfill wall, provision of new spillway and provision of new outlet works. Note new rip-rap on upstream slope as wave protection measure.

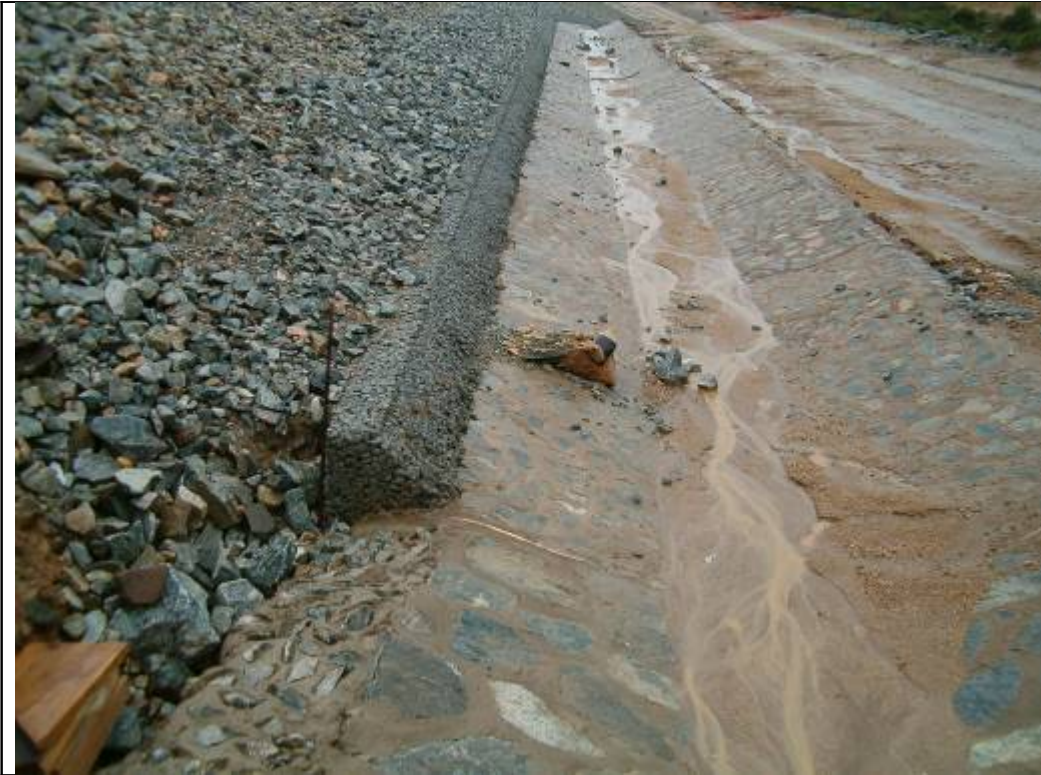
### **Molepo Dam**

New downstream slope protection consists of coarse stone (crusher run). Note small "no fines' concrete" wall on left hand side of storm water drain at down- stream toe of dam wall.

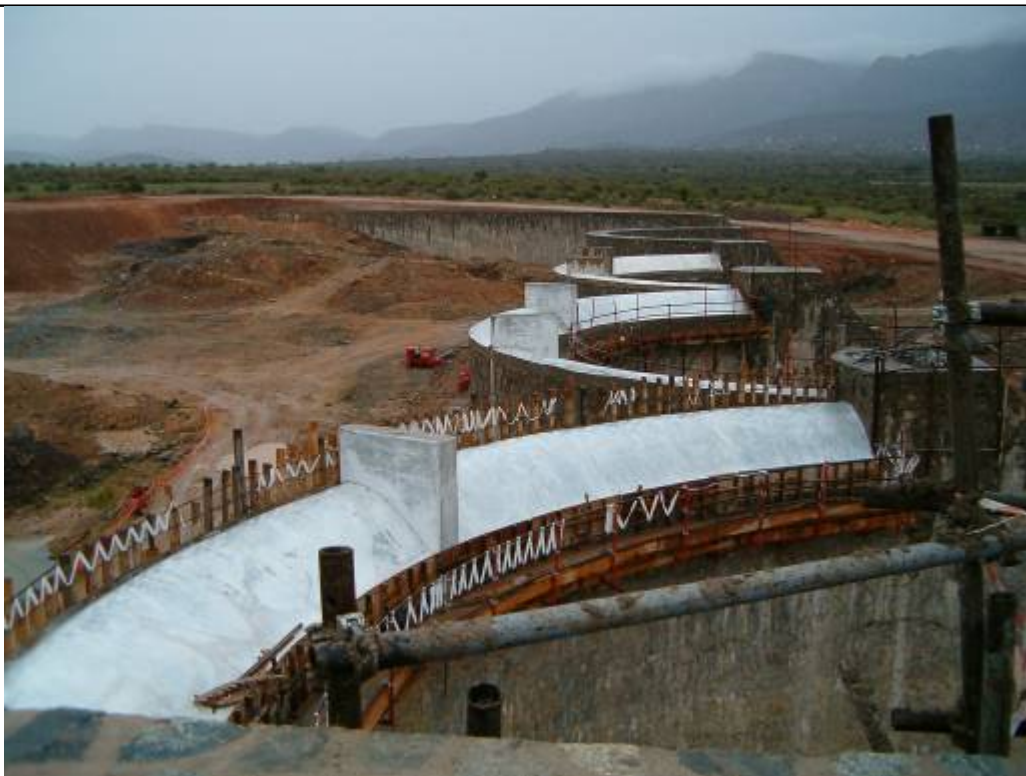
### **Molepo Dam**

The new multi arch "rubble" masonry spillway structure is nearing completion. The "rubble" masonry concrete construction method is labour intensive and a further spin-off is that local people are taught basic masonry skills. The "rubble" was obtained from a quarry by blasting, but it could also consist of natural stone of reasonable size and quality.
