# **FINAL REPORT**

STUDY INTO THE CAUSES OF THE JAGERSFONTEIN FINE TAILINGS STORAGE

**DAM FAILURE ON 11 SEPTEMBER 2022**

Prepared by: University of Pretoria and University of the Witwatersrand

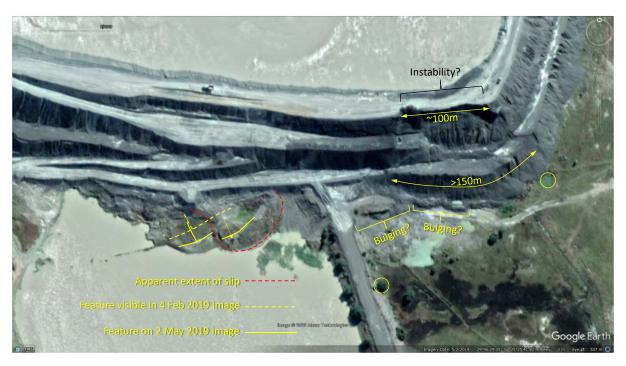
in Figure 5. Measured at the crest, the length of wall affected by apparent instability amounted to approximately 100 m, widening to more than 150 m at the toe. The toe at the south-eastern corner was displaced outwards, bounded to the east and west by what appears to be steps or cracks, giving rise to apparent elevation differences between the affected area and the adjacent part of the slopes not affected by the movement. Signs of bulging were evident at the toe of the wall in this area. In addition, a linear feature identified on the 4 February 2019 image appears to have undergone substantial non-uniform displacement by 2 May 2019 as indicated in Figure 5.

FIGURE 5 SOUTH-EASTERN CORNER OF THE JAGERSFONTEIN TAILINGS DAM FROM THE 2 MAY 2019 GOOGLE EARTH IMAGE SHOWING SIGNS OF INSTABILITY.

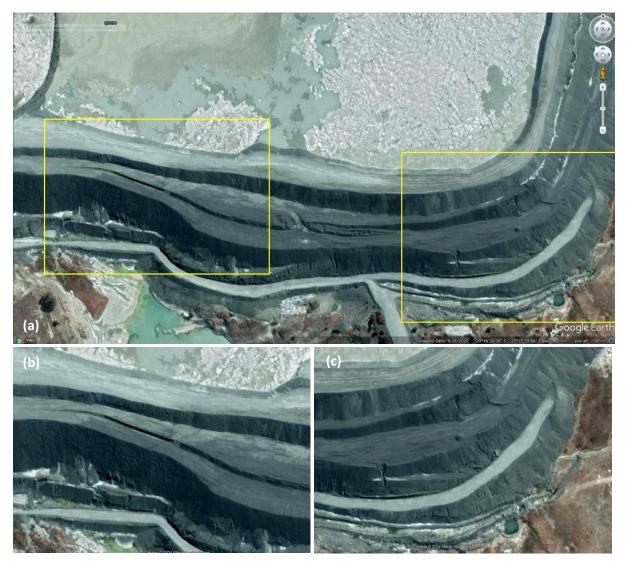
The eastern feature seems to be accompanied with a step across the middle berm and upper slope of the tailings dam, suggesting subsidence of the wall to the west of the feature. What appears to be the same feature can also be seen in the GoogleEarth image of 2 May 2019 (Figure B12). It seems that the feature formed the eastern boundary of the previously discussed instability that affected the south-eastern corner of the tailings dam (as discussed previously).

FIGURE 7 (A) CRACKS VISIBLE ON THE SOUTHERN WALL FROM THE GOOGLE EARTH SATELLITE IMAGE DATED 2020/9/24; (B) WESTERN CRACK ENLARGED; (C) AND EASTERN CRACK ENLARGED.

The western feature seemed to be less severe but is also indicative of movement within the dam wall. Figure B17 was captured by the WorldView2 satellite which has a resolution of approximately 50 cm. Accordingly, it is estimate that the cracks must have had a thickness of at least half a pixel (i.e. 25 cm) to be clearly detectable.

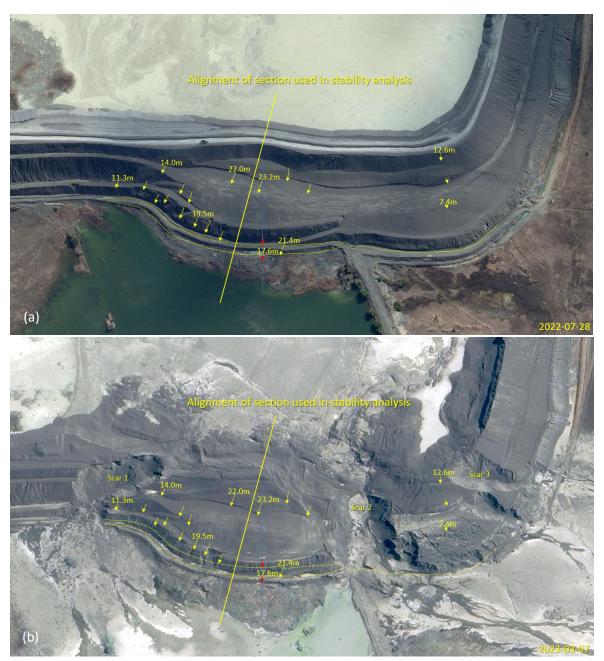
Figure 9a shows the last pre-failure satellite image from 28 July 2022 and highlights points that are also identifiable in a post-failure satellite image from 7 March 2023 which is shown in Figure 8b. Tracking these points enabled the estimation of the displacement vectors shown in Figure 8b. The reason for not using an earlier post-failure image of September 2022 (Figures B23 and B24) is that their resolution was not as good as that of the March 2023 image. This reduced resolution made identification of features difficult. Additionally, there was uncertainty regarding the digital elevation model used for the orthorectification of the image from 24 September 2022. Vector lengths are indicated in some cases. These lengths are approximate due to inaccuracies associated with scaling and orthorectification of the images. Additionally, since the post-failure image (Figure 8b) was captured on March 2023, and not immediately after the failure, the vectors may overestimate the real displacement if post-failure movement took place before March 2023. Indeed, a somewhat smaller movement of approximately 14 m is suggested by pre- and post-survey data (see Section 6.7).

Also shown in Figure 8 is the alignment (in plan) of the cross-section profile that was studied in the stability assessment that follows in Section 7.2. The cross-section was chosen to be parallel to the predominant direction of the displacement vectors and to pass approximately through the centre of the block that displaced towards the south-southwest during the failure.

FIGURE 8 DISPLACEMENT VECTORS ASSOCIATED WITH THE FAILURE EVENT AND THE ALIGNMENT FOR THE CRITICAL CROSS-SECTION STUDIED FOR STABILITY ASSESSMENT SHOWING (A) THE LATEST AVAILABLE PRE-FAILURE HIGH RESOLUTION SATELLITE IMAGE AND (B) THE EARLIEST AVAILABLE POST-FAILURE HIGH RESOLUTION IMAGE.

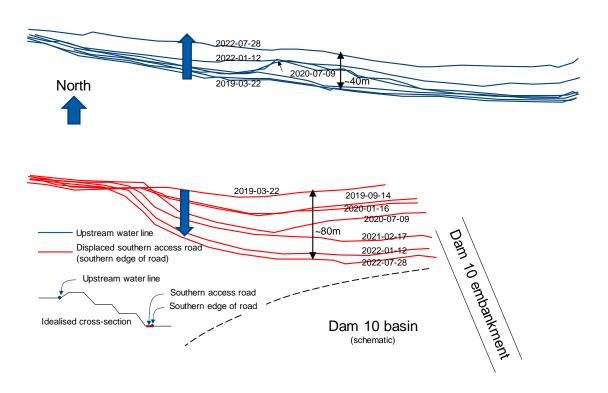
FIGURE 9 EVOLUTION OF UPSTREAM WATER LINE AND ROAD'S EDGE AT SOUTHERN TOE AT BREACH LOCATION FROM FEBRUARY 2019 TO JULY 2022 SEEN IN PLAN.

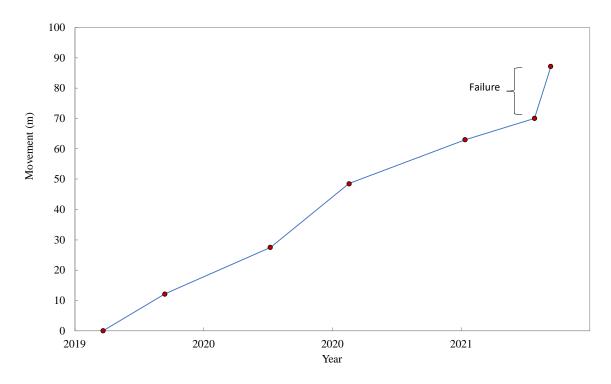
FIGURE 13 DISPLACEMENT WITH TIME OF THE FEATURE TRACKED IN FIGURE 12 (RECORDED FROM 22 MARCH 2019).

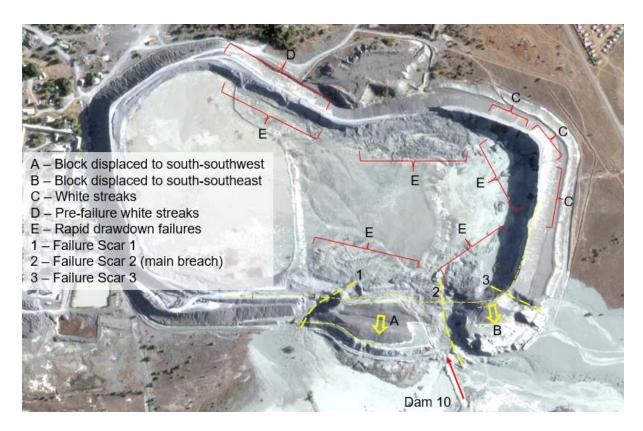
FIGURE 34 FEATURES ASSOCIATED WITH THE FAILURE EVENT. IMAGE FROM 12 SEPTEMBER 2022.

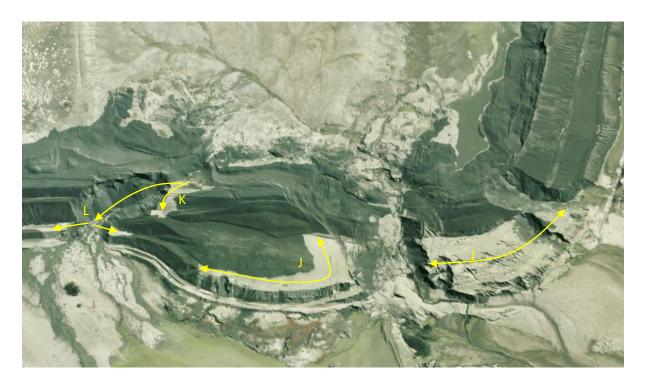
FIGURE 35 ENLARGED IMAGE FROM THE FAILURE AREA SHOWING AREAS REACHED BY OVERTOPPING FINE TAILINGS (IMAGE FROM 24 SEPTEMBER 2022).

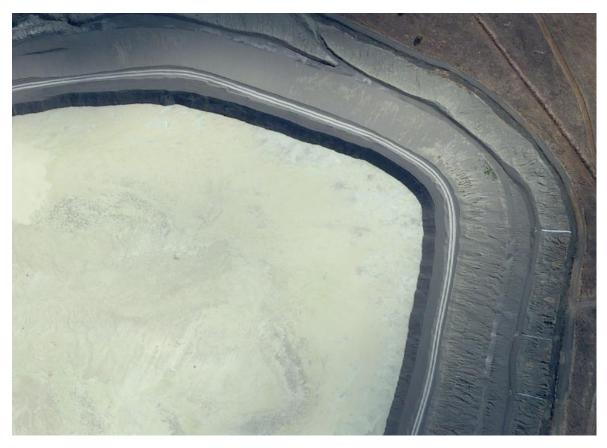
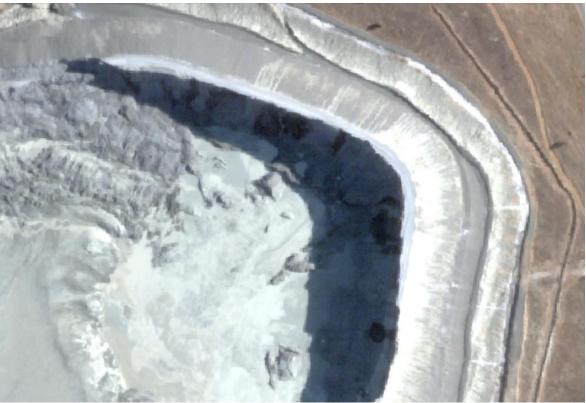
FIGURE 36 THE NORTH-EASTERN PART OF THE TAILINGS DAM BEFORE AND AFTER FAILURE (26 JULY 2022 AND 12 SEPT 2022 RESPECTIVELY). THE WHITE STREAKS ON THE NORTHERN AND EASTERN SLOPES VISIBLE ON THE POST-FAILURE IMAGE SUGGEST THAT LIMITED OVERTOPPING MAY HAVE OCCURRED AT THESE LOCATIONS.

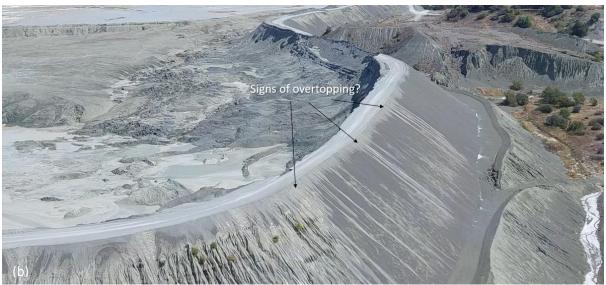
FIGURE 37 IMAGES FROM CELL PHONE FOOTAGE TAKING DURING HELICOPTER INSPECTION ON 12 SEPTEMBER 2022 SHOWING POSSIBLE SIGNS OF LIMITED OVERTOPPING NEAR NORTH-EASTERN CORNER OF DAM (SOURCE: MR A HAVENGA AND/OR MR WM RAMOKOPA).

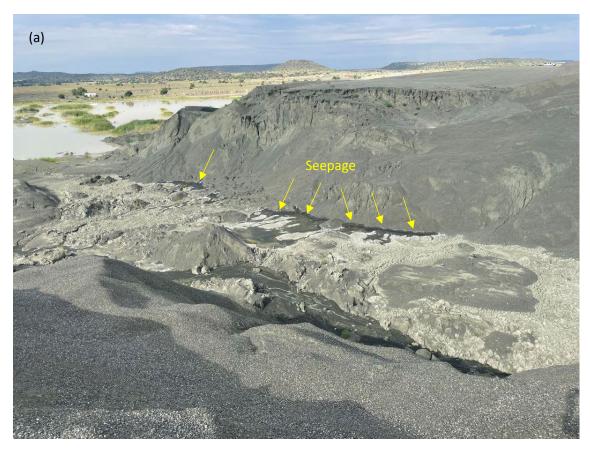
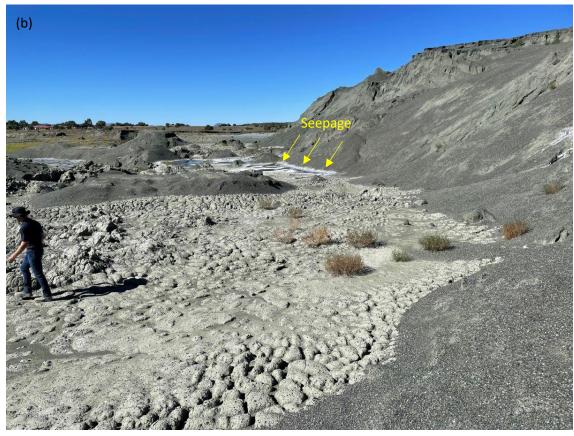
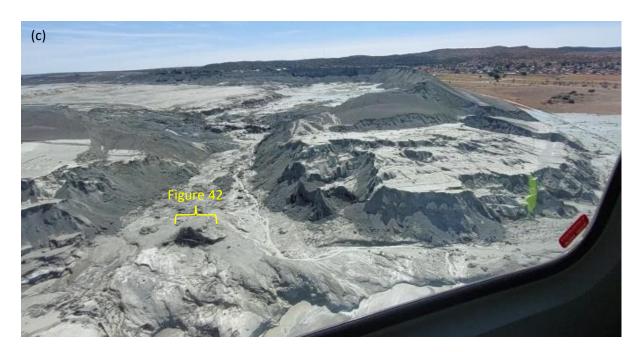
FIGURE 41 THE BREACH FLOOR COMPRISES A LAYER OF CONSOLIDATED TAILINGS THAT RESISTED EROSION DURING THE FAILURE. (A) LOOKING DOWN TOWARDS THE BREACH FROM THE EASTERN SIDE OF THE BREACH. (B) LOOKING SOUTH ALONG THE WESTERN SIDE OF THE BREACH. (C) TAKEN FROM HELICOPTER ON 12 SEPTEMBER 2022 SHOWING EMBANKMENT UNDERLAIN BY CONSOLIDATED TAILINGS.

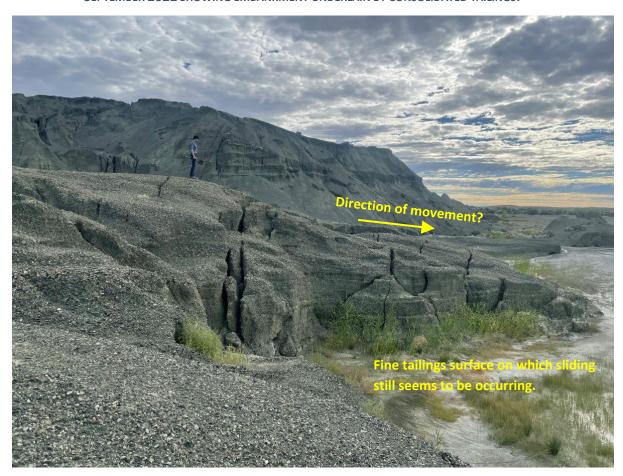
FIGURE 42 GRANULAR MATERIAL THAT REMAINED IN THE BREACH STILL SHOWING SIGNS OF MOVEMENT ON THE UNDERLYING LAYER OF TAILINGS. (LOCATION INDICATED IN FIGURE 41 ABOVE).

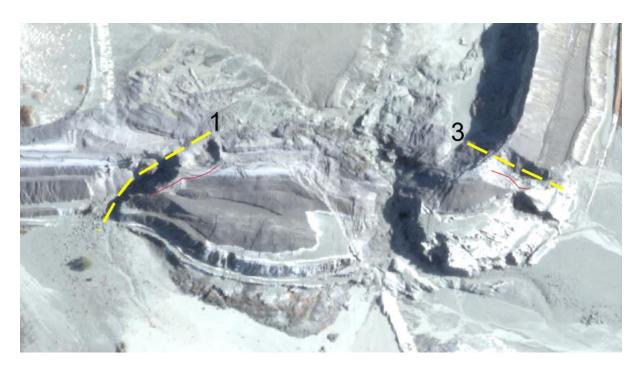
FIGURE 45 THE LOCATION OF CRACKS (IN RED) OBSERVED ON THE 24 SEPT 2020 SATELLITE IMAGE, SUPERIMPOSED ON THE FAILED SOUTHERN EMBANKMENT, SHOWS CLOSE CORRELATION WITH EROSION SCARS 1 & 3.

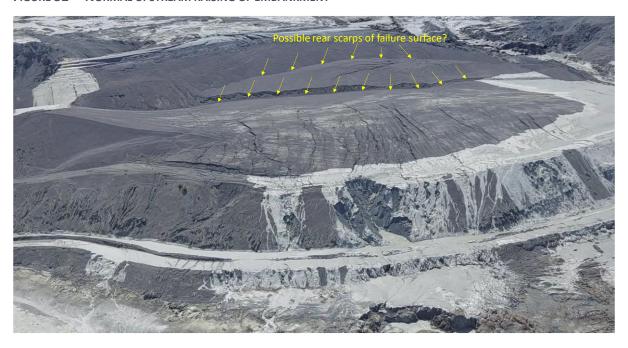
FIGURE 53 CANDIDATE REAR SCARP OF FAILURE SURFACE BEFORE 11 SEPT 2022 EVENT (SOURCE: MR A HAVENGA AND/OR MR WM RAMOKOPA).

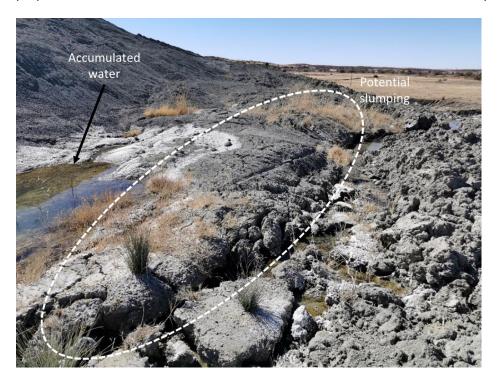
FIGURE 2 WET CONDITIONS AND SLUMPING ALONG THE TOE OF THE DAM WALL TO THE EAST OF DAM 10.

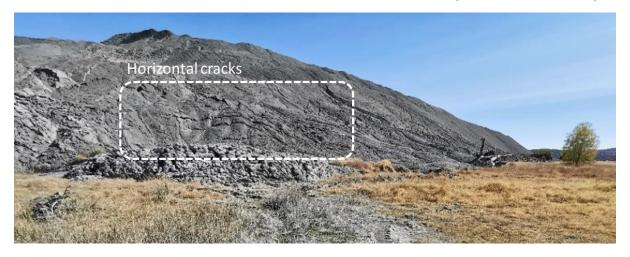
FIGURE 3 WET CONDITIONS ALONG THE SOUTH-EASTERN TOE OF THE DAM WALL. NOTE HORIZONTAL CRACKS VISIBLE ALONG EMBANKMENT SLOPE, POSSIBLY INDICATIVE OF MOVEMENT. (DATED 28 AUGUST 2019.)

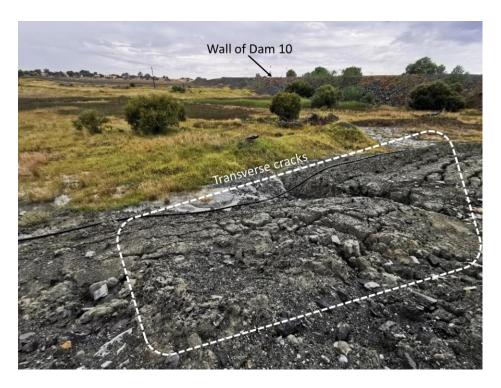
FIGURE 4 TRANSVERSE CRACKS ON SOUTHERN WALL INDICATIVE OF MOVEMENT PERPENDICULAR TO CRACK DIRECTION. (DATED 21 APRIL 2020.)

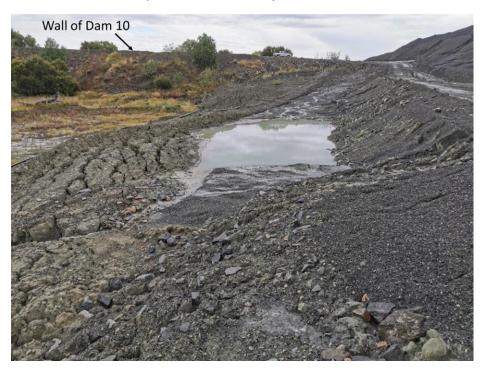
FIGURE 5 ALTERNATIVE VIEW OF LOCATION SHOWN IN FIGURE 4, WITH CRACKS VISIBLE TO THE LEFT AND ACCUMULATED WATER VISIBLE NEAR THE CENTRE. (DATED 21 APRIL 2020.)

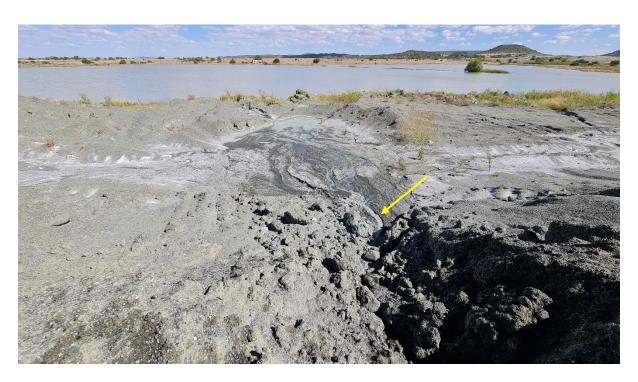
FIGURE 6 TURBID SEEPAGE WATER EMERGING FROM THE TOE OF THE TAILINGS DAM OPPOSITE DAM 10. (DATED 28 MARCH 2022.)

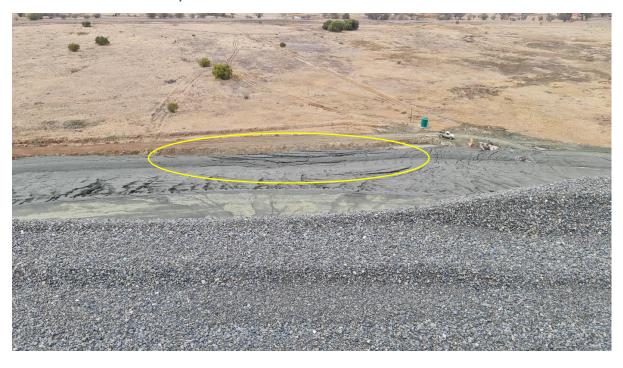
FIGURE 7 CIRCLED AREA HIGHLIGHTING TRANSVERSE CRACKS ON THE SOUTH-EASTERN WALL WHICH MAY BE INDICATIVE OF SUBSIDENCE TOWARDS THE DOWNSTREAM TOE OF THE DAM WALL. THE CIRCLED AREA COINCIDES WITH FAILURE SCAR 3. COMPARE TO SATELLITE IMAGE B23. (DATED 27 JULY 2022.)

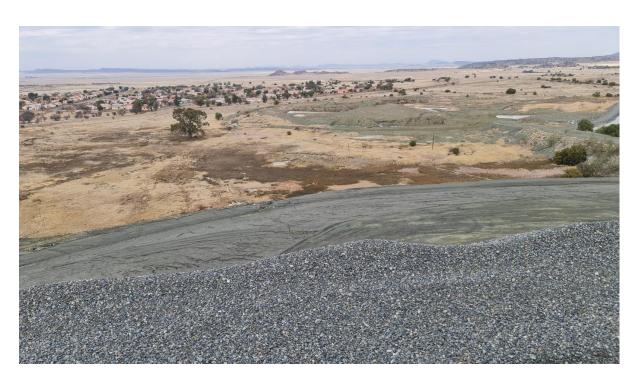
FIGURE 8 SIMILAR VIEW TO FIGURE 6 WITH THE DAM 10 EMBANKMENT VISIBLE ON THE RIGHT, INDICATING CRACKS VISIBLE IN THE BUTTRESS ALONG THE SOUTH-EASTERN CORNER OF THE TAILINGS DAM WALL. (DATED 27 JULY 2022.)

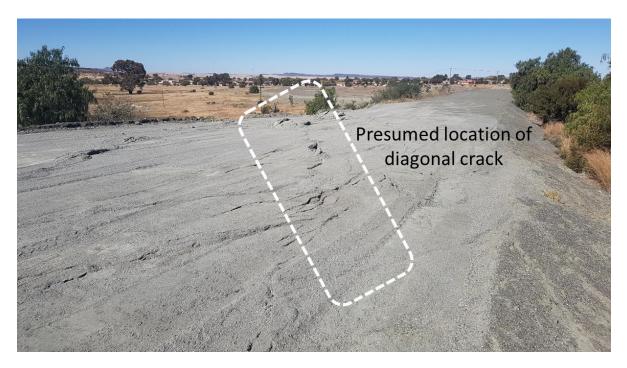
FIGURE 9 VIEW ALONG THE DIRECTION OF CRACKS WHICH APPEARED WHERE THE DAM 10 EMBANKMENT ABUTS THE SOUTHERN WALL OF THE TAILINGS DAM. (DATED 1 JUNE 2020.)

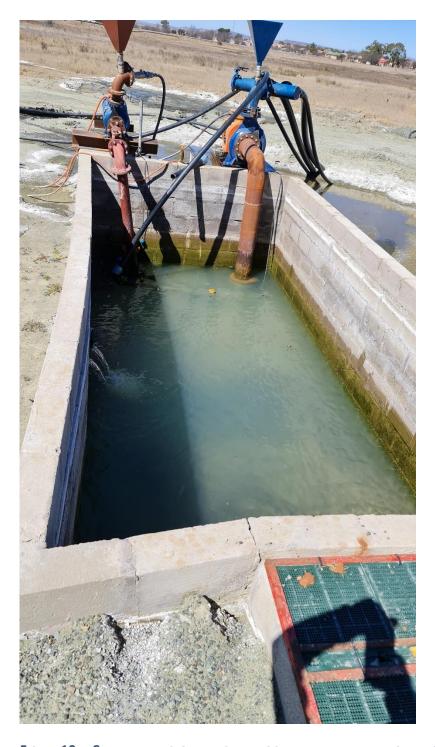
FIGURE 10 CURVED WALLS OF THE SUMP LOCATED IMMEDIATELY TO THE SOUTHEAST OF THE TAILINGS DAM. (DATED 30 AUGUST 2022.)

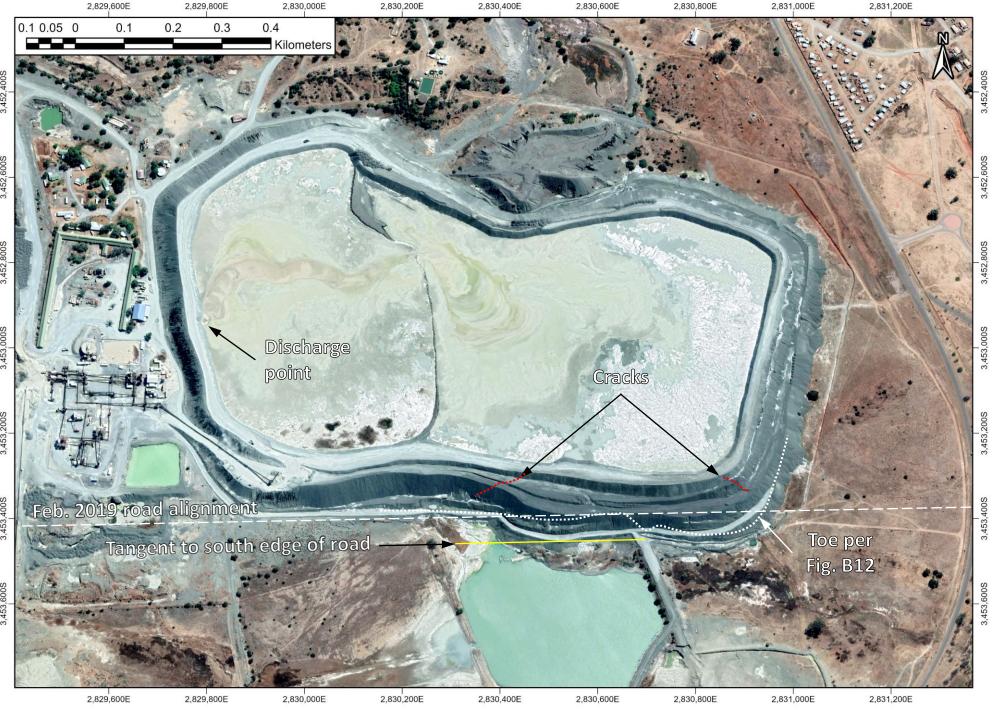
Two high resolution GoogleEarth images, taken approximately a month apart, respectively dated 20 August 2020 (Figure B16) and 24 September 2020 (Figure B17), are available within the above-mentioned period. Again, when comparing against the previous GoogleEarth image of May 2019 (Figure B12), substantial movement of the toe of the southern wall of Compartment 2 into Dam 10 is evident, resulting in increasing curvature in the alignment of the southern access road. Examination of the southern wall of Compartment 2 in the September 2020 (Figure B17) image reveals two features resembling cracks. These features are indicated in Figure B17 by red lines. Enlargements of the cracks are presented in Figure 7.

**Figure B17:** 2020-09-24 WorldView 2 satellite image highlighting the separation between the February 2019 (Figure B10) and the current location of the southern edge of the southern access road. Cracks visible in the southern wall are also indicated. Note: Cracks can be better appreciated by viewing the image in Google Earth Pro.

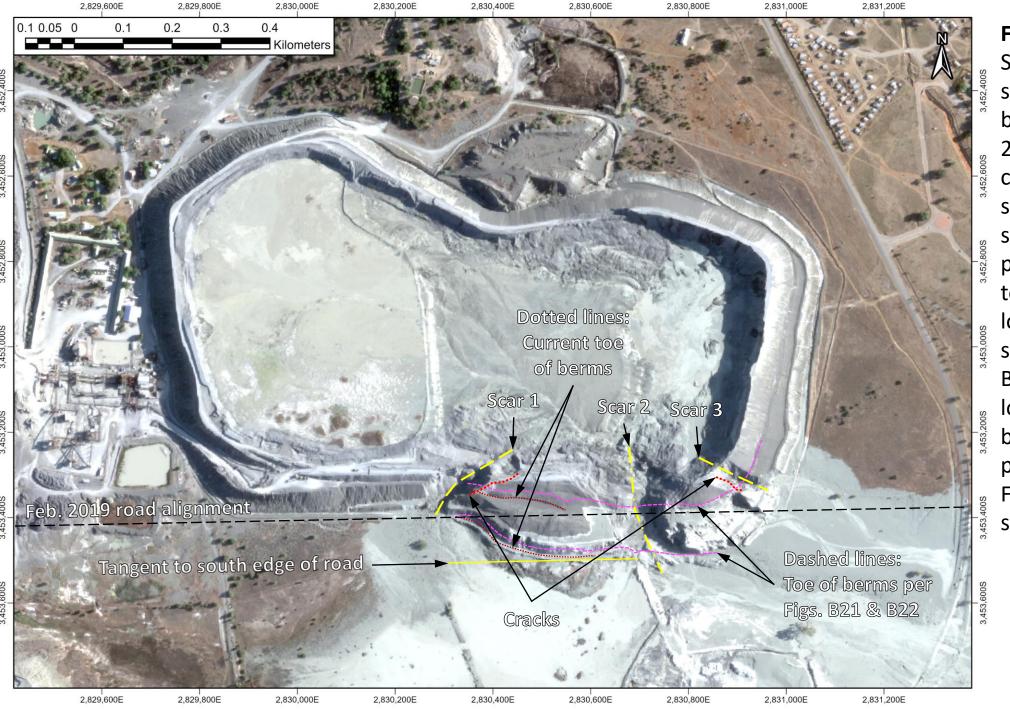
Figure B23 presents a satellite image captured on the morning of 12 September 2022, the day after the failure. The image shows essentially three major failure scars, i.e. the largest scar where the tailings dam breached opposite the Dam 10 embankment (Scar 2), as well as an eastern (Scar 3) and western scar (Scar 1) consistent with the locations where cracks were observed in the September 2020 Google Earth image (indicated in red). It is noted that Scar 1 exits the dam at the location where longterm seepage was mentioned to have been occurring by Robinson (2015) since shortly after commissioning of Compartment 1 (discussed in the overview of the March 2016 image). Comparing the post-failure to the last pre-failure images indicates that the part of the embankment bounded by the main failure and the western scar (Scar 1) displaced largely intact by approximately 19 m (scaled from image) to the south-southwest (at, on average, approximately 22° west of south). Similar movement, but of a lesser extent, is evident for the part of the wall between the main failure and the eastern scar (Scar 3). The failure resulted in the uncontrolled discharge of virtually all tailings slurry and water in Compartment 2 that were deposited after 2010, i.e., tailings that were not part of the De Beers dam. Additionally, the tailings slurry in Compartment 1 lying above the crest of the partition wall between Compartments 1 and 2 were also discharged. The partition wall between the compartments remained largely intact. The discharge of tailing resulted in the old De Beers Dam becoming exposed. Figures B24 to B25 show additional post-failure high-resolution satellite images captured in September 2022 and March 2023 respectively.

**Figure B23:** 2022-09-12 SkySat satellite image showing: the separation between the February 2019 (Figure B10) and the current location of the southern edge of the southern access road; the pre-failure location of the toe of the upper and lower berms on the southern wall per Figures B21 & B22; current location of the toe of the berms; the location of the pre-failure cracks per Figure B17; and the three scar locations.

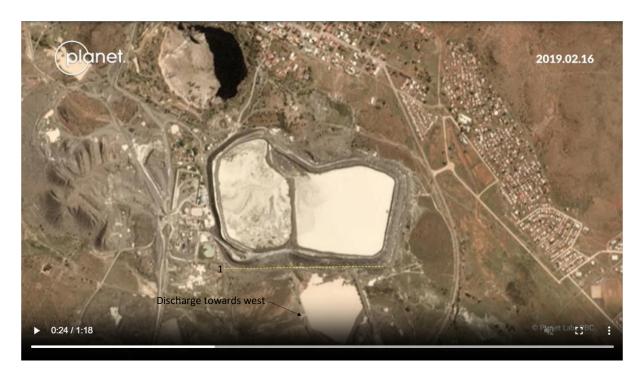
FIGURE 2 PLANETSCOPE SATELLITE IMAGES TAKEN ON 2019/02/16 SHOWING WATER DISCHARGING FROM DAM 10, UPSTREAM TOWARDS THE WEST, SUGGESTION THAT WATER IN DAM IS DID NOT ORIGINATE FROM NATURAL RUN-OFF.

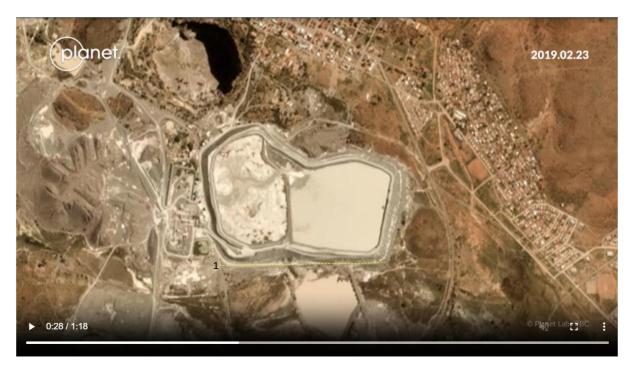
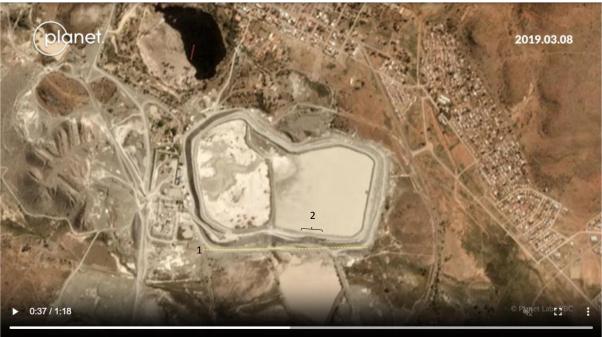
FIGURE 3 PLANETSCOPE SATELLITE IMAGES TAKEN ON 2019/02/23 AND 2022/03/08 SHOWING SIGNS OF SLOPE INSTABILITY ALONG THE SOUTHERN WALL OF COMPARTMENT 2.

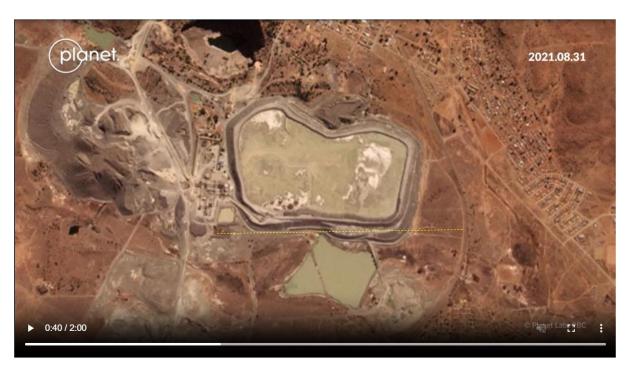
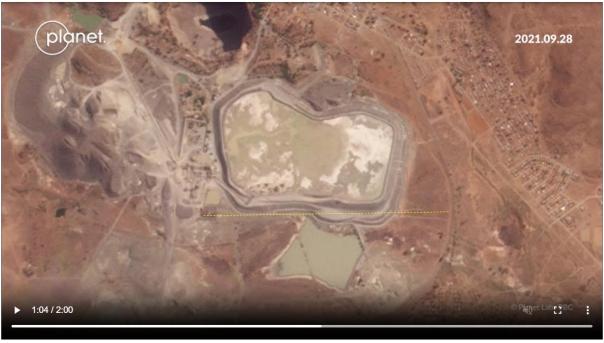
FIGURE 13 PLANETSCOPE IMAGING DATED (A) 2021/08/31 AND (B) 2021/09/28 SHOWING SIGNIFICANT ADDITIONAL DEFORMATION ALONG SOUTHERN AND SOUTHEASTERN TOE OF COMPARTMENT 2.

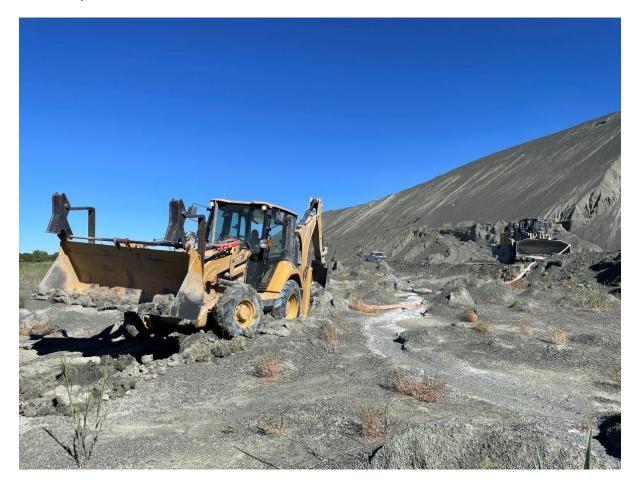
FIGURE 1 WATER LOGGED CONDITIONS ALONG THE SOUTHERN TOE PREVENTED ACCESS BEYOND THE ACCESS ROAD.
