## Introduction

Wastewater services delivery is performed by twelve (12) Water Services Authorities in Gauteng via an infrastructure network comprising of 56 wastewater collector and treatment systems.

## Provincial Green Drop Analysis

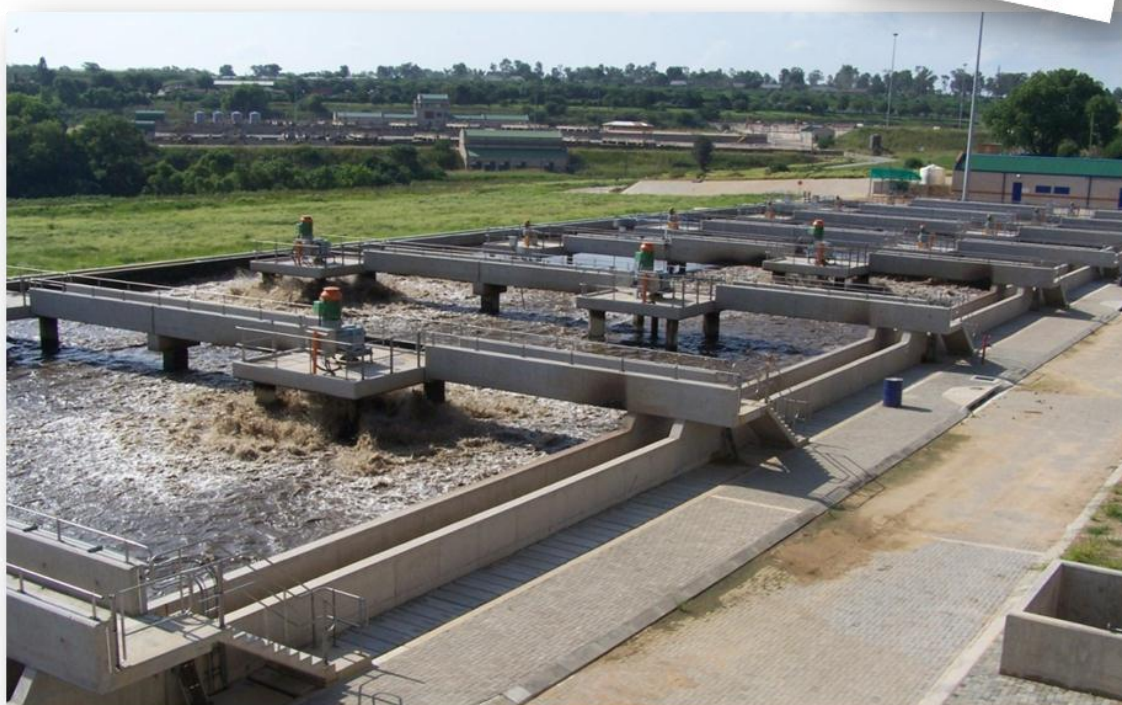
*Johannesburg Northern Works – achieving excellent biological phosphate removal and revert to chemical dosing as a secondary measure.*

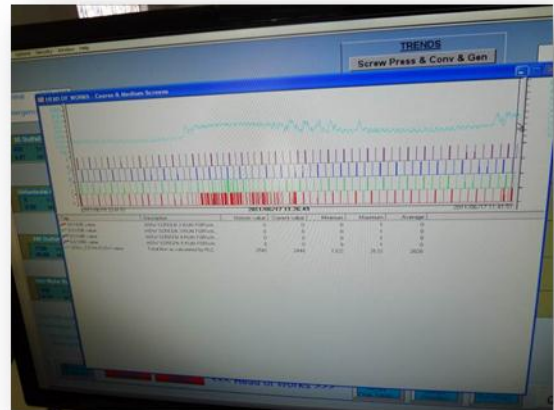
Top: Use of SCADA to operate and manage plant, use to store records and draw trends

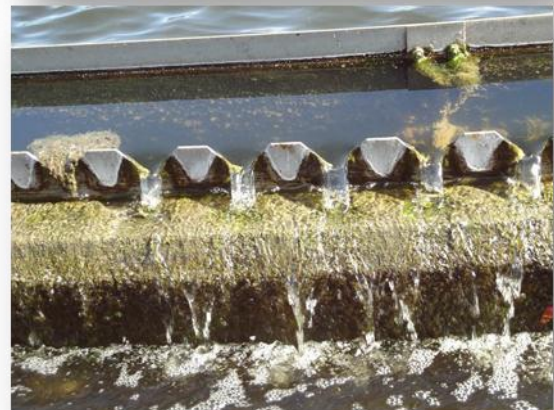
Below: Clear effluent from secondary clarifiers

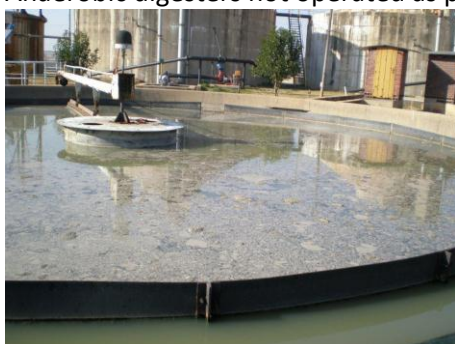
- MLSS, DO concentrations not optimal, now WAS recycle, nutrient and loading parameters not in spec
- Poor sludge settling in clarifiers and poor effluent quality, probably as result of unfavourable operational conditions in ASP

Left: sludge carry over at the sludge settling tanks; Right: ponds filled to capacity at the Rooiwal plant

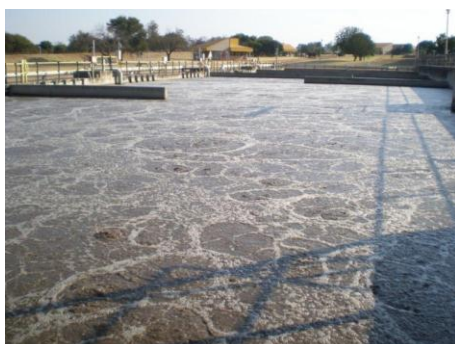
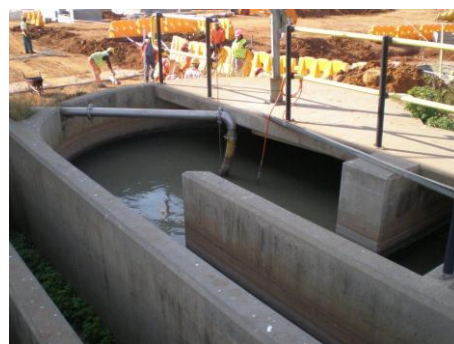
Left: well maintained fine bubble aeration; Right: construction ongoing at the Zekoegat plant

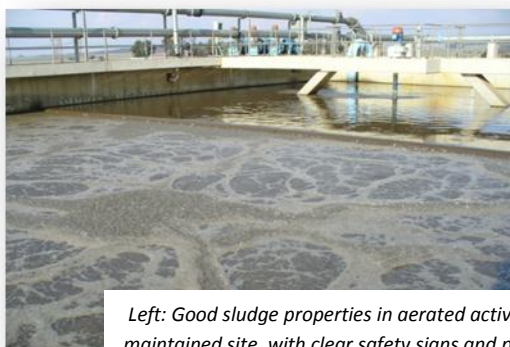
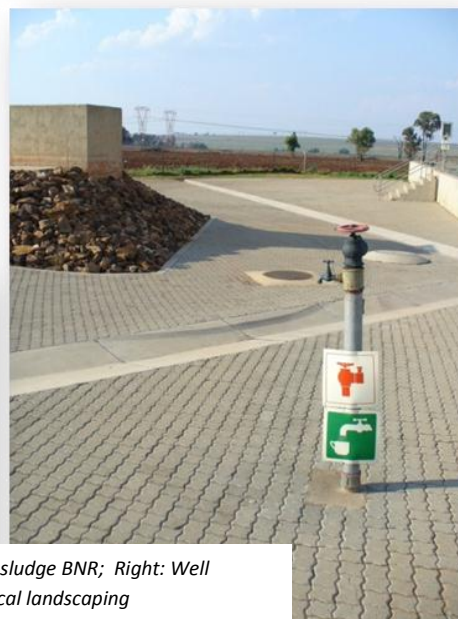
Left: Good sludge properties in aerated activated sludge BNR; Right: Well maintained site, with clear safety signs and practical landscaping

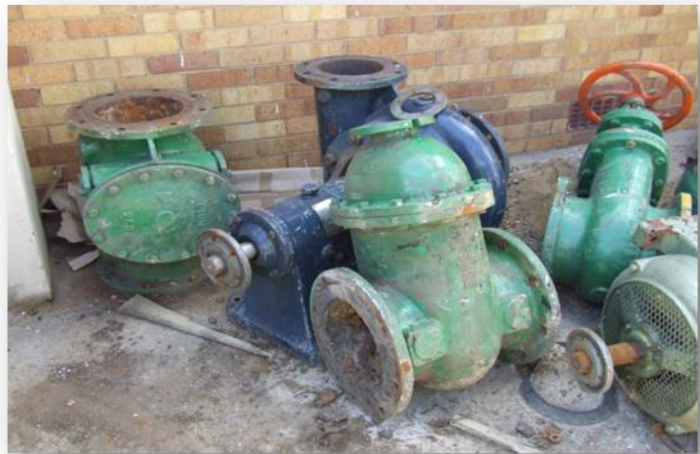
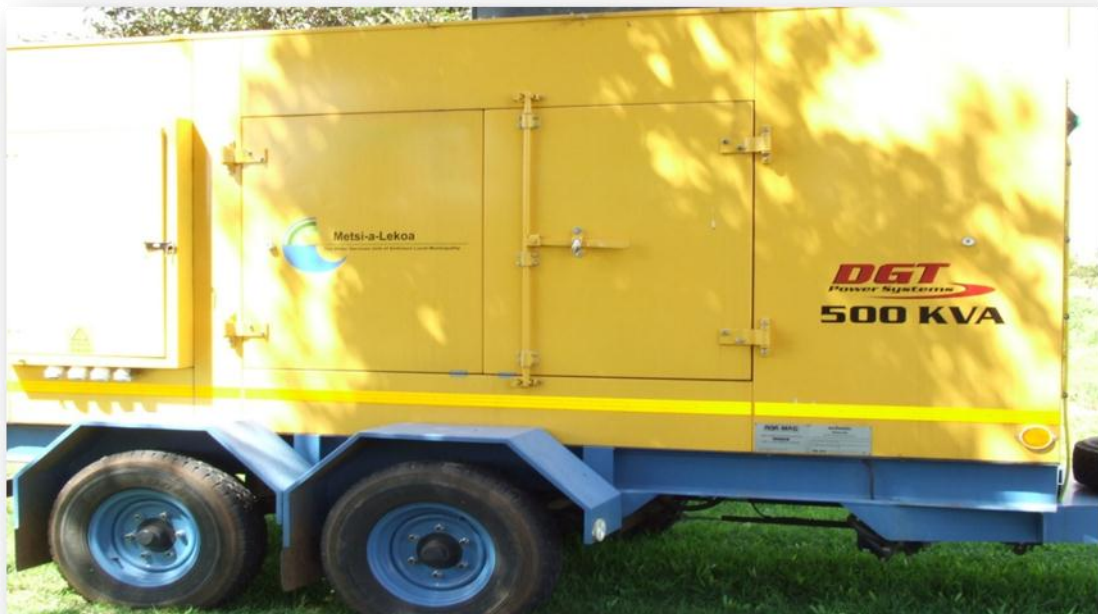
*Right: Dated 1955 equipment being replaced,  
after service of 44 years*

*Below: stand-by generator to support critical unit  
functions during power outages*

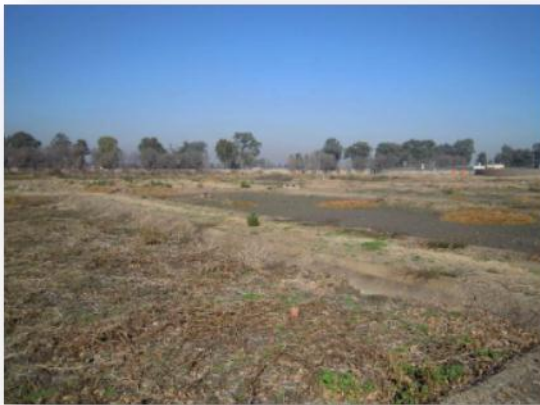
- Classification status is not displayed, but manuals and procedures available
- Screens at inlet works recently refurbished and operational, but fine screen not operational
- Two of 4 PSTs not operational as sludge draw off pipes are blocked
- All 11 biofilters functional, good distribution
- Two of 6 humus tanks blocked and not operational
- Civil, electrical and mechanical components of activated sludge in good condition, design flaws being addressed
- Secondary clarifiers overloaded and functional to full capacity
- Disinfection is taking place and adequate stock in place
- Anaerobic digesters operational but area surrounding unkept
- Sludge drying beds unkept and poorly maintained

Left: unmaintained sludge drying beds; Right: scum formation on the secondary clarifiers under overload conditions

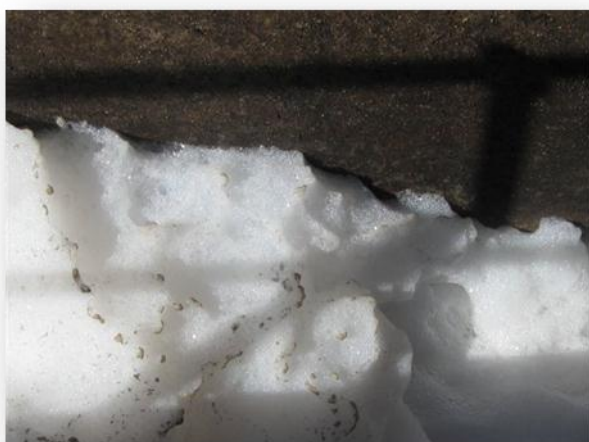
*Absence of activated sludge and incorrect F:M ratios resulting in foam conditions*

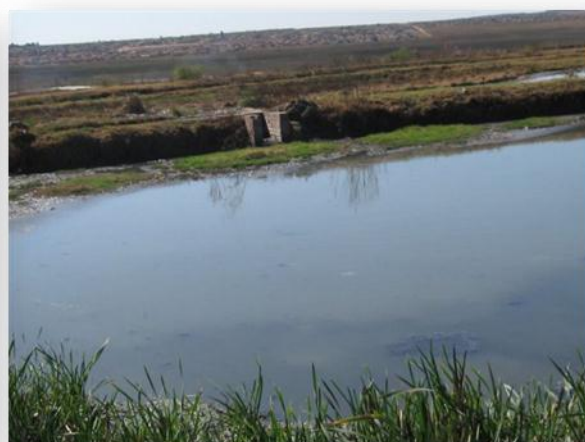
*Sludge accumulation in the pond system, highly overloaded*

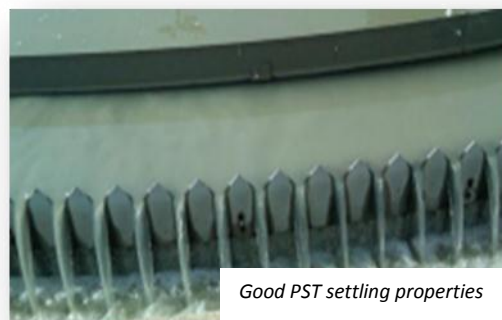
*Good PST settling properties*

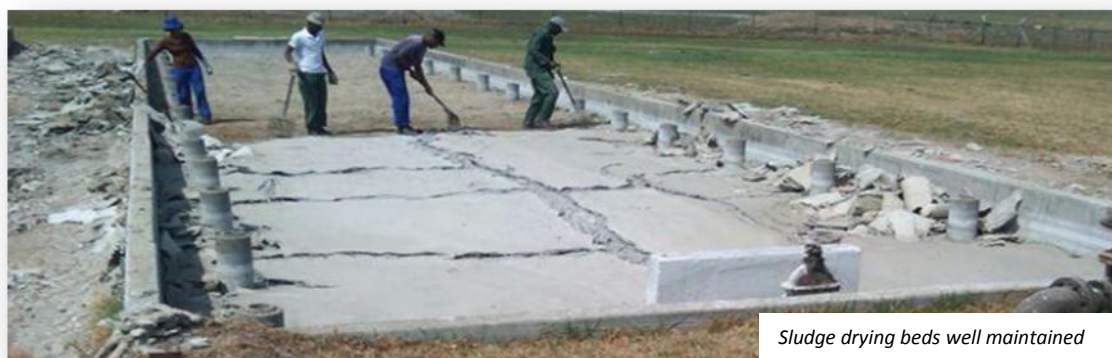
*Sludge drying beds well maintained*

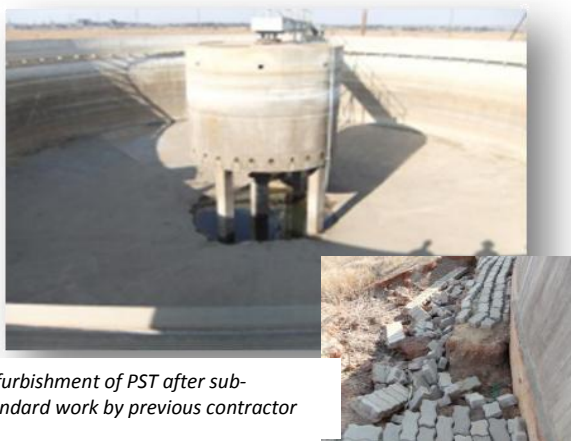
*Refurbishment of PST after sub-standard work by previous contractor*

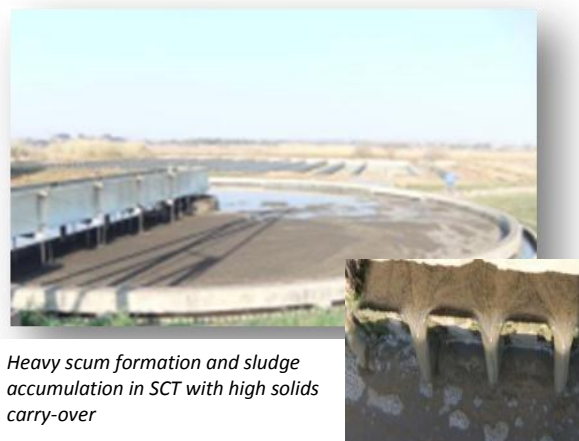
*Heavy scum formation and sludge accumulation in SCT with high solids carry-over*

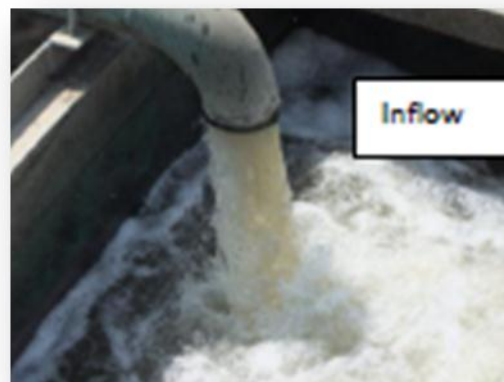
*Diluted low COD inflow to plant*

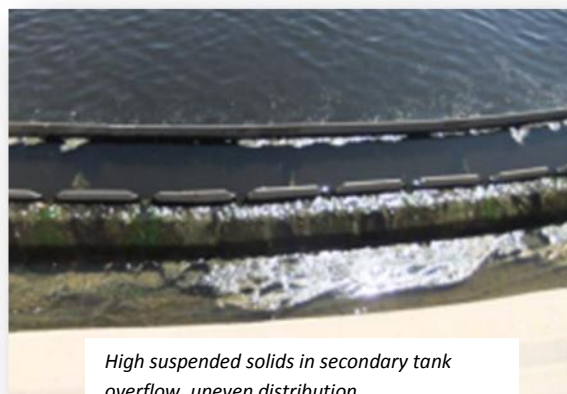
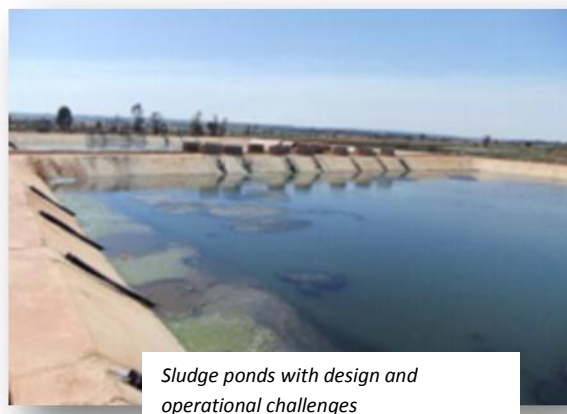
- Secondary clarification functional but sludge carryover, especially where short circuiting and algae growth not removed
- Poor disinfection control, high suspended solids increase the chlorine demand unnecessarily

- Poor sludge handling although facilities are available in terms of drying beds and line pond systems
- Maturation ponds reported to have plunged with sinkhole formation. Contingency measures for such critical hazards and risks must be put in place as part of the municipality’s Risk Abatement Plan.
