## Introduction

## Provincial Green Drop Analysis

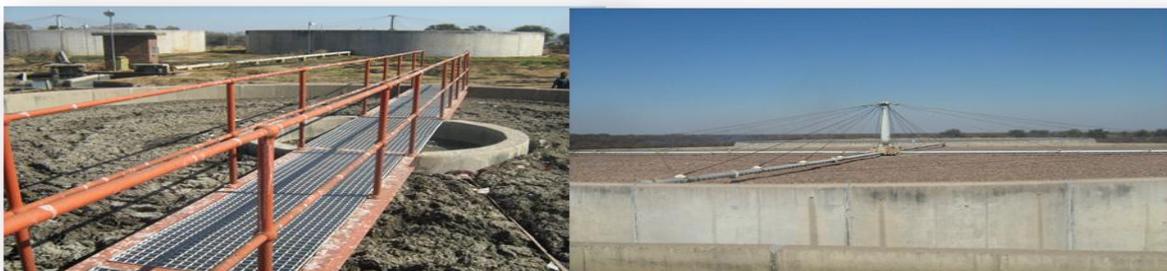
- Three biofilters in place: 1<sup>st</sup> biofilter has been recently constructed, but has never worked; 2<sup>nd</sup> biofilter is not operating effectively; 3<sup>rd</sup> is not operating due to the broken motor which pumps effluent to the division box to the biofilter. Subsequently, all flow is diverted to one biofilter, resulting in an overloaded filter with poor effluent quality

- In addition, the biofilters' civil structure are not good and not well maintained - severe cracks
- Four humus tanks are functional but not producing good quality effluent

*Unmaintained state of primary settling tanks (left) and dysfunctional (newly constructed) biofilter (right) - result in substandard effluent quality being discharged to the receiving environment*

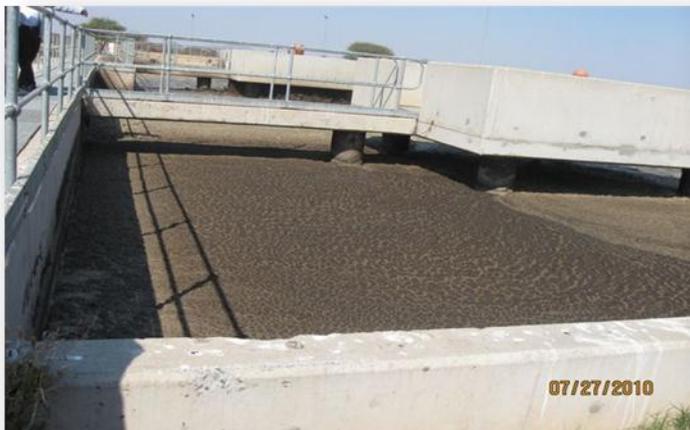
- The terrain is in a reasonable condition with grass burnt, clean buildings, organised supervisor office and adequate visitor's access control
- No maintenance records and limited operational recording in place
- Samples are send to Polokwane Laboratory, but operational equipment has been acquired for the upgraded plant and existing practice is said to improve in future
- The assessors found the supervisor to have a fare knowledgeable on the process and plant
- However, limited process control takes place on the activated sludge plant – attempts are made to maintain the sludge age at 30 days via daily sludge wasting
- Sludge drying beds are not properly maintained, and sludge are not classified
- Plant is overloaded, and upgrade to 6 MI/day ASP is planned.

*Inadequate process control, with severe scum formation and short circuiting in the anaerobic basin of the activated sludge reactor*

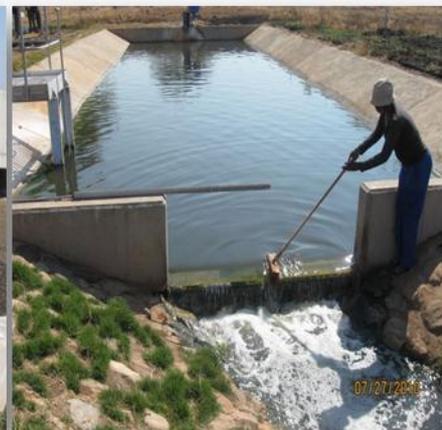
*Disinfection taking place - final effluent channels are clean and clear of solids*

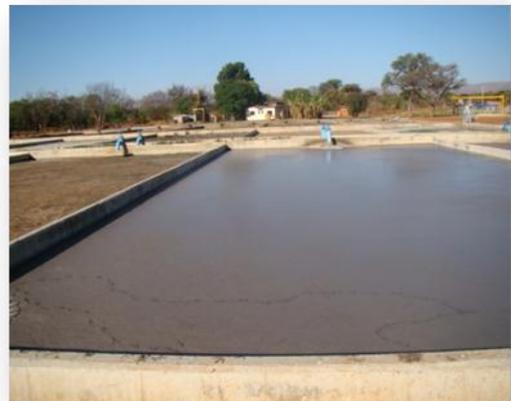
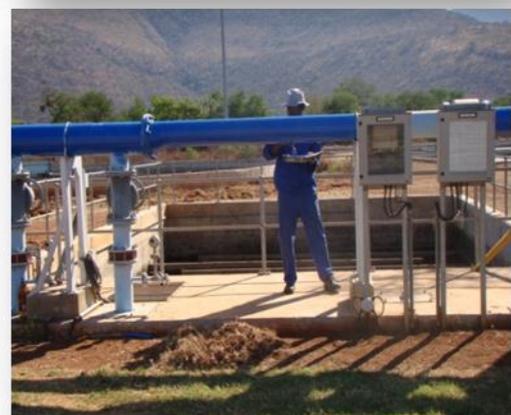
- The plant’ overall appearance was negative, terrain unkept, buildings not maintained, offices dirty and unpleasant, unhygienic working conditions
- Inlet works unclean and screenings removed and dumped in trench – poor control evident
- Flow meter in place and functional on new plant
- Primary tanks being maintained, decommissioned temporary
- 50% of old plant aerators not functional, one of new plant aerators not function – on activated sludge plant
- No disinfection taking place, no records for chlorination in place
- Sludge drying beds unkept and not maintained.

*Since the technical site inspection, Mogalakwena made determined efforts to improve the plant. The following photographic evidence shows the painting of pipe work, the improved maintenance and use of the sludge drying beds and improved process control at the plant. Readers will receive an update on progress after the GDC 2011/12 inspection cycle.*

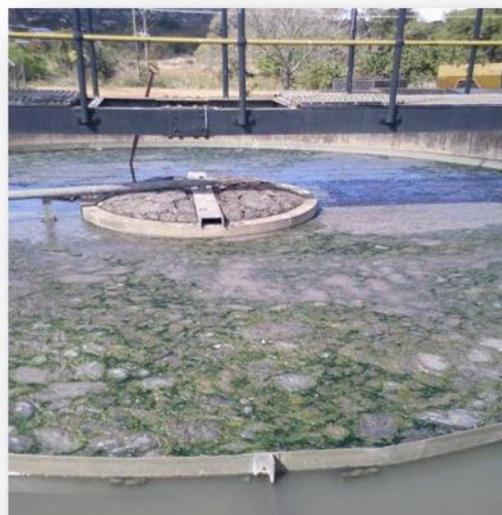
- On day of inspection, flow meters, sludge pumps, chlorination units, inlet screens, drying beds and digesters were not in operation
- Flow meter in place, not operated since 2009
- The plant presents a definite health risk as it is located in the middle of a middle class suburb within close proximity of residential households
- Effectively, no operation is taking place during the upgrade period and no monitoring is taking place to ensure continued treatment to a minimum standard effluent quality
- No chlorination taking place.

*PST has not been desludged for an extended period, due to breakdown of sludge pumps. Sludge build-up is compromising the down-stream treatment units*

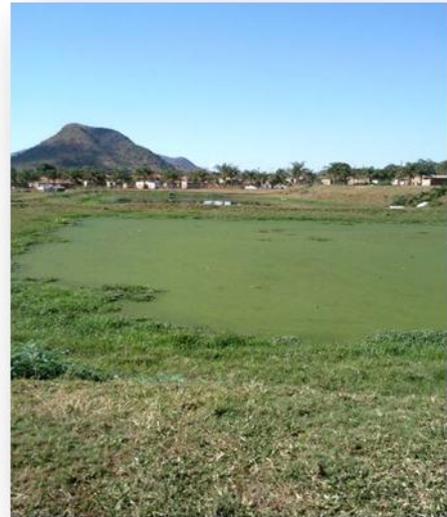
- A new pumpstation and a series of aerobic/anaerobic ponds are under construction
- The current ponds are in a serious state of neglect with 4 pond bypassed, breakdown in walls, sludge build-up and no chlorination of final effluent
- The oxidation ponds are in the middle of a suburban area and are used as a short-cut route due to the lack of access control and inadequate fencing
- Poor effluent quality is discharged as result of inadequate treatment during upgrading of the plant, presenting a significant risk to public health and the environment, given that the receiving resource is the sensitive Lethaba River which flows into the Kruger National Park.

*4 of 7 ponds operational – overloaded and producing poor effluent quality at point of discharge – pipes between ponds broken*

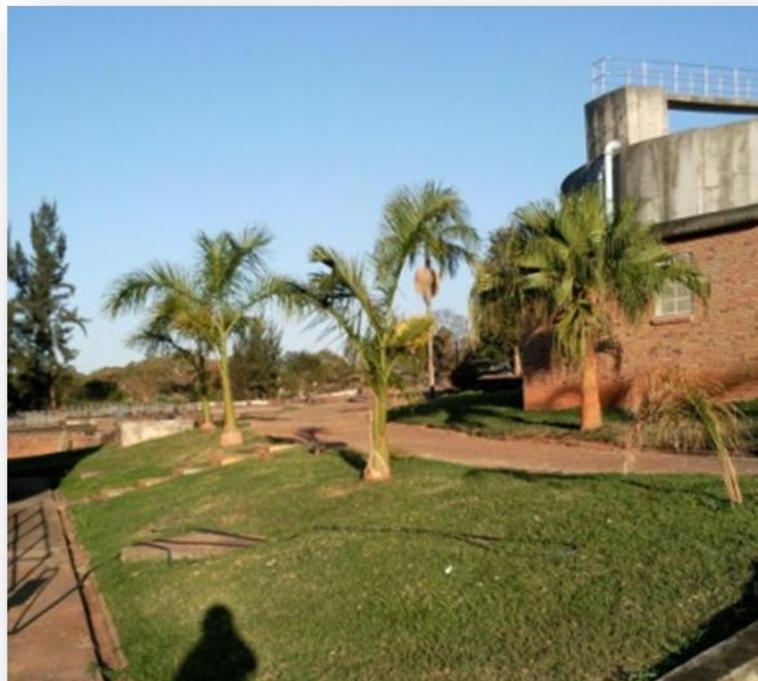
- The plant is fenced and has a gate that is locked
- Unit processes are well maintained except one clarifier that is operating below operational capacity resulting in reduced flow and consequent build-up of algae
- The chlorination facility is well maintained and locked at all times - adequate backup of chlorine gas and standby chlorinator
- Safety and warning signs are displayed and operators have full PPE and protective clothing.

*Tzaneen plant is a prime example of a well maintained and operated plant*

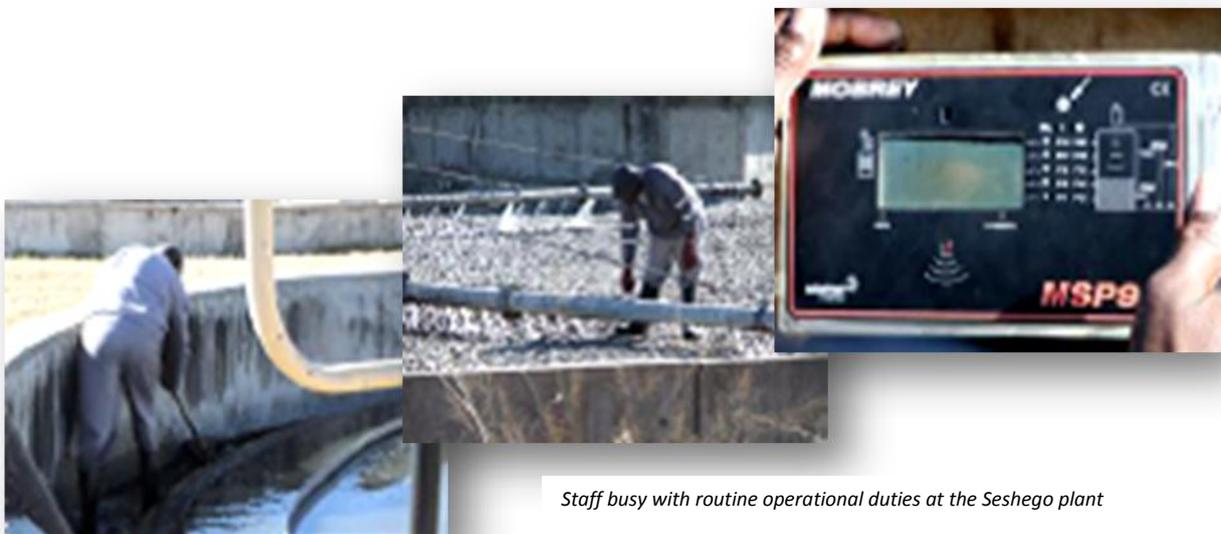
- Sludge spillage remains have not been cleared
- Site workers display optimistic attitudes and positive workplace satisfaction
- Flow meter in position but not always functional – to be replaced under DWA contract
- Community fish breeding project ongoing – fenced off
- Grit accumulation and pooling on biofilter impede on treatment efficiency – refurbishment project planned to address some of the shortcomings
- Very poor sludge handling practice and facilities – scheduled for upgrade, high risk to environment
- Anaerobic digesters operational, but limited process control or efficiency testing.

*Staff busy with routine operational duties at the Seshego plant*

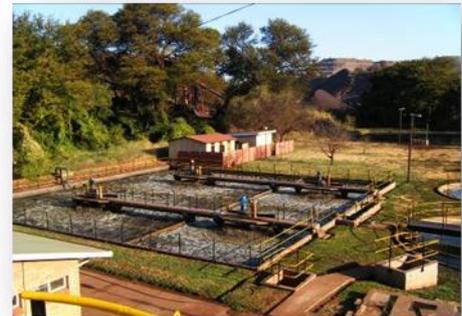
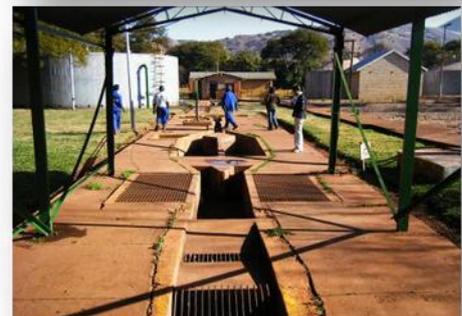
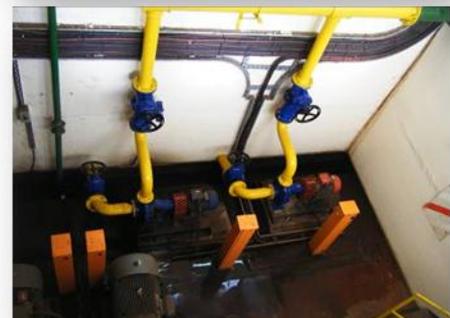
*Thabazimbi Process Controllers take immense pride in the orderly and well maintained inlet works and pumpstations*

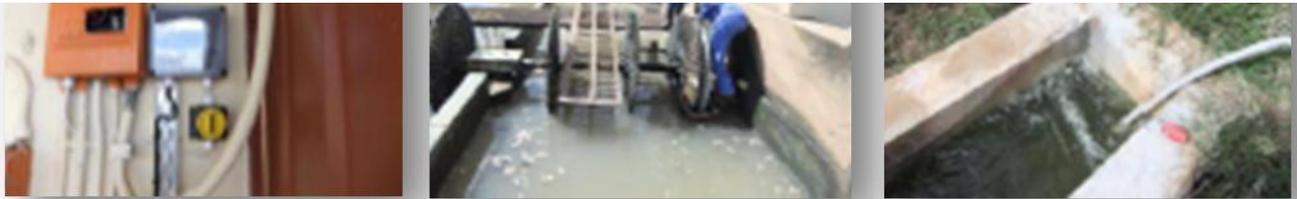
*Middle: repairs to aeration discs. No process control of sludge age.*

*Right: chlorine dosing controlled at 1-1.5 mg/l*
