Report Number: P WMA 06/D00/00/3423/2

Greater Mangaung Water Augmentation Project Site Visit Report

Xhariep Pipeline Feasibility Study

Site Visit Report

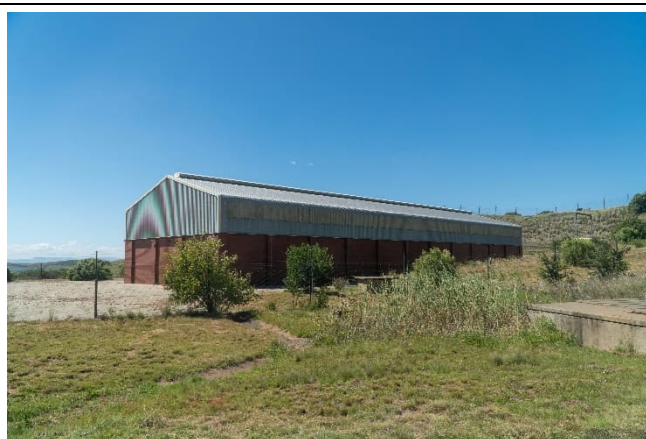
- ▶ The grounds and pump station were in reasonable condition, however, there are many general housekeeping aspects to attend to (painting, clearing and cutting grass from access road etc.)

- ▶ The building was in good condition, again housekeeping needs to be attended to.
- ▶ Three pump sets were installed, two were the original 750l/s pumpsets and the additional 1450l/s pump set installed to increase the capacity of the pump station.

Figure 3-1: Novo Pump Station building

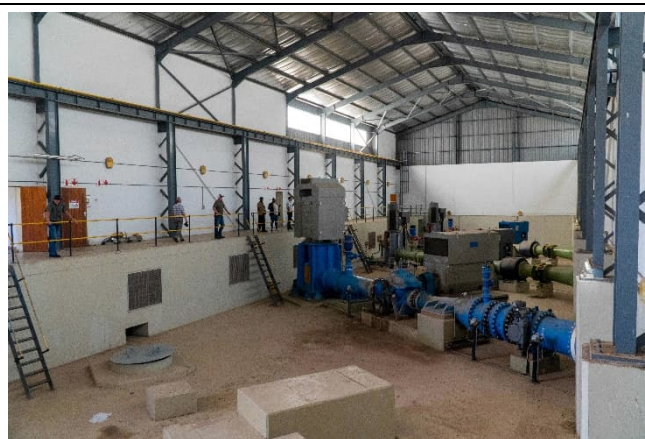
- ▶ The electrical switchgear appears to be in reasonable condition.
- ▶ The pump station has space to fit a fourth pump in future.
- ▶ The Novo pipeline operates without problems. It is uncertain whether the cathodic protection of the pipeline is functional.

Figure 3-2: Novo pump sets with one open pump bay

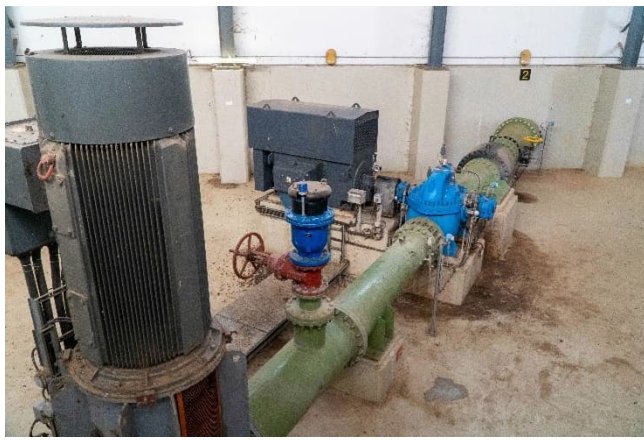
- ▶ The pumpsets (pump and motor), pipework and valves appear to be in a reasonable condition. The operator did not report any problems with the pumpsets.

Figure 3-3: Original pump set

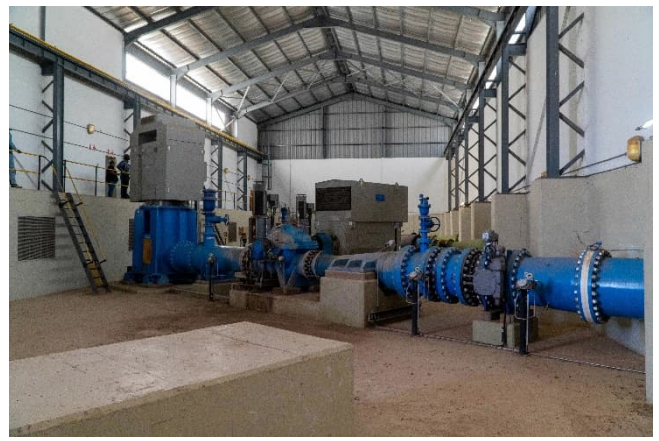
Figure 3-4: New pump set

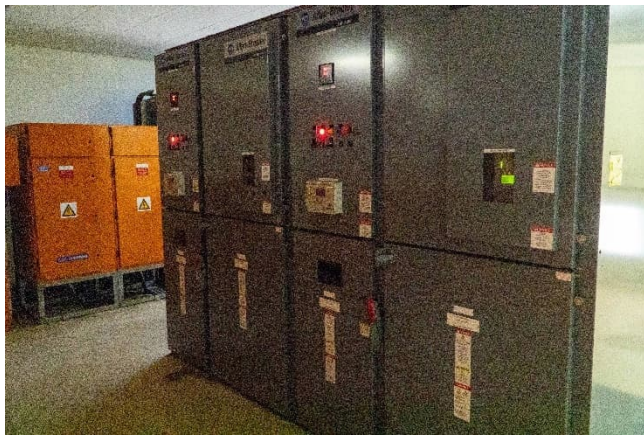
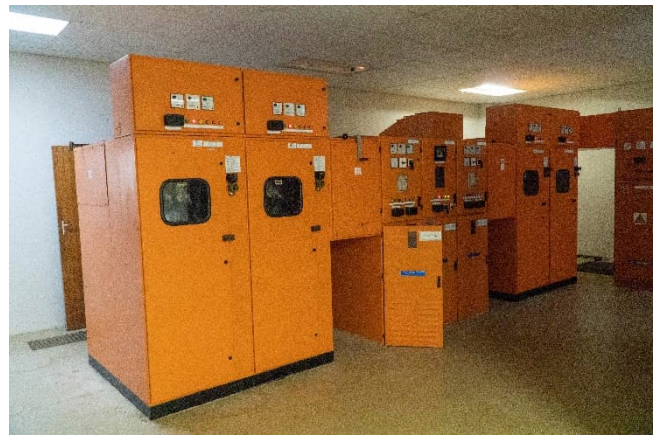
Figure 3-5: MCC in Control Room

Figure 3-6: MCC in Control Room

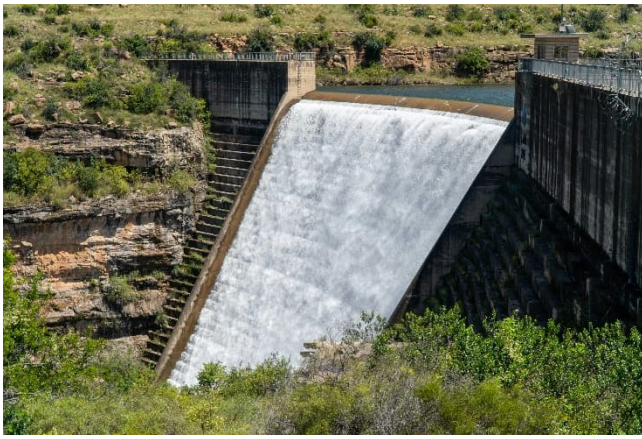
Figure 3-9: Knellpoort Dam Wall spilling

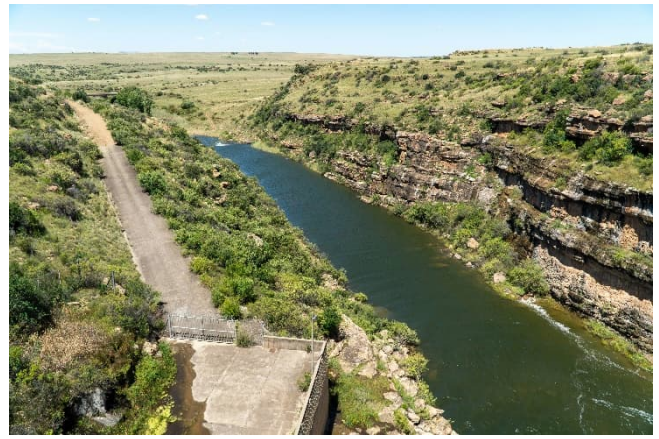
- ▶ Evidence of seepage on the dam wall and roof of the structure on the downstream side of the dam.
- ▶ The outlet works chamber was left open which was a safety risk.
- ▶ Pipework seems to be in good condition.
- ▶ Drawings of the Knellpoort Dam were available in Tienfontein Pump Station.

Figure 3-10: Downstream side of Knellpoort Dam, water on top of structure in bottom left corner

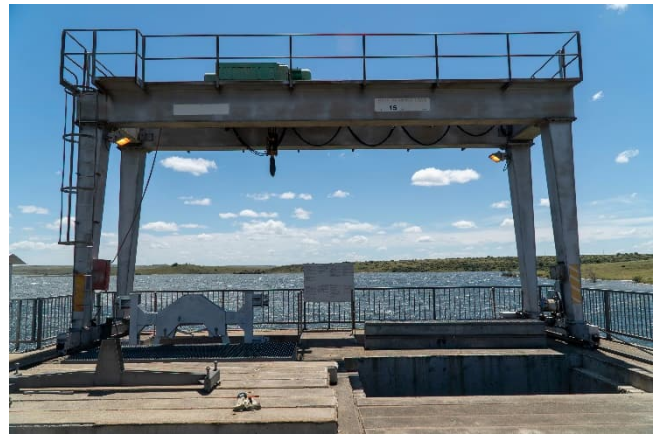
Figure 3-12: Outlet works left open

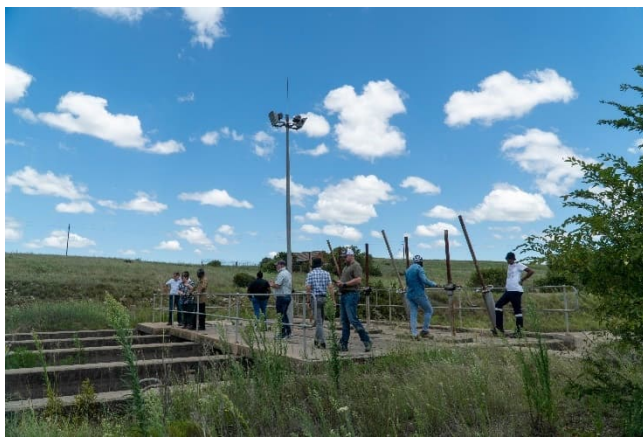
The silt traps at Tienfontein Pump Station were overgrown and not functioning at the time of the site visit. Observations from the Zutari team are:

Figure 3-17: Silt trap above Tienfontein Pump Station

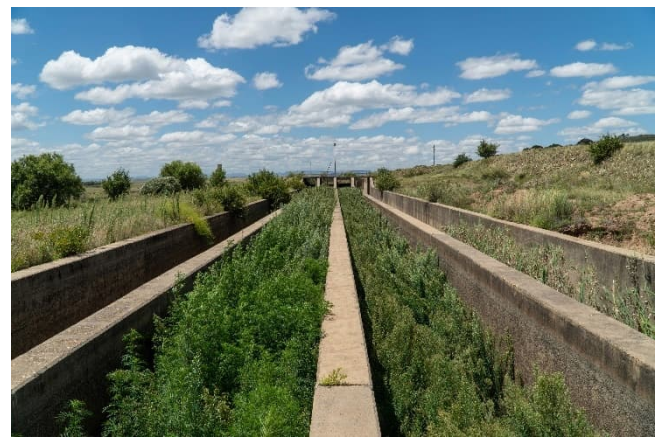
- ▶ Silt traps were overgrown and not used for at least two years.
- ▶ The sluices for scouring of the silt traps are manually operated.
- ▶ The mechanical equipment of the silt traps are in a very bad condition and unlikely to function if the pump station is to be used.
- ▶ The headstock for some of the sluices is inoperable due to the shafts being buckled or other damages.
- ▶ Design changes to the silt traps can improve the effectiveness and ease of operation of the facility.
- ▶ Substantial work is required to clear the traps and to reinstate or replace equipment, before they can be used again.

Figure 3-18: Overgrown and silted up channels

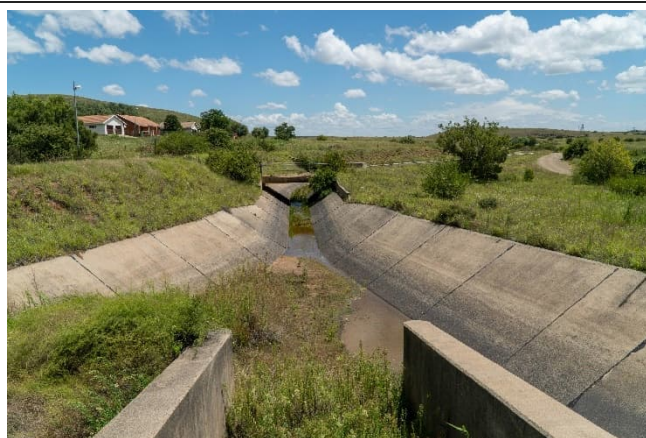
Figure 3-19: Downstream channel also overgrown

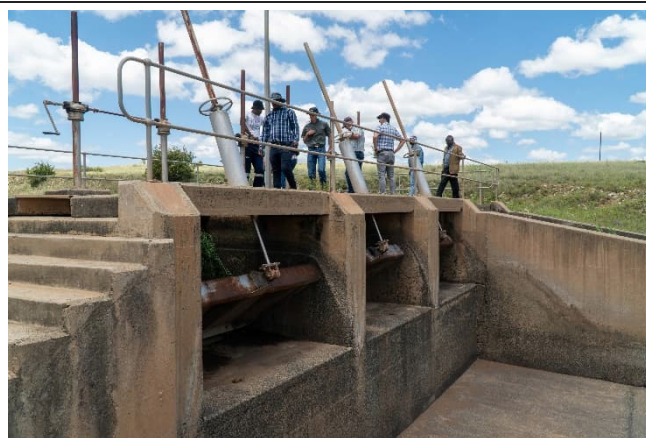
Figure 3-20: Rusty equipment

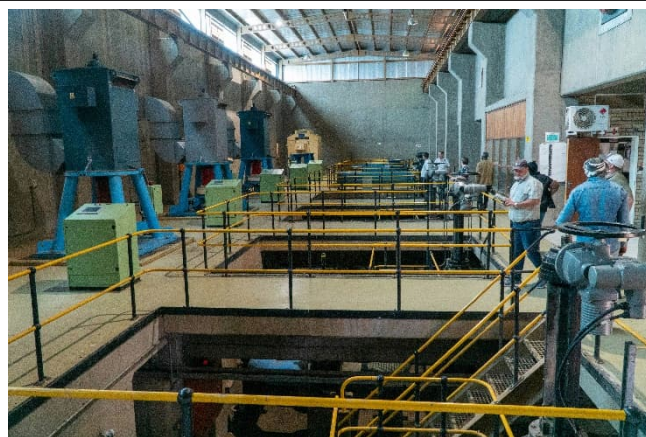
- ▶ Six vertical turbine pumps are installed.
- ▶ The pump station were upgraded to 4 m³/s not long ago.
- ▶ Siltation problems at the inlet of the pump station prevent the pump station to operate at maximum capacity.
- ▶ Siltation is a major problem for the operators and causes frequent breakages.
- ▶ Pump station building seems to be structurally in reasonable condition, although general housekeeping needs to be attended to.
- ▶ The mechanical and electrical equipment seems to be in good condition although general maintenance and cleaning is required.
- ▶ There are no additional bays for new pump sets to be installed and larger pumps will need to be installed if the capacity of the pump station is to be increased.

Figure 3-22: Six pump sets installed

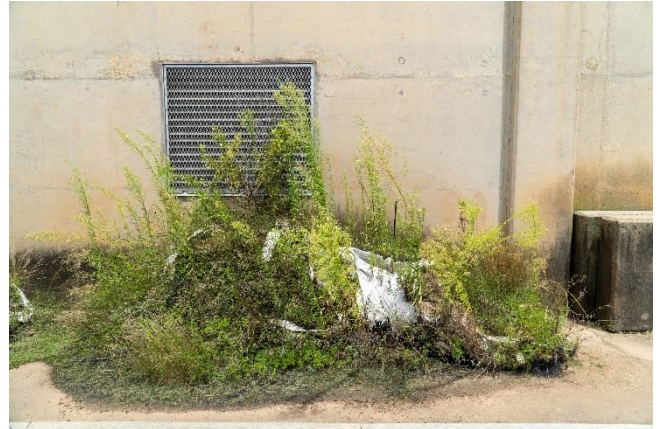
Figure 3-28: General housekeeping not done

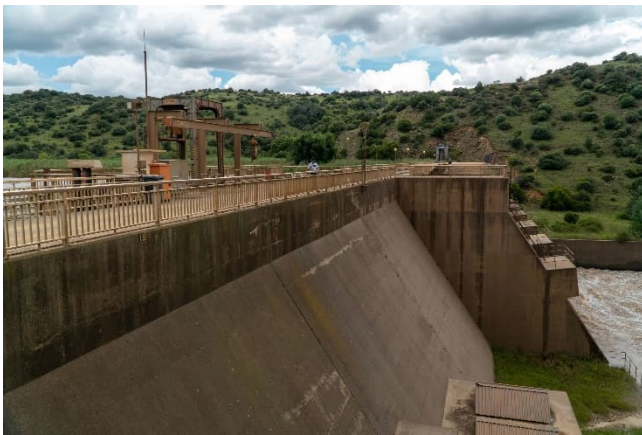
- ▶ Evidence of the siltation of the dam basin is clearly visible and most of the dam basin is covered with reeds.
- ▶ Releases from Knellpoort takes roughly 1.5-2 days to reach Welbedacht with high (50% according to the operators) losses along the route.
- ▶ Upstream scouring of the dam basin is not effective as only two sluice gates are functioning.

- ▶ Scouring efforts resulted in scouring at toe of dam wall due to the sluices not functioning and unbalanced release of the water.
- ▶ Scouring at the downstream side of the dam wall is evident.

Figure 3-29: Dam wall

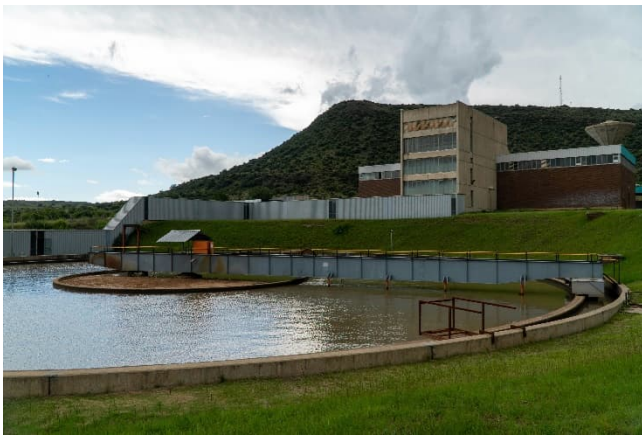
- Primary sedimentation - clariflocculator
 - The rotating bridge and the attached flocculation mixers have reportedly not been functional for over a year. The combined flocculation and sedimentation processes of the clariflocculator cannot function without the mixing and settled sludge collection provided by the bridge. The process is thus compromised and should be repaired urgently. Failing this, both flocculation and sedimentation are inefficient, resulting in

Figure 3-41: Primary sedimentation - clariflocculator

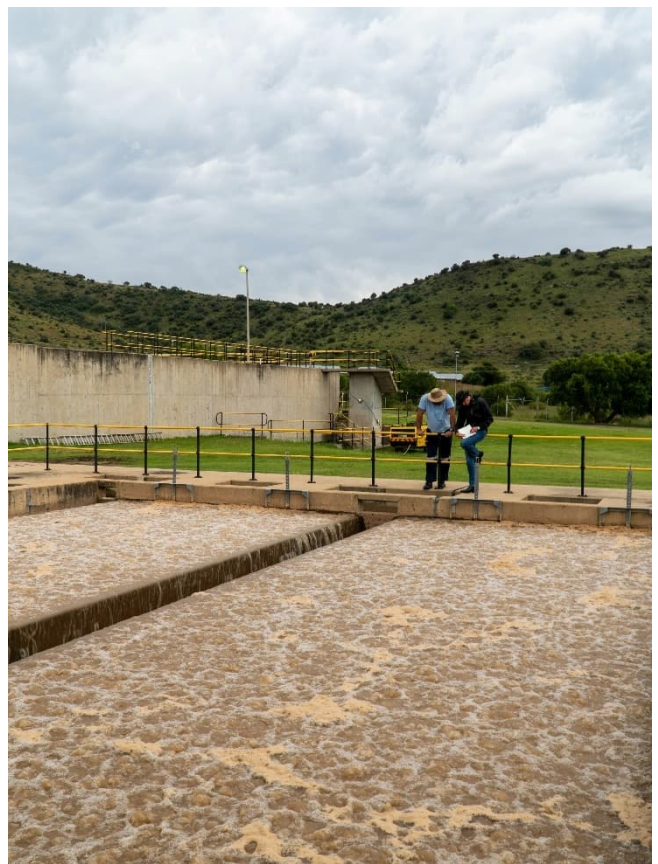
- One filter was permanently out of service due to various problems and needs repair.
 - A filter backwash cycle was observed for one of the eastern banks of filters. During air scour, air bubbling was noticed in other filters indicating that valves are leaking.

Figure 3-44: Filters backwashing

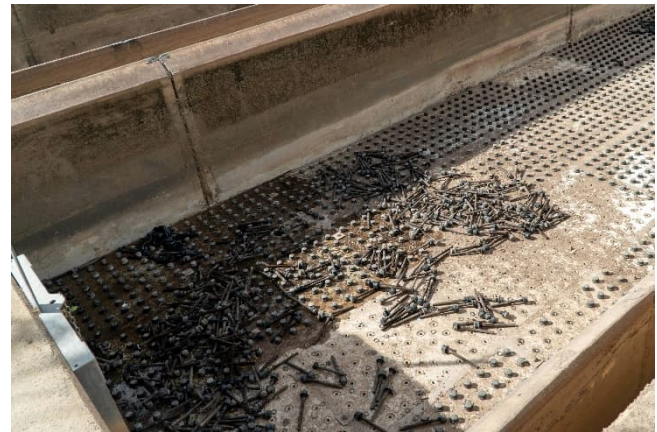
- One of the filters was out of operation for refurbishment of the filter underdrainage system. It was evident that several other filters, if not all of them, would also require refurbishment. The filter nozzles had become brittle and were failing, resulting in uneven filtration and collection of filtered water, uneven air scour and backwash water collection, uneven and compromised backwashing, and loss of filter media. The filter media loss was significant in some filters and filtration efficiency is thus compromised.

- The filter under-drainage system was constructed using Degremont type precast filter panels, with are bolted and grouted in place. The grout joints for this under-drainage system are notorious for failing after several years in service. The joints in the filter that was being refurbished and hence had its filter media removed appeared to be intact. However, the joints for the other filters should be inspected as it is possible that there have been failures. The uneven filter media distribution in the filters gives evidence of some disturbance, whether by broken nozzles or failed panel joints, or both.

Figure 3-48: Filtration nozzles being replaced

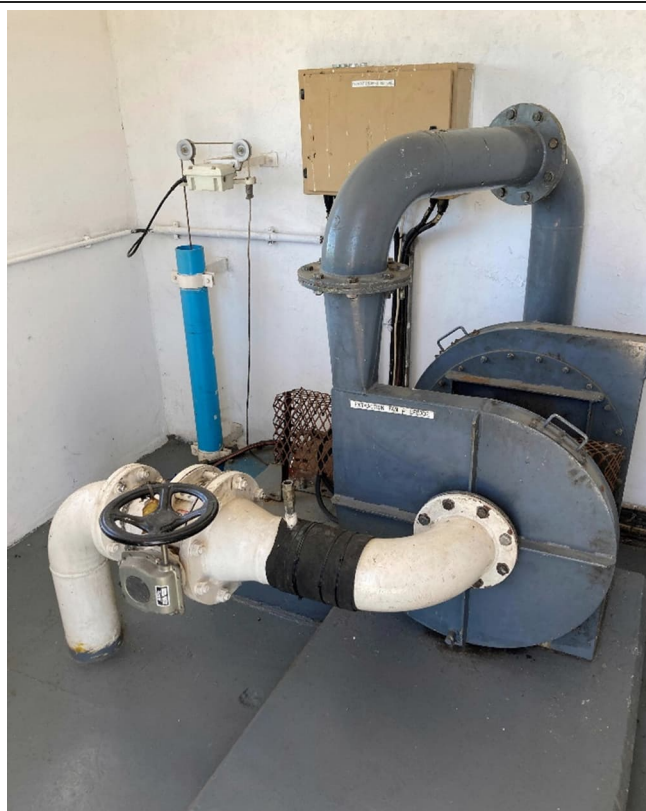
- The plant manager reported that the vacuum system was previously only able to lift the water level by about 20 to 30 mm, versus a required 40 mm. The design target value should be investigated, and the vacuum generation and control system repaired to restore the pulsation system.

Figure 3-55: Pulsator vacuum pump (not operable)

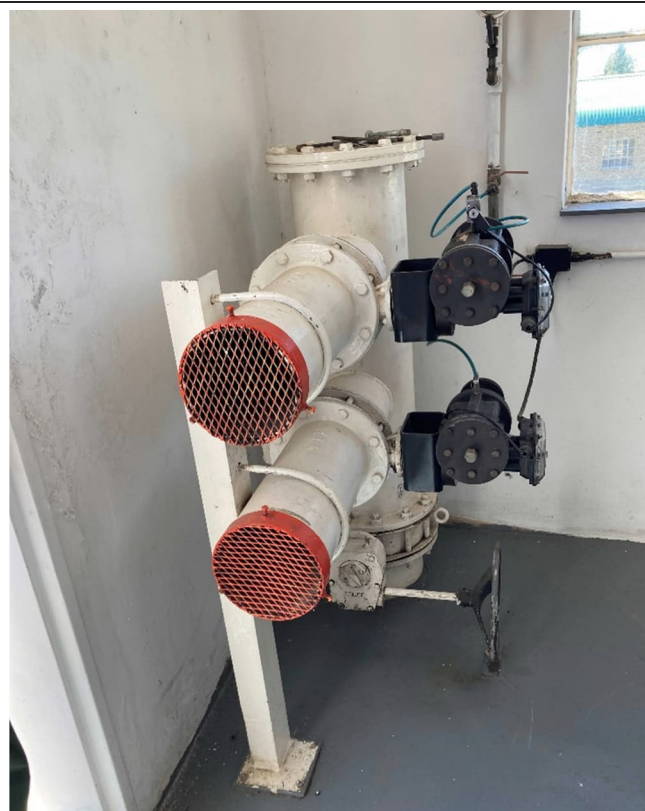
Figure 3-56: Pulsator vacuum control equipment (not operable)

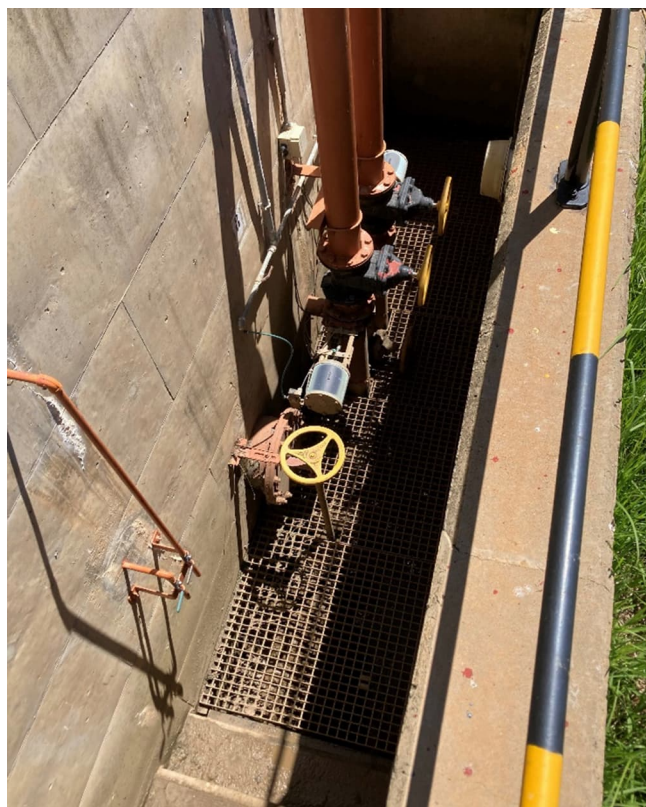
- Each Pulsator is provided with eight actuated de-sludge valves; four to de-sludge the floc blanket control hopper and four to de-sludge solids that have settled to the bottom of the Pulsator. The valve actuators are not working. The manual opening and closing of the valves takes longer than with an actuator (to reach fully open and full design flushing flow) and hence more water is lost and the efficiency of the units is reduced. The actuators should be repaired and maintained in good working order.

Figure 3-57: Pulsator de-sludge valves (actuators not operable)

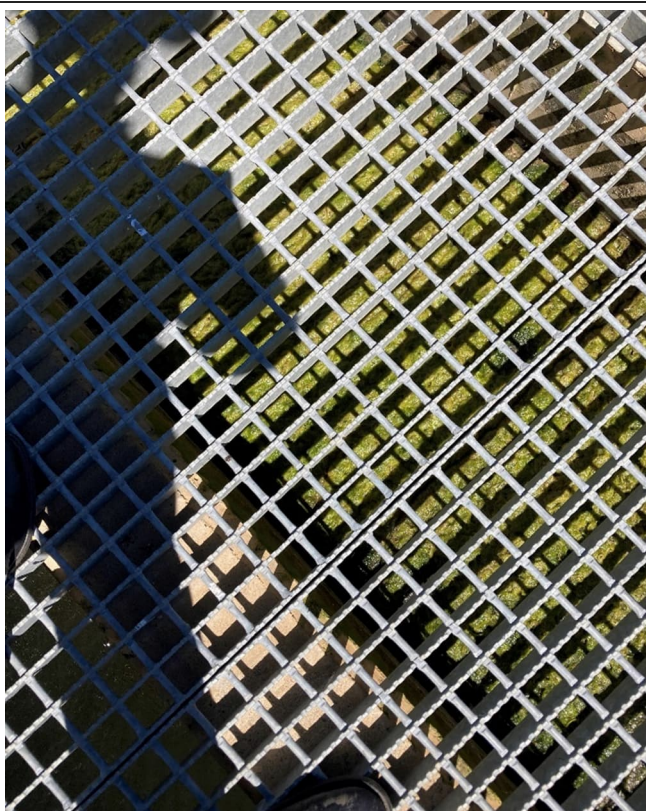
products may be produced by the reaction of chlorine with the algal metabolites. This should be investigated. The cyanobacteria cause shortened filter runs and loss of plant efficiency due to the need for more water to be used for filter backwashing. The operations team reported that filter runs are reduced from the normal time of around 45 hours, to between 20 and 30 hours when cyanobacteria is present.

Figure 3-59: Algae scum in filter inlet channel

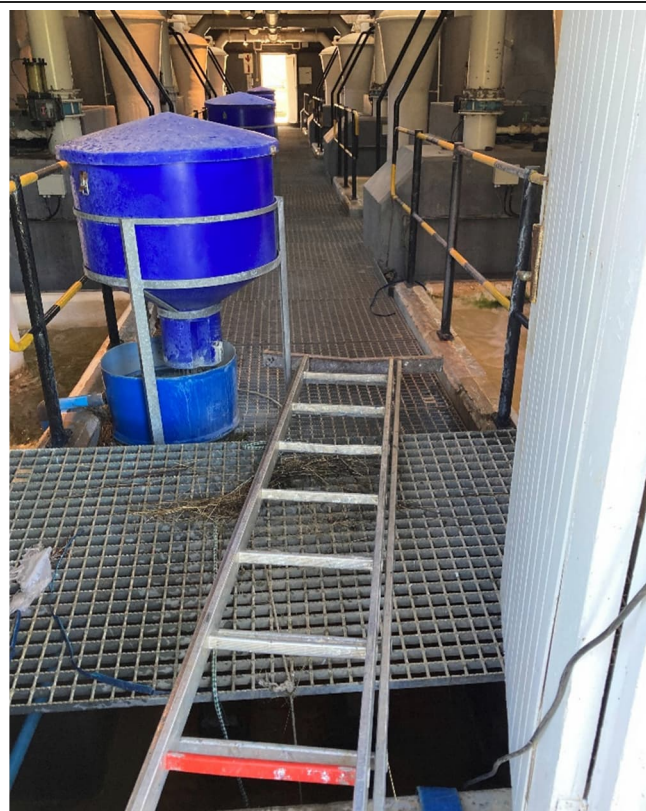
Figure 3-60: Lower filter gallery (unsafe access)

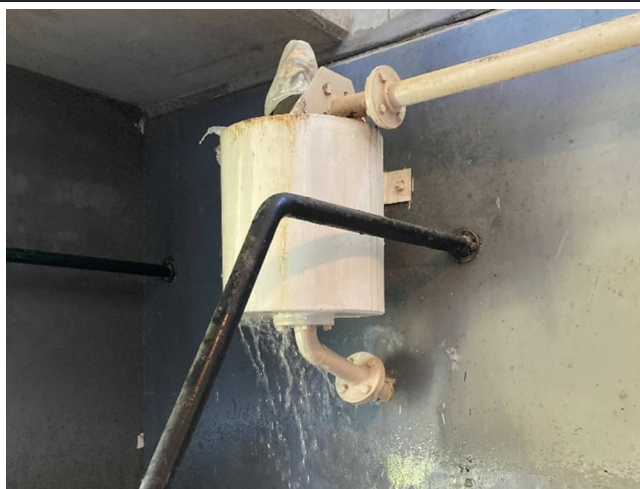
- Hydraulic control through each of the filters is via a Degremont partialisation / syphon system. As at Welbedacht WTP, these were not functioning properly and hence the hydraulic control and filter performance is compromised. The system components should be checked, cleaned, and repaired as necessary. The float chambers for these systems are prone to being choked by sediment accumulation that prevents the float from moving freely. The float chambers should therefore be cleaned out regularly as part of routine maintenance (as least monthly). A drainage system can be used but this has limited effectiveness unless the shape of the float chamber is changed to one with a 60-degree sloped settling cone.

Figure 3-61: Filter float chamber overflowing

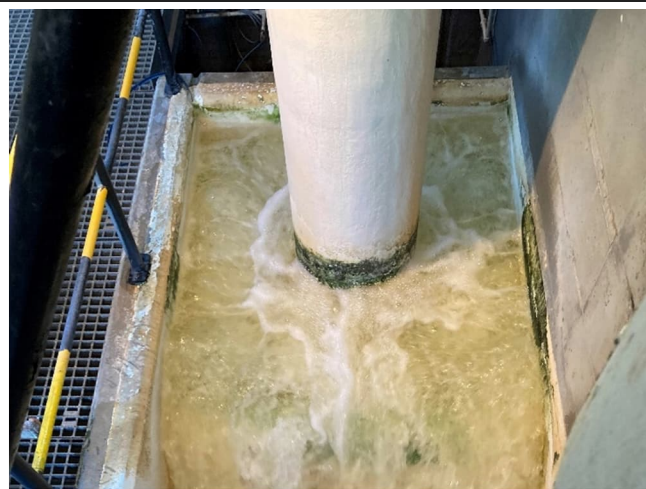
- As the time of the site visit some of the operational filters were operating in a drowned state, with water backing up to the inlet control weir, and with other filters having a reasonably high drop over the corresponding weir. This results in uncontrolled and improper flow proportioning between the various filters and compromised filtration performance. It is likely that the problem is caused by the malfunctioning partialisation / syphon systems. The problem should be further investigated and remedied.

**Figure 3-62: Filtered water inspection chamber
(partialisation-siphon system over-aerating)**

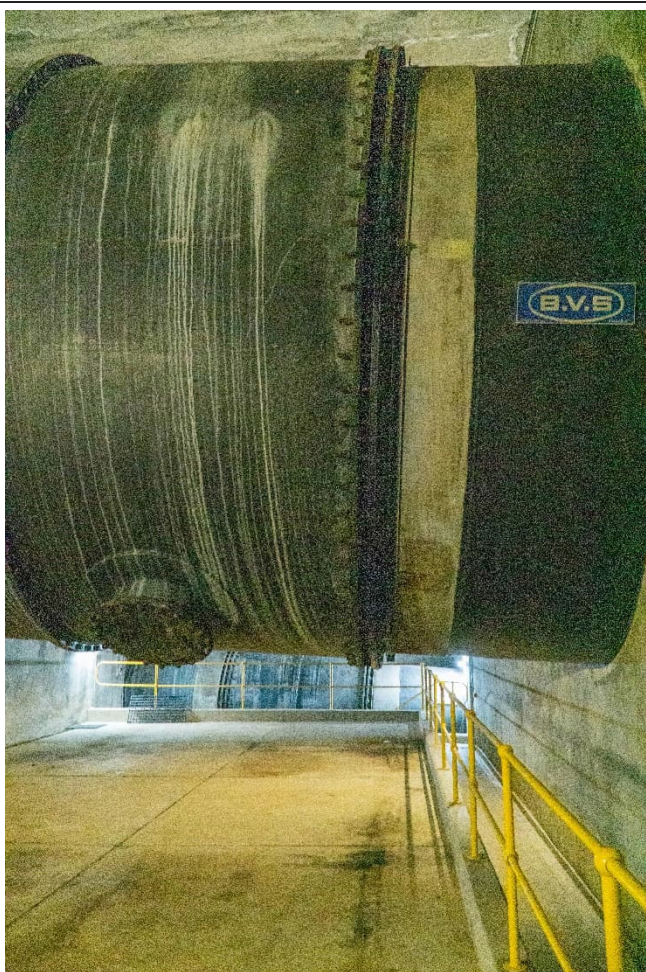
- These two 2.1m pipelines seemed to have been earmarked for connection to Bloemfontein.

Figure 3-73: One of the existing 2.1m Ø pipes within the dam wall
