Report Number: P WMA 06/D00/00/3423/2

# Greater Mangaung Water Augmentation Project Site Visit Report

## Xhariep Pipeline Feasibility Study

| <b>Date</b> | : | 04 September 2023 |

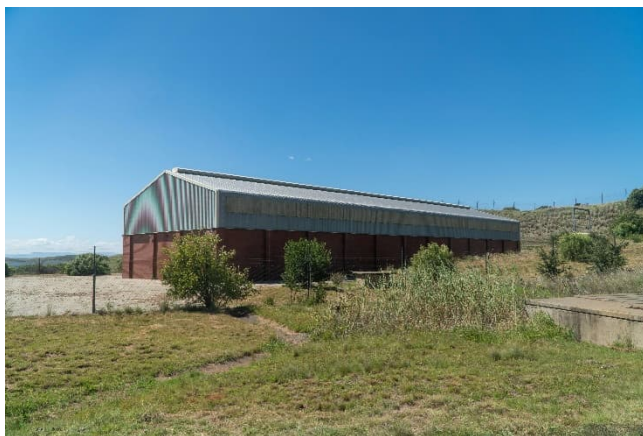
- ▶ The grounds and pump station were in reasonable condition, however, there are many general housekeeping aspects to attend to (painting, clearing and cutting grass from access road etc.)

- ▶ The building was in good condition, again housekeeping needs to be attended to.
- ▶ Three pump sets were installed, two were the original 750l/s pumpsets and the additional 1450l/s pump set installed to increase the capacity of the pump station.

**Figure 3-1: Novo Pump Station building**

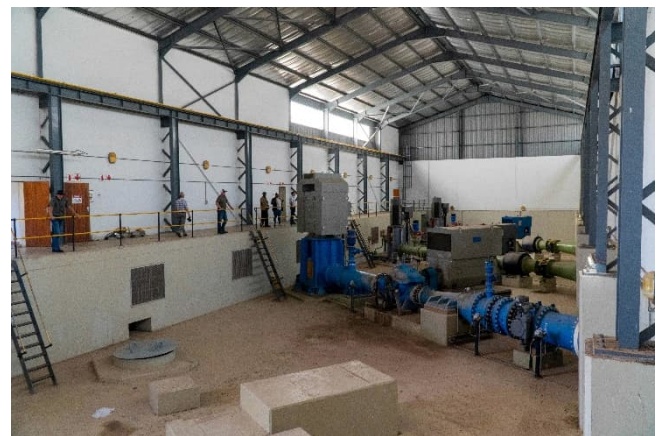
- ▶ The pumpsets (pump and motor), pipework and valves appear to be in a reasonable condition. The operator did not report any problems with the pumpsets.

**Figure 3-2: Novo pump sets with one open pump bay**

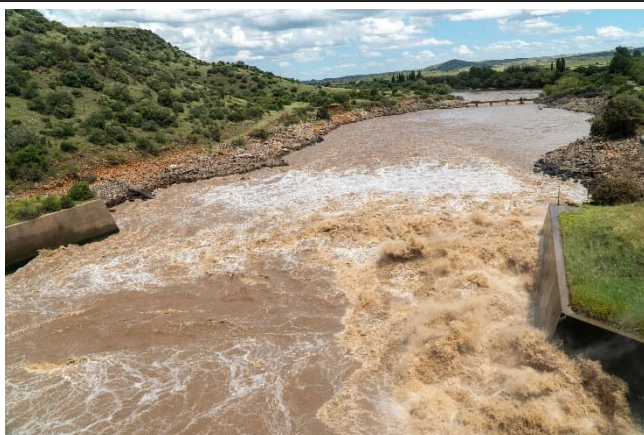
- ▶ Scouring efforts resulted in scouring at toe of dam wall due to the sluices not functioning and unbalanced release of the water.
- ▶ Scouring at the downstream side of the dam wall is evident.

**Figure 3-33: Evidence of downstream scouring and debris**

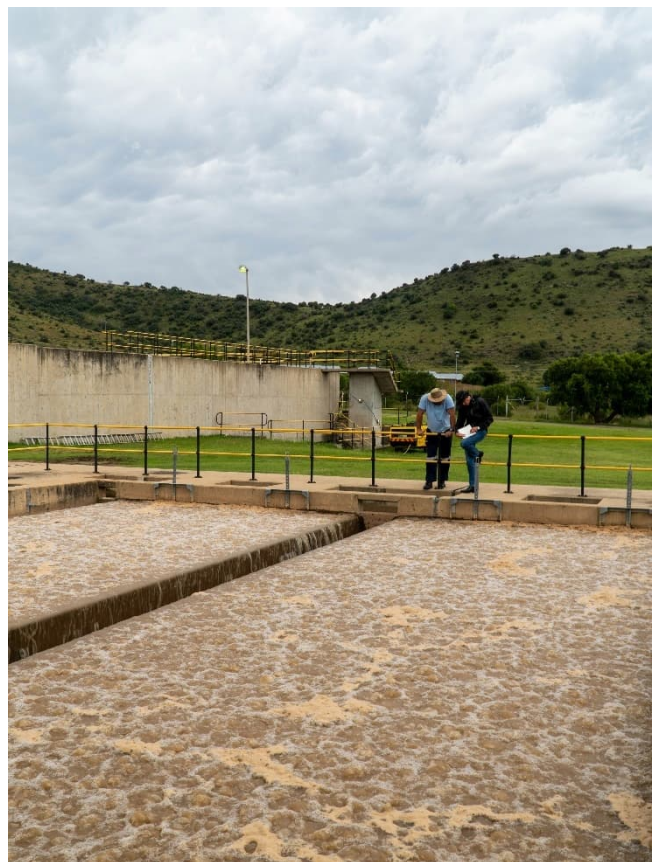
- One filter was permanently out of service due to various problems and needs repair.
  - A filter backwash cycle was observed for one of the eastern banks of filters. During air scour, air bubbling was noticed in other filters indicating that valves are leaking.

**Figure 3-44: Filters backwashing**

- Improvements to the system for controlling the filter backwash cycles (valves, control of pumps and blowers) should be considered.
- Despite the challenges encountered, the plant is reasonably well operated. This is in part due to its simplicity, which fosters an intuitive “feel” for the plant by the operators. It is thus not recommended that any extensive automation is provided as this will place a barrier between them and the plant. When it fails (which will happen), the operators will then not be able to respond as intuitively to the requirement for manual operation. Automation will also introduce significantly more advanced equipment that must be maintained and serviced, and which will fail from time to time.

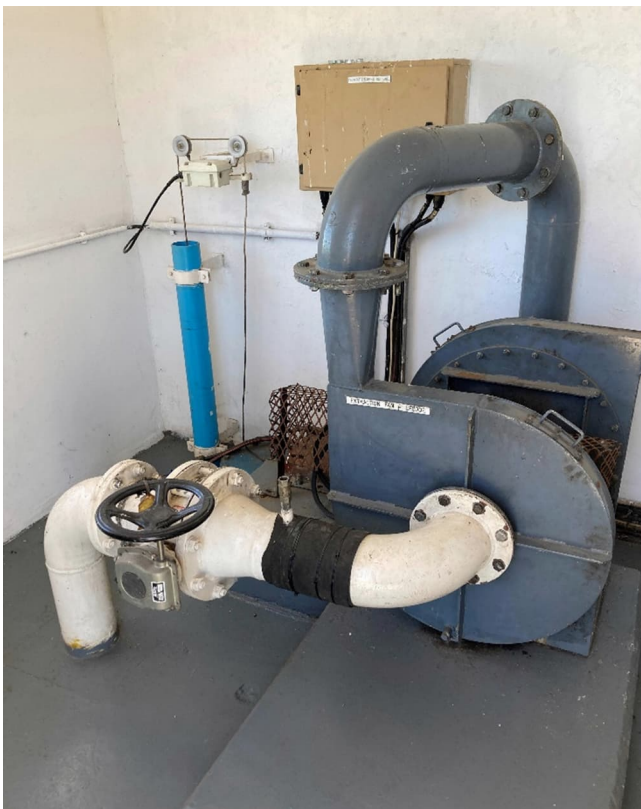
- The plant manager reported that the vacuum system was previously only able to lift the water level by about 20 to 30 mm, versus a required 40 mm. The design target value should be investigated, and the vacuum generation and control system repaired to restore the pulsation system.

Figure 3-55: Pulsator vacuum pump (not operable)

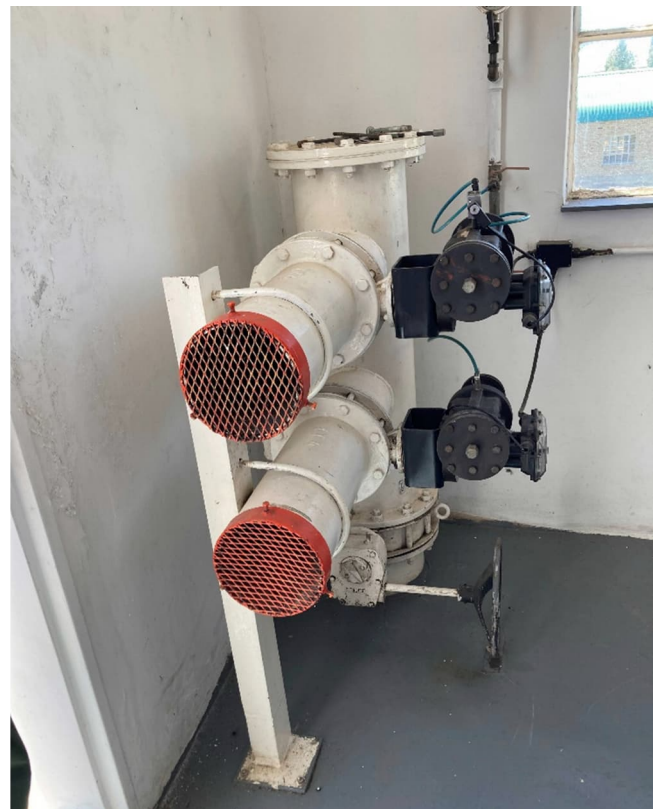
Figure 3-56: Pulsator vacuum control equipment (not operable)

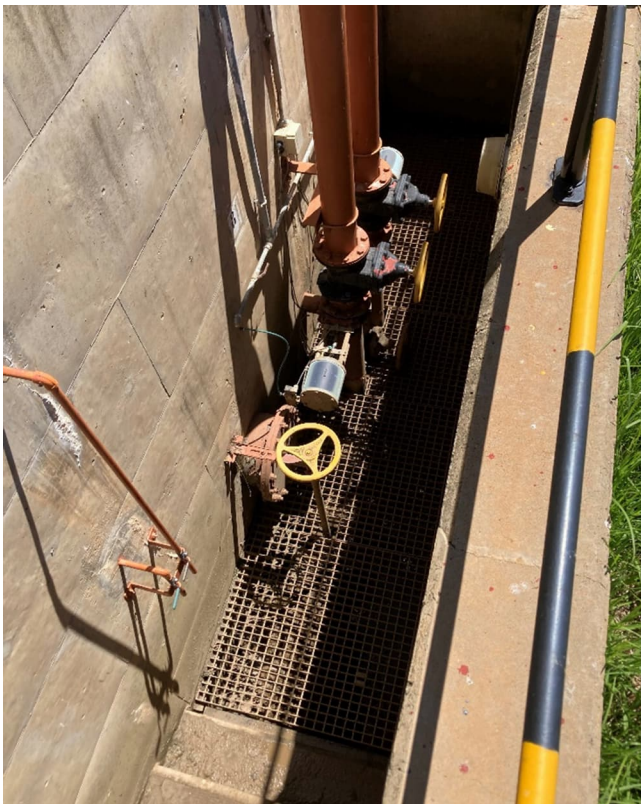
- Each Pulsator is provided with eight actuated de-sludge valves; four to de-sludge the floc blanket control hopper and four to de-sludge solids that have settled to the bottom of the Pulsator. The valve actuators are not working. The manual opening and closing of the valves takes longer than with an actuator (to reach fully open and full design flushing flow) and hence more water is lost and the efficiency of the units is reduced. The actuators should be repaired and maintained in good working order.

Figure 3-57: Pulsator de-sludge valves (actuators not operable)

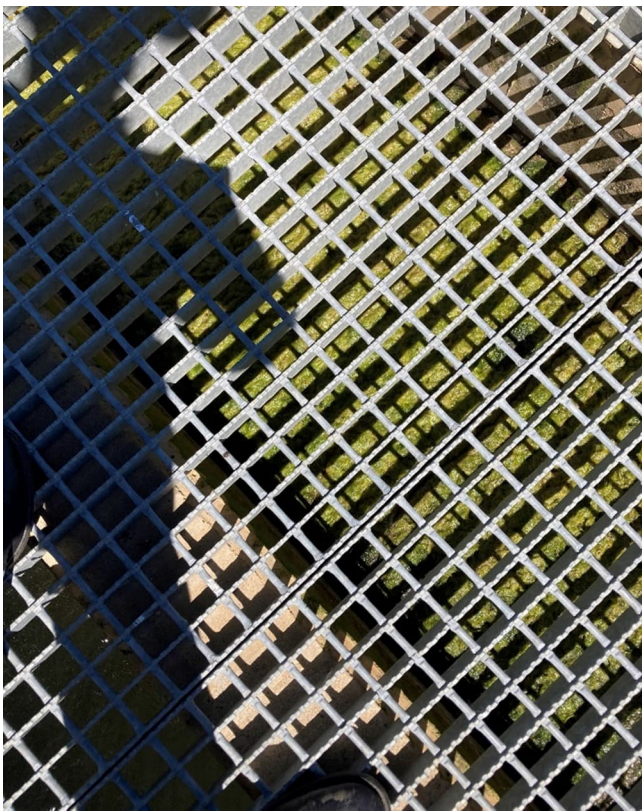
products may be produced by the reaction of chlorine with the algal metabolites. This should be investigated. The cyanobacteria cause shortened filter runs and loss of plant efficiency due to the need for more water to be used for filter backwashing. The operations team reported that filter runs are reduced from the normal time of around 45 hours, to between 20 and 30 hours when cyanobacteria is present.

Figure 3-59: Algae scum in filter inlet channel

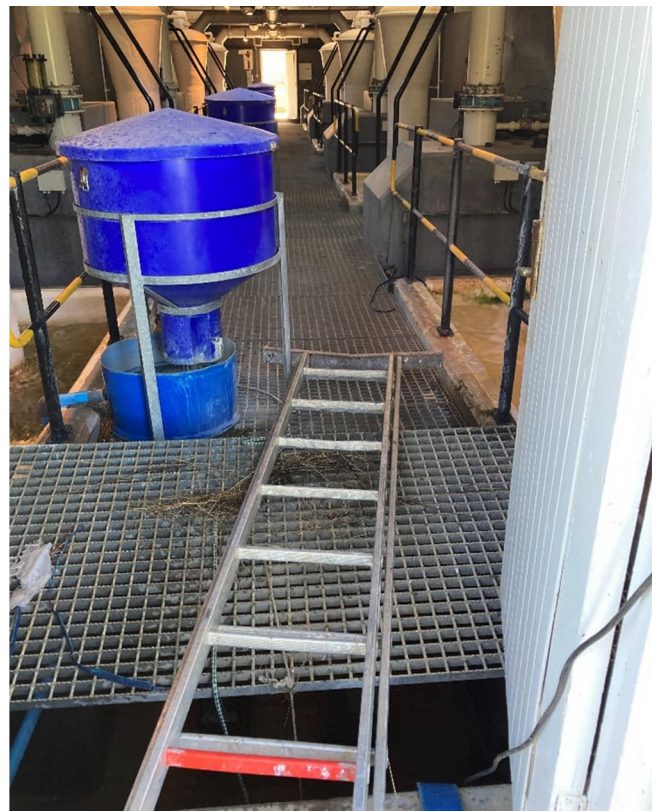
Figure 3-60: Lower filter gallery (unsafe access)

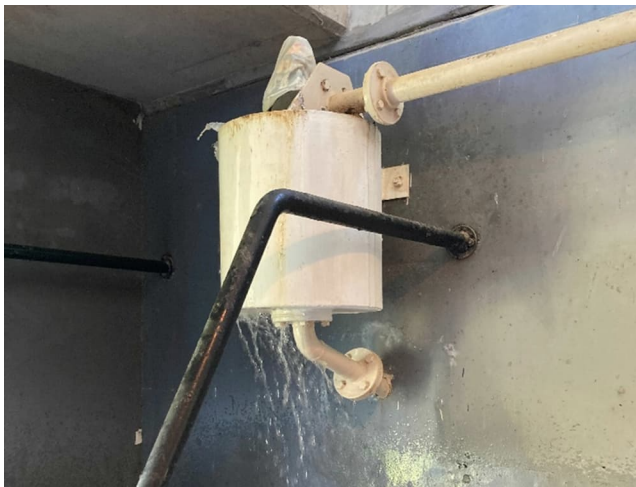
- Hydraulic control through each of the filters is via a Degremont partialisation / syphon system. As at Welbedacht WTP, these were not functioning properly and hence the hydraulic control and filter performance is compromised. The system components should be checked, cleaned, and repaired as necessary. The float chambers for these systems are prone to being choked by sediment accumulation that prevents the float from moving freely. The float chambers should therefore be cleaned out regularly as part of routine maintenance (as least monthly). A drainage system can be used but this has limited effectiveness unless the shape of the float chamber is changed to one with a 60-degree sloped settling cone.

Figure 3-61: Filter float chamber overflowing

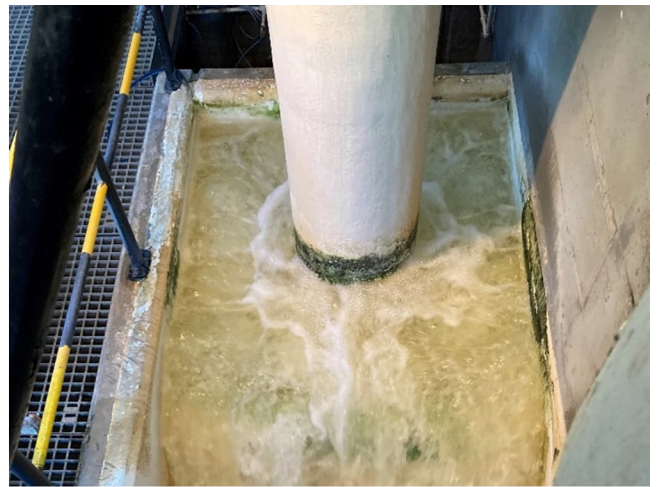
- As the time of the site visit some of the operational filters were operating in a drowned state, with water backing up to the inlet control weir, and with other filters having a reasonably high drop over the corresponding weir. This results in uncontrolled and improper flow proportioning between the various filters and compromised filtration performance. It is likely that the problem is caused by the malfunctioning partialisation / syphon systems. The problem should be further investigated and remedied.

Figure 3-62: Filtered water inspection chamber  
(partialisation-siphon system over-aerating)
