# Der Brochen Dam

## FOURTH DAM SAFETY EVALUATION REPORT

DAM SAFETY INSPECTION CARRIED OUT ON 27 JULY 2010 AS  
REQUIRED IN TERMS OF GOVERNMENT NOTICE R. 1560 OF JULY 1986

February 2011

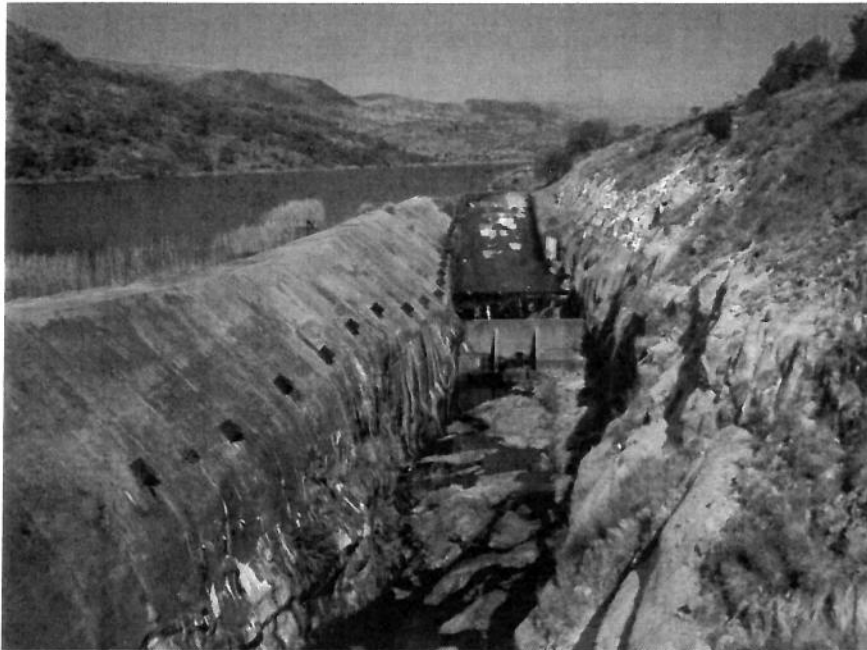
The design report stated that the spillway was formed in rock in places, and on a soil cement stabilised fill in other places. Refer to **Photograph 1** and **2**. Concrete was used for the construction of the upstream portion of the spillway crest. For the downstream section a thin concrete slab of 75 mm was cast on top of the soil cement fill. A proper rock foundation was apparently too deep which would have resulted in excessive cost. Shotcrete was used to protect rock against possible erosion from the water. The level of overflow varies, with the upstream concrete section overflowing first, followed by the downstream stabilised fill sections.

**Photo 1: Upstream section of side channel spillway (2010/07/27)**

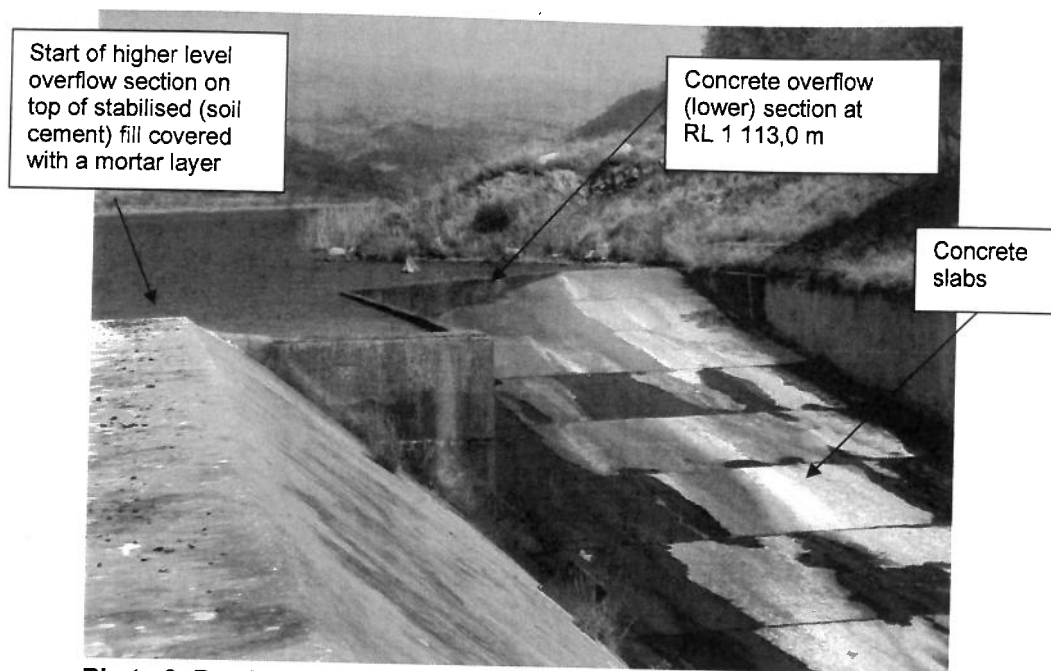
**Photo 2: Detail of upstream section of spillway (2010/07/27)**

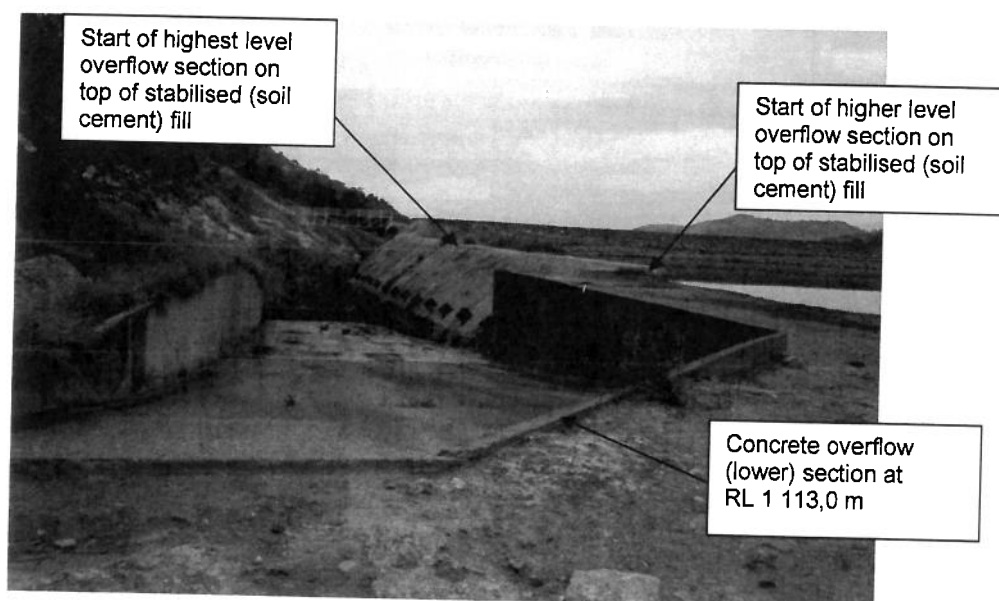
**Photo 3: Detail of spillway levels (2010/11/17)**

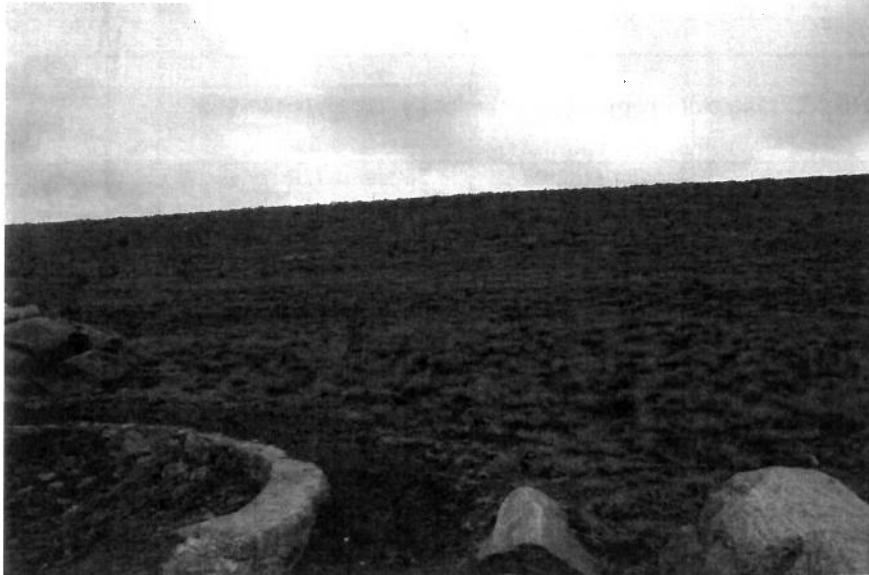
**Photo 7: Downstream slope of embankment after recent burning of the grass cover (2010/11/17)**

The downstream slope protection consists of grass cover. The grass was partially cut during the first inspection, and burned during the second inspection, enabling inspection of the slope for seepage and the manholes. No animal/termite activity was noticed. Grass and reeds in the proximity of the gauging weir should be removed. Erosion on the downstream slope close to the downstream toe is evident due to stormwater run-off over a large downstream surface.

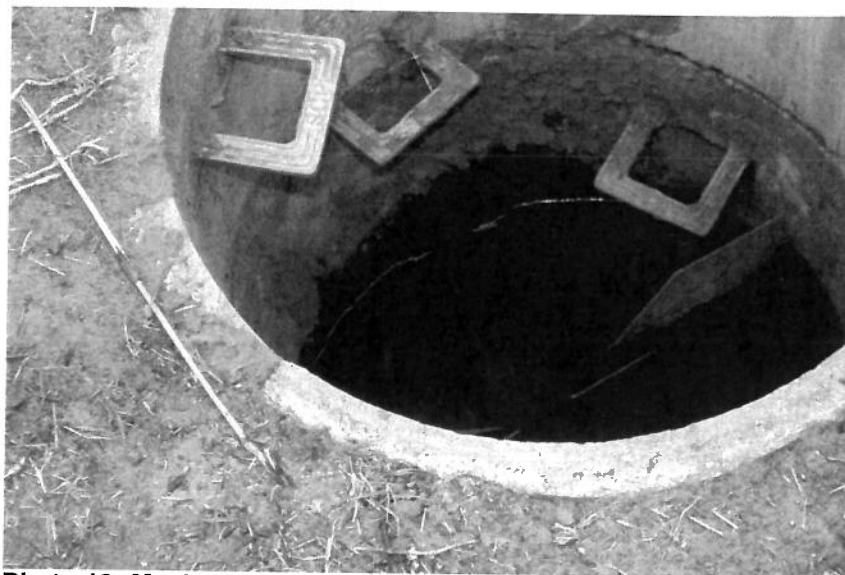
- Manhole 6: Manhole is silted up. Reeds are present. Stormwater ponds around the manhole.
- Manhole 7: Standing water is present in manhole with slight in-flow. The outlet drainage pipe is blocked.

**Photo 10: Manhole 7 on the left bank with seepage water ponding on the inside due to a blocked outlet pipe (2010/11/17)**

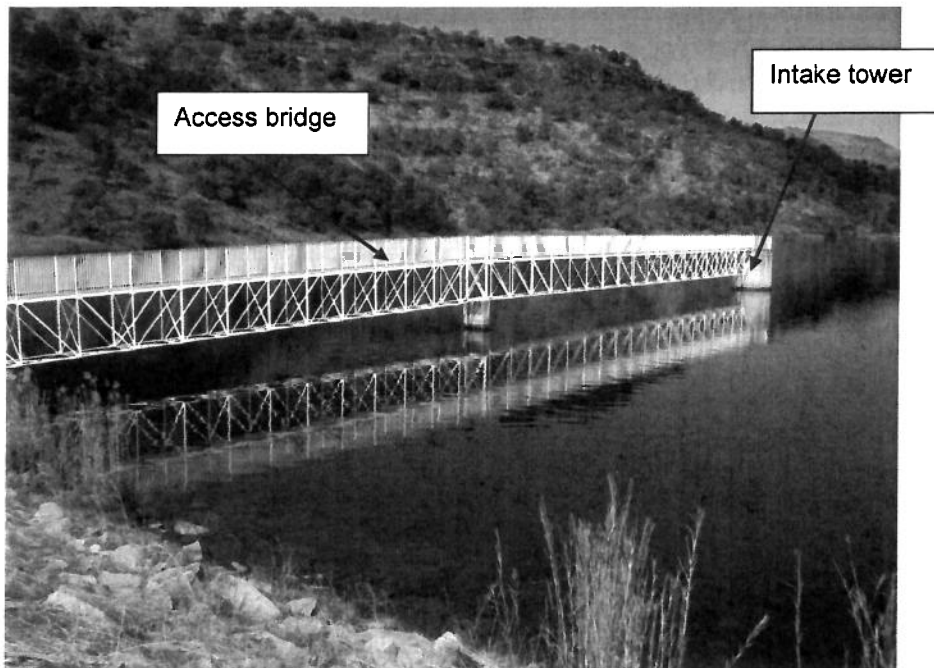
**Photo 12: Intake tower and access bridge. Note kink in bridge girder at the pier sloping towards the embankment (2010/07/27)**

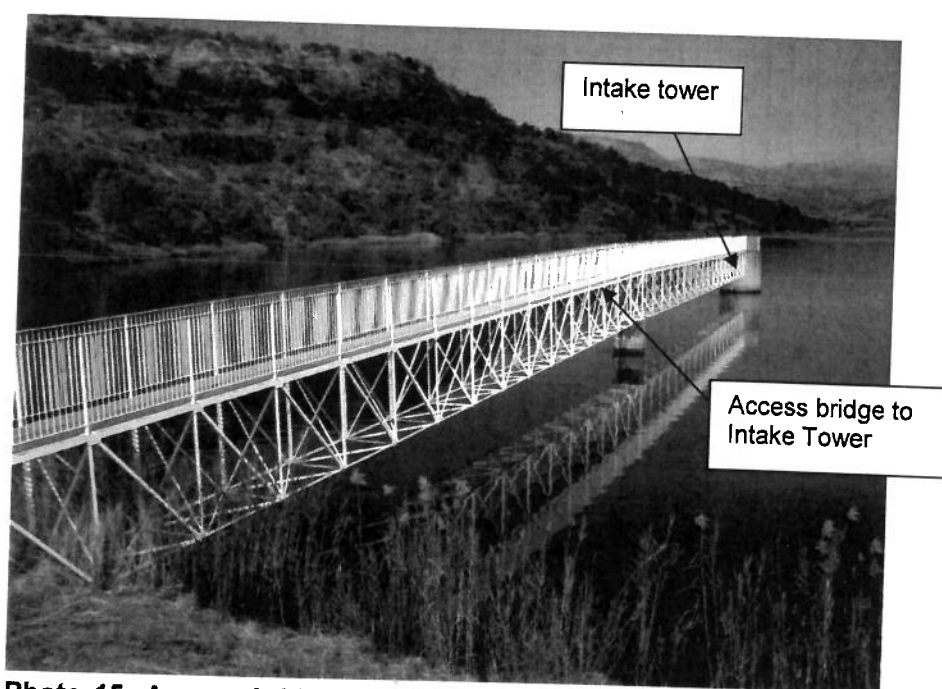
**Photo 15: Access bridge to the Intake Tower from the earthfill crest. Note the kink in the vertical alignment at the pier due to settlement of the bridge abutment of approximately 600 mm. The lateral stability of the bridge is a concern.**

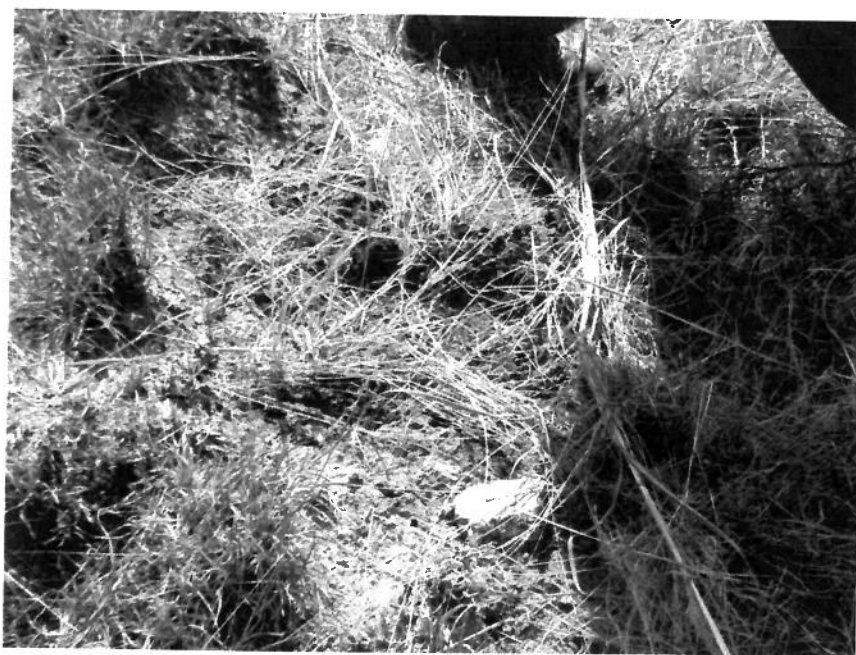
The NOC is covered with thin grass cover. Minor signs of local settlement are present on the crest, but no animal burrows, cracks or holes are present. Settlement has occurred under the support of the inlet tower bridge, as well as on the right abutment of the bridge across the spillway. The crest is uneven causing, downstream erosion due to surface water not being drained upstream. It is recommended that the crest be shaped to ensure proper surface run-off, as part of reinstating the design freeboard. This will also prevent ponding of water. Trees close to the toe of the wall should be removed.

**Photo 17: Signs of settlement on the embankment crest.**

- It is recommended that the dam crest be rehabilitated to its original height (or higher if needed for improved spillway capacity). The drain outlets must also be cleaned and maintained.

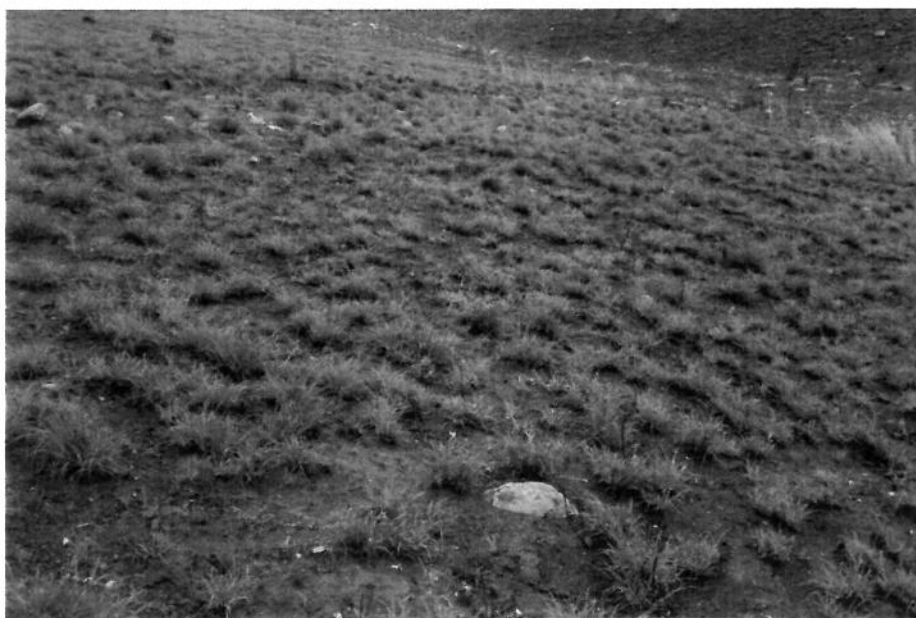
**Photo 20: Downstream slope of embankment seen from the downstream toe. Cutting and burning of grass took place during the period from August to October 2010.**

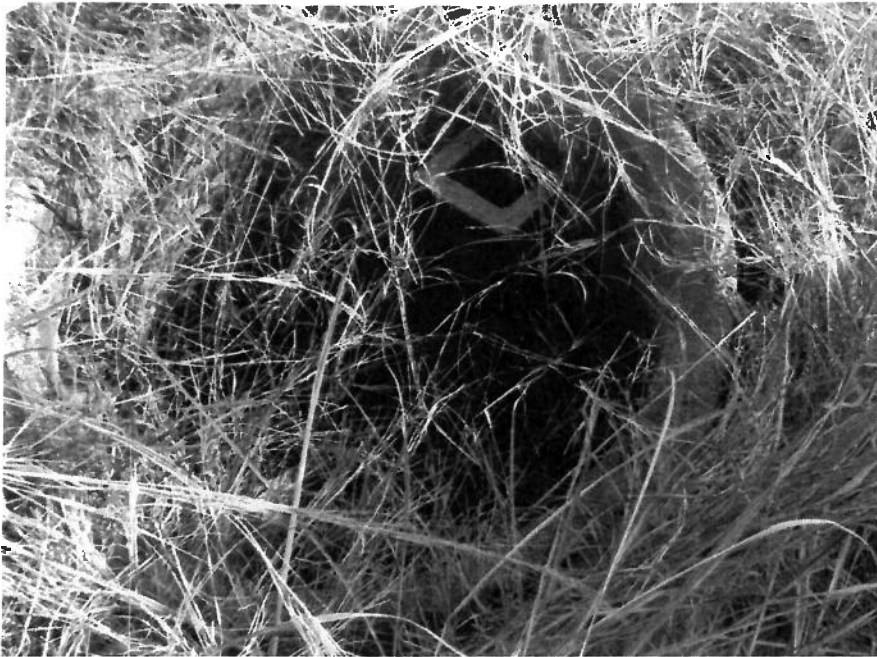
**Photo 21: One of the toe drain manholes that was previously overgrown with grass. Refer to Section 6 for details. Manhole covers are to be provided.**

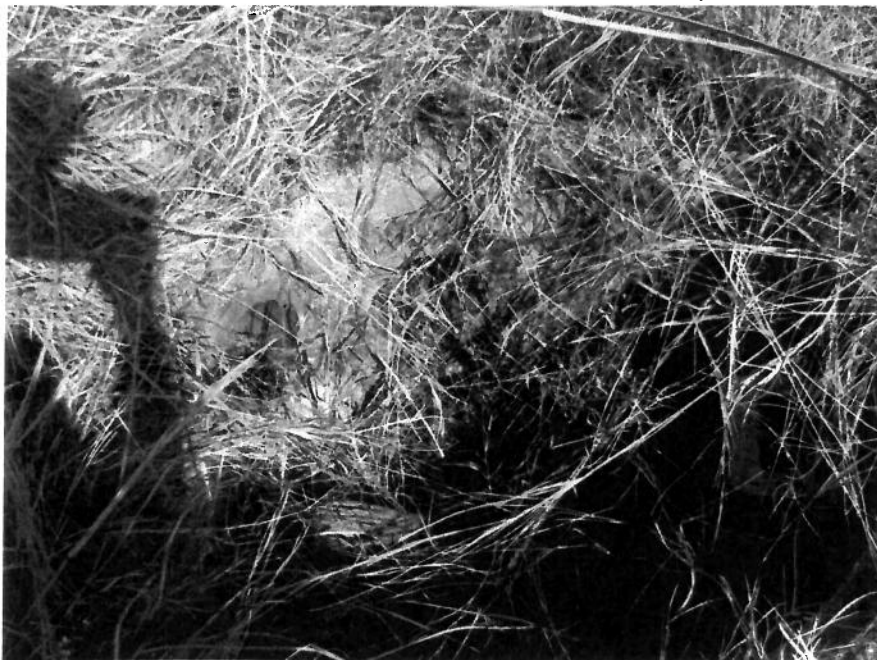
**Photo 22: Pipes in manholes previously covered with sediment.**

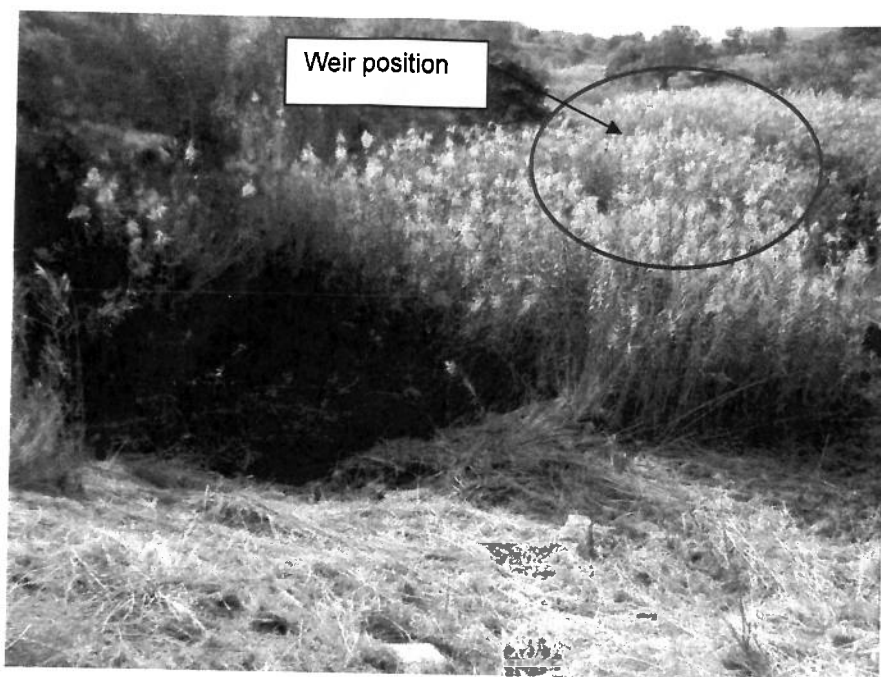
**Photo 23: Gauging weir to monitor river releases and leakage from toe drains somewhere hidden in the reeds. Long grass in the area makes reading difficult. No signs of seepage could be found, but it is recommended that the grass and reeds in this area be cut and signs of seepage identified.**

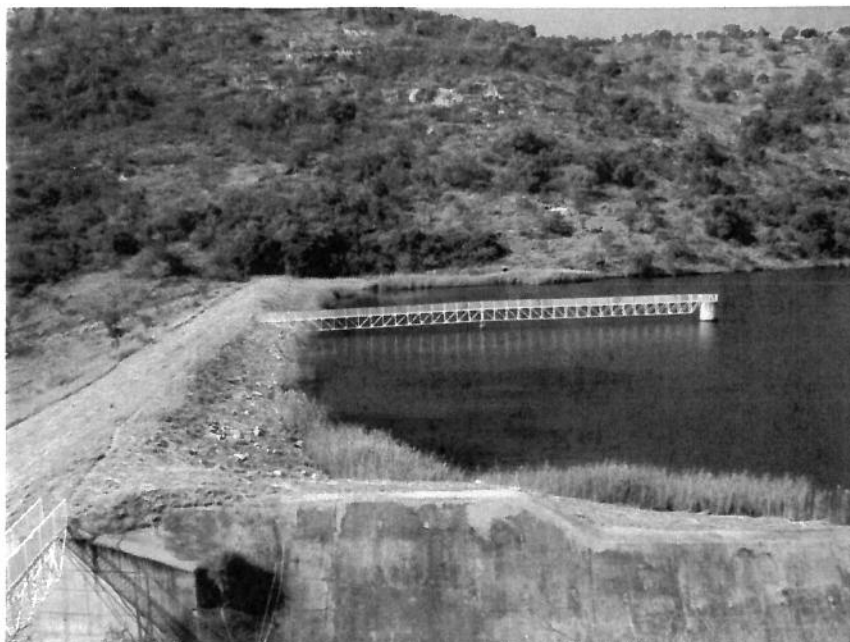
**Photo 24: General view from the left hand of the side channel spillway. Note the kink at the pier of the access pedestrian bridge from the dam crest towards the intake tower.**

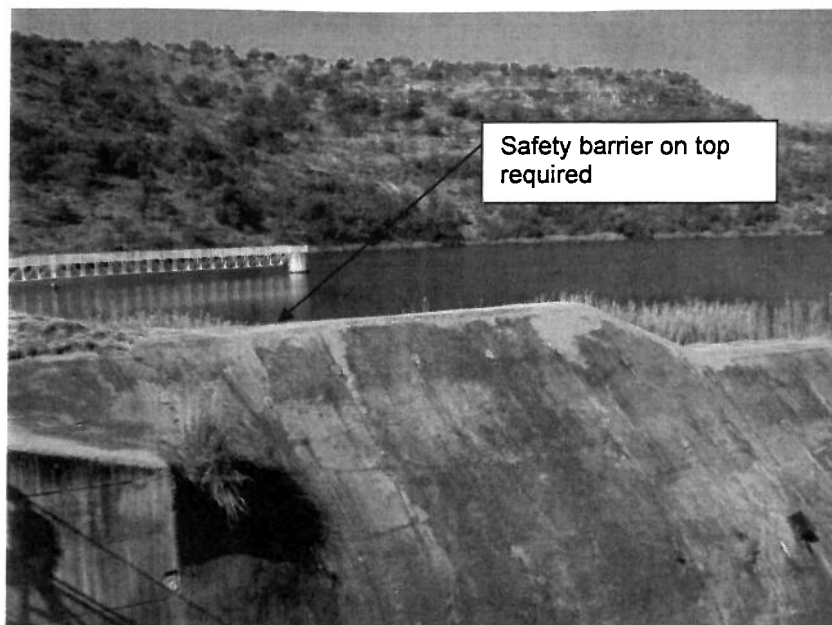
**Photo 26: Side channel spillway and retaining wall at the connection between the spillway and earthfill embankment. It is recommended that a safety barrier be provided to prevent personnel from falling into the spillway.**

- Grass growing in the cracks of the spillway crest is to be removed. The loose spillway cladding will wash away during a flood event.
- No safety barrier of any kind as fall protection is present along the top of the side channel spillway return channel. Personnel working at the dam are endangered.

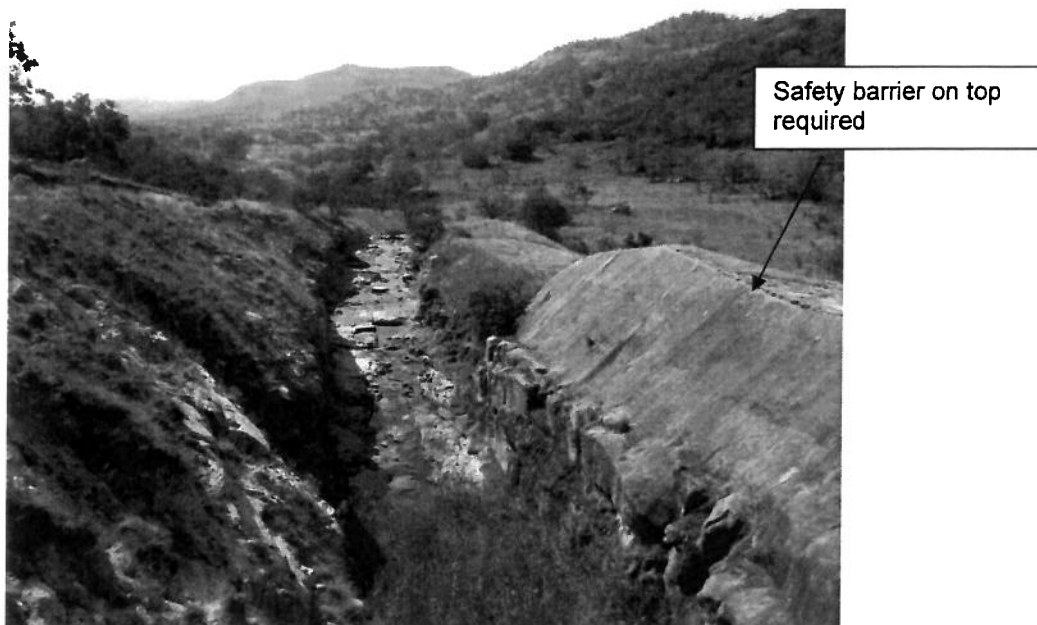
**Photo 27: Downstream view of side channel spillway (photo taken from pedestrian foot bridge). Note shotcrete on right hand side.**
