JERICHO DAM

FOURTH DAM SAFETY EVALUATION REPORT

January 2016

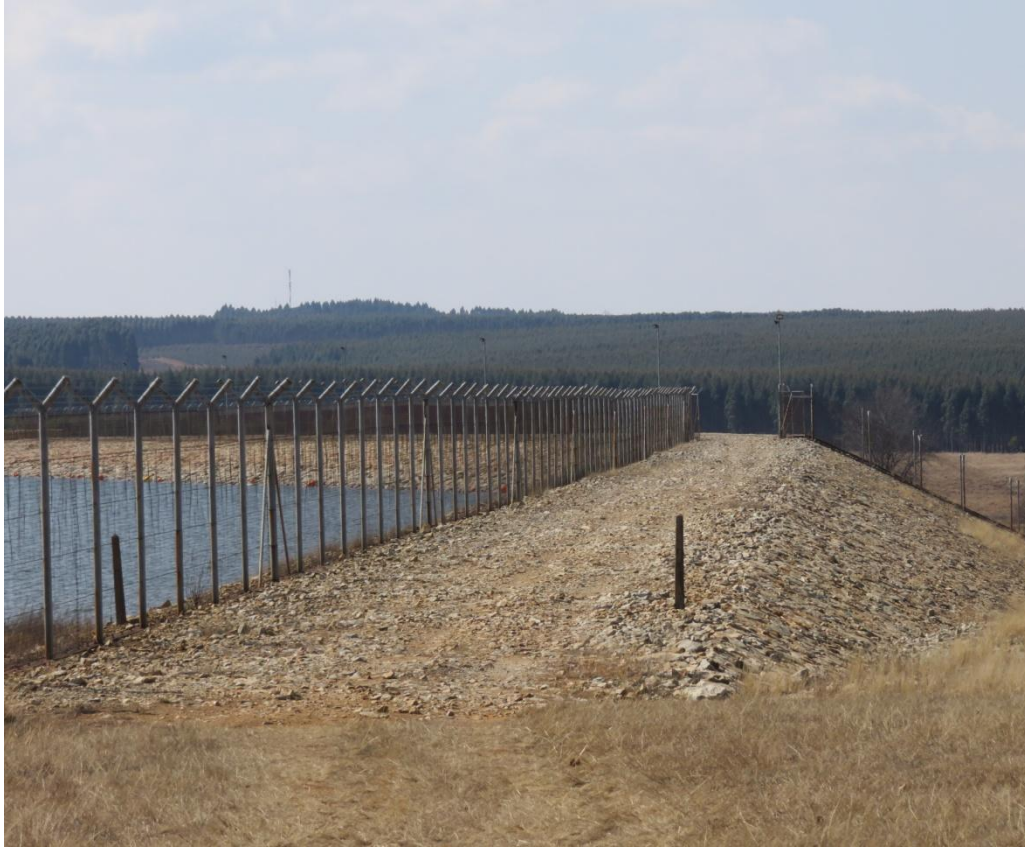
The right bank earth fill wall is generally in a very good condition - see photos 1 and 5.

1) View of the right bank earth fill wall

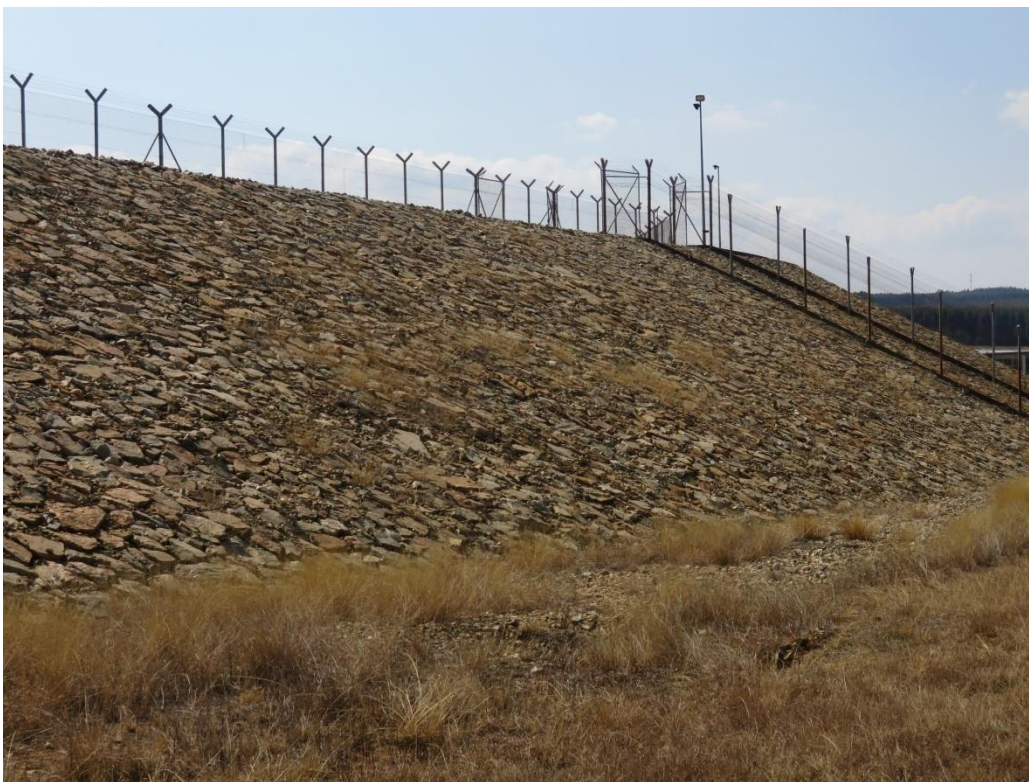
The downstream slope of the right bank earthfill section is maintained in an excellent condition with minimal vegetation and no signs of movement (cracks, settlement, bulging or sliding), no animal burrows. No signs of leaks or wet pathes. The areas between the packed rip-rap is mostly filled with finer gravel without any significant erosion. See photo 2.

2) Downstream slope of the right bank earth fill wall showing some grass growth but mostly in excellent condition

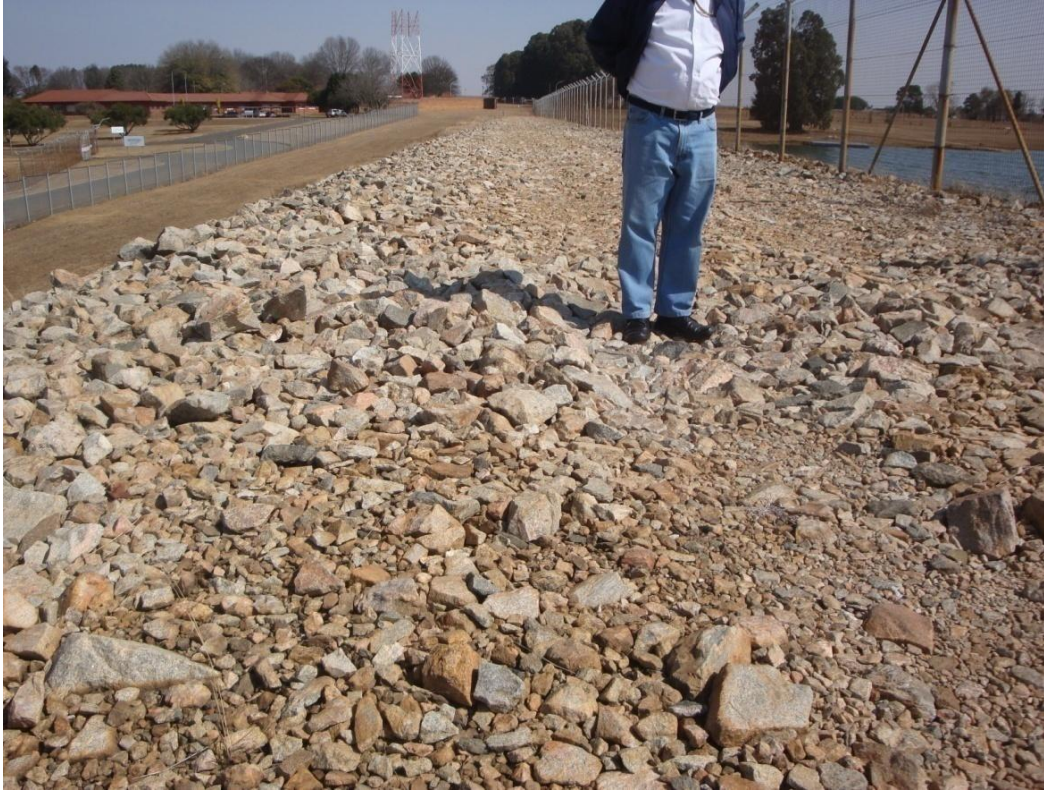
The non-overspill crest (NOC) is generally in a good condition. The NOC is covered by a course crusher run. Some disturbance or rutting was observed here and there and most noticeably about halfway along the right bank due to vehicles driving on the wall (photo 3). It is not considered a maintenance problem yet, but it should be monitored and levelled from time to time.

- 3) Disturbance because of trucks on the crest. Has been filled with larger rocks

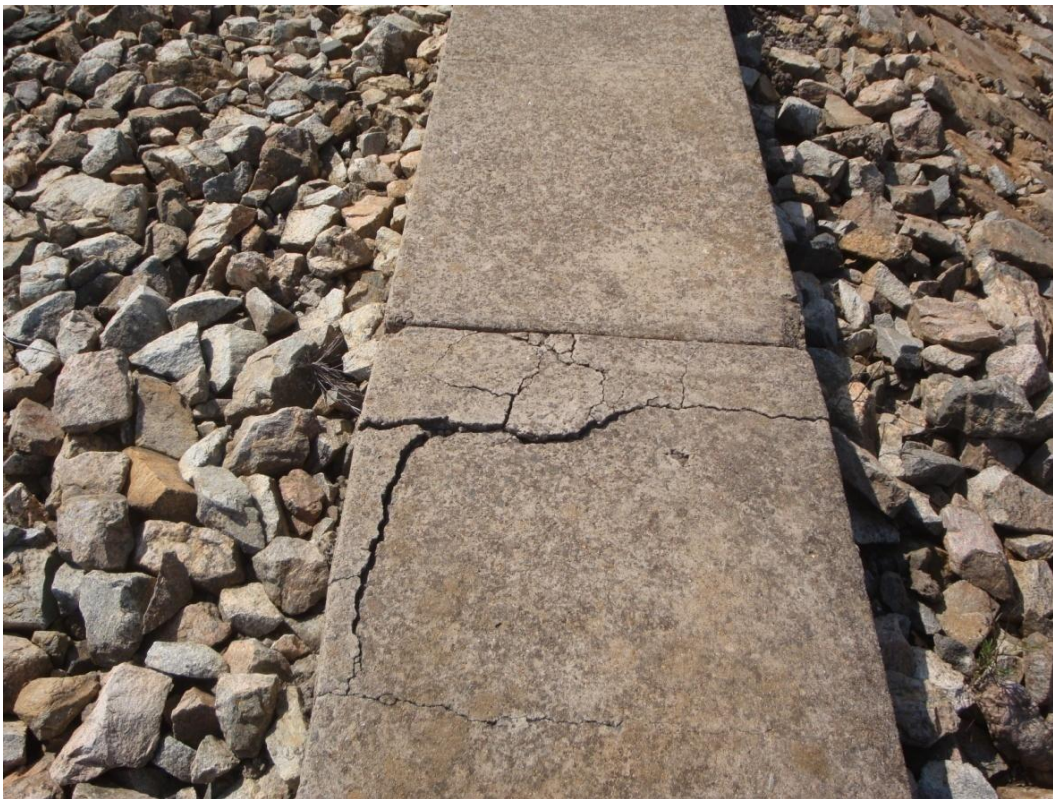
- 4) Cracking on the concrete sill on the earth fill crest

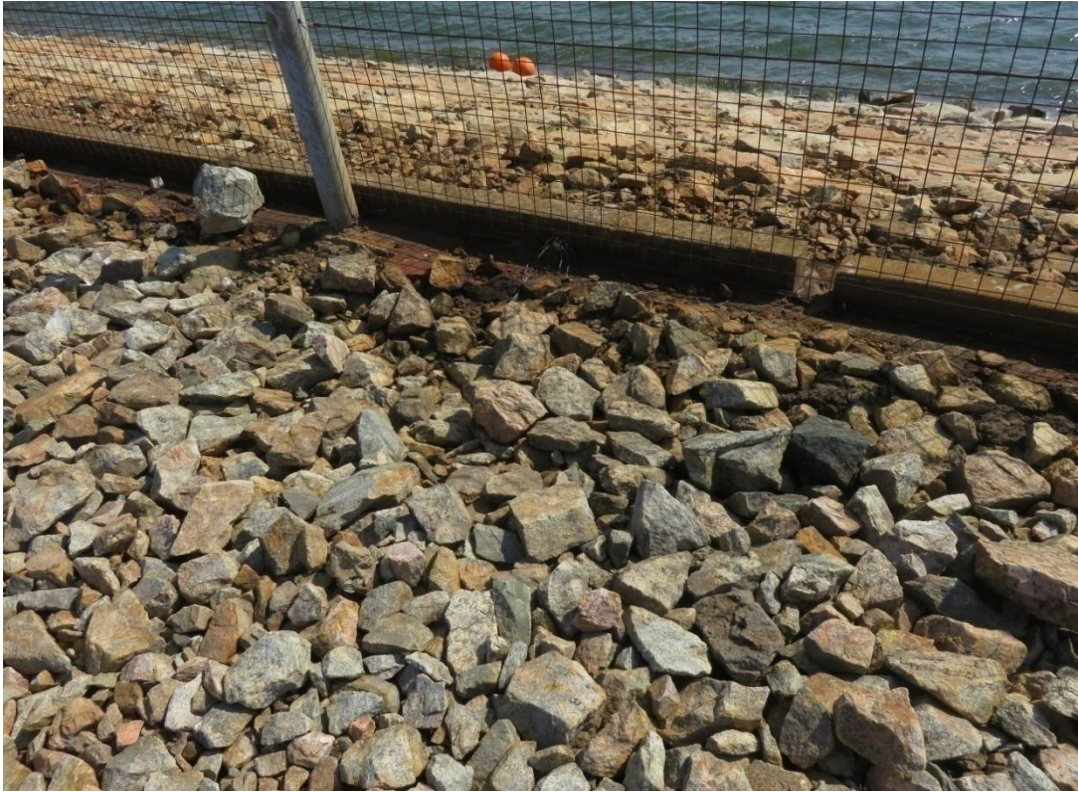
The safety/security fence along the crest was in generally good condition but showed some rusted areas (photo 5).

5) Corrosion of the base plate strip of the fence

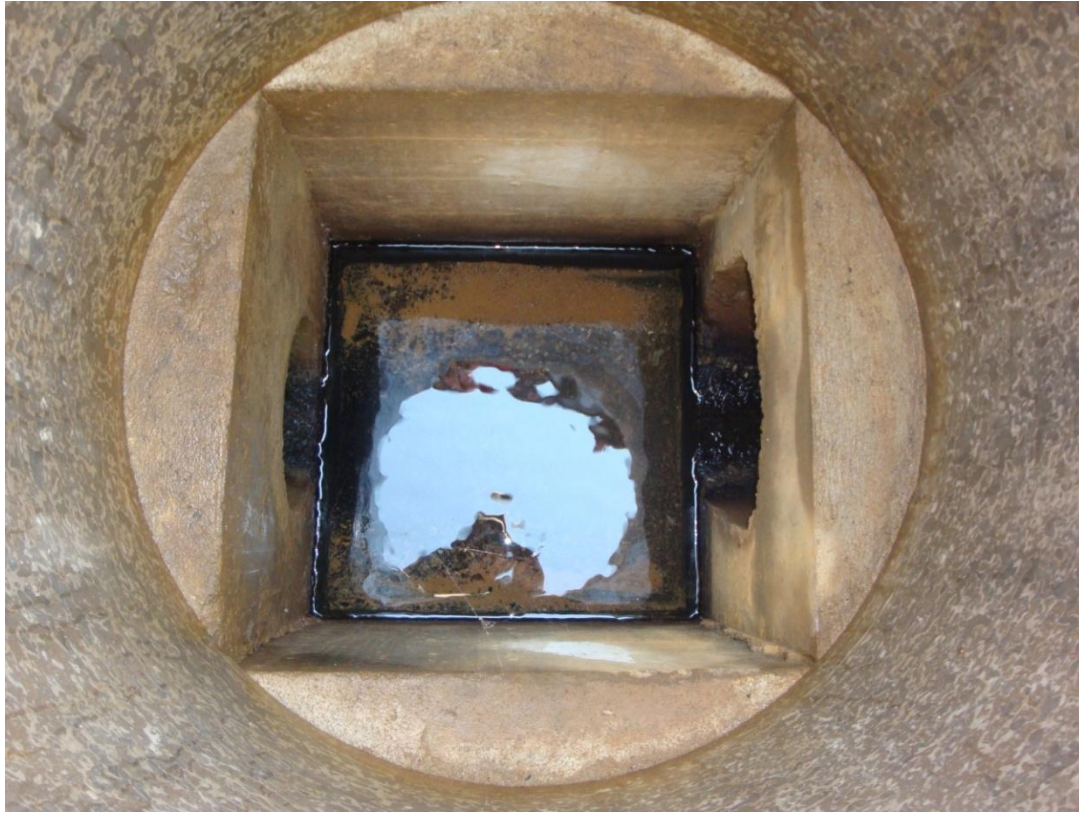
9) Slow flowing water in one of the tow drain wells close to the spillway

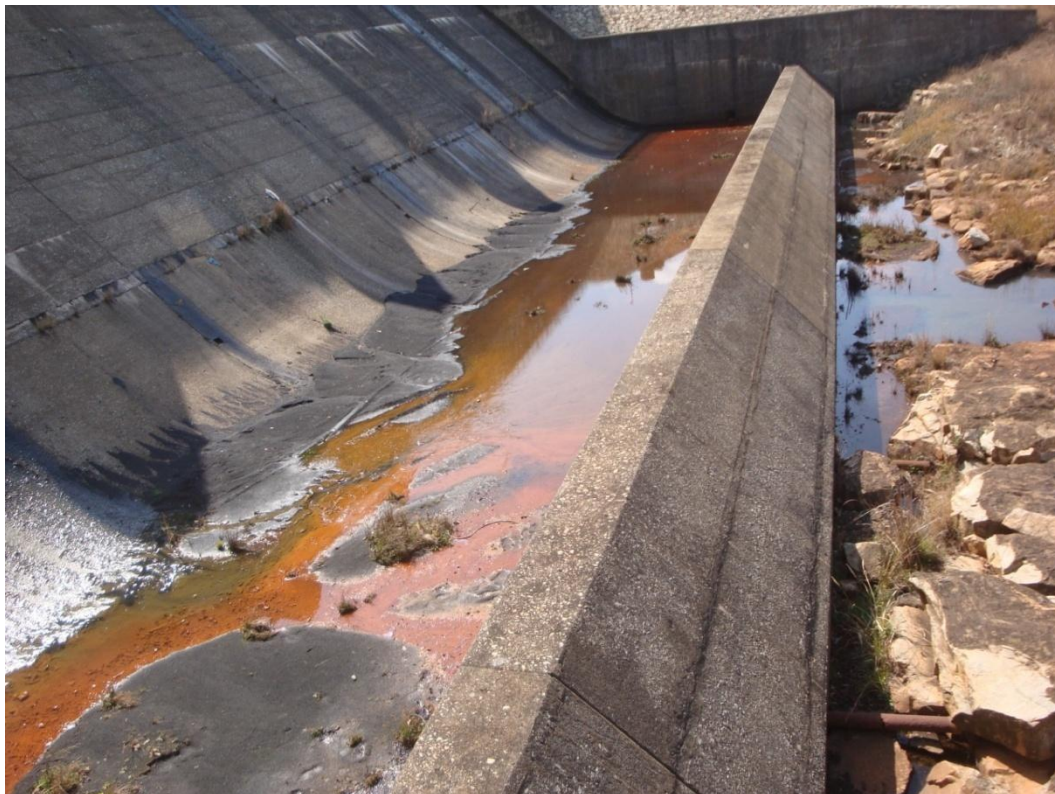
The apron / stilling basin is in good condition with no significant erosion visible. There were orange clay deposits from the toe drain into the stilling basin. See photo 10. Black residue from

10) Apron of the spillway. The orange clay in the water washes out from the galleries discharge holes

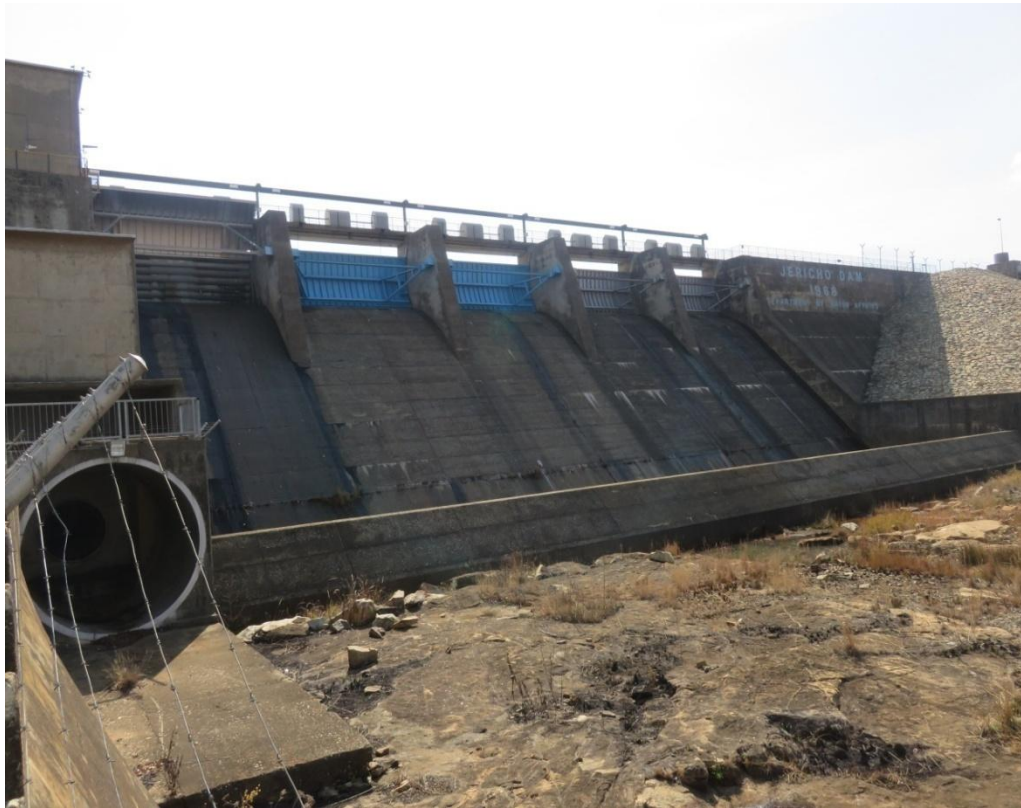
11) Downstream view of the spillway with the five radial gates visible. Downstream area with exposed foundation in the foreground.

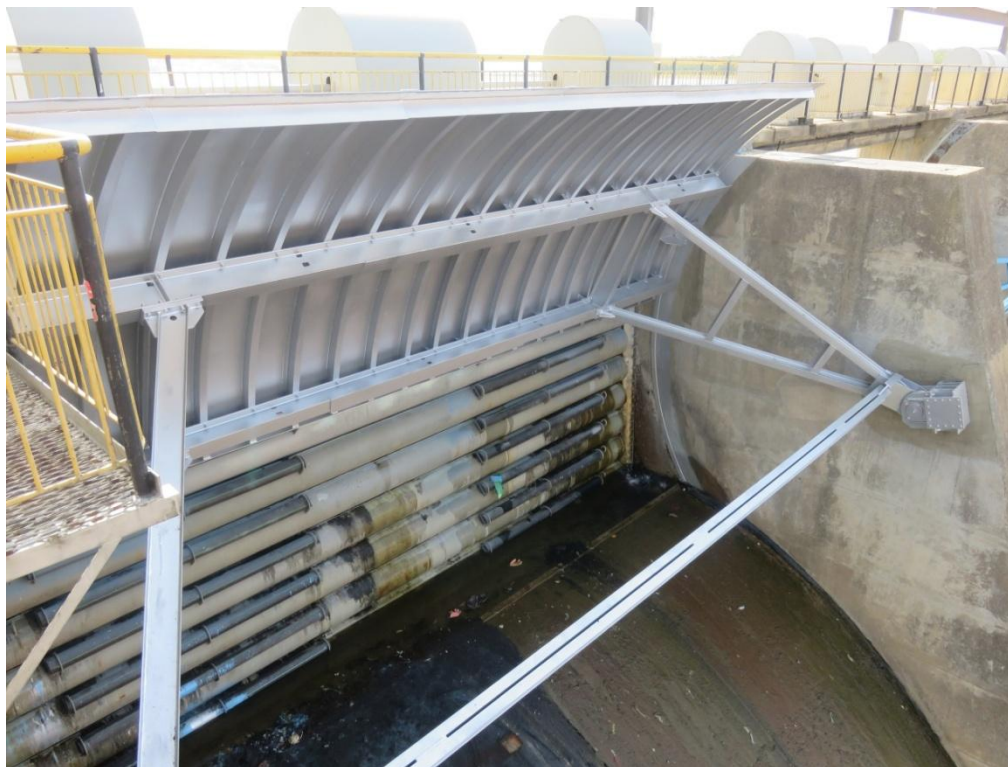
12) The 1st gate undergoing refurbishing. The water stops / "dryf blok sluise" to close the opening under the gate are visible under the gate

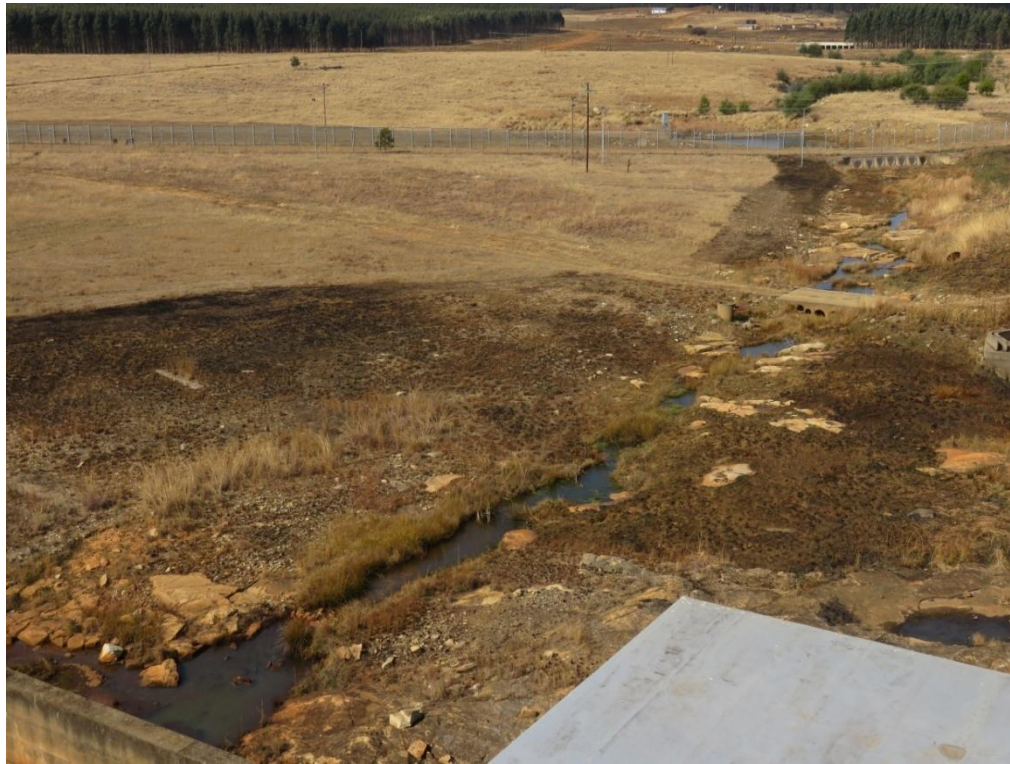
15) Downstream river bed of spillway. Note the exposed solid granite bedrock exposed closer to the stilling basin.

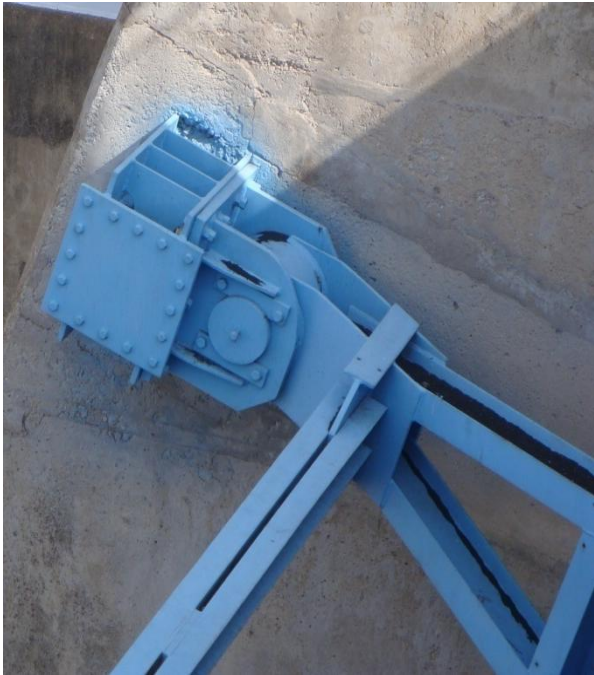
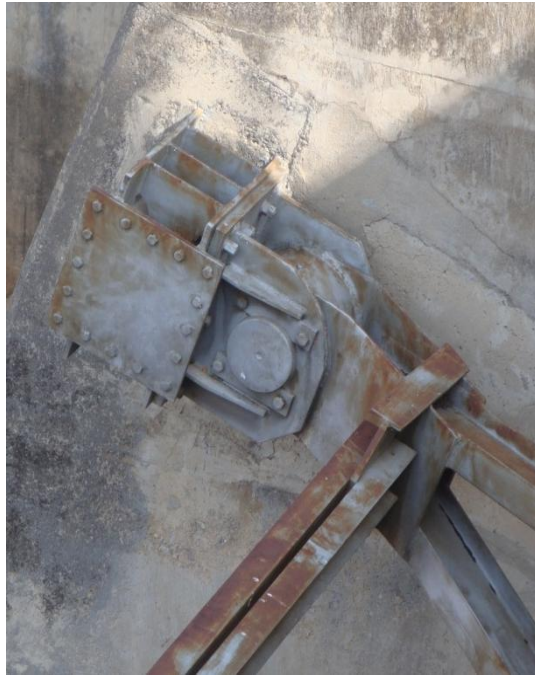
There was some minor spalling further up on the piers in areas (photo 18), but the concrete is generally good condition. No cracking was visible in the reinforced concrete in the areas where the forces of the radial gates are transferred to the piers.

18) Spalling on one
of the piers'
upstream
surfaces.

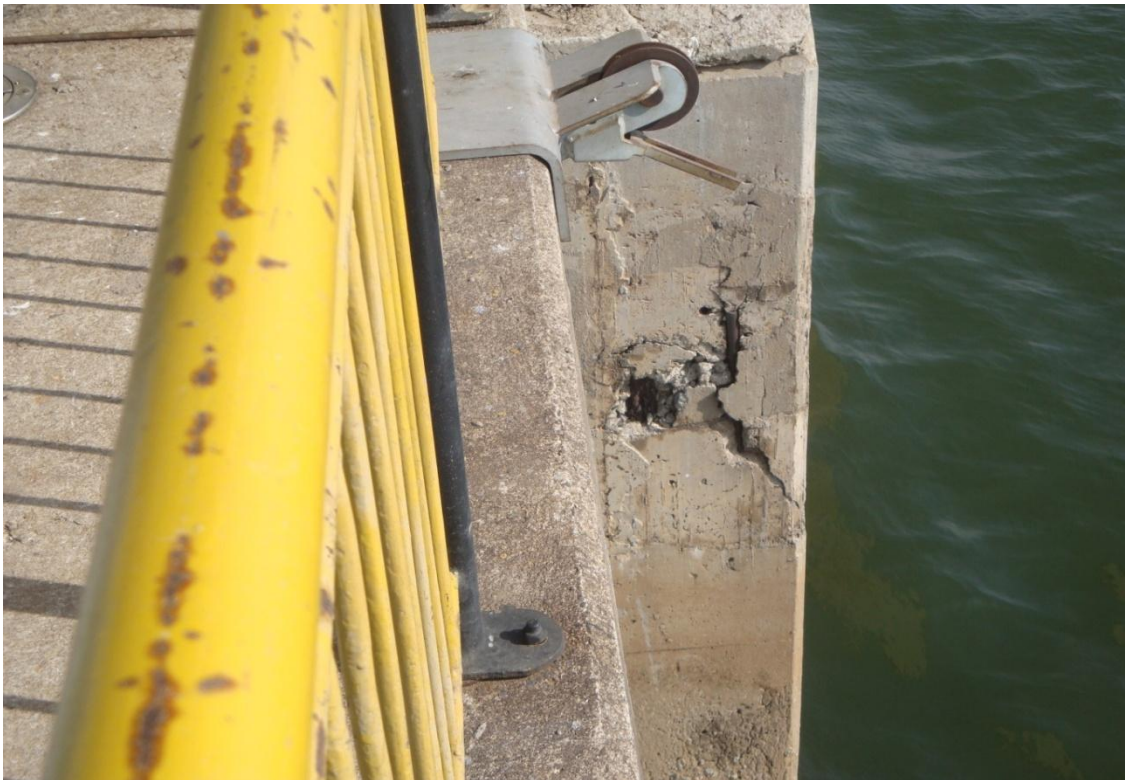
The downstream face is in a good condition with no significant deterioration or cracks. Minor plant growth was observed in some areas that should be removed at some stage. Minor leaks were noted on a few horizontal construction joints and a few calcite stains also below horizontal construction joints. See photos 19 & 20.

19) Minor leaks
and vegetation
seen on the
spillways ogee

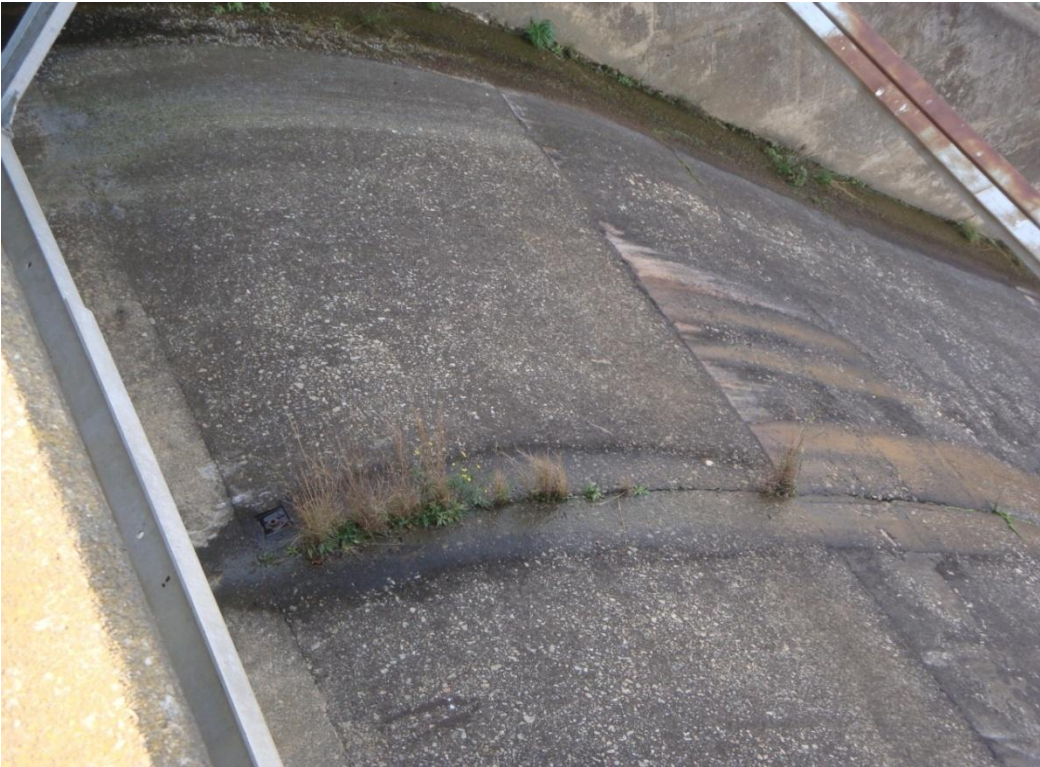
20) Downstream
slope of the
concrete wall.
Some
vegetation
growth and
leakage visible.

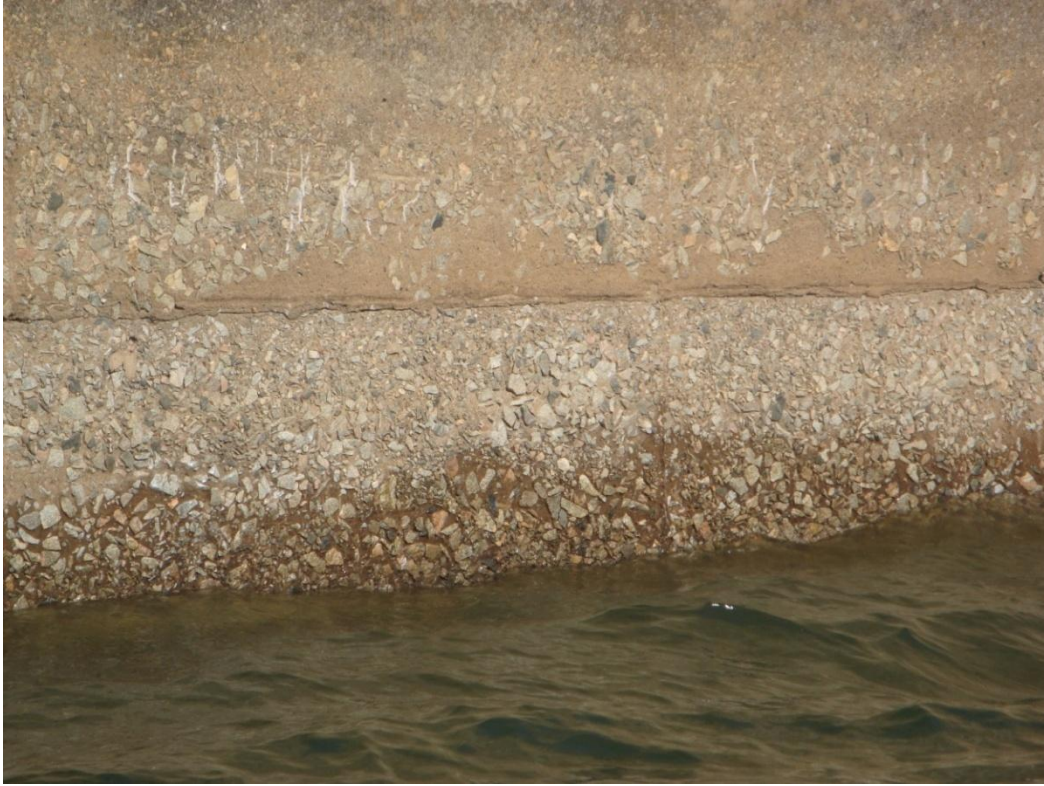
With the dam's water level being fairly high on the day of the inspection (80 % full) not much of the upstream face of the spillway could be evaluated. Some corrosion (exposed aggregate) was however visible on the concrete face just above the water mark. See photo 21 & 22.

21) Minor corrosion (exposed aggregate) on the upstream face of the wall.

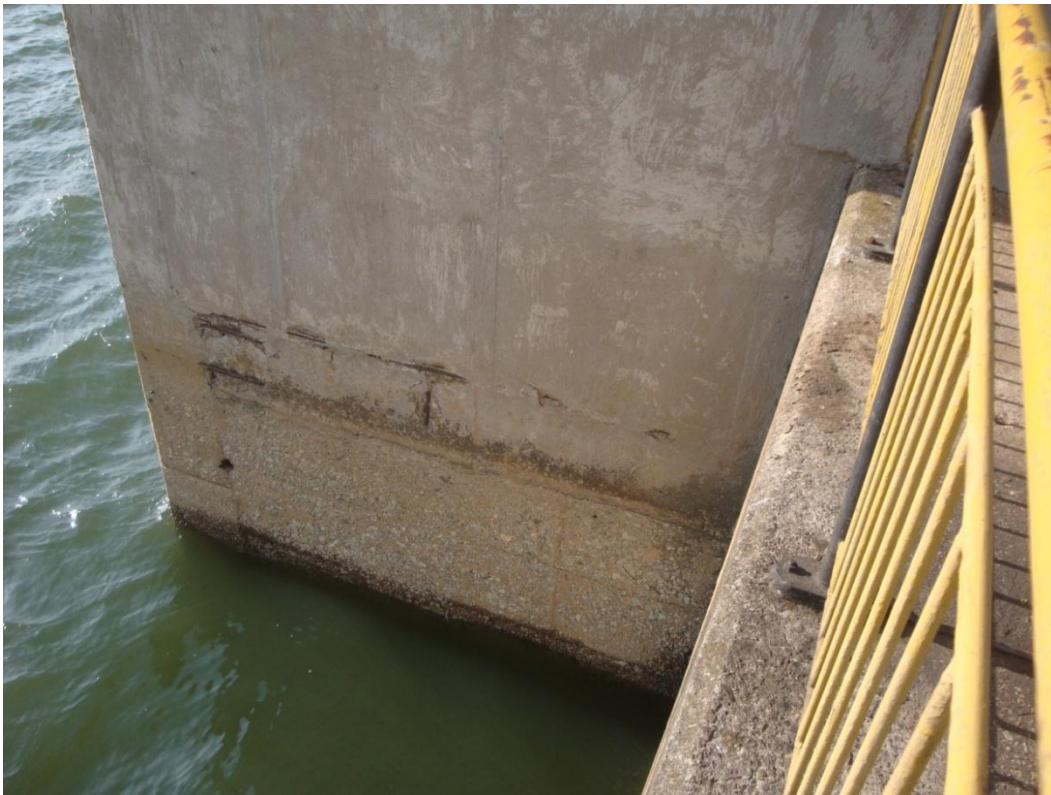
22) Minor corrosion (exposed aggregate) on the upstream face of the wall.

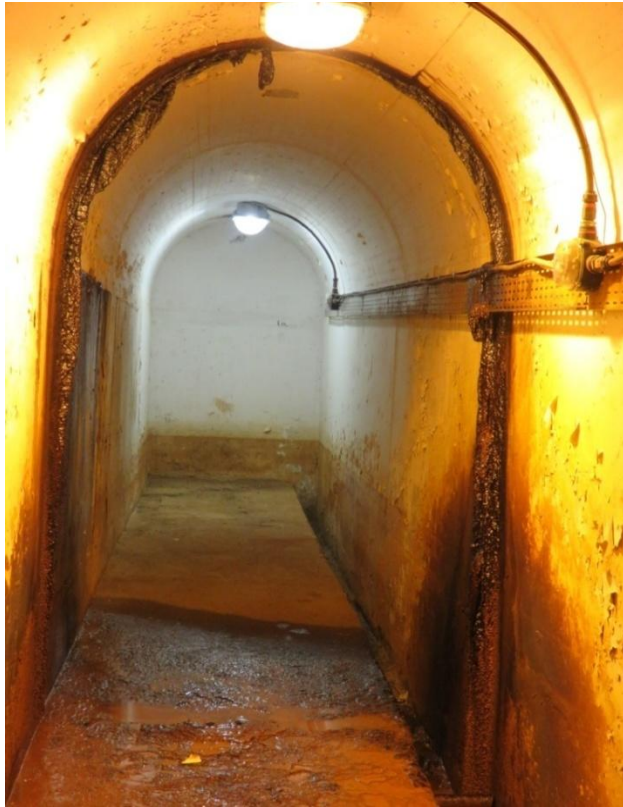
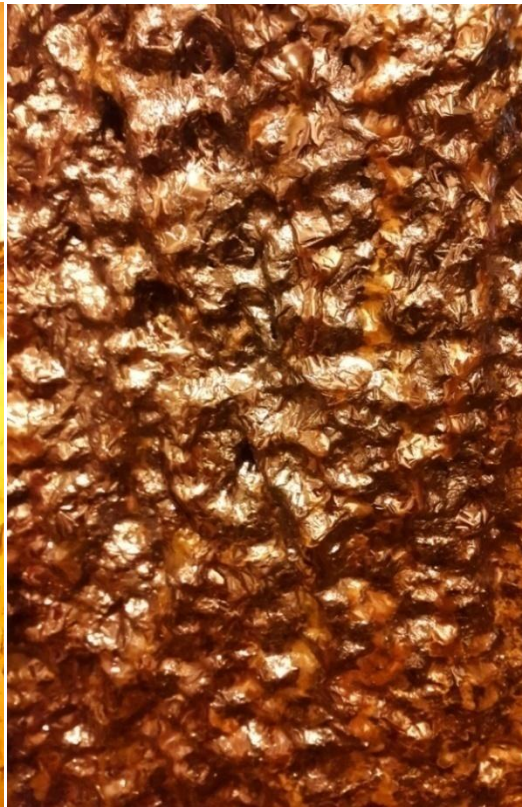
The drainage gallery is clean and well maintained. Block numbers are clearly marked on both sides of most of the vertical contraction joints. No significant movement can be seen on vertical contraction joints or horizontal construction joints. A few cracks are visible but they are minor and do not infer any movement or swelling. Some of the vertical contraction joints in the core wall sections are leaking slightly with a build-up of calcite with a dark colour. This is probably due to clay leaking through the joints from the earth fill around the core wall. In the spillway section the calcite marks are white with no dark staining. See photos 23 to 25.

- 23) Left:
Mineral/clay
leakage at the
vertical
contraction
joint between
blocks 1 and 2.
- 24) Right close up
of the mineral
clay deposits.

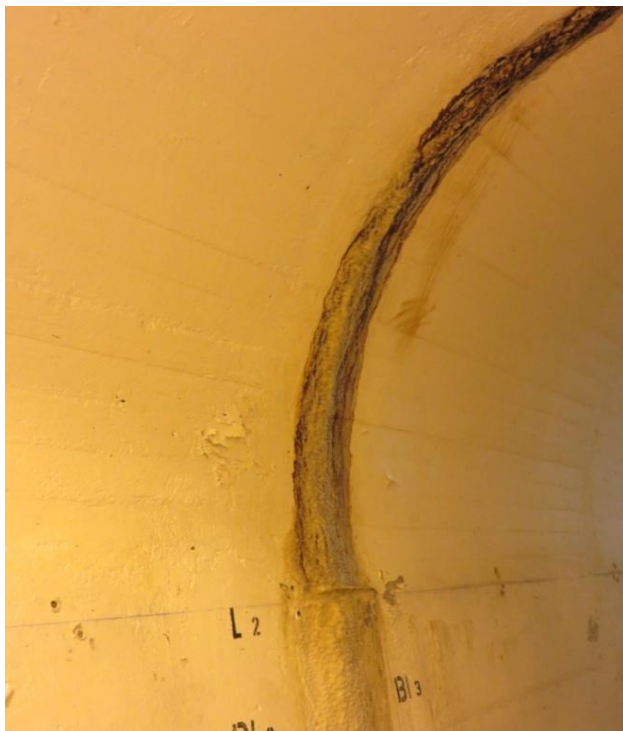
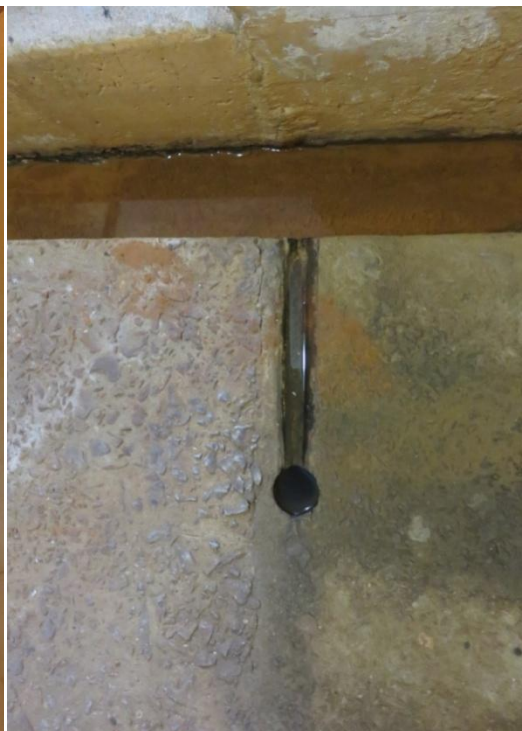
- 25) Left: Mineral
deposits at one
of the vertical
contraction
joints.
- 26) Right: Water
discharge out of
one of the
pressure relief
holes

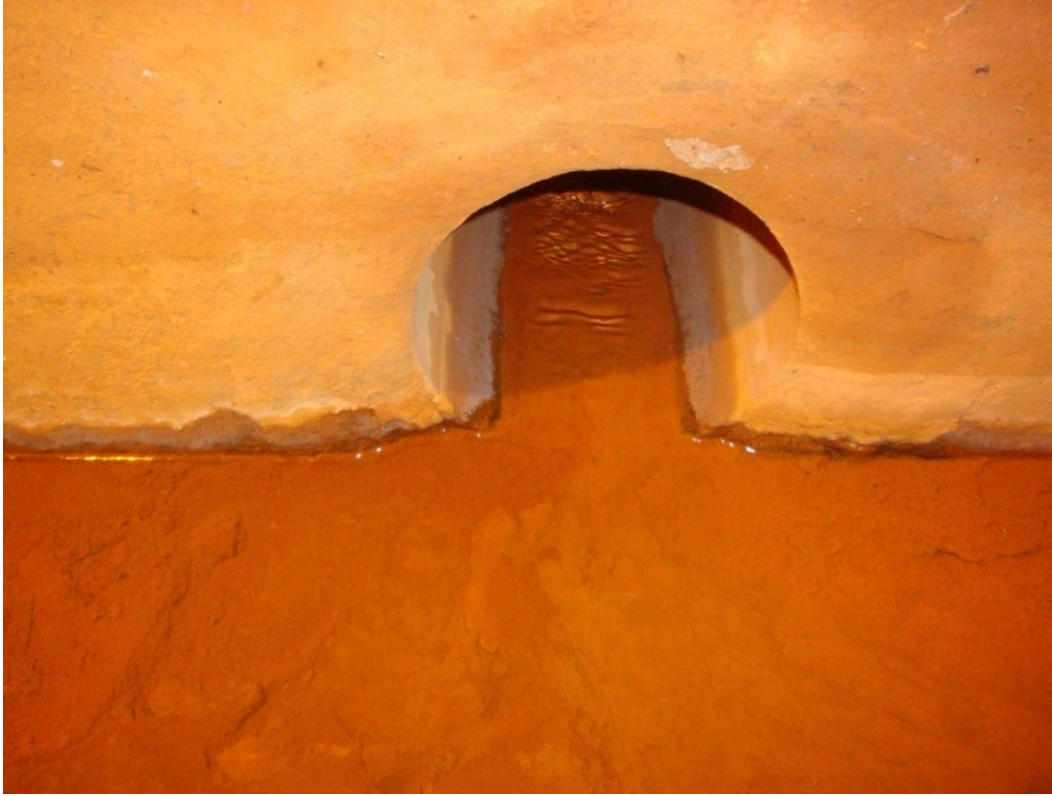
29) The clayey water from the pressure relief holes being carried away through the outlet

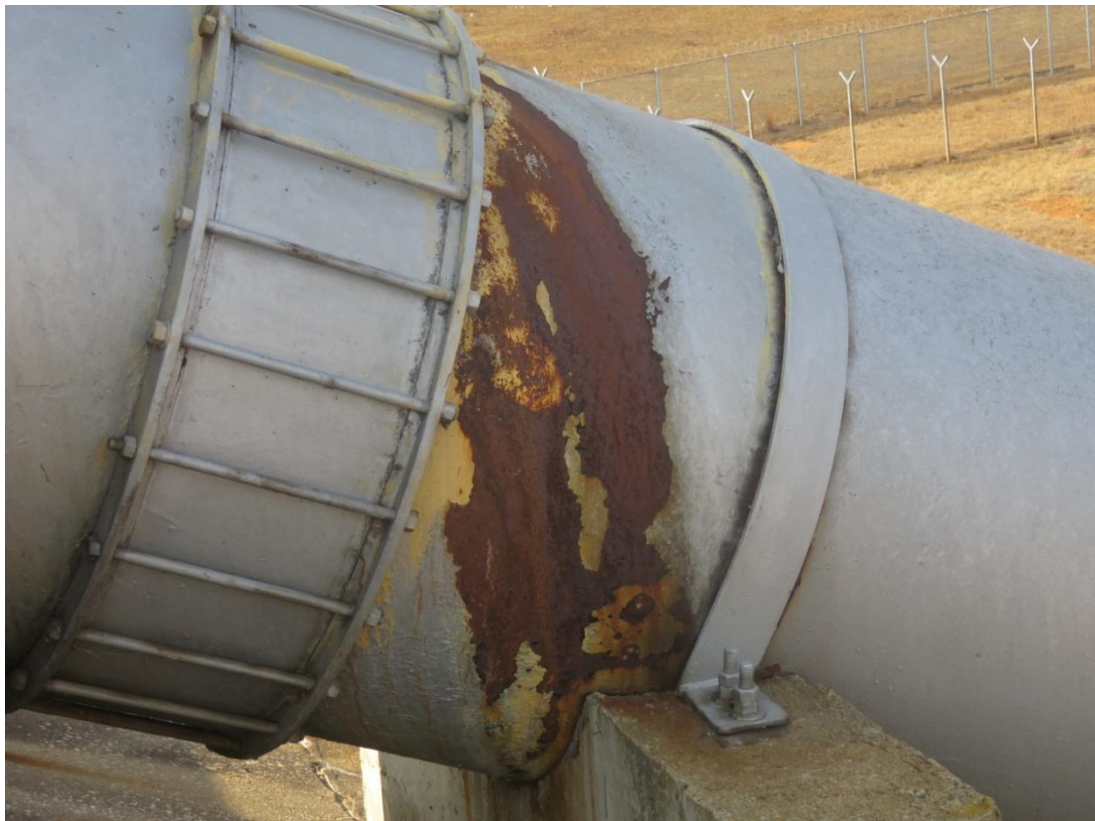
32) Westoe delivery pipe showing some rust at the top connection.

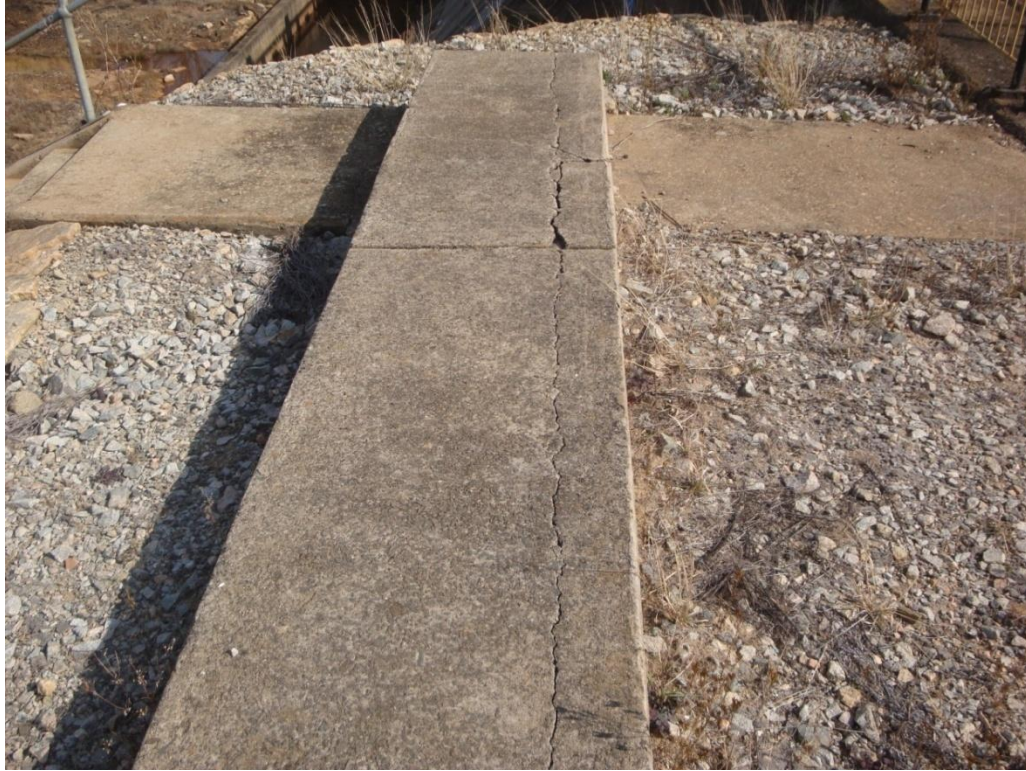
35) Minor cracking
in the concrete
sill on the crest.

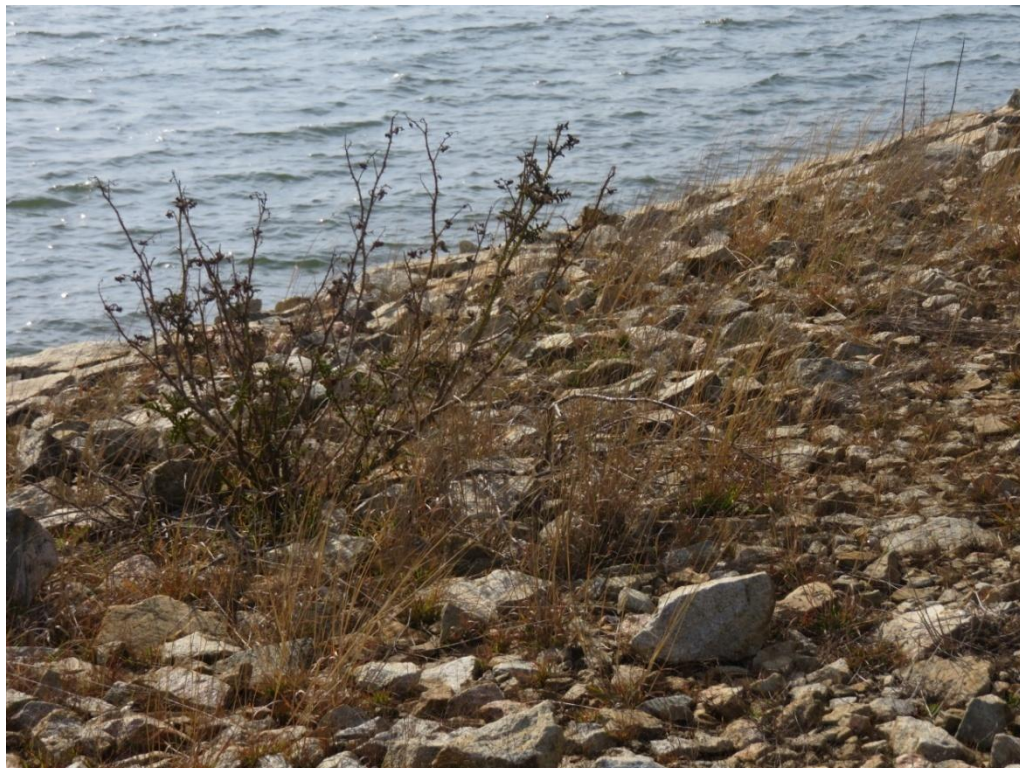
There is more vegetation in some places on the left bank than the right, but is minor and the slope is still considered to be in very good condition.

38) Some of the
few minor
vegetation on
the upstream
slope of the left
bank
