Department:  
Water Affairs  
**REPUBLIC OF SOUTH AFRICA**

# **DAM SAFETY OFFICE 2012/2013 ANNUAL REPORT**

**ADMINISTRATION OF THE DAM SAFETY  
LEGISLATION IN TERMS OF  
CHAPTER 12 OF THE NATIONAL WATER ACT,  
1998 (ACT № 36 OF 1998)**

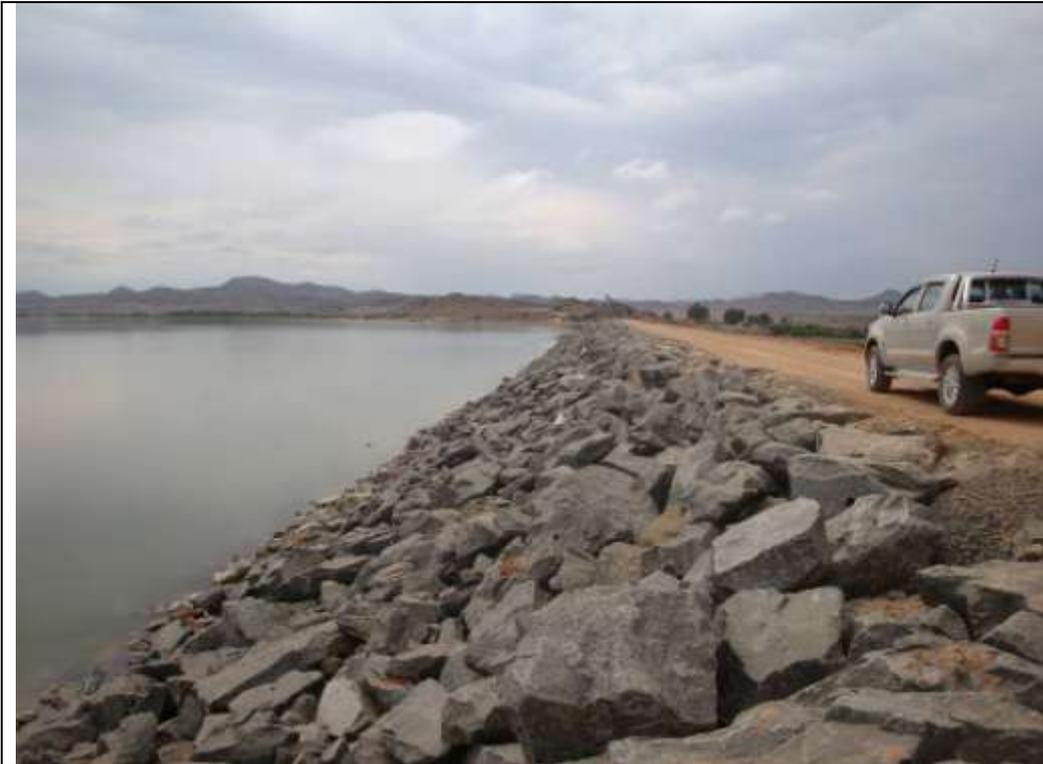
Rehabilitation of the upstream face showing the new rip rap already at crest level. A gravel layer at crest level is still outstanding.

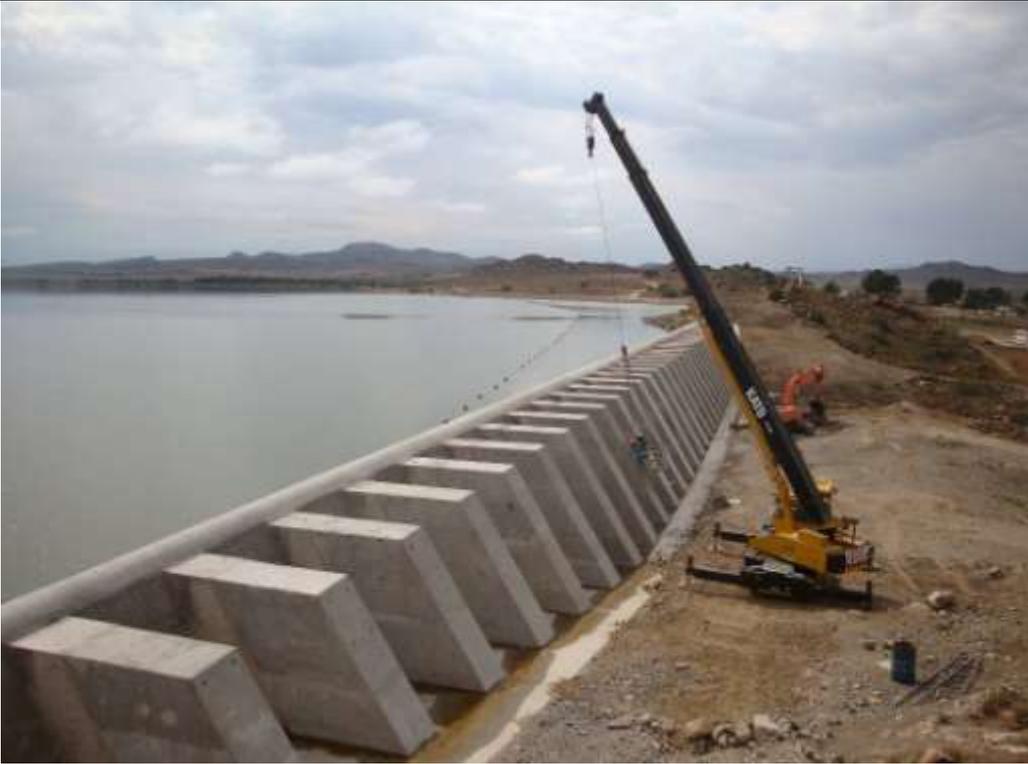
Rehabilitation of the main spillway.

The crest was cut down and rebuilt with a round shape to improve the discharge coefficient.

The buttresses were extended to the downstream side to improve stability.

The foundation rock between the buttresses were protected with a concrete slab.

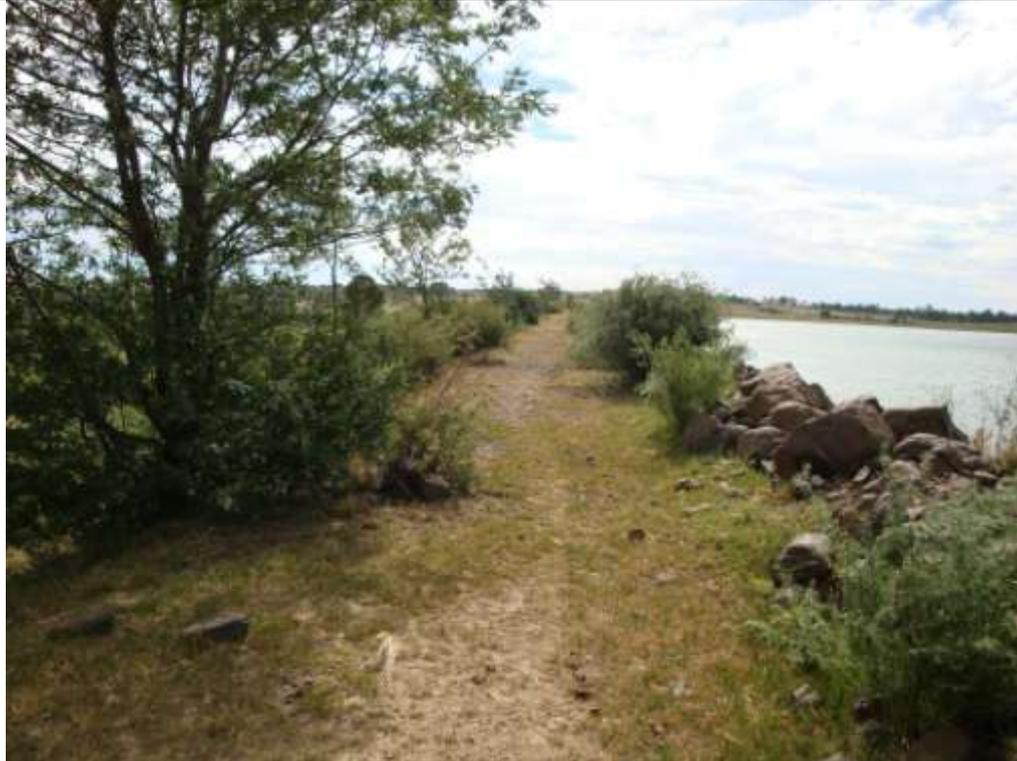
View along crest of damwall. There are trees that need to be cleared away urgently.

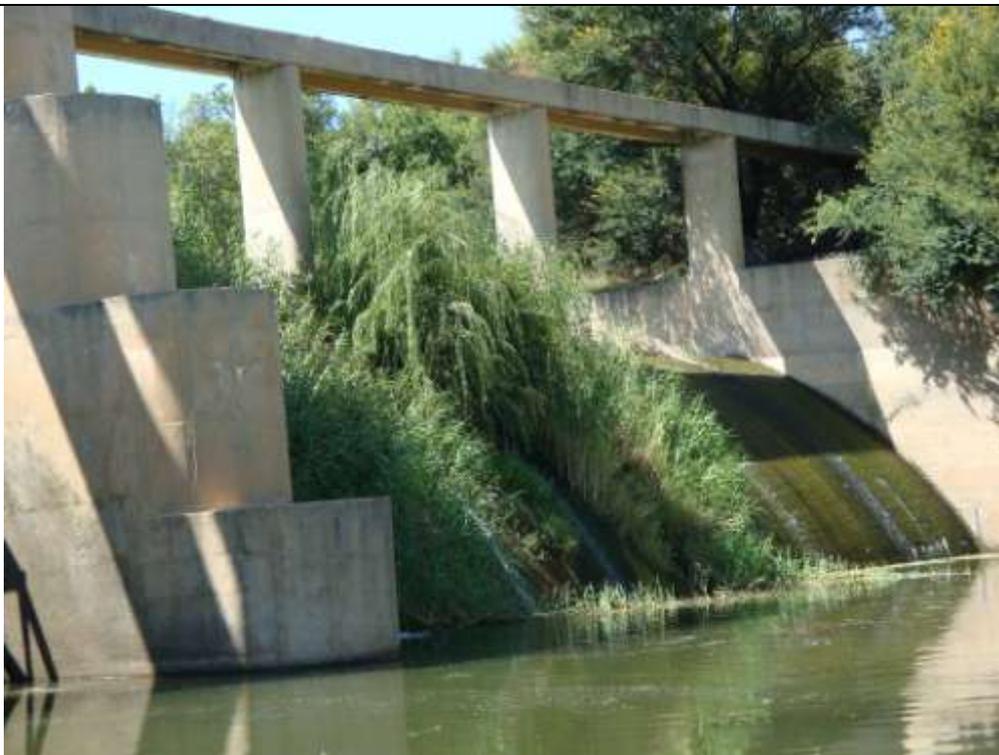
Erosion was detected by the APP in the last dam safety inspection report under the right side of the spillway downstream toe. The APP estimated the depth of the undercutting to 2m but needs a diver to measure its width.

In the picture vegetation can be seen growing out the expanding construction joints on the dam wall. These expanding cracks could be a sign of the instability of the dam wall.

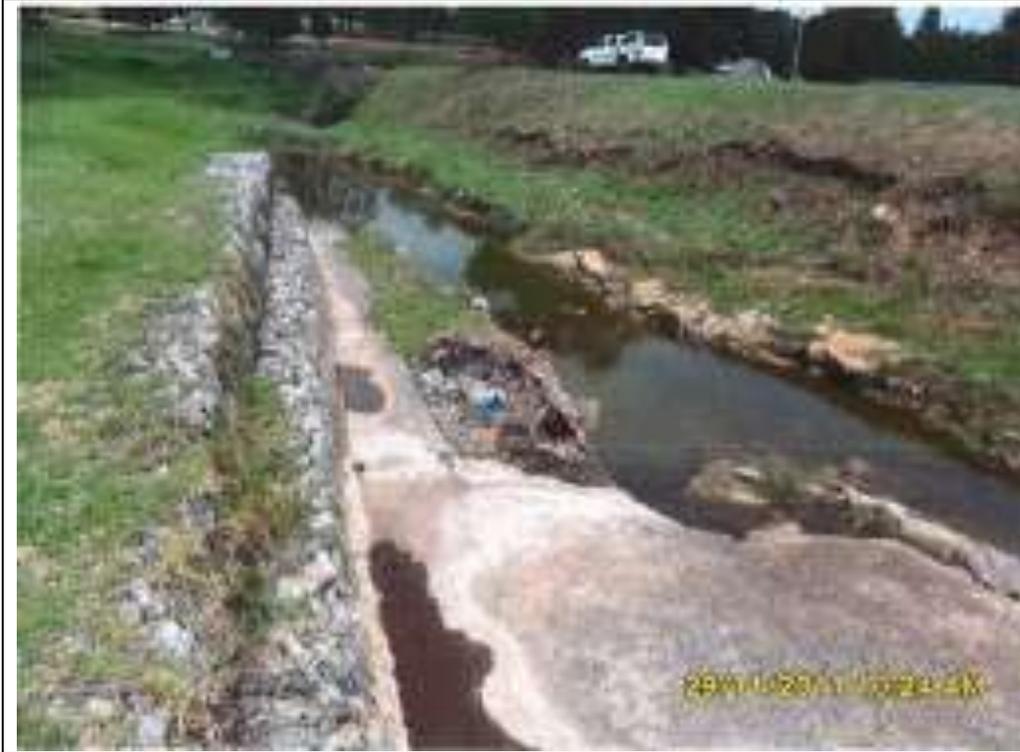
BEFORE: Right Bank Spillway chute of Modderfontein Factory Dam No 1

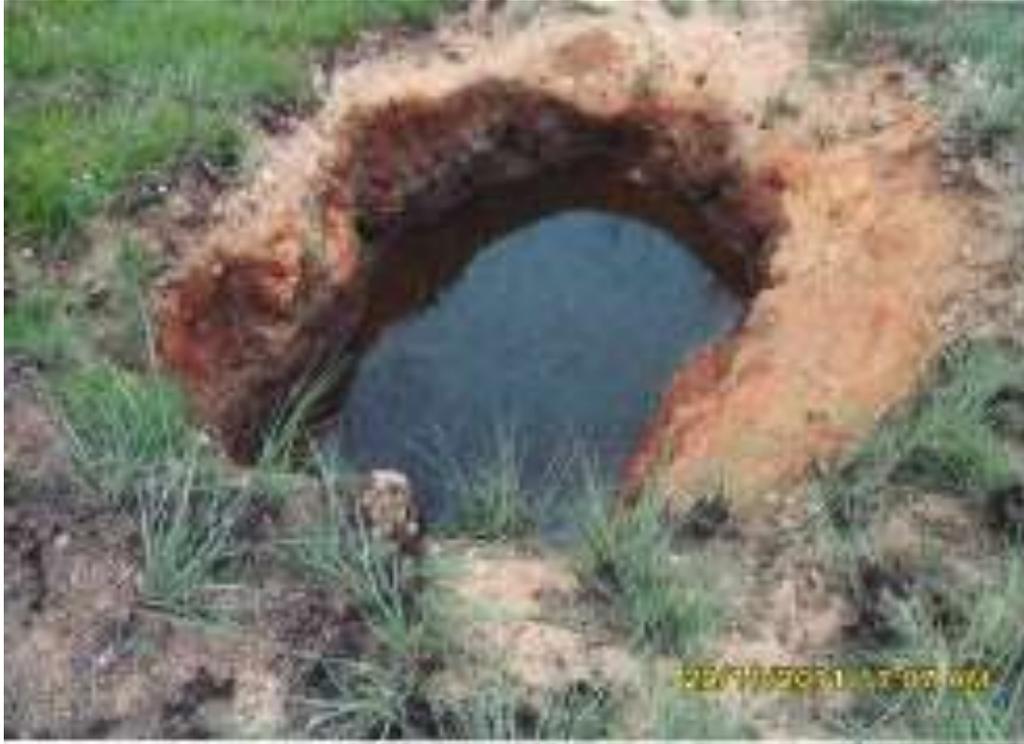
BEFORE:  
Erosion hole in  
right bank  
spillway chute  
of  
Modderfontein  
Factory Dam  
No 3.

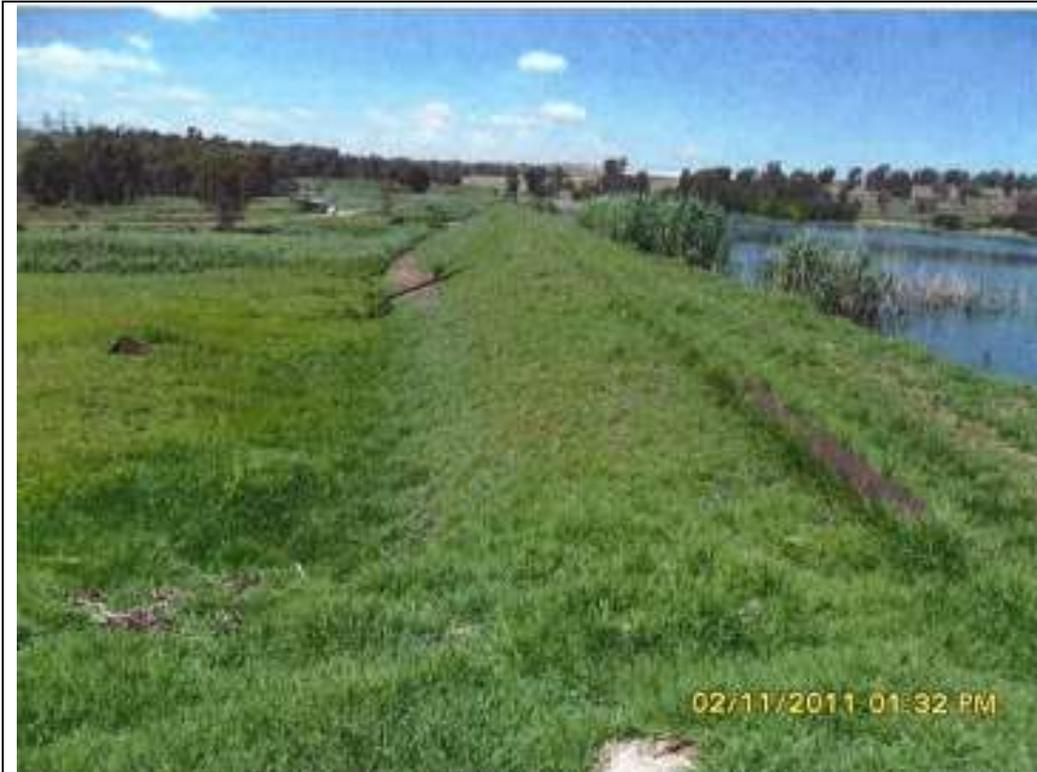
BEFORE: Note the lush green colour of the reeds on the downstream slope of Modderfontein Factory Dam No 4.

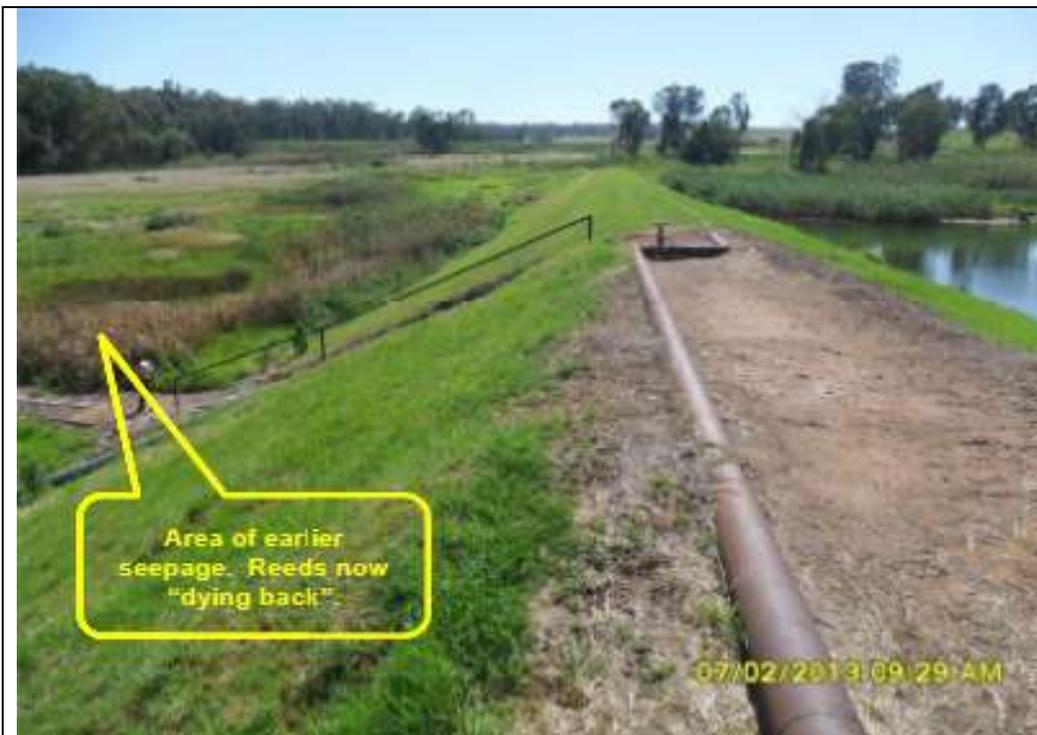
AFTER: Seepage has reduced substantially due to the lowering of the dam water level.

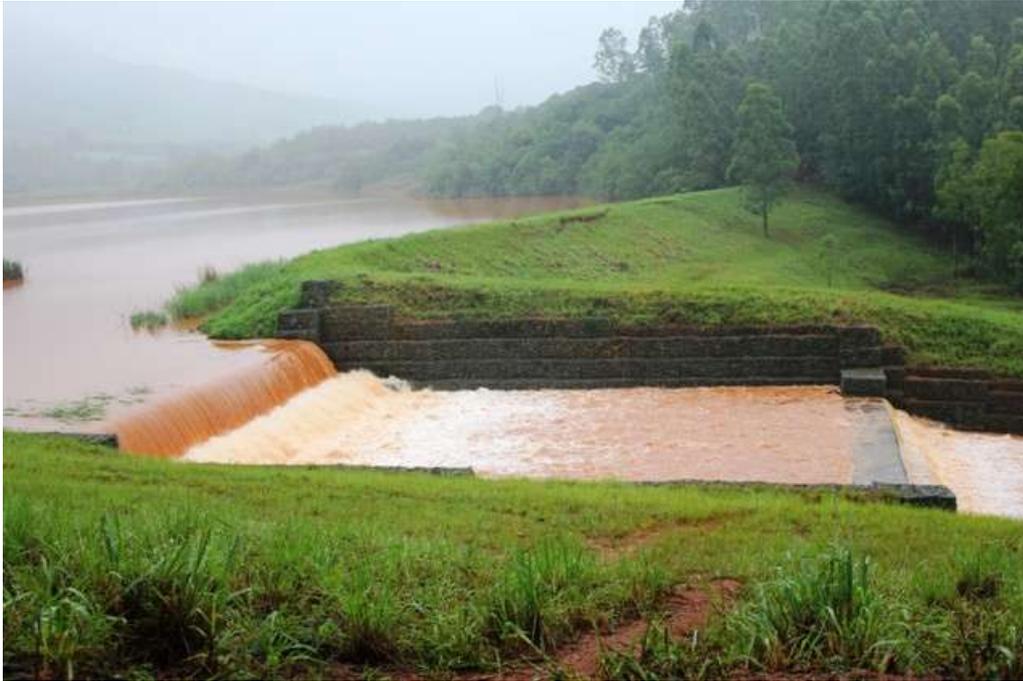
During local floods in Limpopo during January 2013 a number of category I farm dams were damaged or breached.

In this case a partial slip occurred on the downstream slope due to the steep slope and wet conditions.

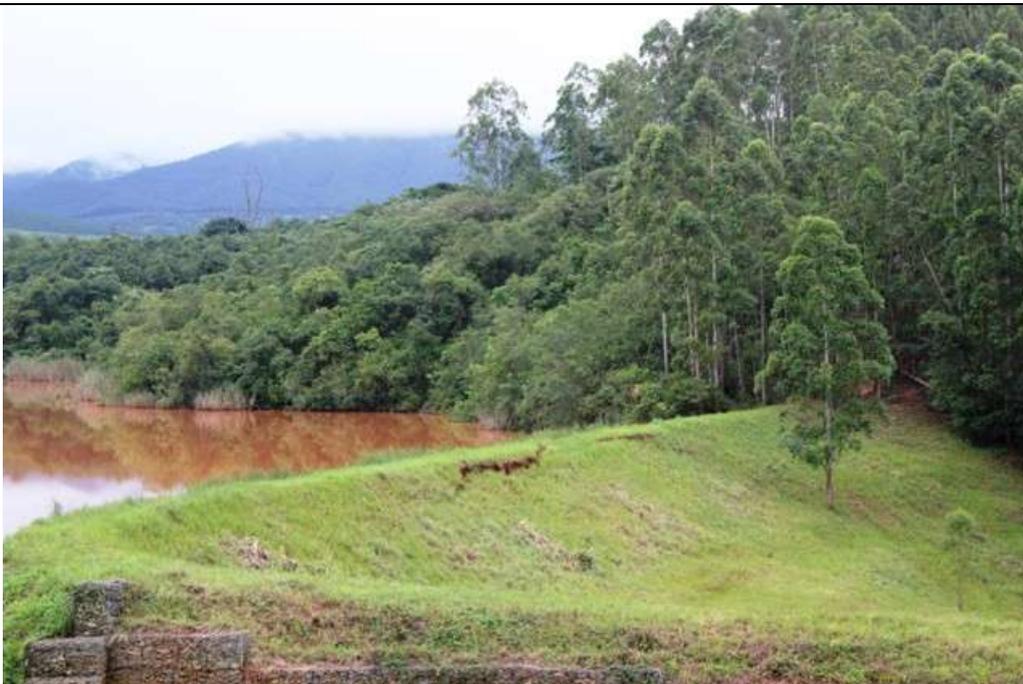
Close-up view of slip which is a typical form of slope failure.

The dam did not breach, but the downstream slope must be stabilized.

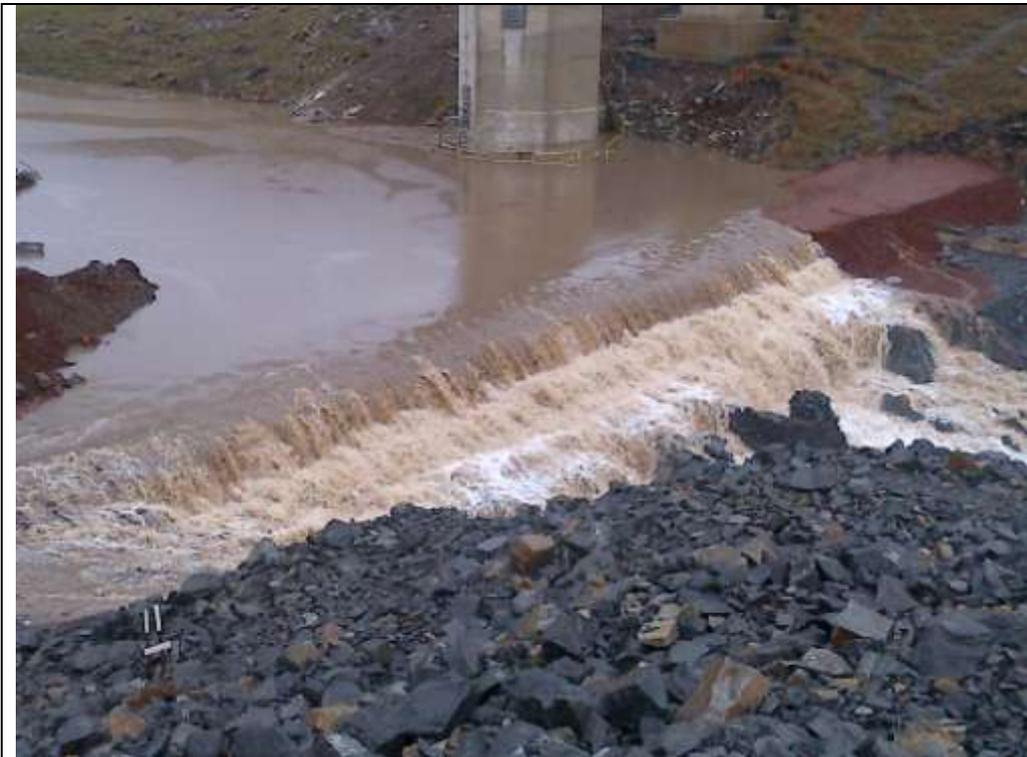
Coffer wall being overtopped by small flood, when discharge capacity of diversion pipe was exceeded.

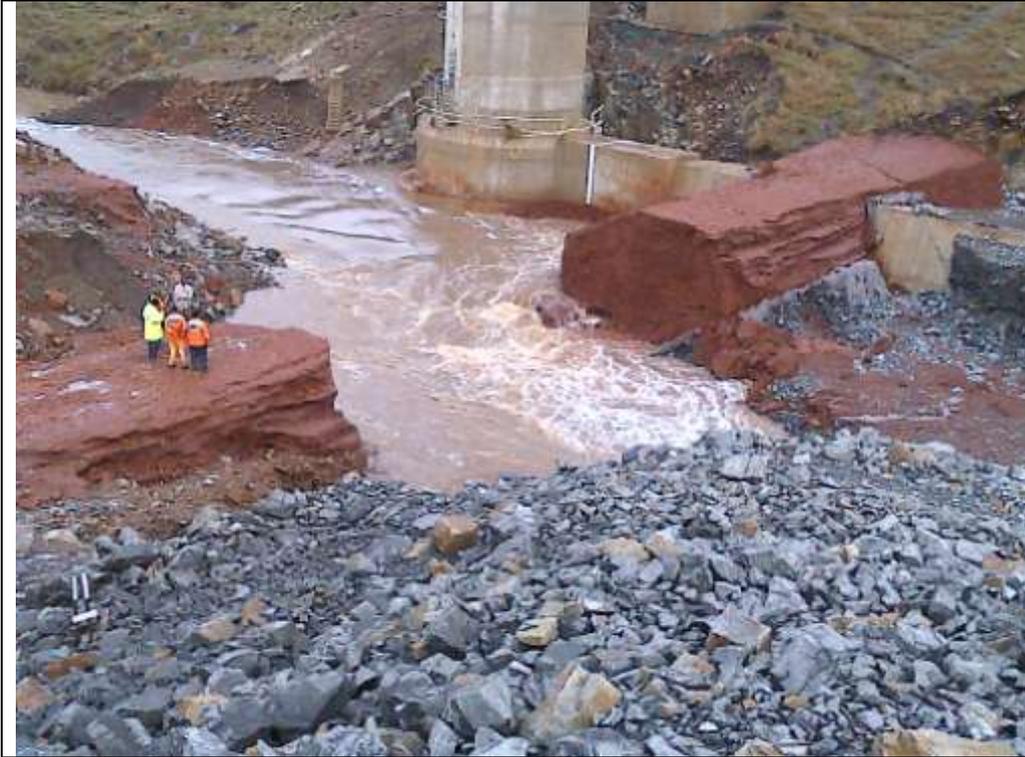
Failure of coffer wall after being overtopped by a small flood.

Correct sizing of river diversion works is one of the challenges faced by contractors, and is typically based on balancing the cost of the diversion works against the risk cost of damage to the dam wall.

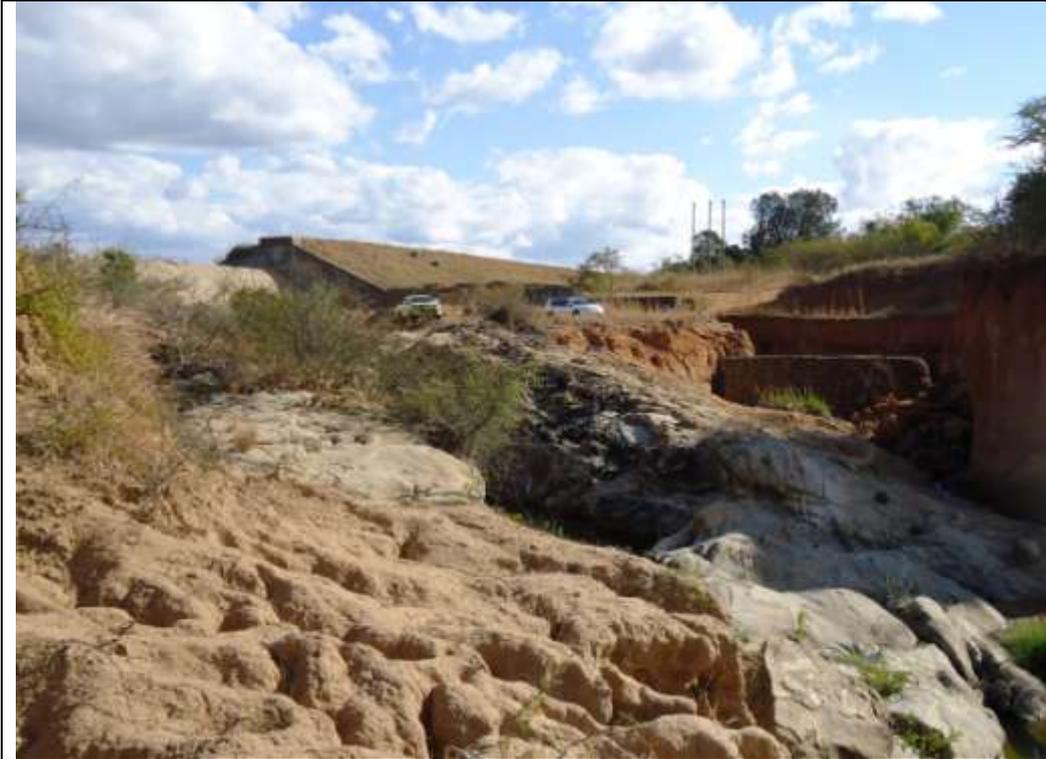
Erosion damage occurred in the spillway channel, encroaching towards the earthfill dam wall in the background.

This took place during isolated floods in Limpopo during January 2013.

A filter structure (at RHS of picture) to control a concentrated leak was also undermined.

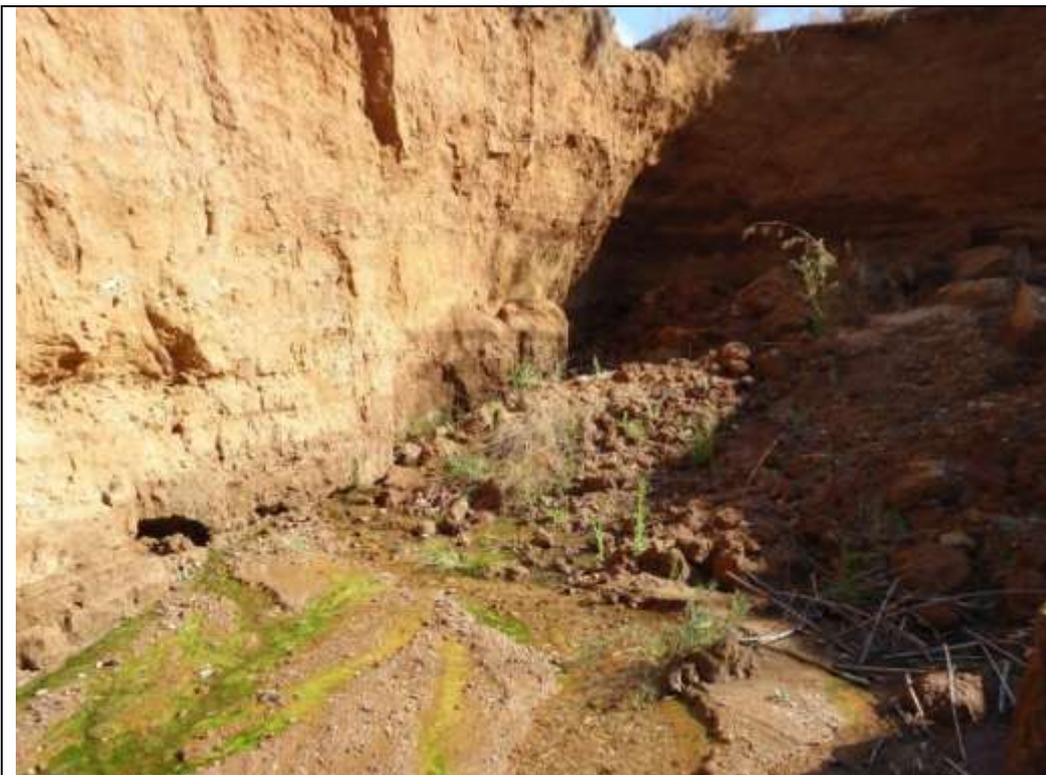
This donga has progressed in an upstream direction towards the right flank of the earthfill wall.

The concentrated leak occurs at the upstream bottom of this donga and has the features of an erosion pipe, although it is possible that the leak is coming through the foundation.
