**WASTE-TECH (PTY) LIMITED**

**Geotechnical and Geo-hydrological Conditions**

**Proposed SA Quarry Site**

**Project 199.111**

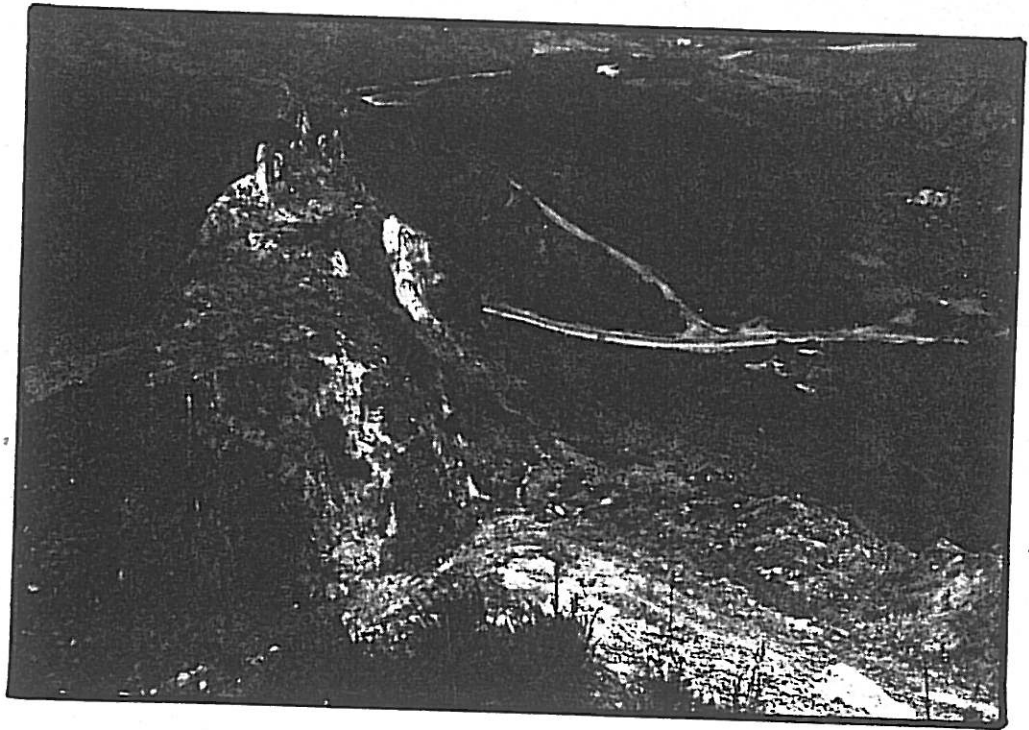
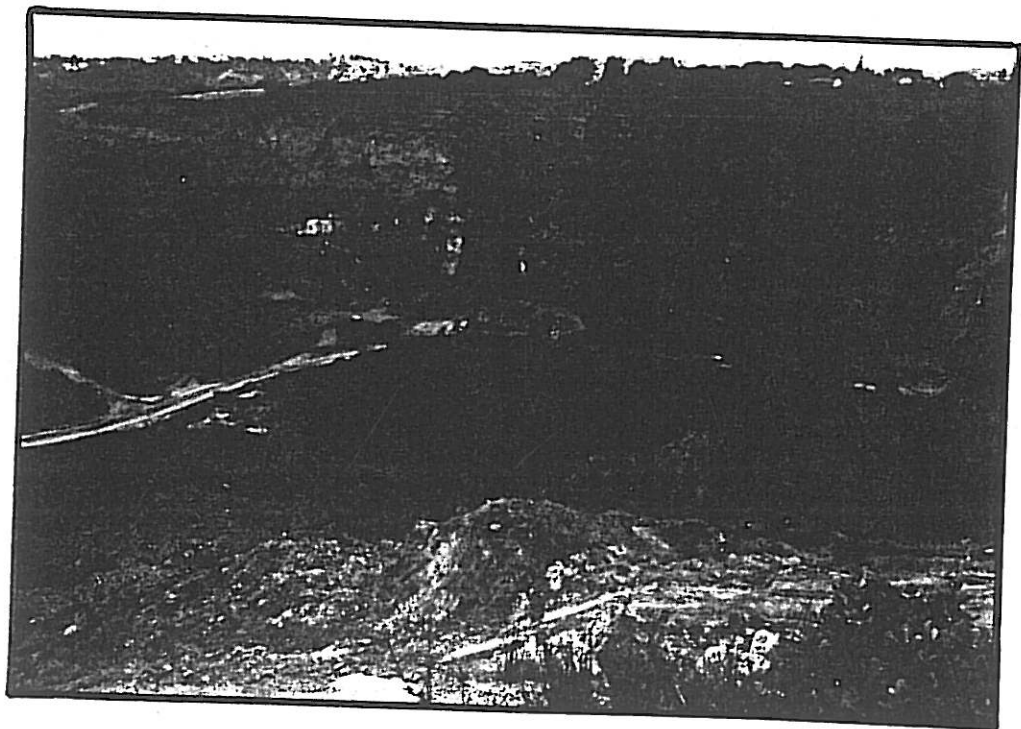
PLATE I. General view of the site showing the irregular shape of the quarry. Note the steep rock slopes and the large island remnant of highly weathered and sheared tillite in the above photograph.

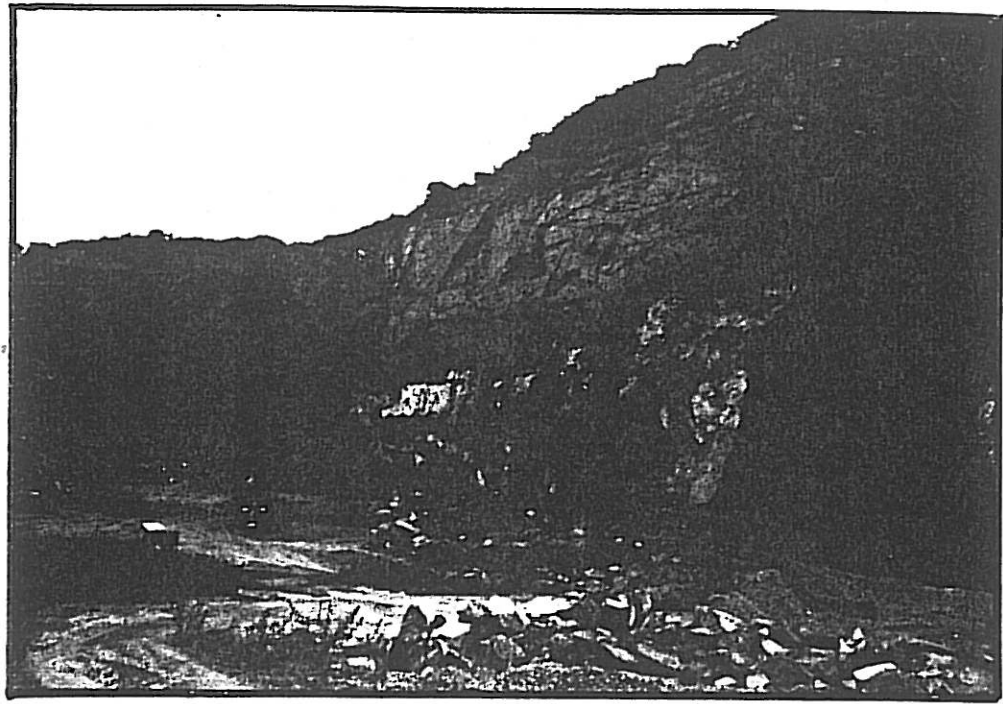
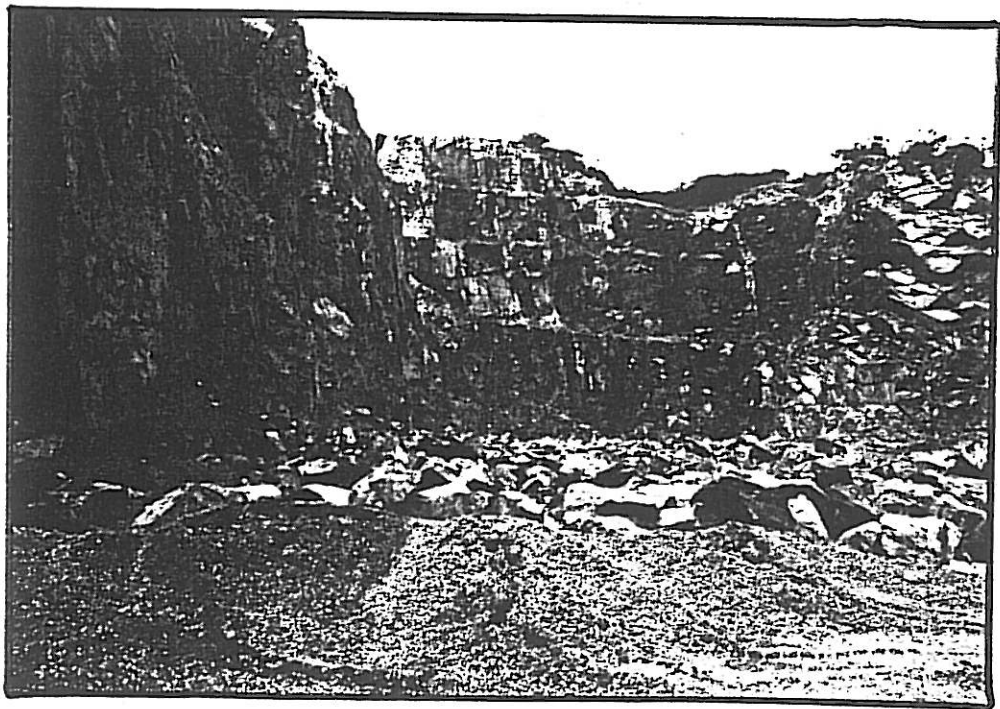
PLATE II. Typical exposures of some major joint planes in the tillite rock formation.

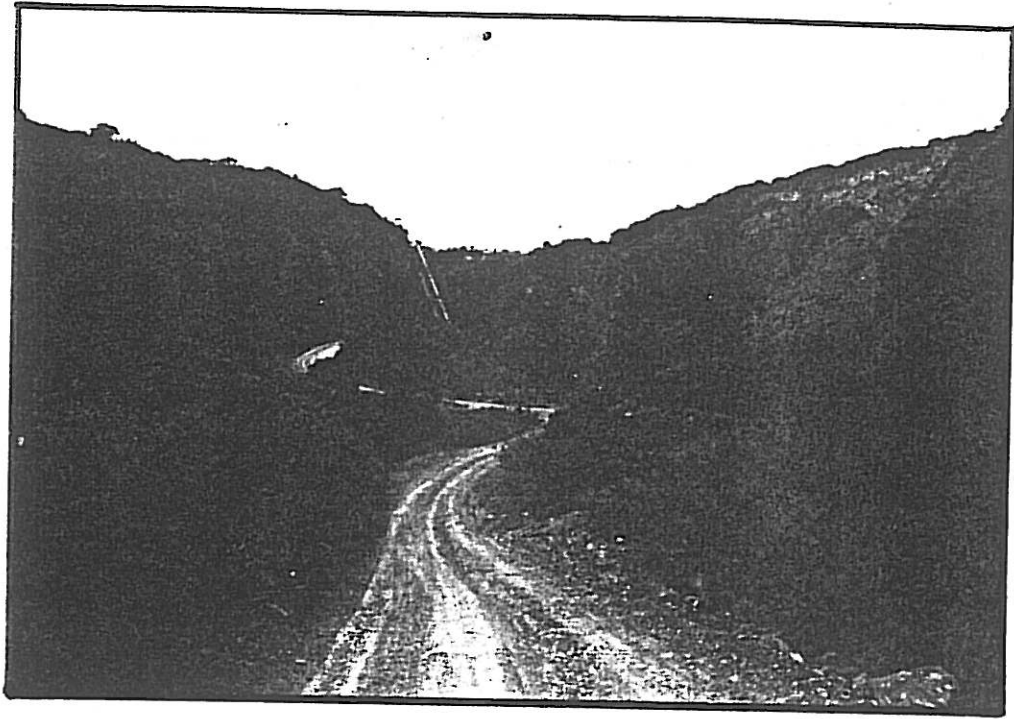
PLATE III. General view of the quarry looking south towards the plant area (above) and local deep section at southern end presently filled with water which is regarded to represent the ground water phreatic level.

**Site Conditions:** Ground water seepage is evident at various positions in the quarry. At the southern top end, close to Route 103, the mined out section of the quarry has water standing at a level of about 105 metres. It is believed that this is ground water and although it may contain some accumulated run-off, it represents the phreatic level of the ground water. See Plate III, lower photograph.

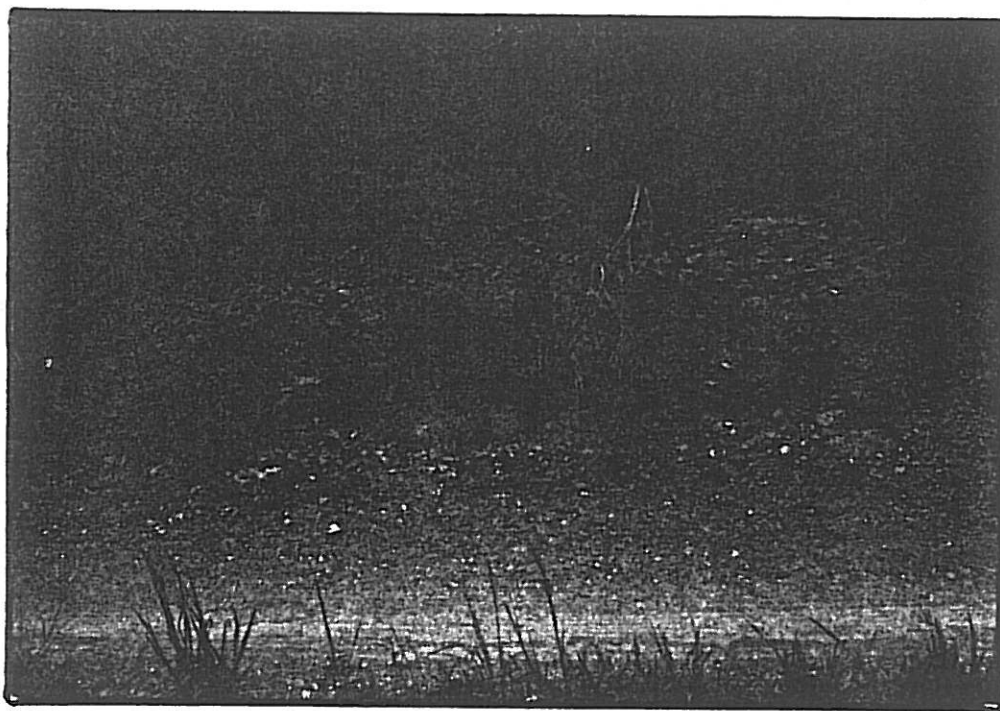
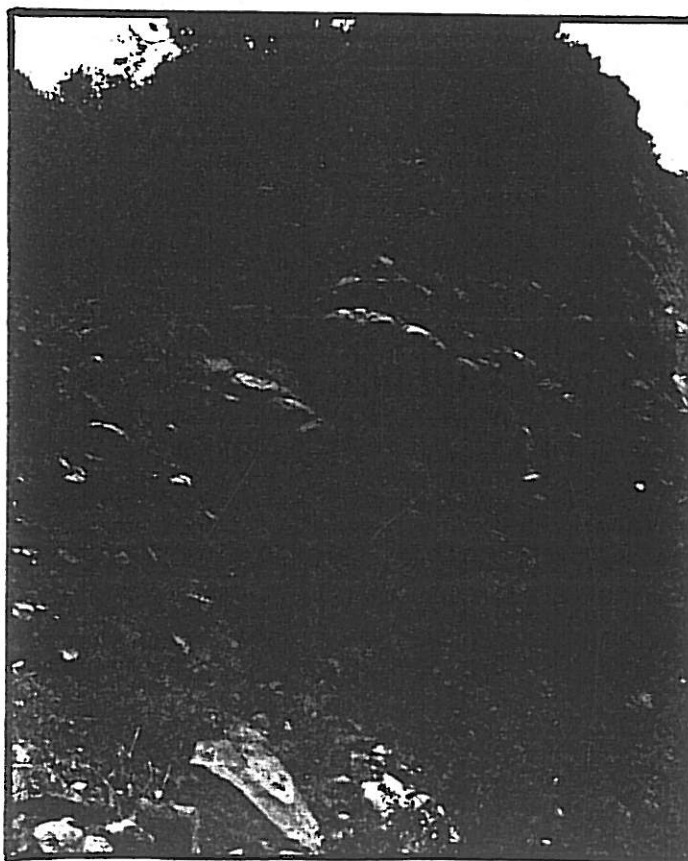
PLATE V. Typical thin ground cover (top photograph) and corestone development in the tillite formation near the Palmet River at the north-western corner of the quarry.

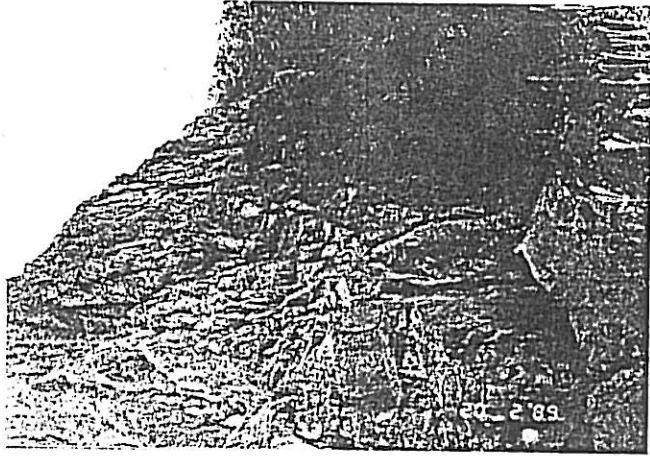
PLATE 4 - East facing slope of 'box-cut'. - considered unstable. Note loose scree material at the toe of the slope.

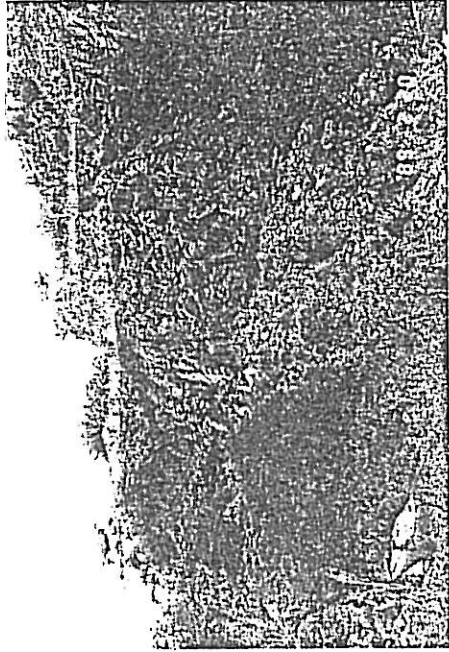
PLATE 10 - Showing highly weathered potentially unstable Tillite near the crest of the unmined buttersill.

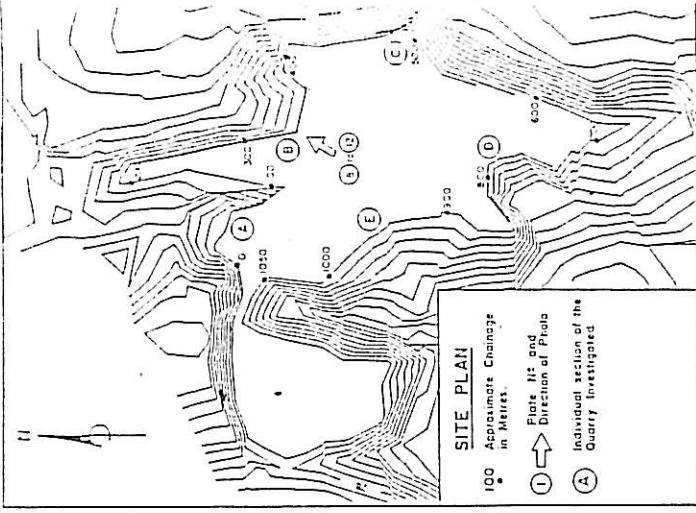
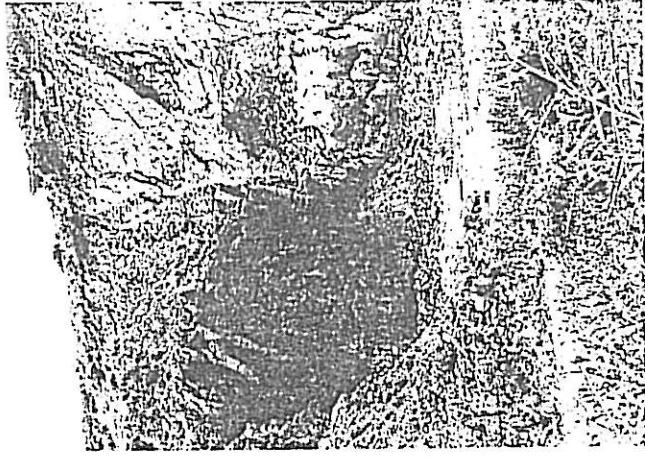
390 to 410	South facing slope	11 & 12	Approximately 30 metre high rock slope overlain by loose residual tillite and fill material. The loose overburden is considered unstable as is evident from the failure, and scree material present at the toe of the slope - See Plate 12. The loose overburden requires to be battered back to a slope of at least 1 in 1½ from the crest of the hard competent blue tillite. Groundwater seepage is evident in this rock slope, approximately

Section	Chainage * (metres)	Slope Face	Plate No.	Description
<u>SECTION D</u> (Cont'd)	390 to 410	South facing slope	11 & 12	10 metres up from the toe. Potential wedge type failures along joint sets 1A and 4B, and 1B and 3B, as shown in Figure 6b, are considered possible. In addition, toppling type failure is also considered likely due to joints 2A and 4A. The overall stability of this south facing slope is considered sensitive. The stability of this slope will have to be carefully assessed by a detailed investigation.
<u>SECTION C</u>	410 to 650	West facing slope	13 & 14	Approximately 60 metre high W2/3 tillite rock slope dipping at about 80 degrees from the horizontal. W2/3 tillite overlain by residual soil and brown, highly weathered and fractured tillite. The overall rock slope considered stable except for the possibility of relatively small potential wedge type failures along joint sets 2A and 3B, 1A and 3A, and 3B and 4A, as shown in Figure 7b. The sensitivity of this slope to wedge type failures will have to be carefully assessed. The residual soil and weathered overburden will require to be battered back to a slope of at least 1 in 1½.

PLATE 12 - Note failure at the crest of the slope and loose scree at the toe of the slope.

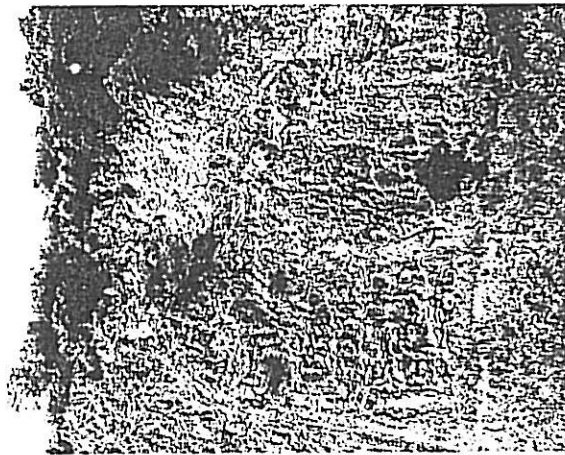
410 to 625	Northwest facing	13, 15 and 16	Approximately 50 metre high tillite rock slope. The tillite is bisected by a number of near vertical shear zones which trend in north to south and east to west directions. The presence of these shear zones have reduced the overall stability of the rock slope. Plate 15 shows the intersection of two shear zones at approximately 90 degrees to each other behind a wedge of W2/3 tillite. Note the failure which has occurred in the shear zone material at the crest of this section of the slope. The wedge of W2/3 tillite in front of the shear zones is considered unstable. The overall stability of this portion of the quarry will have to be carefully assessed by a detailed investigation.
<u>SECTION D</u>	700 to 750	East facing	17	This east facing slope, situated adjacent to the primary crusher, is considered unstable. A large portion of this section of the rock face overhangs. Toppling failure along joint set A1 is considered likely, as shown in Figure 7c. This type of failure is evident in the exposed rock face.

PLATE 15 - Note failure in weathered zone near the crest of the slope, due to presence of two intersecting shear zones.

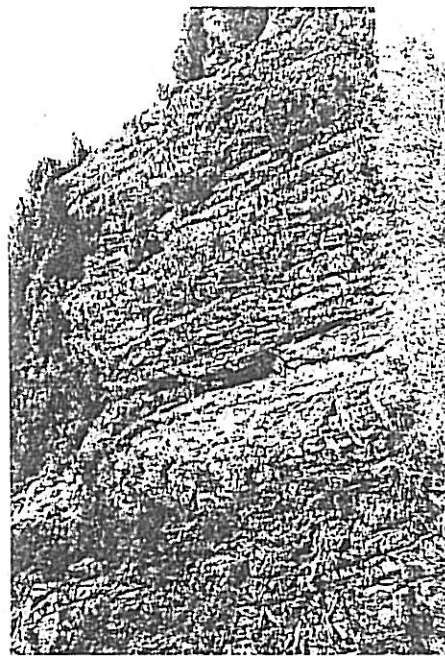
PLATE 16 - Shear zone (light coloured rock) within the Dwyka Tillite.

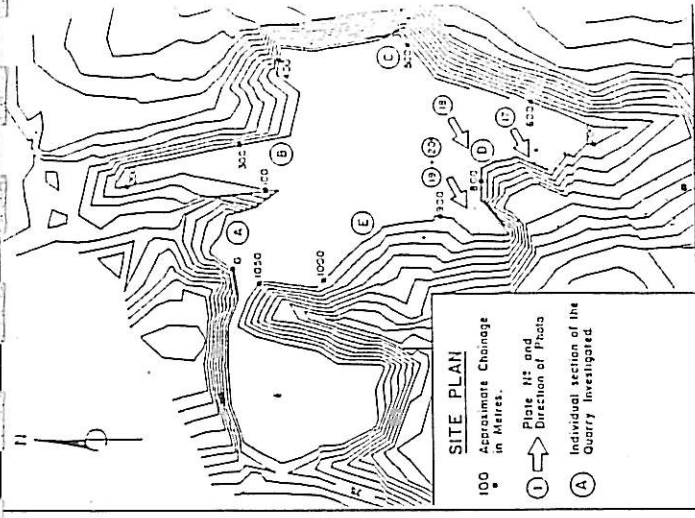
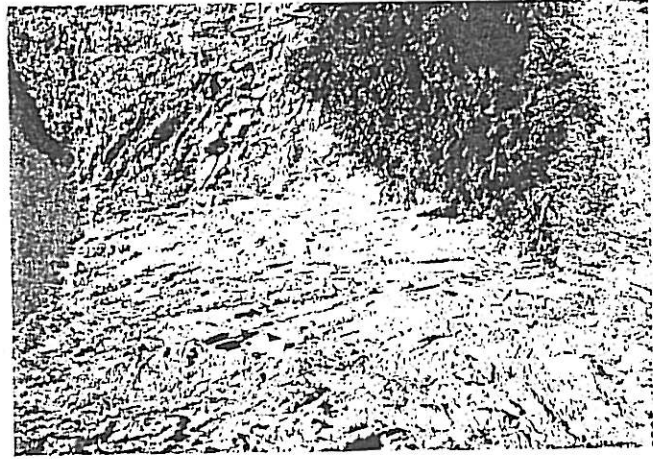
PLATE 19 - West facing slope of unstable peninsular material comprising shear zone material.

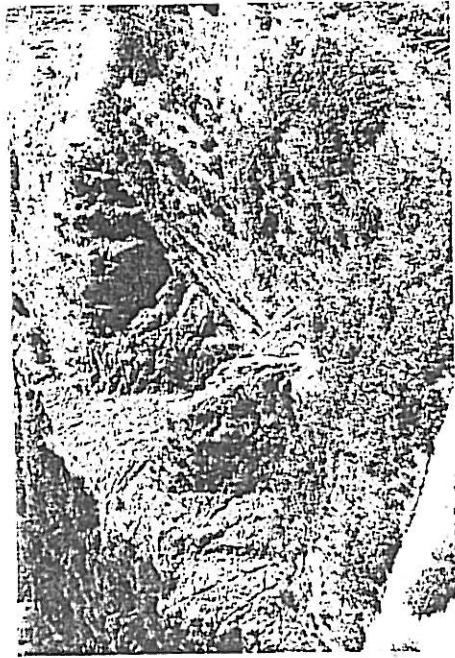
750 to 875	Peninsular and Box Cut	18, 19 and 20	Rock peninsular, comprising a near vertical shear zone together with the unmined W3/2 tillite on either side - See Plate 18. This rock peninsular is considered unstable, and it is recommended that it be removed. Consideration could be given to placing and compacting the removed material in the 'box-cut' in the southwestern corner of the quarry to stabilise the rock slopes. The north facing rock slope in the 'box cut' is considered

PLATE 18 - General view of 'box-cut'. Note unmined peninsular of shear zone material with slightly weathered Tillite on either side.

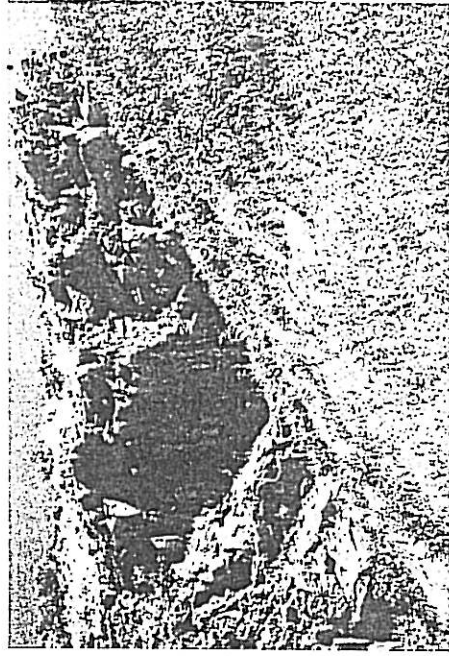
PLATE 20 - East facing slope of 'box-cut'. Note overhanging rock slope due to inclined north-south trending joint which dip towards the west.

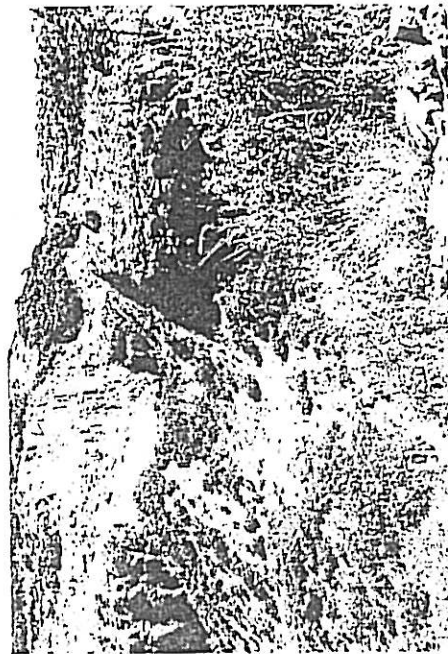
PLATE 22 - Showing failure debris in the foreground.

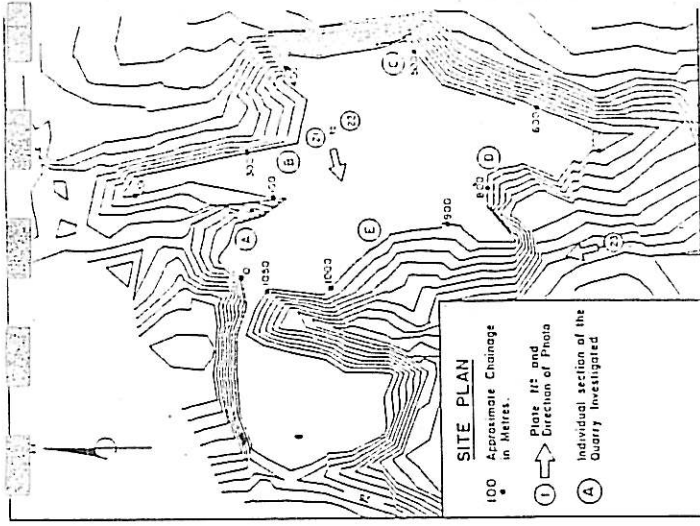
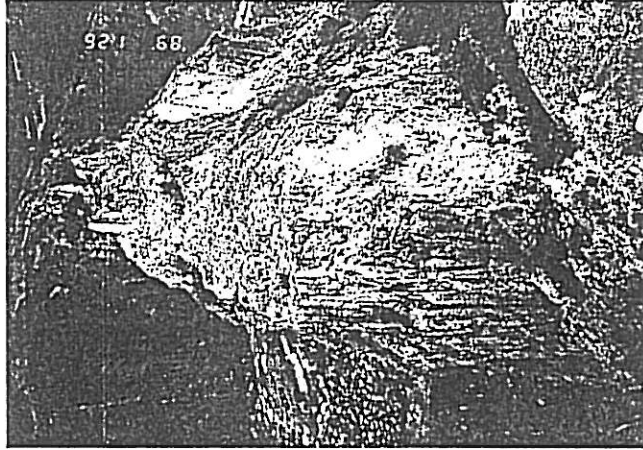
PLATE 23 - Showing the unmined peninsular, comprising a north to south trending, near vertical, shear zone in the Dwyka Tillite.

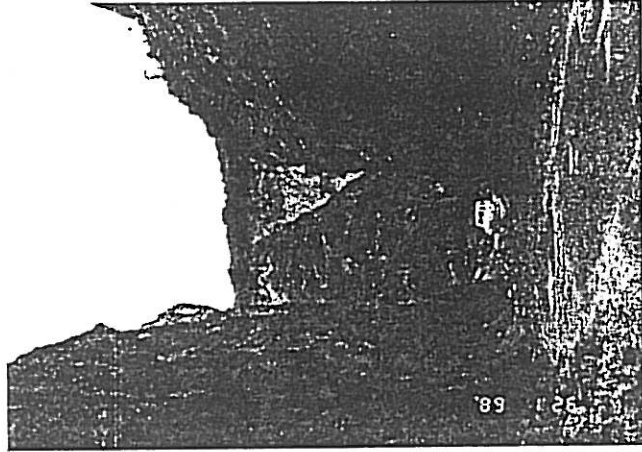
PLATE 26 - This narrow, near vertical cut through the shear zone in the Tillite is the only entrance to this portion of the Quarry. The unstable condition is demonstrated by the failed debris blocking the entrance.

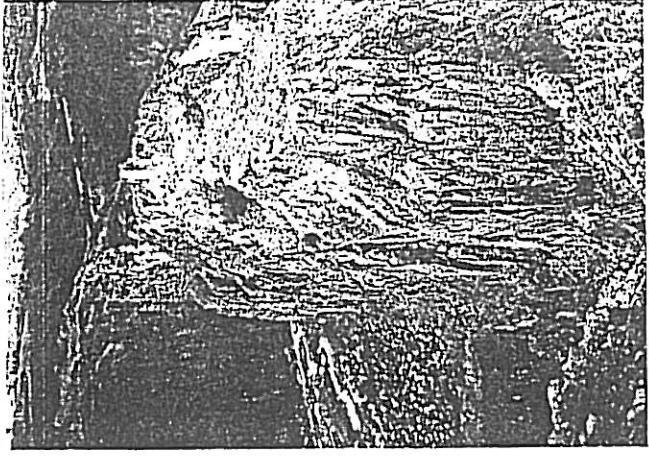
PLATE 27 - Unstable peninsular of rock, comprising near vertical shear zone in the Dwyka Tillite.
