**HYDROGEOLOGICAL INVESTIGATION  
SPRINGS at KWANOVUKA  
IMPENDLE LOCAL MUNICIPALITY**

## HYDROGEOLOGICAL INVESTIGATION - SPRINGS KWANOVUKA – IMPENDLE LOCAL MUNICIPALITY

### 1. Introduction and Terms of Reference.

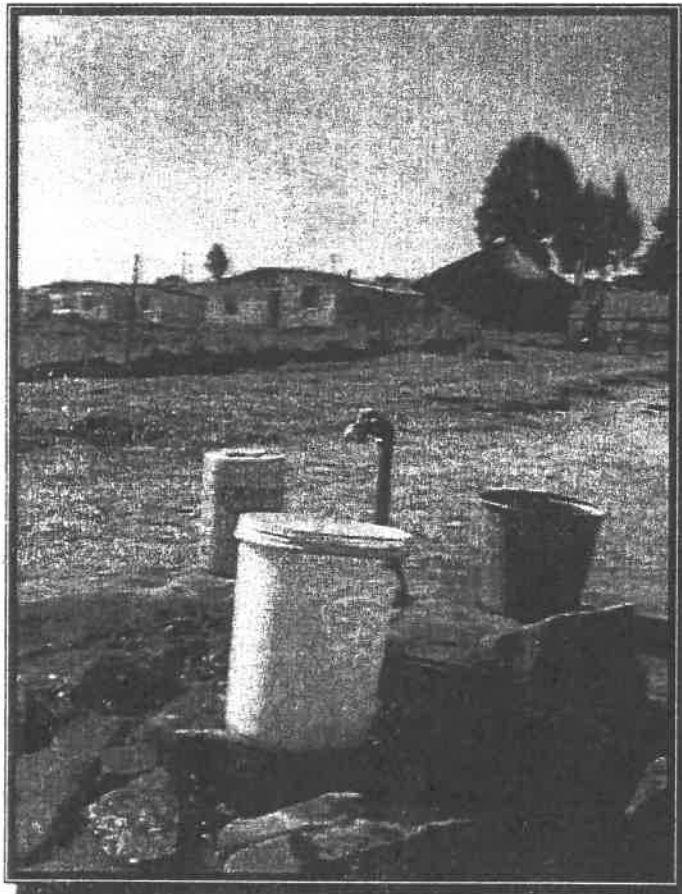
KwaNovuka is situated some 3km north of the town of Impendle located approximately 70 km from Pietermaritzburg. At the time of the investigation, domestic water was being piped from springs to various plastic or concrete storage reservoirs and distributed from there to communal and in some instances self installed tap stands inside private residences. See Photo 1 below.

*Photo 1: Existing Communal Tap*

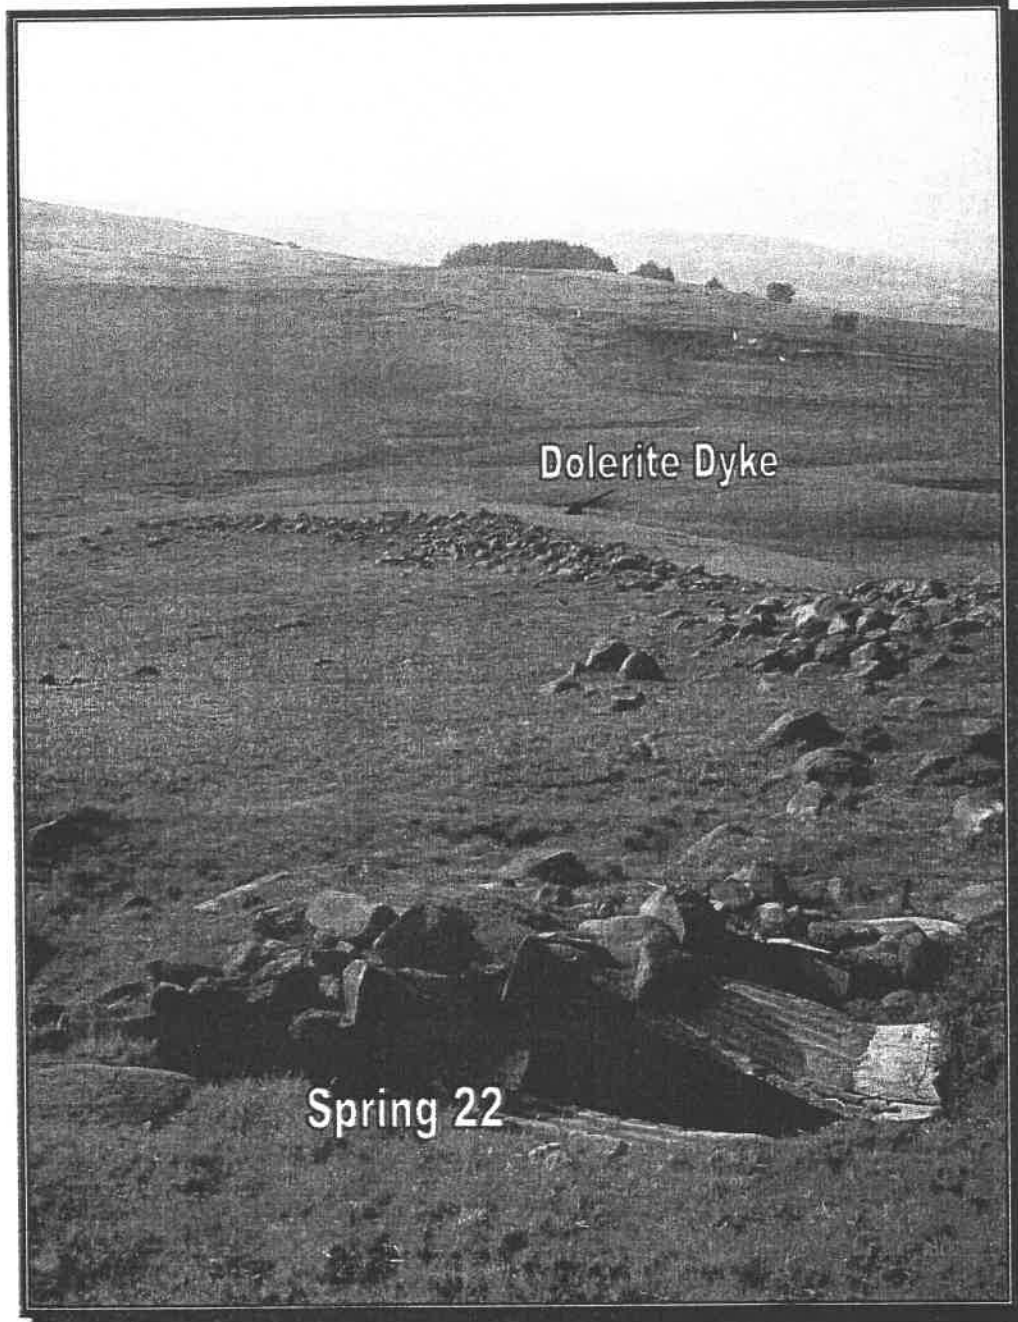
Other prominent structural features such as two large Dolerite dykes intersect the site, one in a W-E and the other in a N-S direction respectively. These structural features are usually closely associated with springs and groundwater seeps and most of the springs in the study area are probably caused by this structure. See also Photo 2 below.

Based on experience elsewhere in the area with similar hydrogeological conditions, the Dolerite dykes are ideal targets for groundwater investigations and drilling of boreholes. An excerpt from the Drakensberg geological series has been included on the opposite page-Figure 2. More detailed geological descriptions of each spring source and its setting is given in section 5.

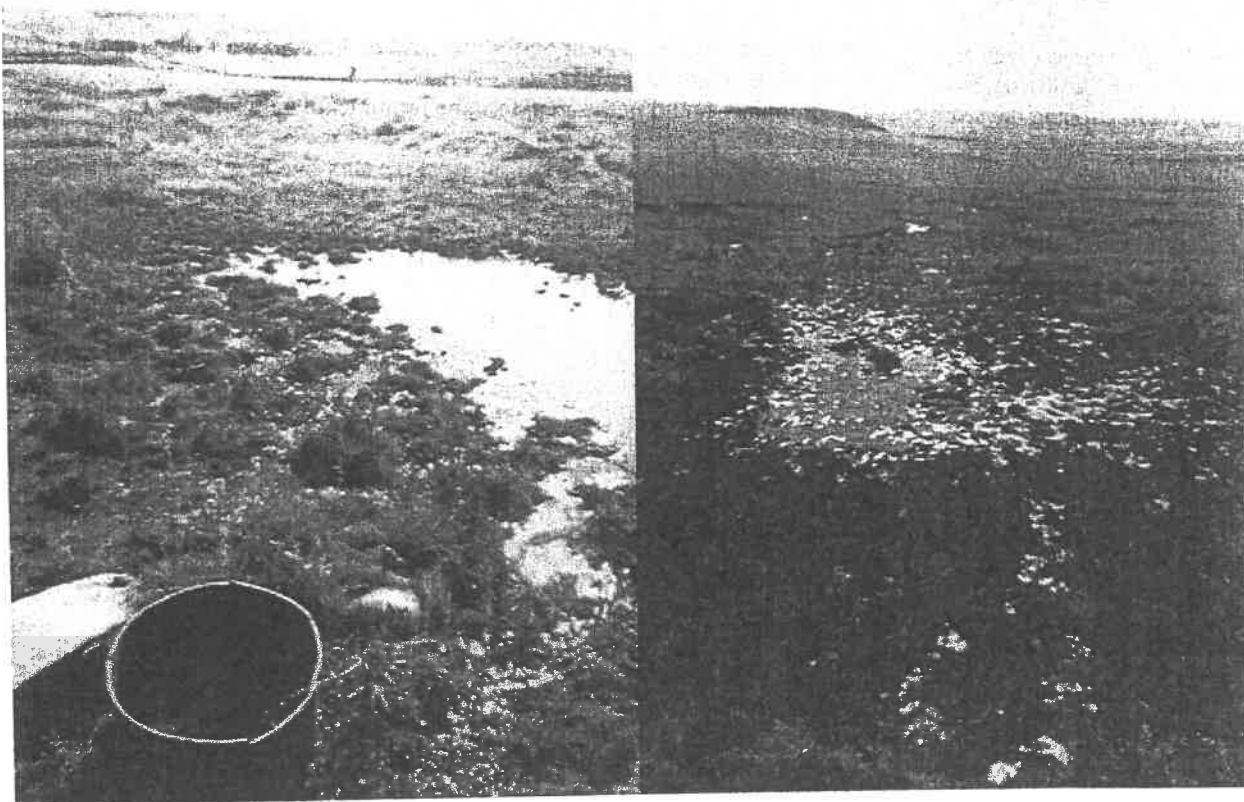
*Plate 3: Trampled and polluted springs used for stock watering.*

**Springs 8, 16, 17 and 18:** These are springs currently used for stock watering mainly due to their location and yield. They are low yielding springs towards the lower sections of the community that has been damaged mainly by animals. See Plate 3 on the opposite page indicating a few of these sources.

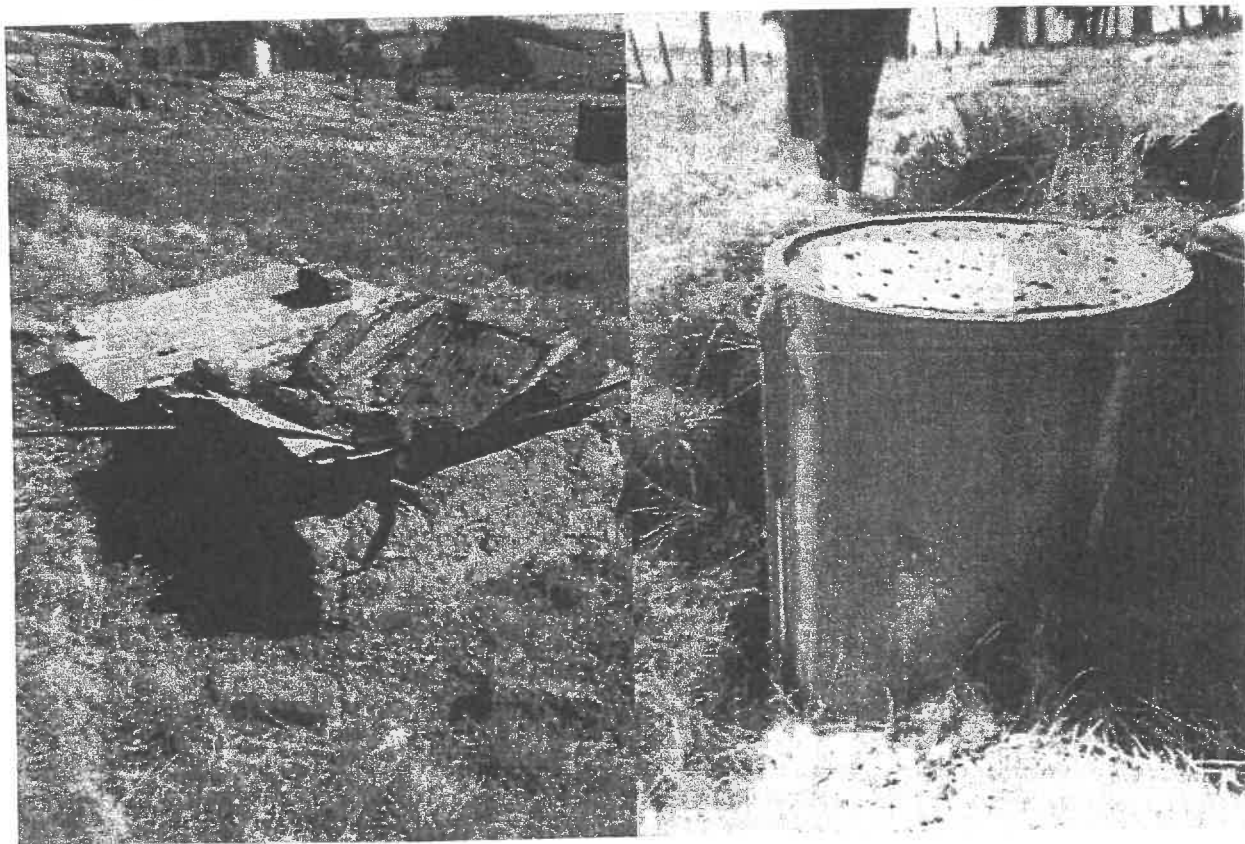
*Plate 4: Self constructed v-box and reservoir systems for private use by one or two households only.*

**Spring 11, 12 and 15:** These spring sources are very low yielding spring sources that have been protected by some sort of device by the local community with the aim of supplying either one private household or the local community garden. Unfortunately these sources are capable of supplying a small household only. See Plate 4 on the opposite page.

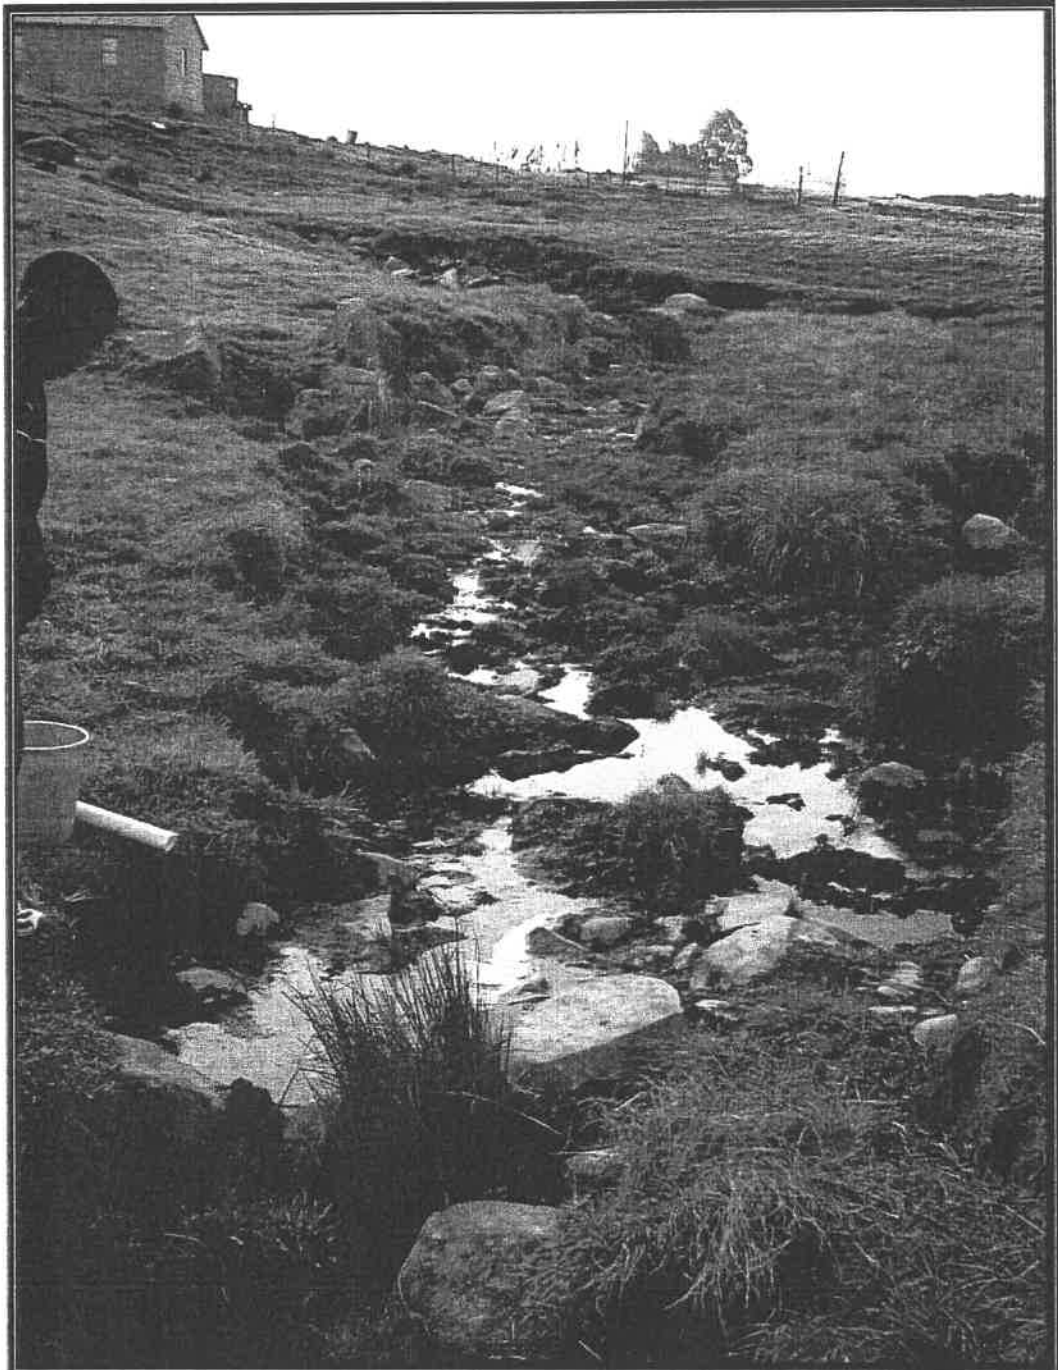
**Spring 19:** This relatively strong flowing spring is located next to the road from Impendle to KwaNovuka. In contrast to almost all the other spring sources in the area, this spring drains southwards towards the lower lying village of Ntshinini.

The spring is unprotected and emanates as result of the major E-W striking dolerite dyke intruding into the older sedimentary shale formation. The fairly large catchment consists of mainly shale and sandstone sedimentary rocks surrounded by dolerite dyke and sill intrusions. The first flow measurement on the 20<sup>th</sup> of July was 450 l/hour. This remained constant and on the 9<sup>th</sup> of September 2005 the same flow of 450 l/hour was measured. Therefore it seems that the spring is sustainable and could be protected to supply the lower lying Ntshinini village. See Photo 5 below.

*Photo 5: Spring 19 – unprotected and possibly contaminated.*

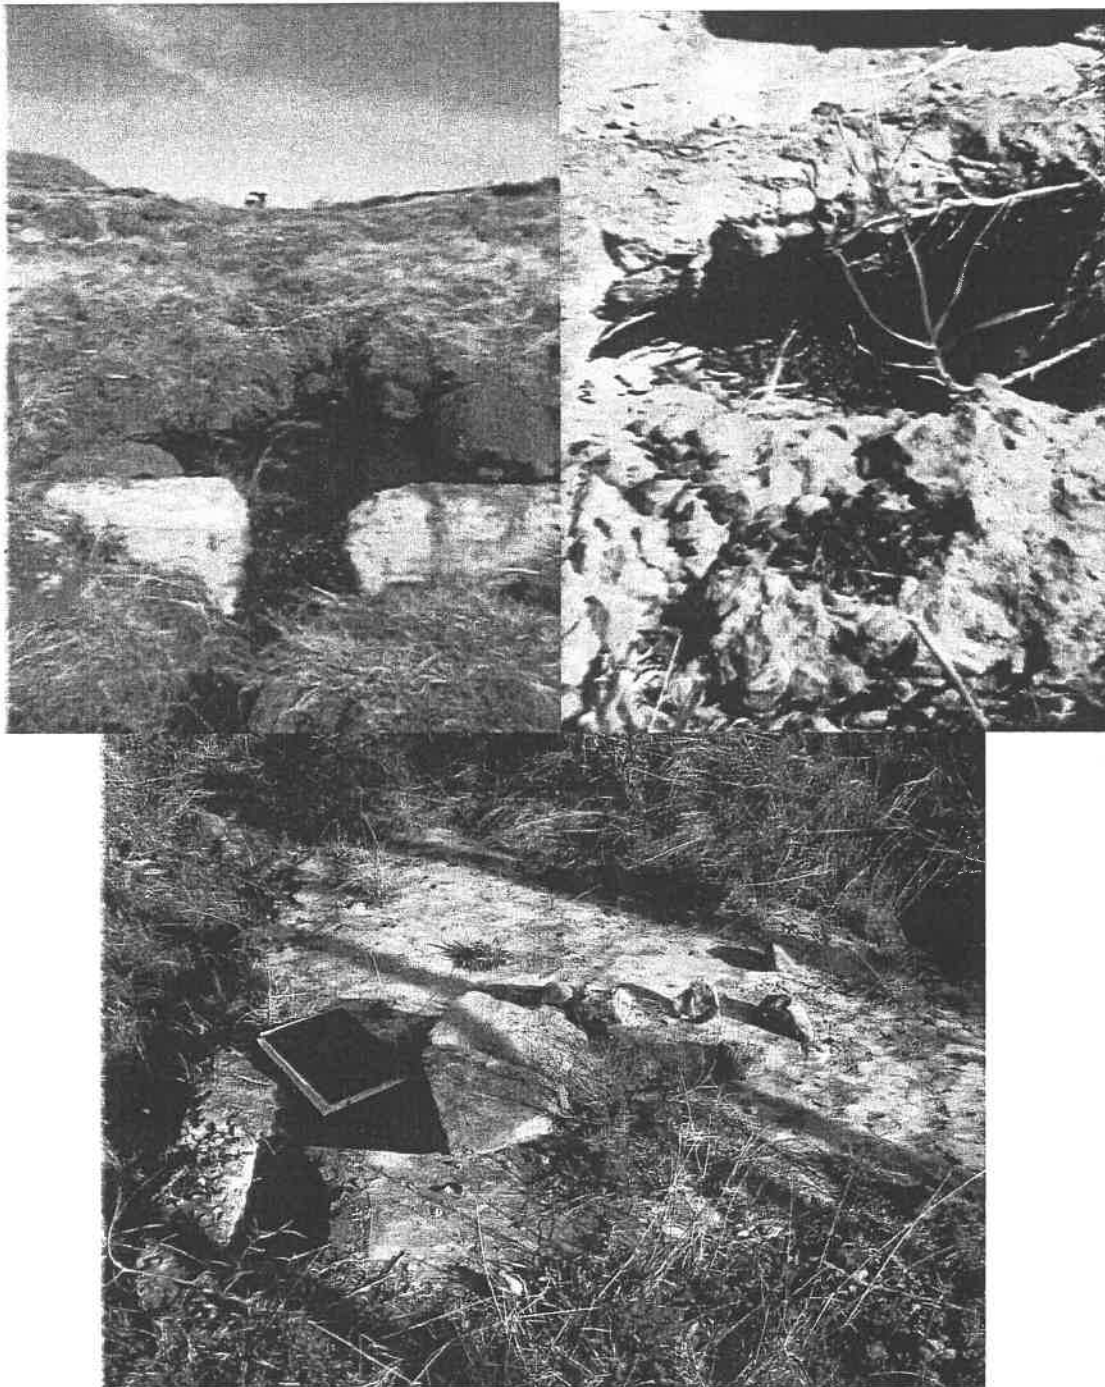
**Spring 20:** This spring is relatively low flowing and has been poorly protected. See plate 6 below. The spring is located towards the northern section of Novuka 1. To the west of this village, a relatively large catchment drains to the north, but a small spring flows from the dolerite sill making up the eastern boundary of this catchment.

*Plate 6: Cement dam structure flowing into concrete protection (broken). Also visible is the rat droppings underneath the sink lid and inside the cement chamber.*

The spring is dammed but unprotected and water is gravity fed to a small concrete protection as can be seen in Plate 6 above. Both of these structures are broken and by the time of the second measurement on the 9<sup>th</sup> of September 2005, the flow could not be measured as the spring had dried up. Therefore it seems that the spring is unsustainable and could not be protected.

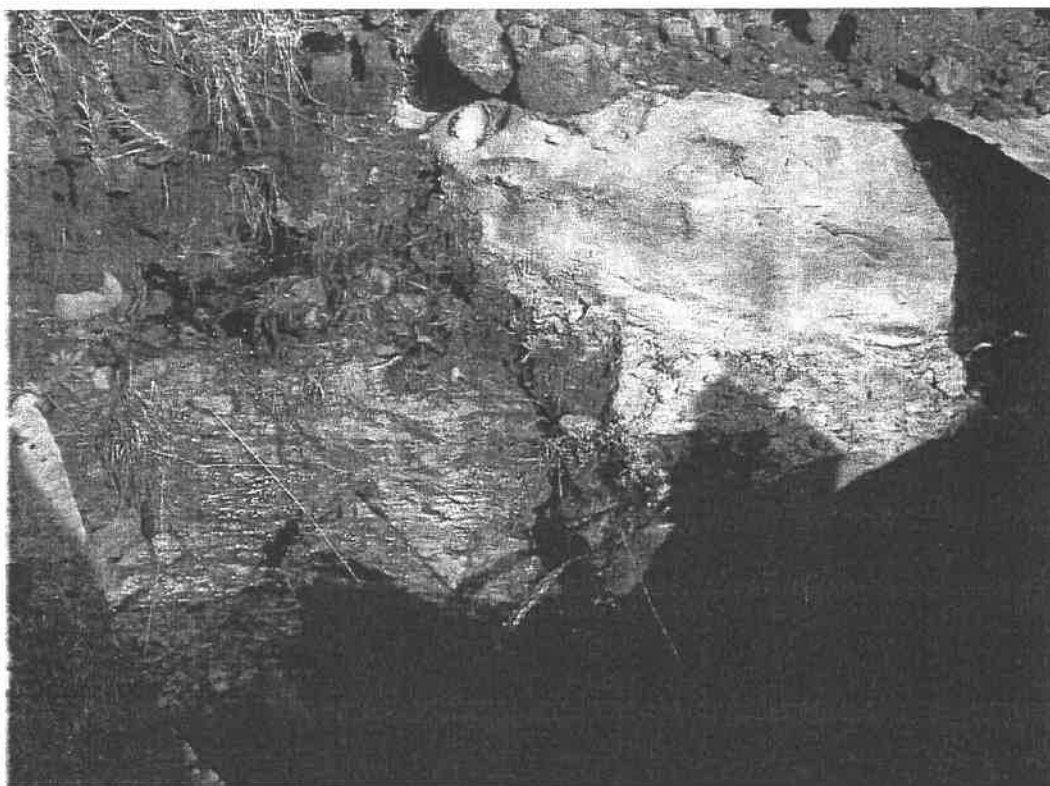
*Photo 7: Existing protection at spring 22.*

Two plastic tanks serve as storage reservoirs, but due to the location of the spring and the lack of hydraulic head, these are not easily filled. A further problem is the fact that the local community has made illegal connections to the supply line from the spring before it reaches the first reservoir. Most of the times, these illegal connection pipe lines are not properly closed by means of a valve or tap, but are merely folded back or blocked.

Geologically, the spring is situated on the side of a large E-W striking Dolerite dyke. As is the case in most instances in this village, the dolerite intruded into the older sedimentary rocks causing fracturing and brittle contact zone material. This zone is the preferred pathway for groundwater movement through the subsurface and results in a spring line where the perched water table reaches this zone. The flow measured on the 20<sup>th</sup> of July and the 9<sup>th</sup> of September remained relatively constant at around 800-1000 l/hour. Therefore the spring seems to be sustainable and the existing protection should be repaired and upgraded.

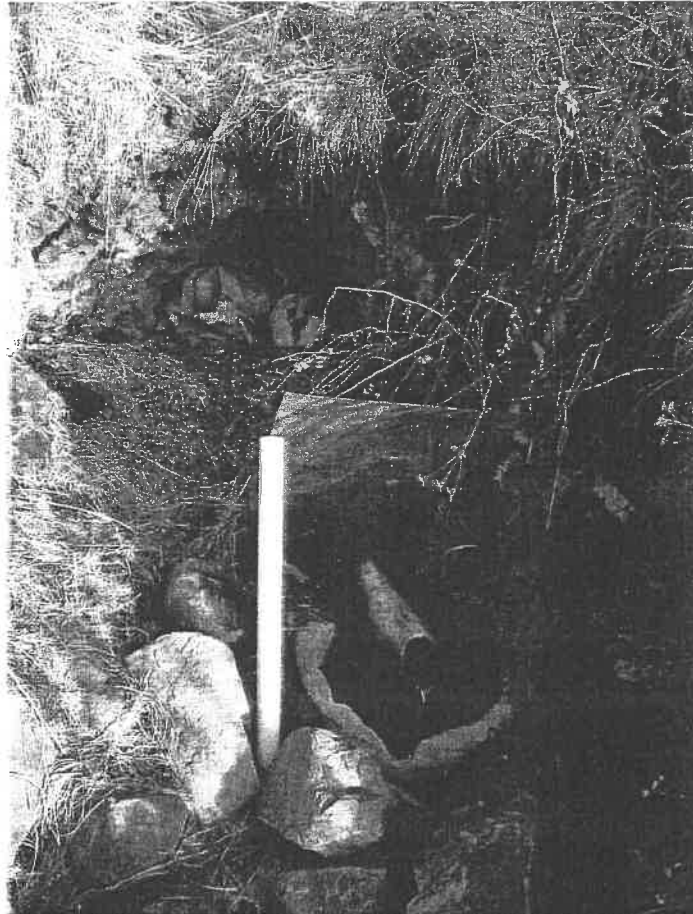
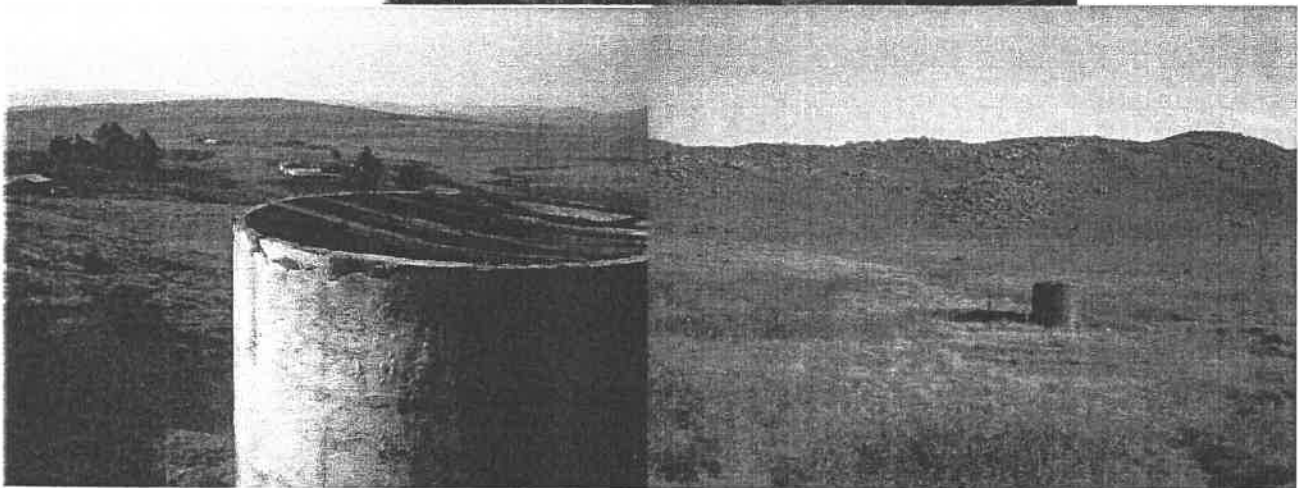
**Spring 23:** In principle, this spring is caused similarly to spring 22 in that hydrogeologically it is formed as a result of the same dolerite dyke as discussed in spring 22 above. Located slightly lower down from spring 22, it feeds a cement reservoir located some distance lower down at spring 20. Water is gravity fed from the position near spring 22 to one 5000 liter plastic reservoir. From here water is piped to the cement protection discussed in spring 20 (see plate 6). This “protection”, with rat droppings in the cement chamber, allows water to be fed to the storage reservoir without a lid as indicated in the Plate 8 on the following page.

The initial protection of spring 23 was done by the local community and although no apparent contamination takes place, the cover of corrugated iron sheets is insufficient and could result in the spread of water bourn deceases if the source is not properly protected. See Plate 8 below for current protection of the spring eye.

*Plate 8: Existing home made protection, plastic tank and cement reservoir.*

The flow measured on the 20<sup>th</sup> of July and the 9<sup>th</sup> of September remained relatively constant at around 700 l/hour. Therefore the spring seems to be sustainable and the existing protection and supply scheme should be repaired and upgraded.

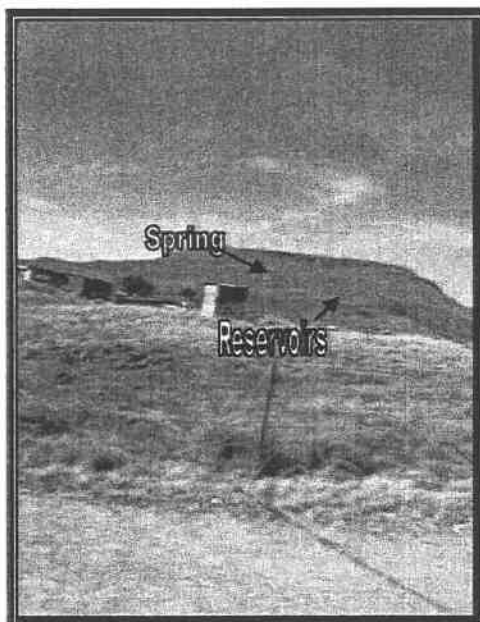
**Spring 25:** Situated high above the Novuka 4 community on the side of the Ntshangwe mountain, the spring consists of a old v-box protection, 2 x cement reservoirs that are badly damaged and approximately 4 taps. The spring emanates from the side of the mountain where the impermeable dolerite sill causes a perched water table and together with the steep topography results in the discharge of this relatively constant flowing spring. See photo 9 below.

*Photo 9: Spring 25 and 2 x cement reservoirs side of Ntshangwe*

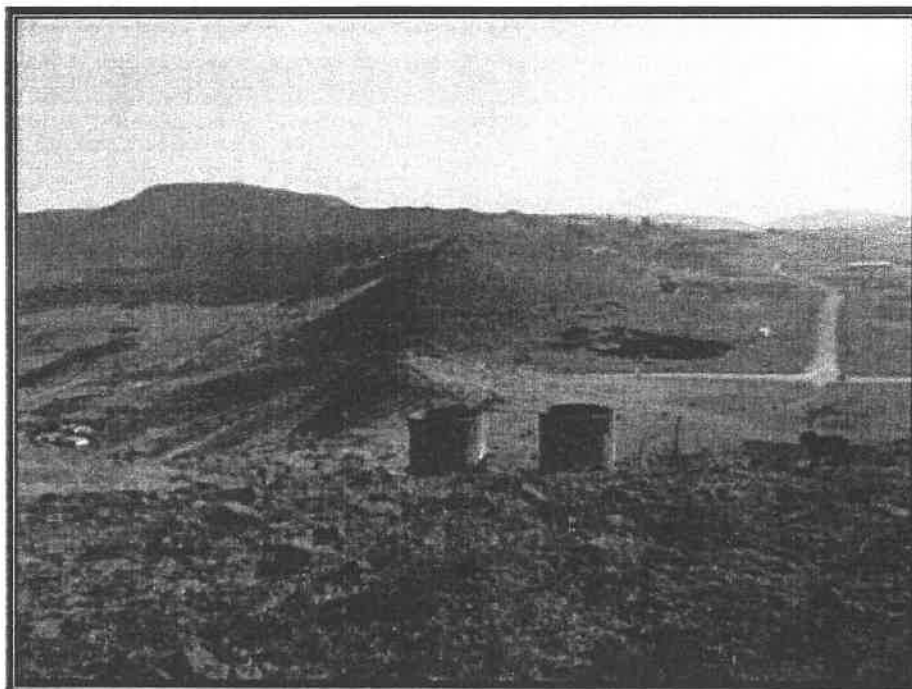
Even though the flow rate could not be measured at the spring eye, the flow into the reservoirs was estimated at 300 l/hour on both occasions (20<sup>th</sup> of July and 9<sup>th</sup> of September 2005). This amount of water is not capable of filling these two reservoirs mainly due to the demand and water basically enters the reservoirs and exits within a few seconds. Photo 9 below indicates the 2 x cement reservoirs with the KwaNovuka community below and the large dolerite dyke discussed in spring 22 and 23 in the background.

*Photo 9: Above the 2 x cement storage reservoirs at spring 25.*
