# **GROUNDWATER SITE INSPECTION REPORT FOR THE PRODUCTION BOREHOLES LOCATED AT ONVERWACHT, CULLINAN**

**March 2024**

## **Production Boreholes located at Onverwacht (Cullinan)**

Visited on the 13 March 2024 by LV Mmako (DWS), A Kganyago (DWS), J Mabona (COT), L Sidu (Ward Counsellor) and S Ndhlala (Ward Counsellor)

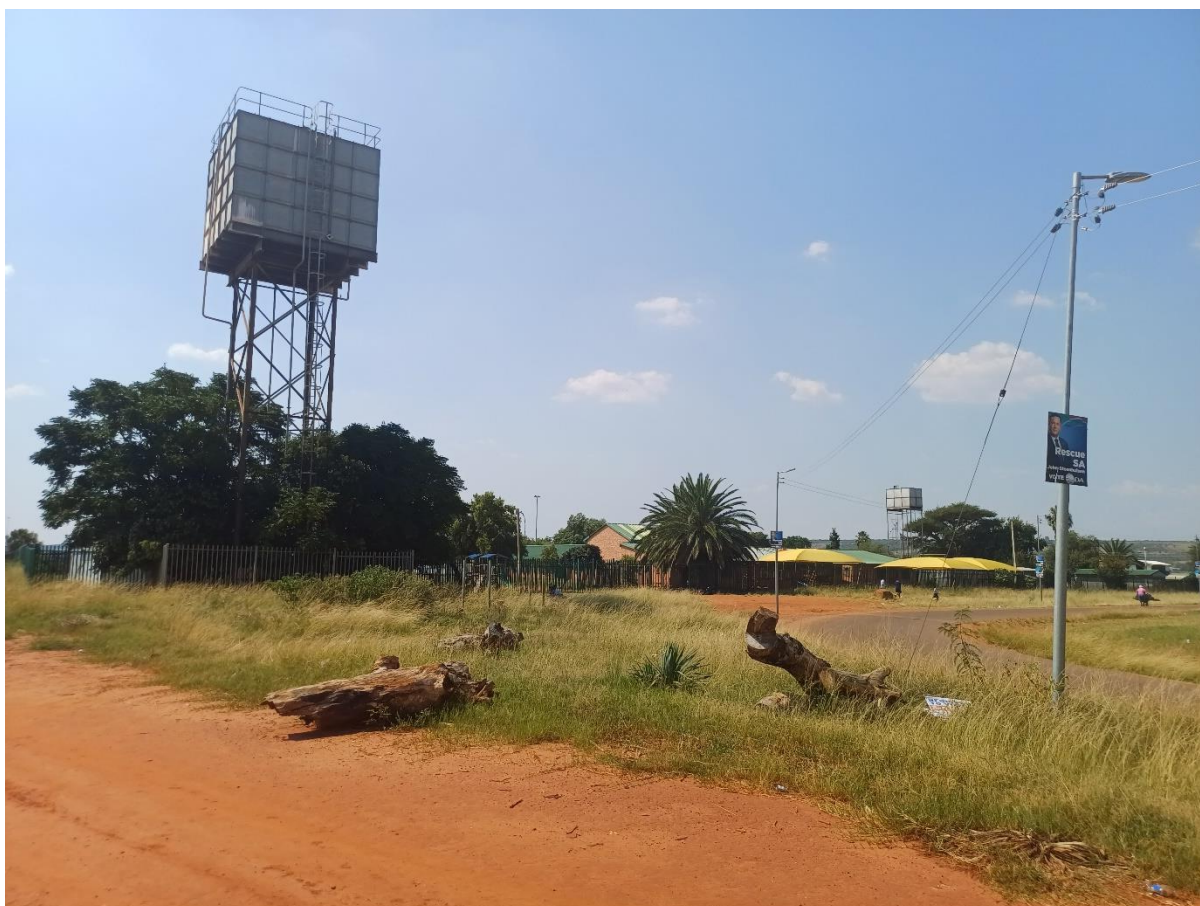
The boreholes are connected to a 40 000 Litre Slimline Steel Water Tank at primary school, that supply the community with portable groundwater (Photograph 1). The steel tank is elevated up to 10 m above the ground surface. The boreholes are equipped with submersible pumps and a small water treatment systems. The boreholes are pumped for roughly 3 – 4 hours to fill the steel tank. BH1-Clinic was tested using a drawdown method up to 4 hours and the yield was 0.3 l/s with a 1.0 m<sup>2</sup>/d transmissivity rate (Matikwane and Mohlala, 2022). However, the recommended abstraction rate for this boreholes is 0.2 l/s for 4 hours duty cycle and 4 hours of groundwater recovery (no pumping). Table 1 showing the position information at Onverwacht settlement.

*Photograph 1: View of the Slimline Steel Water Tank at Primary School*

- The overgrown vegetation in and around the boreholes and steel water tank should be cleared as soon as possible to allow easy access.
- The padlocks at the gates of BH2 - Cemetery and BH3 - Veld should be installed.

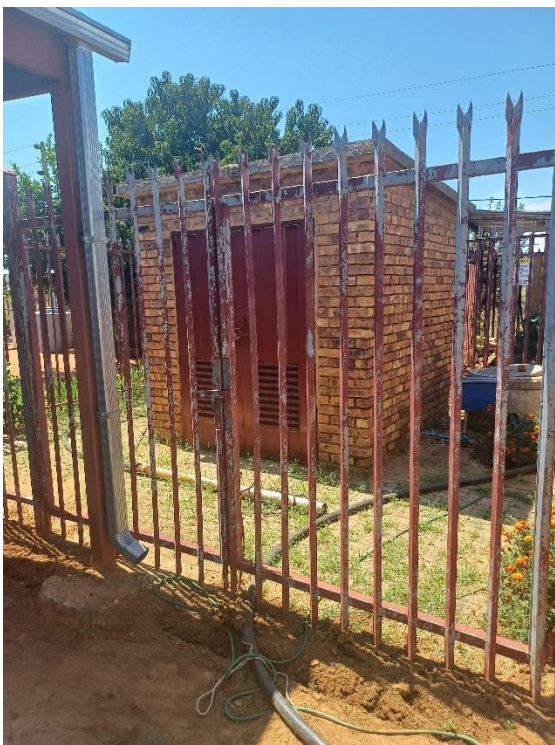
BH 1 – Clinic site was locked with pad locks on the gate but we were informed the ward counsellor Mr. Ndhkala that the pump is no working due cable thief. Ms Lutendo Masemola from Magalies Water confirmed this information telephonically. She also highlighted that vandalism is a constant problem and they required Eskom for solution but it require a significant revenues that can be sourced in the next financial year. The plan is to source electric power directly from the transformer at the clinic. The 5.5 Kw submersible pump and motor connected to approximately 60 m long pipe was observed with the clinic premise (Photo 3). The borehole is located about 200m from the steel water tank. The site was fairly clean but small weeds should be monitored regularly.

*Photo 2: View of BH1 - Clinic*

| Geo-sites | BH Depth (m)* | Reading (m) | Date | Time | Remarks |
|---|---|---|---|---|---|
| BH1 - Clinic | 75 | --- | 13/03/2024 | 12h17 | BH has concrete/grout sanitary seal and protected by manhole |

- Magalies Water Board should use non-copper cables for the scheme operations in order to slowdown vandalism in this area and further engage Eskom with new power source(s).

- The damaged palisade fence at BH2 - Cemetery should be repaired.
- Submersible pump and motor with 60m long pipe at the Clinic should be re-installed inside the well, if necessary repairs were done.

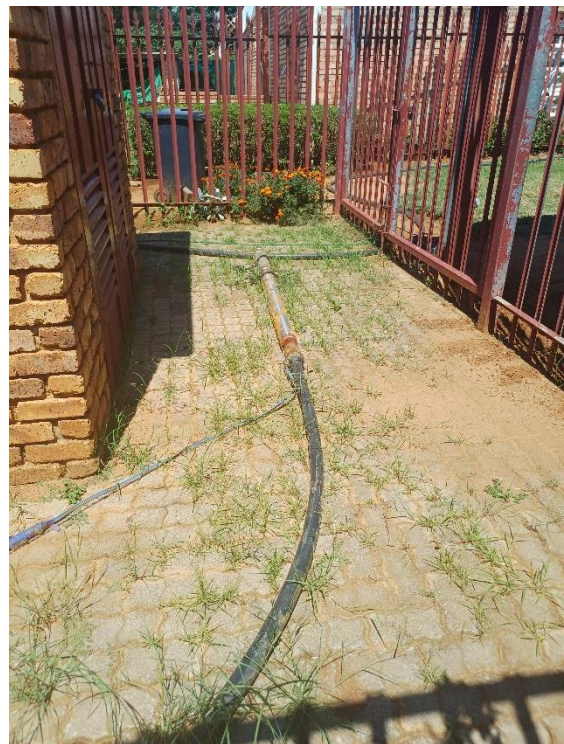
*Photo 3: View of 5.5 Kw pump at BH1*

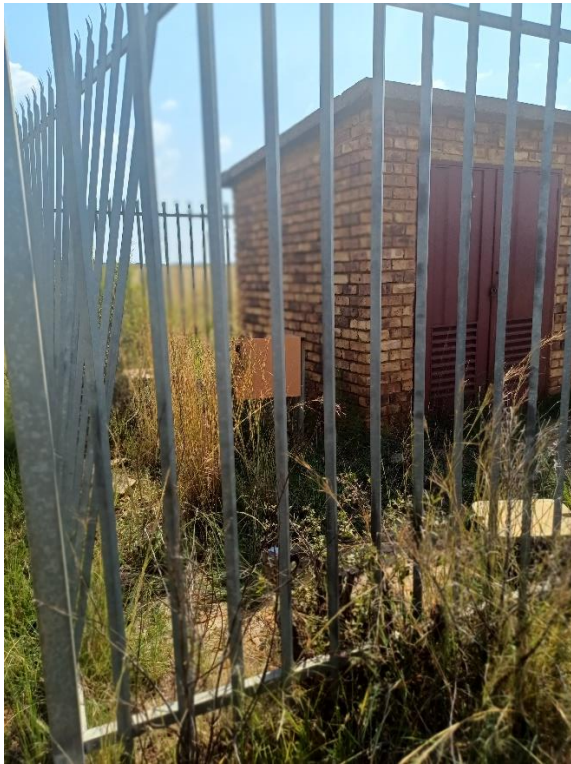
BH 2 – Cemetery site was accessible because the padlock on the gate was missing and palisade on the right corner was loss due to vandalism (Photo 4). The borehole is

*Photo 4: View of damaged palisade*

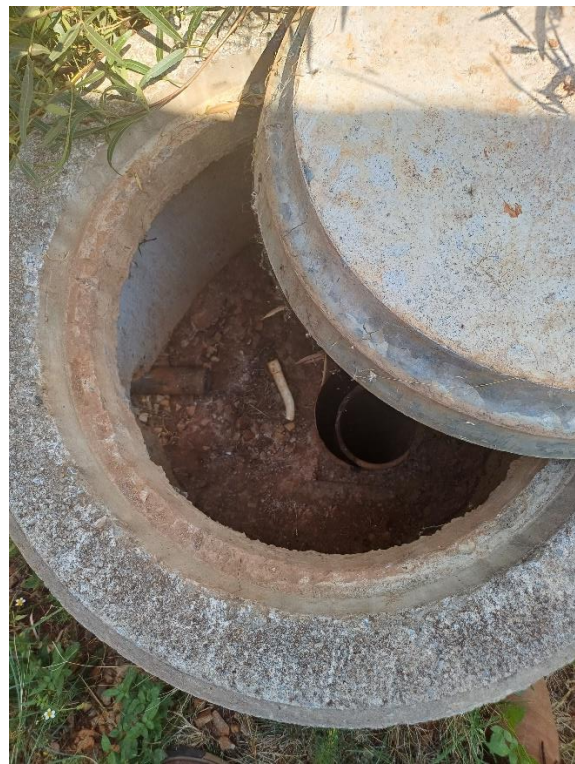
positioned about 180 m from the Cemetery and approximately 300m from the steel water tank. There was no submersible pump inside the well and some of the electric equipment outside were missing (Photo 5). A huge hole underneath the manhole was observed and this tend to provide pathway for runoff into the well. Therefore, should be sealed as soon as possible with cement and gravel/sand. Magalies Water did indicate that the borehole dry out after 4 hours pumping and this could be due to a well depth of 30 m. The water table was sitting at 5.60 metres below ground level (mbgl) during site inspection. The borehole can be an ideal groundwater quantity/quality monitoring point in this area. The site was overgrown with small scrubs and grassveld vegetation, making this borehole dangerous to assess, as this condition will enable lethal animal to habitat.

*Photo 5: View of the BH2 at Cemetery*

| Geo-sites | BH Depth (m)* | Reading (m) | Date | Time | Remarks |
|---|---|---|---|---|---|
| BH2 - Cemetery | 30 | 5.60 | 13/03/2024 | 14h00 | BH has broken concrete/grout sanitary seal underneath the manhole |

- BH2 should be drilled or exploited further down up to the depth of below 80 below ground surface. Alternately, a new well can drilled nearby and use BH2 to establish a new DWS groundwater quality and quantity monitoring in this area.

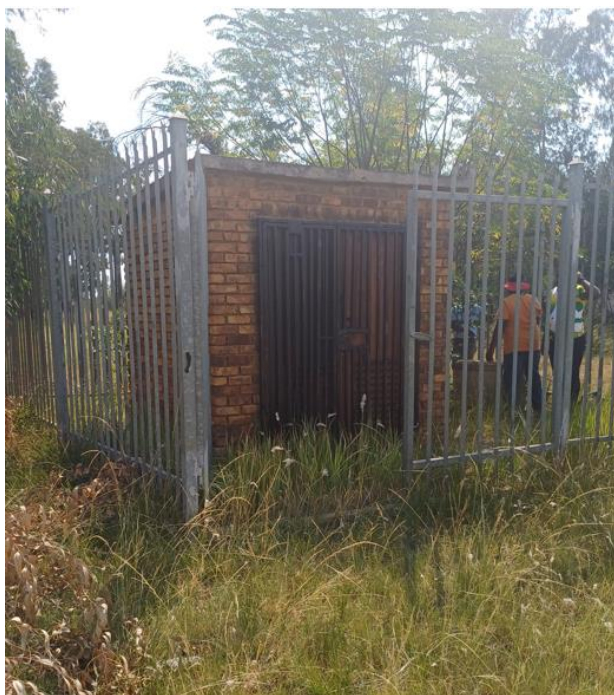
A private fence currently surrounds Borehole 3 – Veld site and it was accessible since the padlock on the gate was missing. The borehole is positioned roughly 500 m from borehole 1 at the Clinic. The palisade fence around the borehole is still good condition and the surrounding is overgrown with trees/grassveld vegetation (Photo 6). It was noted at this site that the electric copper cables from the well to the pump hut were stolen. The manhole was not accessible but through the help of the community, we

Photo 6: View of the BH3 at Veld

| Geo-sites | BH Depth (m)* | Reading (m) | Date | Time | Remarks |
|---|---|---|---|---|---|
| BH3 - Veld | --- | 3.13 | 13/03/2024 | 14h40 | BH has concrete/grout sanitary seal and protected by manhole |

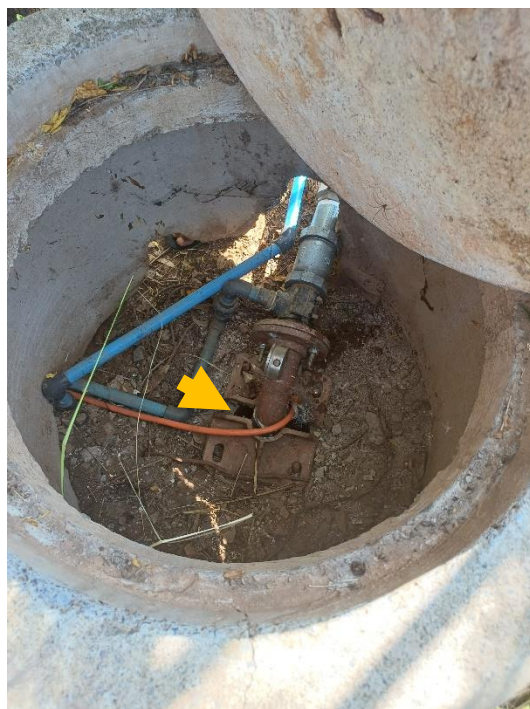
managed to secure a vital tool that can open. The water table was sitting at 3.13 metres below ground level (mbgl) during site inspection (Table 2). The dip meter was inserted in a small hole next to the pipe (Photo 7). The submersible pump is connected to a newly installed water-reading meter to determine the flow volumes out of the well.

Photo 7: View of the submersible pump

- The daily meter readings should be shared with DWS in order to determine the actual water usage from this groundwater scheme.
- Magalies Water Board should be conduct pump testing for BH2 - Cemetery and BH3 - Veld in to determine the aquifer potential or capacity. The pump test was only performed at BH1 - Clinic according their latest hydrogeological report in 2022.
