South African – Danish Strategic Sector Cooperation Project Support Facility

Borehole Optimization Project

Borehole optimization and strategic planning in Modimolle-Mookgophong Municipality

July 2022

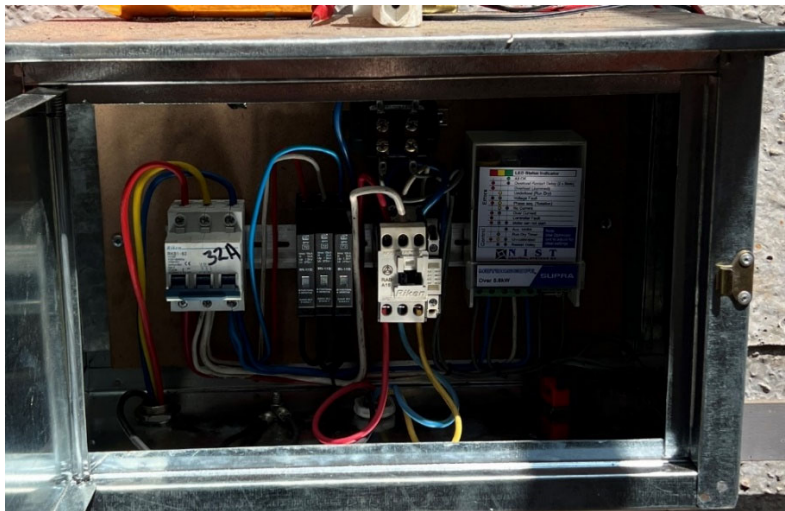
Figure 5.1: Example of medium level of electrical component, from borehole H24-0024 in Vaalwater

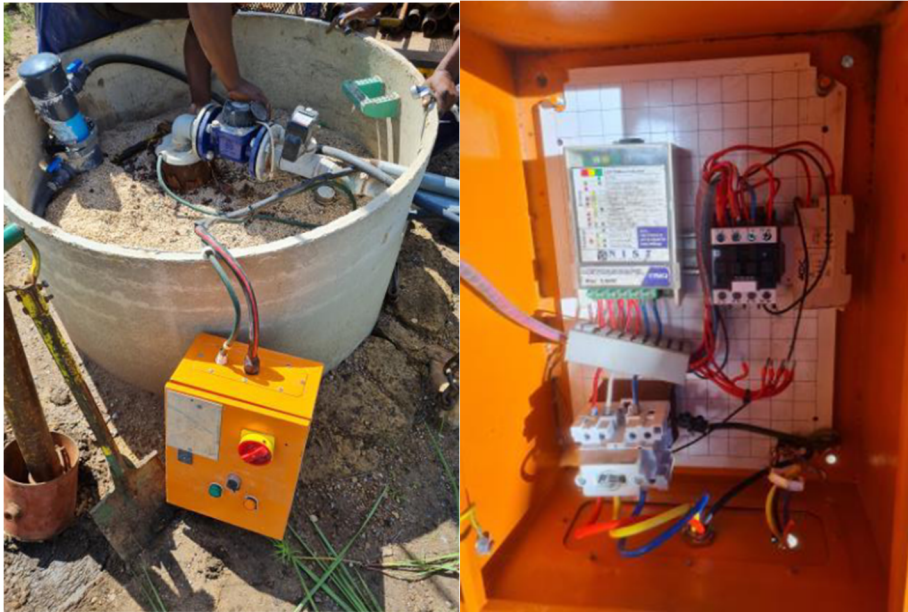
Figure 5.2 show an example of a good quality switchboard, with main switch and control buttons on the front of the electrical box for easy operation by operating personnel.

Figure 5.2: Example of medium level of electrical box, from borehole H24-0049 in Modimolle

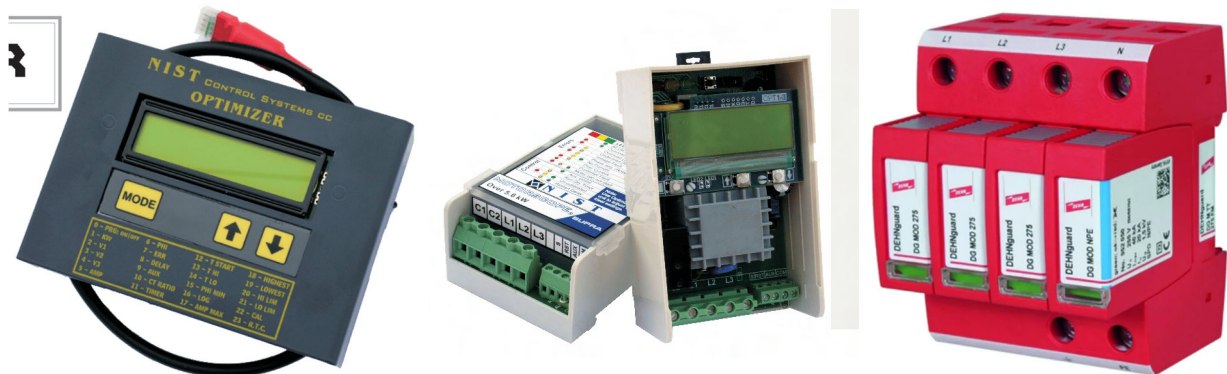
In the event of overvoltage's on the public electricity grid, the surge arrester will switch off and a manual action must subsequently be performed, which includes replacing the tripped module, but this can easily be done by instructed operating personnel, See figure 5.3

Figure 5.3: Optimizer, Motorscope and Surge arrester
