DAM SAFETY EVALUATION REPORT:

ROODEFONTEIN

FOURTH REPORT

MARCH 2020

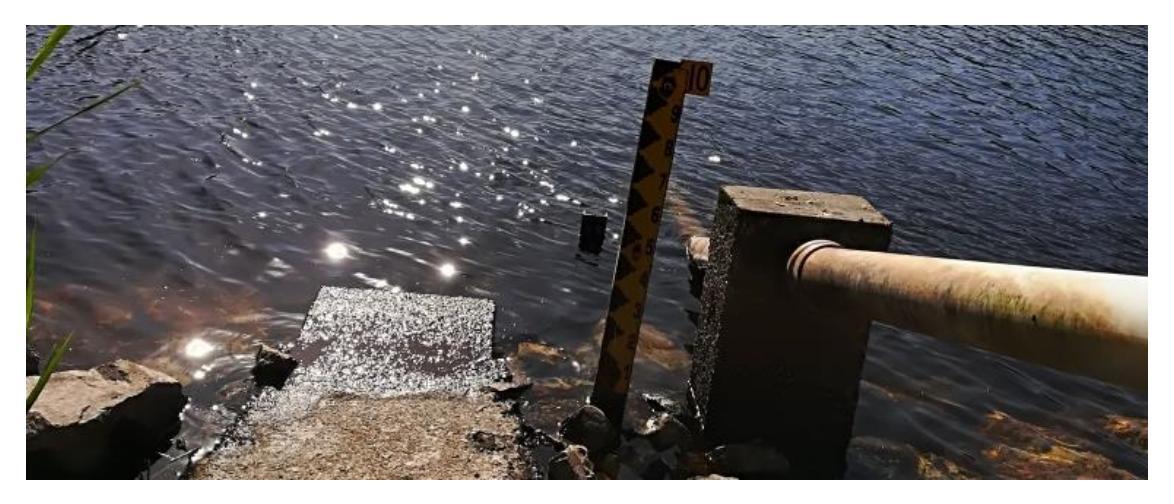
VISUAL INSPECTION DATA			
Date:	25 September 2019		
Gauge Plate reading:	About 9.8 m (Figure 15)		
Had it recently rained?	Yes, on 24 September 2019. Rain Intensity: 10 - 50 mm		
Describe weather:	The skies were clear

Figure 15: Gauge Plate reading

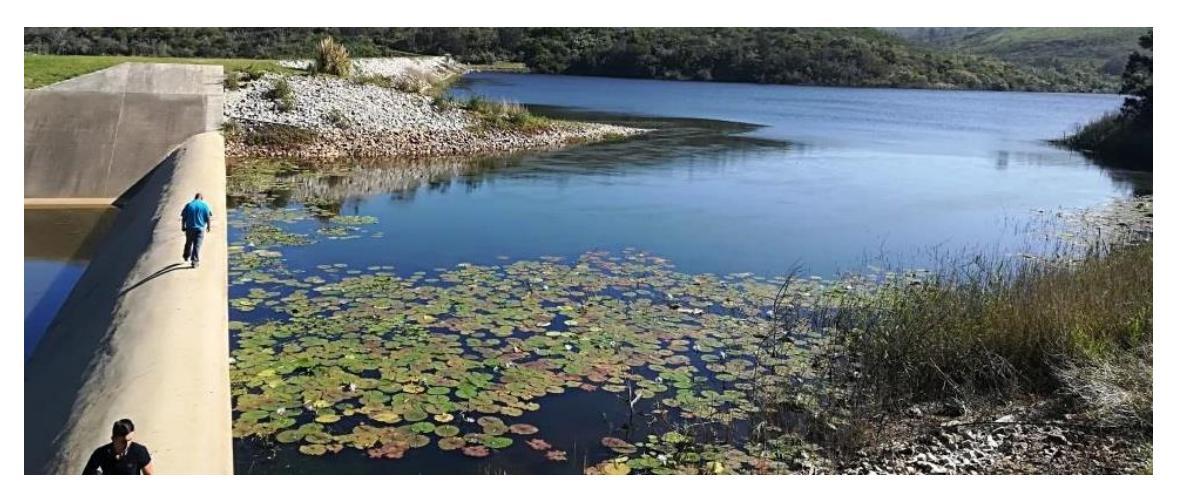
There is no safety boom installed at the dam, see Figure 21.

Figure 21: Side view of the spillway showing a lack of safety Boom

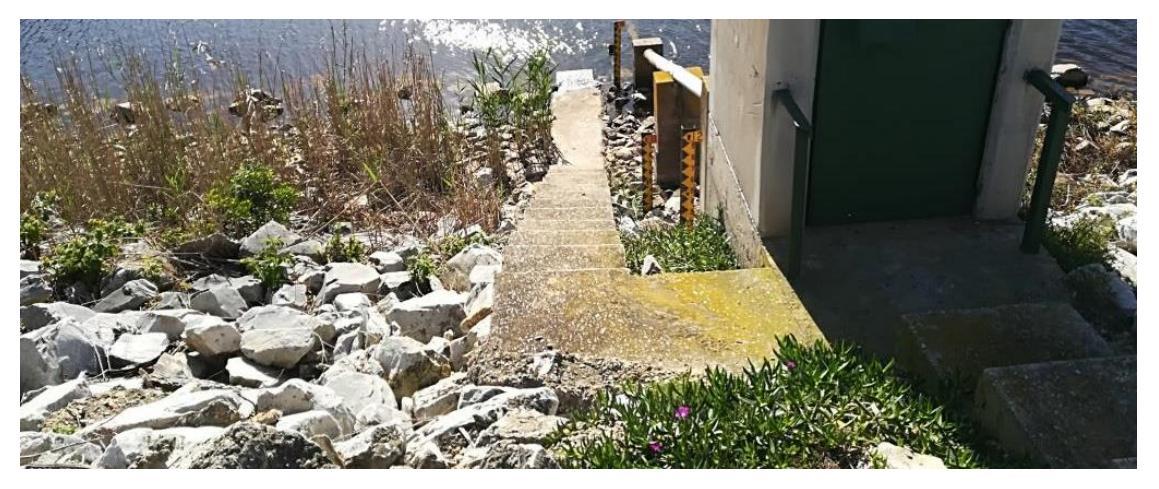
The stairway on the upstream slope leading to the gauge plate is relatively steep and it does not have railing, see Figure 22. This setup might expose officials working at the dam to a danger of falling. The evaluation team did not observe any unsafe practice on the day of inspection nor find evidence proving that there is unsafe practice at the dam.

Figure 22: Stairway leading to the gauge plate.

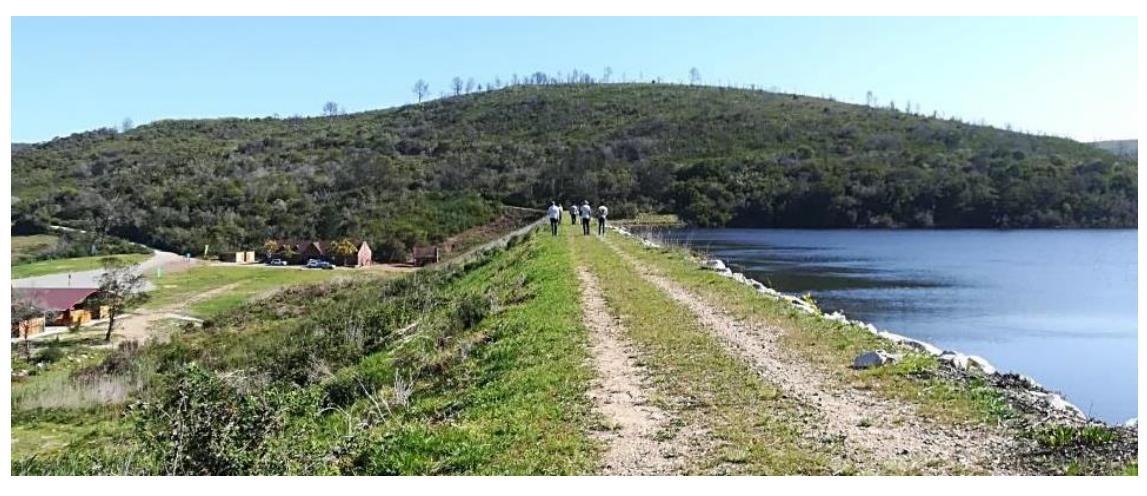
As-Built drawing No. 150195/06 (WA166401/020) indicates that a 20 mm layer of gravel protects the non-overspill crest. During the inspection it was realised that grass has been incorporated and it performed satisfactory in protecting the NOC, see Figure 27.

Figure 27: Non - Overspill crest of Roodefontein Dam.

There is evidence of ratting caused by vehicle wheels on the crest, see Figure 27 above. The only found evidence concerning animals is the presence of ants at their early stage as shown in Figure 28; however, at this stage these activities are not critical to an extent of causing a dam failure.

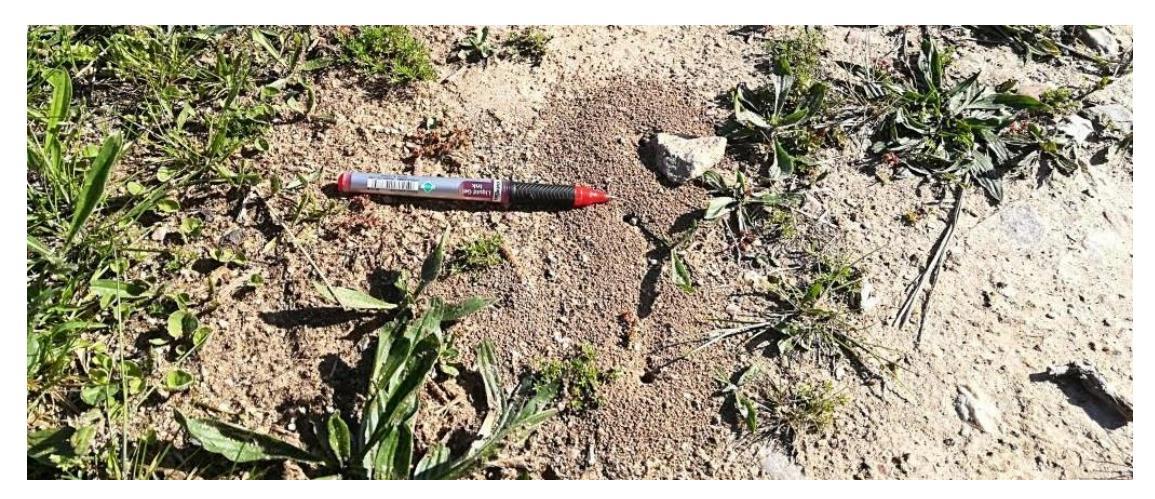
Figure 28: Ants activities on the crest

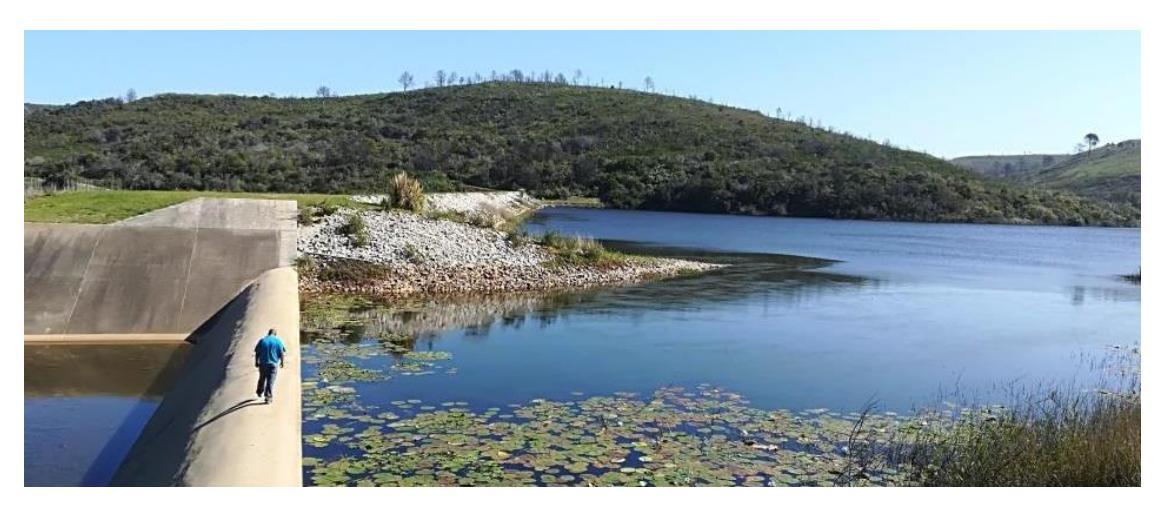
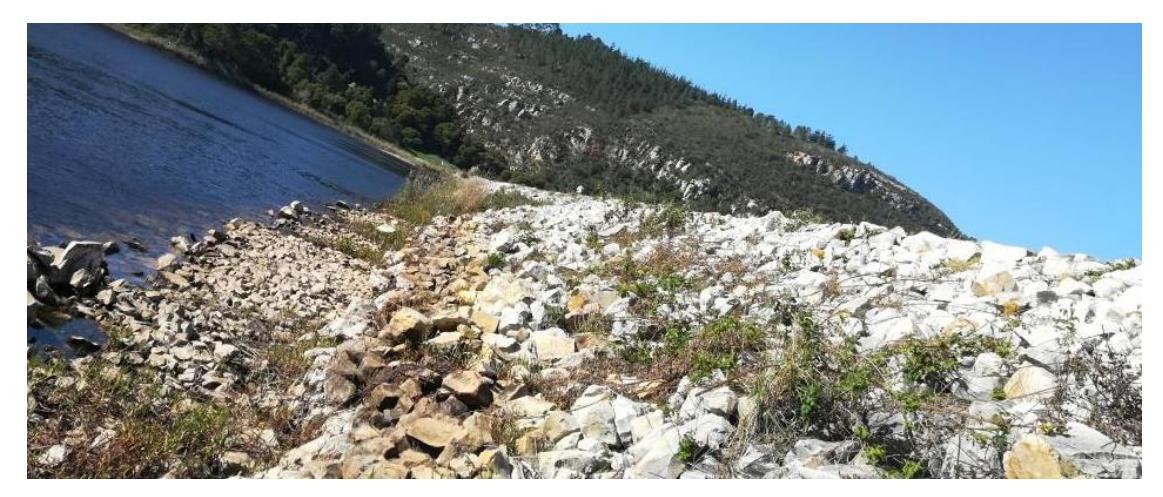
On the day of inspection, the slopes had some isolated vegetation as can be seen in Figure 29 and Figure 30 below. The quantity and height of this vegetation should not cause any failure of the dam. However, the Owner of the dam should clear this vegetation regularly.

Figure 29: Isolated vegetation on the upstream slope.

Figure 30: Upstream slopes of the dam wall.

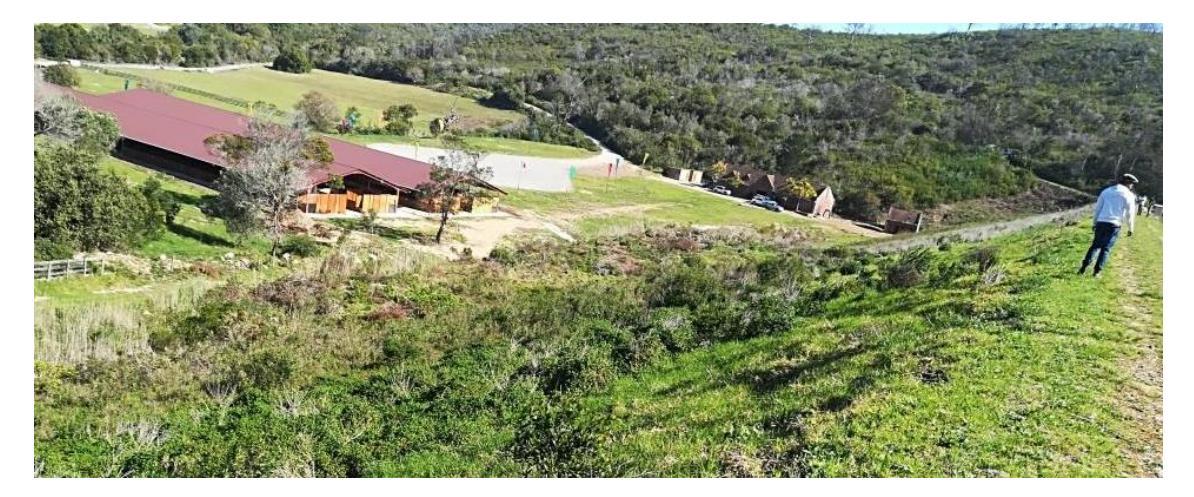
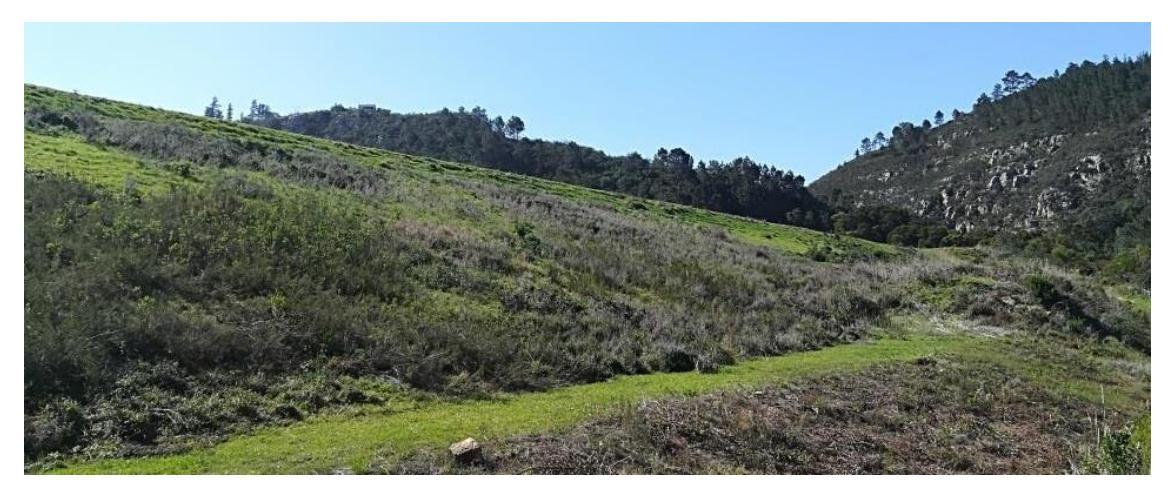
The area downstream of the outlet works has been kept well with grass trimmed correctly. The area close to the spillway has a few bushes, see Figure 31 and Figure 32. Despite the bushes, the overall condition of the downstream slope as far as vegetation growth is concerned is satisfactory.

Figure 31: Some vegetation on the downstream slope of the wall.

Figure 32: View of the dam wall showing some bushes on the downstream slope.

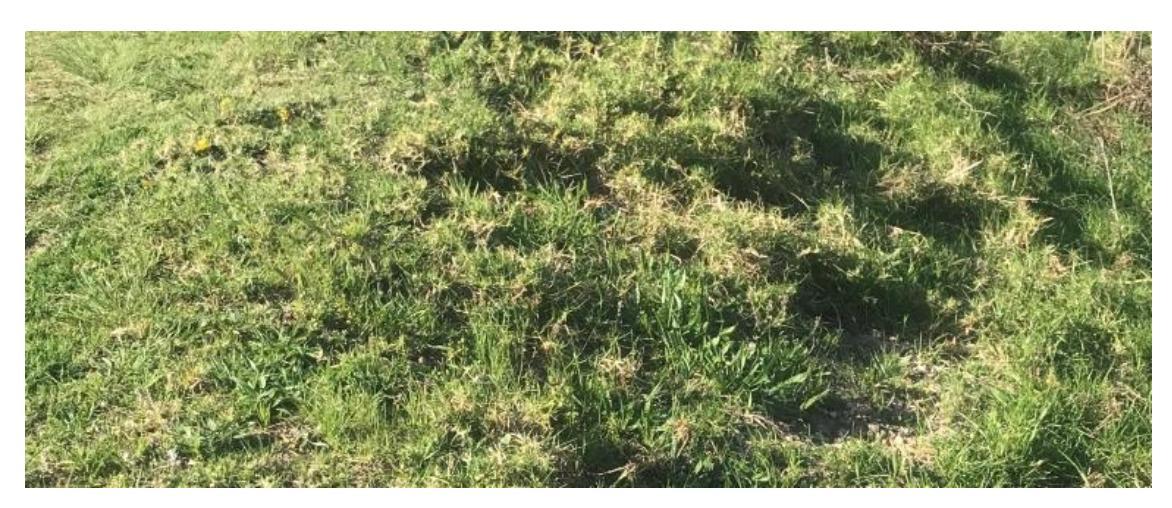
Figure 35: Existing horizontal crack covered by grass on the downstream slope.

- j) Department should determine an appropriate action concerning the newly built horse stable downstream of the earthfill embankment.
- k) Rehabilitate the earthfill embankment in order to address the horizontal crack on the embankment and the slope instability.

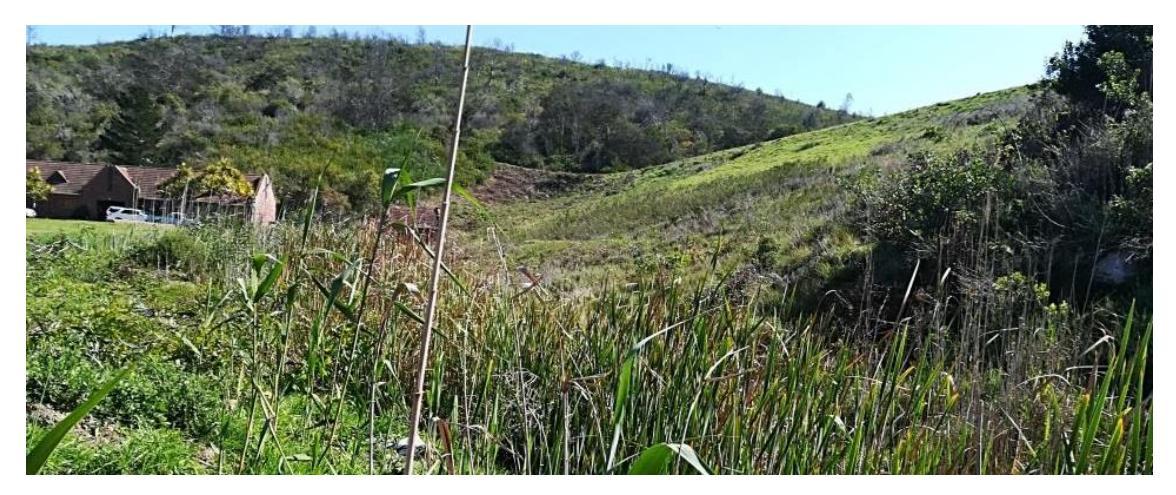
The dam does not have a conventional toe drain system. The study of existing as-built drawings, existing reports, and the physical inspection of the dam confirmed the nonexistence of the toe drain. On the toe there is surface water drain in a form of unlined channel, see Figure 36.

Figure 36: Strong vegetation growth in the Toe-Channel.

- d) Increase Freeboard of the dam to ensure compliance with 2011 Guidelines on Freeboard for Dams.
- e) Repair the damaged roof of the outlet house.
- f) Install a proper toe drain system to manage seepage on the downstream of the dam.

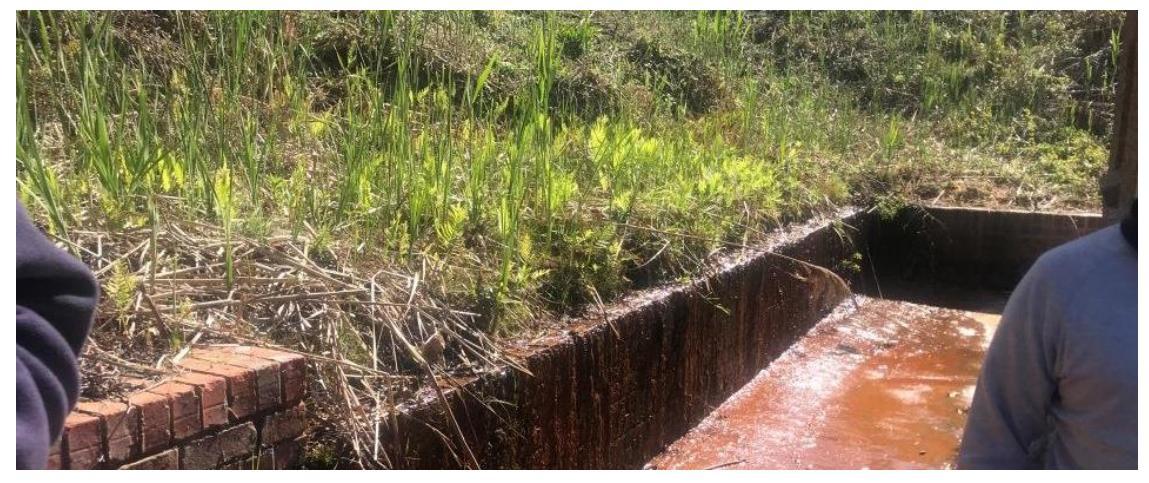
Downstream of the right flank, a sizeable amount of seepage was observed, see Figure 37. The seepage water collects behind the outlet house and is channelled through a small channel which connects to the toe-channel, see Figure 38.

Figure 37: Seepage from the right flank day lighting next to the outlet house

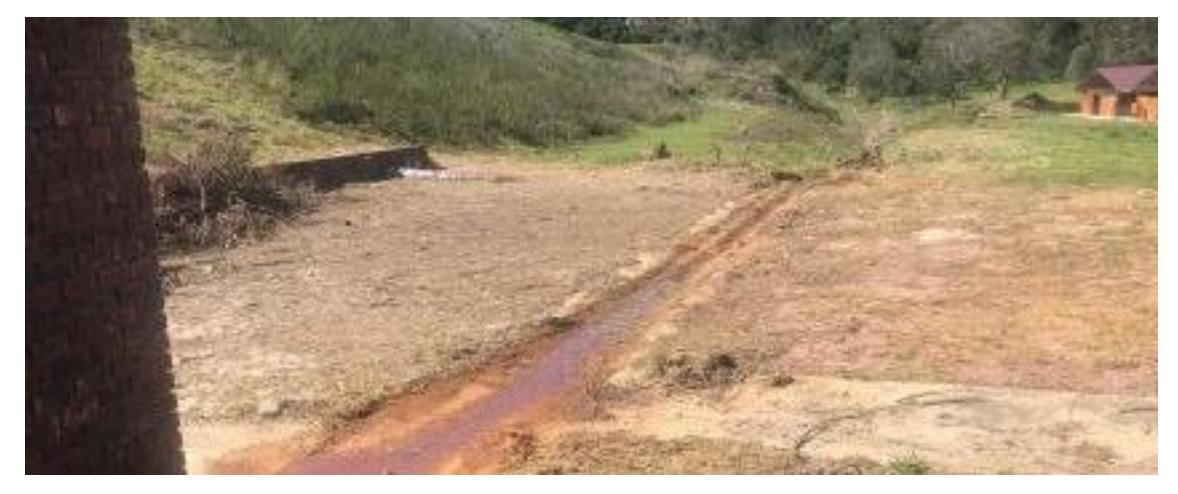
Figure 38: Seepage water channel to a Toe-Channel and discharge in the river

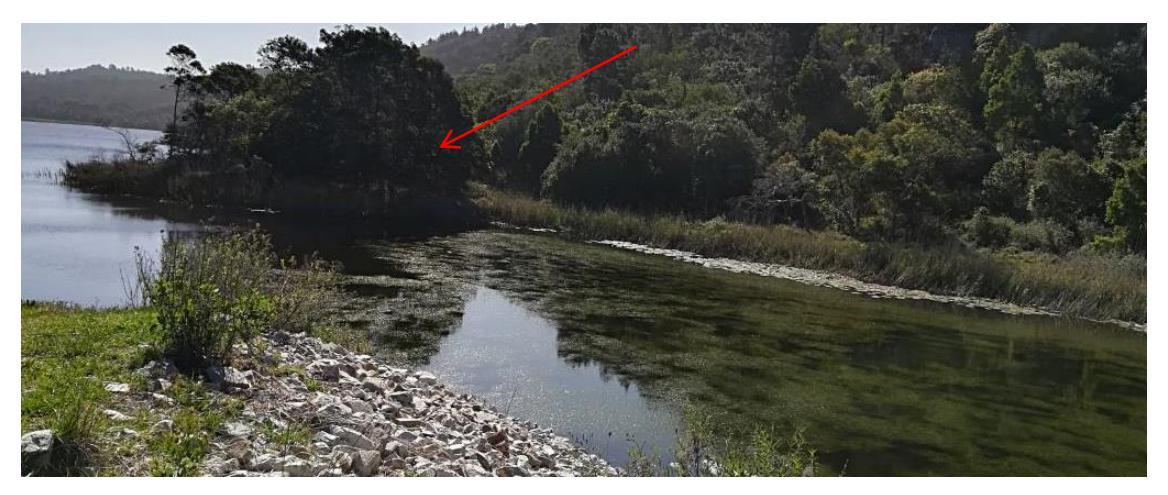
Previous reports indicate that the left flank experienced a slip failure in the past. Material from this failure was deposited in the approach channel, see Figure 40 and Figure 41 below. The influence of these deposits on the dam should be investigated.

Figure 40: Spillway approach channel.

Other than the material deposits from the slip failure, there is no additional loose material in the approach channel.

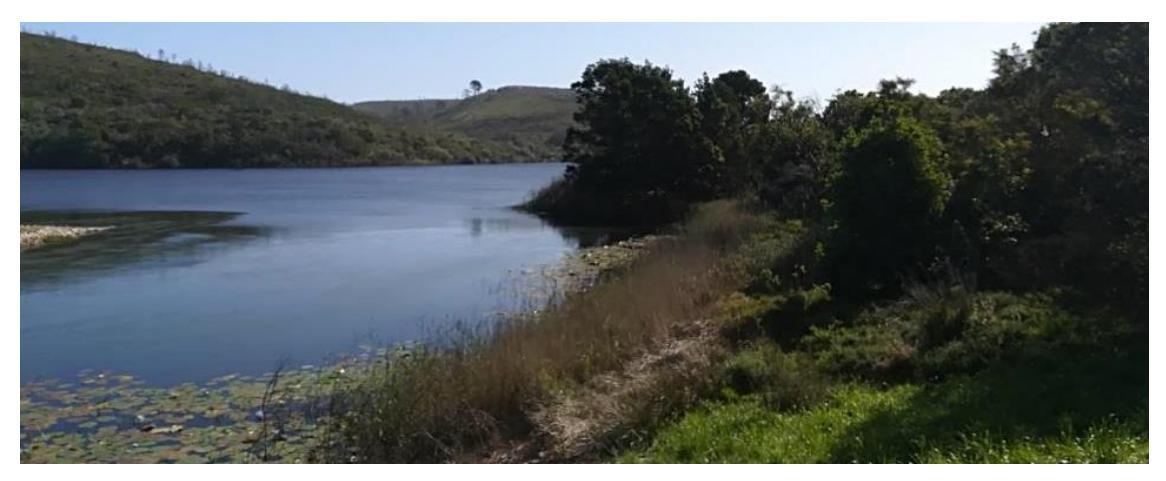
Figure 41: material deposit due to a slip failure on the right flank

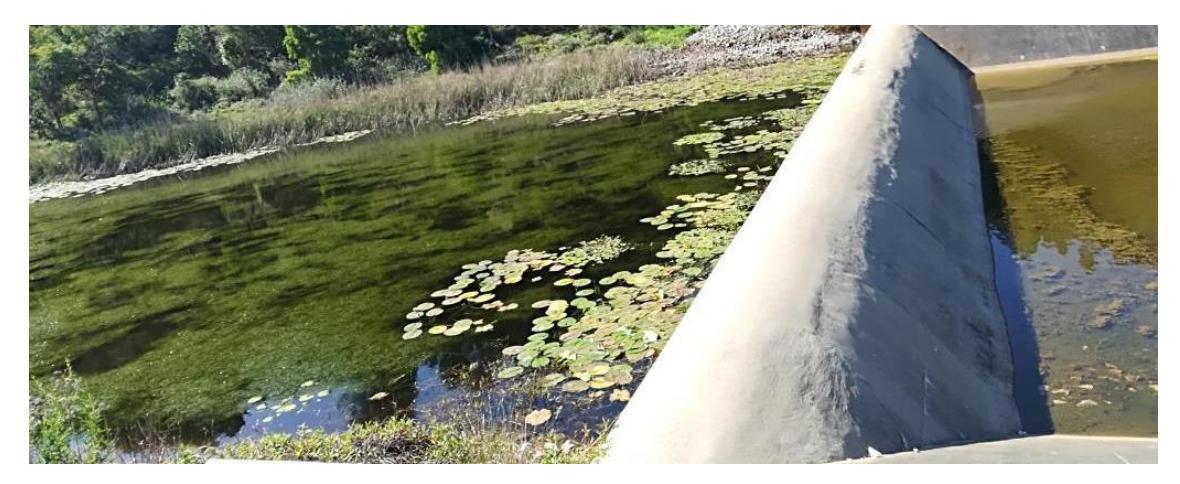
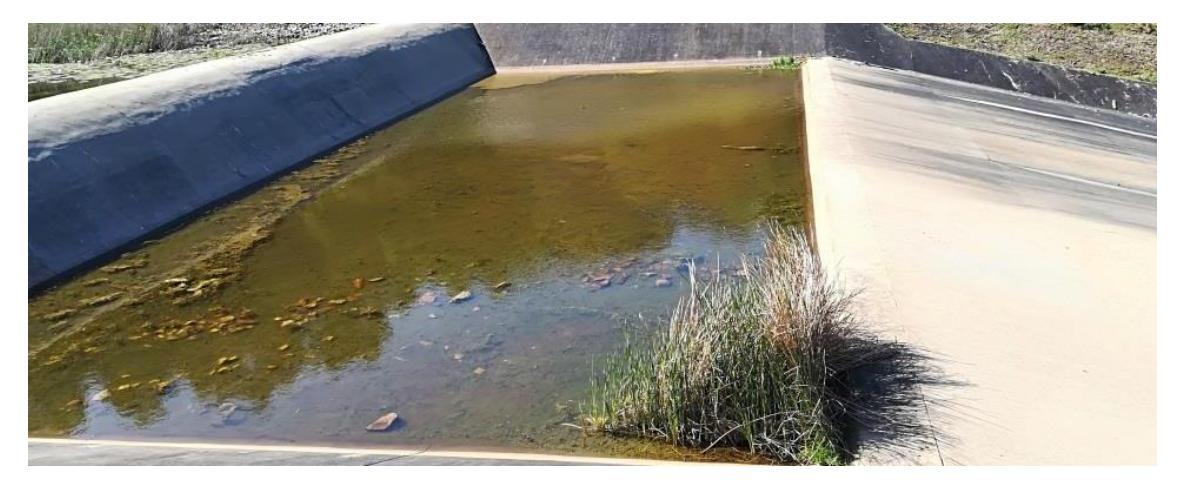
On the day of inspection water level was below the full supply level, allowing the team to closely inspect the spillway, see Figure 42 and Figure 43 below. The concrete used on the spillway is intact with no signs of major cracks or seepage.

Figure 42: Side view of the spillway

Figure 43: Concrete conditions of the Staling Basing

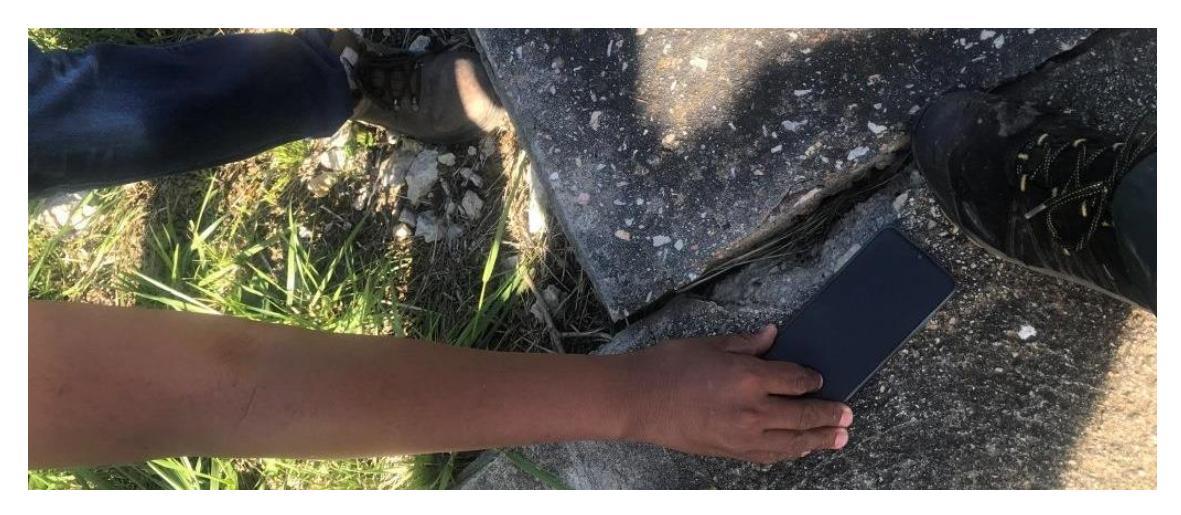
Other than these minor movements, there are no signs of significant cracking, significant movement or settlement on the spillway.

Figure 44: Signs of minor concrete panel movement.

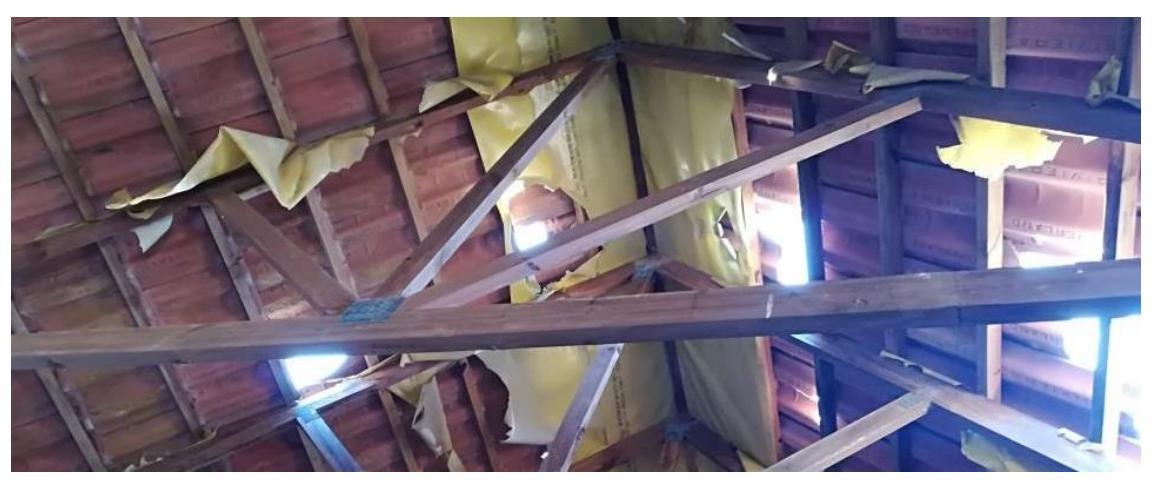
Detailed inspection of the outlet works is covered in the appended Electro-Mechanical Report. The roof of the outlet house has been damaged and it requires repair work, see Figure 45.

Figure 45: Damaged roof of the outlet house

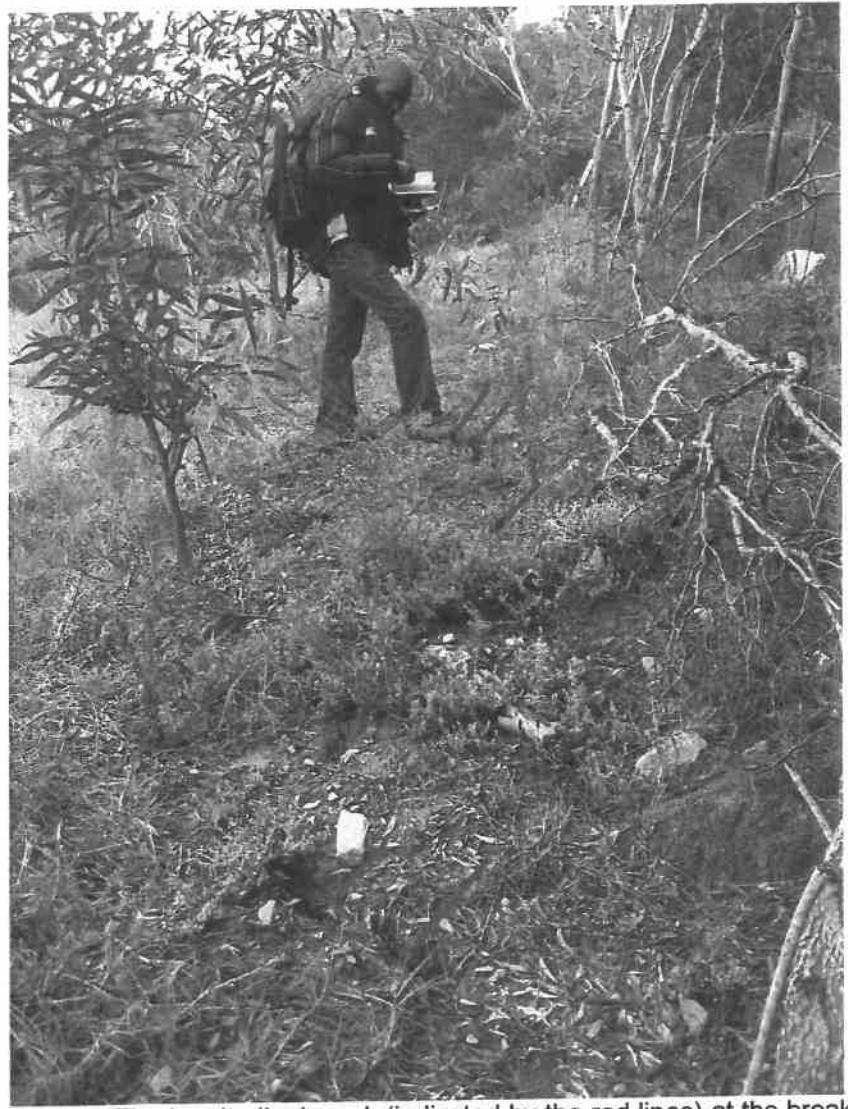
Plate 1: The longitudinal crack (indicated by the red lines) at the break in slope immediately to the north of the spillway, indicating some movement in the slope.

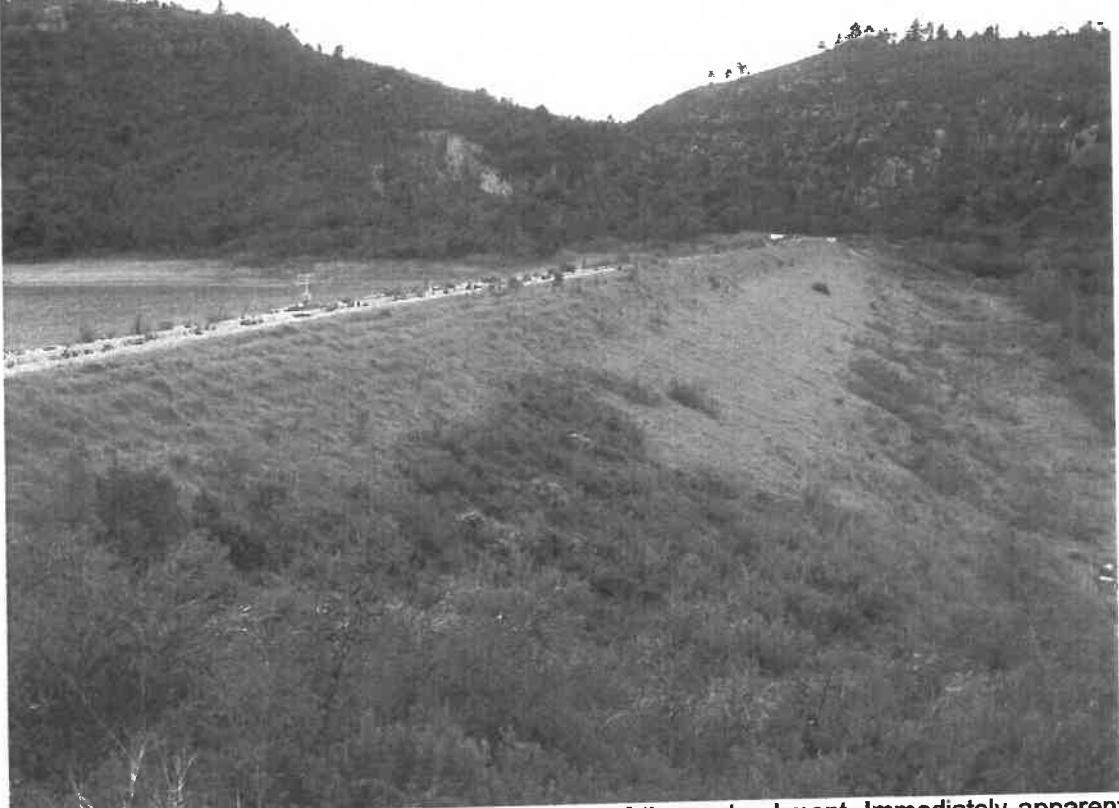
Plate 2: A general view of the downstream face of the embankment. Immediately apparent are the horizontal lines visible near the crest which closer inspection reveals to be prominent cracking.

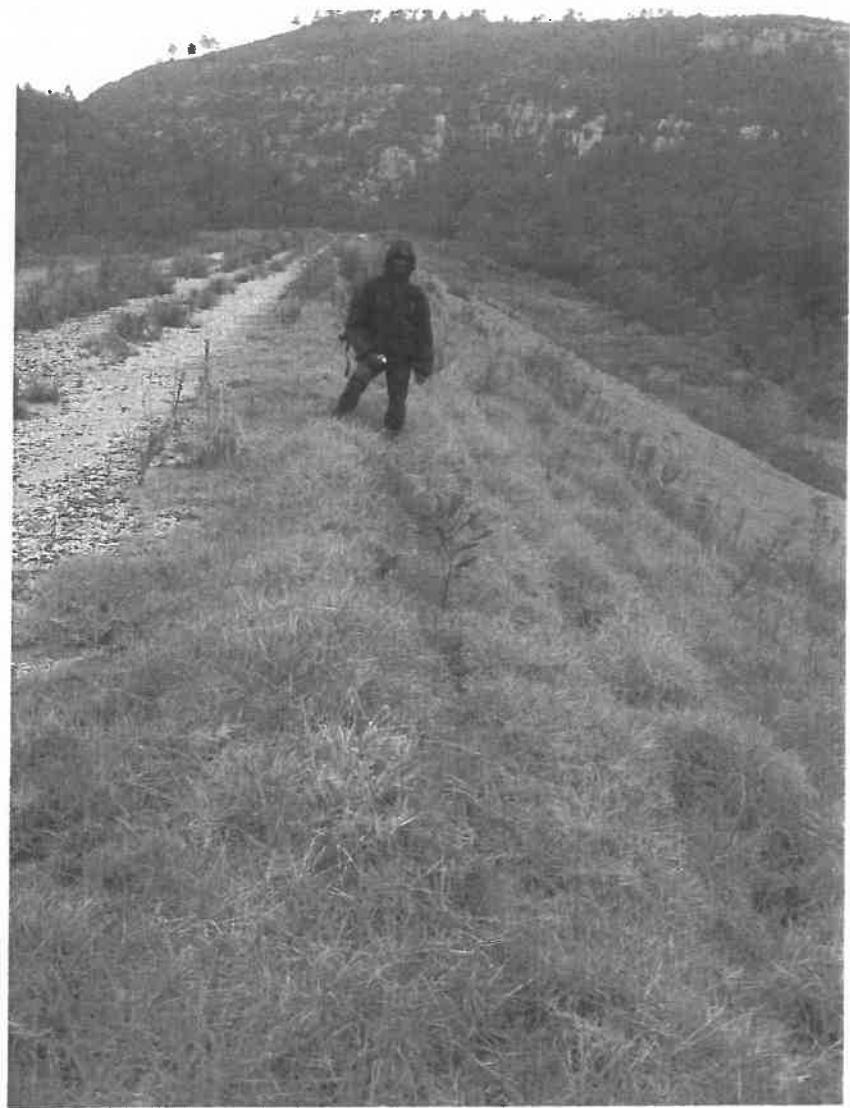
might be traced for a significant length along the face (Plate 3). It is surmised that the origin of these cracks is linked to material placement and / or compaction during construction. These cracks suggest there has been some degree of downslope movement. At present the cracks provide for enhanced water ingress into the downstream face of the embankment. Note that the thick grass cover precluded detailed observation of the depth of these cracks, and it is not certain to what extent there has been any associated downslope movement. It might also be noted that the slope of the downstream face is estimated at approximately 30° (1:1.7), while available sections indicate a flatter gradient of approximately 22° (1:2.5).

Plate 3: A closer view of the prominent cracking. Although largely hidden by the dense grass cover, at surface these cracks are almost 100 mm in width.
