# DEPARTMENT OF WATER AND SANITATION

## Determination of Water Resource Classes, Reserve and the Resource Quality Objectives in the Keiskamma and Fish to Tsitsikamma Catchments

### WP11354 River Field Survey Report 2

REPORT NO.:  
WEM/WMA7/00/CON/RDM/1423

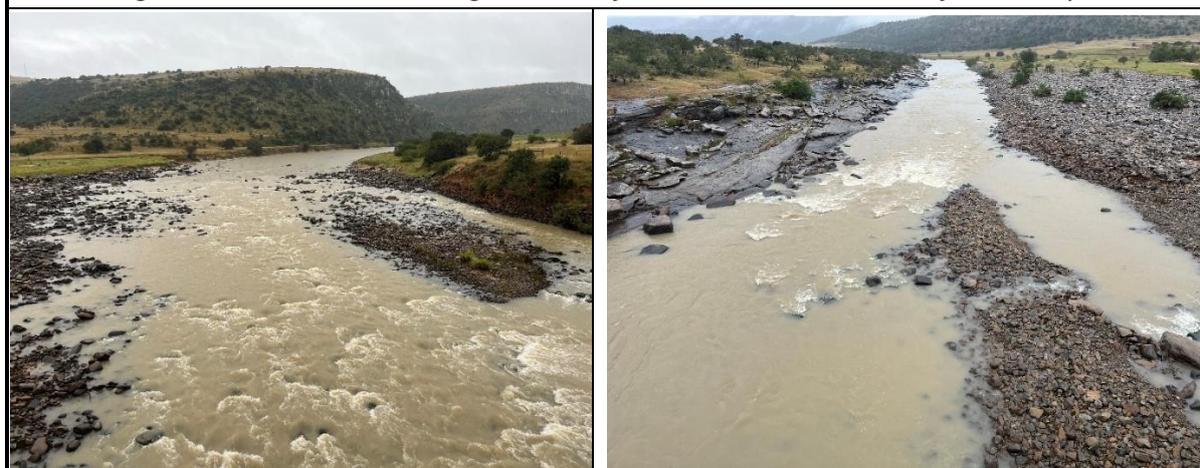
The marginal zone and portions of the flood benches had been scoured or removed from recent floods. Marginal zone vegetation was sparse and scattered and comprised clumps of *Phragmites mauritianus*, *Cyperus longus* or scattered remnants of *Gomphostigma virgatum*. Flood benches were a mix of scoured bedrock/boulder/cobble, mostly unvegetated and consolidated alluvia with overgrazed lawns dominated by *Cynodon dactylon*. The left bank was steep, with *C. dactylon*, *Agrostis lachnantha*, scattered trees, mostly *Combretum caffrum* or *Vachellia karroo* and a band of *V. karroo* seedlings and saplings. The right bank had been altered with artificially piled rocks and incised by a lateral tributary feeding into the main channel just upstream of the site. As such, vegetation was artificially aligned and comprised mostly alien shrub species including *Sesbania punicea*, *Lantana camara*, *Senna didymobotrya* and *Solanum torvum*.

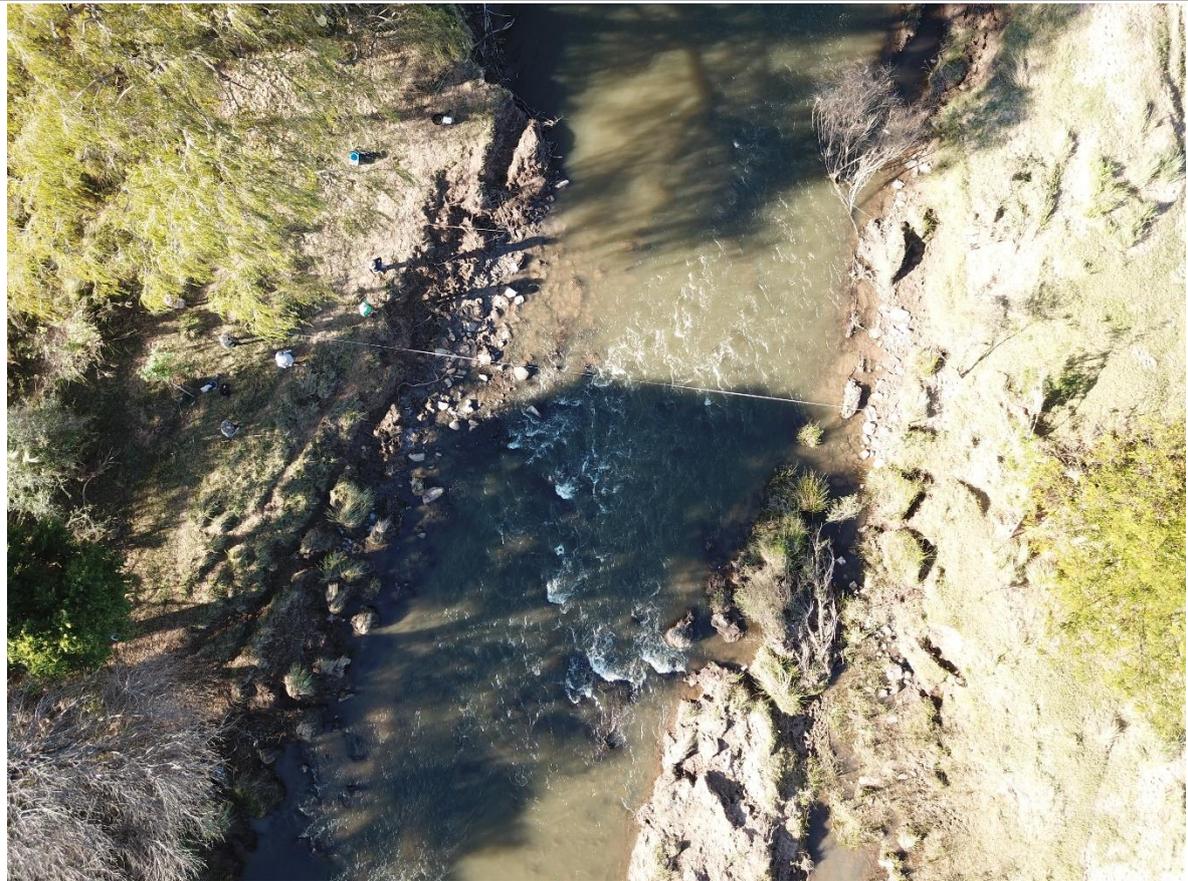
Following the flood event that took place in February 2023, clear evidence of bank collapse and further bank erosion was observed, particularly along the left bank. This was exasperated by the continued cattle trampling and grazing along that bank.

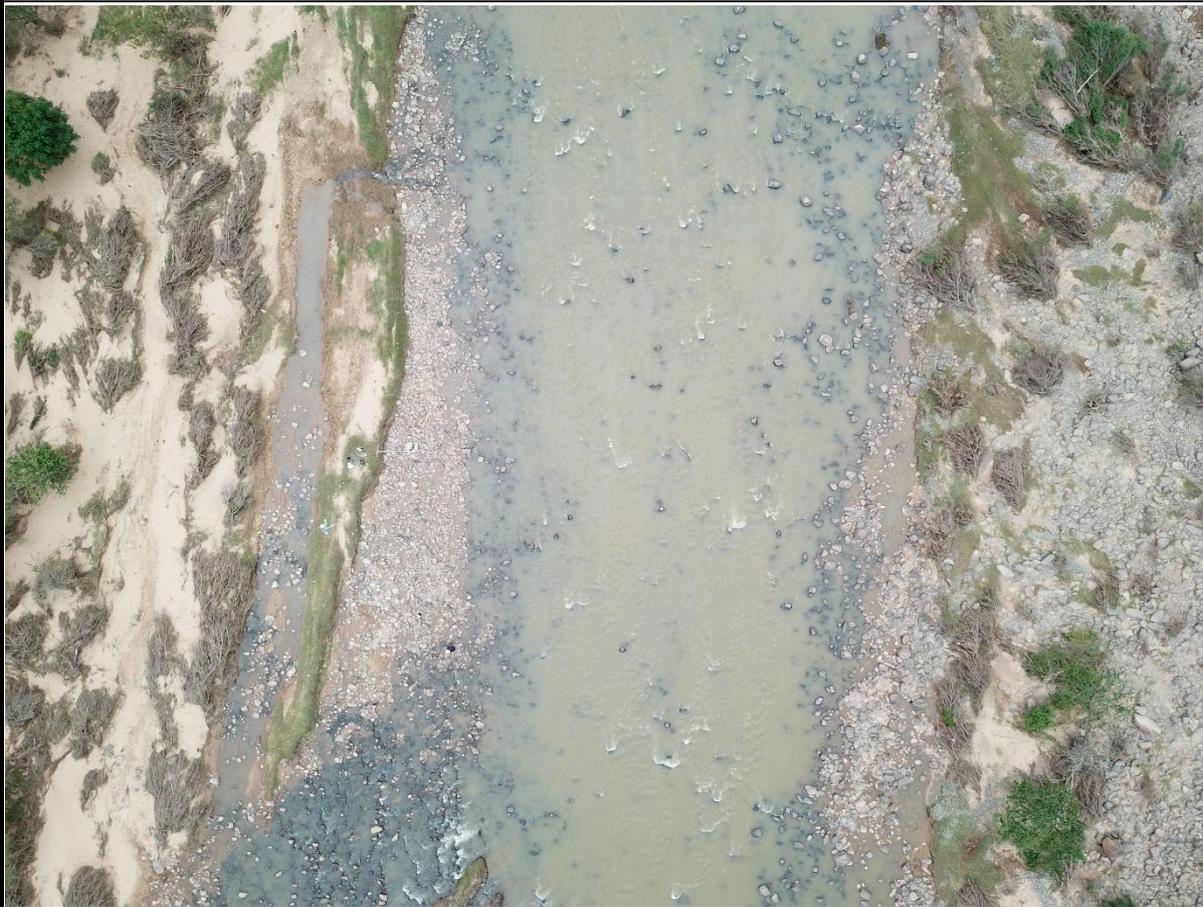
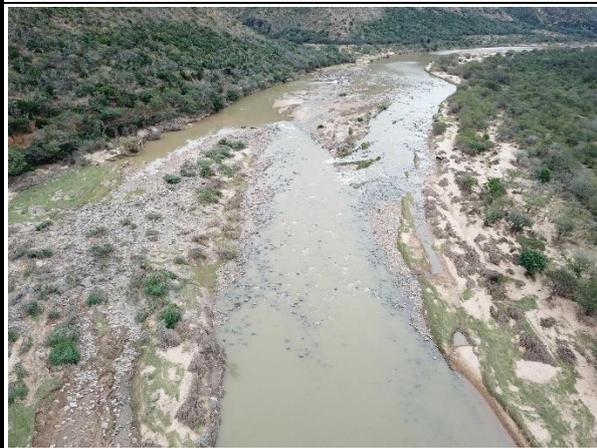
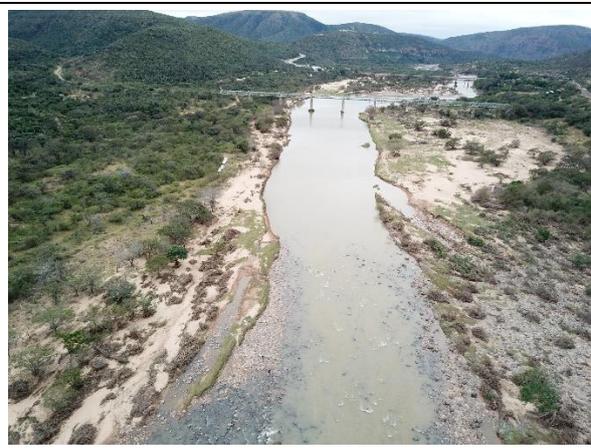
Following the flood event which took place in February 2023, it was clearly observed that this reach of the Great Kei has been positively reset. Considerable sediment deposits were observed along both banks and terrestrial species (i.e *Vachellia robusta* (*Splendid* Thorn) flooded out along the riparian marginal zone. The boulders and SIC, SOOC have been scoured and a considerable difference in the population of Simuliidae larvae, which previously smothered and dominated the biotopes.

The marginal zone had been mostly scoured out by recent floods with only remnants of vegetation clumps scattered between bedrock/boulder/cobble with newly deposited alluvia in-between. Vegetation comprised mostly *Cyperus longus*, *Gomphostigma virgatum* and *Hemarthria altissima*, although the latter had been grazed to form lawns. Flood benches and the floodplain were extensively covered by new, mostly unvegetated sediment deposits from recent floods and flood damage and flood-related plant deaths were extensive. The *Vachellia robusta* population which had dominated the floodplain before has been vastly reduced, although much remained, and dominance persisted. Other floodplain species included *Ficus sur*, *Combretum caffrum*, *Gymnosporia buxifolia* and *Lantana camara*. The banks were dominated by thickets of *L. camara* and wood removal and overgrazing were extensive.

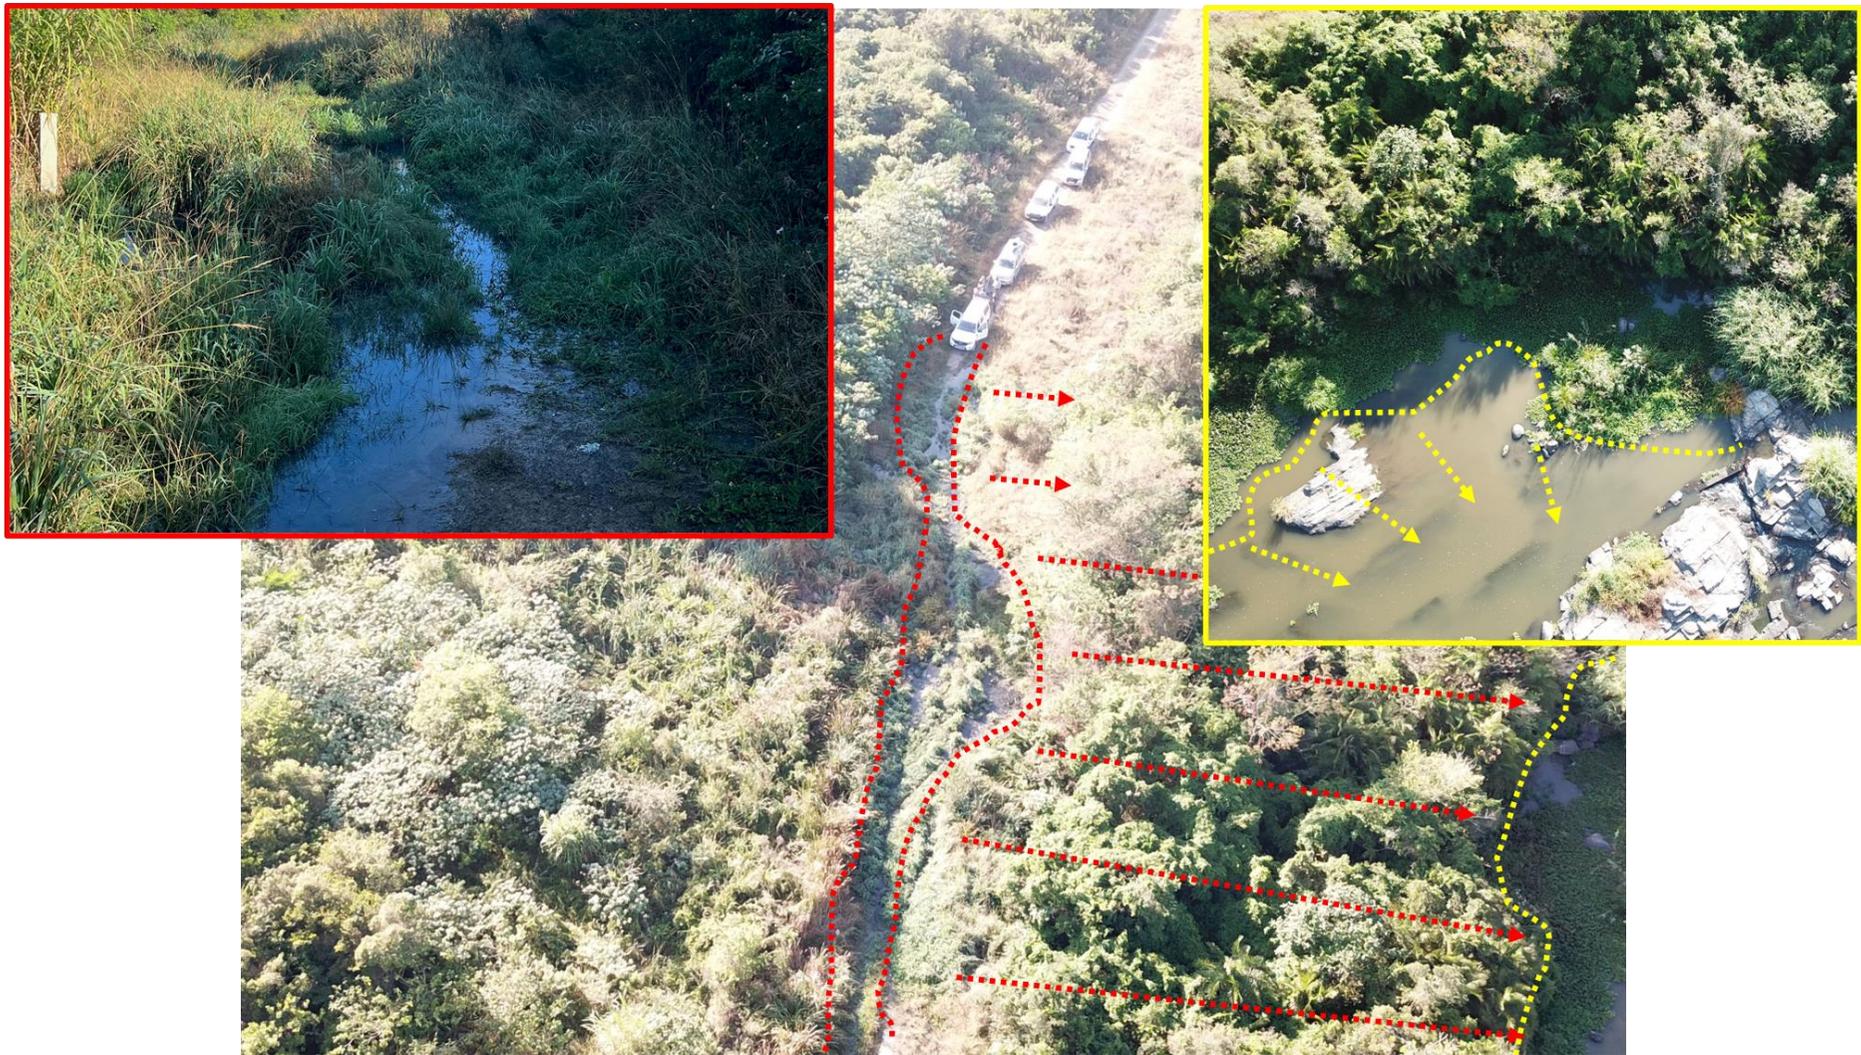
<b>Red Flag for actioning from the Department</b>			
<p>During the May 2023 survey, evidence of raw sewage flowing directly into the lower reaches of the Buffalo River, where our EWR site is located, was observed. The source of this sewage appears to be sourced from the residential and rural area of Reeston and beyond. The observed flow of raw sewage was higher than what was previously observed in September 2022. The bypassing of the Wastewater</p>

Treatment Works (WWTW), which is located just downstream of this site and adjacent to the water pump house along the River, exacerbates these issues, posing health hazards to both humans and the environment.

Figure 1 illustrates the accumulation of raw sewage in the road and flowing through the vegetated riparian zone and directly into the river where excessive growth of hyacinth can be observed along the margins. This is further illustrated from google earth (Figure 2). The colouration is also an indication of sewage inflow (Figure 3a, b). The DWS also has a monitoring site along this stretch called R2BUFF-ZWELI, which too has not been surveyed owing to raw sewage inputs into the river and its associated health hazards.

Figure 1: Accumulation of raw sewage along the access road to the Lower Buffalo Reach and the concentrated hyacinth along the margins

At the time of the survey, DWS colleagues observed the raw sewage inputs with the specialist project team, and discussions were had regarding the severity of the current state of this river, emphasizing the need for urgent attention and action to be taken by the Catchment Management Agency (CMA).

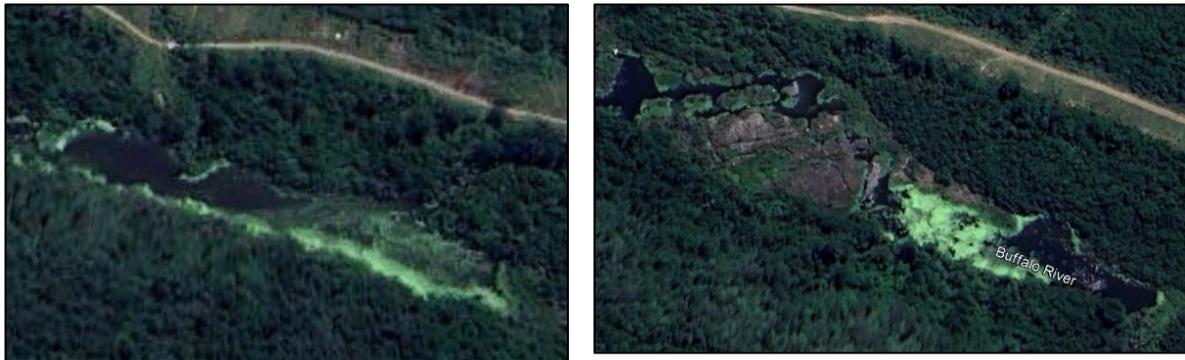
Figure 2: Google earth imagery of the effects of the raw sewage inputs into the lower Buffalo River

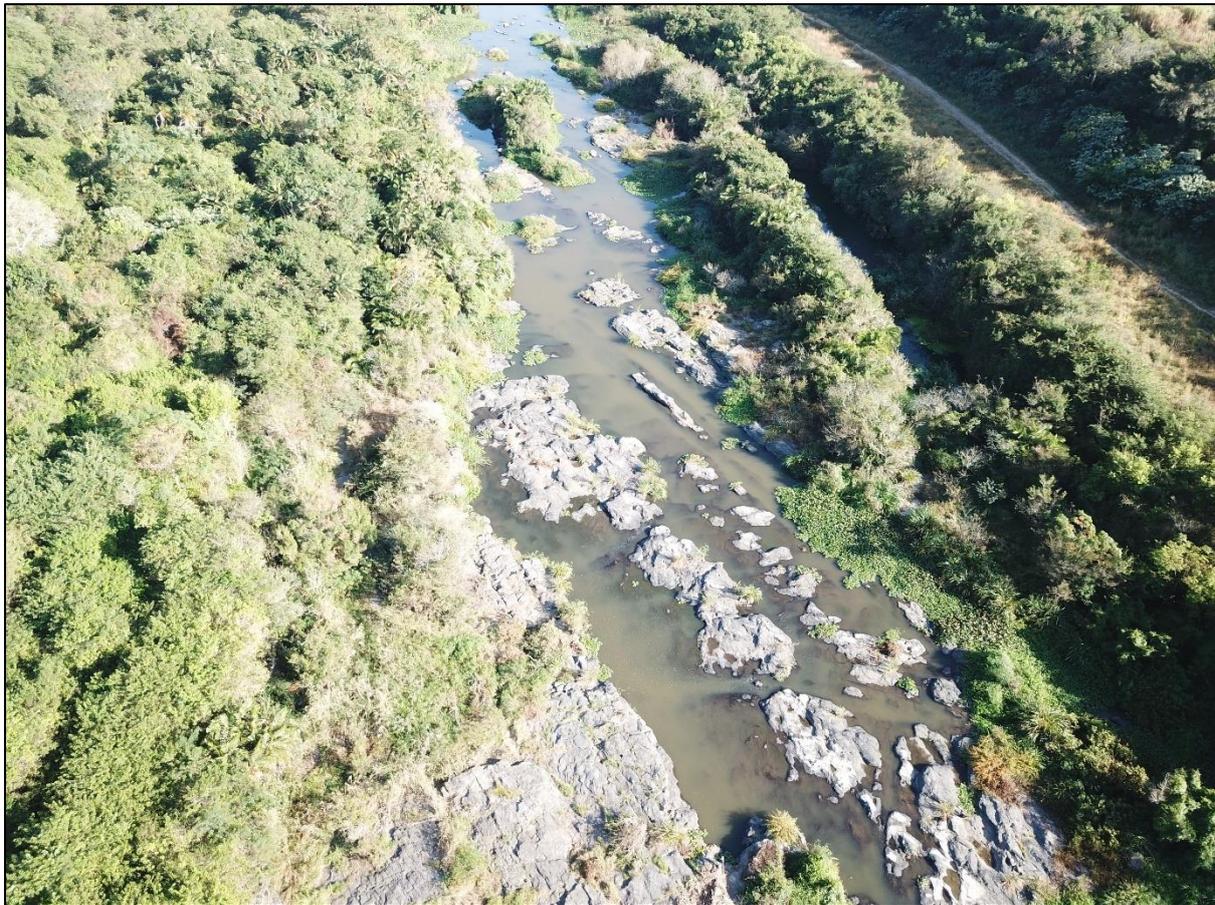
Figure 3a: Sewage inputs

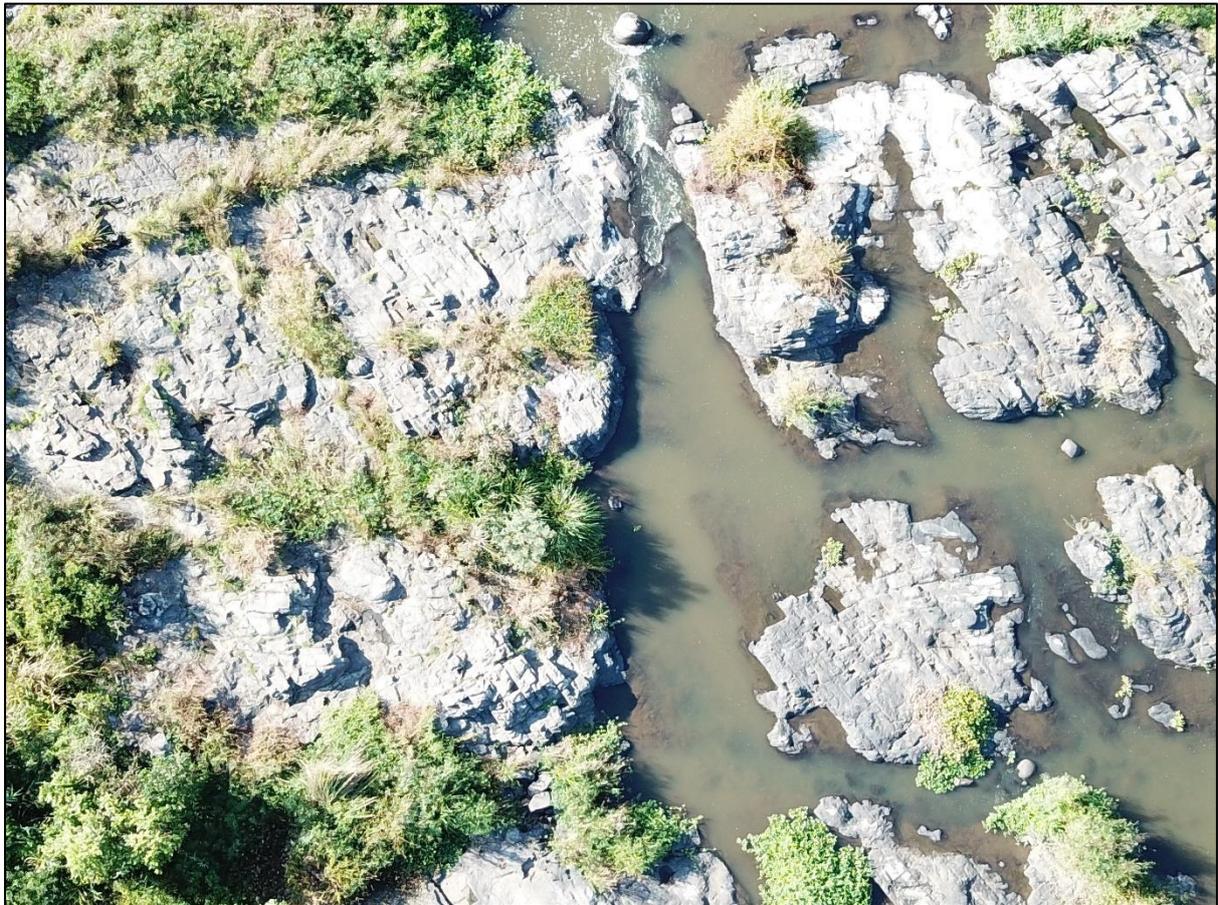
Figure 3b: Sewage inputs
