**2005/01/02/GENV**

**Detailed Geo-Environmental Investigation for the Cala  
Sanitation project – Sakhisizwe Local municipality  
EASTERN CAPE PROVINCE**

**Prepared for:  
ARCUS GIBB**

January 2005

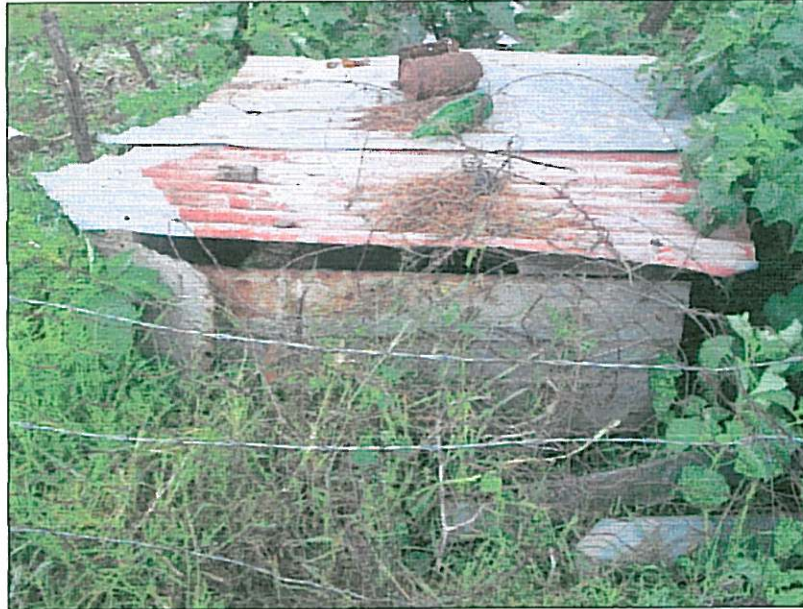
The hydrocensus data also revealed that the majority of these boreholes are equipped with submersible pumps. Water levels could not be measured from these boreholes as most of them were found secured around the wellhead, protecting pumps from being stolen. The hydrocensus results are summarised in Table 1

*Photo 3 Some of the material used to protect borehole pumps from being stolen*

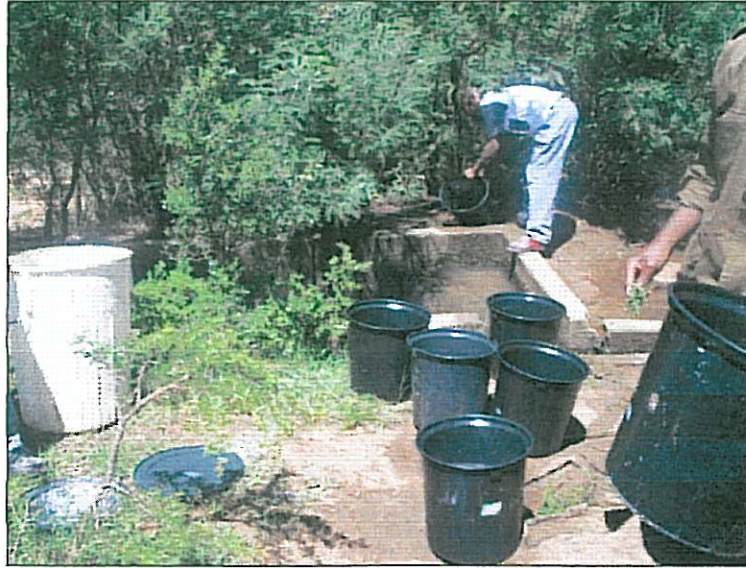
The Furrow River or stream was also reported to be a main source of water for the Extension 13 community. This stream emanates as a spring from the mountains and is captured halfway on its channel for use. The picture below depicts the capturing point of this stream as it is diverted to a small dam approximately 300m to the south of this position.

*Photo 4 Furrow stream capturing point*

A sanitation engineer and hydrogeologist should conduct a site inspection in order to assess the continued use of the nearby stream in order to recommended further actions required to ensure a acceptable water supply to the project area.

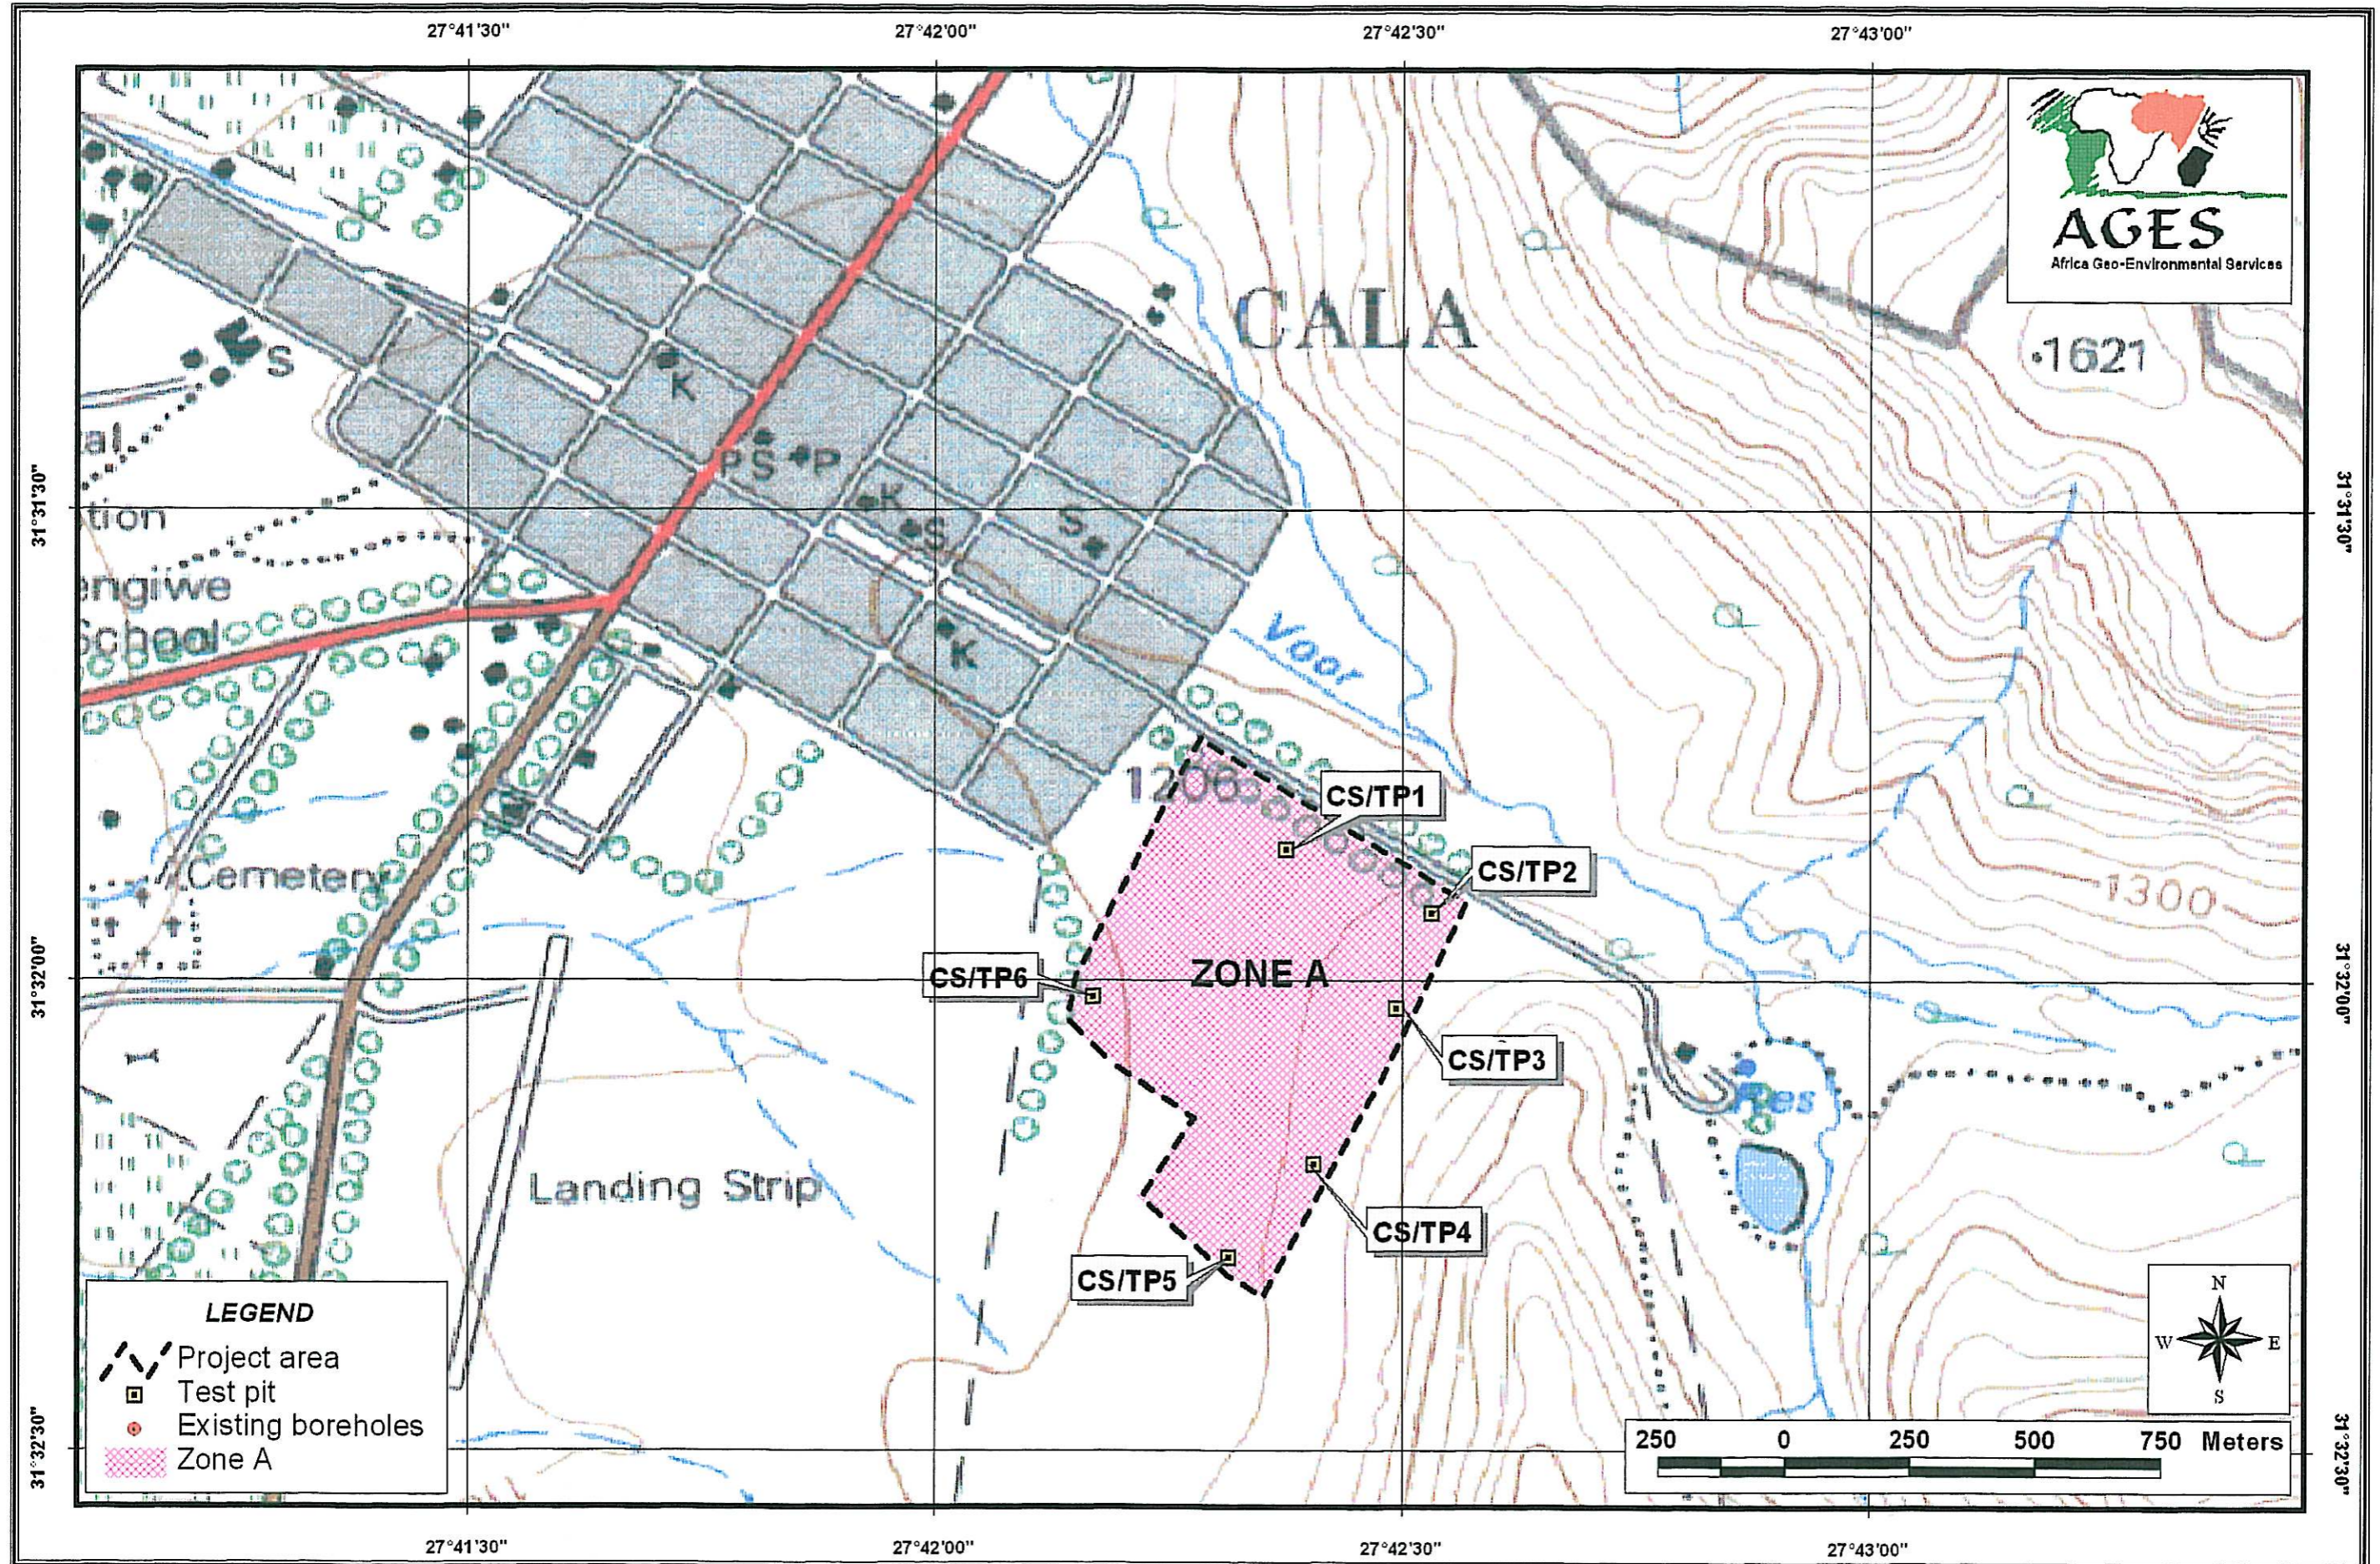
Figure 3: Project area zonation map

- *a risk of excavatability problems at or near the surface in localised areas due to the presence of dolerite corestones and fractured dolerite bedrock with a very soft rock to soft rock consistency. This is expected over approximately 80 % of the entire zone*

- *The presence of slightly to extensively ferruginised material from which seasonal seepage could take place could be encountered during excavation – it is recommended that the specific pit be lined or partially lined to prevent the ingress of seepage into the pit and to prevent pollutants from seeping out of the pit.*

- *The following recommendations are made for this zone:*
  - *The use of power tools or a mechanical excavator may be required in cases where the required depth cannot be reached in the area, alternatively the pit latrine has to be elevated to obtain the required depth or wider shallow pits must be constructed.*

- *Localised rock outcrops have to be avoided by moving pit latrine sites.*
  - *Should extensively ferruginised material from which seepage takes place be encountered during excavation – it is recommended that the specific pit be lined to prevent the ingress of seepage into the pit or the ferruginised material will have to be removed within a radius of at least 0.5 metres of the edges of the pit and replaced with an impermeable soil material.*

- *No pit latrine should be excavated into fractured bedrock. If this is unavoidable, the specific pit should be lined to prevent the possible pollution of the deep aquifer. Alternatively pits should be constructed shallower and wider to allow for shallow bedrock conditions*

From the preliminary results it is recommended that **all latrines in this zone must be partially lined** with a

clay/slurry mixture or cement to prevent the movement of liquids to and from the pit due to the small basal buffer zone that is expected and the proximity to groundwater and surface water features. It is recommended that a system be implemented that does not rely on seepage for the disposal of liquids or sealed units be installed.
