**GEOHYDROLOGICAL INVESTIGATION TO  
DETERMINE THE RISK OF GROUNDWATER**

**CONTAMINATION FROM ON-SITE**

**SANITATION**

Report No. 327600/1

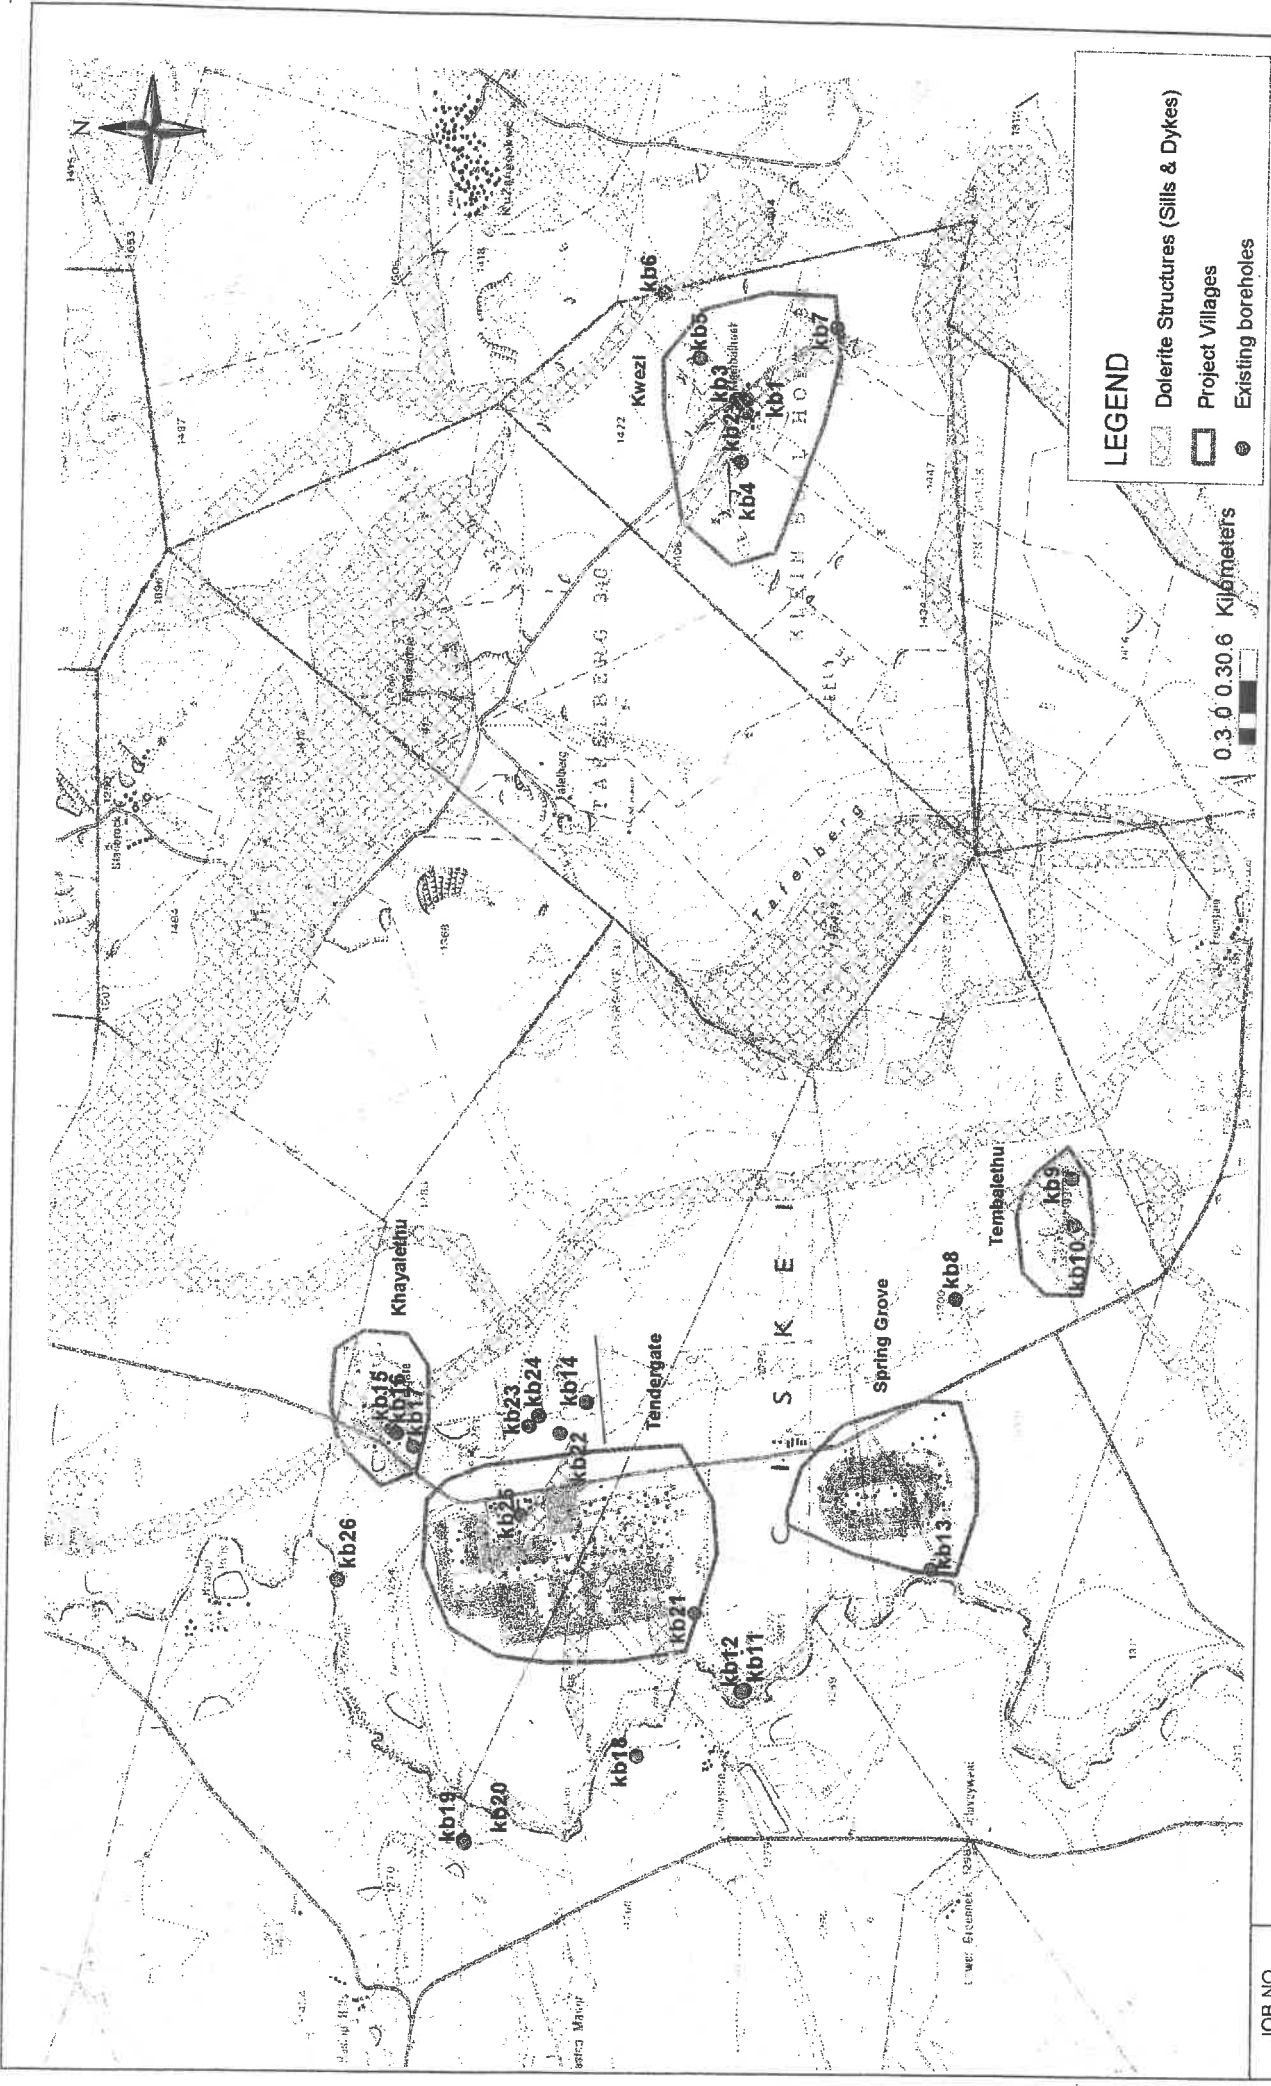
**Fig 1: Geohydrology Map**

**Local scale:** The development potential of groundwater in the study area revolves mainly around the occurrences of dolerite dykes and sheets (sills) which cuts across all the project villages, with the exception of Spring Grove (see Map 1: Geohydrological Map, Appendix 1). This does however not imply that groundwater is only found near or in the above structures, but implies that the development potential of groundwater is normally the highest around these features. Groundwater can also be encountered in fractured and/or weathered media away from the above structures.
