**GROUNDWATER RESOURCE INFORMATION PROJECT
EASTERN CAPE PROVINCE**

FINAL REPORT:

**HYDROGEOLOGICAL & ENGINEERING GEOLOGICAL SURVEY FOR THE
CONSTRUCTION OF PIT LATRINES AT UPPER GQUMASHE VILLAGE,
NKONKOBÉ LOCAL MUNICIPALITY - EASTERN CAPE PROVINCE**

February 2004

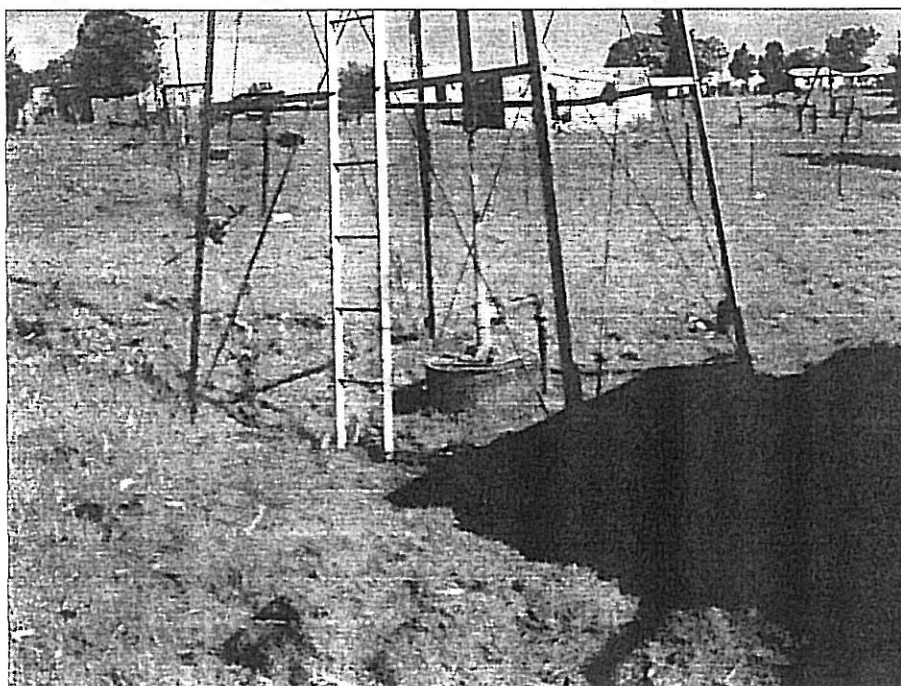
Photo 5: Spring S1 located in Upper Gqumashe village

None of the existing boreholes, or the spring, was found to be currently in use. The boreholes are both in disrepair, and due to the low yield of the spring, community members prefer walking down to the river. Over the course of this project a bulk water system was installed at Upper Gqumashe village. The local spring is still being used for livestock watering.

A sanitation engineer and hydrogeologist should conduct a site inspection in order to assess the continued use of the two boreholes at Upper Gqumashe village and to recommended further actions required to ensure a acceptable water supply to the village.

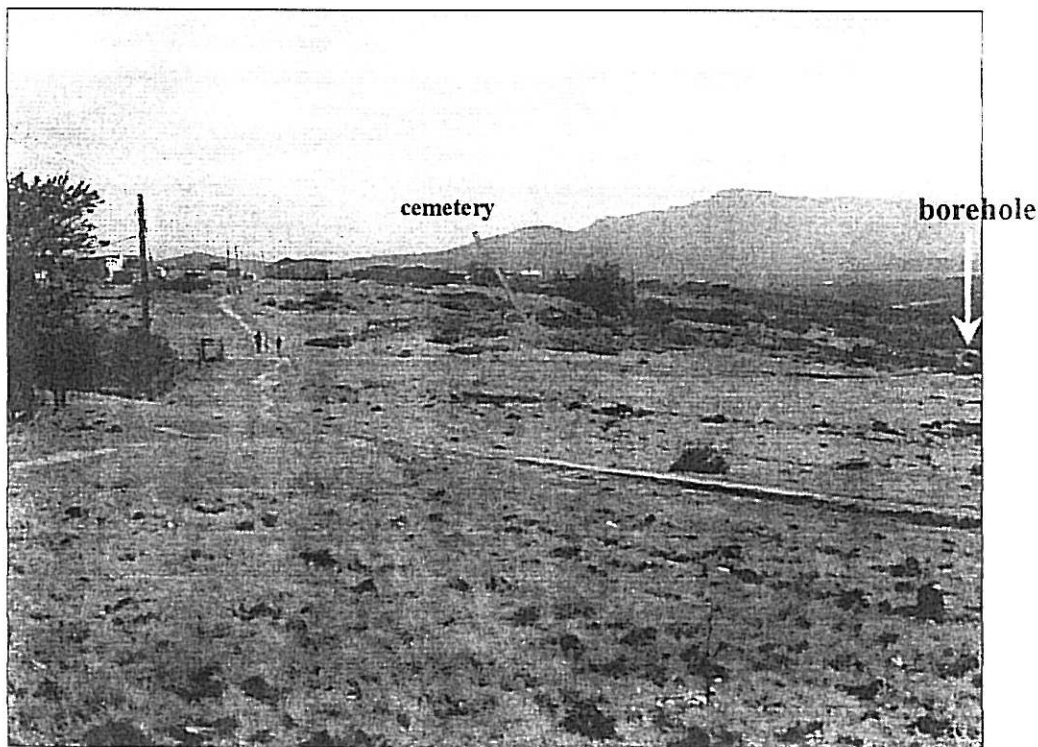
It was noted during the hydrocensus that the community graveyards are situated along streams and drainages throughout the villages, mostly within a distance of less than the required 60 m as proposed by DWAF. The proximity of the graveyards to borehole CDB1501 is indicated in photo 6.

Photo 6: Graveyards near spring and borehole CDB1501

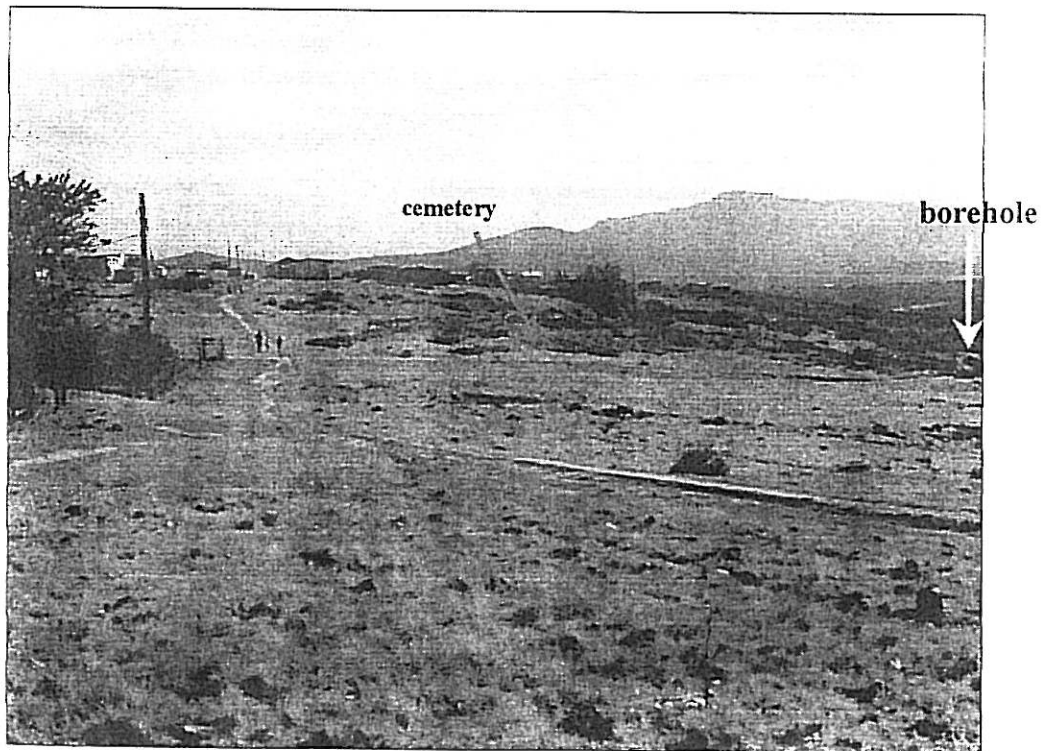
It was noted during the hydrocensus that the community graveyards are situated along streams and drainages throughout the villages, mostly within a distance of less than the required 60 m as proposed by DWAF. The proximity of the graveyards to borehole CDB1501 is indicated in photo 6.

Photo 6: Graveyards near spring and borehole CDB1501

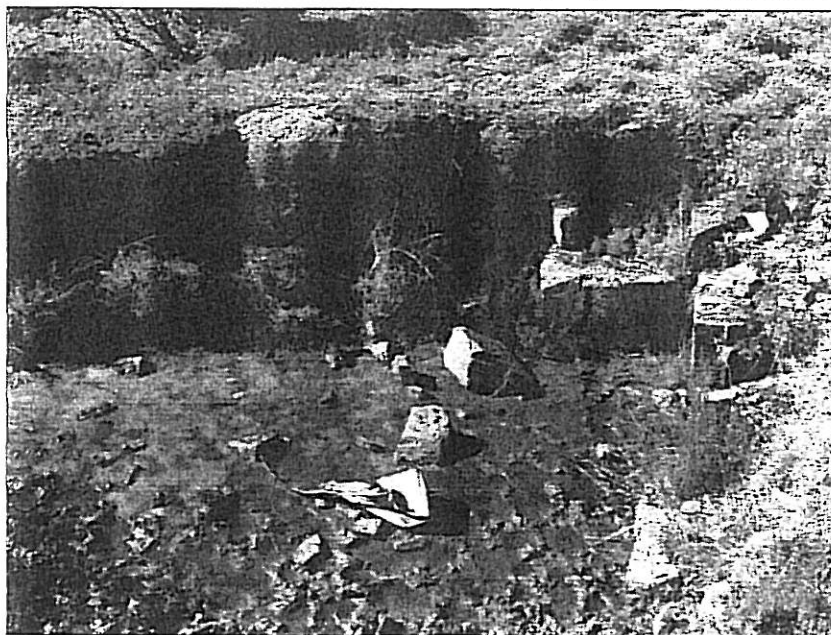
No samples from the existing boreholes were taken due to the fact that the boreholes were in disrepair for a long period and are no longer being used by the community. Indication is that the drinking water quality of these sources is expected to be marginal to poor, with contamination by faecal coliforms. Possible high nitrate levels at the sources can be expected as a result of migration of contaminants from the nearby cemetery. Water samples from the boreholes should be taken if and when they are rehabilitated for possible future use. Contamination from faecal coliforms is also noted. The spring zone is indicated in Photo 7 below.

Photo 7: Spring zone in Upper Gqumashe village

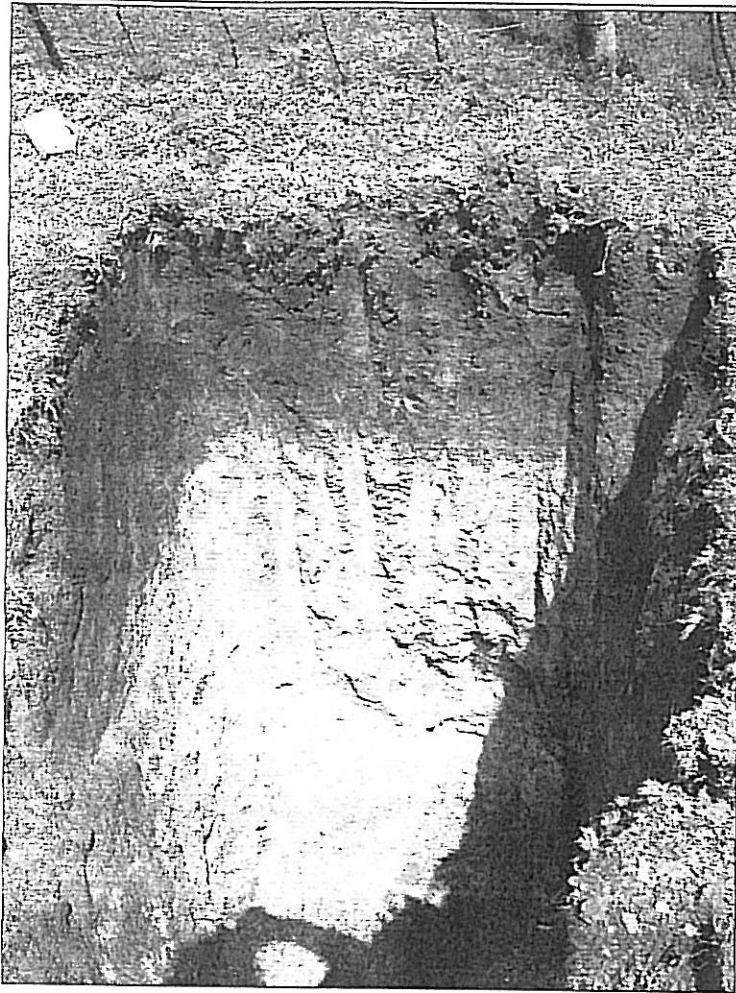
Highly to moderately weathered siltstone bedrock was encountered in all of the test pits excavated on sedimentary formations. The bedrock material is generally very fine-grained, very thinly jointed and fractured, exhibiting a very soft rock to soft rock hardness. The joint surfaces are generally narrow and stained with rough joint surfaces. Some joints were observed to be clay filled. The depth to bedrock material varied between 0.10 m and 0.90 m (mean 0.46 m).

Photo 8: General soil conditions encountered on sedimentary formations

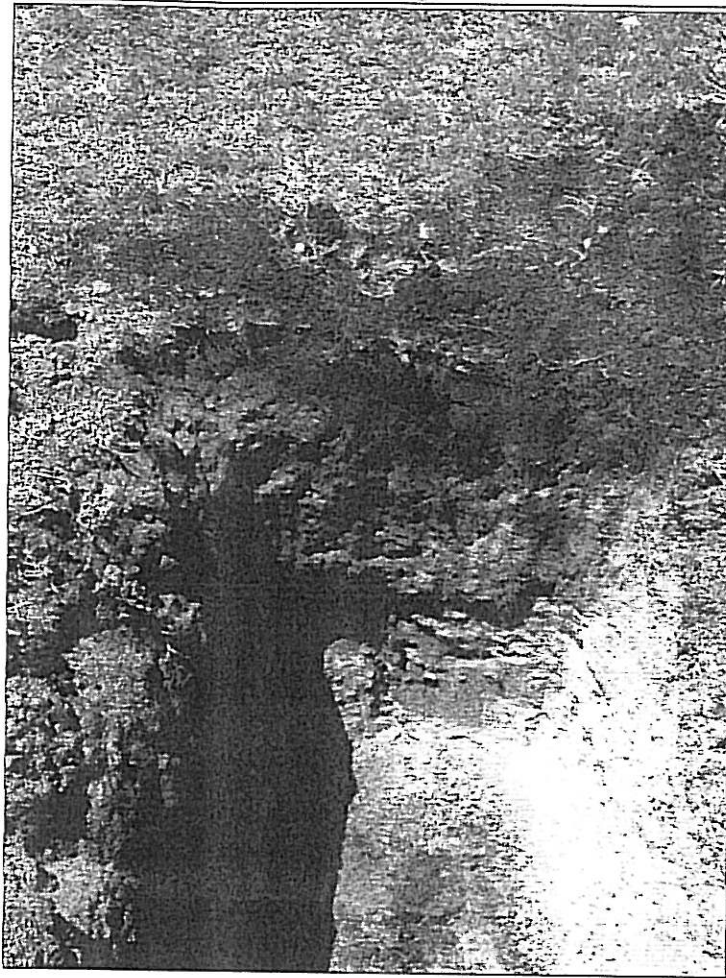
The hillwash is underlain by highly to moderately weathered dolerite bedrock that was encountered in all of the test pits excavated on igneous formations. The dolerite bedrock is generally fine-grained, very thinly jointed and fractured, exhibiting a very soft rock to soft rock hardness. The joint surfaces are generally narrow and stained with rough joint surfaces. Some joints were observed to be partially clay filled. The bedrock shows classical "onion peel" weathering pattern. The depth to bedrock material varied between 0.30 m and 0.40 m (mean 0.35 m).

Photo 9: General soil conditions encountered on igneous formation
