## **GROUNDWATER MONITORING OPTIMISATION WITHIN THE UPPER VAAL SUB-CATCHMENT AREA**

**PART A: EVALUATION AND RECOMMENDATIONS ON THE  
PROPOSED NETWORK AT MATHOPESTAD AREA**

**June 2023**

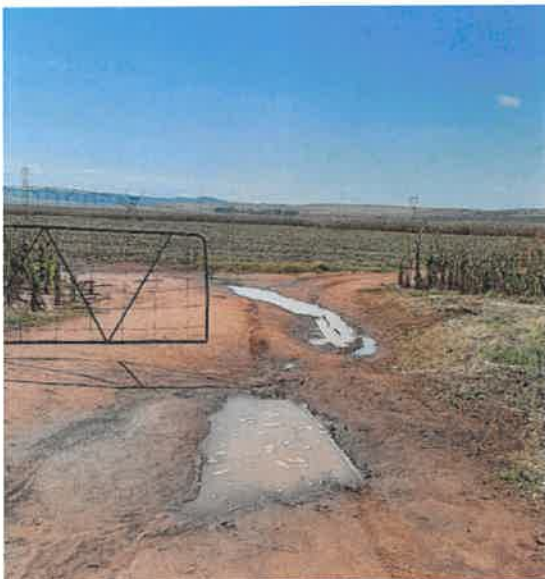
- The first point visited was **295**, which is a proposed trendline monitoring, located at -26.093687 S and 27.190526 E. This site is located inside a private farm and the access road is not easy during rainy season (*photo 5*). From the field observation it may be very difficult to drill a borehole inside this farm as the Owner could take advantage by installing a pump inside the well for crop irrigation. There is an NGA borehole located within a 1 km proximity to the proposed site, but it is currently being used for water supply in the farm (*photo 6*).

Photo 5: View of 295 proposed site

- Proposed point number **295**, is not suitable for trendline monitoring mainly due to the fact that it is located inside the private farm and where the access route would be impossible during the rainy season
- Proposed point number **294**, appeared to be an ideal position to conduct trendline monitoring due to easy access. But there a need to engage the farmer with regards to the benefit of establishing a groundwater monitoring network in his/her farm. The new trendline monitoring is positioned in an area with high yield karst aquifers of Malmani Formations.
- Proposed point number **280**, is not suitable for trendline monitoring due to the fact that it is located inside the private property. The drilling can be done outside the property 5 meter from the road for easy access at -26.195588 S and 27.166910 E at an elevation of 1481 m MSL.

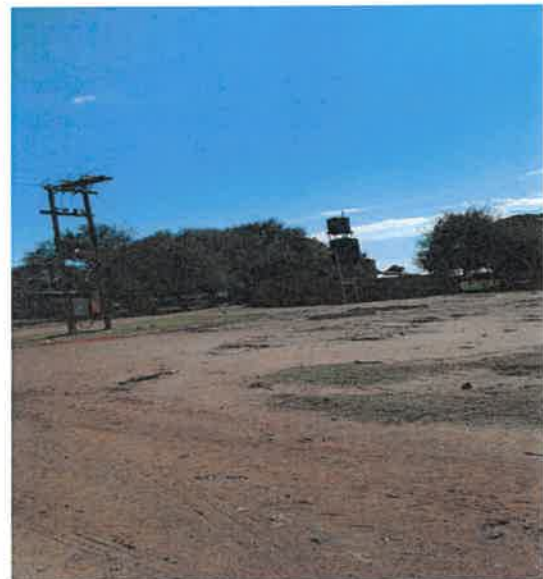
Photo 6: View of NGA site near 295

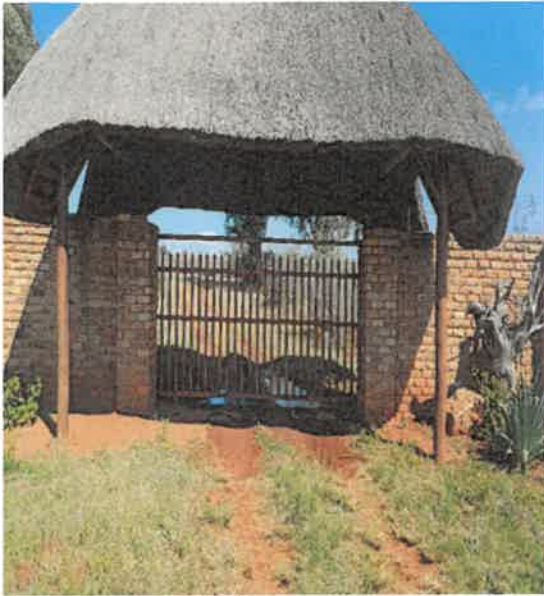
- The second point was **294**, which is also a proposed trendline monitoring, at -26.093771 S and 27.092849 E. The coordinate of this point is also located in a private farm with a lock gate (*photo 7*). This site can be easily be accessible by heavy machinery (Drilling Rig) to construct a monitoring borehole station. An NGA borehole was observed nearby (> 1 km radius) but it is utilised for production at the farm (*photo 8*). Perhaps there is a great need to engage the Farmer(s) in order to request permission on using the borehole as a monitoring point.

Photo 7: View of 294 proposed site

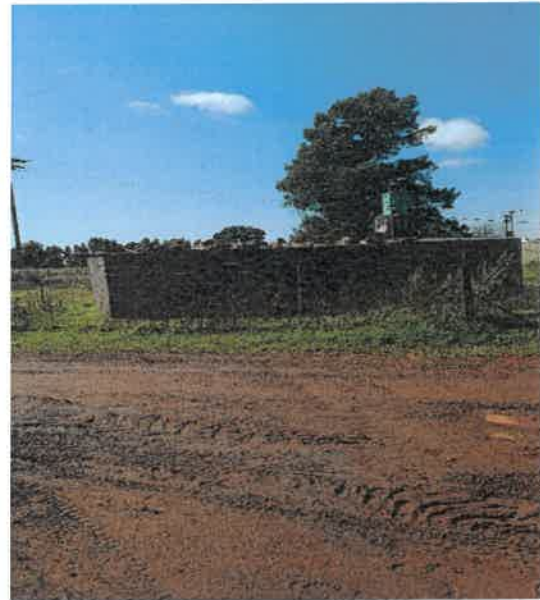
Photo 8: View of NGA site near 294

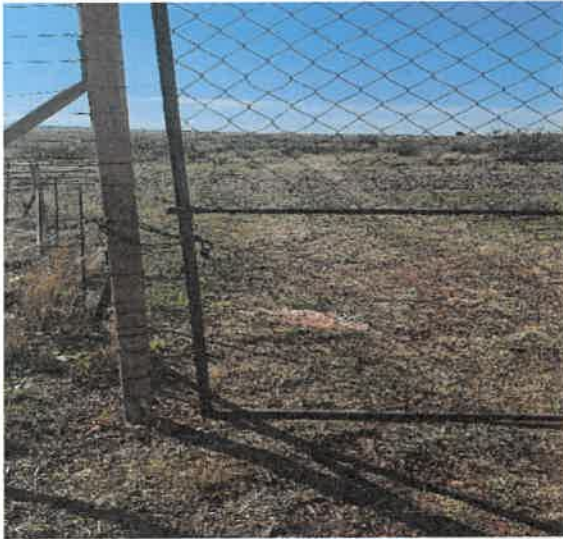
- The first point visited was **280**, which is proposed for trendline monitoring and it is located at -26.186093 S and 27.190617 E. This site appeared not to be suitable for trendline monitoring due to the fact that it is located inside the private property (*Photo 9*). However, the monitoring point can be established outside the property approximately 5 meters from the road for easy access at -26.195588 S and 27.166910 E, at an elevation of 1481 m MSL. There is no NGA borehole near this proposed site.

*Photo 9: View of 280 proposed site*

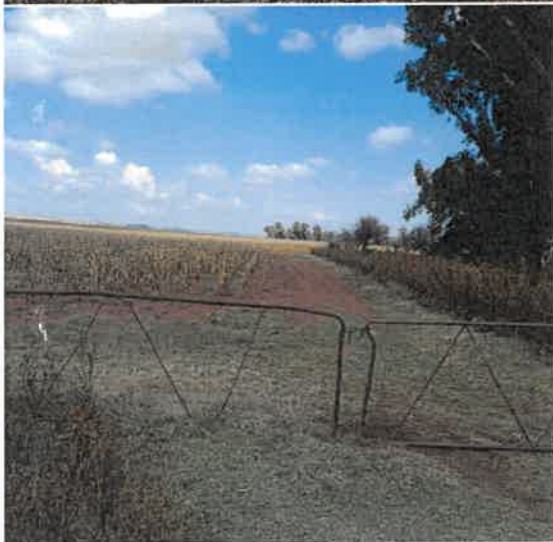
- The second point visited was **276**, which is proposed for baseline monitoring and it is positioned at -26.185424 S and 27.092276 E. The site is located inside a private farm (*photo 10*) and there was nobody nearby to give further information. There is an NGA borehole within close proximity to the proposed site, but it is currently used as a working windmill (*photo 11*).

*Photo 10: View of 276 proposed site*

- Proposed point number **276**, is not suitable for baseline monitoring due to the fact that it is located inside the private property. Furthermore it was difficult to find a new position near the proposed site.

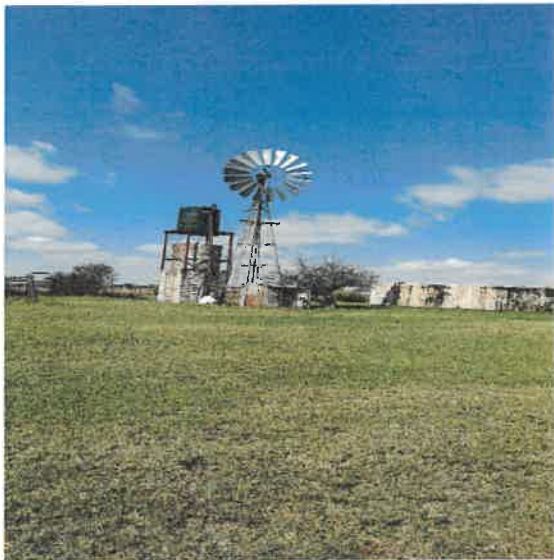
*Photo 11: View of NGA site near 276*

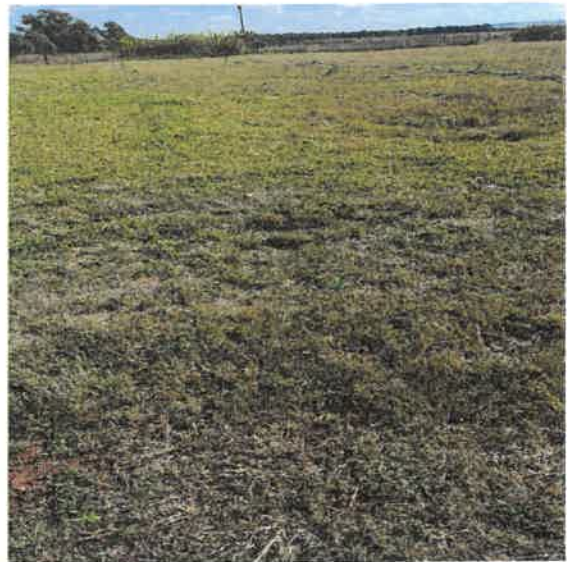
- The next point visited was **311**, which is proposed for trendline monitoring and it is placed at 26.002999 S and 27.086608 E. This point appeared to be suitable for establishing a groundwater monitoring because it is positioned in an open field where it would easily be accessible (*photo 12*). There are no NGA boreholes located nearby that can be used as an alternative.

*Photo 12: View of 311 proposed site*

- Proposed point number **311**, is located in a pristine position, with no issues with the access therefore the drilling can be done on this proposed site. The new trendline monitoring is positioned in an area with low yield aquifers of Timeball Hill Formations.

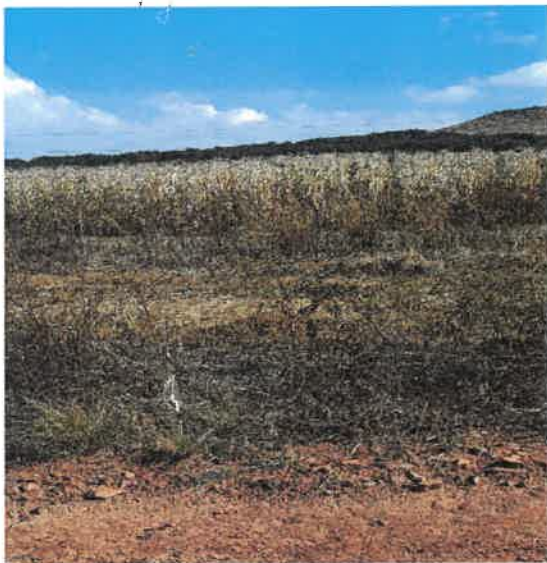
- The next point visited was **308**, which is proposed for trendline monitoring and is located in a private farm. This site is not suitable for trendline monitoring due to accessibility (*photo 13*). However, a monitoring point can be established outside the gate next to the gravel road at -26.068121 S and 27.361119 E, at elevation level of 1688 m MSL.

*Photo 13: View of 308 proposed site*

- Proposed point number **308**, which is located in a private farm which makes it not suitable for trendline monitoring. The new proposed site can be drilled just outside the gate next to the gravel road at -26.068121 S and 27.361119 E, elevation level of 1688 m MSL.

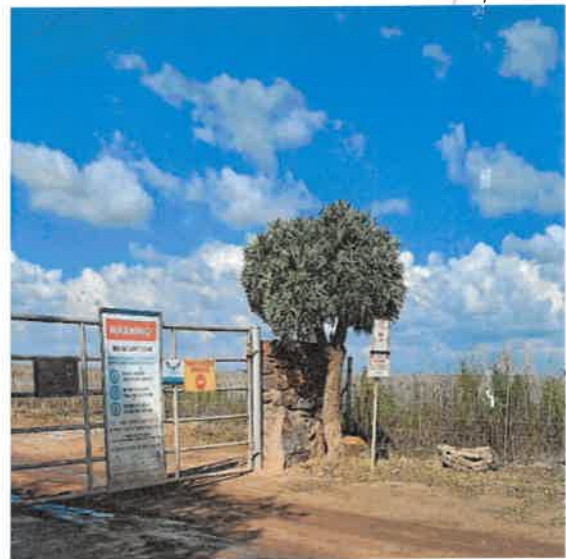
- The next point visited was **290**, which is a proposed baseline monitoring and is located inside Custodia Security facility (*photo 14*). This site is not suitable for baseline monitoring mainly due to accessibility. However, a monitoring point can be established outside the facility at -26.123874 S and 27.462784 E, at an elevation level of 1551 m MSL. There is no NGA borehole located close to the proposed site.

*Photo 14: View of 290 proposed site*

- Proposed point number **290**, the proposed site is located inside Custodia Security facility which makes it not suitable for baseline monitoring. However, new position can be established just outside the facility at -26.123874 S and 27.462784 E, at an elevation level of 1551 m MSL.

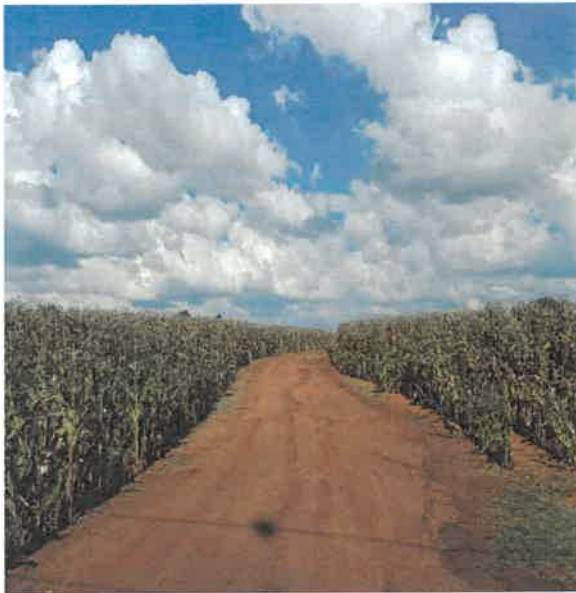
- The next point visited was **272**, which is proposed for trendline monitoring and it is located inside the private farm, at -26.224289 S and 27.457804 E. The site appeared to be

a suitable position for trendline monitoring due to accessibility (*photo 15*). However, the farm Owner(s) should be engaged and be informed on the potential plan by DWS to carry out groundwater monitoring in future. There is also an NGA borehole observed closer to the proposed site, but it is currently being used for water supply in the farm (*photo 16*)

Photo 15: View of 272 proposed site

- Proposed point number **272**, is located inside the farm therefore it is not suitable for trendline monitoring. The new proposed site is recommended outside the farm at -26.221145 S and 27.453664 E, at an elevation level of 1572 m MSL.

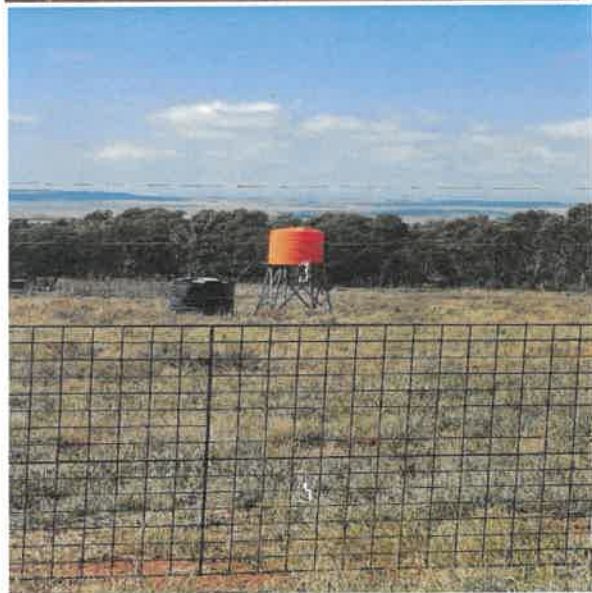
Photo 16: View of NGA site near 272

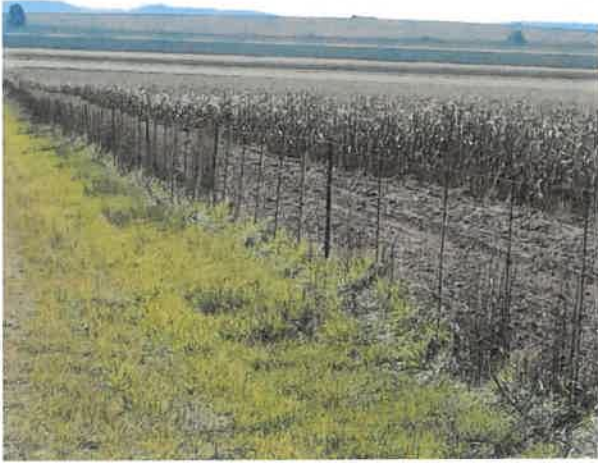
- The point visited on the day is **273**, which is proposed for trendline monitoring and is located inside the farm at -26.224289 S and 27.343589 E. The site is not suitable for trendline monitoring due to accessibility (*photo 17*). There is no NGA borehole(s) located closer to the proposed site.

*Photo 17: View of 273 proposed site*

- Proposed point number **273**, the proposed site is located inside the farm and the new site is proposed outside the farm next to the N14 highway road for easy access.
