RIPARIAN CONTENTS

RIPARIAN

1. Hydrological Modification

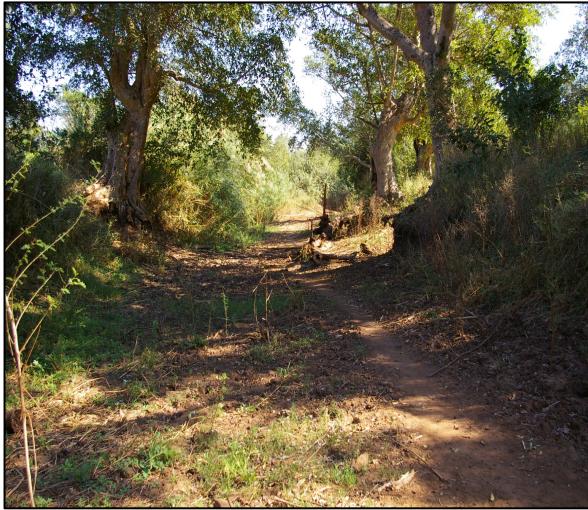
Ingwavuma

Photo shows complete encroachment and terrestrialisation. Older trees are surviving but there is little replacement of vegetation by younger riparian species.

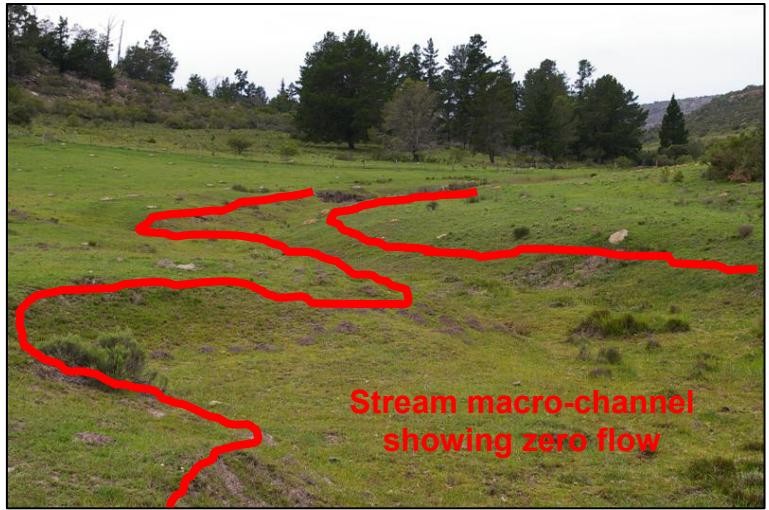
Bushmans River downstream of the Jameson Dam

Due to zero flows typical riparian species have largely disappeared. Terrestrial grassland species now dominate the entire riparian and instream zones.

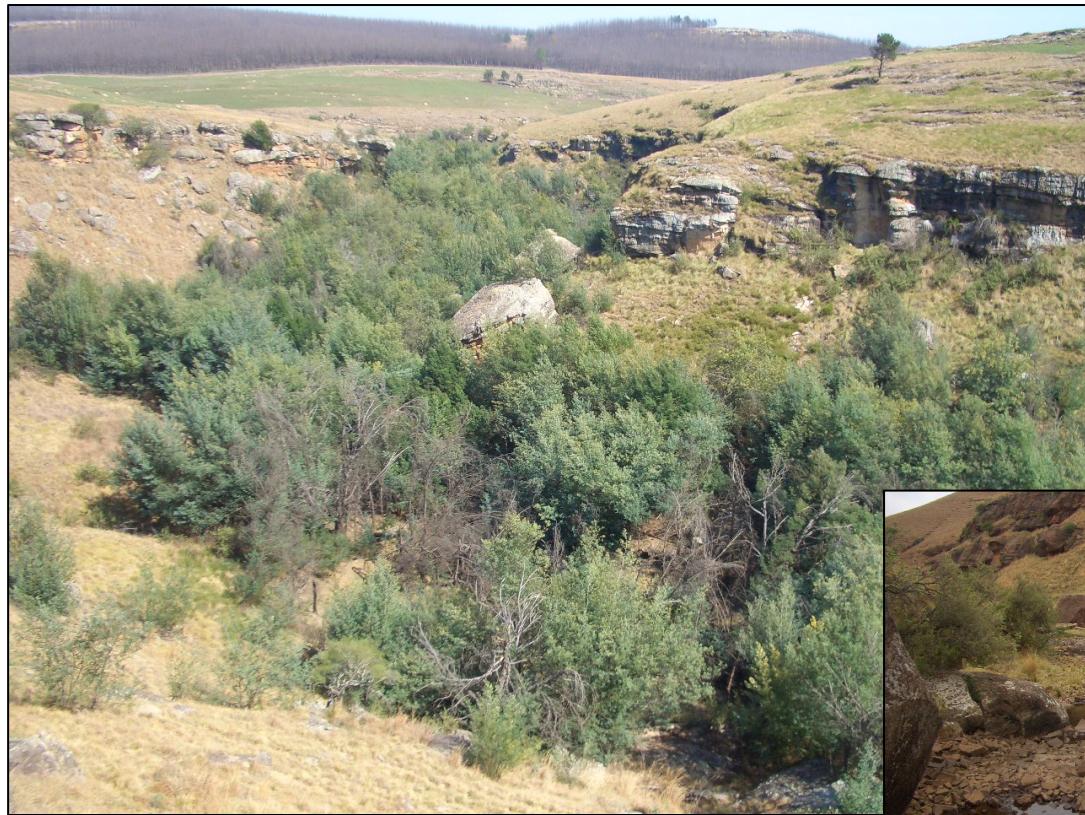
NECF Funeray Plantation

Afforestation in upper catchment and trees within the riparian zone have dramatically reduced base flows. Photo inset shows normally perennial river reduced to seasonal pools.

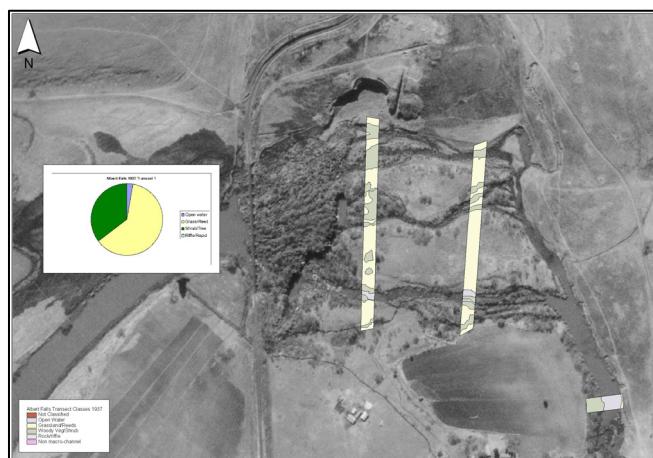
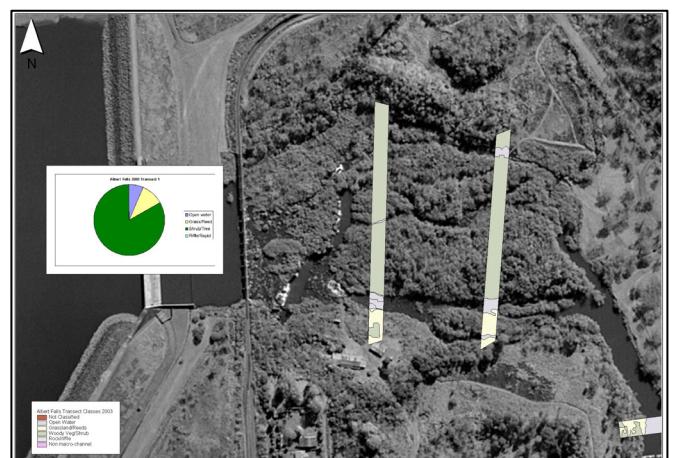
The 1937 aerial photograph below shows the uMgeni river before the construction of Albert Falls dam. Note the lack of encroachment of vegetation within the riparian zone. Compare this with the same area in 2003. Vegetation has progressively thickened, due to a reduction in large and moderate floods and their frequency.

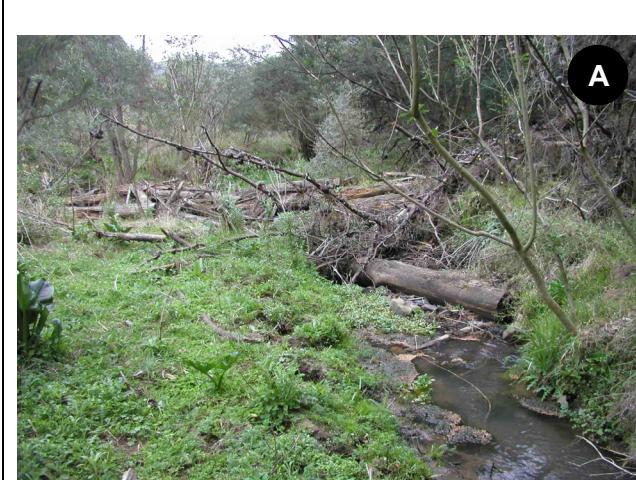
Snake

Forestry harvest debris in channel with localised bank erosion and exposure. Also evidence of cattle grazing within the riparian zone. Cattle hoof action is destabilising riparian zone banks.

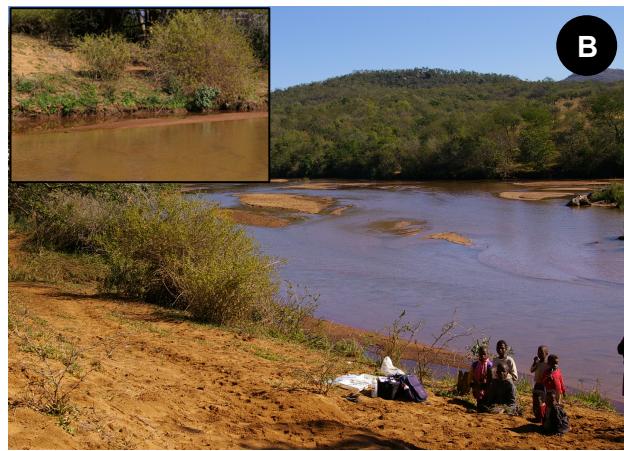
Ngwempisi

Riparian vegetation removal by livestock grazing and trampling particularly on near bank. Insert shows sparse cover in areas. Far bank is well covered.

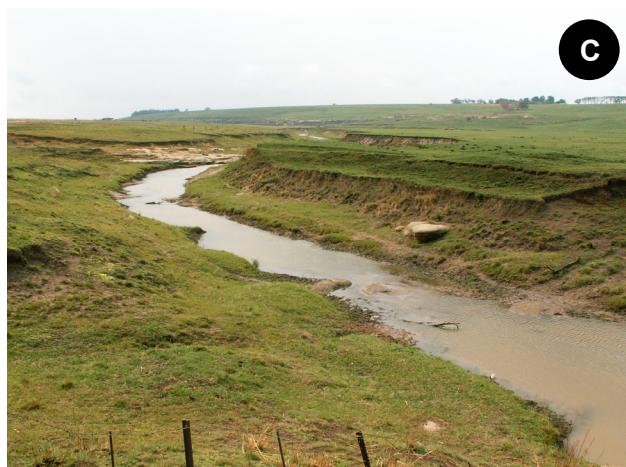
Unknown

Overgrazing in the catchment and slumping of riparian banks combine to produce moderate substrate exposure.

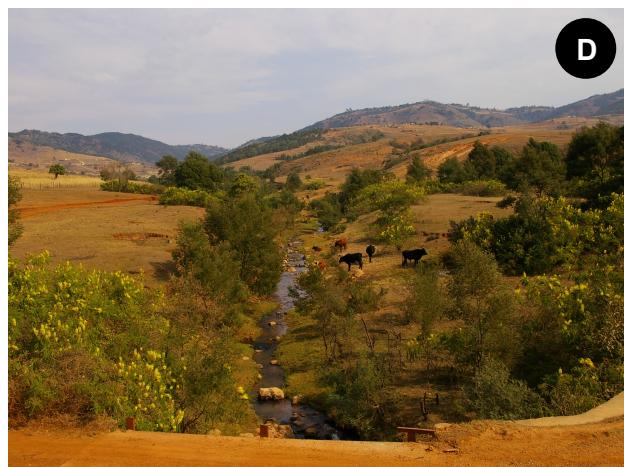
Mhlatuzi (Swaziland)

Mauritius thorn and wattles can be seen on both banks. Loss of typical marginal vegetation has exposed underlying substrate and destabilised the banks in places.

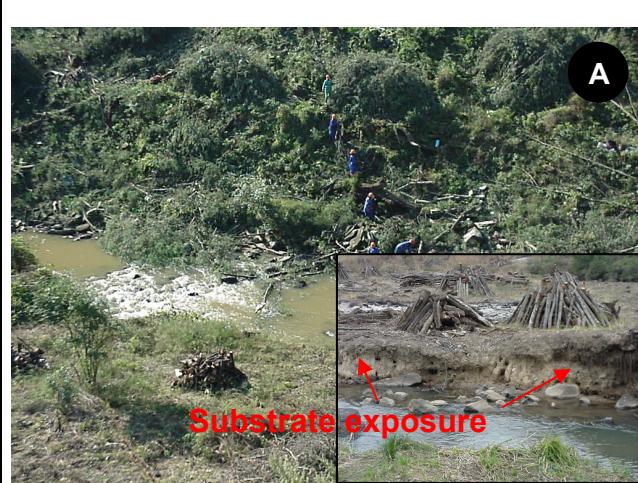
Lion

Alien weed control, removal, stacking and burning of aliens has led to severe substrate exposure along banks.

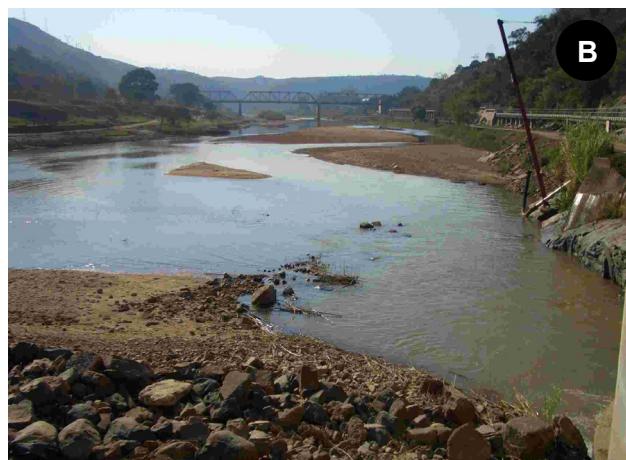
Umkomaas (downstream from Sappi Saicor barrage)

Flow modification and sand mining upstream of estuary has exposed large areas of sandy bank.

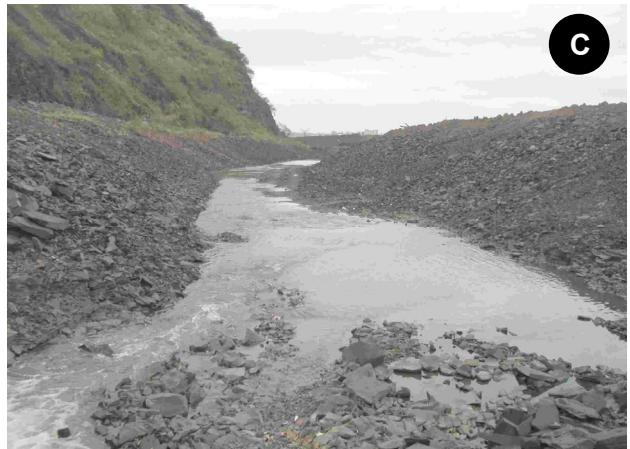
Town Bush Stream

Channel re-alignment and exposure of new bank is evident. There is complete loss of riparian zone vegetation and total modification of the bank.

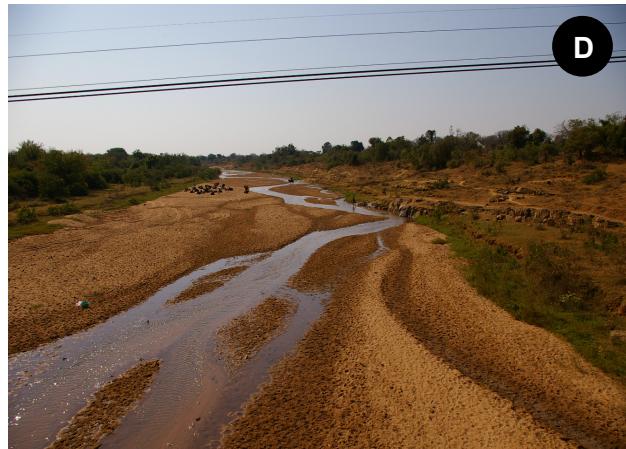
Mhlatuzi (Swaziland)

Overgrazing and trampling by livestock on both banks leading to virtually 100% bank exposure.

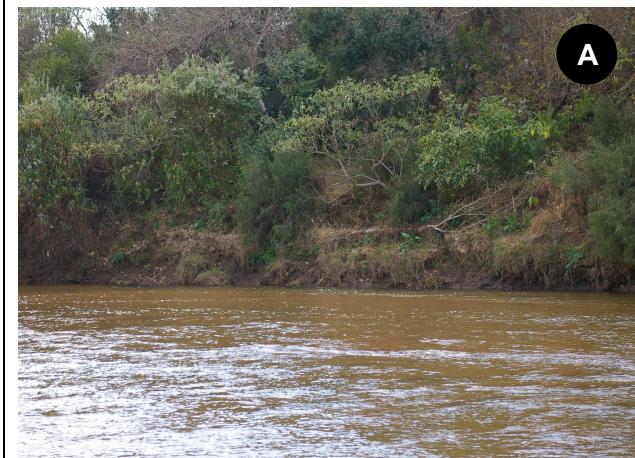
**A**

Approximately 50% of bank is covered with alien weeds (bugweed). Marginal vegetation only supplying limited instream habitat.

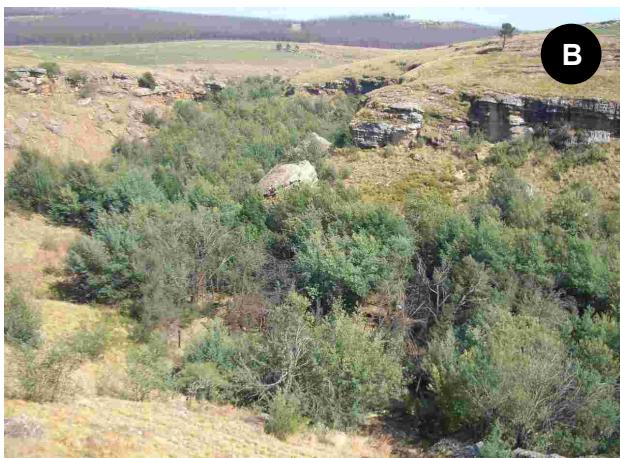
Kloof on river with localised 100% cover of wattles. Along riparian zone virtually complete loss of natural vegetation. Localised transformation of riparian zone. Had this been more widespread, the rating would have increased.

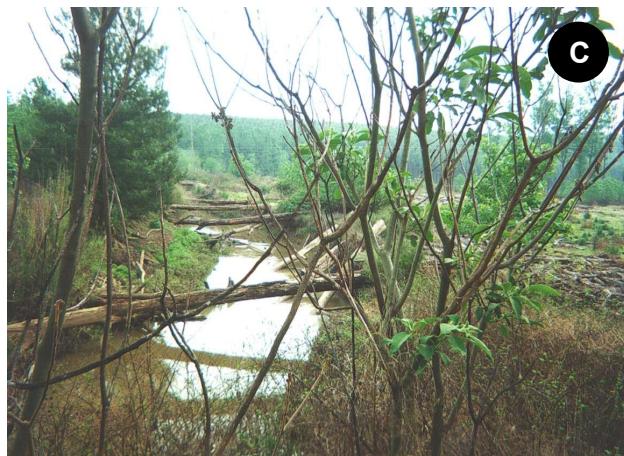
**C**

Bugweed and bramble in foreground within gum and pine plantations. Photo also shows moderate bank erosion and harvest debris left in the stream.

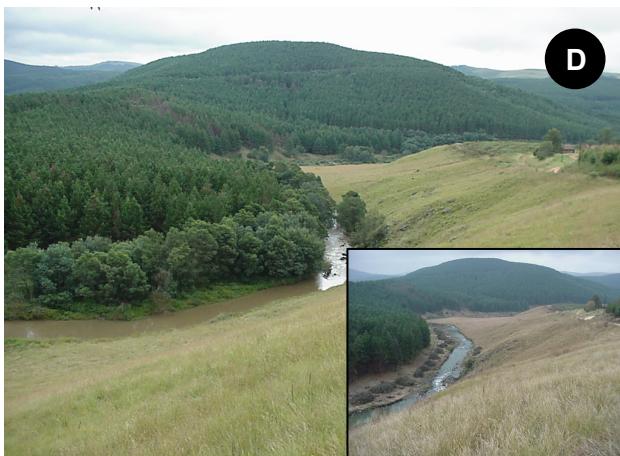
Left hand bank of main photo shows very extensive alien weed infestation. Insert shows this cleared and natural riparian zone buffer re-established. If both banks had been infested this would have increased the rating.

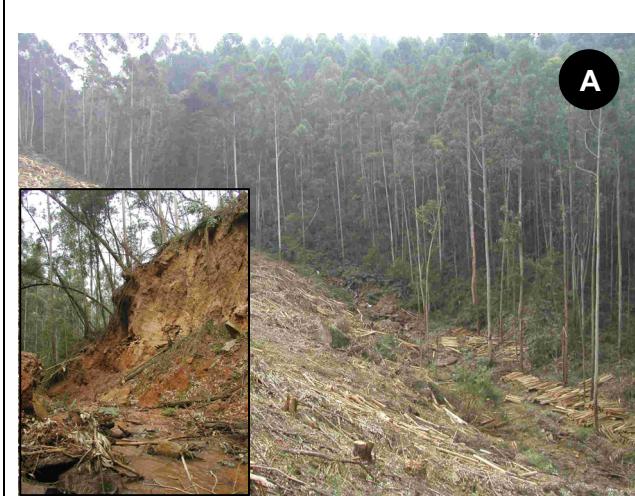
Town Bush Stream

Gums planted through riparian zone. Insert shows destabilisation of bank due to adjacent plantation and shading out of natural riparian zone species. Loss of these riparian zone species results in bank erosion and collapse.

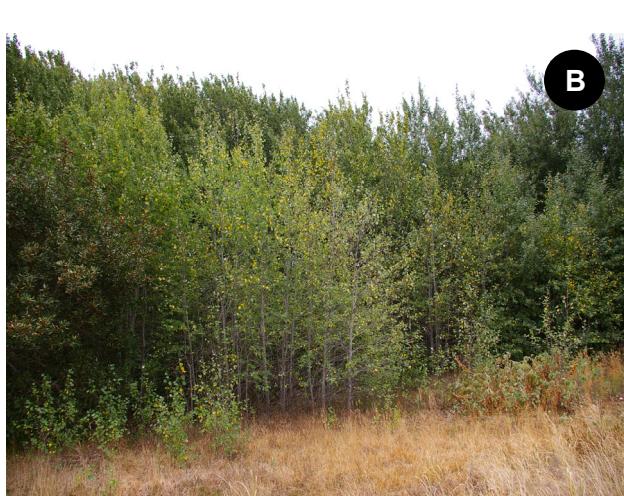
uMgeni

Poplars have totally invaded and modified this bank. Natural riparian zone species have been outcompeted and bank structure has been significantly modified.

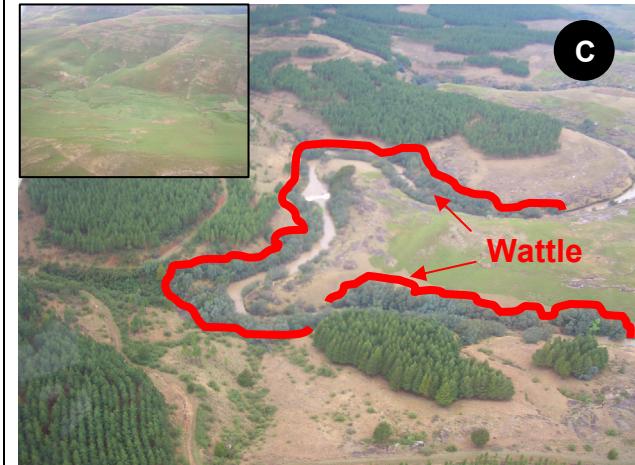
Wildebees

Extensive infestation of wattles along riparian zone is severely modifying the bank. Compare this to the same area (primarily grassland) with no weeds (see insert).

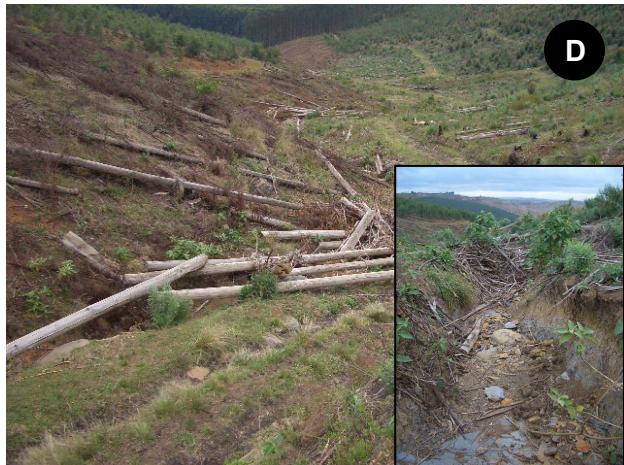
Unnamed

Commercial afforestation and poor weed control management have negatively impacted on the banks of this stream in the KwaZulu/Natal Midlands. Harvest debris in the stream further exacerbates bank instability.

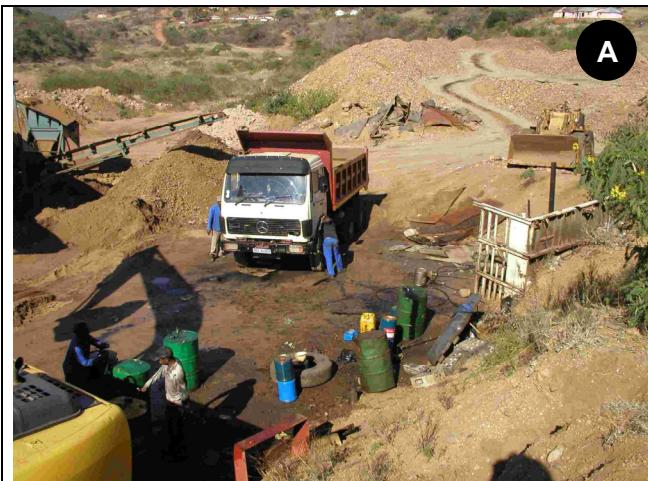
A

Photo illustrates diesel and oil spillage in riparian zone associated with illegal sand mining operations.

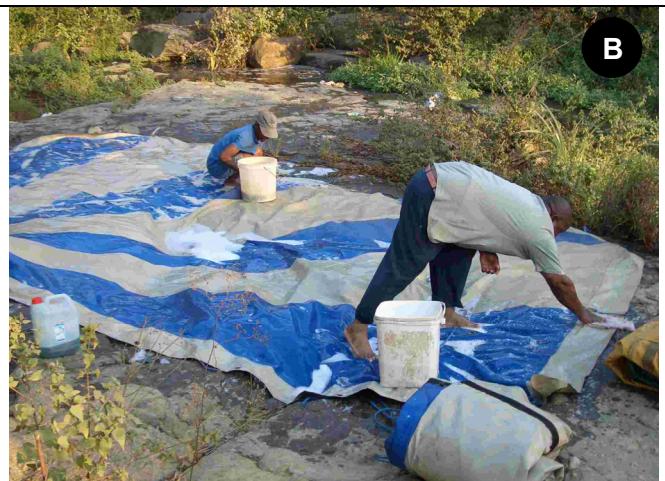
B

Tent washing is a common sight in riparian zones following weekend funerals and weddings.

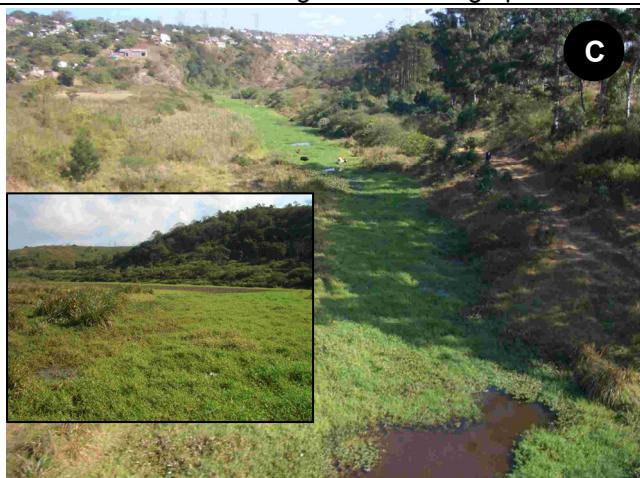
C

Hippo grass infested riparian and instream zones due to nutrient enriched water.

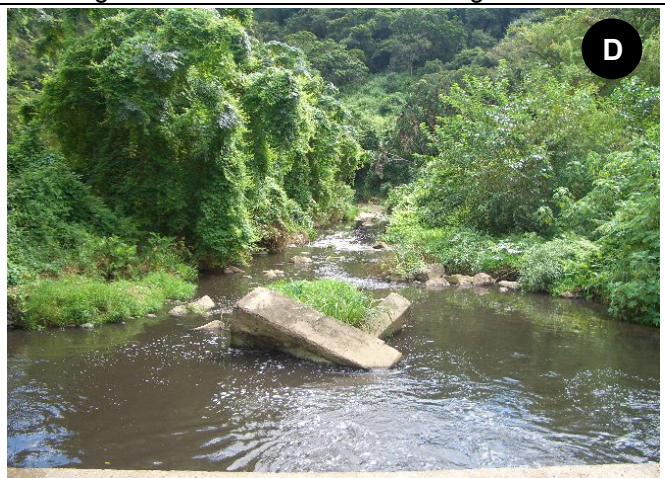
D

Sewage works discharge has resulted in abundant nutrients and a flourishing alien weed community.

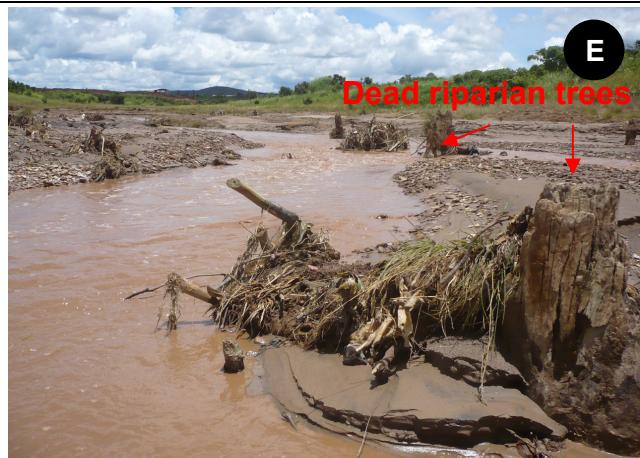
E

Acid mine drainage and excessive sedimentation have killed riparian tree species.

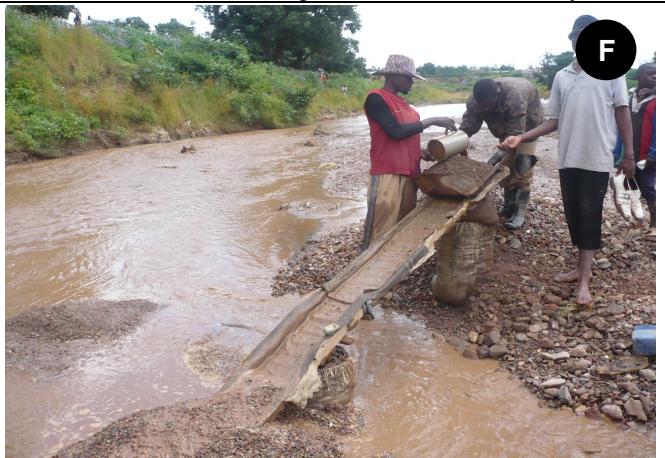
F

Artisanal mining and working of riparian sediments have changed the physical structure of the bank.

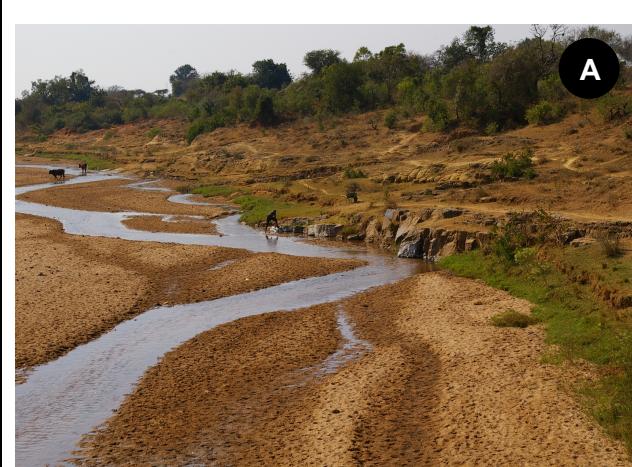
A

Extensive erosion of both left and right bank along long reaches of river. Livestock pressure has caused instream and riparian modification.

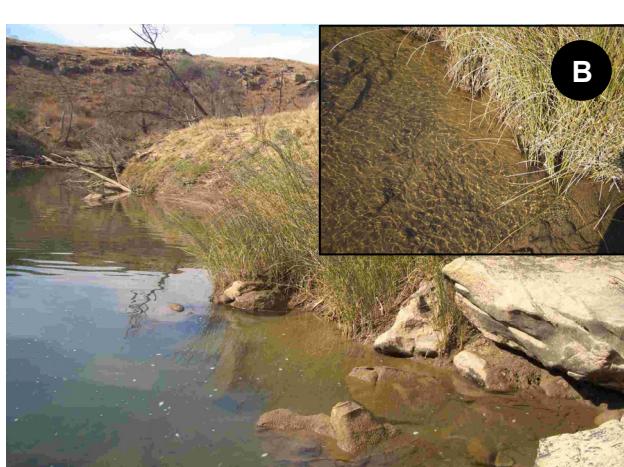
B

Moderate erosion of banks with sedges stabilising areas.

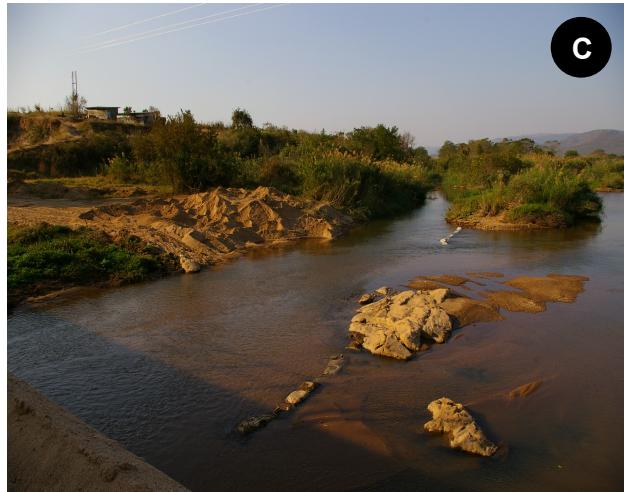
C

Localised erosion at river crossing due to artisanal sand mining. Banks outside of impact zone in fair condition.

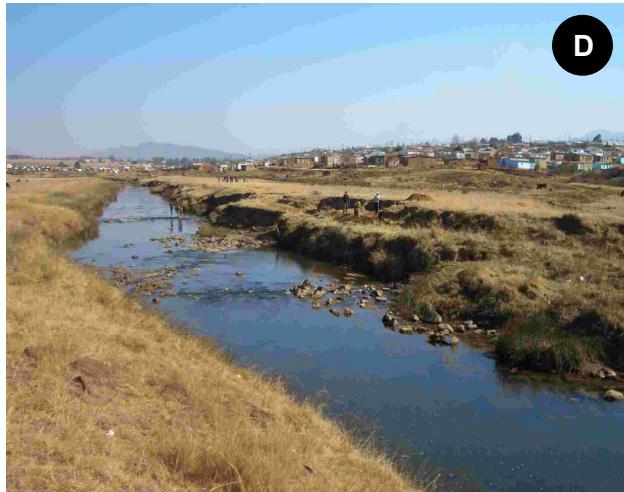
D

Moderate bank erosion due to human settlement activities and artisanal small-scale sand mining along the far bank.

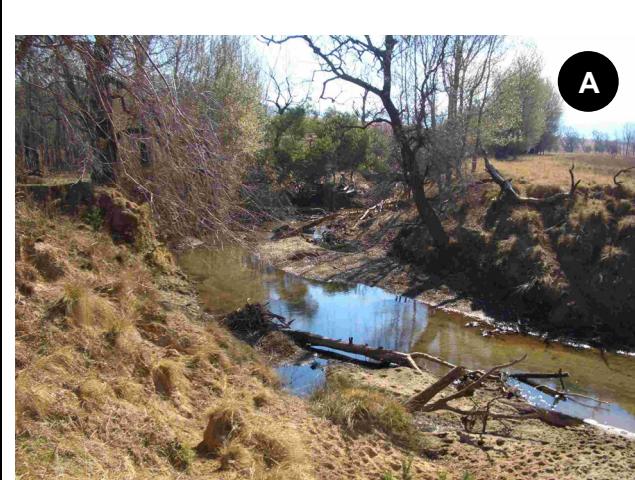
Unknown

Alien trees and livestock hoof impact have caused large-scale bank erosion and sedimentation of channel.

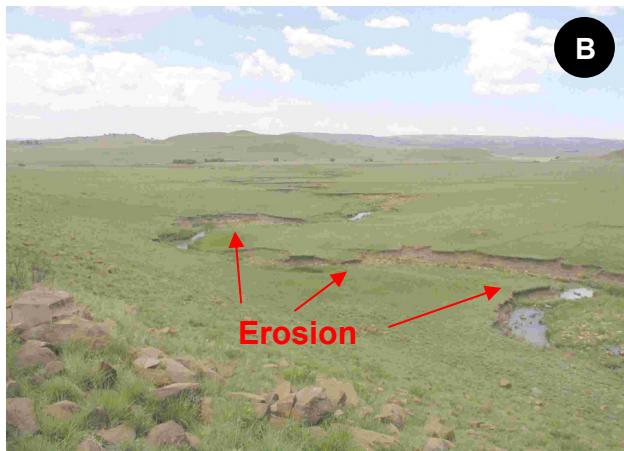
Unnamed stream (in Bergville area)

Extensive erosion of both left and right banks.

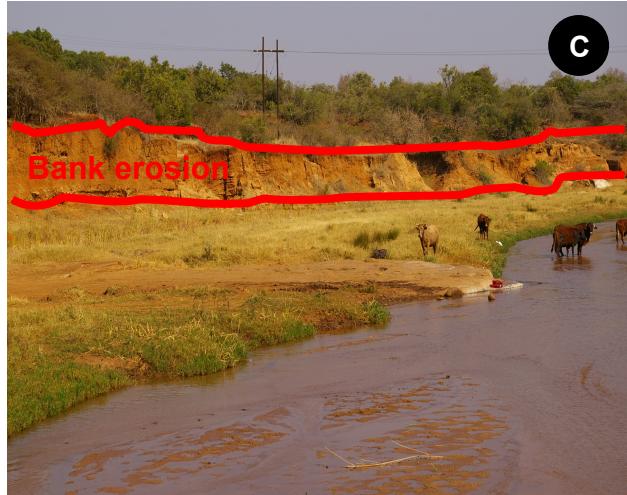
Ingwavuma

Livestock pressure has contributed to extensive slumping and bank erosion.

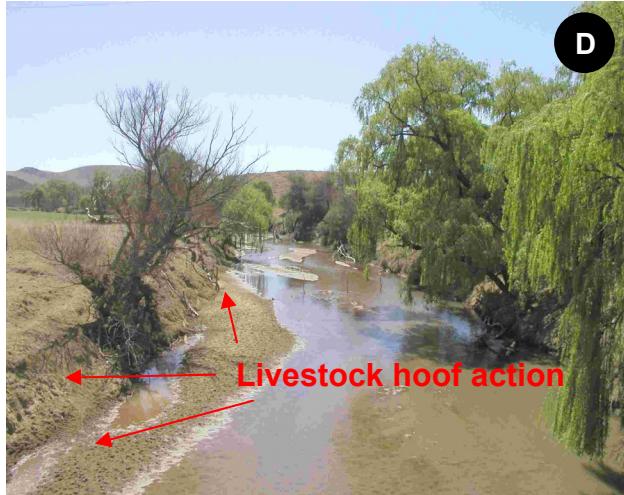
Mzimvubu

Both banks severely compromised by livestock hoof action and overgrazing. Exotic willows exacerbate this impact through shading out of natural riparian zone species.

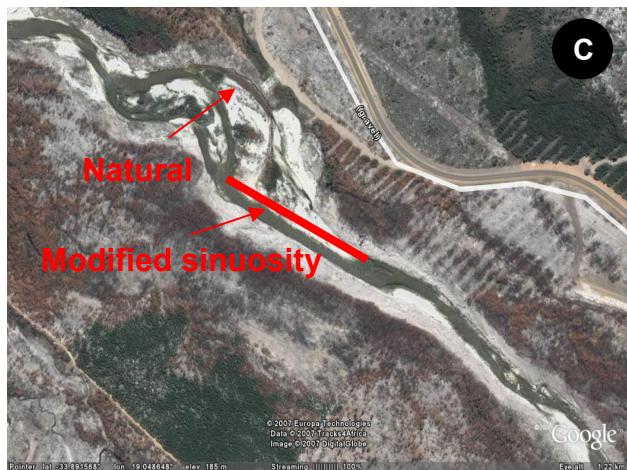
C

Natural sinuosity of this river has been modified to accommodate cultivation along river flood plains. Encroachment by orchards is evident.

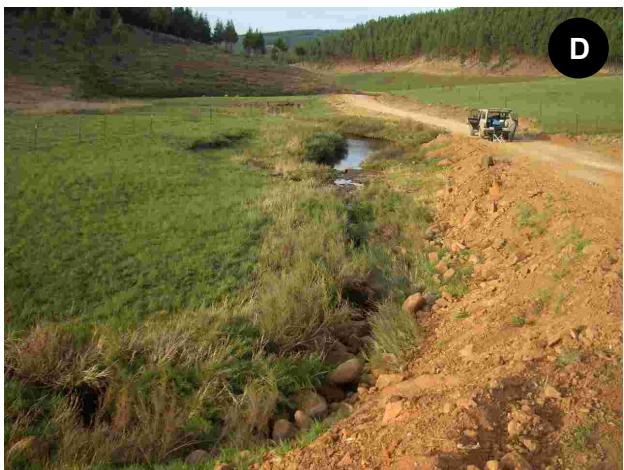
D

Road works contribute to very localised channel modification, hence a low rating.

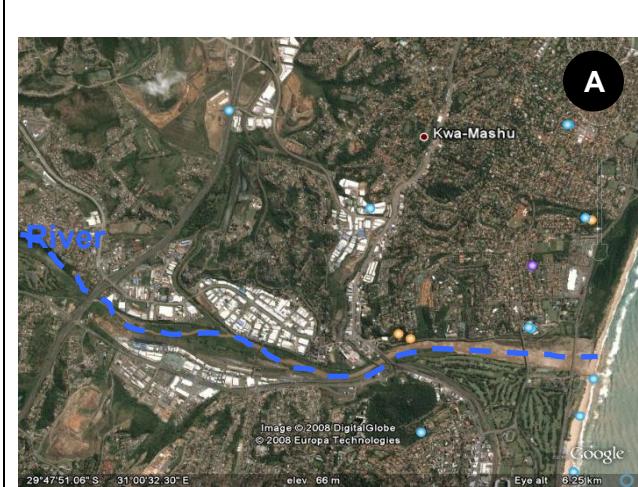
Lower uMgeni

Previously a broadly meandering river, the uMgeni is now confined and straightened by development on the Springfield Flats (previously the flood plain).

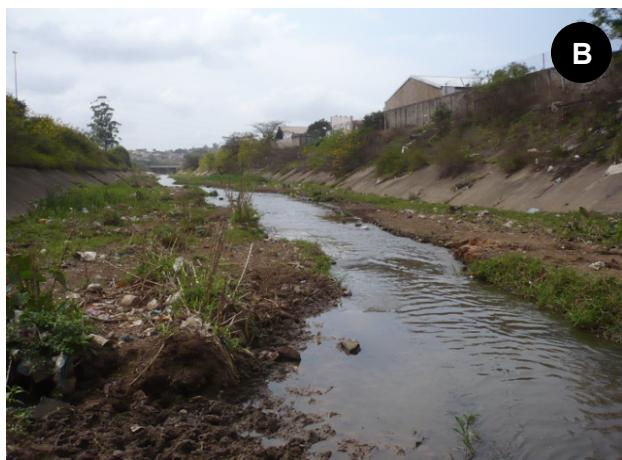
uMhlangane

Canalisation of this river has reduced natural sinuosity of this river. This is localised to accommodate local industrial development, hence the moderate rating.

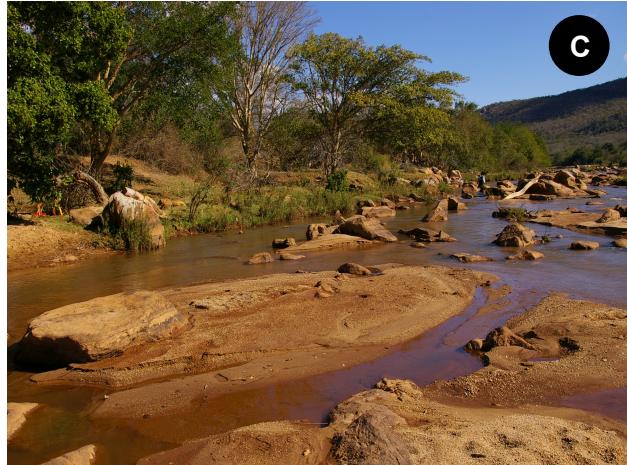
Mkhondvo

High sediment loads and deposition interfere with natural braiding and sinuosity of this river.

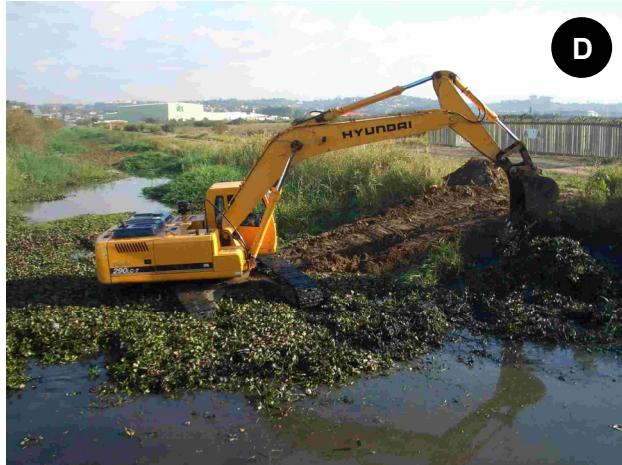
Isipingo Canal

Canalisation to drain lowland floodplain for industrial development, alien weeds and mechanical clearance of canal has interfered with natural channel sinuosity.

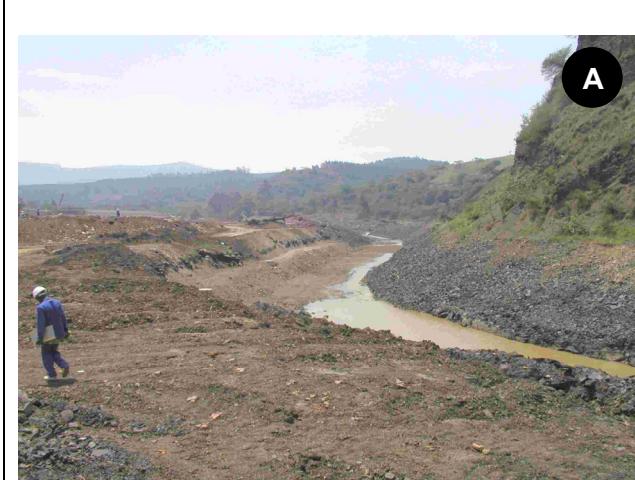
Town Bush Stream

Extensive channel realignment to accommodate new shopping complex.

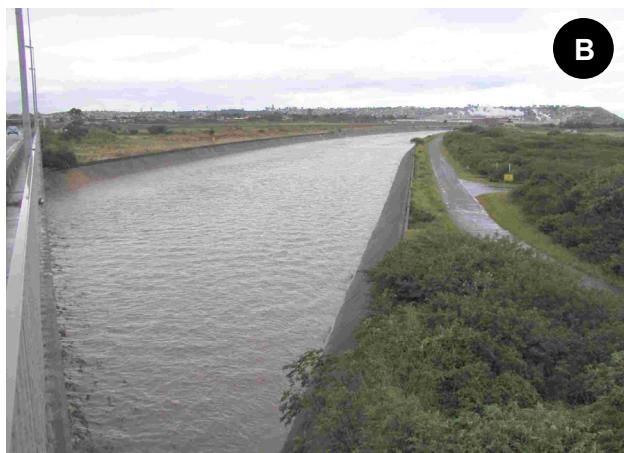
Umlaas Canal

Meandering flood plain transformed by concrete canal diverting entire river flow away from natural coastal flood plain wetlands into the sea.

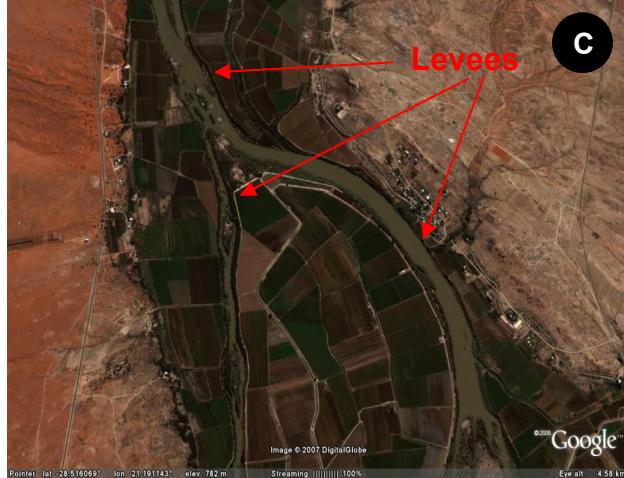
Lower Orange

Levees and agriculture within the riparian zone have confined the natural channel significantly, modifying the banks and reducing channel sinuosity.

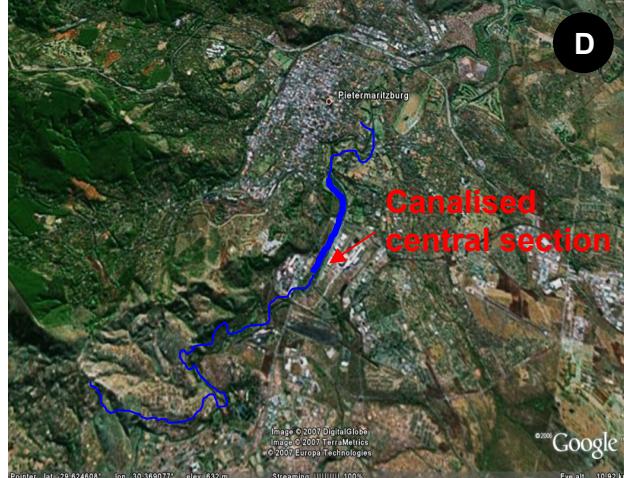
Duzi

Urban development has significantly modified the riparian bank and channel sinuosity as the river passes through the city. This is particularly visible in the canalised central section.

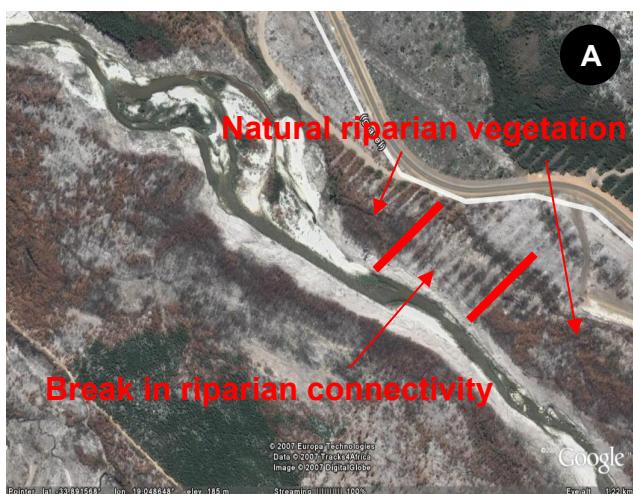
Berg

Cultivation in riparian zone has interfered with longitudinal connectivity.

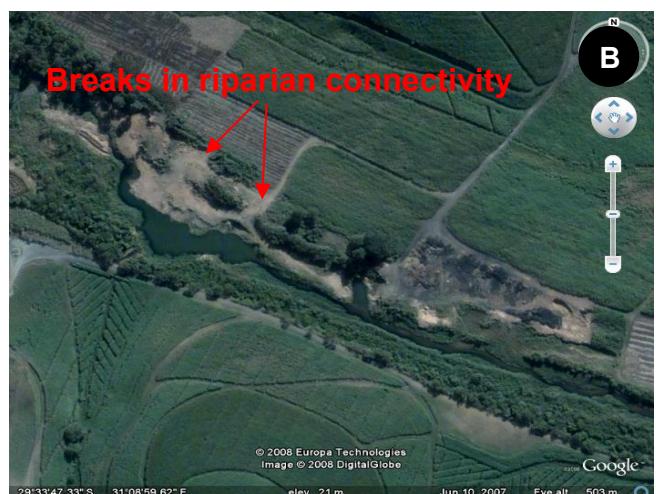
Tongaat

South bank shows good connectivity of the riparian zone. The north bank connectivity has been broken by agriculture in the riparian zone.

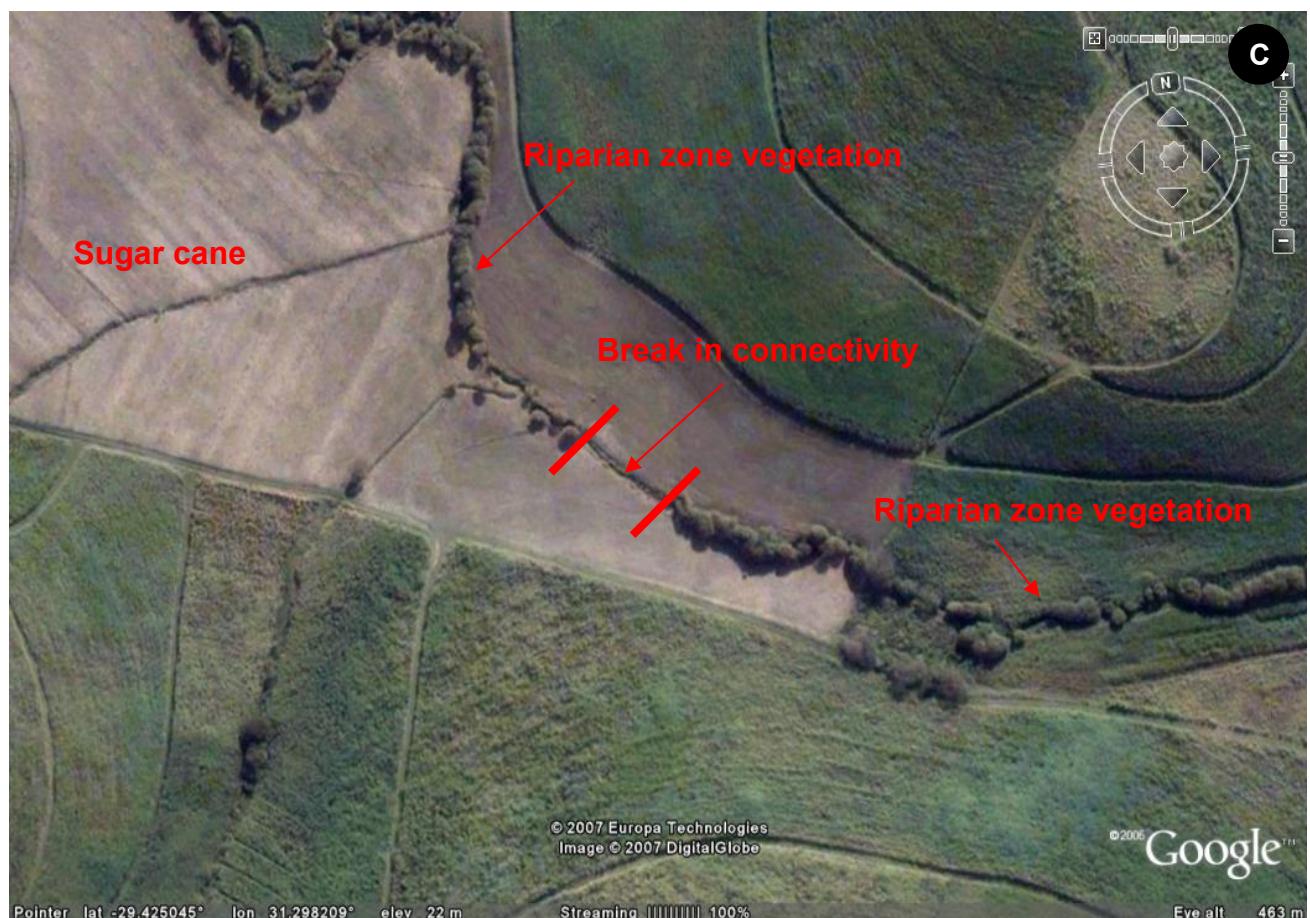
KwaZulu-Natal coastal river through sugar cane fields showing breaks in riparian zone connectivity due to cultivation to the edge of the stream.

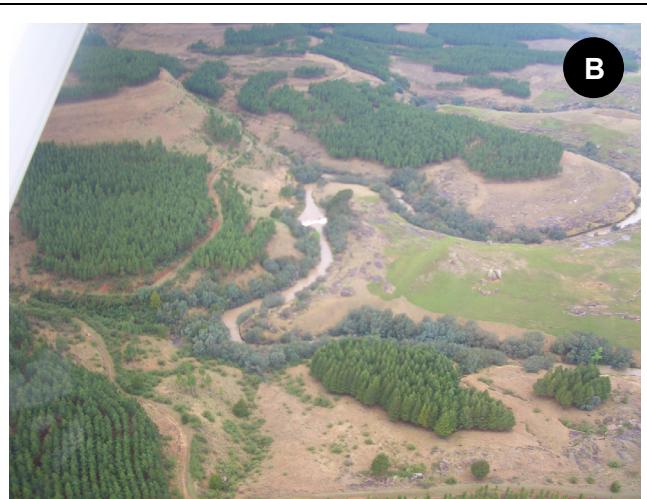
NECF Sephton wetland

Extensive connectivity modification by wattle invasion in this lower area of the NECF Sephton wetland.

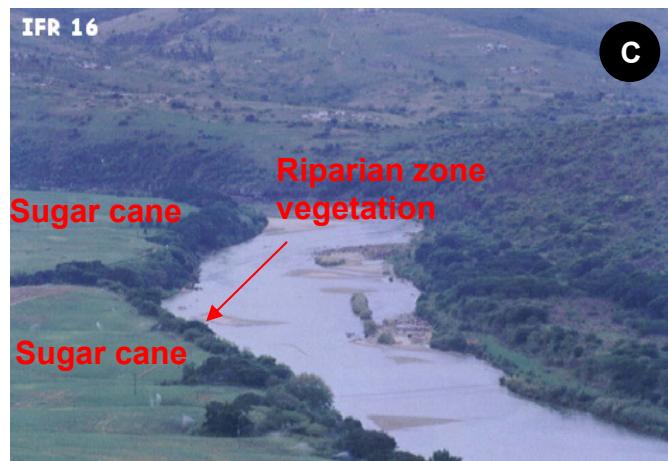
Thukela

Cultivation along the riparian zone has significantly altered the lateral connectivity between the river and the riparian zone. Sugar cane on the flood plains and left bank have reduced the width of this riparian zone and isolated it from the natural flood plains.

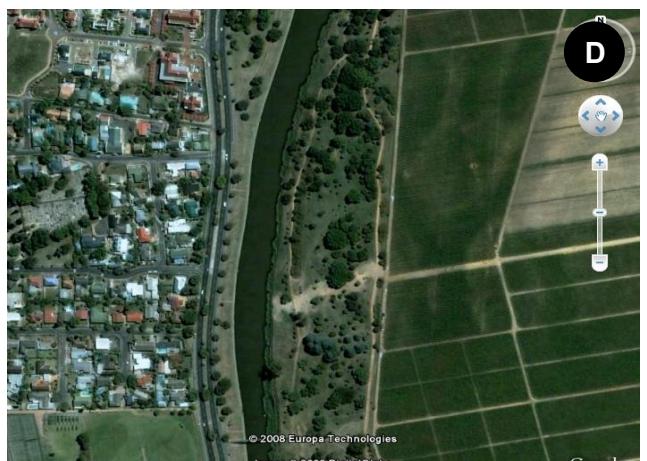
Berg

Parklands have been established on the west bank with grass planted to the water's edge, as opposed to the more natural riparian zone vegetation on the east bank.
