MONITORING OF THE BUFFALO RIVER

30 Oct - 01 Nov 2007

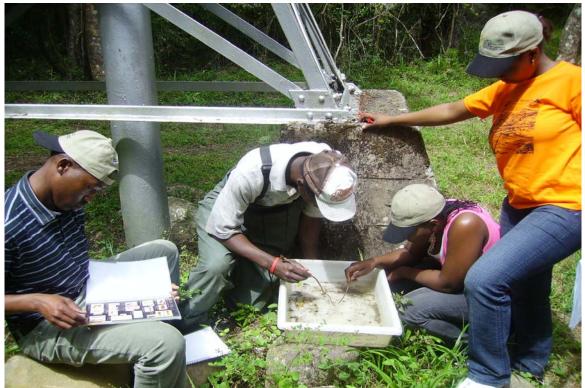
Fig 1.The team conducting SASS 5, using invertebrates
