MZIMVUBU RIVER SPRING SURVEY

SEPTEMBER 2008

Mkosana Kululwa Resource Protection, Department of Water Affairs & Forestry (ELS)

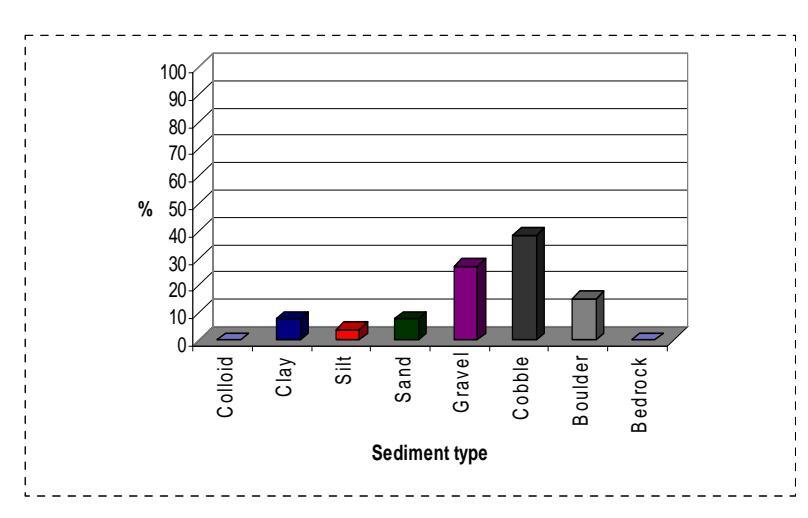
Figure 6. Showing percentage distribution of sediment types at Tsitsa above Potrivier Pass.

The site is located at a confined channel between two steep valleys. This means that no portion of a reach where sediment from eroded hillslope can be trapped by any means, especially if the riparian zone vegetation has been removed. It is a mixed channel where both the bedrock and alluvium are present but it is mainly dominated by bedrock. The channel is a pool-riffle. It has about 49% of morphological units where the living biota can survive. There is a localized erosion and sedimentation. Vegetation removal and subsistence farming are major disturbances. The figure below shows the percentage of sediment proportions on a site. It can be noted that there were fines deposited in the river channel.

The Geomorphological Assessment Index (GAI) model shows that the site is at B/C class in terms of its present ecological state.

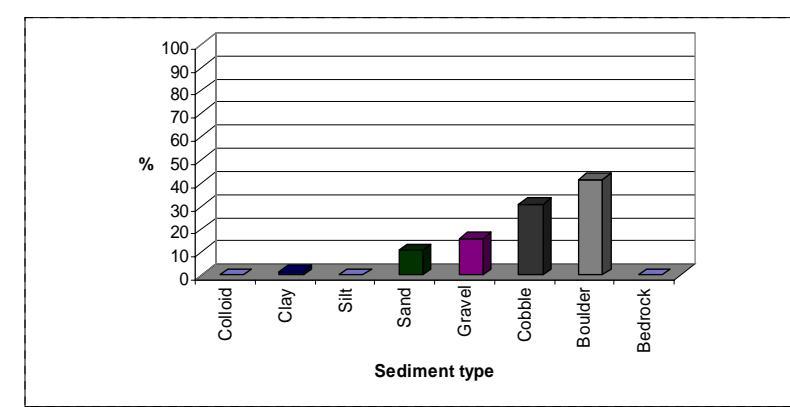
Figure 7. Showing percentage distribution of sediment types at Kinira at Mabua.

The site is also located at a reach confined on one side. It is a single thread pool-riffle system in an active meandering state. Overflow channel was observed, suggesting increased flooding combined with vegetation removal. Flat sand bed was also noticed which is an evidence of increased sedimentation. The sources of sediment at a reach scale are gullies and sheet erosion on the hillslope, accompanied by presence of alien *Acacia meansii* species. The latter also plays a significant part on river bank failure and collapse with the resultant increase in the deposition of fine material. Figure 6 below shows the variability of sediment found in the channel. Although boulders and cobbles are dominant material, sand and gravel deposits can also be noticed.

The Geomorphological Assessment Index (GAI) model shows that the site is at C class in terms of its present ecological state, suggesting a change in geomorphology and instream habitat

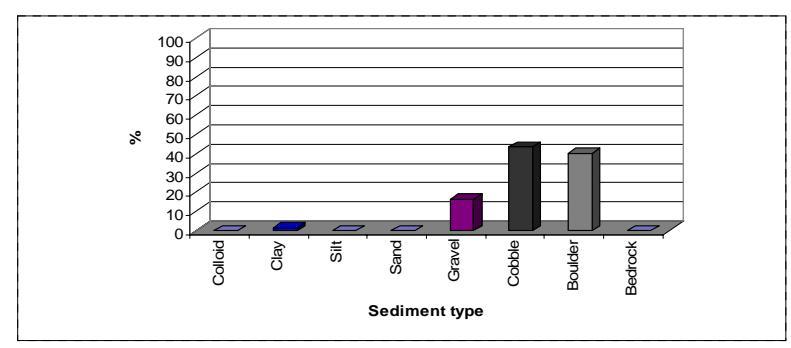
Figure 8. Showing percentage distribution of sediment types of Mzimvubu at Springfontein.

The site is also located at a reach where the floodplain is confined on one side. This means that the eroded sediment from the hillslope can either be trapped alternatively at a floodplain either at the right or the left side of the river, but never both. It is a single thread, alluvial and a pool-riffle system. This is where the river is experiencing a sinuous situation, with erosion of the river bank alternating with deposition of sediment on either left or right bank. The morphological units on a river constitute about 33%. Boulders and cobbles are dominant features of the system with gravel material and small proportion of fines deposited in between the dominant material. The figure below shows sediment proportions of a site.

The GAI model reveals that the river at a site is at A/B; a near natural condition with negligible modifications.

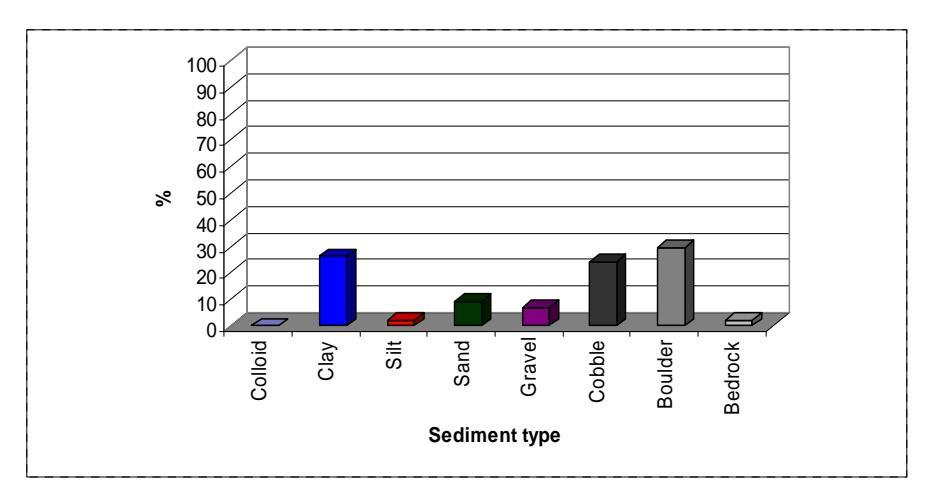
Figure 9. Showing percentage distribution of sediment types of Tina at Tsolobeng.

had also been removed, possible for fuelwood collection. A dam under construction above the site also contributes to sedimentation of the entire reach hence it is a seriously embedded river system. As it can be detected in the figure below, the site had a lot of fine material like gravel, sand, silt and clay in between the boulders and cobbles, with other fine material attached to the bedrock.

While running the GAI model, it shows that the river at a site is at C/D class; a situation whereby the geomorphic changes have been largely modified.

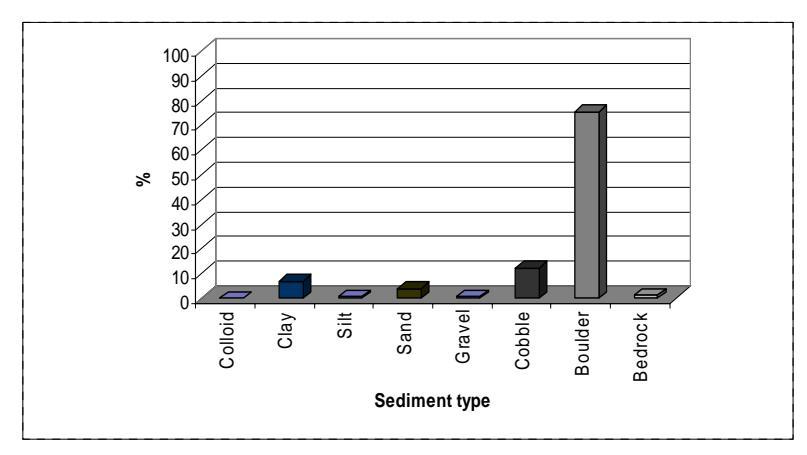
Figure 10. Showing percentage distribution of sediment types of Mzintlava at Ntshakeni.

This is also a confined valley floodplain. It a pool-rapid river system with a straight and a single thread channel. The river at a site is dominated by boulders; a character of a transitional zone. It has about 79% of morphological units suggesting diversity of habitat for aquatic biota. However, active hillslope erosion, vegetation removal and overgrazing are abundant. This is a characteristic of poor pasture management which can affect adjacent water resources. Sediment sampling was carried out at a site. The figure below shows the results of sediment sampling.

From this it can be examined that the site is invaded by fine material like sand, silt and clay particles. When running the GAI model, the site can be classified as in a C class on its Present Geomorphological State.

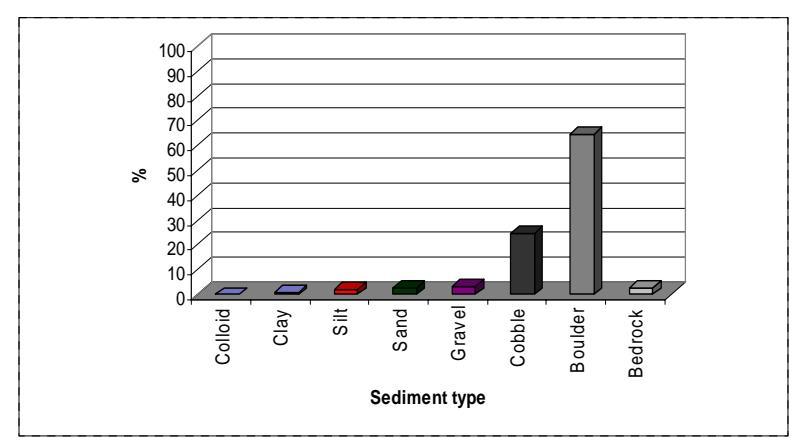
Figure 11. Showing percentage distribution of sediment types of Tina River at N2.

The site is at a confined valley floodplain. It is a multi-thread, mixed, pool-riffle system dominated by boulders. Erosion at catchment scale very minimal and there is less vegetation removal. About 83% of morphological units were present. As it can be illustrated in the figure below, very little fine material is found in the river at that site.

The GAI model demonstrates that the Present Geomorphological State of the river at a site is at B class.

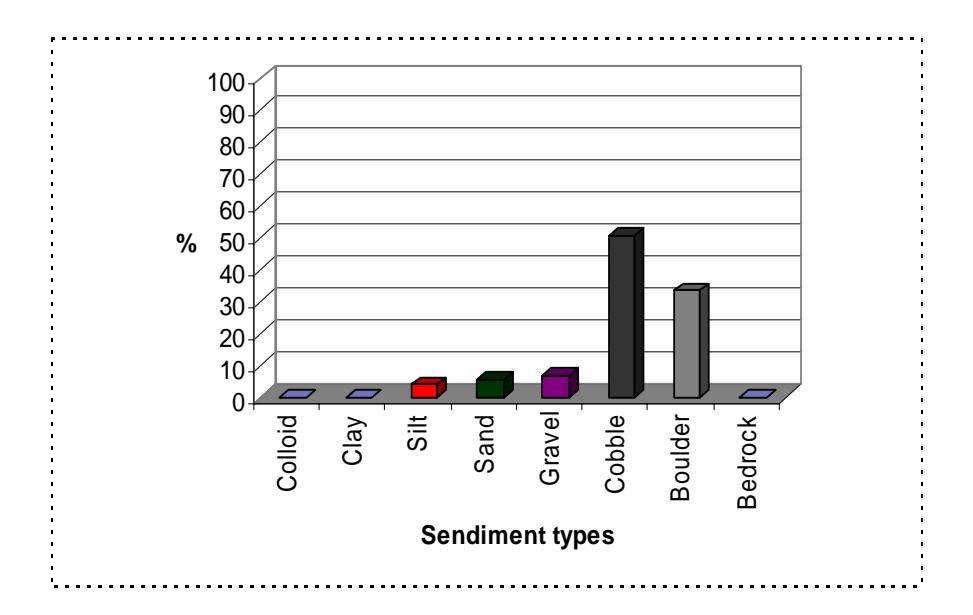
Figure 12. Showing percentage distribution of sediment types of Tsitsa at Laleni.

The site is also at a confined valley floodplain. It is a single thread, sinuous, pool-riffle and a mixed channel although it is composed of the cobbles as a dominant sediment type. Active erosion at a reach scale could be noticed. Deep gullies were present throughout the adjacent hillslopes of the river reach. Vegetation removal and extensive livestock grazing was also evident. Weirs and causeways were also present. The figure below show the proportion of sediment types on the river at a site. It can be noticed that the cobbles are dominant features though the boulders are also evident. The silts, sands and gravel deposits are probably from sediment sources like gullies and the overgrazed and moderately eroded neighboring hillslope.

The GAI model illustrates that the river at a site is at B/C Present Geomorphological State.

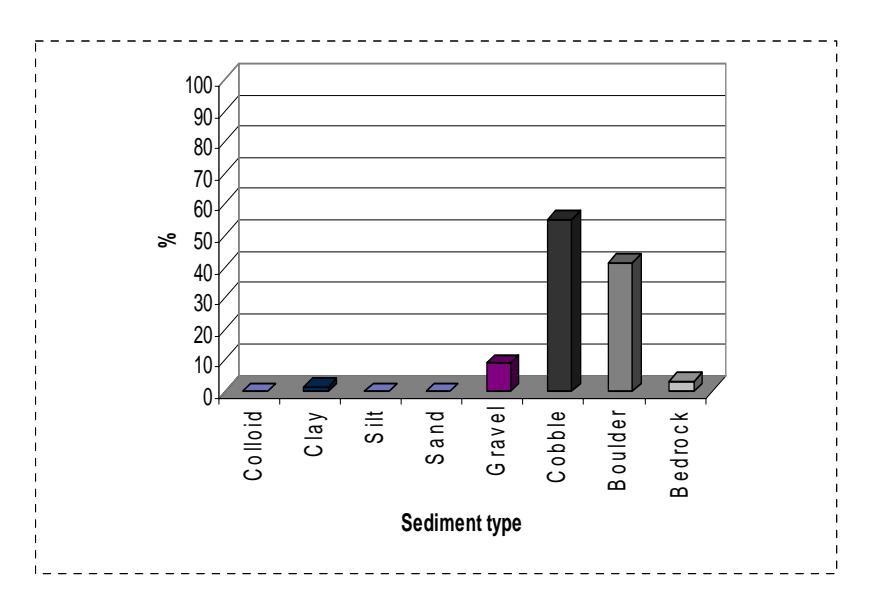
Figure 13. Showing percentage distribution of sediment types of Mzintlava at kuPoyi.

The figure below shows the results of sediment types sampled at a site. It can be noticed that the sediment sampled is dominated mainly by cobbles though the boulders are also major features observed. Some gravel deposits also exist that are probably from adjacent hillslopes and upstream of the site as well as from the river bank.

The GAI index revealed that the site can be considered as at its natural or near natural condition in terms of its fluvial geomorphology (A: negligible or no change).

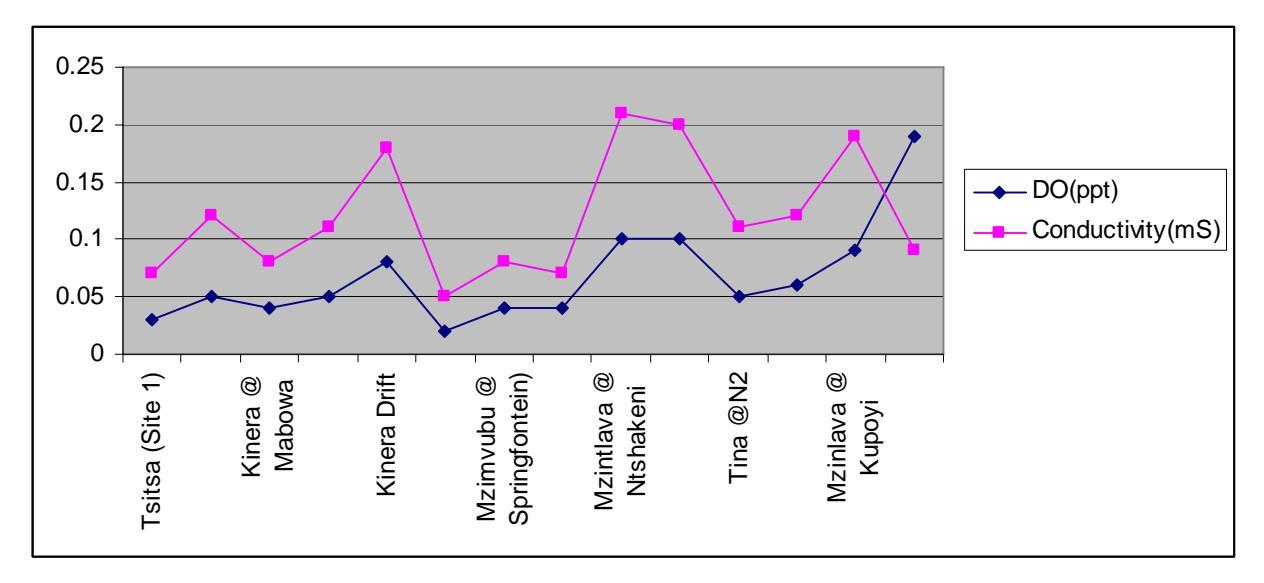
Figure? Comparing dissolved oxygen (DO) and conductivity (note the positive correlation except at Mzintlava at KuPoyi.
