## Feasibility Study for Foxwood Dam (WP10580)

### Geotechnical Reconnaissance

Final Issue

DWA Report Number: P WMA 15/Q92/00/2113/4

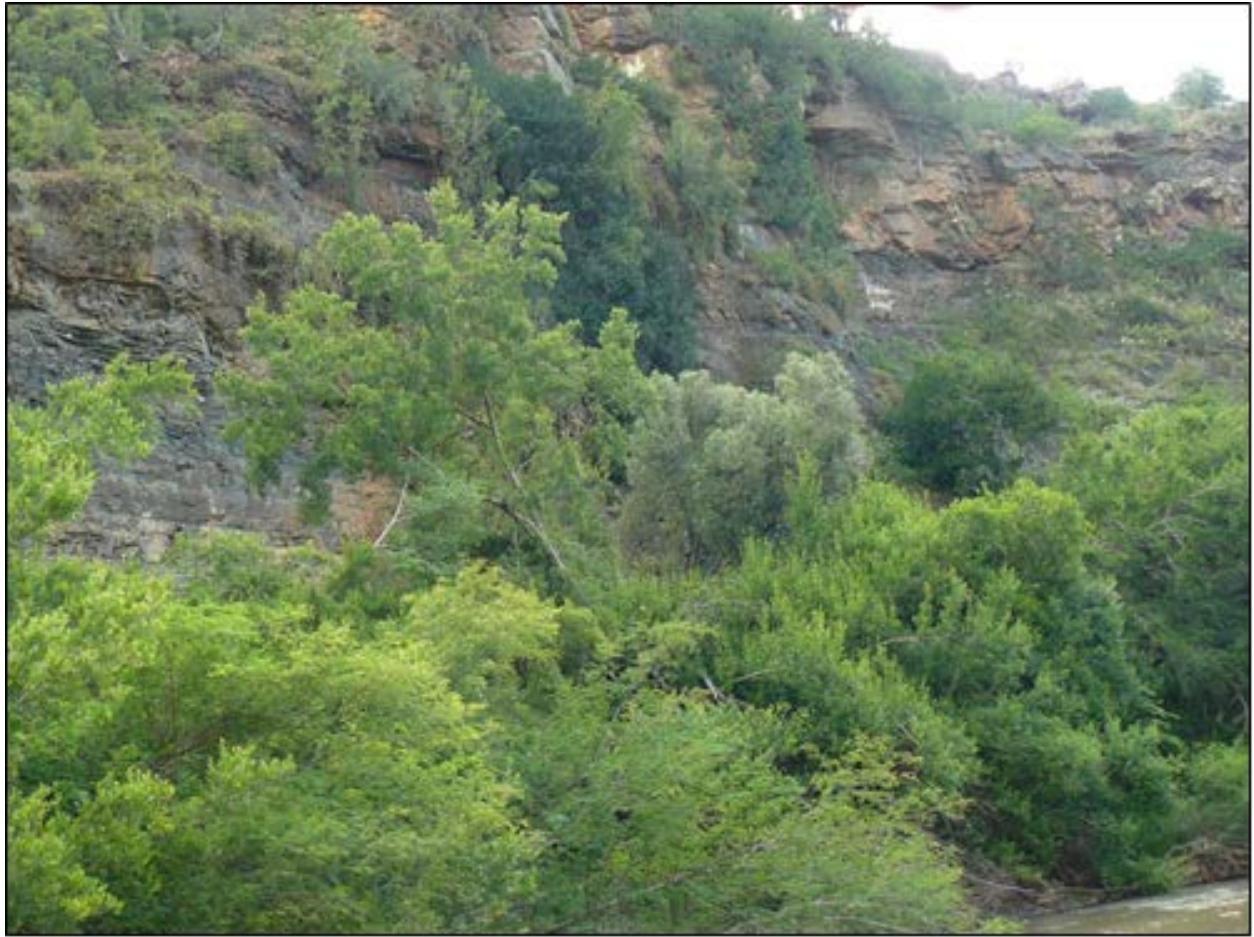
Figure 2 Left Flank Slope

The left flank is characterised by a steep sandstone scarp, or cliff, overlying a gentler lower slope of exposed mudstone, followed lower down by a pediment of sandstone fragments and block - combined with alluvial detritus - overlying mudstone. Borehole 1 drilled at the scarp summit intersected 22,6m of hard, massive, or bedded/ cross-bedded sandstone. The borehole did not extend down to the underlying mudstone which is unfortunate, since this could have provided important information with respect to the contact zone between the two rock types.

Central and lower parts of the flank slope consist of mudstone which disintegrates on exposure. This has resulted in undermining of the sandstone capping resulting in sandstone debris - both small fragments and large blocks - littering the lower parts of both abutment slopes.

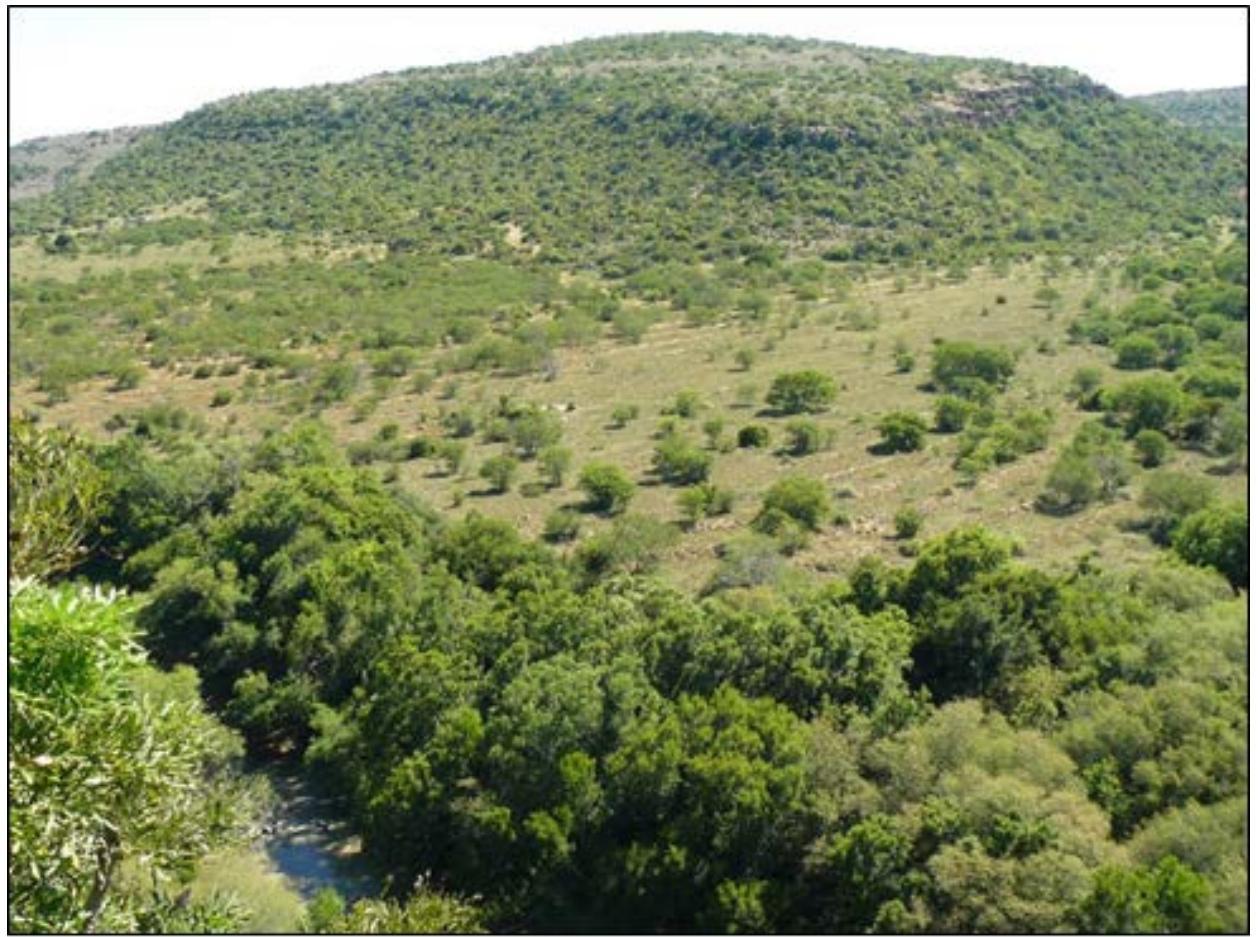
Figure 3 River Section

The wide river section has a gentle rise from the river channel on the extreme left side towards higher ground on the right flank. Fine grained silt blankets the exposed surface and the two boreholes drilled in this section in 1962 - one next to the river channel and one midway along the centreline - indicate an upper layer of alluvial silty sand 3m to 9m thick overlying gravel; cobbles, and boulders (borehole logs indicate boulders but the report text suggests gravels) 2m to 3m thick, overlying unweathered mudstone with thin siltstone and sandstone intercalations.

Depth to the rockhead contact is 5,8m in the borehole adjacent to the river channel and 10,8m midway along the centreline.

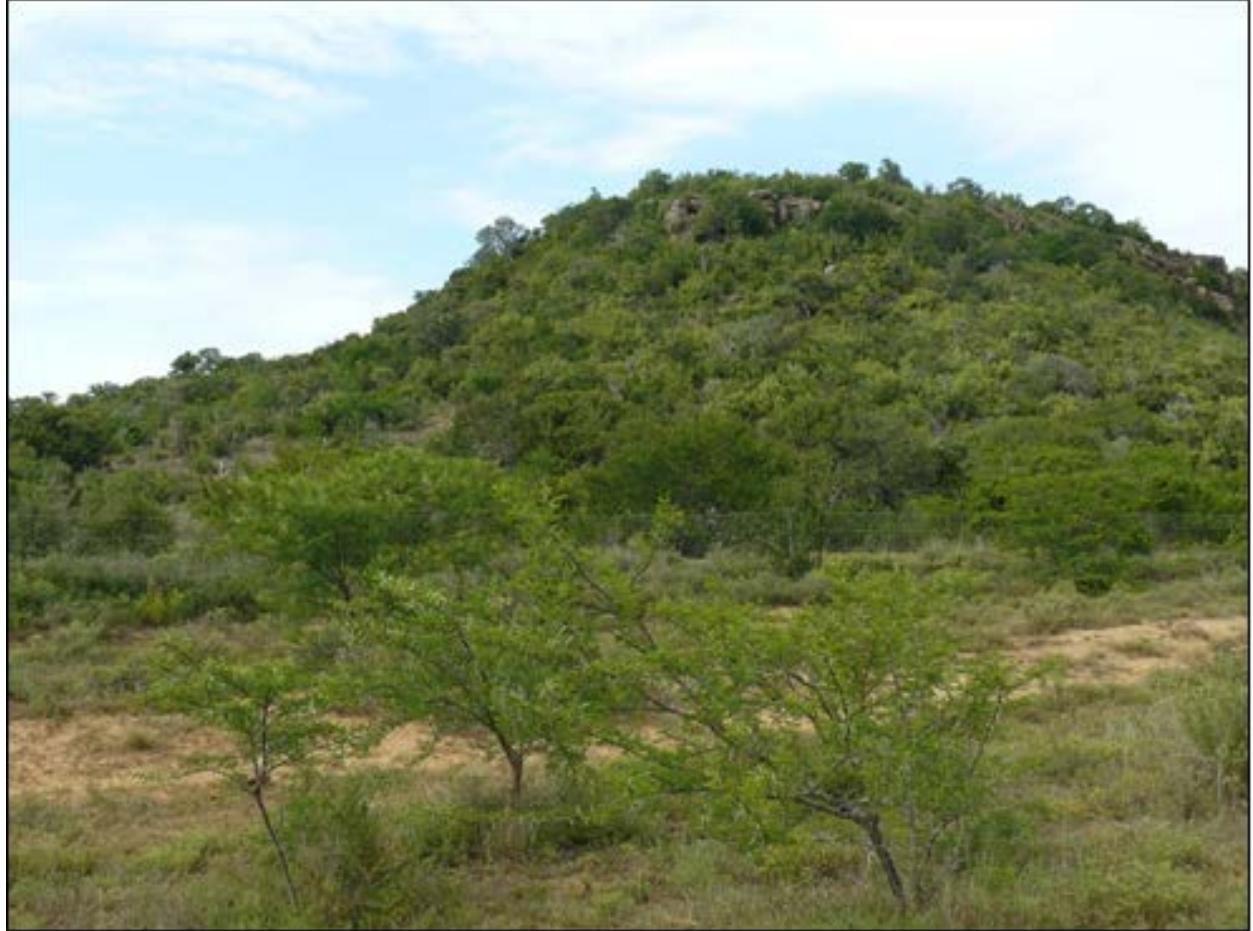
Figure 4 Right Flank

The right flank is not as steep as the left and has a greater proportion of slope debris. The sandstone capping in prominent at the top of the flank but most of the central and lower slope geology is hidden by a layer or colluvium; bush and grass. One borehole drilled slightly downslope of the flank summit indicates 9,1m of massive feldspathic sandstone overlying green to grey mudstone. The contact zone has a 75mm layer of 'clay with secondary lime'. Mudstone is reportedly of lower strength than on the left flank but this will require confirmation via rock core testing of still to be drilled borehole cores.

The 1962 report suggests that the 'right flank consists practically entirely of mudstone being capped at its crest by a sandstone layer of 35 feet (10,7m) thickness only'.

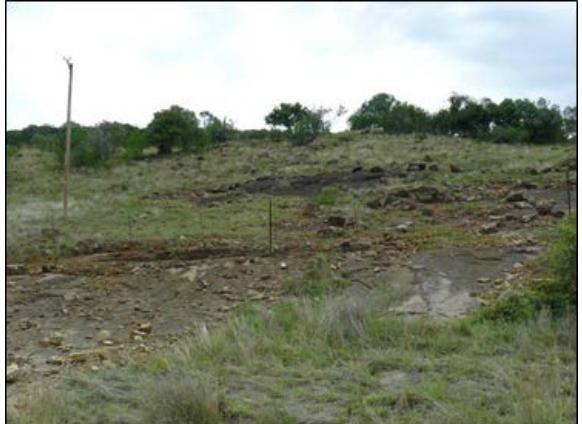
Figure 8 Quarry Q1 S 32° 36' 48.60" / E 26° 15'

Potential quarry site Q1 is located alongside and east of the Adelaide/ Tarkastad road where unweathered, massive, domed dolerite outcrops at surface. Figure 6 below provides a photograph of the site where quarrying alongside the length of road in the narrow cutting between road and river could also improve the road alignment, and with it, safety of road users. It is therefore an attractive prospect.

Quarry Q1 appears to be the better option. The preferred site will require as minimum 3 boreholes - preferably 5 - to determine available reserves; allow removal of samples for strength and durability testing, and most importantly: the drilling of boreholes is a mandatory requirement for permitting/ licensing of the quarry as required by the Department of Minerals & Energy.

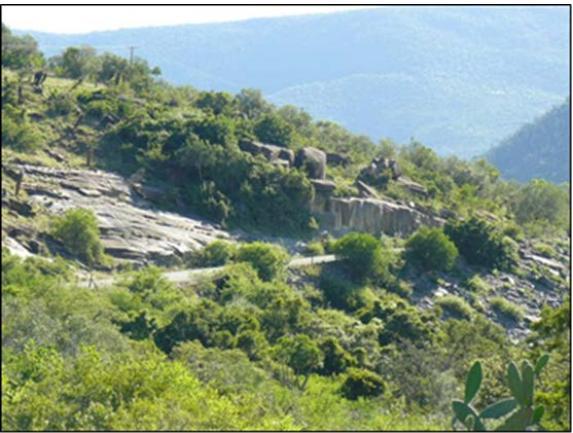
Figure 7 Quarry Q2 S 32° 36' 04.79" / E 26° 15' 48.53"

Potential Quarry Q2 comprises similar domed, massive dolerite at surface with location on the same dolerite sill. It has a gentler slope thereby requiring a lower cutface but is further from the dam site with greater haulage distance. Both sites have telephone/ electricity poles requiring relocation.

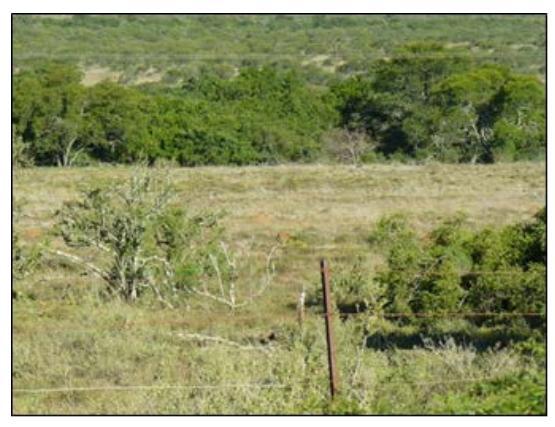
Figure 10 Borrow Pit C2 S 32° 39' 08.25" / E 26° 16' 01.36"

Red brown slightly clayey silt on east side of road. The nearby dam east of the road has been constructed of this material.

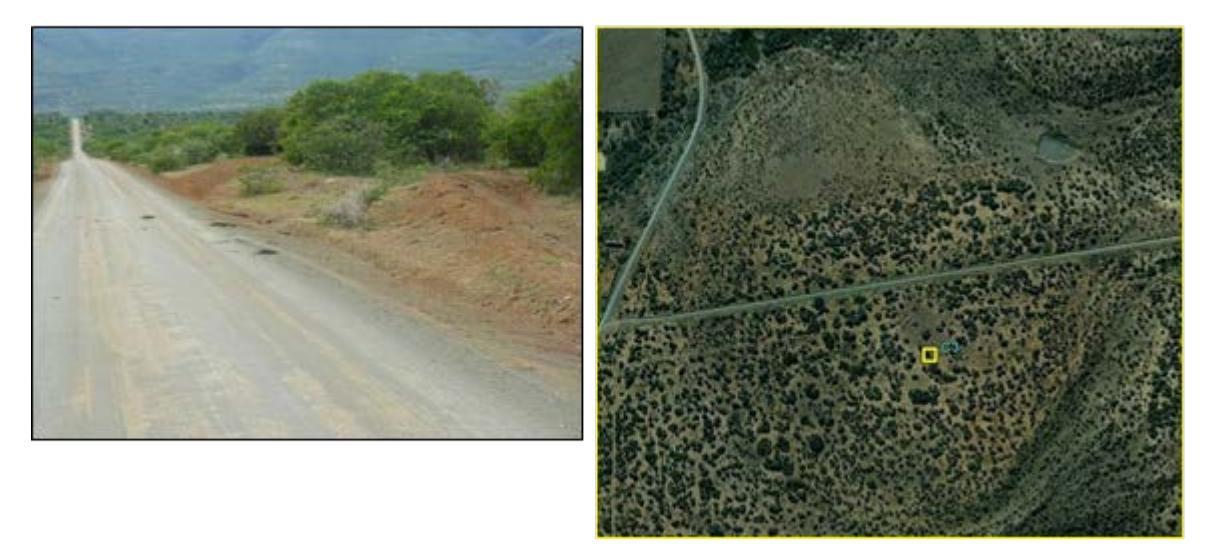
Figure 11: Borrow Pit C3 : S 32° 38' 39.56" / E 26° 16' 25.47"

Borrow Pit C3 comprises of the same ubiquitous red brown slightly clayey silt but in this case is located alongside an easterly orientated road leading off the main Tarkastad / Adelaide Road.

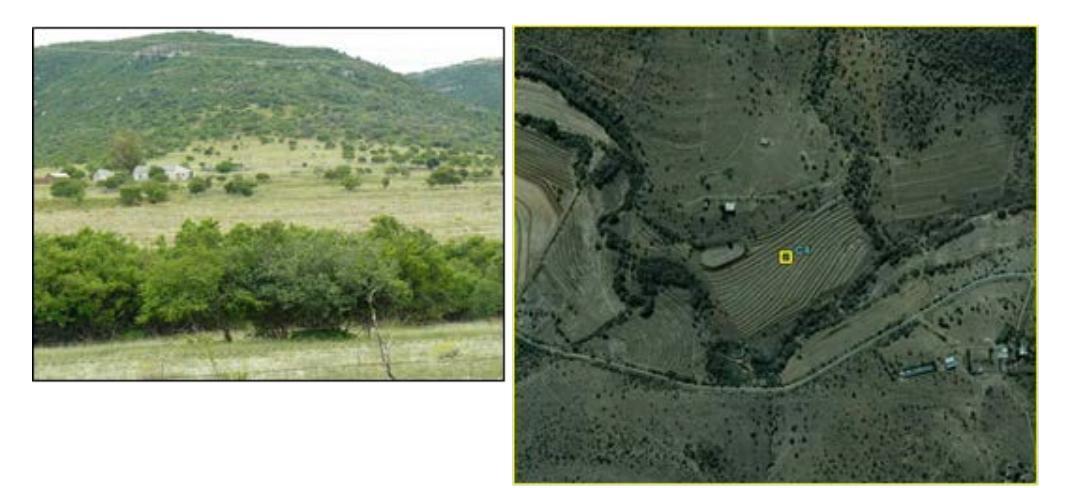
Figure 12: Borrow Pit C4 : S 32° 35' 31.93" / E 26° 14' 55.90"

Borrow Pit C4 consists of red brown slightly clayey silt as located in cultivated lands far to the north along a westward orientated branch road.

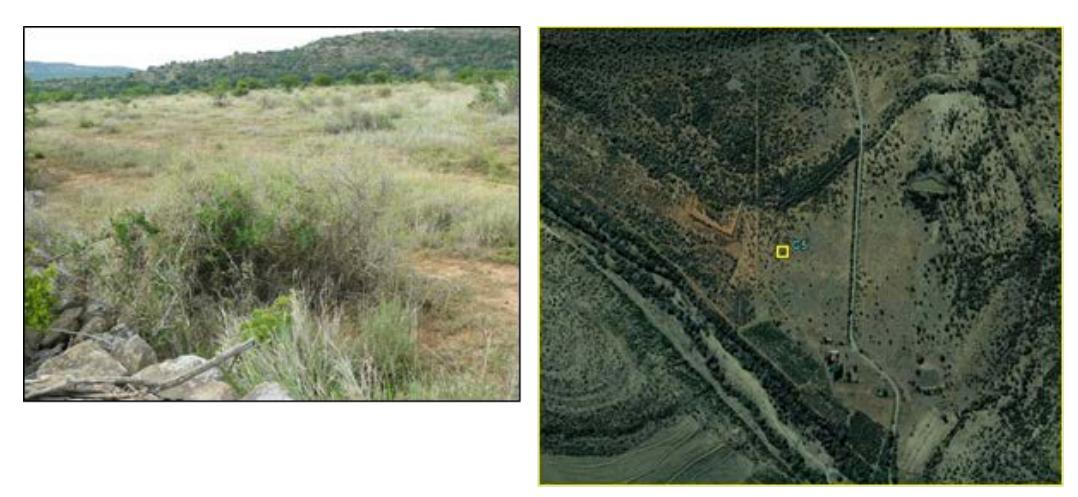
Figure 13: Borrow Pit C5 : S 32° 37' 43.69" /E 26° 18' 17.40"

Borrow Pit C5 - red brown slightly clayey silt - has material borrow opportunities either side of the local district roads. It is a fairly long distance from Foxwood dam.

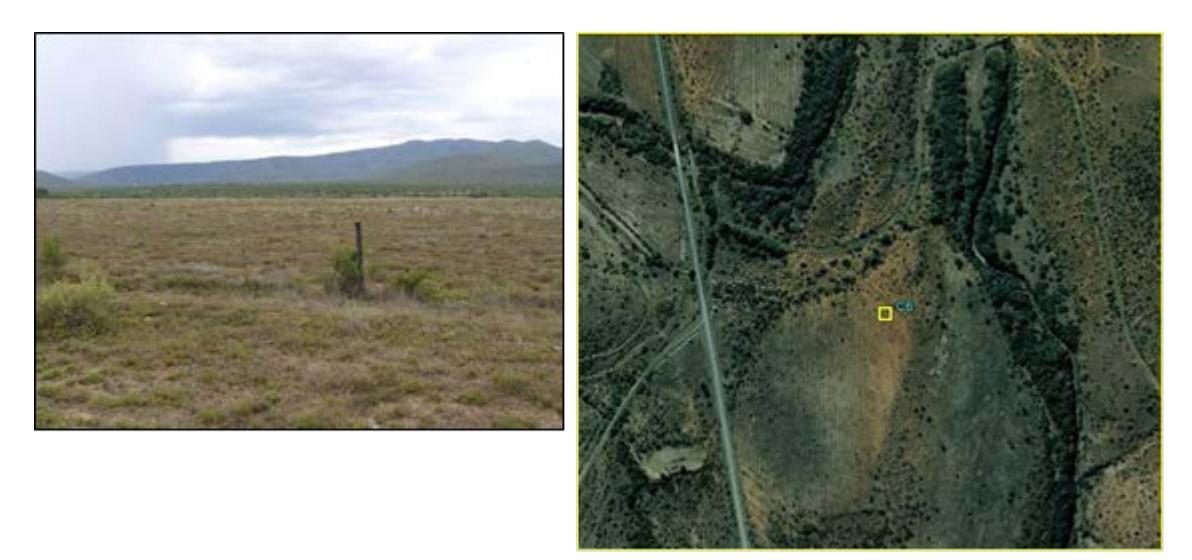
Figure 14: Borrow Pit C6 : S 32° 39' 26.59" / E 26° 16' 13.51"

Borrow Pit C6 also comprises red brown slightly clayey silt as located east of the Tarkastad/ Adelaide road, and importantly, in close proximity to Foxwood dam site.

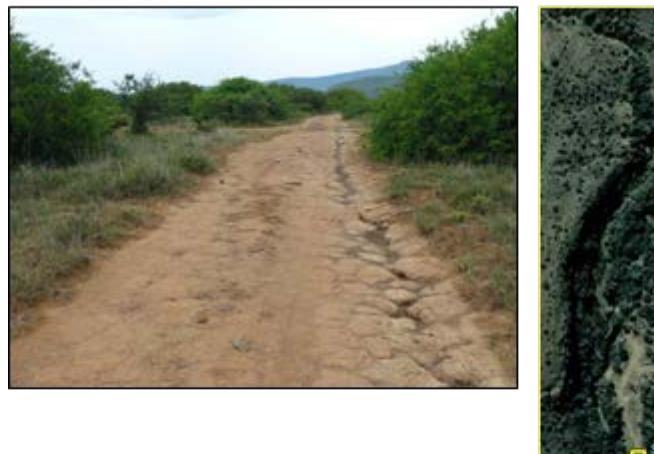
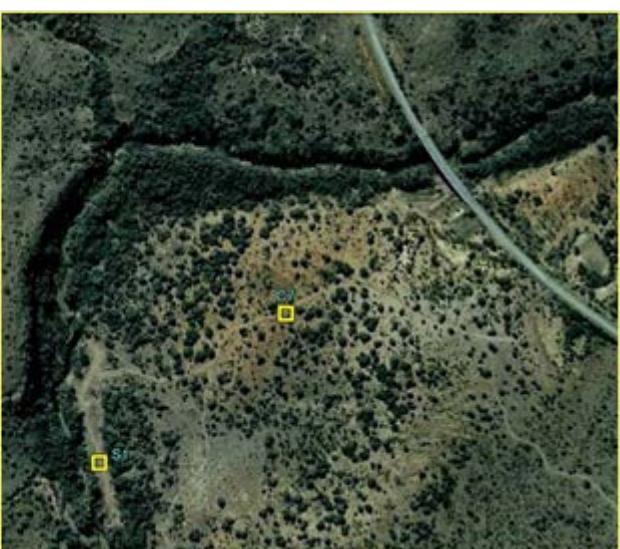
Figure 15: Borrow Pit C7 : S 32° 39' 53.18" / E 26° 16' 02.71"

Borrow Pit C7 is the closest 'core' borrow location to Foxwood dam site. Its location is immediately upstream of the dam and west of the main road.

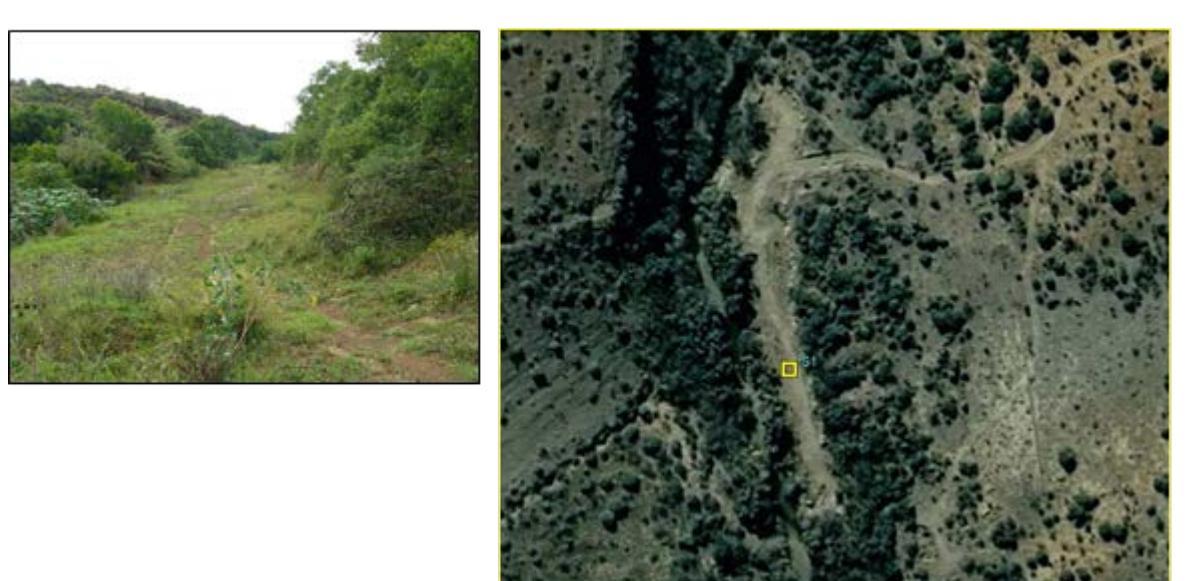
Figure 19: Very Fine Grained Sand/Silt Borrow Pit and "Sand" Borrow Pit S 32° 39' 58.41" / E 26° 15' 54.96"

Natural occurring river sand sources are in short supply along the relatively immature Koonap River system. There is an old 'sand' borrow pit alongside the river at position S1 (see Figure 19) where material has been borrowed presumably for local building purposes: possibly plaster 'sand'. The material though is a too fine grained silt, with an unacceptably high organic content, to be of use as a fine grained aggregate source for the dam project. It is suggested rather that fine grained aggregate be crushed from rock sourced at the proposed dolerite quarry.
