REPORT NO .: P WMA 02/B810/00/1110/2

GROOT LETABA RIVER WATER DEVELOPMENT PROJECT (GLeWaP)

TECHNICAL STUDY MODULE: Preliminary Design of Nwamitwa Dam

VOLUME 6 Annexure 2: Appendix B (Part 1): Geotechnical Investigations

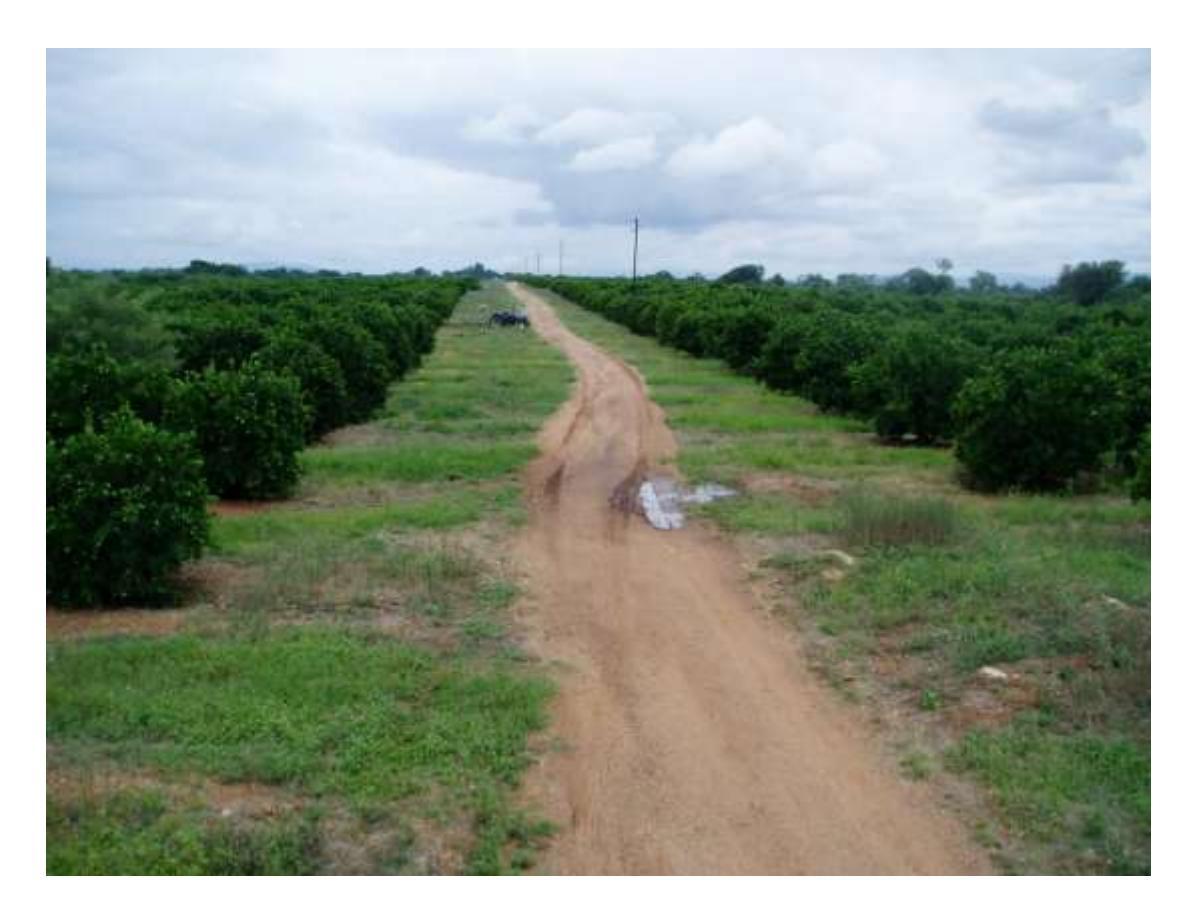
Plate 1 A general view of the upper left flank, illustrating the gentle topography

At the time of the geotechnical investigations the proposed dam site was being used for agricultural purposes and primarily comprised citrus orchards although access roads also traverse the site (**Plate 1**).

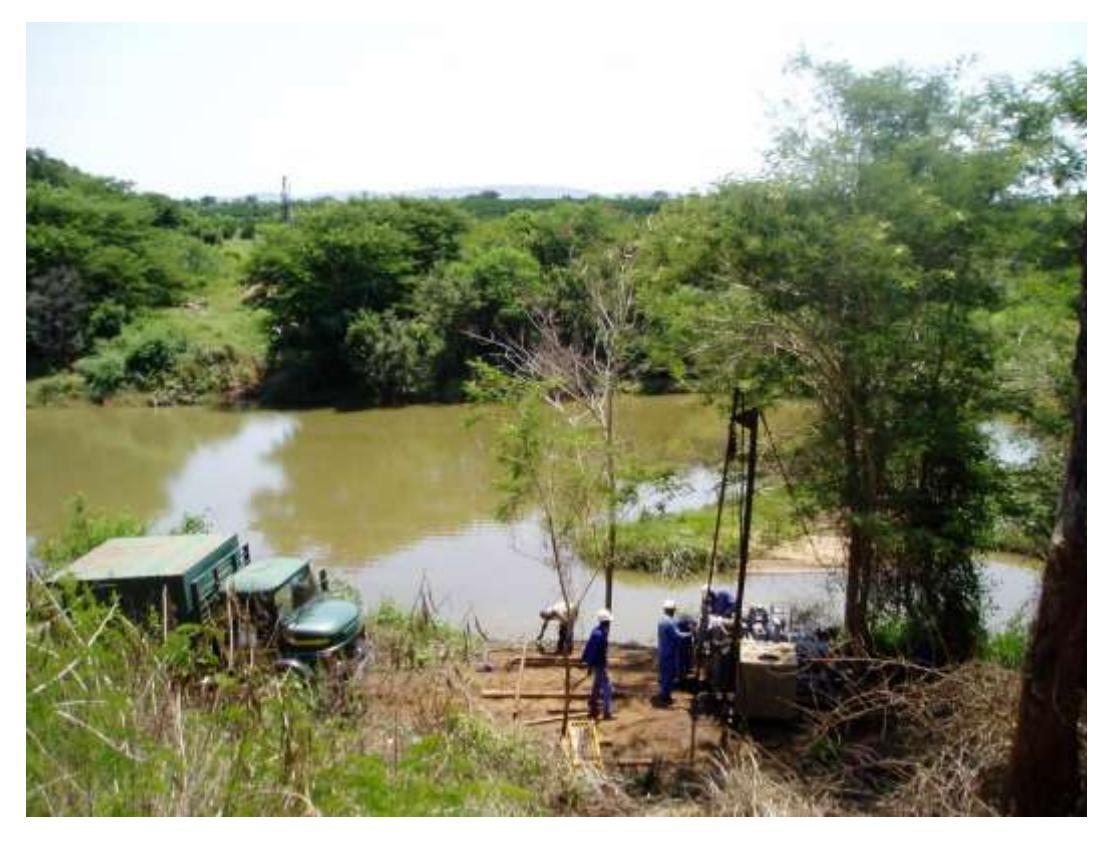
Plate 2 A view of the river section, illustrating the thick alluvial deposits on the river banks and the absence of rock outcrop

In situ conditions within the alluvial deposits were investigated by means of the test pits, although only the upper 3 m of the profile could be inspected. On the river bank (NTP01) two horizons of alluvium are recognised; an upper horizon with thickness of 0,7 m comprising slightly moist, light brown, intact but horizontally laminated, loose sand, with roots. This is underlain by slightly moist to dry, brown, shattered, intact to shattered, medium dense clayey silt, with roots. Test pits excavated from the top of the river bank reveal the alluvium to comprise slightly moist, reddish brown or dark grey-brown becoming brown, medium dense or dense, silty sand or clayey to silty sand. Occasional rounded to sub-rounded cobbles and boulders are present, with diameter varying between 60 mm and 300 mm.

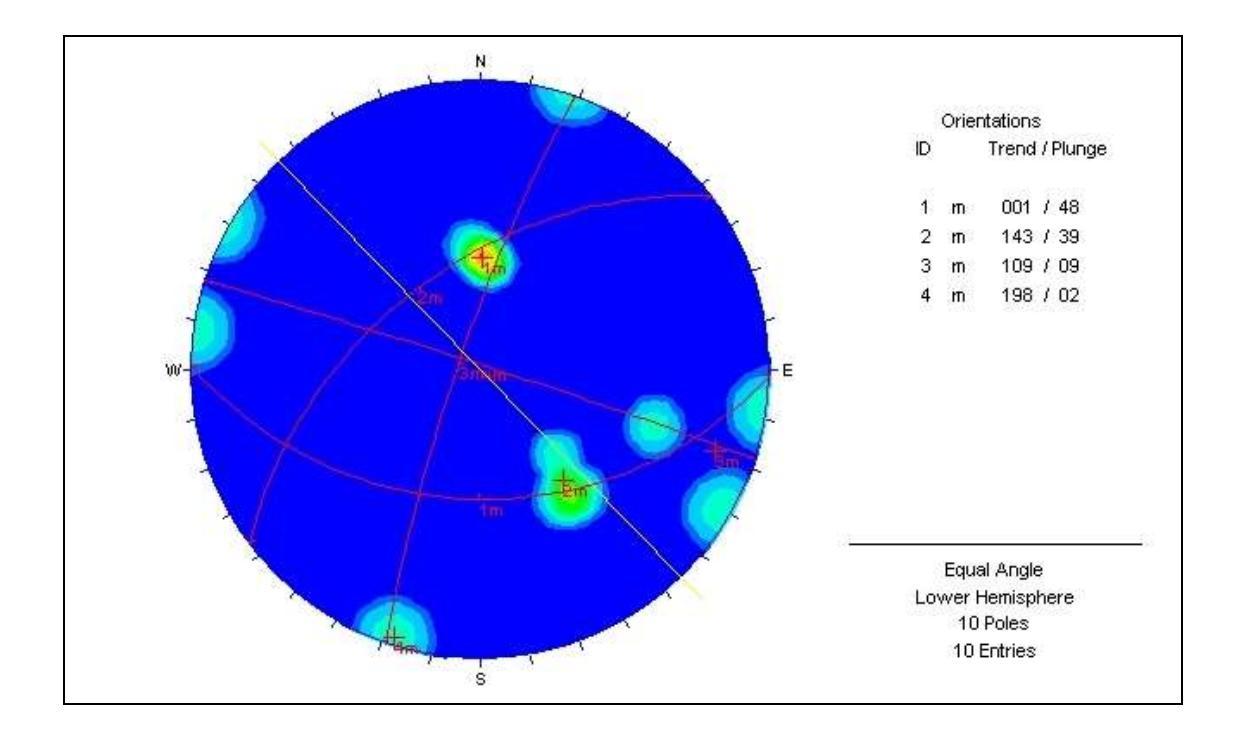
Figure 6.1 Stereographic discontinuity data (river section). The orientation of the centre-line is indicated, and the respective joint sets are defined.

Up to three or four joint sets are generally recognised within the borehole cores. In the absence of oriented cores, no firm conclusions can be made on the attitude of the respective joint sets, however. Sub-vertical and sub-horizontal joint sets may

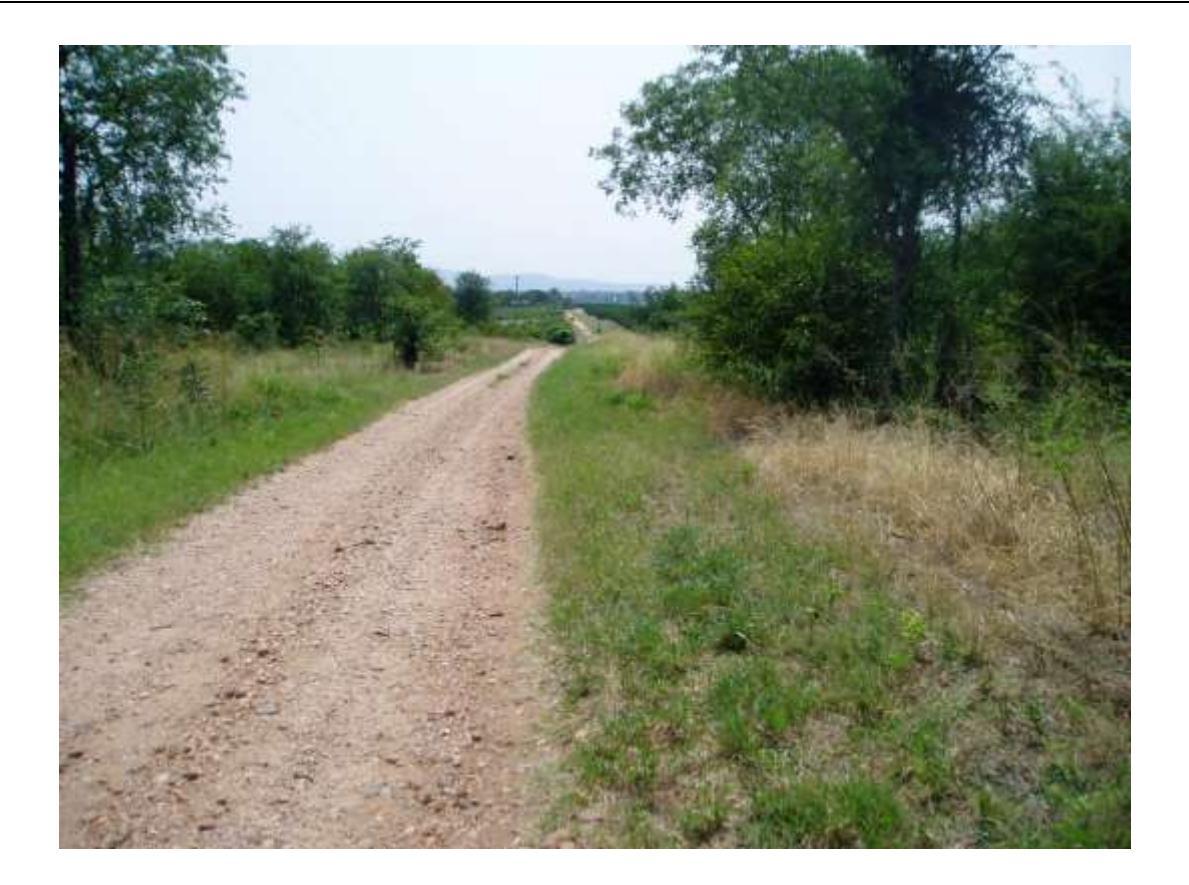
Plate 3 A general view of the upper right flank, viewed from the high point at approximate Chainage 3000 (m) looking towards the saddle in the middle distance and the local topographic high at Chainage 2200.

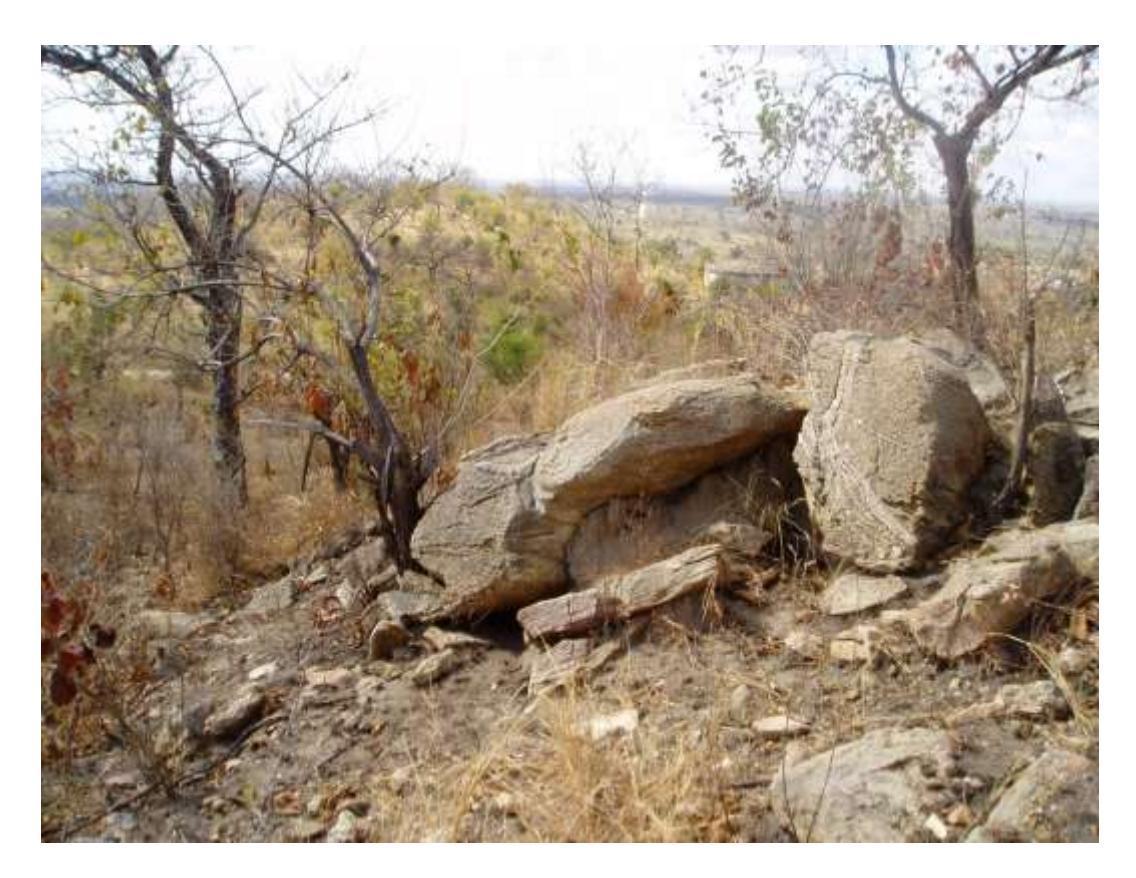
Plate 4 A general view of Potential Quarry Site A, illustrating scattered outcrop. A concrete reservoir may be discerned in the distance

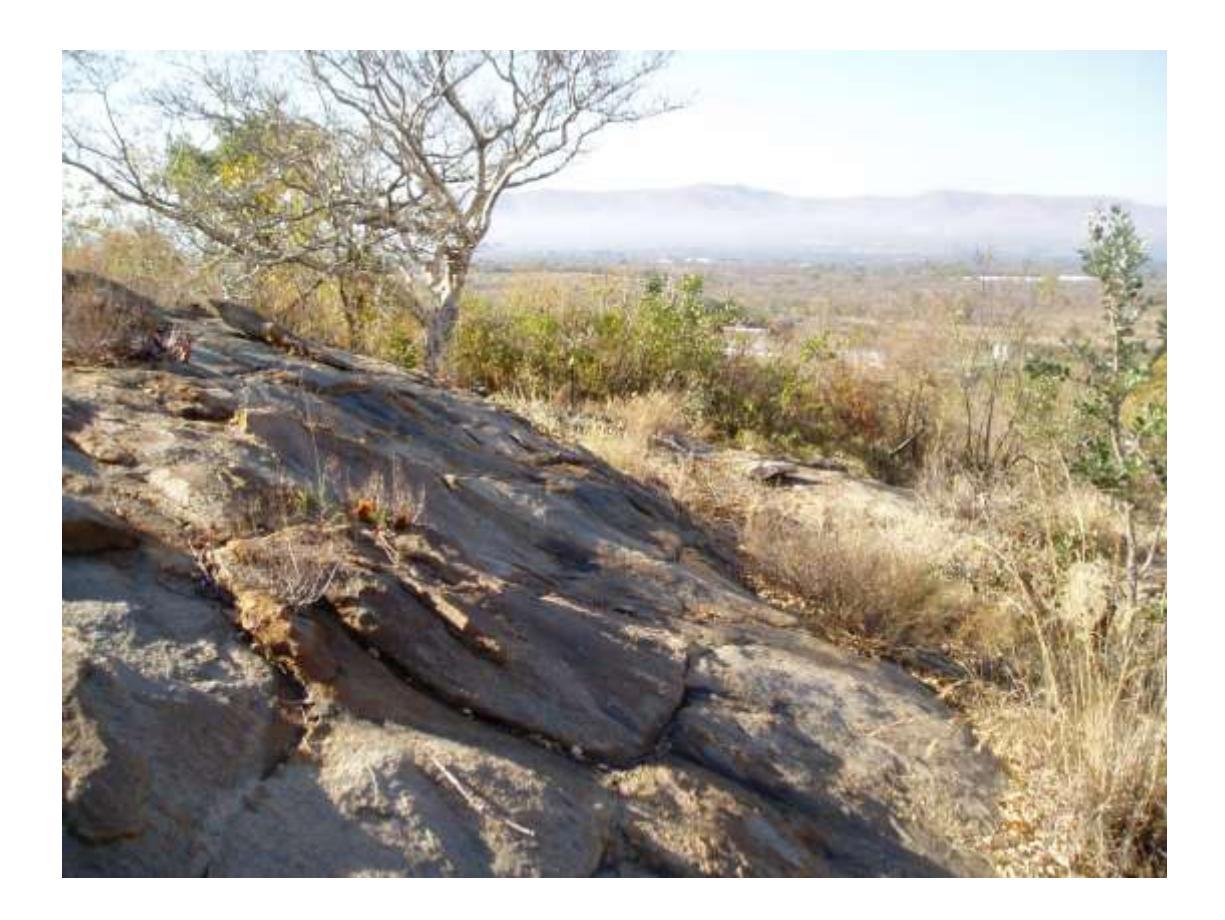
Plate 5 A view of the granite outcrop at Potential Quarry Site B

The site comprises a series of koppies where outcrop of massive, slightly to moderately weathered, hard rock granite gneiss is noted (**Plate 5**). The site is located relatively close to the main R71 road, and a chicken farm is located at the foot of the koppie slopes, on the original farm known as Portion 57 California 507. A minor road cutting on the R71 which has been blasted through the unweathered granite gneiss provides an indication
