**PRE-FEASIBILITY AND FEASIBILITY STUDIES FOR AUGMENTATION
OF THE WESTERN CAPE WATER SUPPLY SYSTEM BY MEANS OF
FURTHER SURFACE WATER DEVELOPMENTS**

**REPORT No.1 – VOLUME 1
Riverine Environmental Water Requirements**

APPENDIX No.5

Habitat Integrity – Breede River

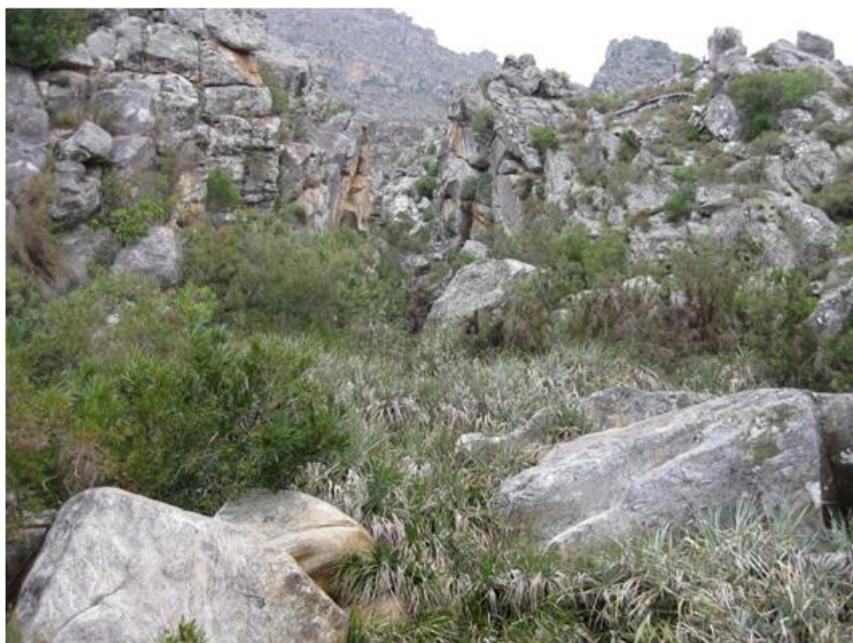
A bedrock/boulder bed mountain stream with a limited sand bedload component. Bedrock riffles and rapids with pools dominate the morphology. Palmiet in-channel and *Podocarpus* (yellowwood) along the bank were the common riparian plants (Figure 3.2). This morphology is insensitive to flow modification. The catchment was largely pristine and the geomorphology was estimated in an A or A/B category.

Figure 3.2 Niv1: Koekedou River

The overall condition of the site was Category C (Table 3.4).

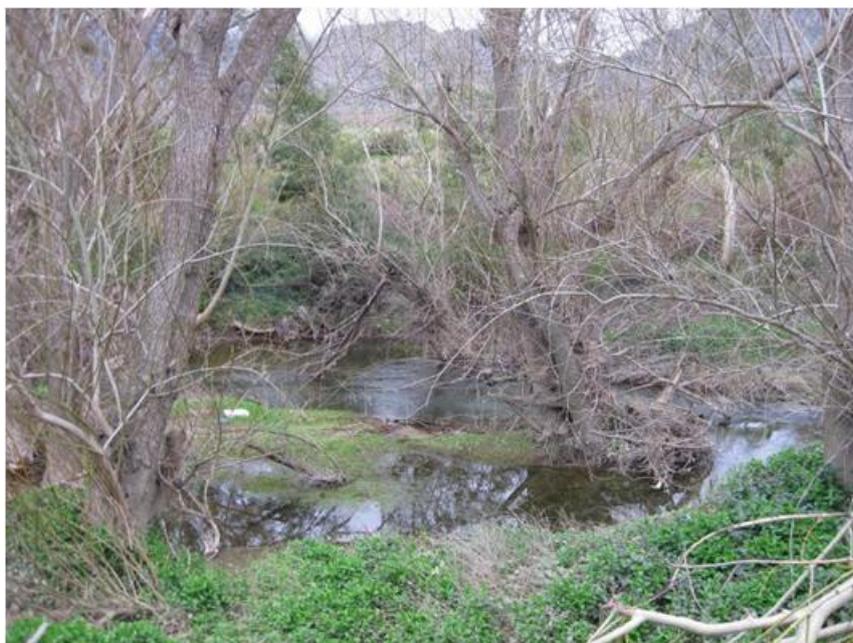
The channel was highly incised as a result of extensive engineering and channelisation along the banks. The reach was a single thread channel with bed and banks composed of fine silts and sands (Figure 3.3), but the reference condition was probably multiple channels across the floodplain with a coarser sediment load. There was also extensive invasion by exotic vegetation (including willows, **Eucalyptus*, black wattle and Spanish reed), which bears testimony to the extent of past disturbance. The geomorphology was estimated to be an E category.

Figure 3.3 Niv2: Dwars River

The overall condition of the site was Category D (Table 3.8)

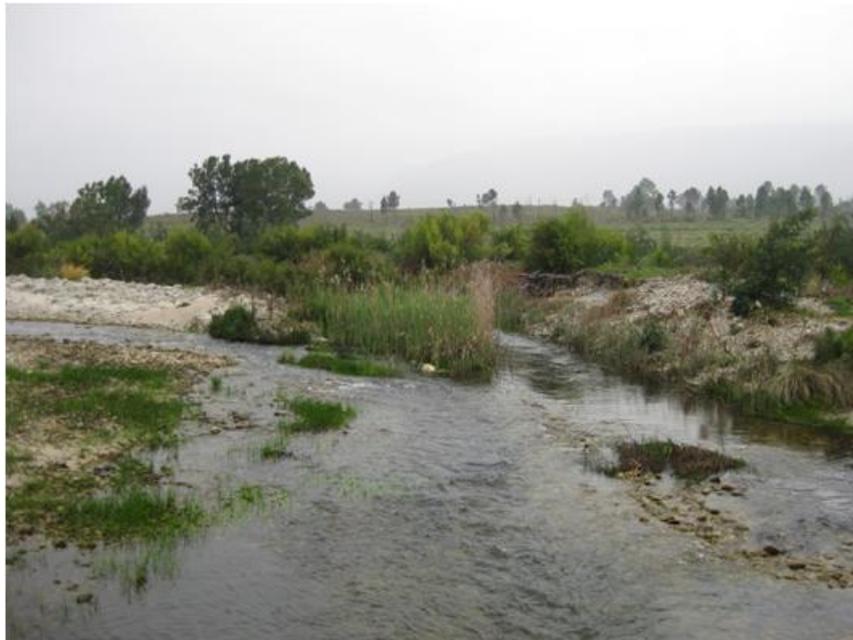
Niv 3 had a similar landscape setting to Niv 2: Dwars River but was in much better condition (Figure 3.4). The geomorphology was estimated to be in a C/D category. The mixed sand and cobble bed river with braid bars, riffles and runs were less confined than in the Dwars River, and there were some remaining near-natural sections in the reach. Large reedbeds were found along the marginal zone, and in some places the incising active channel had exposed peat deposits. These impacts were however localised and on a relatively small scale and much of the riparian wetland was intact. The odour and presence of algae at the site suggested poor water quality.

Figure 3.4 Niv3: Titus River

The overall condition of the site was Category D (Table 3.12)

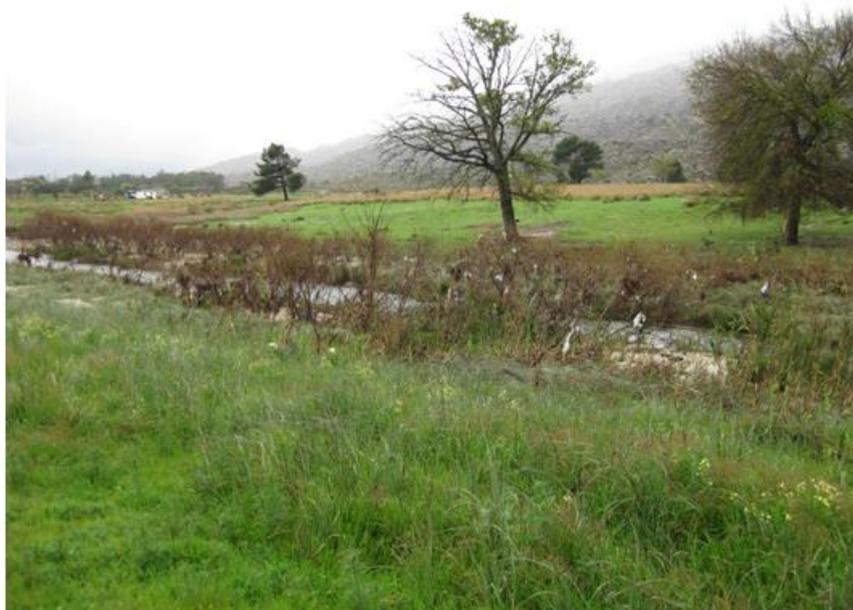
Further downstream the river was in a better condition. The alien trees had been removed, and there was a mobile cobble bed (although fines were still elevated – embeddedness was less marked). The geomorphology was in a C category.

Figure 3.5 Nvi4: Breede River, Ceres

The overall condition of the site was Category C (Table 3.16).

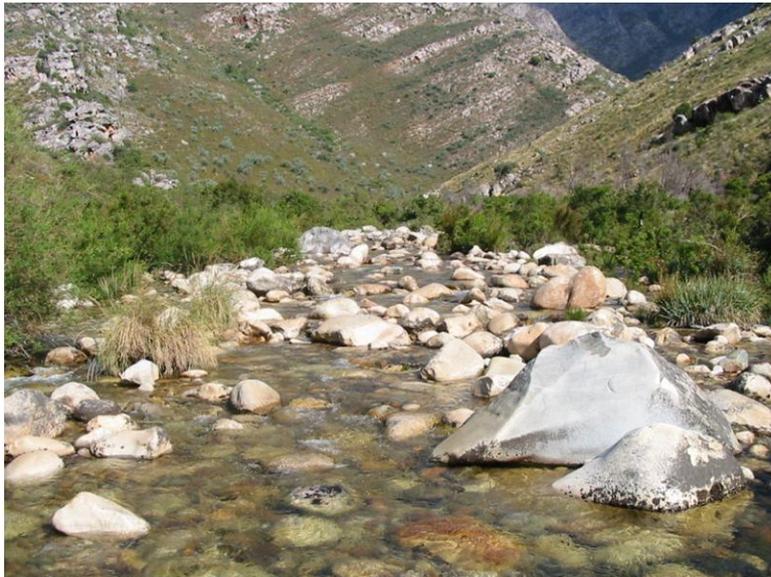
The river was undisturbed in this reach (Figure 3.7). The cobbles on the bed had some algae growth on them, but the geomorphology was considered to be in an A/B condition.

Figure 3.7 Niv4: Witels River

The overall condition of the site was Category B (Table 3.21).

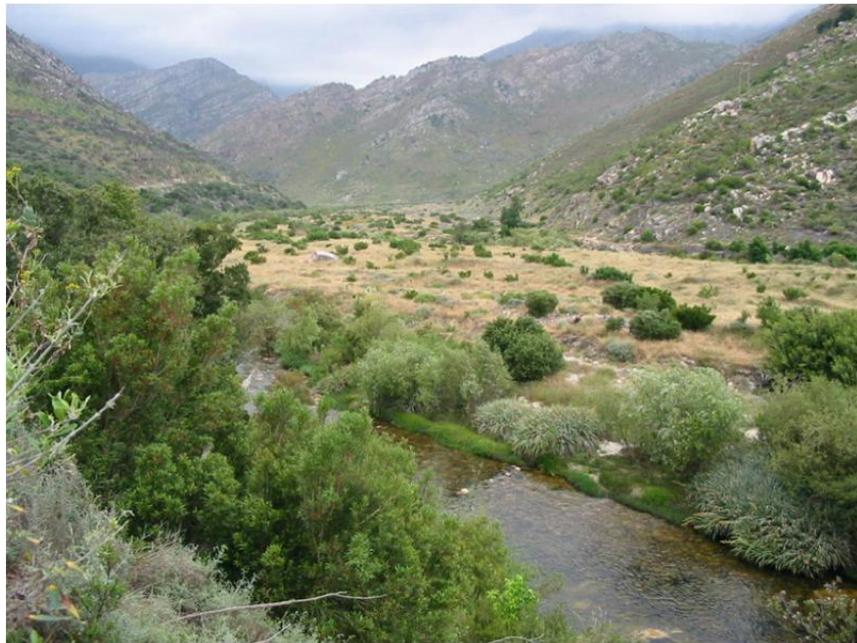
The river flowed naturally alongside a small floodplain. The upper channel banks were intact and floods could have overtopped and inundated the floodplain and upper terraces. There was a mobile cobble bed with some algal growth.

Figure 3.8 Nvi3: Breede River, Mitchells Pass/R43

The overall condition of the site was Category C (Table 3.25)

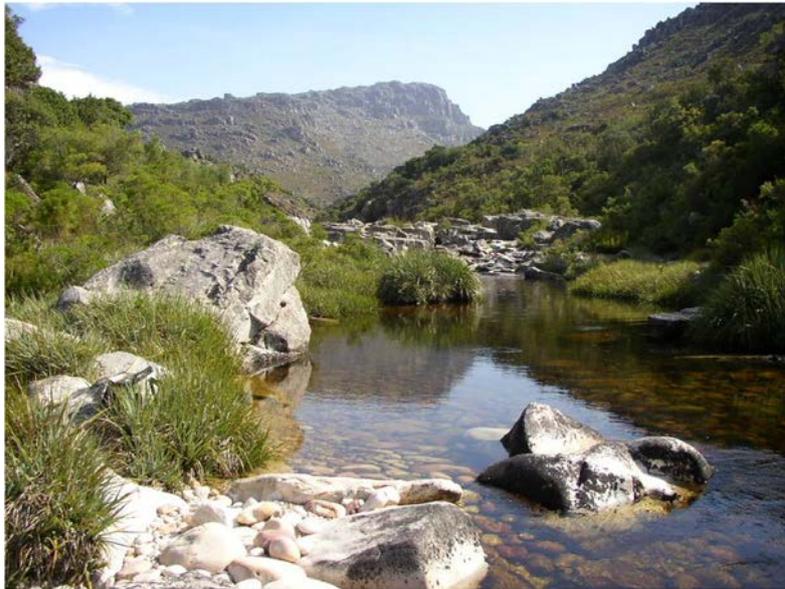
This node is situated at Tweede Tol on the Witte River. The upper reaches of the Witte River flow through a protected area and are relatively undisturbed (Figure 3.9). Downstream of Tweede Tol, however, conditions in the river drop, mainly as a result of past and present invasion of **Acacia* spp. and are similar to that of Nviii1 (section 3.2.4).

Figure 3.9 Nvi2: Witte River

At the node, the geomorphology was in a B category. The riparian vegetation was also in relatively natural condition (Table 3.26), and the macroinvertebrate habitat was varied (Table 3.27).

The overall condition of the site was Category B (Table 3.28).

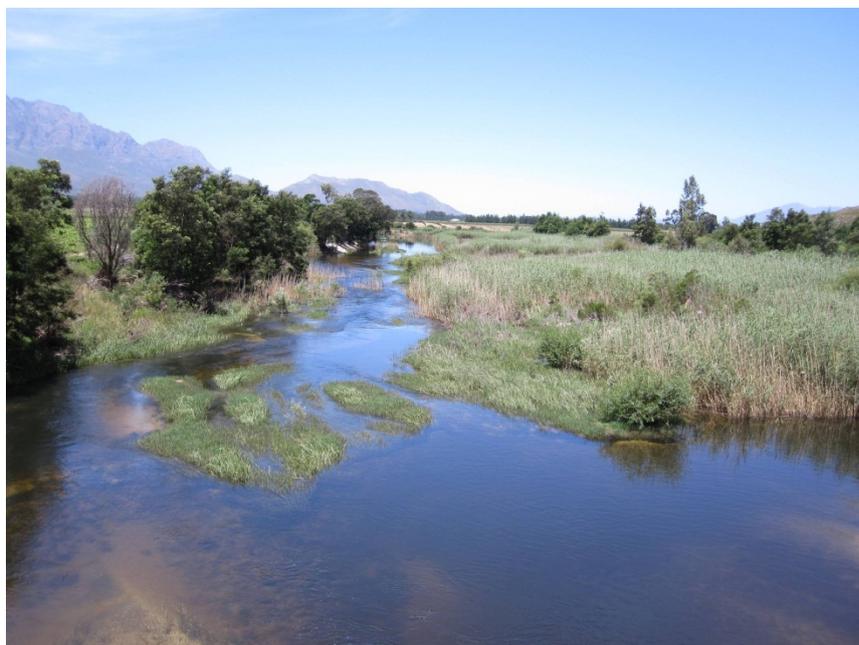
This reach was characterised by a mobile cobble bed with sand. The channel had been infilled and narrowed, and farming occurred over much of the floodplain. Although the reference condition was likely to have been braided, the channel was a single thread, and large *Phragmites* beds that might have been expected had been narrowed due to infilling and bank stabilisation (Figure 3.10). There was some artificial stabilising of the bank using large cobbles and boulders, but despite this, bed sediments were mobile and well sorted.

Figure 3.10 Nviii1: Breede River (IFR1: Witbrug)

There were few indigenous riparian vegetation species present. The wet bank was depauperate and the dry bank was either exotic species or was under cultivation (Table 3.29). The invertebrates were, however, in relatively good condition (Table 3.30)

The overall condition of the site was Category D (Table 3.31).

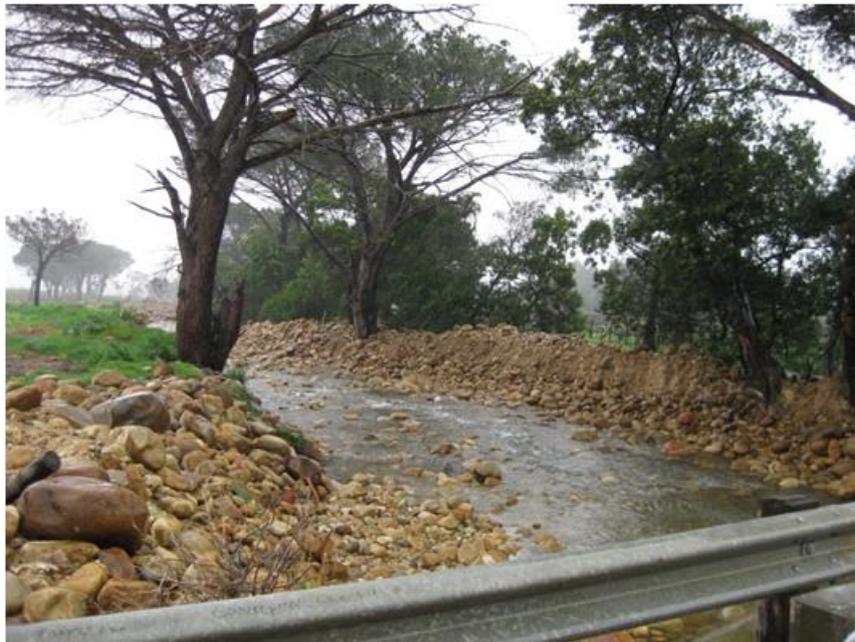
The node was situated in a severely degraded reach of the river. The channel had been dredged, channelized, straightened and the narrow banks armoured with cobbles and boulders, and extensive levees were created above this (Figure 3.11). Further downstream the condition was a little better, but there was dense alien invasion along the banks, levees had been constructed and the floodplain had been infilled. The geomorphology was estimated to be in a D/E category.

Figure 3.11 Niv6: Wabooms River

The overall condition of the site was Category D (Table 3.35).

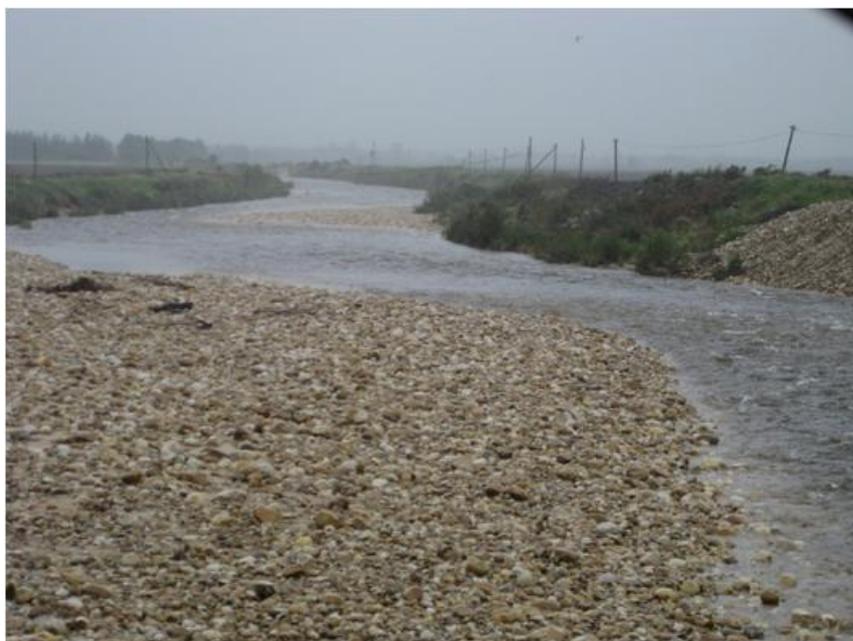
The node is situated in a severely degraded reach of the Slanghoek River (Figure 3.12). The channel was heavily engineered and infilling and levees had all but destroyed the riparian zone. Cobbles and sand dominate the active channel bed, but these were not well sorted, and the excessive fine sediment load had smothered interstitial spaces. The geomorphological condition was estimated to be in an E or E/F category.

Figure 3.12 Niv7: Slanghoek River

The overall condition of the site was Category D (Table 3.39).

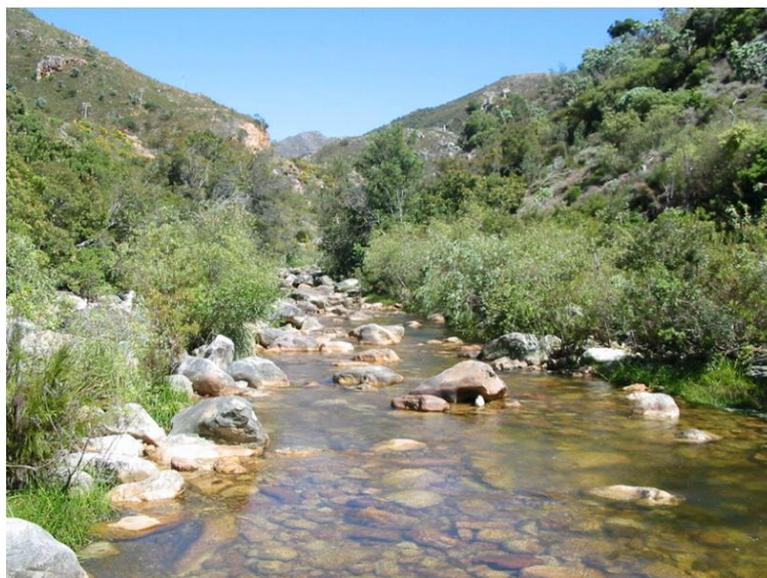
Geomorphic impacts were limited (Figure 3.13). The riparian vegetation was mature and lush (Table 3.40) along the boulder/bedrock reach, and in-channel sediment appeared to be well sorted. There were a few scattered exotic woody trees. The macroinvertebrate communities were also in good condition (Table 3.41 and Table 3.42).

Figure 3.13 Niv41: Krom River

The overall condition of the site was Category B (Table 3.43).

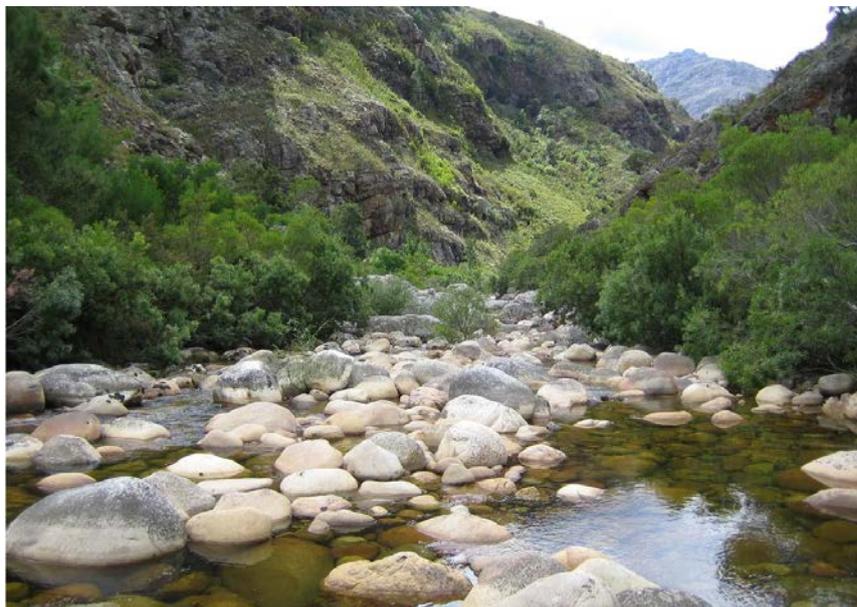
The node is situated upstream of the Huguenot Tunnel and the confluence with the Smallblaar River (Figure 3.14). This cobble/boulder bed river was estimated to be in an A/B category. The riparian vegetation was in near natural condition (Table 3.44), but the macroinvertebrates showed some sign of water quality impacts (Table 3.45).

Figure 3.14 Niv40: Elands River

The overall condition of the site was Category B (Table 3.46).

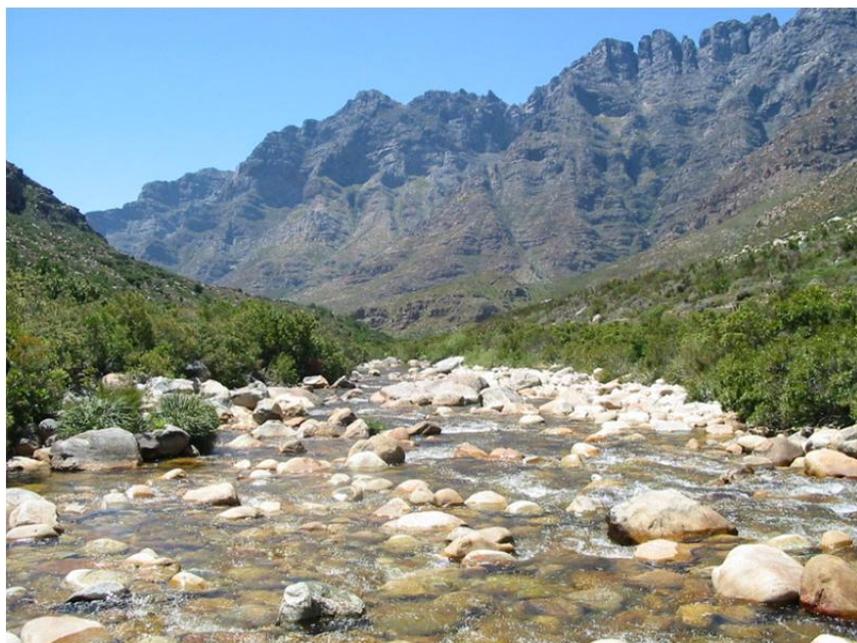
There was some, limited, infilling where the N1 abuts the river. The channel was meandering channel and associated with lateral bars and floodplain pockets. Cobble and boulders dominated the riverbed (Figure 3.15). The geomorphological condition was estimated to be in an A/B category. Indigenous vegetation had not yet fully re-established in the areas that had been cleared of invasive vegetation (This reach was cleared of black wattle (*Acacia mearnsii*) approximately 20 years ago). The riparian scrub community was well established but the slower-growing trees, which were present upstream, were not yet present (Table 3.47). The macroinvertebrate community was in good condition (Table 3.48 and Table 3.49).

Figure 3.15 Nvii2: Molenaars River (IFR2)

The overall condition of the site was Category B (Table 3.50).

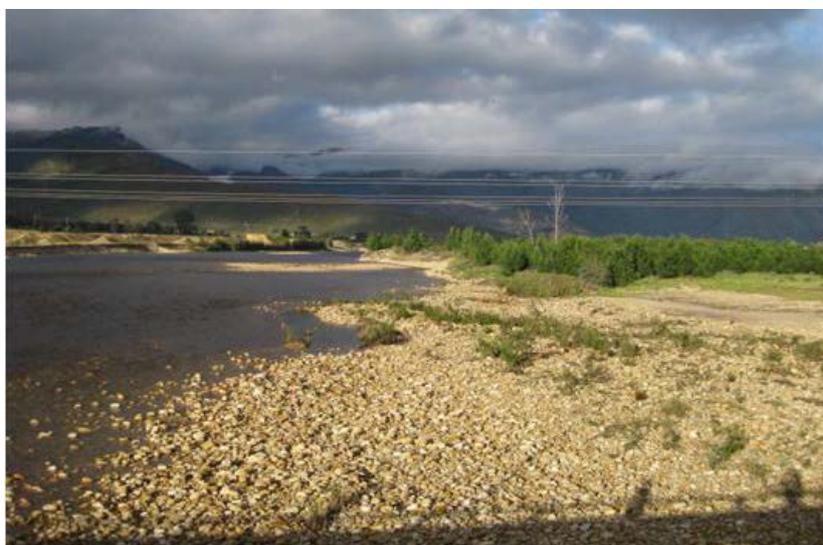
The node is situated at the bridge south-west of Rawsonville. The condition of the Molenaars River dropped suddenly and significantly as it leaves Du Toit's Kloof. In this reach, the bulk of the extensive floodplain was under vineyard cultivation, and the channel had been dredged, mined and channelised, with levees (Figure 3.17). Most of the riparian vegetation had been cleared for farming activities and cultivated fields abutted onto the macro-channel bank edge (Table 3.52). There was considerable disturbance to the inchannel habitats due to sand mining and dredging, the macroinvertebrate community varied (Table 3.53).

Figure 3.17 Niv42: Molenaars (Smalblaar) River

The overall condition of the site was Category D (Table 3.54).

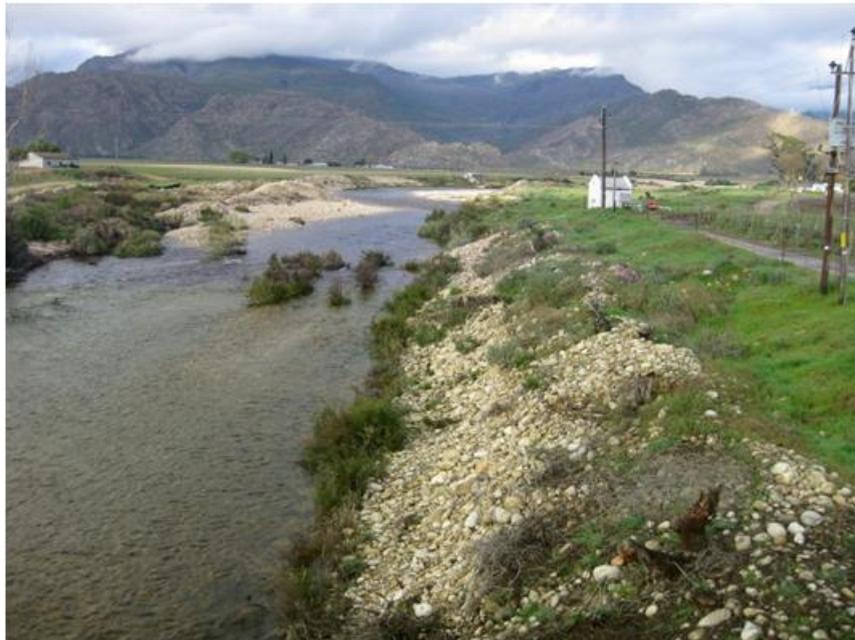
The node is located in the lower part of the Holsloot River, where the floodplain has been cultivated and the river channelised (Figure 3.18). The riparian vegetation had been clear felled (Table 3.55). In the upper portions of the river where the valley was narrower, the riparian vegetation was in considerably better condition. There was considerable disturbance to the inchannel habitats due to sand mining and dredging, the macroinvertebrate community varied (Table 3.56).

Figure 3.18 Niv12: Holsloot River

The overall condition of the site was Category D (Table 3.57).

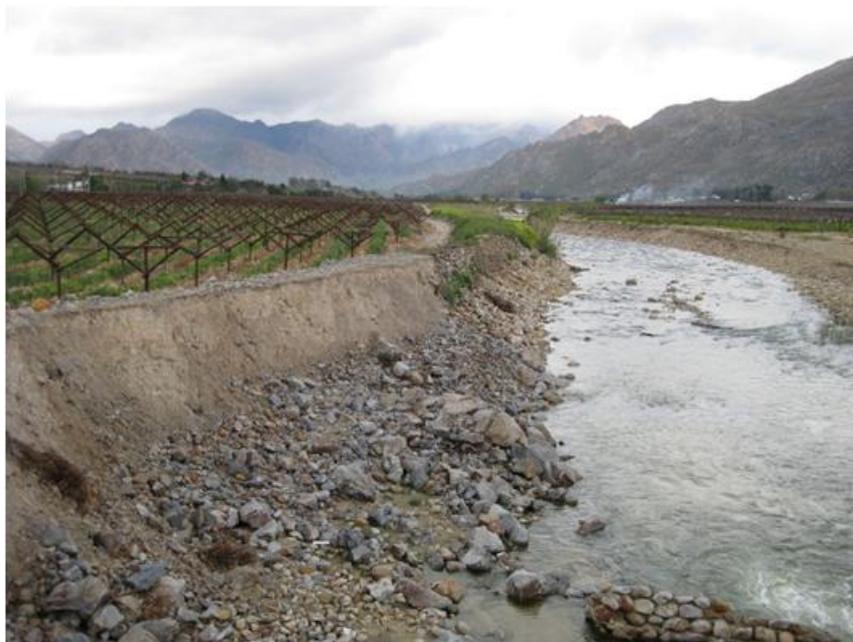
This reach was highly degraded. Levees and drains across the floodplains protected orchards, and in many places infilling had removed the riparian and marginal zones (Figure 3.19). Where fringe vegetation along the channel existed it was heavily invaded by exotic species. The channel had a high fines load due to the eroding banks and infilled material, and the channel was essentially a dredged stormwater conduit. Geomorphology condition was estimated to be an E category.

Figure 3.19 *Nvii7: Upper Hex River*

The overall condition of the site was Category D (Table 3.61).

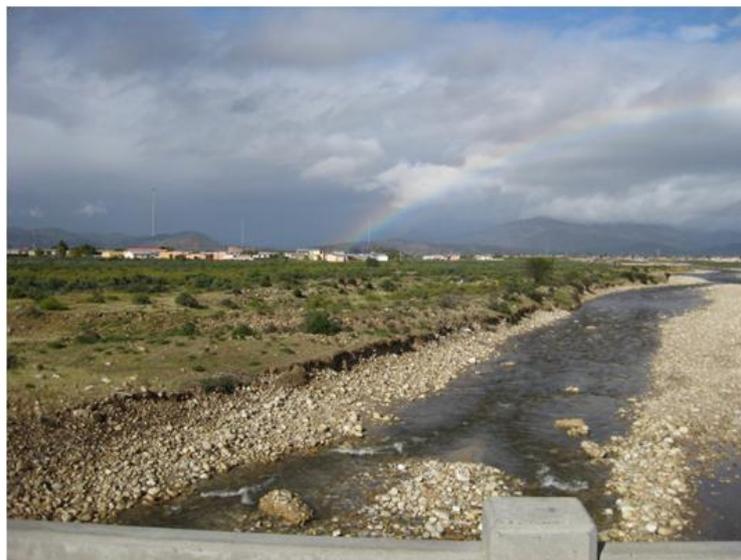
The lower reaches of the Hex River were in better condition than the upper reaches. A wide, braided, unconfined channel existed in many places, with multiple channels allowing for good sediment sorting and high instream habitat diversity, including backwaters (Figure 3.20).

Figure 3.20 Niv10: Lower Hex River

The overall condition of the site was Category D (Table 3.64).

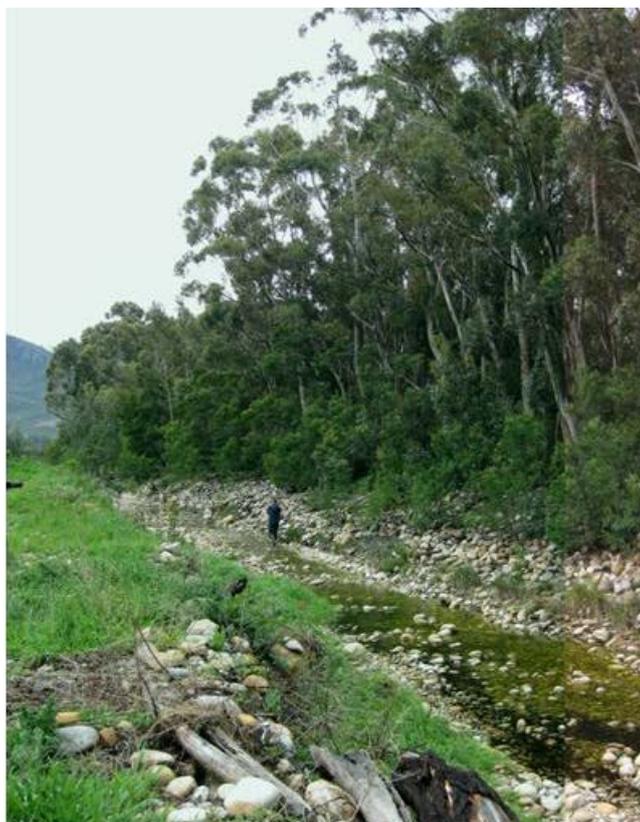
The banks were either cultivated, with orchards or vineyards, or heavily invaded with woody exotics. There was some indigenous vegetation on the channel fringe in parts but the wet bank was not present (Table 3.65). The macroinvertebrates were poor (Table 3.66).

Figure 3.21 Niv8: Bothaspruit

The overall condition of the site was Category D (Table 3.67).

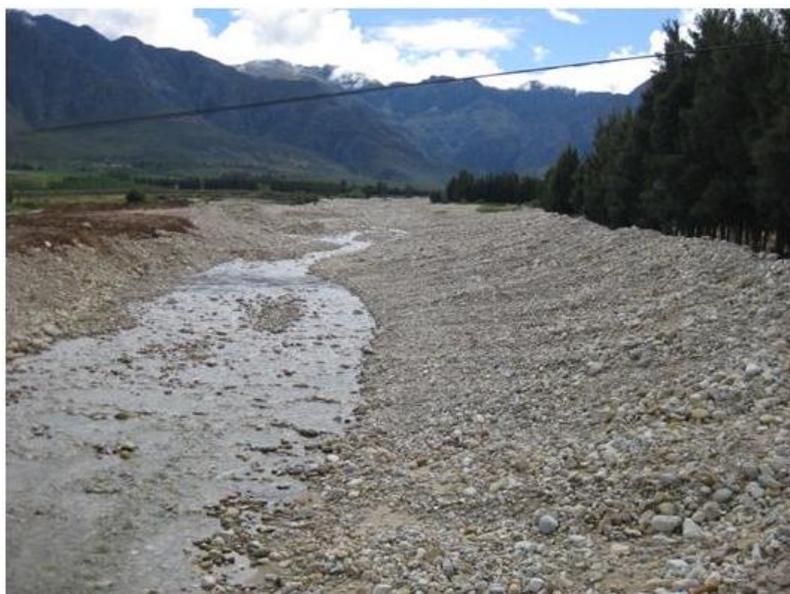
The bed and banks were graded (Figure 3.22). The bed was highly mobile, but there were no pools or sorted material in the channel due to landscaping/bulldozing activities. Geomorphological condition was estimated to be in an E/F category in the upper reaches where these activities were most pronounced. Further downstream in this reach the impacts were less severe and this was estimated to be in a D category. Throughout there was a high fines load resulting from erosion of the banks. Ongoing sand mining operations had armoured the flood terraces through deposition of the cobbles. There was little indigenous riparian vegetation present. The majority had been cleared for agriculture. The banks were completely clear of vegetation (Table 3.68). The macroinvertebrates were poor (Table 3.70 and Table 3.71).

Figure 3.22 Niv9: Lower Hartbees River

The overall condition of the site was Category E (Table 3.71).

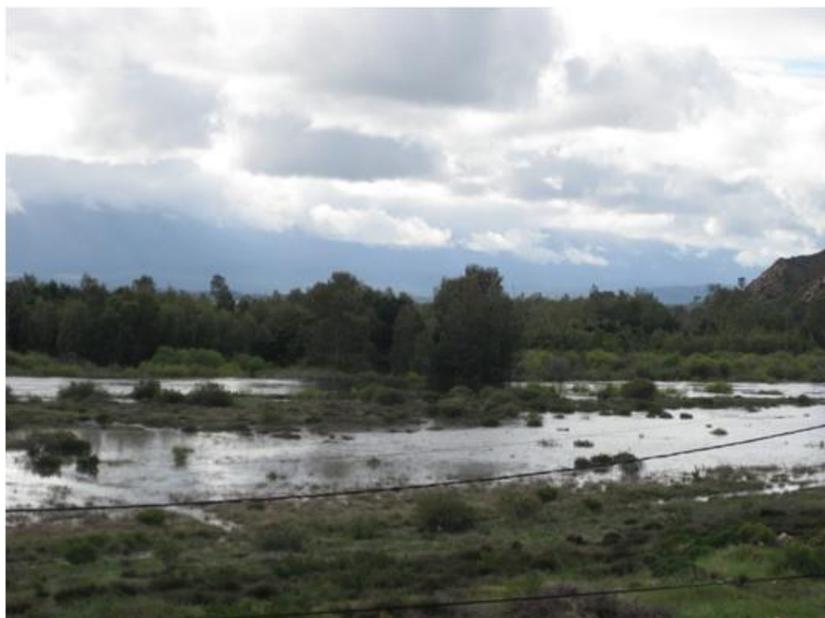
This is a wetland site. The main channel of the Breede River flows to the north of the Papenkuils Wetland, which is a large riparian floodplain (Figure 3.23). The channel is somewhat incised, and there are levees in place that prevent flooding into Papenkuils.

Figure 3.23 Nv3: Breede River (6)

The overall condition of the site was Category C (Table 3.74).

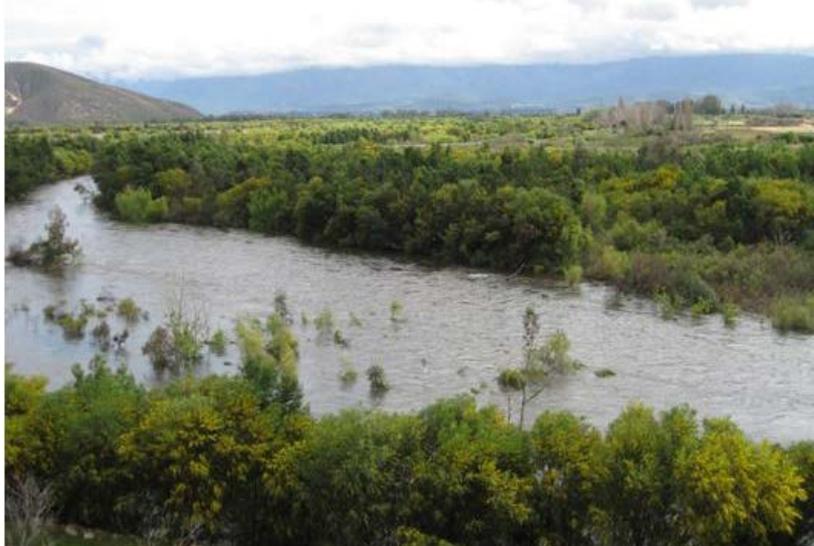
The width of the floodplain is less downstream of Papenkuils and the main channel was lined with woody exotics (Figure 3.24), and the floodplain was cleared for agriculture (Table 3.75). The macroinvertebrate communities were fair (Table 3.76).

Figure 3.24 Nii1: Breede River, d/s of Papenkuils

The overall condition of the site was Category C (Table 3.77).

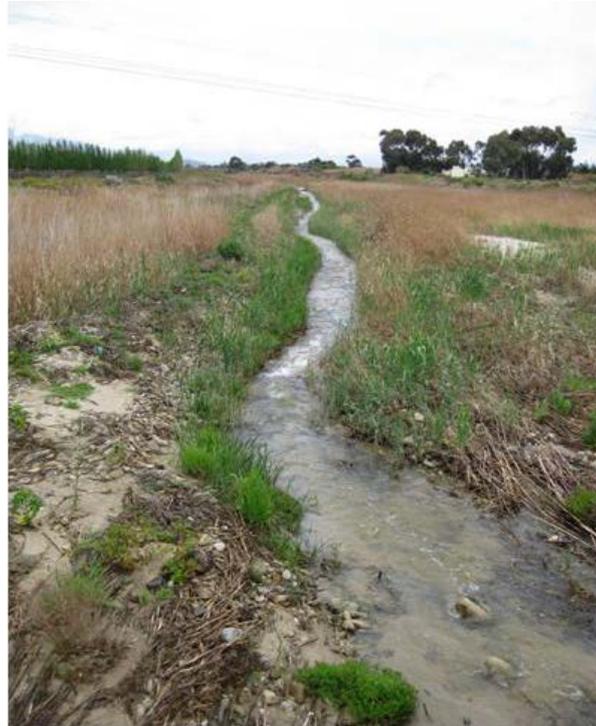
This river had been dredged and straightened in places, and a centre line had been dug in others (naturally this section would probably have been an unchannelled wetland), but there were no levees and the river was still connected to its floodplain (Figure 3.25). There was a high suspended/fine sediment load, the source of which was not known, but could have indicated an incising/eroding section of wetland upstream.

Figure 3.25 Niv11: Nuy River

The overall condition of the site was Category C (Table 3.81).

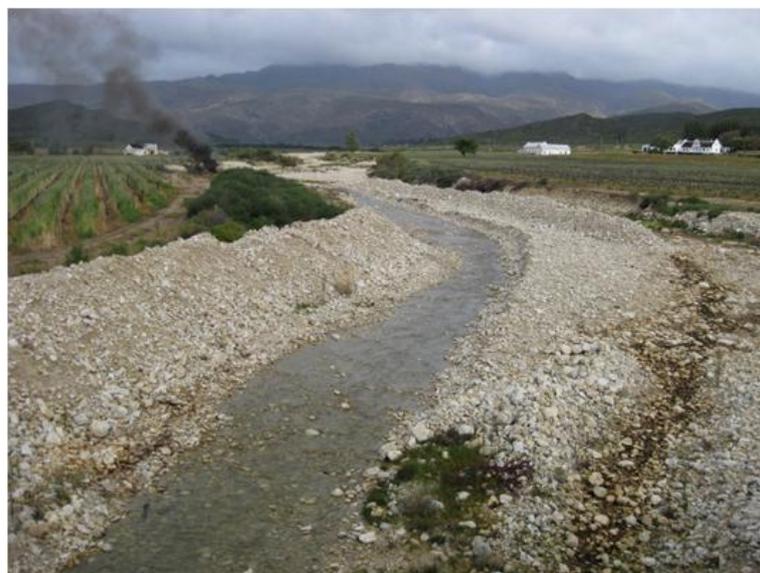
This reach was highly disturbed. The floodplain had been infilled; the river dredged; the riparian zones infilled and/or burnt; large levees constructed along the active channel and all connection with the floodplain had been severed (Figure 3.26). The river channel had been reduced by more than 50% in width, with further reductions still being engineered at the time of the site visit. As a result, riparian vegetation was virtually non-existent (Table 3.82). The macroinvertebrate communities were poor (Table 3.83).

Figure 3.26 Niv13: Doring River

The overall condition of the site was Category E (Table 3.84).

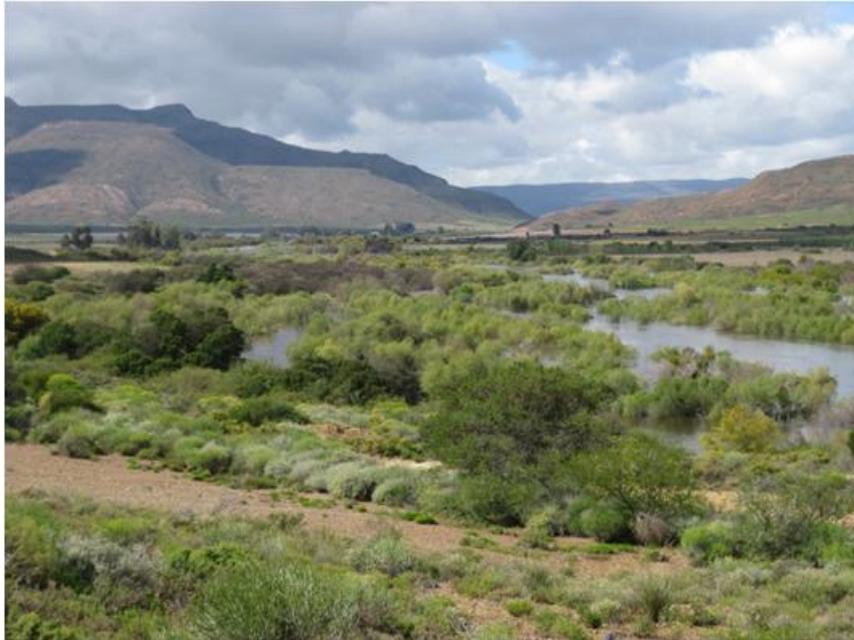
The river flowed through a wide, well-vegetated floodplain (Figure 3.28). There were mid-channel bars and the riparian vegetation was intact on both banks. Though the river flows through farmland, cultivation of the floodplain was not intensive (Table 3.86). The macroinvertebrates were in good condition (Table 3.87).

Figure 3.28 Nvii8: Breede River, Le Chasseur (IFR3)

The overall condition of the site was Category C (Table 3.88).

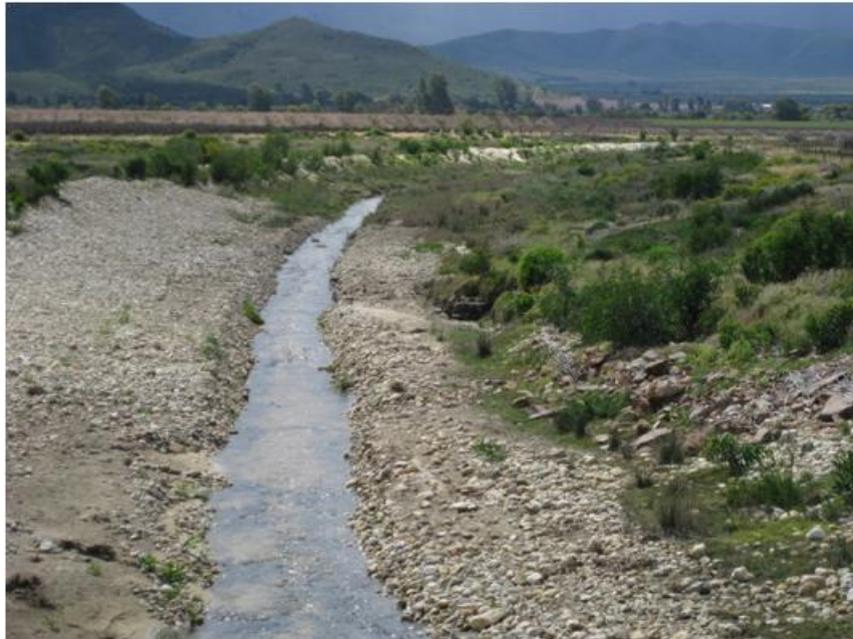
The river channel was heavily modified, cleared of vegetation and dredged. There was little indigenous vegetation present and the floodplain was cultivated on both banks (Figure 3.29; Table 3.89). The macroinvertebrates were poor (Table 3.90).

Figure 3.29 Niv14: Keisers River

The overall condition of the site was Category E (Table 3.91).

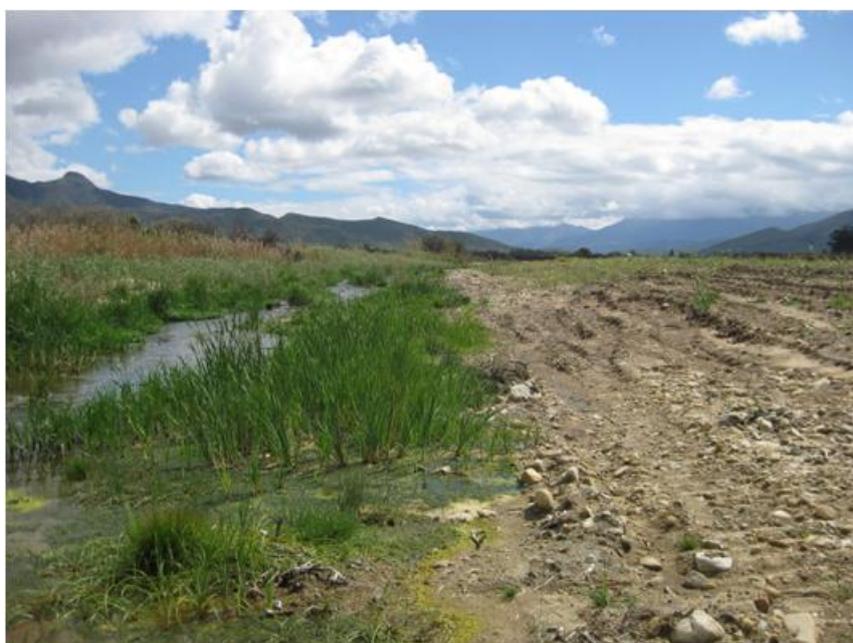
The river was heavily dredged and the riparian vegetation had been removed (Figure 3.30; Table 3.92). There was an excessive sediment load, the source of which was not clear. The presence of algal blooms indicated elevated nutrient levels. The macroinvertebrates were depauperate (Table 3.93 and Table 3.94).

Figure 3.30 Niv15: Vink River

The overall condition of the site was Category E (Table 3.95).

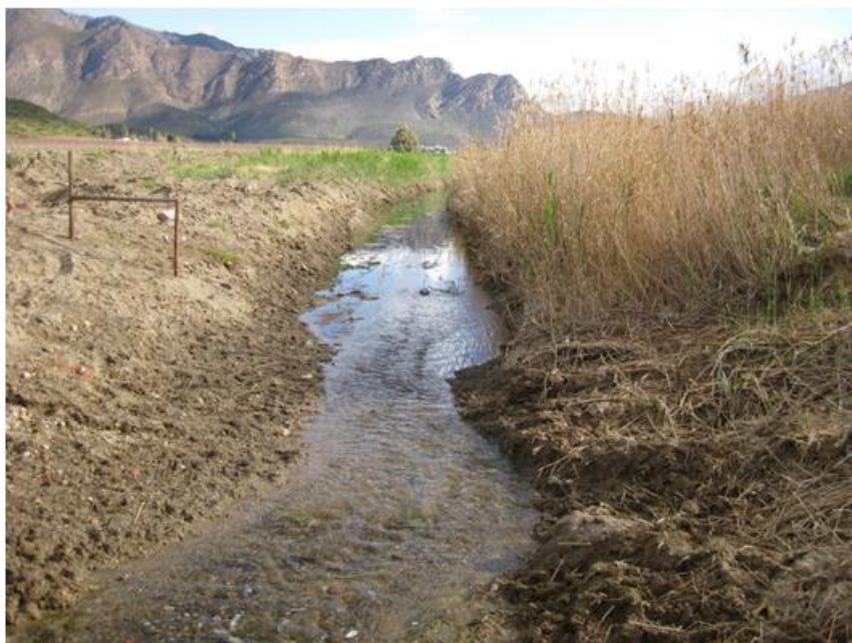
The river was dredging and the riparian area had been cleared (Figure 3.31). There was an excessive load of sediment in the channel, the source of which was unknown. There was sparse vegetation present (Table 3.96) and the macroinvertebrates were depauperate (Table 3.97).

Figure 3.31 Niv20: Pietersfontein River

The overall condition of the site was Category E (Table 3.98).

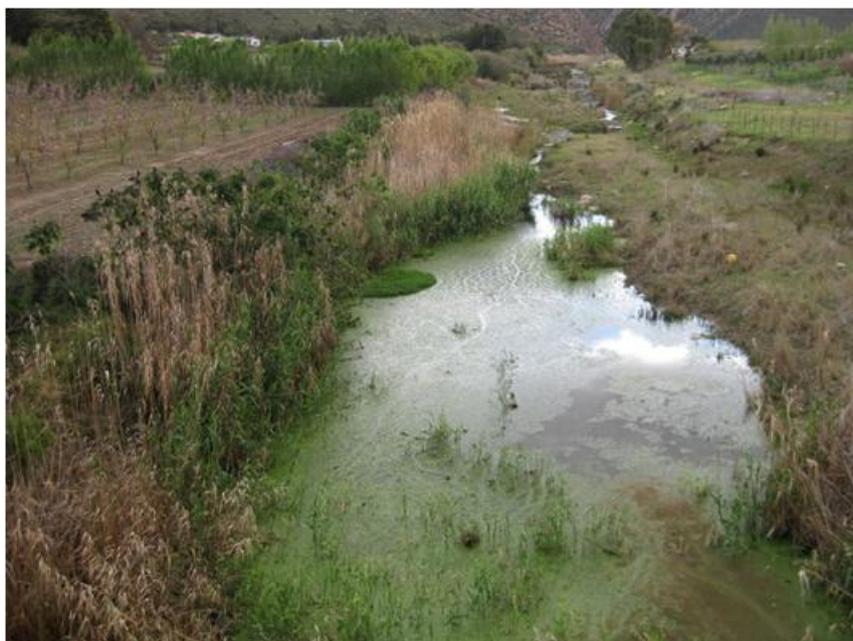
The river was heavily modified due by dredging and clearing of the riparian area (Figure 3.32). The banks were steep and eroding in places. There were algal blooms indicating an excess of nutrients. Stock access paths were present. The exotic floating water fern, *Azolla filliculoides*, was found in the aquatic zone (Table 3.99). The macroinvertebrates were poor (Table 3.100).

Figure 3.32 Niv18: Kingna River

The overall condition of the site was Category E (Table 3.101).

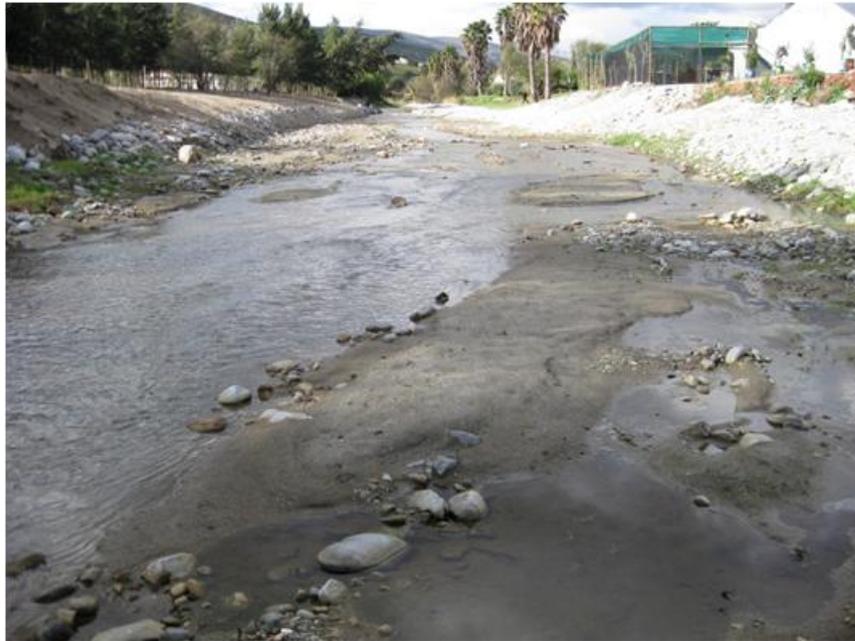
The river was channelized through the town of Montagu (Figure 3.33). The channel was dredged and the riparian vegetation had been cleared (Table 3.102). There was an excessive load of sediment in the channel, the source of which was not clear. The exotic aquatic water fern, *Azolla filliculoides*, was present in the aquatic zone. The macroinvertebrates were depauperate (Table 3.103 and Table 3.104).

Figure 3.33 Nvii9: Keisie River

The overall condition of the site was Category E (Table 3.105).

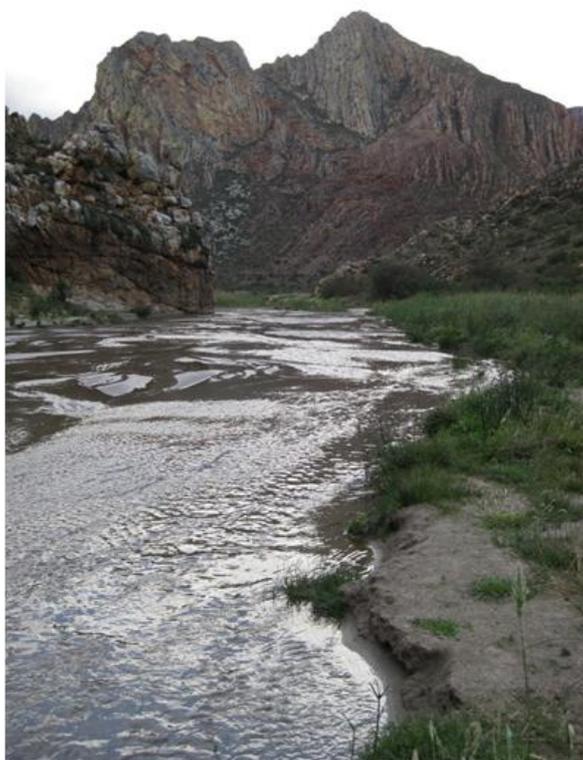
The river was heavily modified from dredging and clearing of the riparian vegetation (Figure 3.34; Table 3.106). There was an excessive load of sediment in the channel, the source of which is not clear. The aquatic water fern, *Azolla filliculoides*, was found in patches at the channel edge. The macroinvertebrates were poor (Table 3.107, Table 3.108).

Figure 3.34 Nii2: Kogmanskloof River

The overall condition of the site was Category D (Table 3.109).

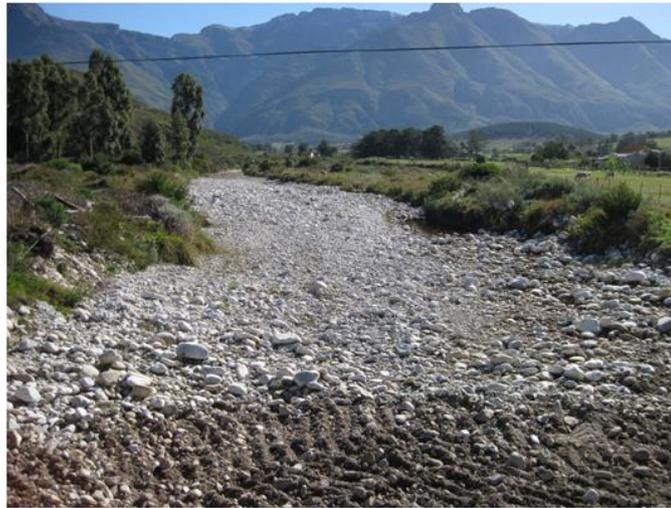
The river was heavily modified by dredging and clearing of the riparian zone and over-abstraction (Figure 3.35; Table 3.110). There was no flow at the time of the site assessment and it was not possible to sample macroinvertebrates (Table 3.111).

Figure 3.35 Niv24: Klip River

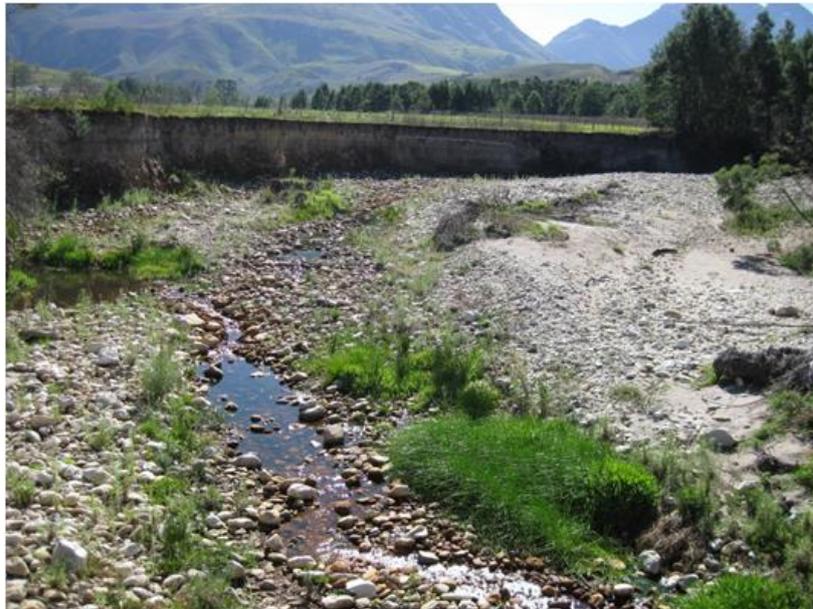
The river was heavily modified by dredging, clearing of the riparian zone and over-abstraction (Figure 3.36; Table 3.113). There was little flow at the time of the site assessment. The macroinvertebrates were poor (Table 3.114 and Table 3.115).

Figure 3.36 Niv24: Leeu River

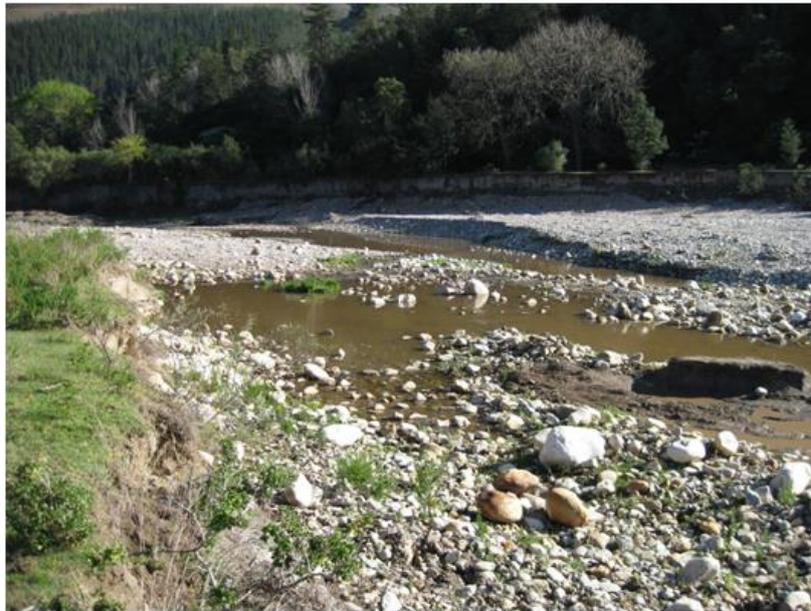
The river was heavily modified by dredging and clearing of the riparian zone and over-abstraction (Figure 3.37; Table 3.117). There was little flow at the time of the site assessment (Table 3.118). The macroinvertebrates were poor (Table 3.119).

Figure 3.37 Nv14: Middle Buffeljags River
