Report No: P WMA 03/000/00/6923/5

CROCODILE EAST WATER PROJECT (CEWP) MODULE 1: TECHNICAL FEASIBILITY STUDY

Pre-Feasibility Study: Geotechnical and Material Investigations Report

January 2024

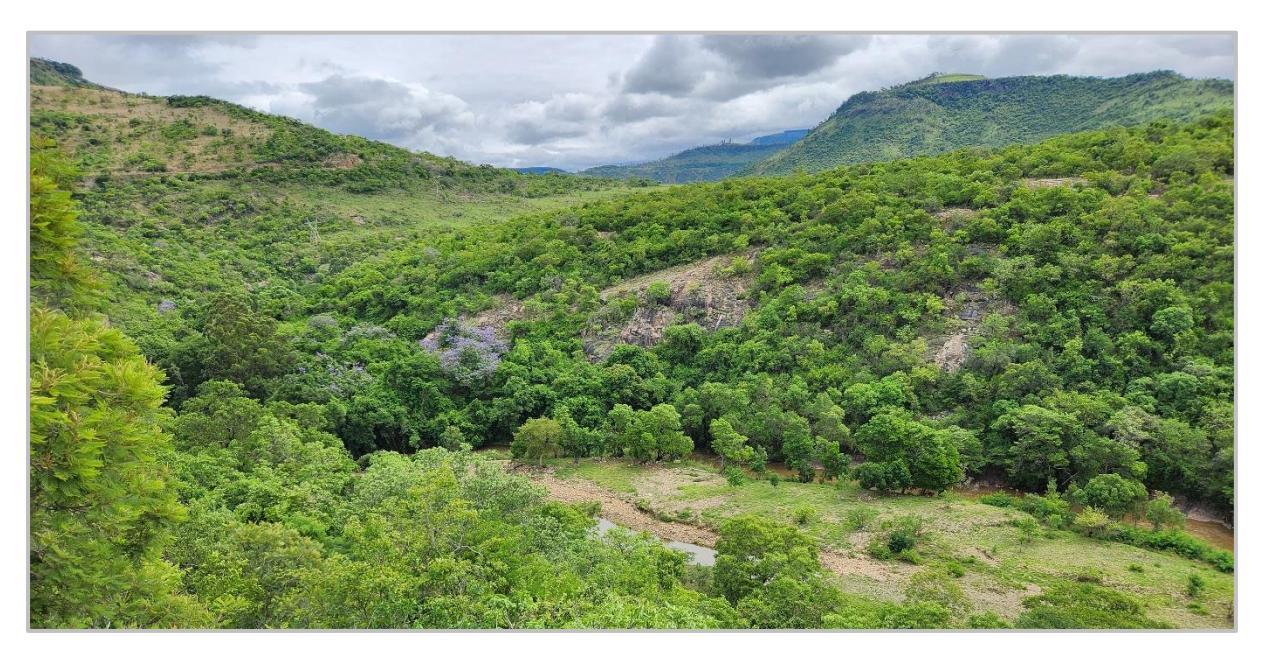
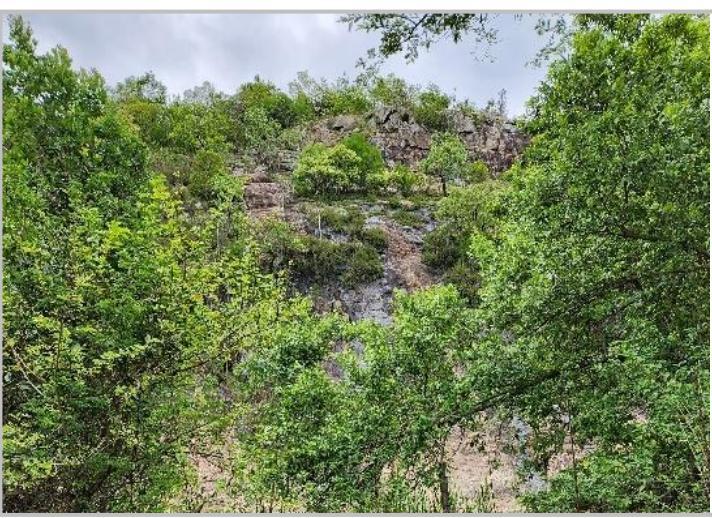
The dam site has an asymmetrical shape with the right flank significantly flatter than the left flank. Whilst vehicle access is possible from the right flank, the left flank access is difficult without any paths or tracks noticeable. It will be difficult to establish drilling equipment on the steep left flank. Widespread granite rock outcrops were however observed on the left flank.

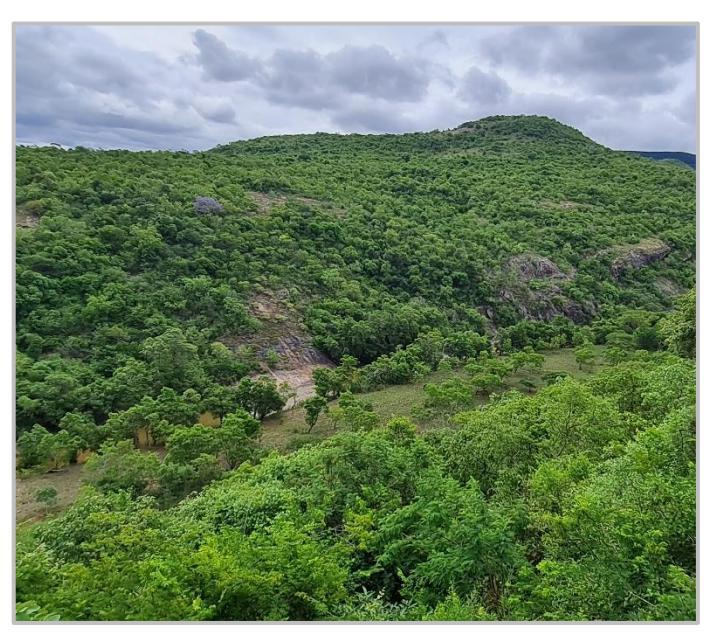
The right flank has scattered granite rock outcrops and the rock weathering profile is clearly very irregular. The river section comprises a wide (approximately 50 m) alluvial terrace on the right bank with no rock outcrops visible in the river channel and rest of the river section.

Engineering geological investigations at Montrose will have to comprise a combination of geophysical surveys (electric resistivity on the flanks and seismic refraction in the river section) before drilling be commenced. The main objective of the geophysical surveys would be to identify the best location for a dam site in terms of founding. Potentially suitable area for a rock quarry was identified on the right flank approximately 600 m downstream of the Elands River confluence.

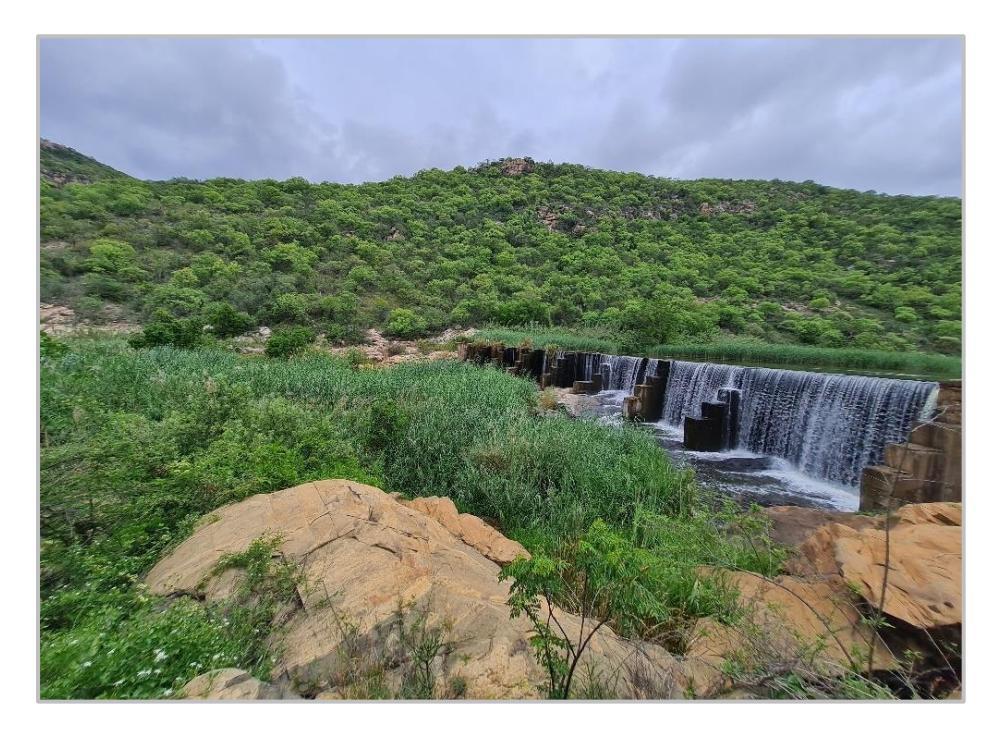
Water in the weir dams up within the river channel section for a distance of about 640 m where a very prominent granite rock outcrop forms an impressive continuous rock outcrop in the river section of approximately 250 m x 90 m, at the upstream end of the prominent gorge. Due to the presence of the weir and widespread water upstream of it, access for geophysical surveys and drilling operations is deemed very difficult.

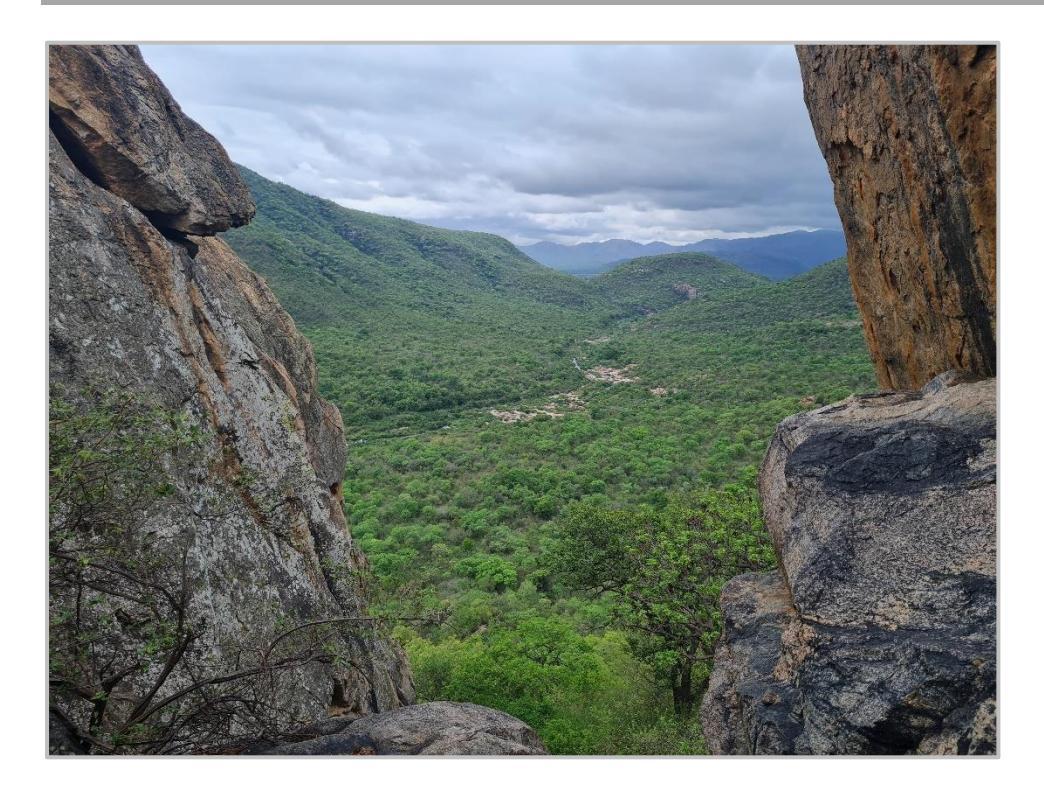
The right flank is very steep and characterised by virtually continuous rock outcrops, giving rise to near-vertical rock cliff faces in places. The closest existing farm track to the upper parts of the right flank is more than 1 km. The right flank is not accessible for geophysical surveys except at the upper portions. The same goes for drilling.

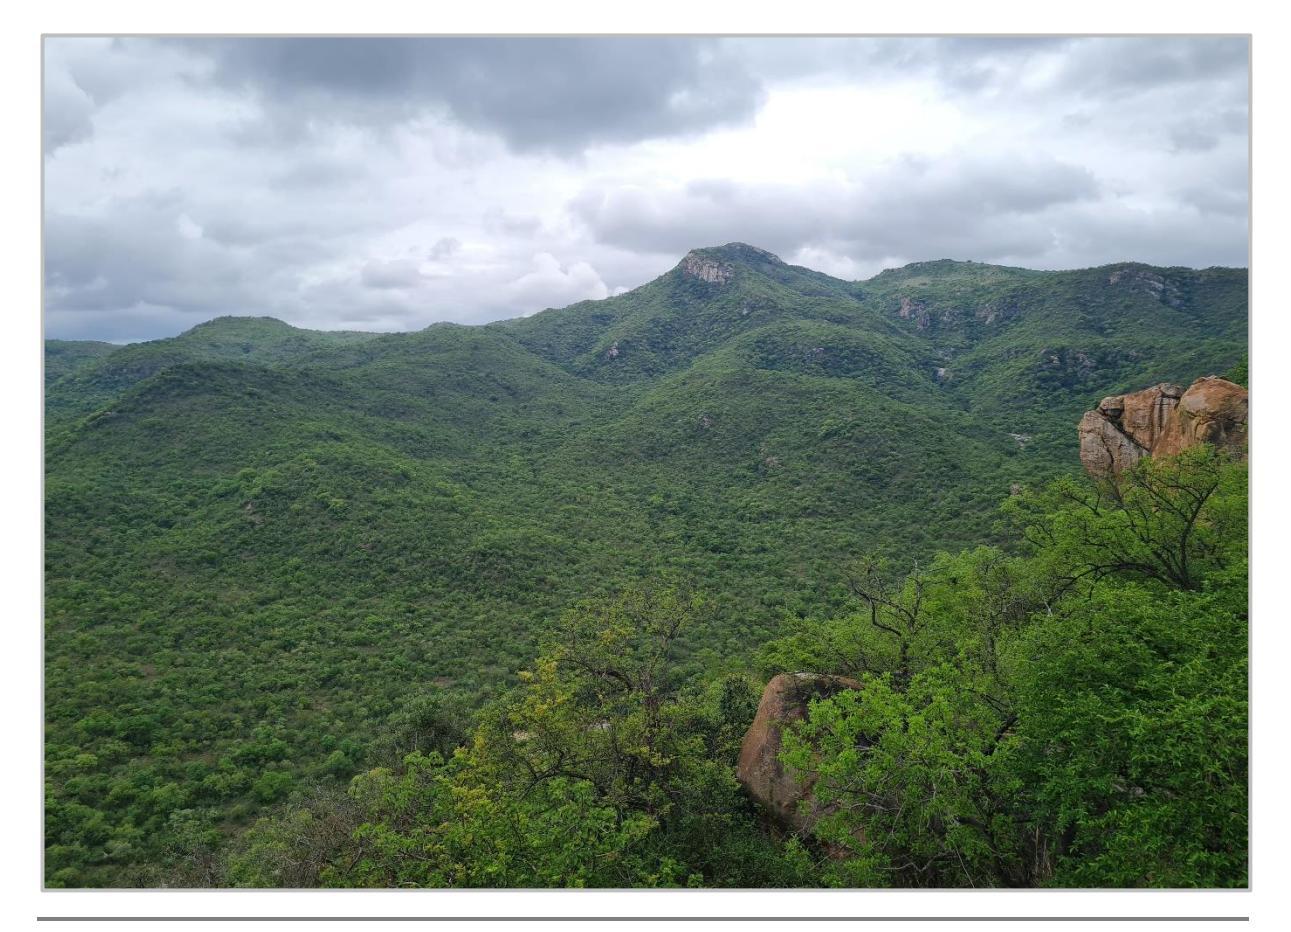
Widespread rock in the dam basin offers several rock quarry site opportunities, particularly on the right flank.

The reservoir area contains steep valley slope of more than 1V:2H in places and reservoir slope stability will have to be investigated as part of the feasibility level studies.

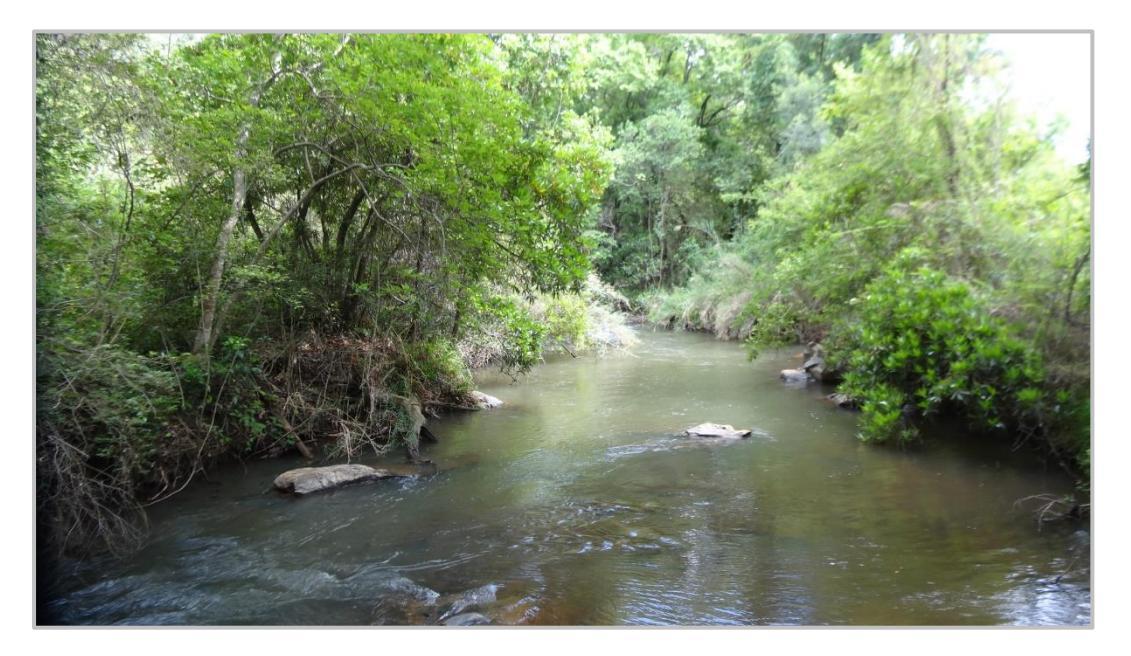
The river section is densely vegetated mostly by large indigenous trees, but contains scattered prominent granite gneiss rock outcrops. Irregular rock profile is expected in the river section although mostly shallow rock.

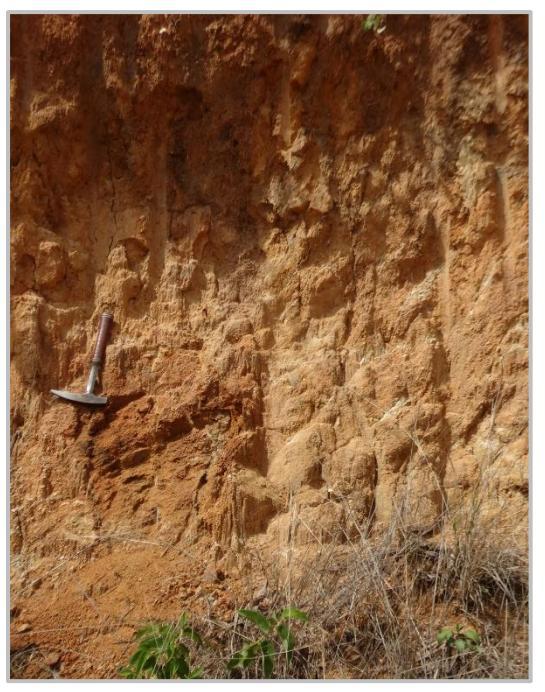
The flat left flank is covered by a well-developed clayey sand surface layer (hillwash) underlain by deeply weathered granite.

Access to the entire site is good. Extensive use of geophysical surveys will be required to delineate the concrete spillway option. Earth embankment wall will be required for the flat right flank. The hillwash and residual granitic soils has a large distribution in the dam basin which should be well suited for embankment construction.

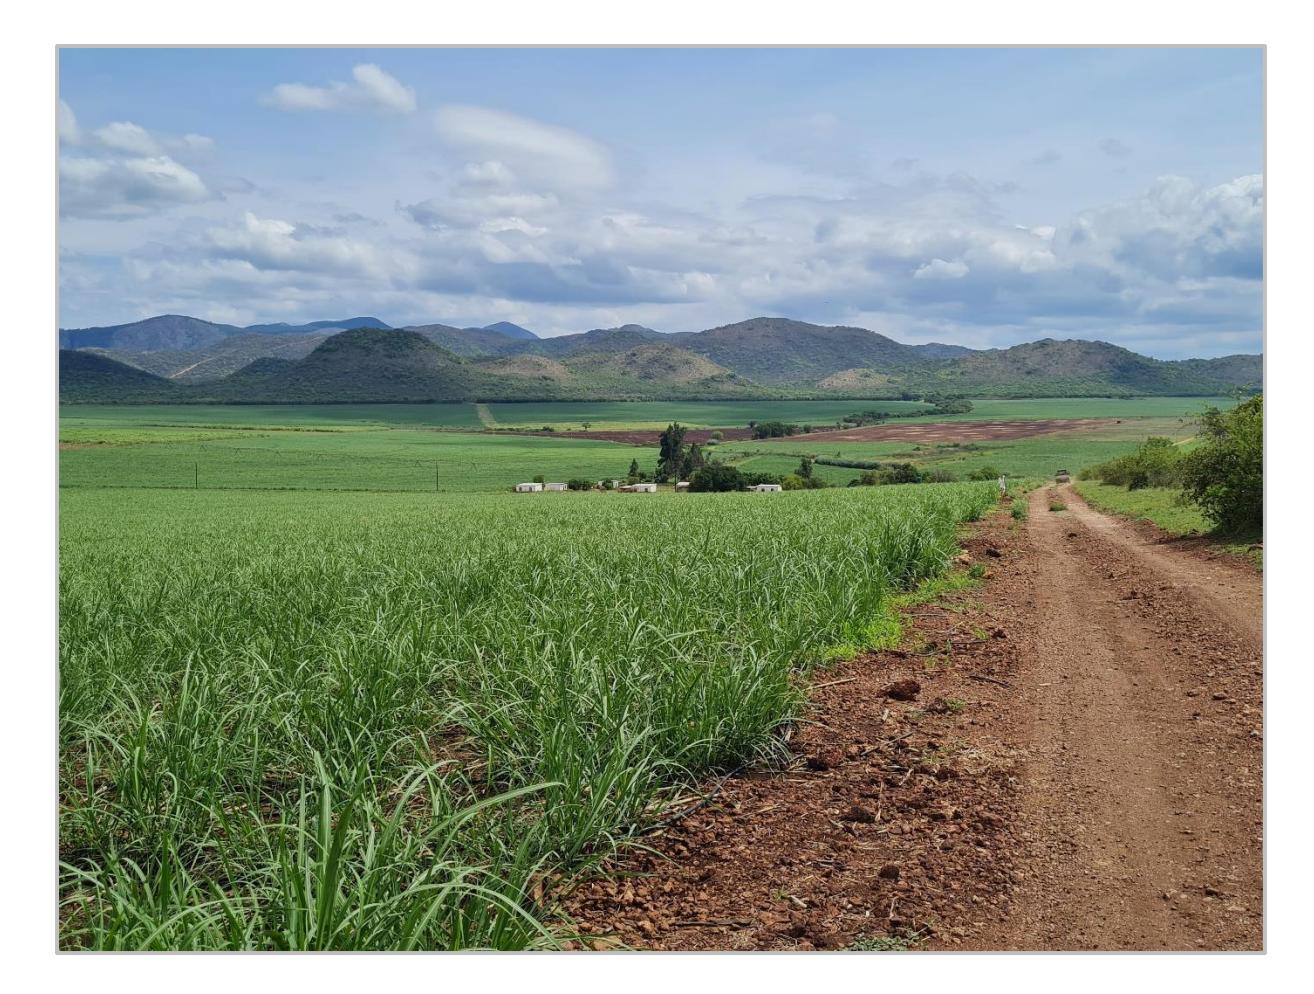
Strathmore Dam Site is an off-channel dam straddling two north-flowing streams. These are separated by a low hill which forms part of a distinct almost east-west striking low hill range that is associated with the ancient so-called green belt rocks of the Swazian Group. These comprise highly metamorphosed rocks such as amphibolite and schist. A third stream flows northwards along the far eastern portion of the reservoir (Salt Creek) which will also require a saddle dam pending the reservoir level.

The entire reservoir area is under cultivation, mostly sugar cane.

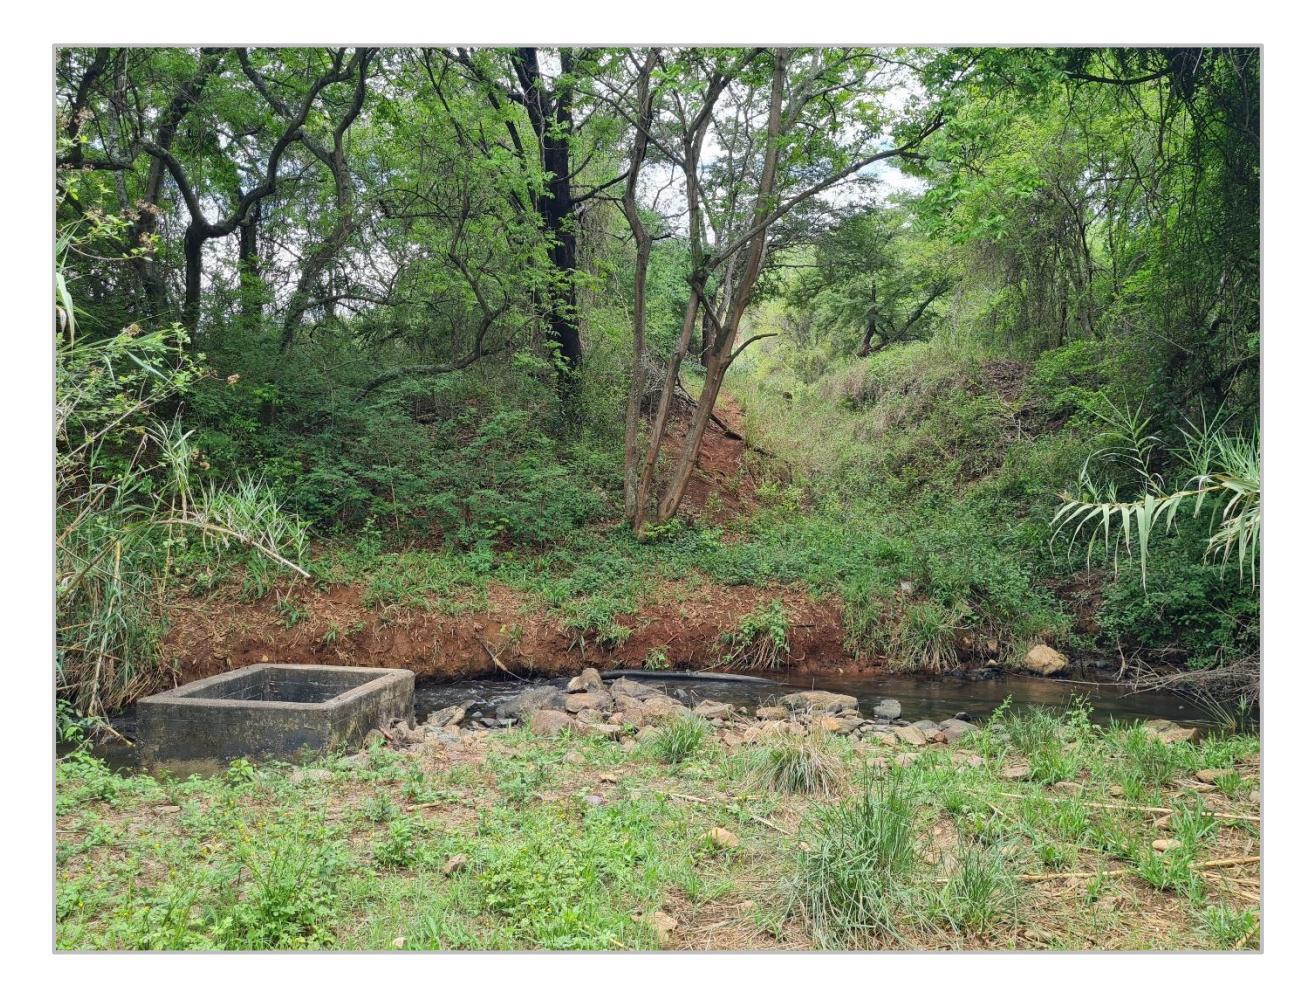
The dam sites positions are not well defined and generally lack distinct rock outcrop, although some areas of shallow rock are expected. The rock mass is generally closely jointed and possibly highly pervious. Extensive foundation grouting is foreseen to render relatively impervious foundations.

A large magnesite mine is situated to the north-east of the dam. The presence of the old mining pits/mine concession area will limit the reservoir level. The possible leakage of reservoir water into the mine pit will have to be assessed.

Two of the dam sites may be affected by existing syphons and canal system.

Geotechnical foundations for this dam site will require geophysical surveys combined with rotary cored drilling particularly to determine rock mass permeability and grouting requirements. The presence of the nearby active mine will require further investigations of the extent and depths of the mine pits, mining lease boundaries and future mine extension planning. Large reserves of clayey soils are present in the basin for embankment construction.
