Determination of Water Resource Classes, Reserve and the Resource Quality Objectives in the Keiskamma and Fish to Tsitsikamma Catchments

WP11354 River Field Survey Report 2

REPORT NO.:
WEM/WMA7/00/CON/RDM/1423

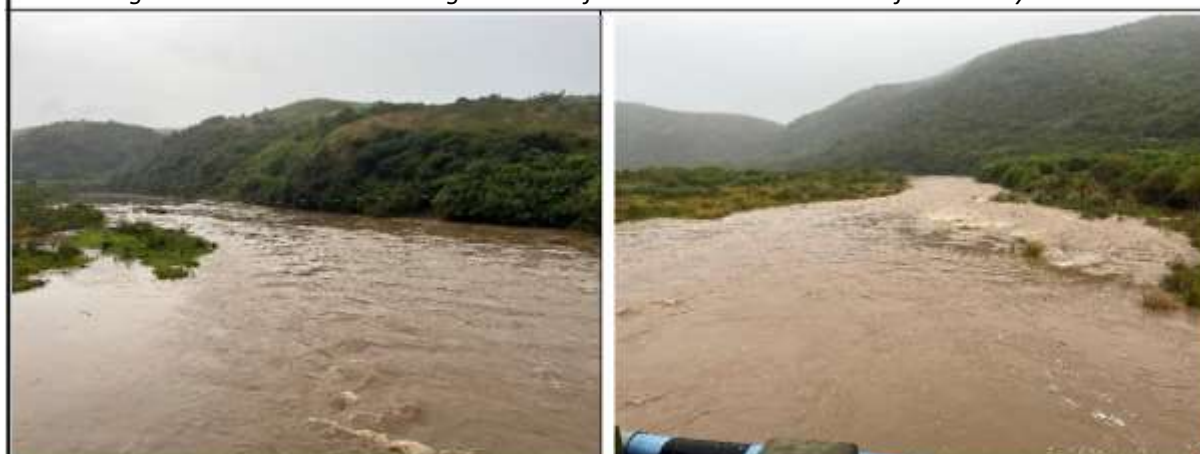
Owing to constant rainfall conditions at the time of the May 2023 survey, saw the Mthatha River in flood and burst banks. Consequently, only water and slope levels could be measured, and the riparian vegetation assessed.

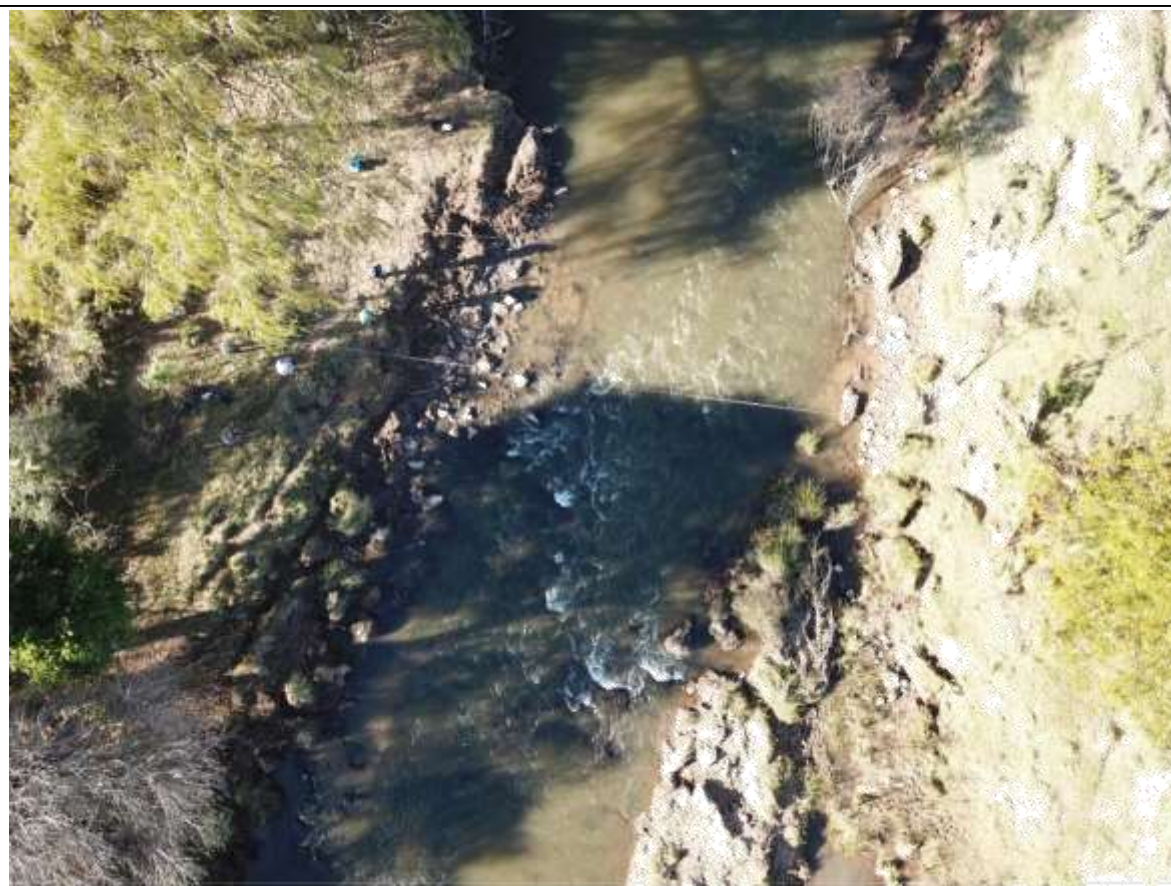
Following the flood event that took place in February 2023, clear evidence of bank collapse and further bank erosion was observed, particularly along the left bank. This was exasperated by the continued cattle trampling and grazing along that bank.

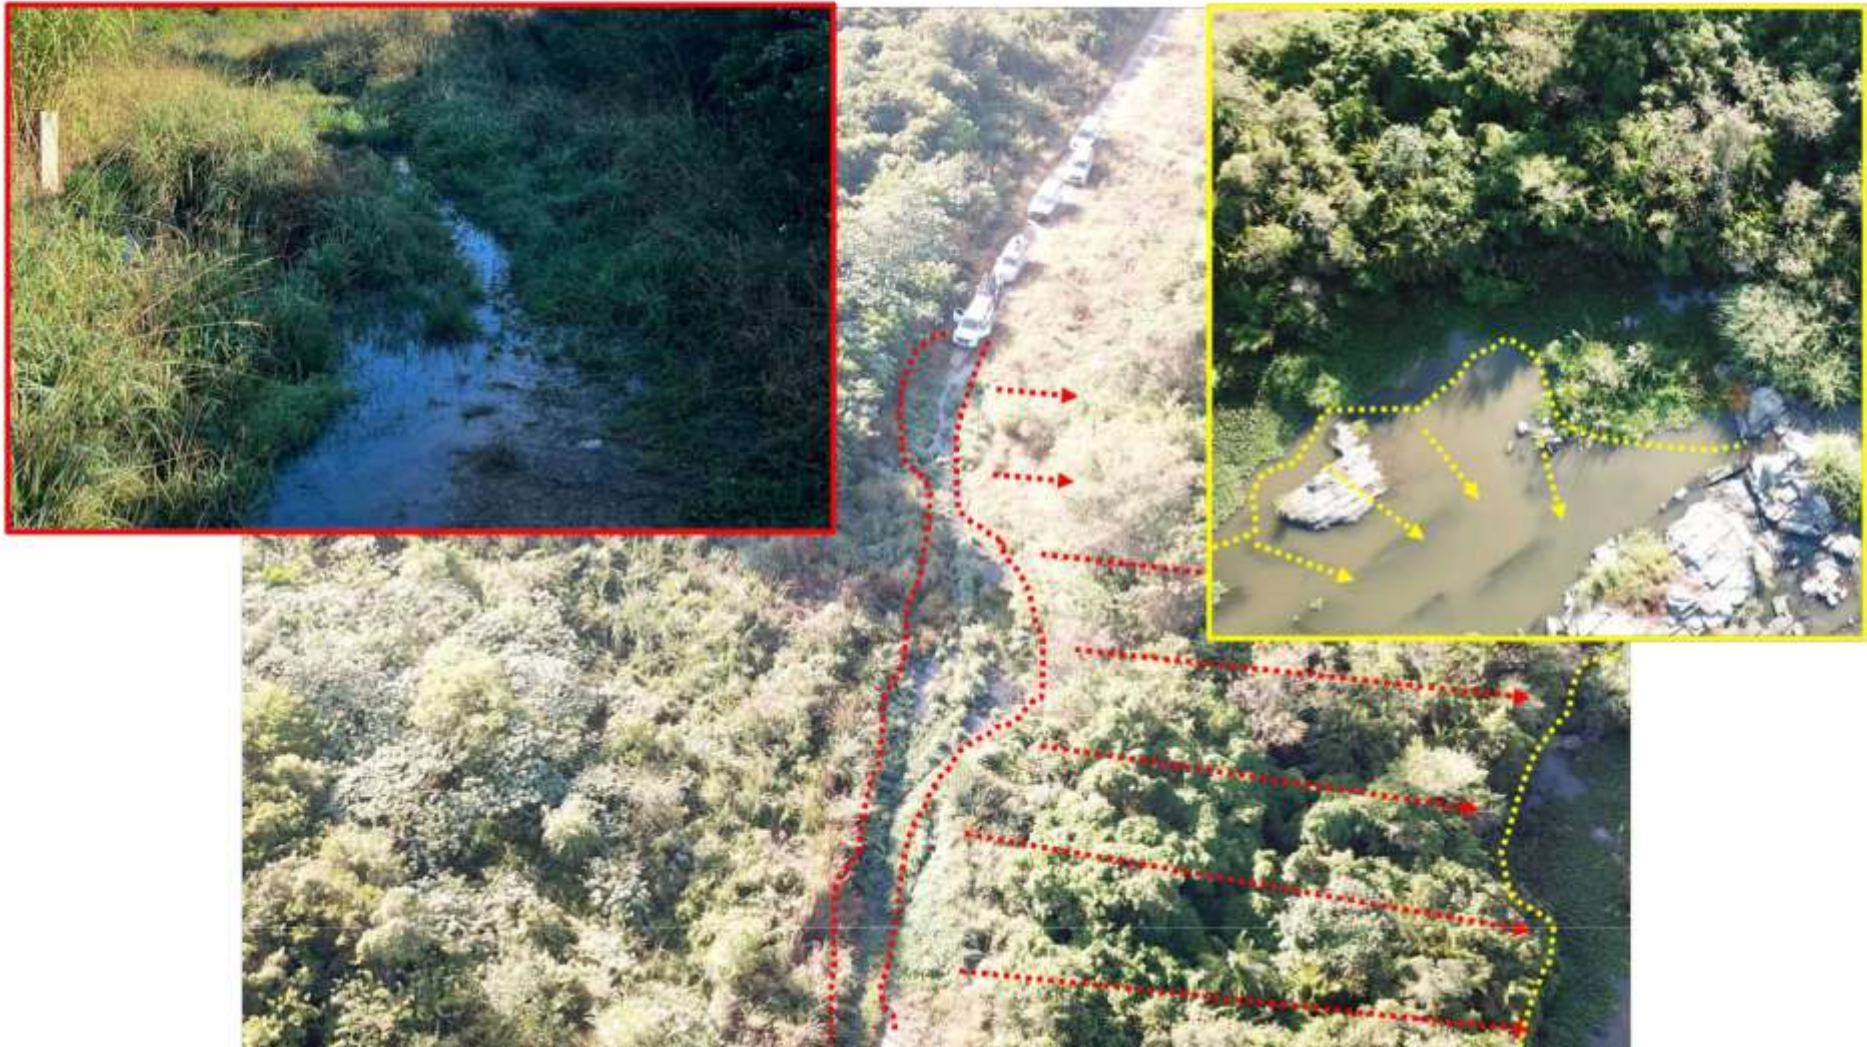
Red Flag for actioning from the Department			
<p>During the May 2023 survey, evidence of raw sewage flowing directly into the lower reaches of the Buffalo River, where our EWR site is located, was observed. The source of this sewage appears to be sourced from the residential and rural area of Reeston and beyond. The observed flow of raw sewage was higher than what was previously observed in September 2022. The bypassing of the Wastewater</p>

Treatment Works (WWTW), which is located just downstream of this site and adjacent to the water pump house along the River, exacerbates these issues, posing health hazards to both humans and the environment.

Figure 1 illustrates the accumulation of raw sewage in the road and flowing through the vegetated riparian zone and directly into the river where excessive growth of hyacinth can be observed along the margins. This is further illustrated from google earth (Figure 2). The colouration is also an indication of sewage inflow (Figure 3a, b). The DWS also has a monitoring site along this stretch called R2BUFF-ZWELI, which too has not been surveyed owing to raw sewage inputs into the river and its associated health hazards.

Figure 1: Accumulation of raw sewage along the access road to the Lower Buffalo Reach and the concentrated hyacinth along the margins

At the time of the survey, DWS colleagues observed the raw sewage inputs with the specialist project team, and discussions were had regarding the severity of the current state of this river, emphasizing the need for urgent attention and action to be taken by the Catchment Management Agency (CMA).

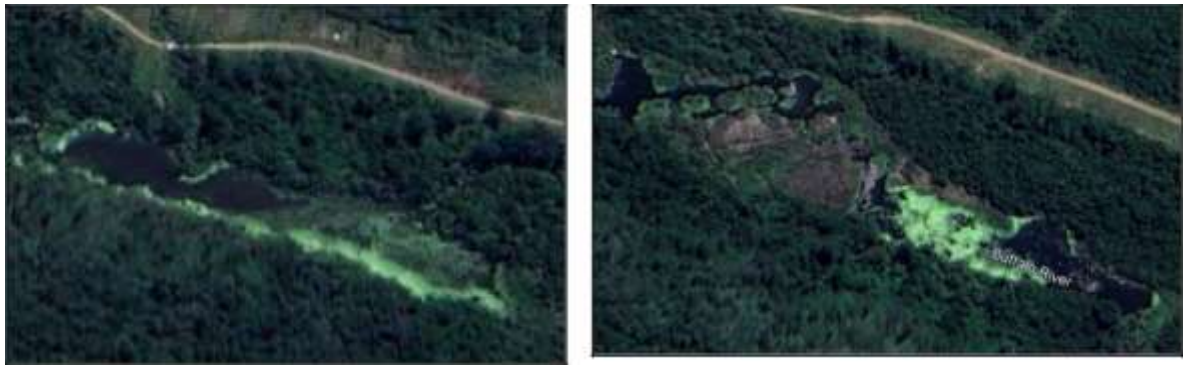
Figure 2: Google earth imagery of the effects of the raw sewage inputs into the lower Buffalo River

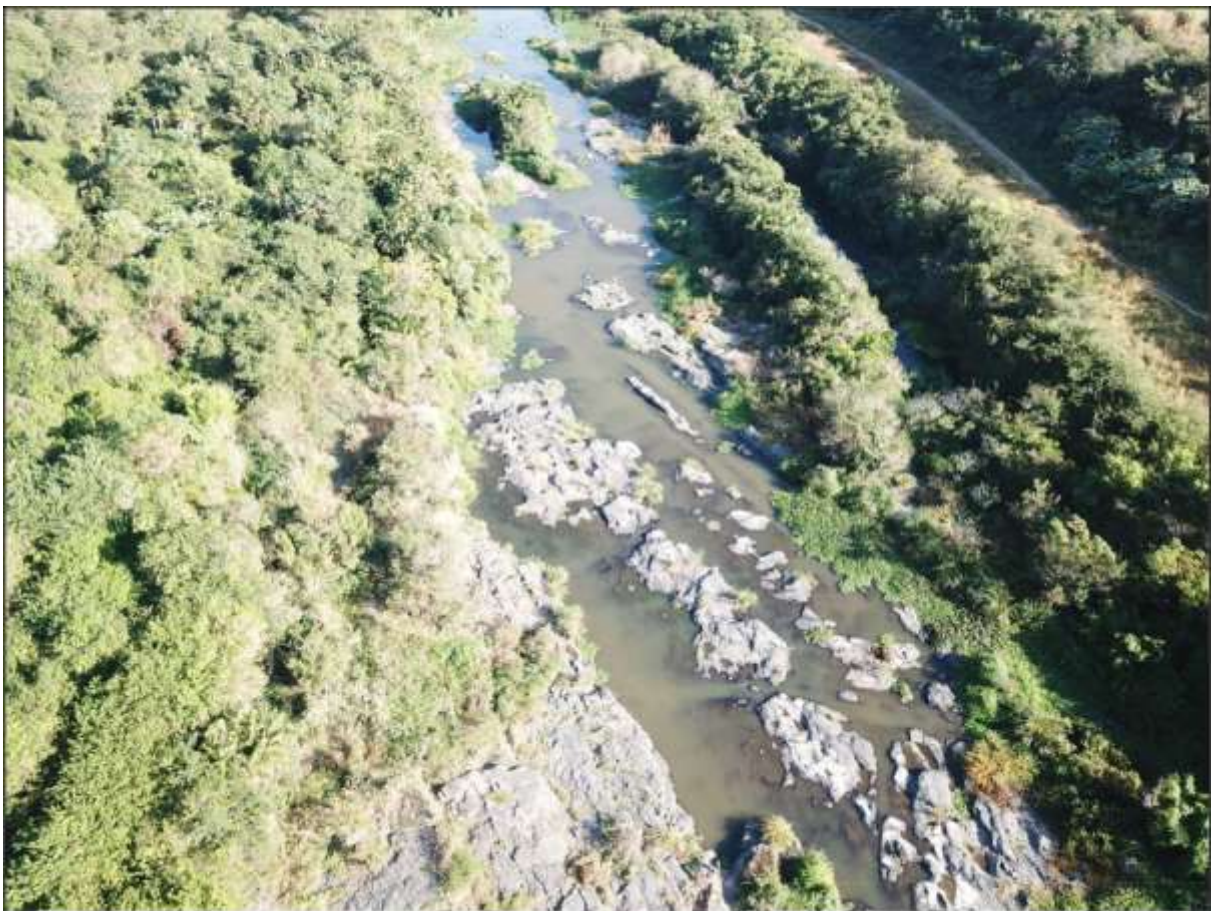
Figure 3a: Sewage inputs

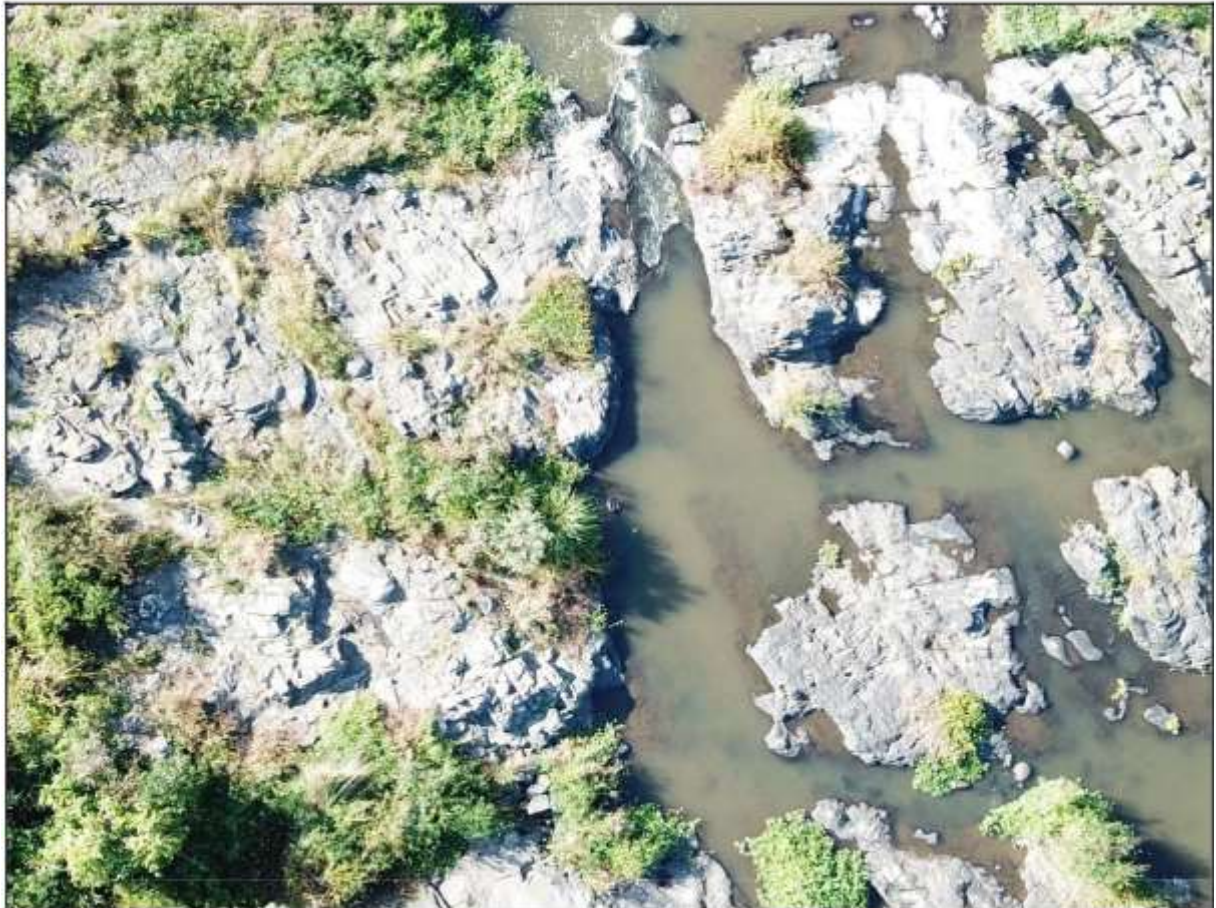
Figure 3b: Sewage inputs
