THE NATIONAL STATE OF WATER RESOURCES QUARTERLY REPORT JULY TO SEPTEMBER 2014

Directorate: Water Information Programmes

REPORT TITLE: THE NATIONAL STATE OF WATER RESOURCES: QUARTELY REPORT FOR JULY TO SEPTEMBER 2014

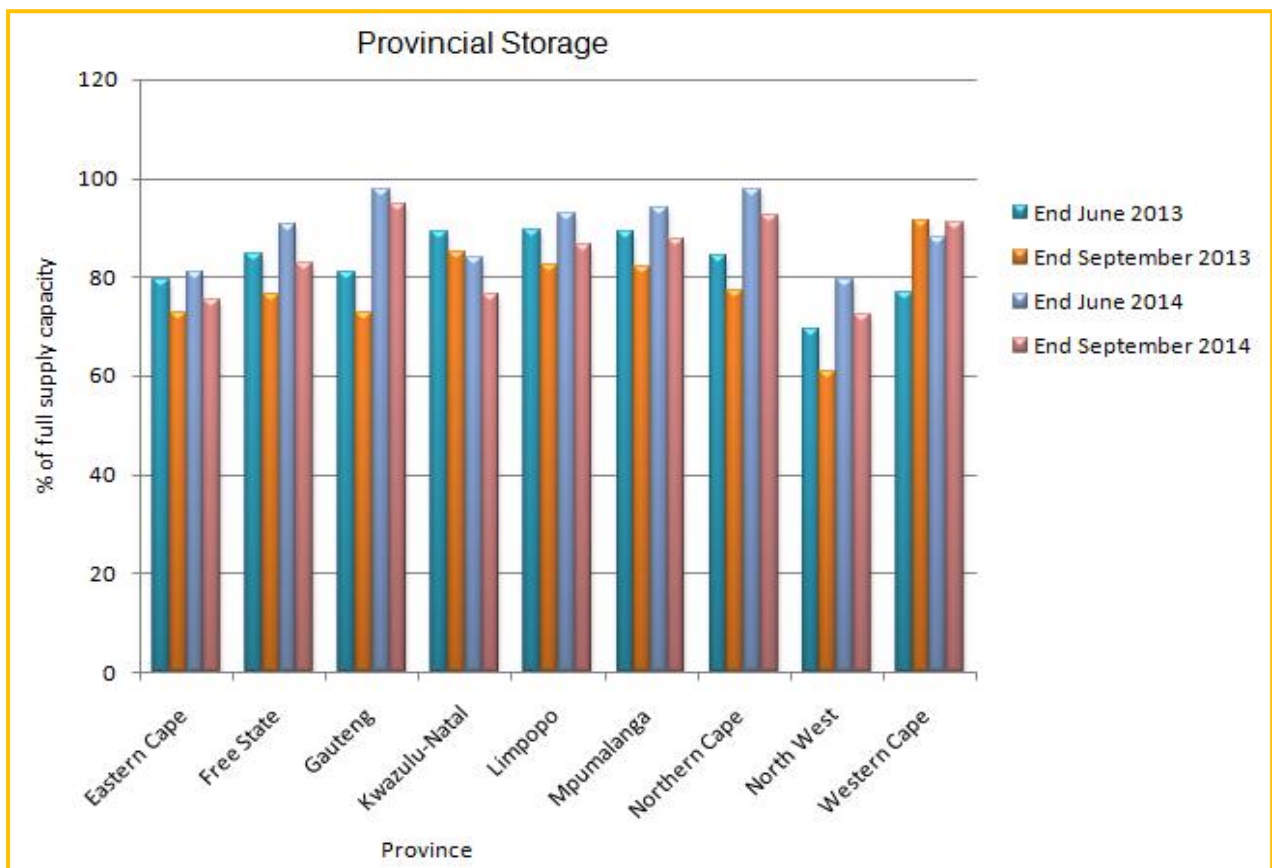
Figure 2.8: A comparison of provincial dam storage levels at end September 2013 and 2014

The provincial storage levels as recorded at the end of September 2013 and 2014 are shown in Figure 3.3. In most provinces, the dam storage levels for the reporting period were slightly higher compared to the same period in the previous year. When comparing provincial storage as recorded at the end of June 2014 with the current reporting period (end September 2014), all the provinces experienced decreased storage percentages, except for the Western Cape where good winter rainfall occurred (Figure 2.8). The total water storage volume for the country as recorded at the end of September 2014 was 25 858 M m³, which is 1173 Mm³ more in comparison to the recorded volumes for September 2013 (24 685 M m³).

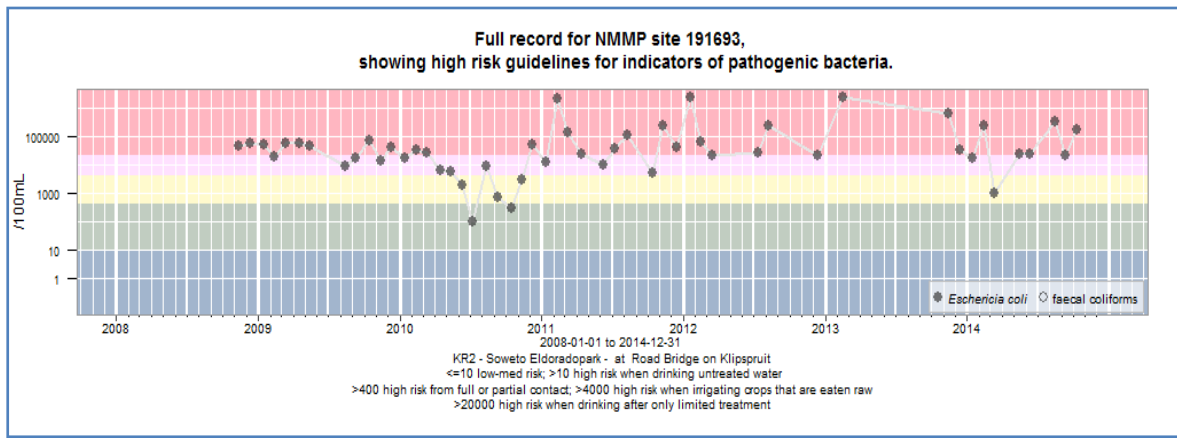
Figure 3.3: The status of faecal coliforms in Eldoradopark at Road Bridge on Klipspruit

In the Vaal WMA the Soweto area is the most affected by faecal pollution. The status of *E. coli* in the areas are very high on all four users. Figures 3.3 and 3.4 show the status of faecal pollution in Eldoradopark at Road Bridge and Goudkoppie on the Klipspruit. In the Giyani the WWTW has been impacting the over the past ten years but things have improved in the past two years (Figure 3.5). In the Olifants WMA, Kwaguqa on the Brugspruit downstream Ferrobank WWTW is impacted seriously (Figure 3.6). The water runs down and is abstracted for Water Treatment Works for water supply. Figure 3.7 shows the status of faecal pollution in Naauwpoort downstream of Naauwpoort WWTW on the Noupootspruit.

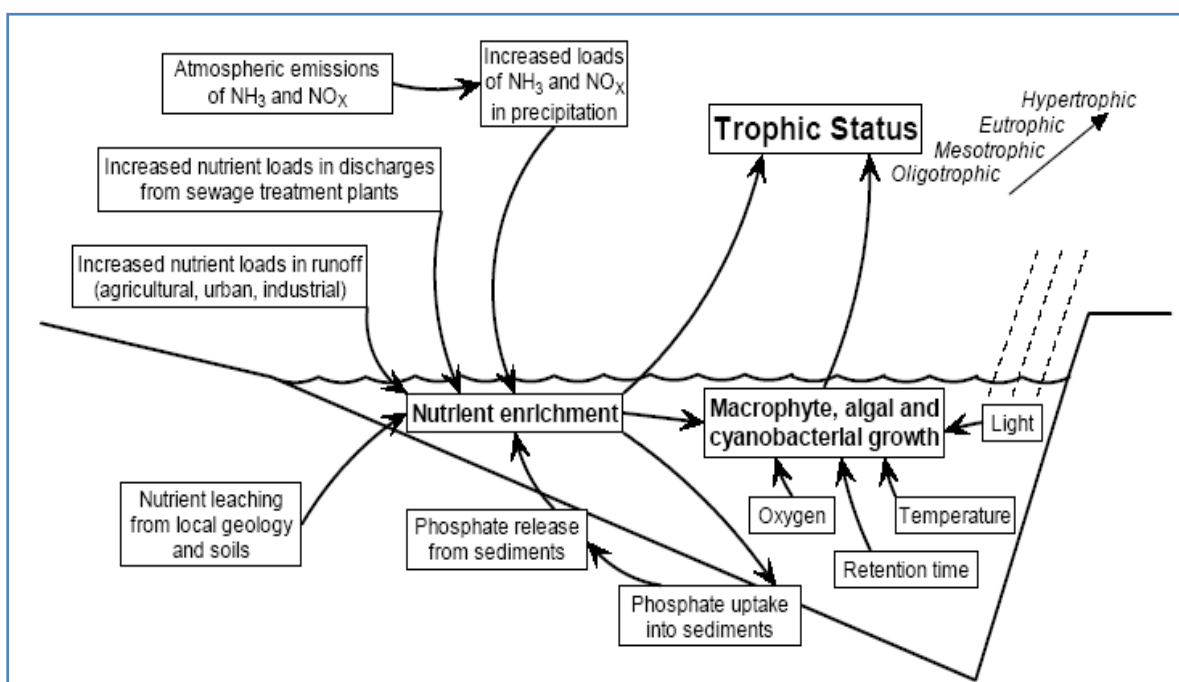
Figure 3.8: The nutrient cycle within a water system, causes and consequences of eutrophication (DWA, 2002).

One of the main problems in water quality is nutrient enrichment in freshwater resources. High nutrient concentrations are the result of cultural and natural influxes of nutrients and may be due to irrigation return flows that contribute to the nitrogen and phosphate loads in rivers and or untreated sewage that overflows into rivers that contribute to increased nitrogen loads and bacterial pollution. Figure 3.8 shows the nutrient cycle within the water system, the causes and consequences of nutrient enrichment. Excessive nutrient loads in river systems can lead to occurrence of toxic and unsightly algal blooms. Eutrophication is the process of nutrient enrichment and the excessive plant growth in water bodies. It can lead to water quality deterioration, algal toxin production, taste and odour problems, oxygen depletion, decline of more desirable fish species, the clogging of waterways. It can also affect flocculation and chlorination processes in water treatment plants.

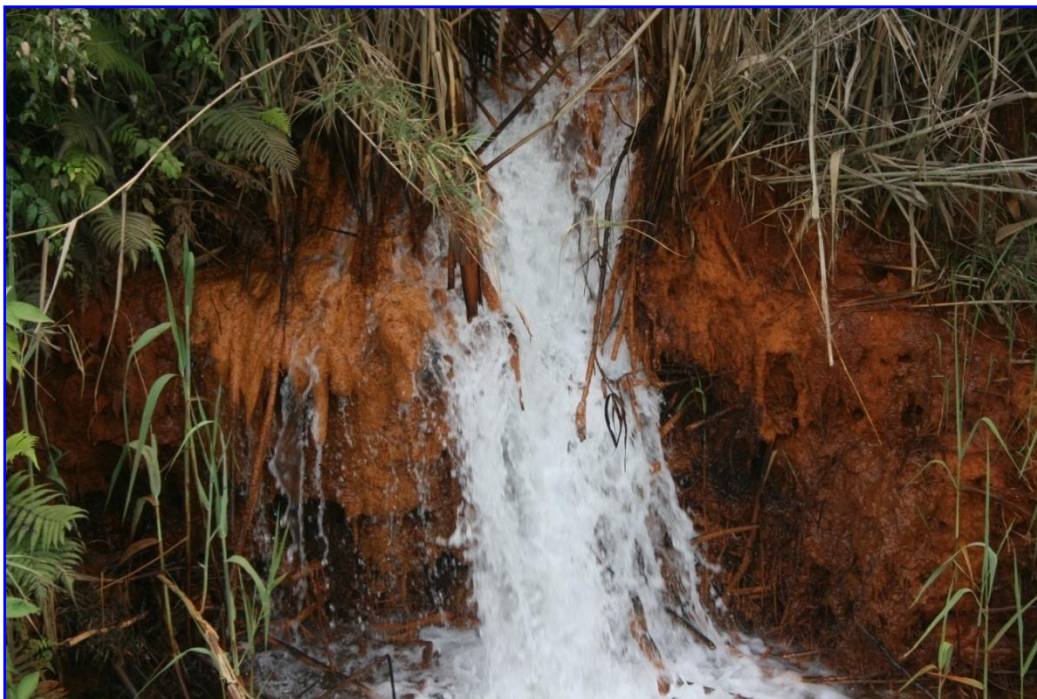
Photo 1: AMD impact resulting from abandoned coal mines in Vryheid KZN Province

Due to the much slower flow conditions of groundwater in comparison to surface water, the quality response of groundwater is assessed as a long-term process, with observations commencing in 1993. The groundwater quality, based on the salinity is reasonably stable with slight seasonal variations. Poor water quality however, is expected in areas affected by mining and industrial activities, especially on a local scale (see mining impact example on Photo 1).

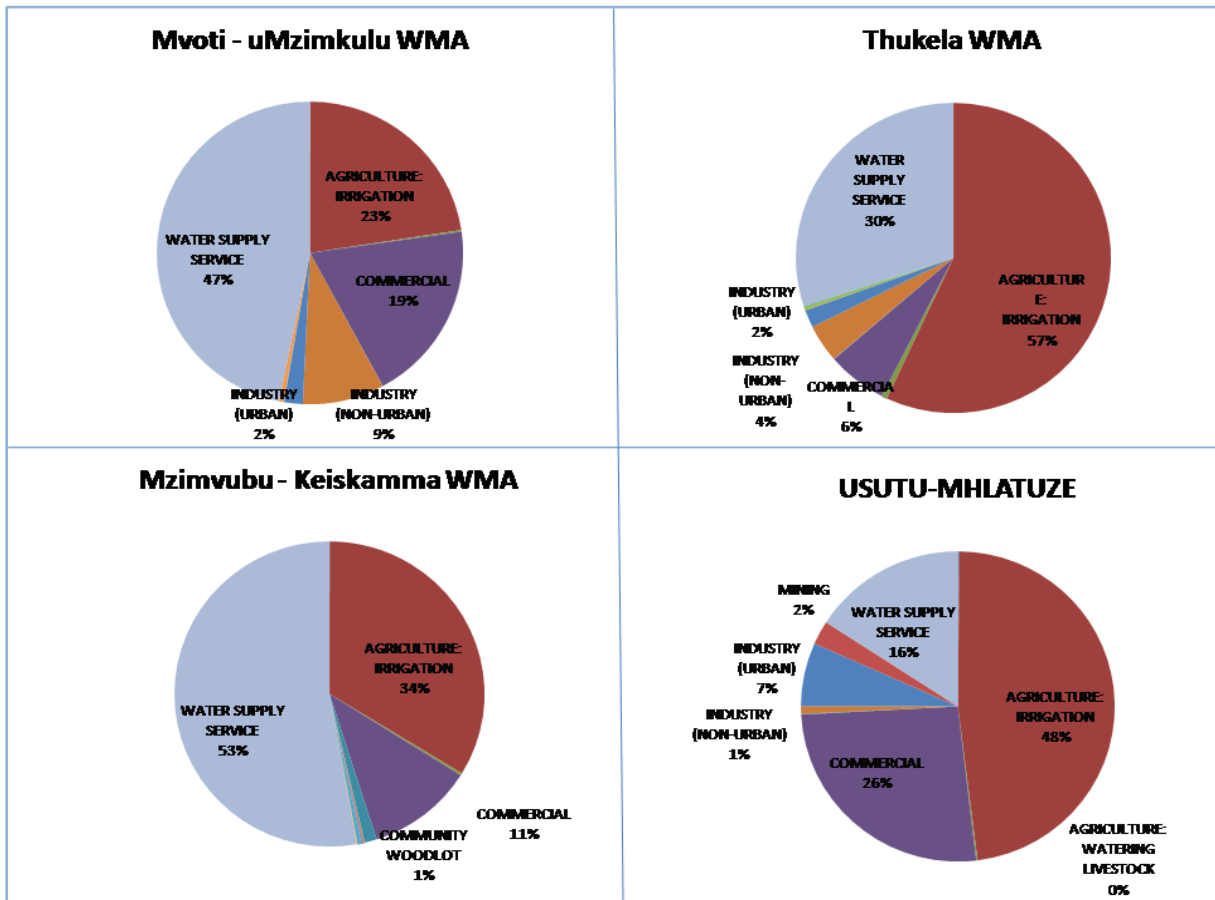
Figure 5.3: Registered water use per WMA – KwaZulu-Natal areas

According to Figures 5.3 – 5.7 and Table 5.2, the WMAs with the largest agricultural irrigation (> 50%) as a percentage of the total volume of the registered water use per WMA are Inkomati (54 %), Luvuvhu – Letaba (63%), Crocodile (W) & Marico (66%), Limpopo (71%), Lower Vaal (79%), Gouritz (83%), Fish-Tsitsikamma (84%), Thukela (87%), Upper Orange (88%), Lower Orange (92%), Breede (94%) and Olifants-Doorn (97%).
