Report on an Integrated Water Quality Monitoring Programme Conducted in the Town of Delmas

November 2005 to June 2006

Report on an Integrated Water Quality Monitoring Programme Conducted in the Town of
Delmas, November 2005 to June 2006

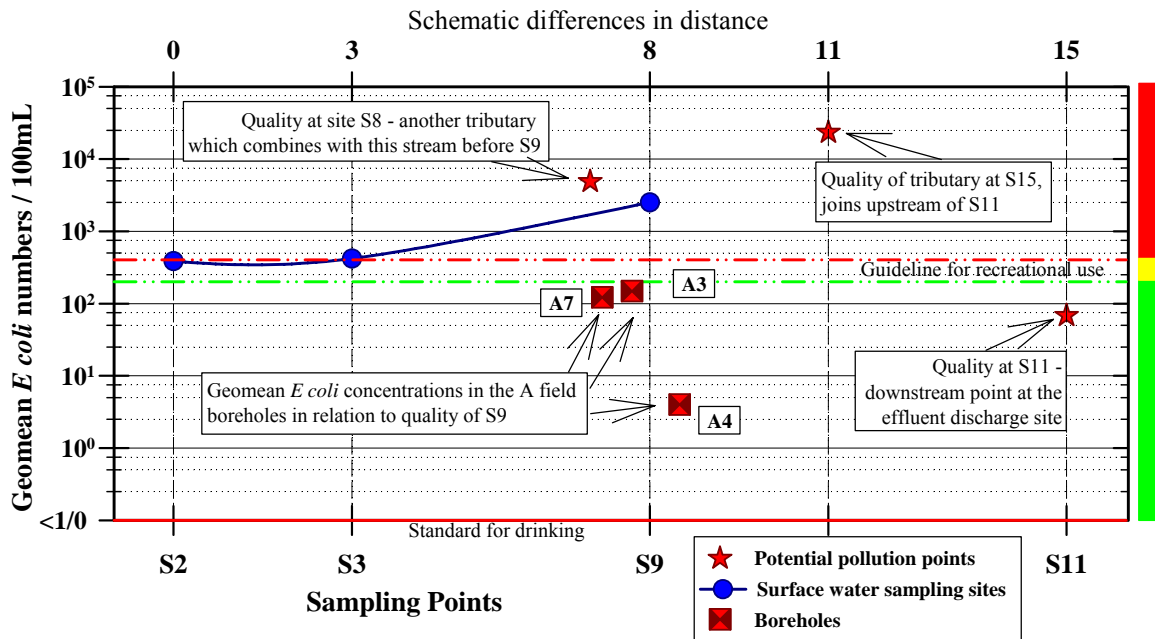
FIGURE 6: Schematic representation of the downstream changes in the geometric mean *E. coli* concentrations in the stream with sampling sites S2, S3 & S9

- **Inadequate protection of surface water resources:** A link is suspected between the microbiological quality of the surface water and that of the groundwater. The link exists especially in the vicinity of sampling point S9 and the boreholes in the A-well field. Land use activities, such as cattle roaming in the vicinity of the A production boreholes, as well as rain-induced run-off from the formal and informal settlements, all contribute to the surface water being unacceptably contaminated by faecal matter from human and animal origin. It is thus important to develop a management plan to protect the surface water but which would also ultimately lead to the protection of the A-well field boreholes. The plan should include:

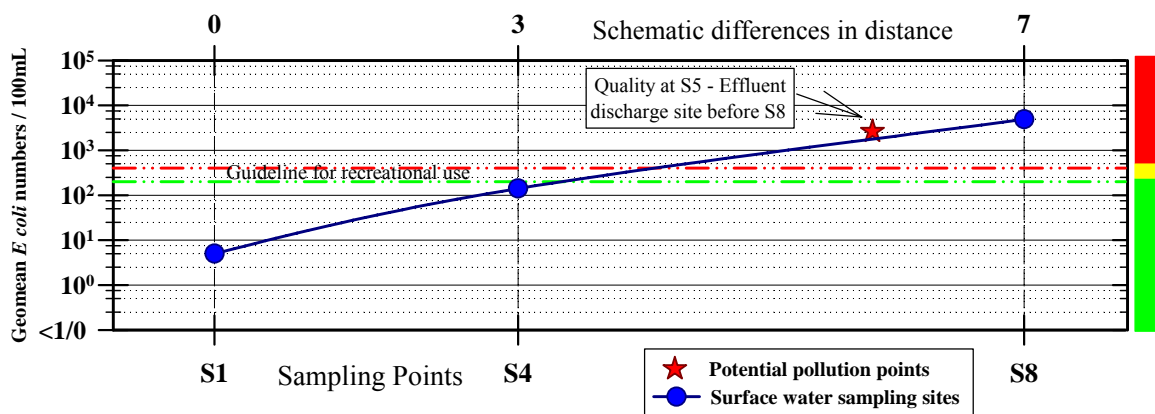
Figure 7 and 8 illustrate the water qualities in the other two tributaries monitored in Delmas. A similar approach to the above was followed, sources believed to influence the quality of the tributary are indicated as well as boreholes in the vicinity.

FIGURE 7: Representation of water quality in the stream ending at S8

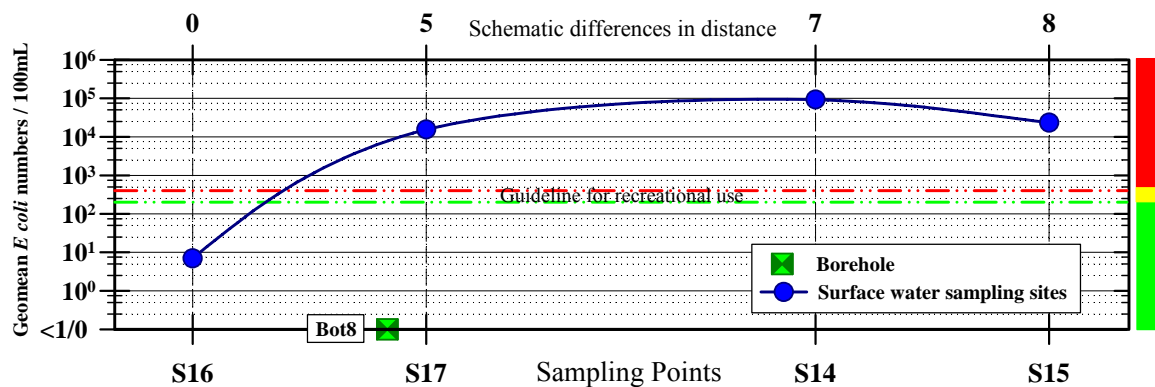
FIGURE 8: Representation of water quality in the stream ending at S15
