FEASIBILITY STUDY FOR THE MZIMVUBU WATER PROJECT

GEOTECHNICAL INVESTIGATIONS:

NTABELANGA, SOMABADI AND THABENG DAM SITES

APPENDICES

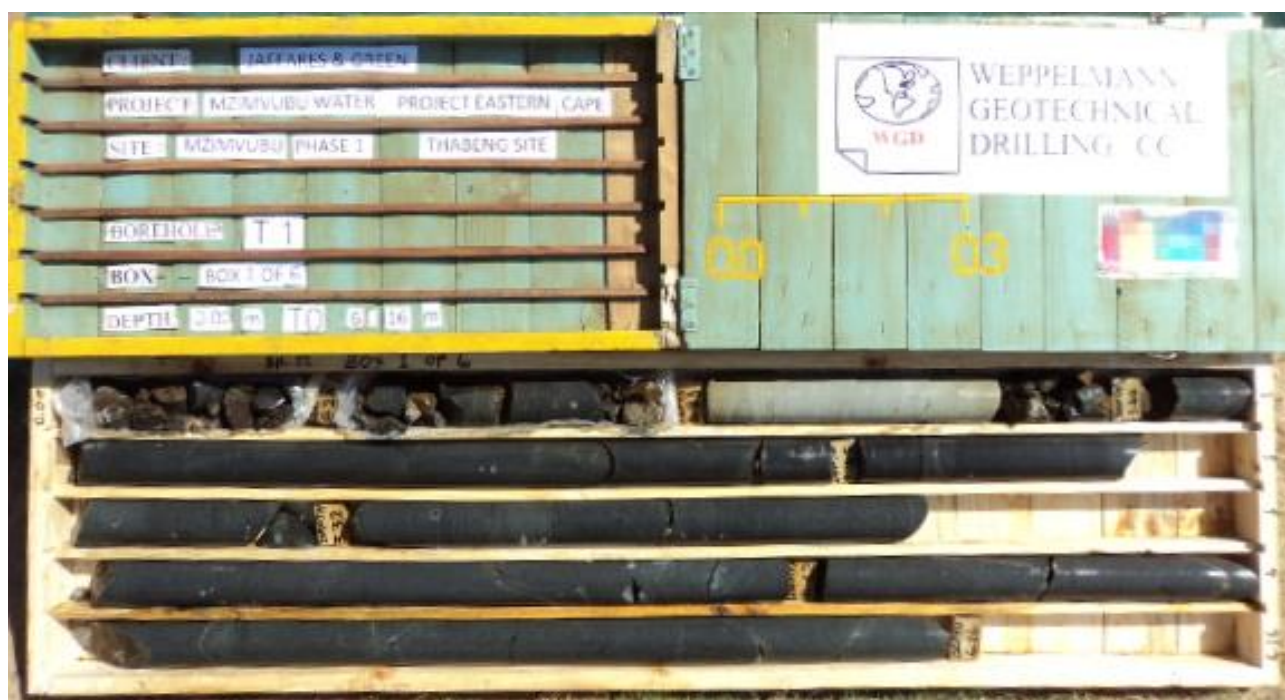
Fig C-3: Borehole T1 Core Box 1 of 6

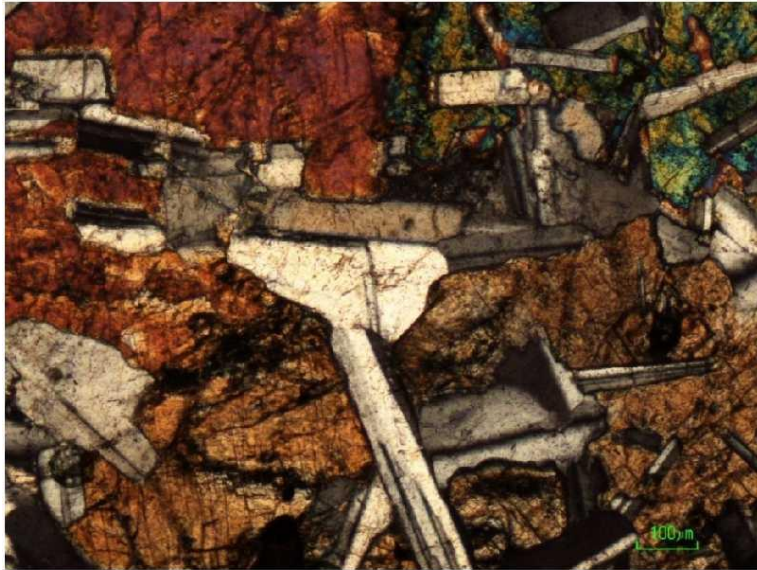
N1_ 11.84-12.2: Plagioclase showing polysynthetic twinning, enclosed by clinopyroxene.

The section is dominated by generally lath-shaped medium to fine grained feldspar (plagioclase) showing polysynthetic twinning, and subhedral to anhedral clinopyroxene (augite). The laths of plagioclase are randomly orientated and the clinopyroxenes (augite) occupy a more interstitial position to the plagioclase. Some of the irregular augite crystals exhibit a pink colour indicative of Ti-content. The pyroxenes show alteration to chlorite and traces of hornblende along cleavage and rims. Some of the plagioclase have been replaced fine-grained white mica (sericite). The few opaques are irregular in shape. The degree of alteration is fairly low.
