P WMA 12/T30/00/5212/10

FEASIBILITY STUDY FOR THE MZIMVUBU WATER PROJECT

GEOTECHNICAL INVESTIGATIONS: LALINI DAM AND HYDROPOWER SCHEME

APPENDICES

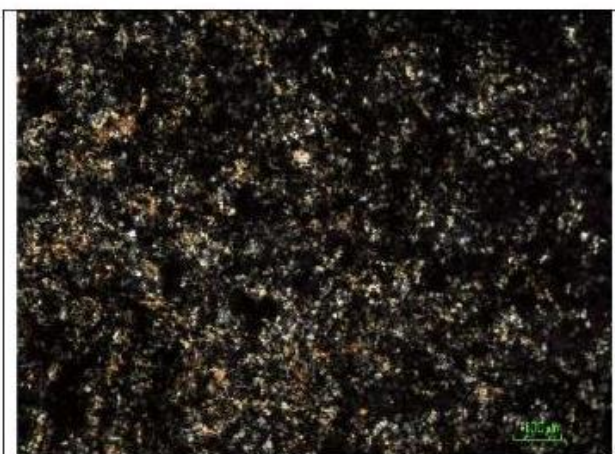
The sample is extremely fine grained. Optical study is hampered by the fine grain and is difficult to distinguish between the various minerals.

Grain Size: <100 micron

Photomicrograph T2 50.63-50.77: Cross polarized light. 10x Magnification.

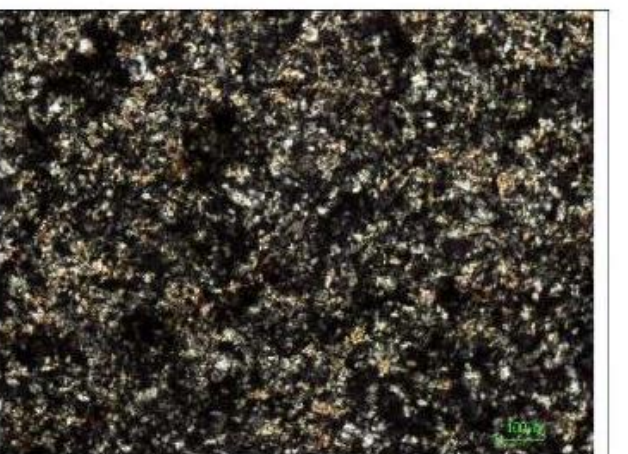
Photomicrograph T2 50.63-50.77: Cross polarized light. 10x Magnification.
