## 3 CLIMATIC ENVIRONMENT

### 3.1 Climate

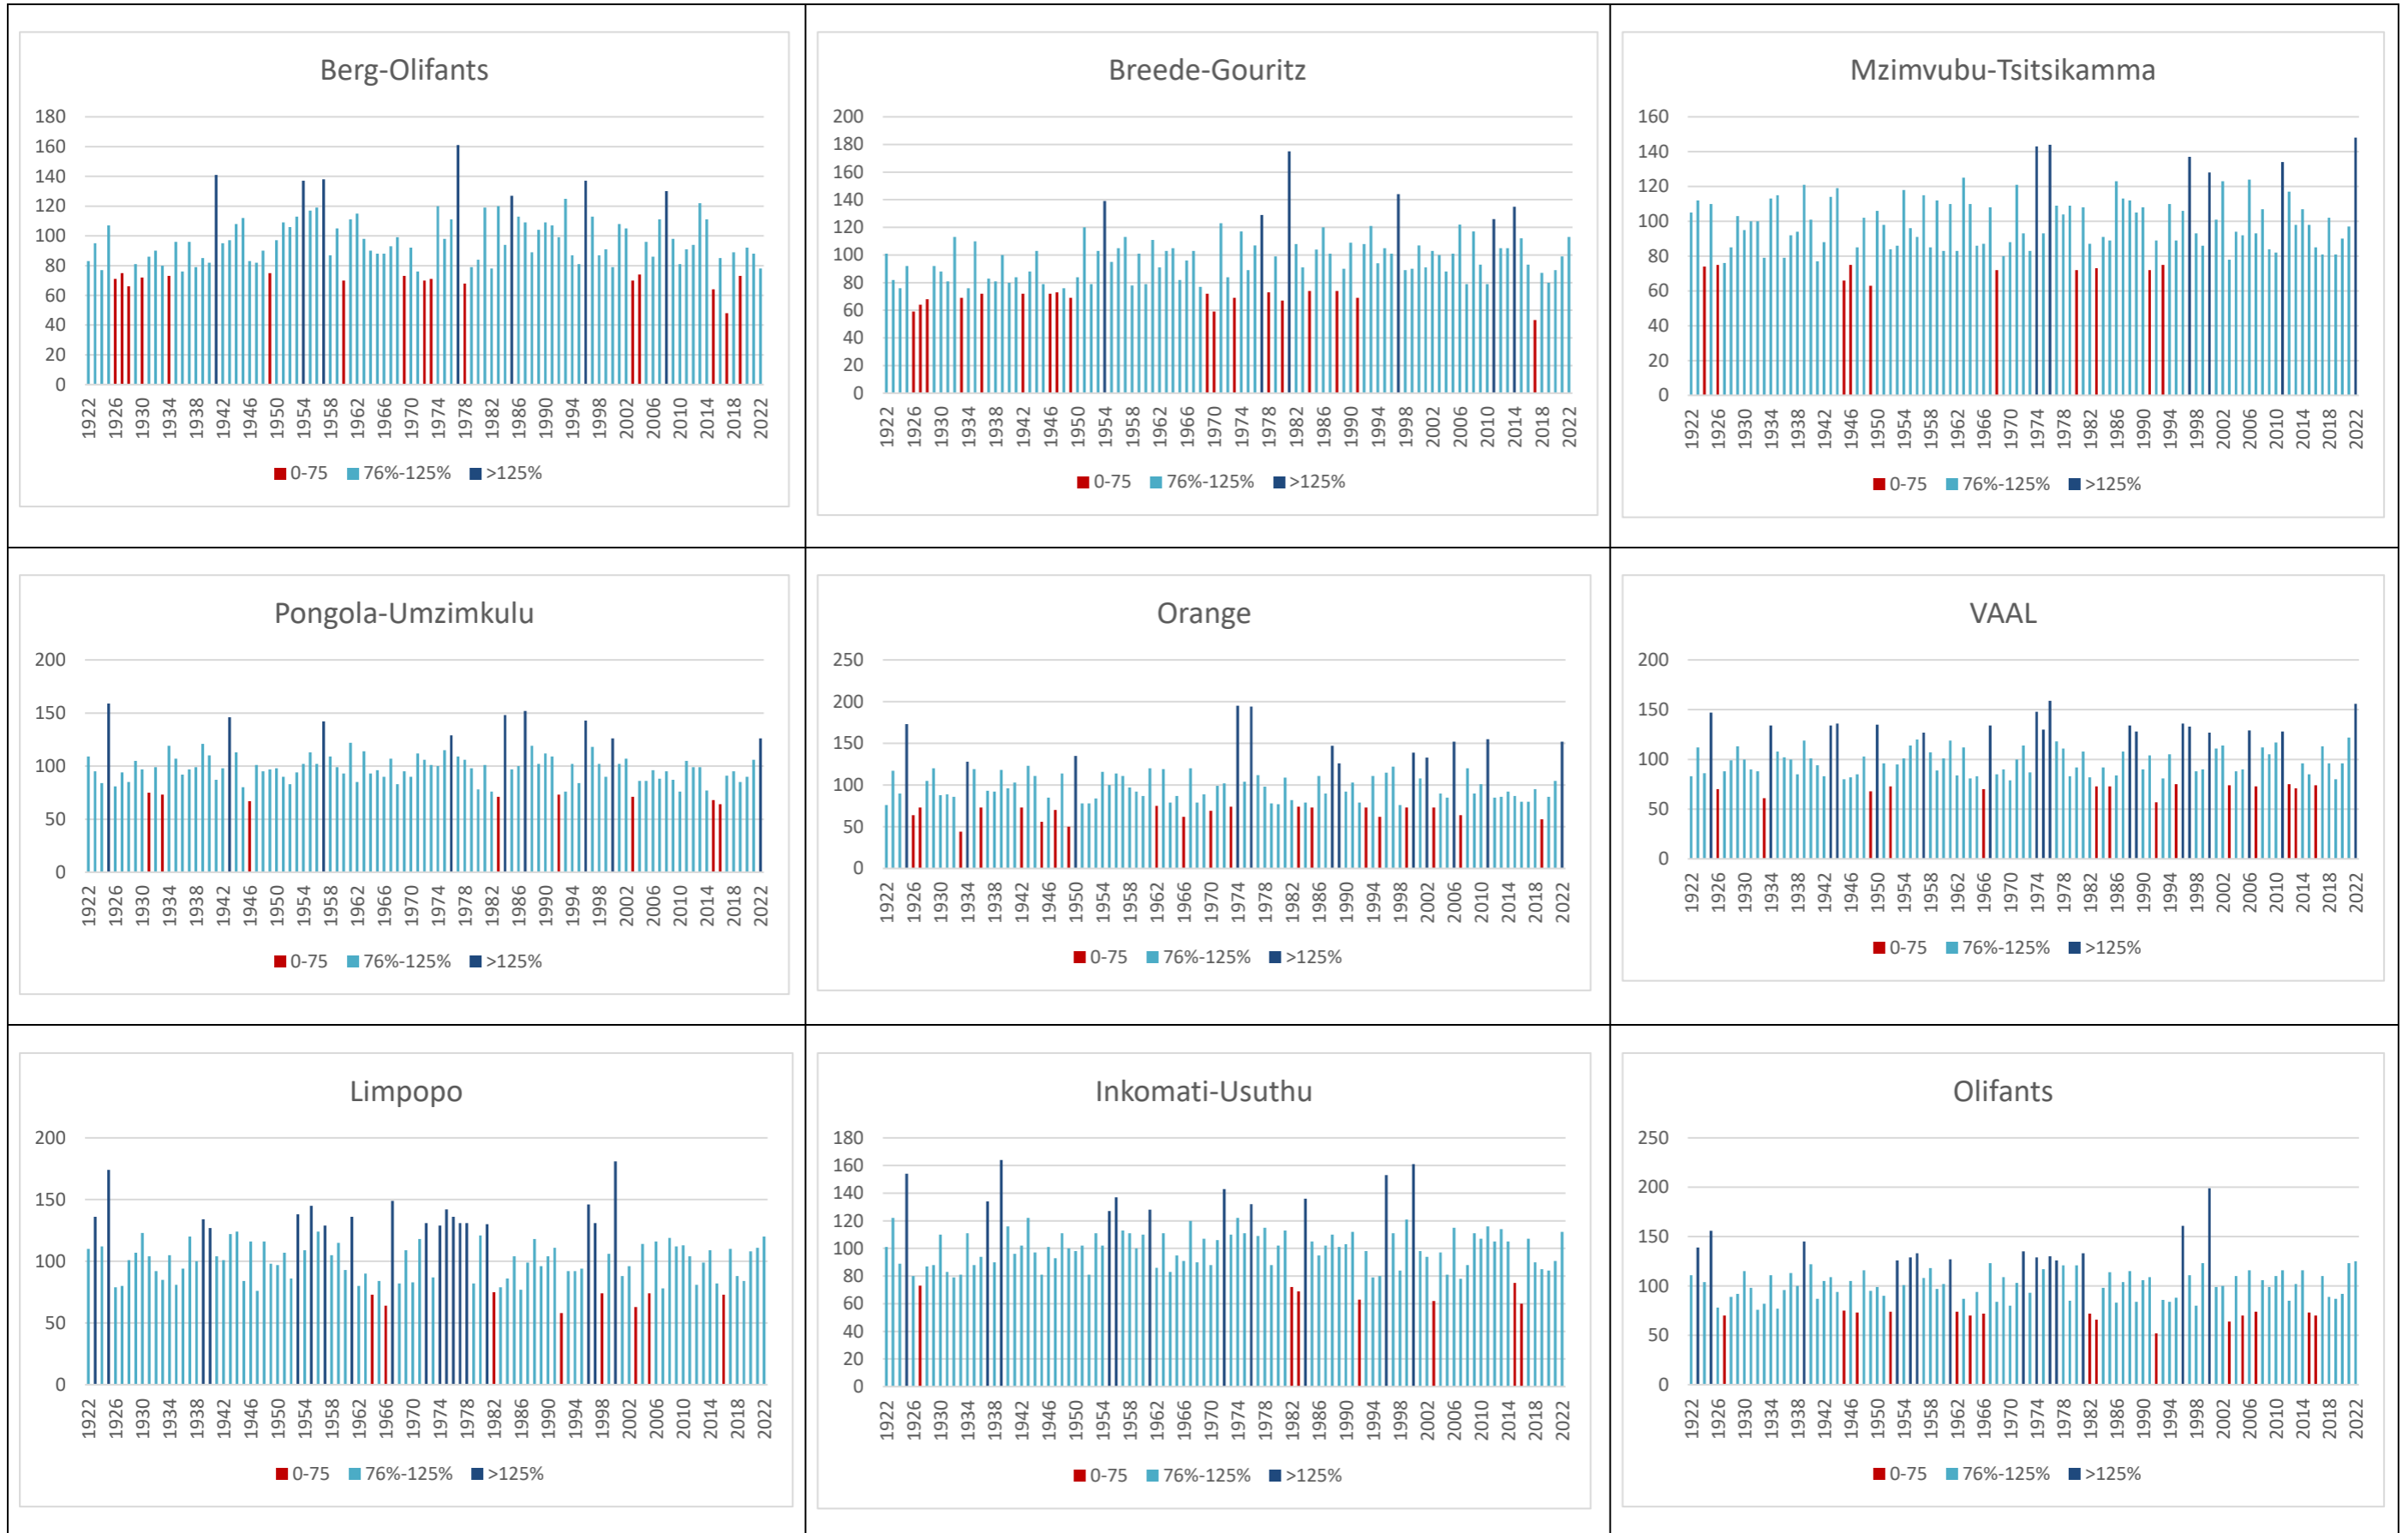
Figure 3.6 Hydrological year long-term trends of Rainfall Anomalies: > 125% (wet) & < 75% (dry) (Data Source: SAWS)

The long-term rainfall trend analysis per water management area is presented in Figure 3.6, Rainfall (% of Normal) for October 1981 - September 2022. The Normal Period used is October 1981 to September 2010.

Highlights from the anomaly's plots presented in Figure 3.6 is that for the 2021/22 hydrological year, most WMAs were classified as having experienced an above-average year. These are the Mzimvubu-Tsitsikamma WMA, Pongola-Umzimkulu WMA, Vaal and Orange WMA. Surface storage Dam levels are expected to have been the highest in these water management areas during the reporting period.

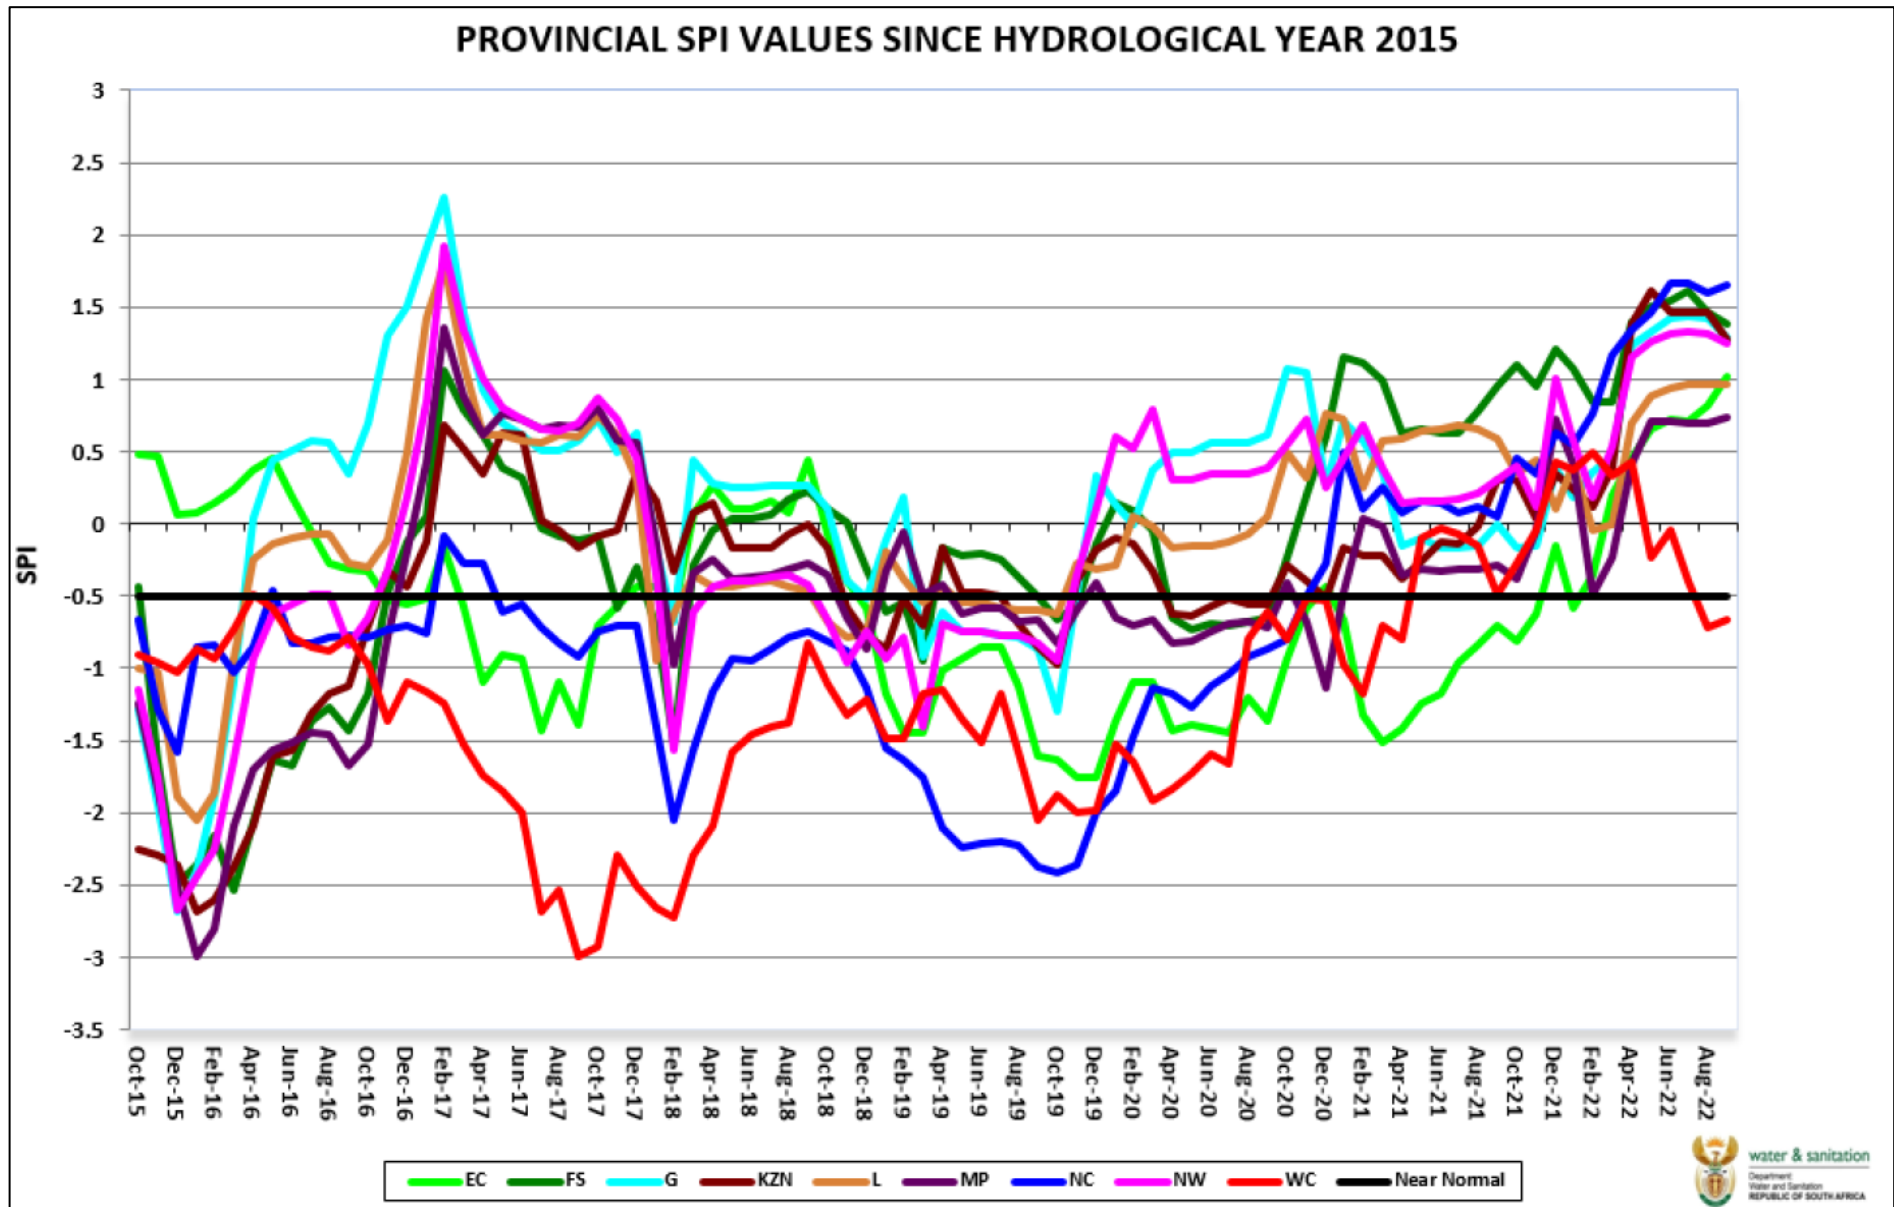
Figure 3.8 Provincial SPI time series from October 2015 – September 2022

Presented as a time series, the SPI shows its evolution of the SPI over time. SPI values of these longer timescales help determine the persistence, magnitudes of drought events, and flash points where hydrological droughts (low streamflow, reservoir levels, and even groundwater levels) are likely. This time series also makes it possible to analyse and visualise the intensity of the drought in an area of interest. Figure 3.8. presents the variation in SPI values for each of the South African Provinces over the past six years.

Drought conditions had already manifested by October 2015 over all the provinces, except for the Eastern Cape, as the SPI values were below the -0.5-threshold line on the graph. These provinces experienced extreme drought conditions from December 2015 to April 2016, resulting in severe water shortages.

In 2016, most Provinces except the Western Cape Provinces had good rains during the summer rainfall season, easing the drought briefly for about a year. In early October 2017, following a below-normal winter rainfall season, Cape Town had estimated five months of storage left before water supplies were depleted. By December 2018, the drought had spread to all provinces except Gauteng, Limpopo, and Mpumalanga, whose SPI values were above the near-normal line. Winter rains led to a rise in dam levels in the Western Cape in 2018. It was a dry year from March to November, but the severity of the drought varied across provinces.

The Northern Cape experienced arid conditions. The dry conditions eased in Free State, Gauteng, Limpopo, and KwaZulu-Natal in December 2019 but persisted in Mpumalanga, Northern Cape, Western Cape, and Eastern Cape until November 2020.

Since December 2020, conditions have been near-normal in most provinces, with the Western Cape, Eastern Cape, and Mpumalanga crossing the near-normal line only in March, June, and November 2021, respectively. The summer rainfall region was usually wet from October 2021 to April 2022, with some areas experiencing rain well into June. Over that time, the SPI for provinces has increased, confirming the wet conditions. There are parts of the summer rainfall region where SPIs have exceeded 1.0 and reached levels last touched five years ago.

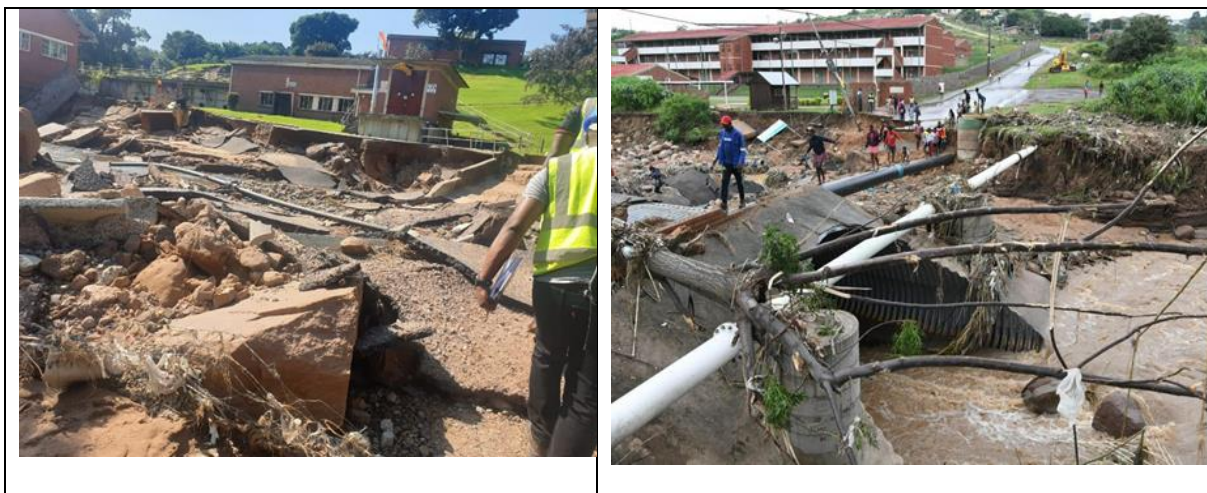
*Figure 3.12 Infrastructure damage caused by Floods in KZN South Africa April 2022*

The worst infrastructure damage in eThekweni was observed at the Surfside residential complex, which suffered significant damage due to a lack of stormwater infrastructure in development under construction upstream of the complex. The May floods also washed away the various repairs underway at the Umdloti Water Treatment Works.
