STATE OF THE RIVERS

4 STATE OF RIVERS

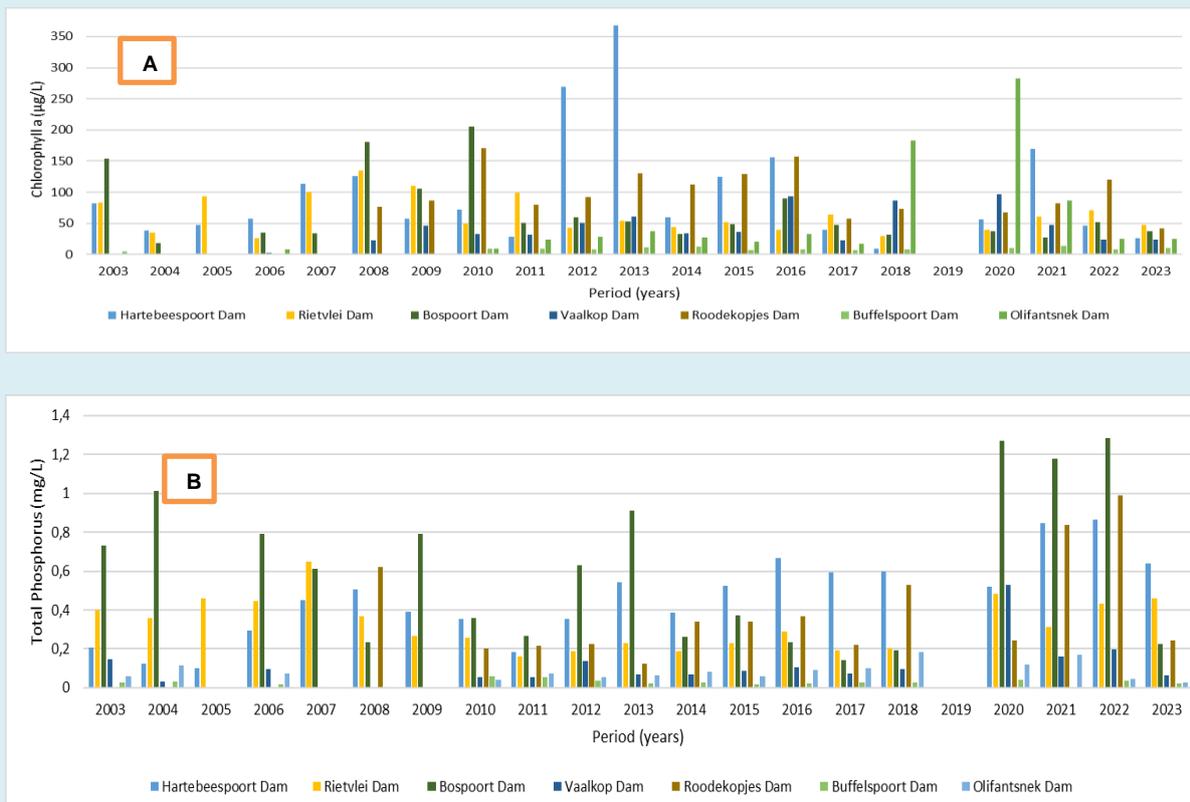
Figure 1. A) Chlorophyll-a and B) Total Phosphorus for the Hartebeespoort, Roodekopjes, Rietvlei, Buffelspoort, Bospoort, Olifantsnek, and Vaalkop dams.

The trophic status of a dam is generally an indication of the level of nutrient enrichment and the resulting algal production of the particular dam. Changes in trophic status over the past two decades (2003 to 2023) for seven dams in the upper Crocodile catchment are represented in Figures 1 A and B below. The chlorophyll-a concentrations falling in the **eutrophic** status range were found in Olifantsnek Dam (25.5 µg/L), Vaalkop Dam (24.2 µg/L) and Hartebeespoort Dam (26.6 µg/L), while Roodekopjes Dam, Rietvlei Dam and Bospoort Dam were all found to be **hypertrophic** with mean chlorophyll-a values of 42.02 µg/L, 47.4 µg/L and 37.4 µg/L, respectively. Buffelspoort Dam was classified as **mesotrophic** based on its chlorophyll-a concentration being in the $10 < x < 20$ range. The Total Phosphorus indicator in

Bospoort Dam, Rietvlei Dam, Hartebeespoort Dam and Roodekopjes Dam was in the >0.130 range, which indicates a **serious** potential for algal and plant productivity. Vaalkop Dam was in the $0.047 < x < 0.130$ range with a mean Total Phosphorus value of 0.06 mg/L for the current year, indicating a significant potential for algal growth and plant growth, while Buffelspoort Dam and Olifantsnek Dam were found to have moderate potential for algal and plant growth.

A more comprehensive view of the two trophic status indicators for the past two decades suggests an irregular and seasonal trend in terms of the data patterns, as the fluctuations do not show constant regularity throughout the time series.
