STATE OF RIVERS

4.1 Streamflow

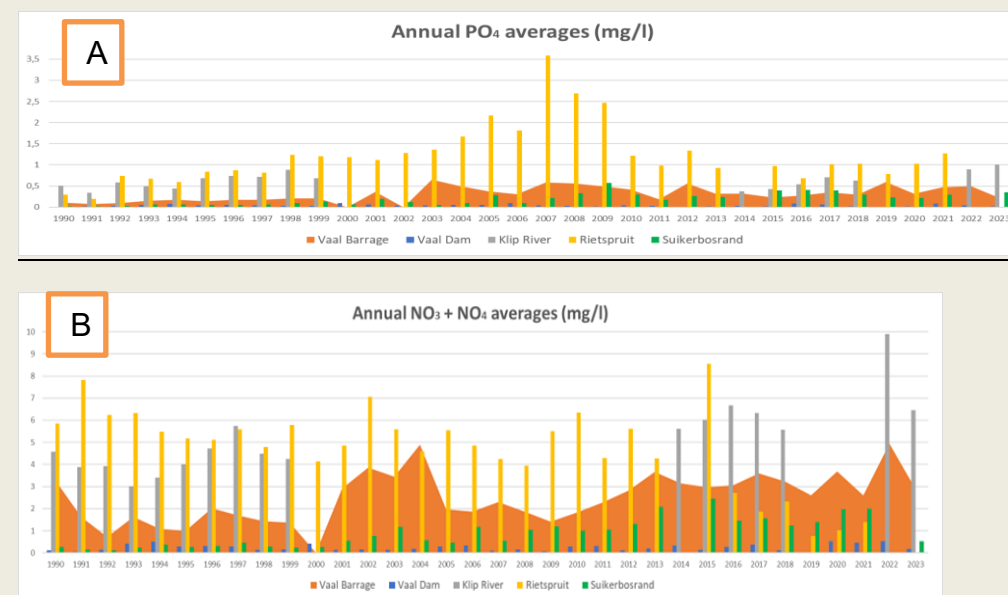
Figure 4.6: Ortho Phosphate, B) Nitrate annual average levels in the Klip, Rietspruit and Suikerbosrand rivers from 1990 to 2023.

The Vaal Barrage is primarily supplied by flows from the Vaal Dam, along with the Klip, Suikerbosrand, and Rietspruit rivers. These three rivers drain large urban areas, both formal and informal, as well as mining and industrial zones located to the east and southwest of Johannesburg. Consequently, there is an increased pollution load in the waters upstream of the Vaal Barrage. The long-term nutrient levels in these three tributaries, measured before they converge with the Vaal River, are illustrated in

[Figure 4.6](#). For reference, the nutrient levels in the Vaal Dam and the Vaal Barrage are also shown. Although the nutrient levels shown in the graphs indicate high pollution levels in these tributaries, it's essential to consider that differences in catchment size and characteristics affect the flow rates and volumes entering the Vaal River. The amount of nutrients (nutrient load) flowing into the Vaal from these tributaries depends on both the concentration of nutrients and the volume of water.

Comparing the general flow rates, the Klip River averages between 15-35 m³/s, while the Rietspruit and Suikerbosrand range from 2-4 m³/s and 2-15 m³/s, respectively. This suggests that, with similar nutrient levels, the nutrient loads from the Klip River could be significantly higher than those from the Rietspruit and Suikerbosrand. From [Figure 4.6](#), it's evident that the Klip and Rietspruit rivers are the main contributors to nutrient loads.
