**DETERMINATION OF WATER RESOURCE
CLASSES AND ASSOCIATED RESOURCE
QUALITY OBJECTIVES IN THE UPPER
ORANGE RIVER CATCHMENT**

**ECOLOGICAL WATER
REQUIREMENTS REPORT
WP 11422**

**Study Report No.
RDM/WMA13/00/CON/CLA/0524**

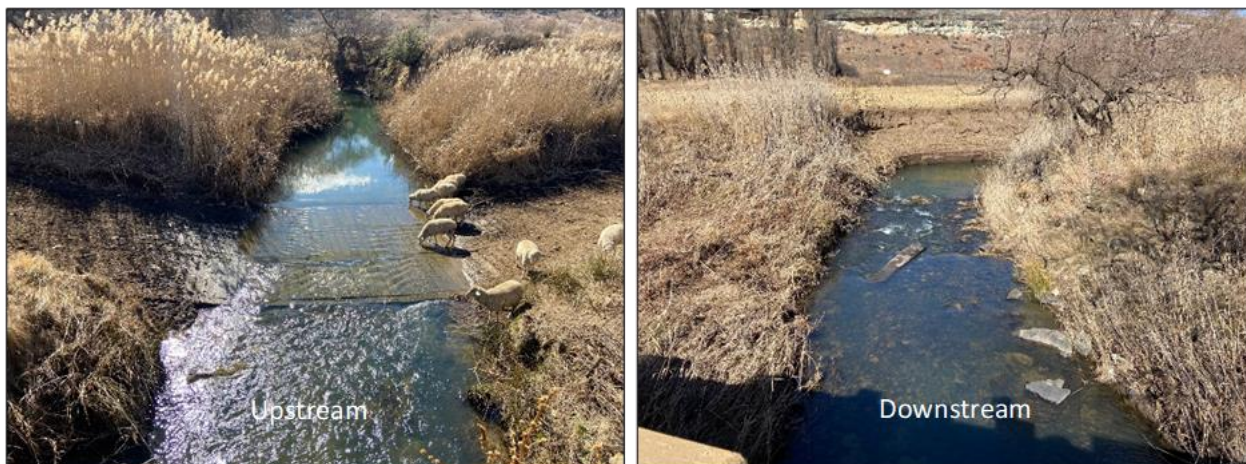
Figure 9: Site photographs of Little Caledon, UO_EWR01_R, during the survey (July 2022)

Figure 9 shows site photographs. Localised channel modification and bank modification are evident. Farm road/bridge crossing, along and immediately upstream a causeway/bridge which is frequently used by farmers and cattle crossing the river. Both banks show localised erosion. No large upstream dams. The river is approximately 5m wide and has a range of biotopes for both macroinvertebrates and fish. For macroinvertebrates the following biotopes are available: marginal vegetation, Stones-In-Current, Stones-Out-of-Current (SIC, SOOC) and Gravel, Sand, Mud (GSM). For fish the following biotopes are available: , Slow Deep (SD), Slow Shallow (SS) and Fast Shallow (FS). The marginal vegetation is limited owing to steep undercut banks and vegetation die-back. There is much in-stream vegetation debris creating additional habitat for biota. The riparian vegetation zone is modified primarily owing to agriculture/croplands encroachment, although thickets of *Phragmites australis* and *Salix sp.* also occur within the zone. Just downstream of the bridge there is a section of riffles and runs downstream of the causeway. There are upstream deep pools with a meandering channel. During the July 2022 survey for the Reserve study, the flows were higher than expected for the dry season owing to enhanced baseflows due to a very wet and late rainfall season.

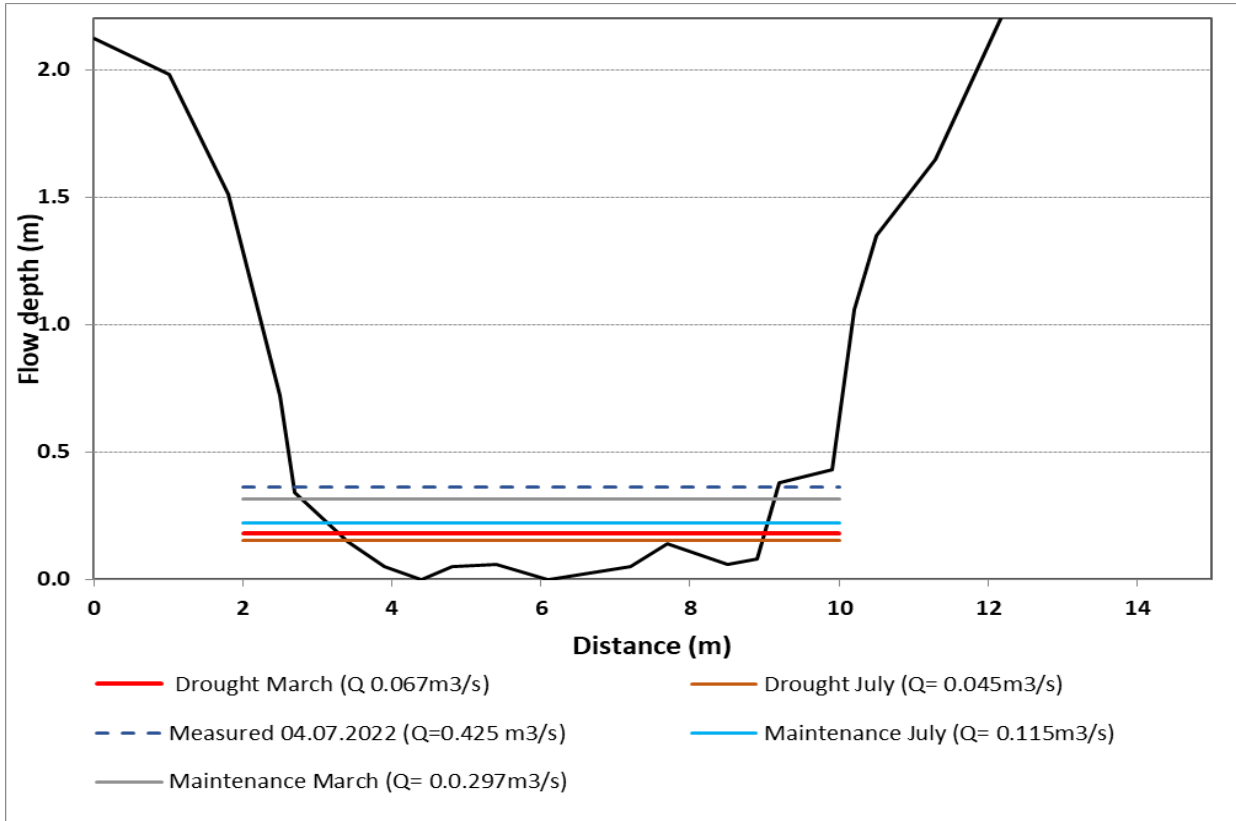
Figure 10: Water levels on cross-section of UO_EWR01_R in the Little Caledon River in D21D

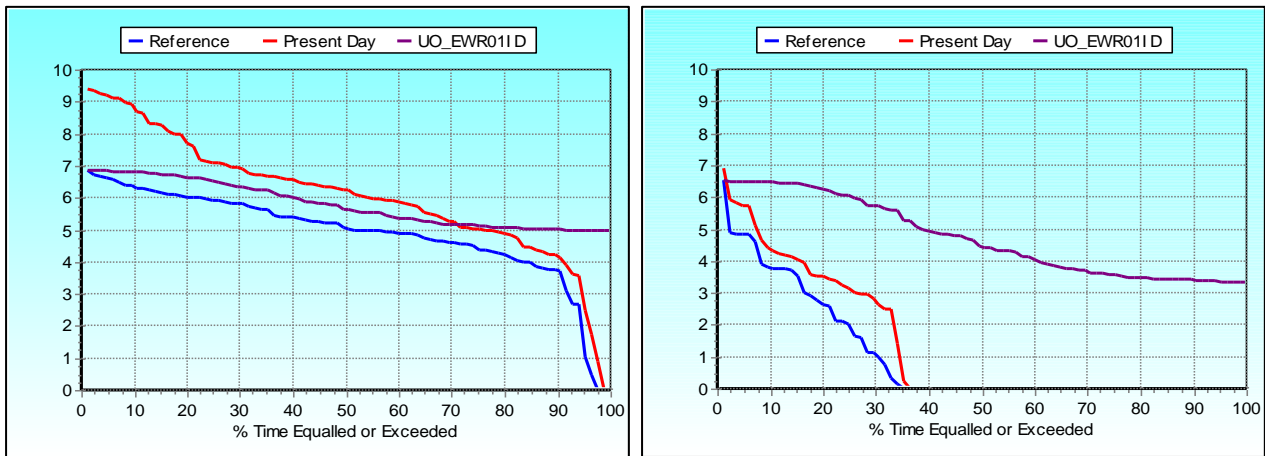
Figure 15: Final stress duration curves – dry season (July) and wet season (February) for UO_EWR01_I

- Increase drought flows from 3.52% to 3.77%
- Increase July maintenance low flows from 0.497 m³/s to 1.304 m³/s
- Increase February maintenance low flows from 1.591m³/s to 4.171 m³/s

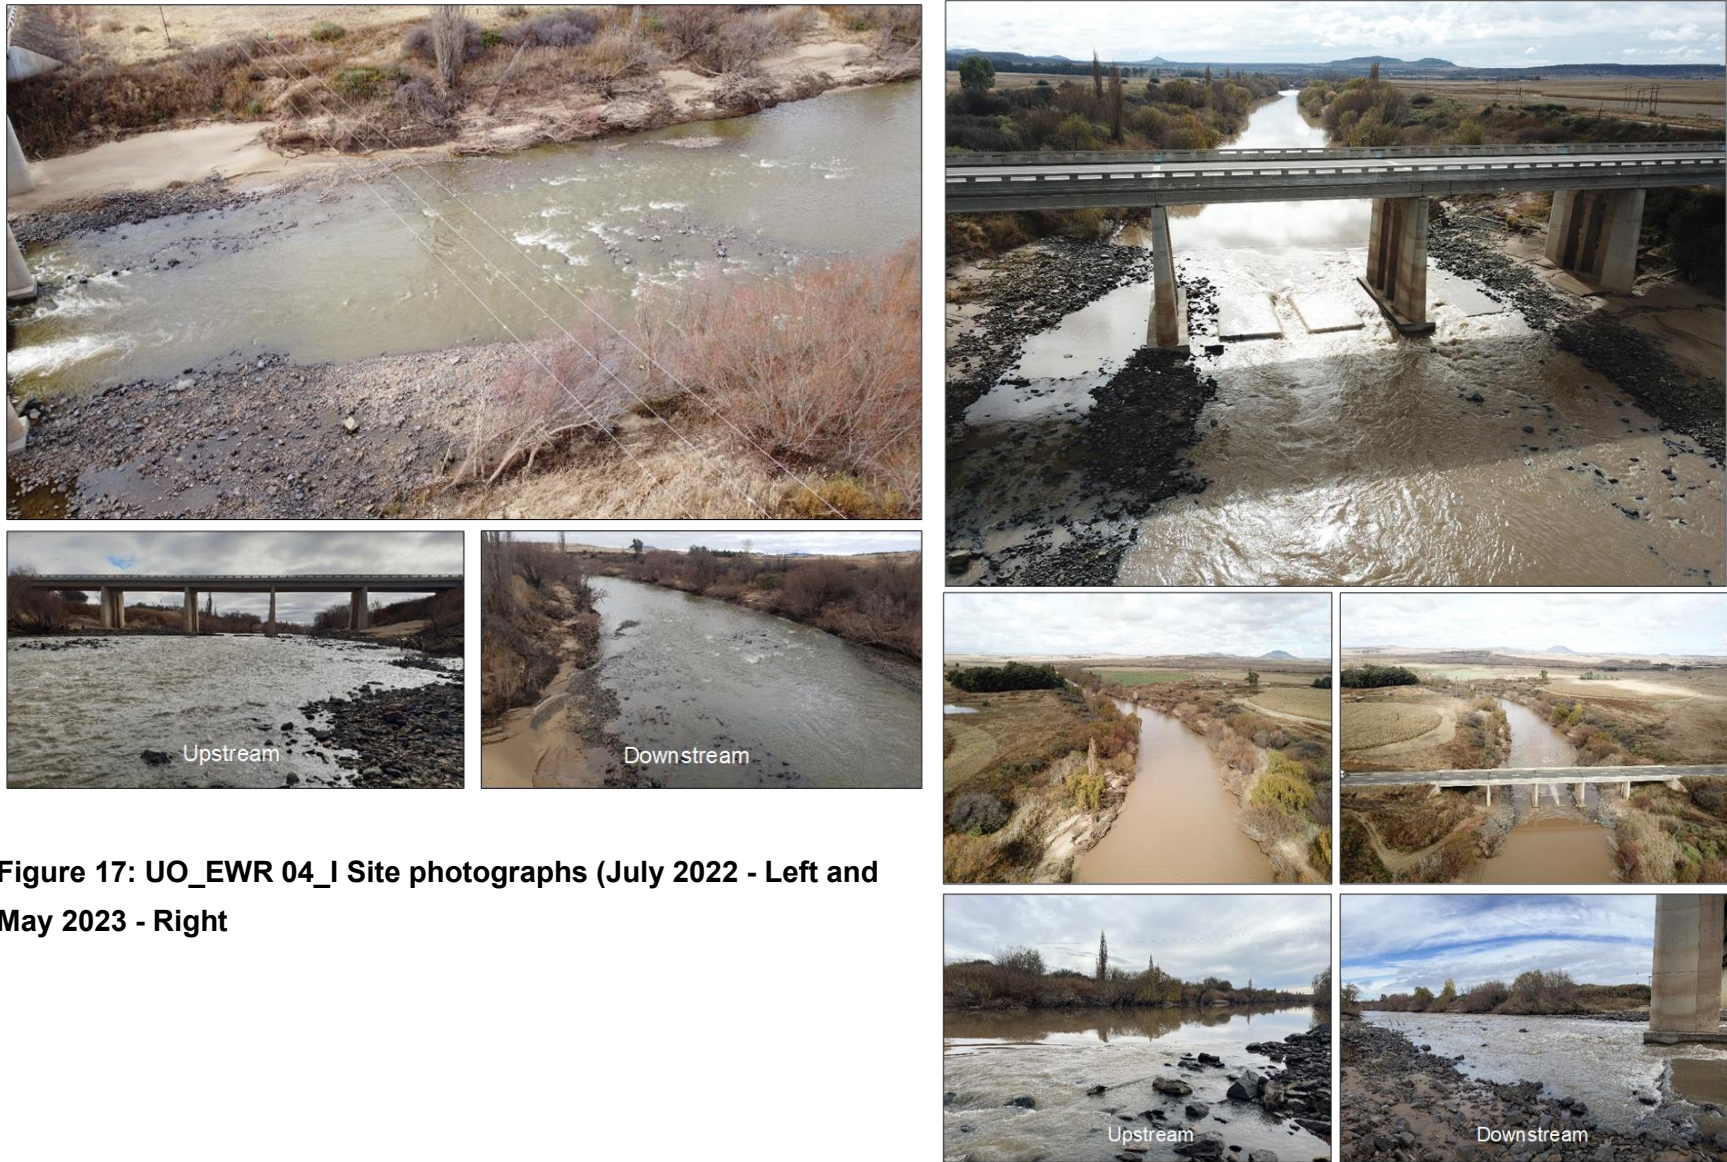
Figure 17: UO_EWR 04_I Site photographs (July 2022 - Left and May 2023 - Right)

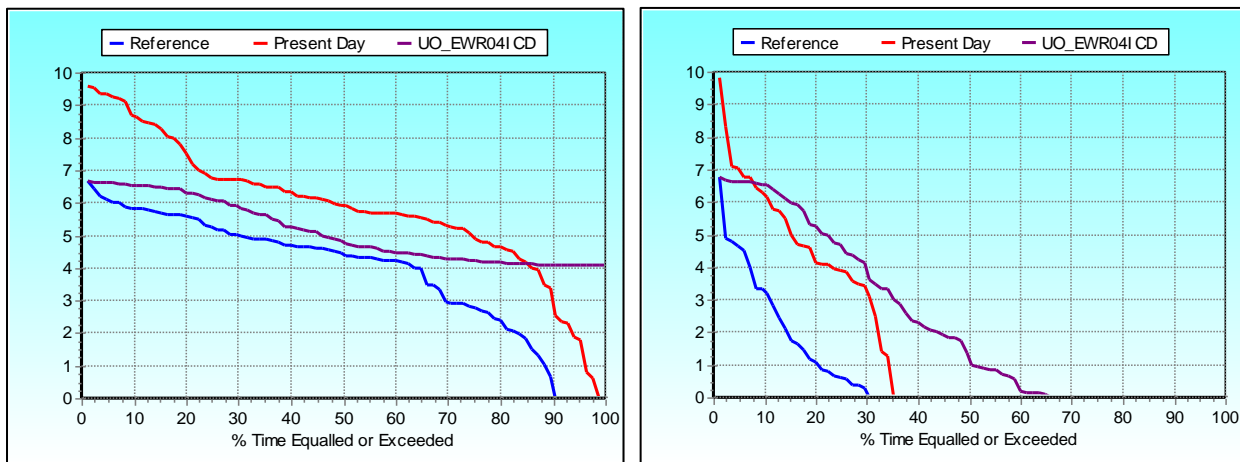
Figure 19: Final stress duration curves – dry season (July) and wet season (February)

- Increase July maintenance low flows from 1.636 m³/s to 3.393 m³/s, and
- Increase February maintenance low flows from 5.310m³/s to 11.015 m³/s.

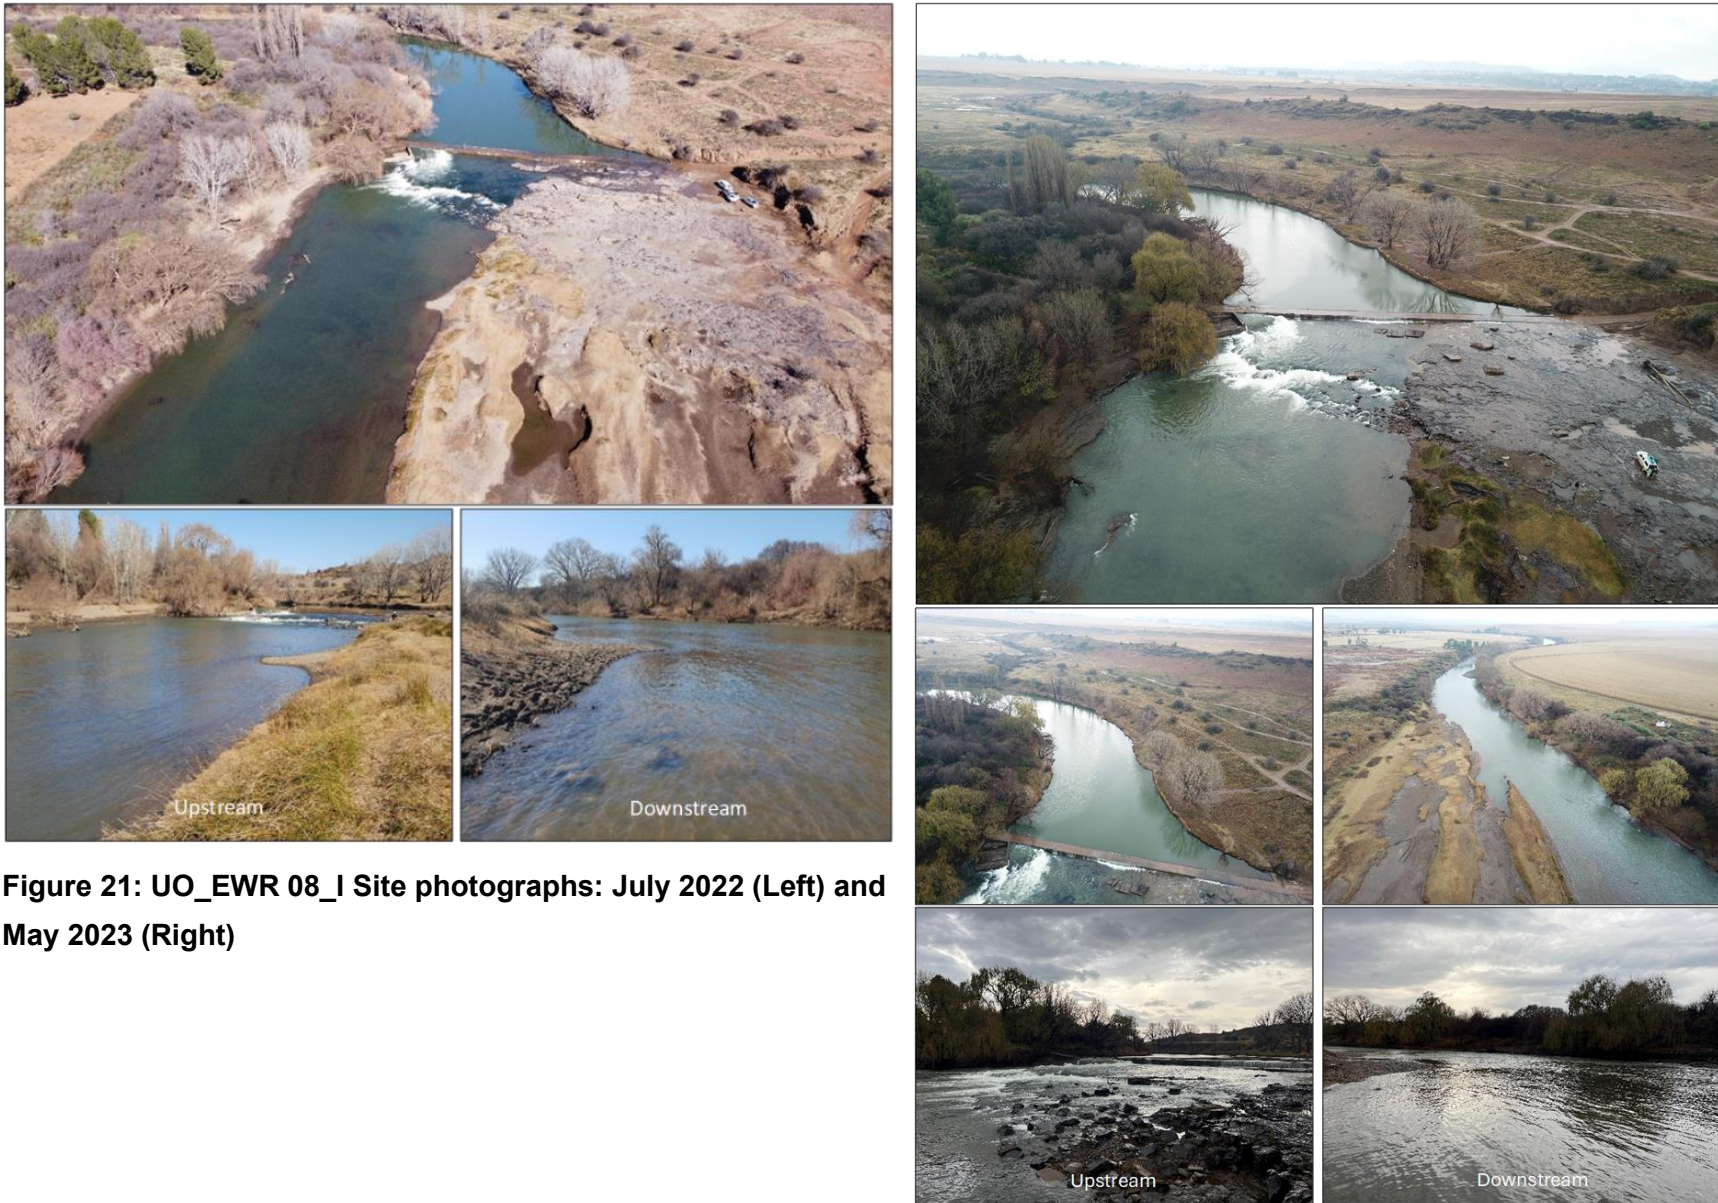
Figure 21: UO_EWR 08_I Site photographs: July 2022 (Left) and May 2023 (Right)

Figure 21 illustrates the site during July 2022 and May 2023. The left bank is dominated by non-woody vegetation, with several, large Poplar trees (*Populus canescens*) growing along the lower banks upstream of the weir. The site is spilt by the weir/ causeway, which results in marginal zone being inundated. Downstream of the weir is a broad, flat bench of mostly bare/exposed alluvium with patches of raised alluvial mounds covered with *Cynodon dactylon* and a narrow strip of dense *Cyperus marginatus* growing along the marginal zone. The outer edge of the riparian is marked

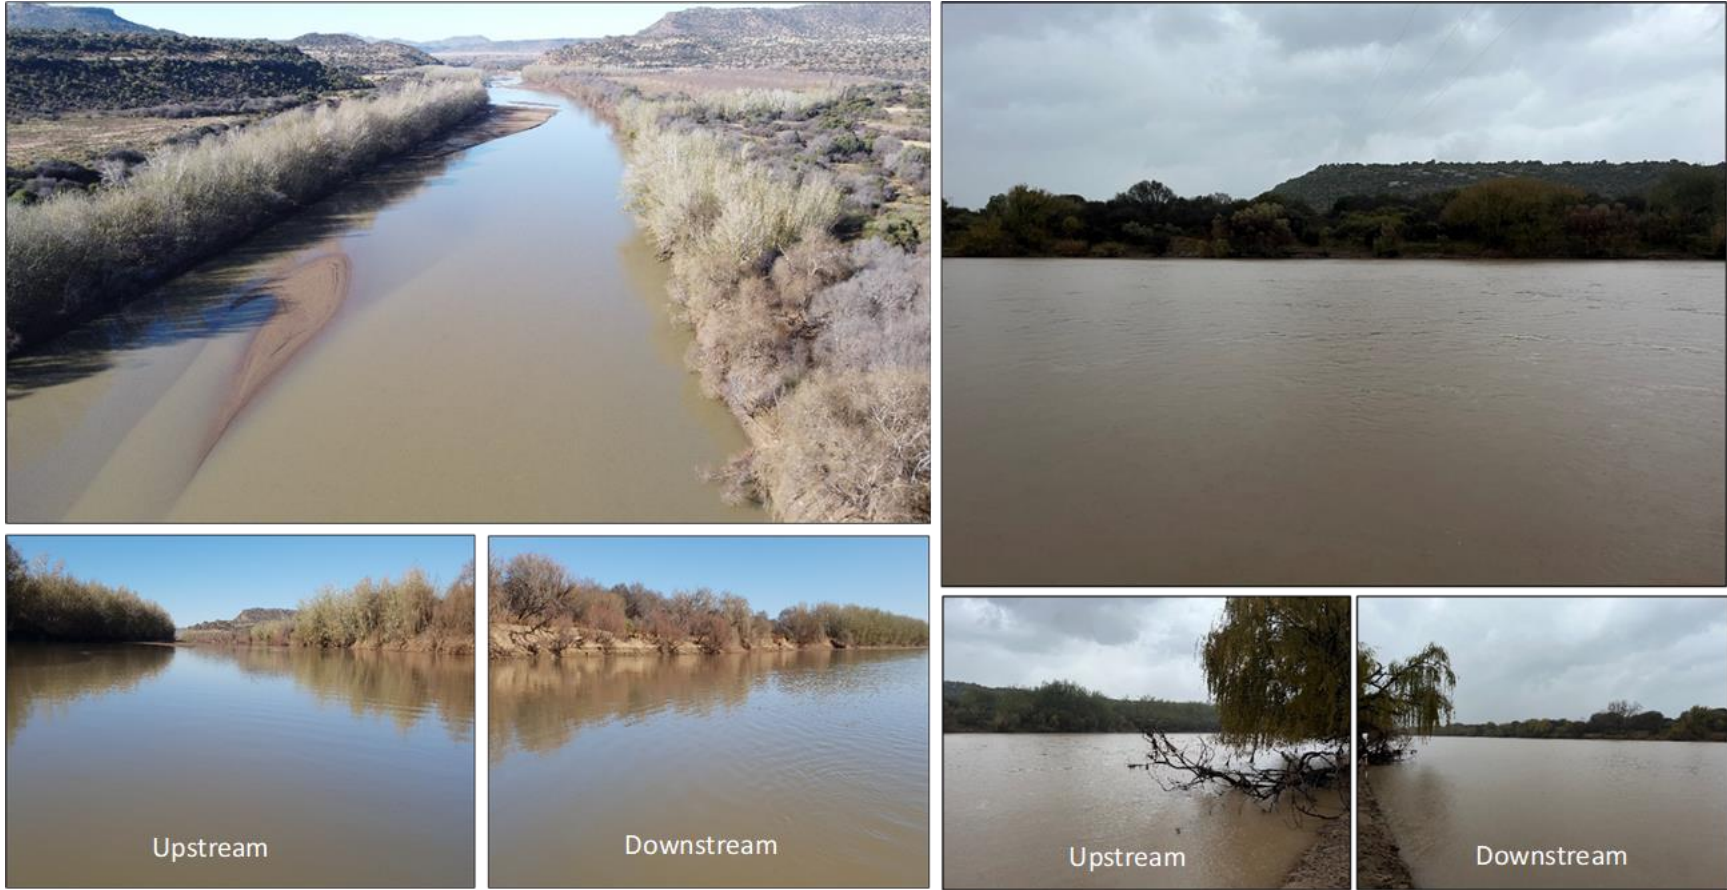
Figure 25: UO_EWR03_I Site photographs during the surveys in July 2022 (Left) and May 2023 (Right)

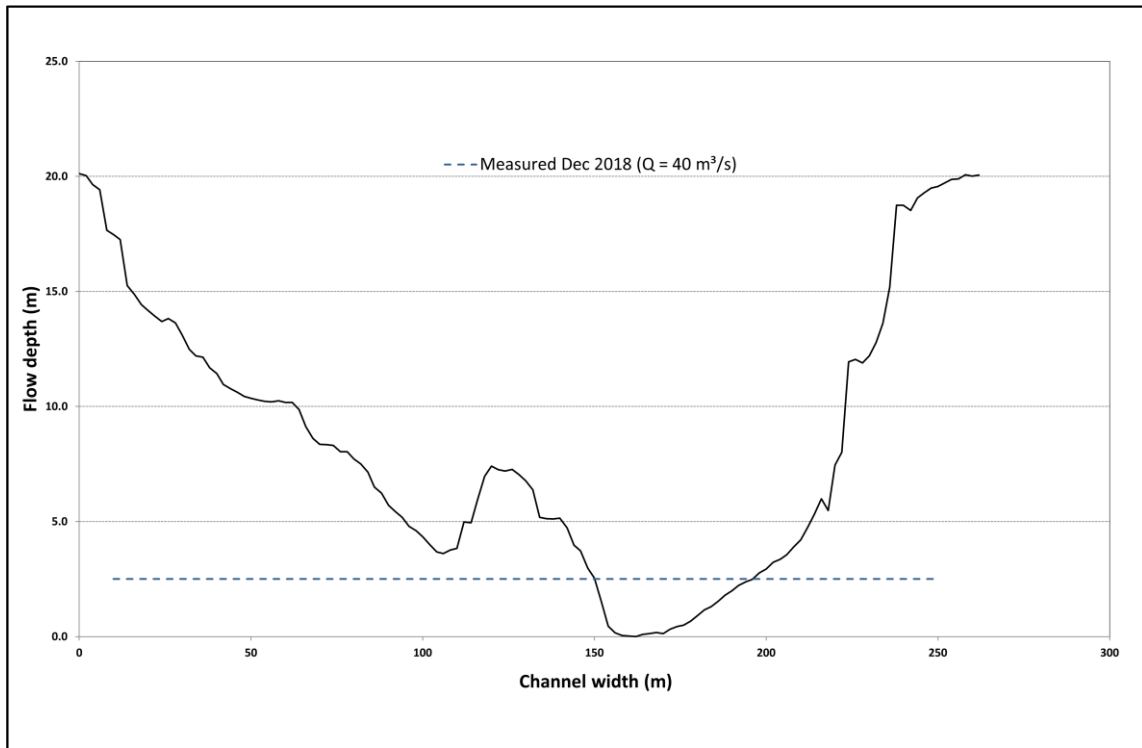
Figure 29: Cross-sectional view of the Gariep to Vanderkloof EWR site (UO_FMP)

The cross-sectional views of the site between Gariep to Vanderkloof dams, stage discharge relationships developed from the modelling and the detailed output tables are shown in Figure 29 and Figure 30.

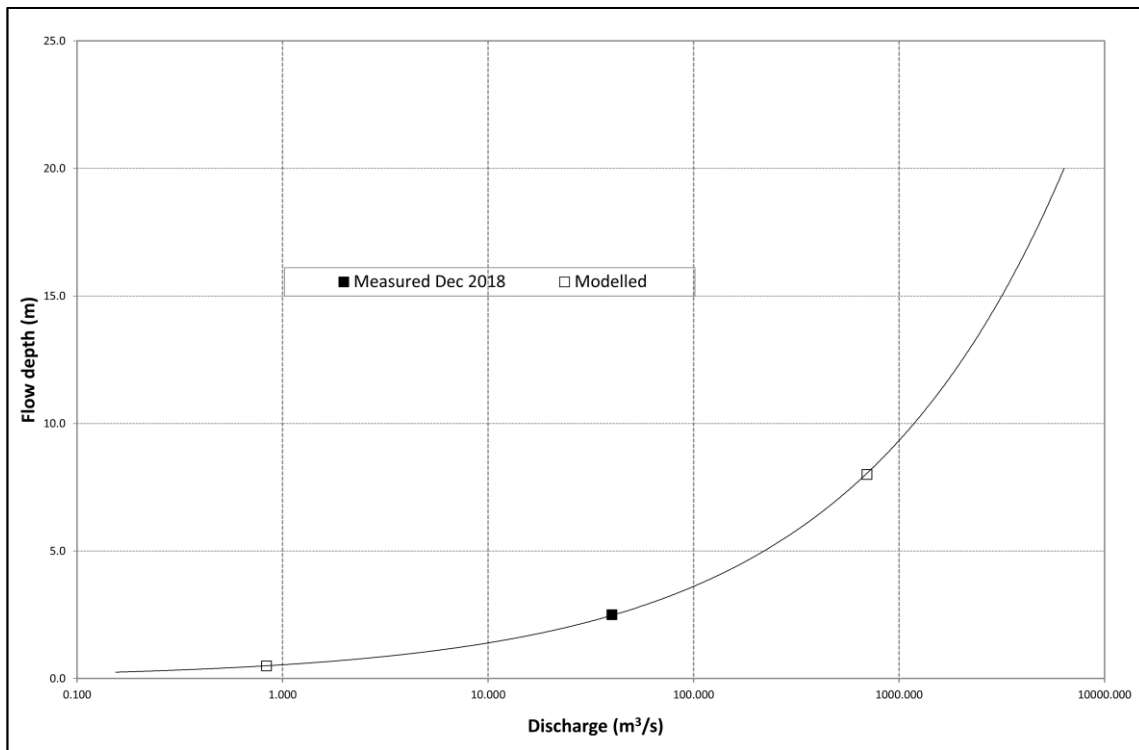
Figure 30 Relationship between flow depth and discharge at Gariep to Vanderkloof EWR site (UO_FMP)

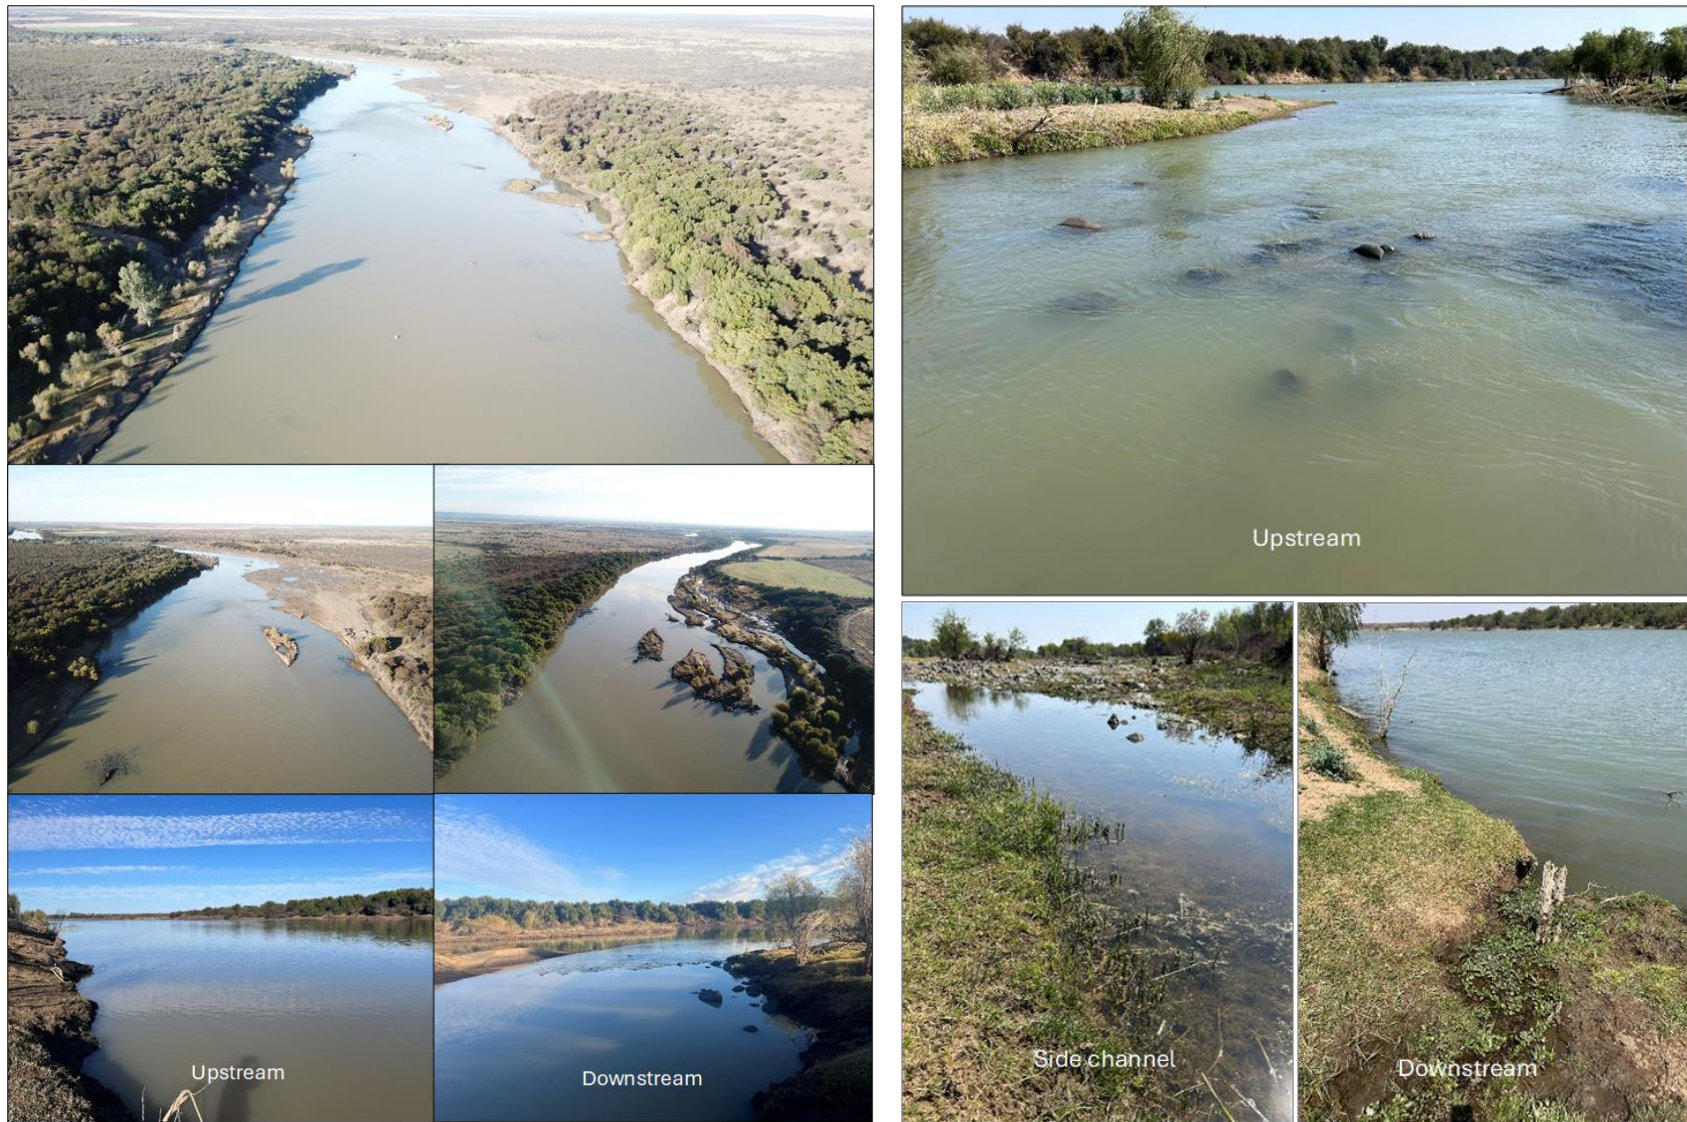
Figure 34: UO_EWR10_I site photographs during the surveys in June 2023 (Left) and October 2024 (Right)

Figure 34 shows site photographs during the surveys in June 2023 and October 2024. The site is defined by an incised macro-channel approximately 160m wide. The channel has a straight to sinuous planform with pool-riffle and pool-rapid reach types. The riffles have cobble and gravel sediment, with bedrock and boulders forming the rapids. The pools are longer than the riffles and have sand bars and lateral bars in places. Islands form on bedrock with sedimentary coverings. The banks are steep due to the incised nature of the river and composed of fine silt and sand.

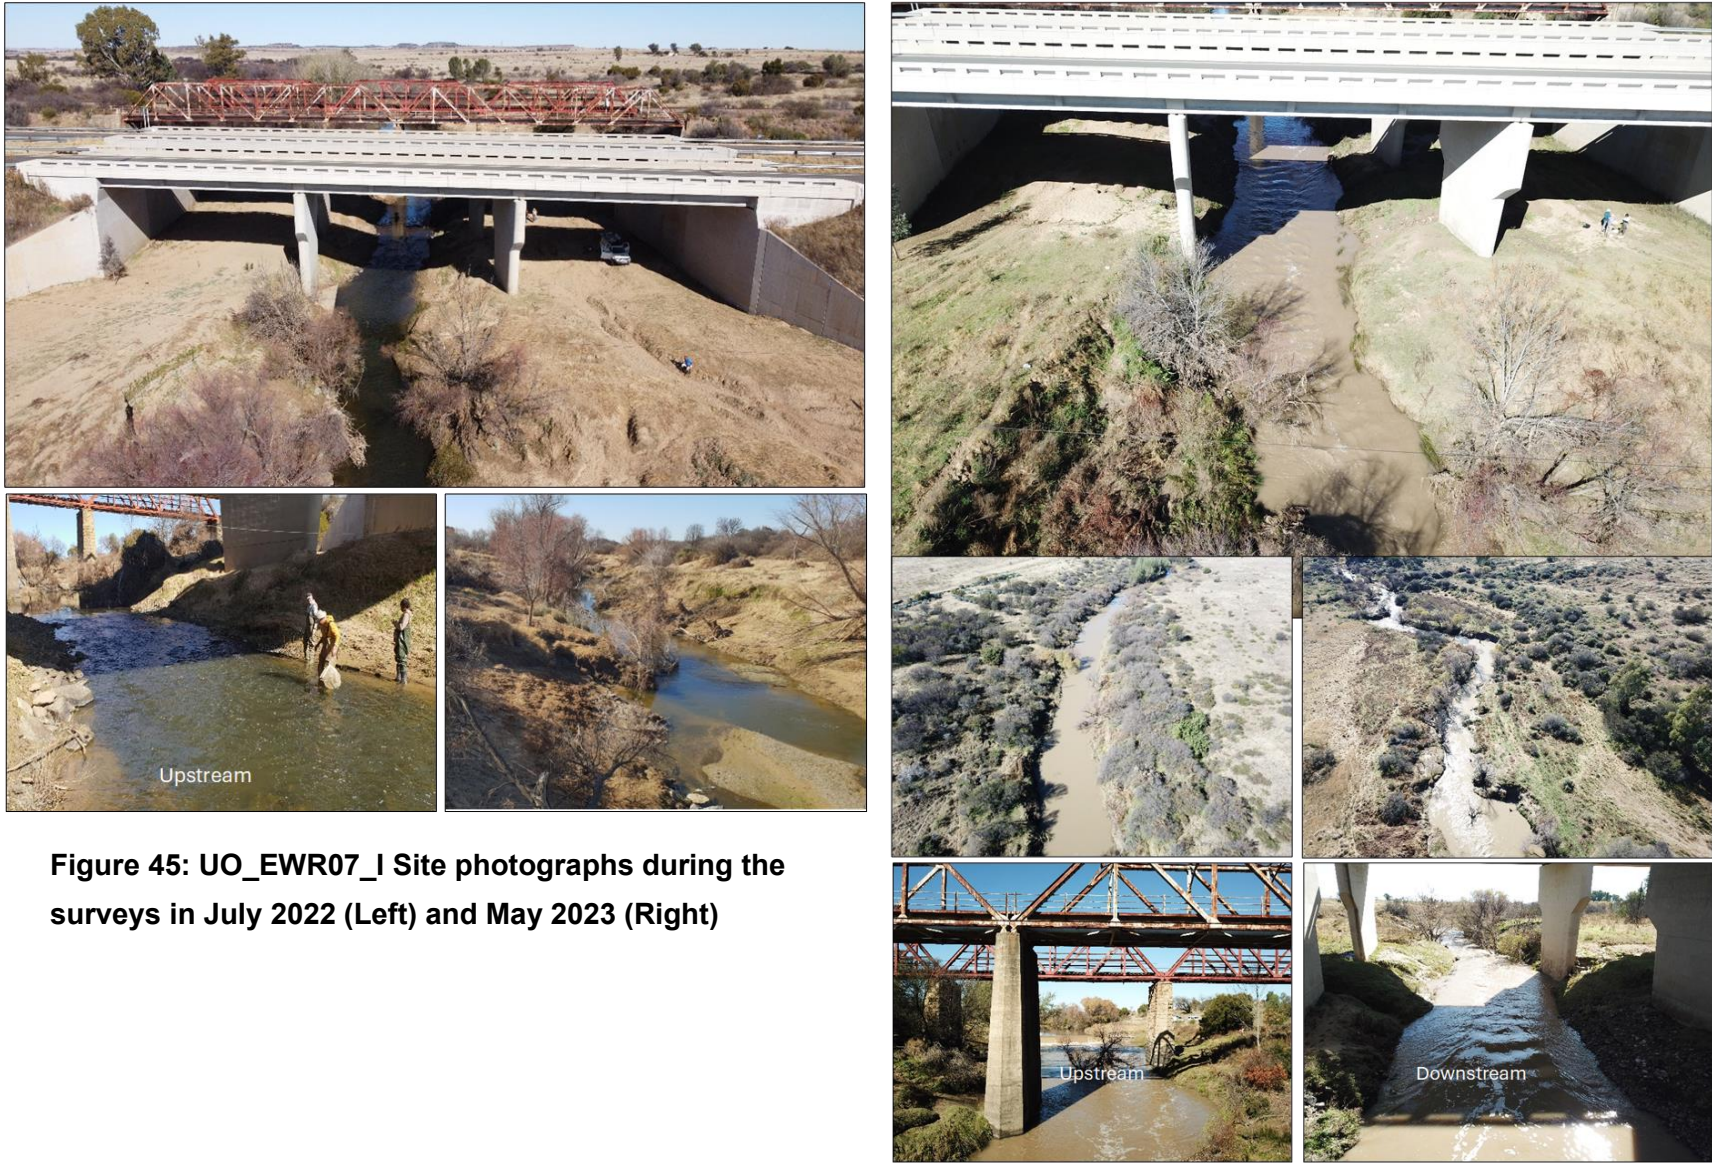
Figure 45: UO_EWR07_I Site photographs during the surveys in July 2022 (Left) and May 2023 (Right)

Figure 45 shows site photographs during the surveys in July 2022 and May 2023. The reach is largely unconfined, with gently sloping hillslopes and an incised channel with narrow flood features. The site is bedrock controlled with silty banks and introduced coarser bed material. Gravel and sand bars are present downstream of the site. The site is situated approximately 13 km downstream of Rustfontein Dam. It is impeded by two (2) railway crossings and a large bridge. Furthermore, a gauging weir is located just upstream of the site. The river width varies from 3 m to 15 m in places with inundation taking place just upstream of the weir. Owing to these influences and impediments, much of the instream substrate, downstream of the weir comprises riffles with artificial loose SIC, and some SOOC. However, bedrock is the dominant substrate from the bridge and further downstream. There is relatively good GSM, but marginal vegetation, being grasses and sedges, was limited owing to undercut banks and vegetation die back during winter (representative of the season). Sedimentation is present downstream of the weir forming a back eddie along the sandbank with algae on the rocks at the river's edge. Overall, considerable channel and bed modification is present at this site. Both banks are heavily eroded owing to recent flooding, flow modifications and cattle trampling.

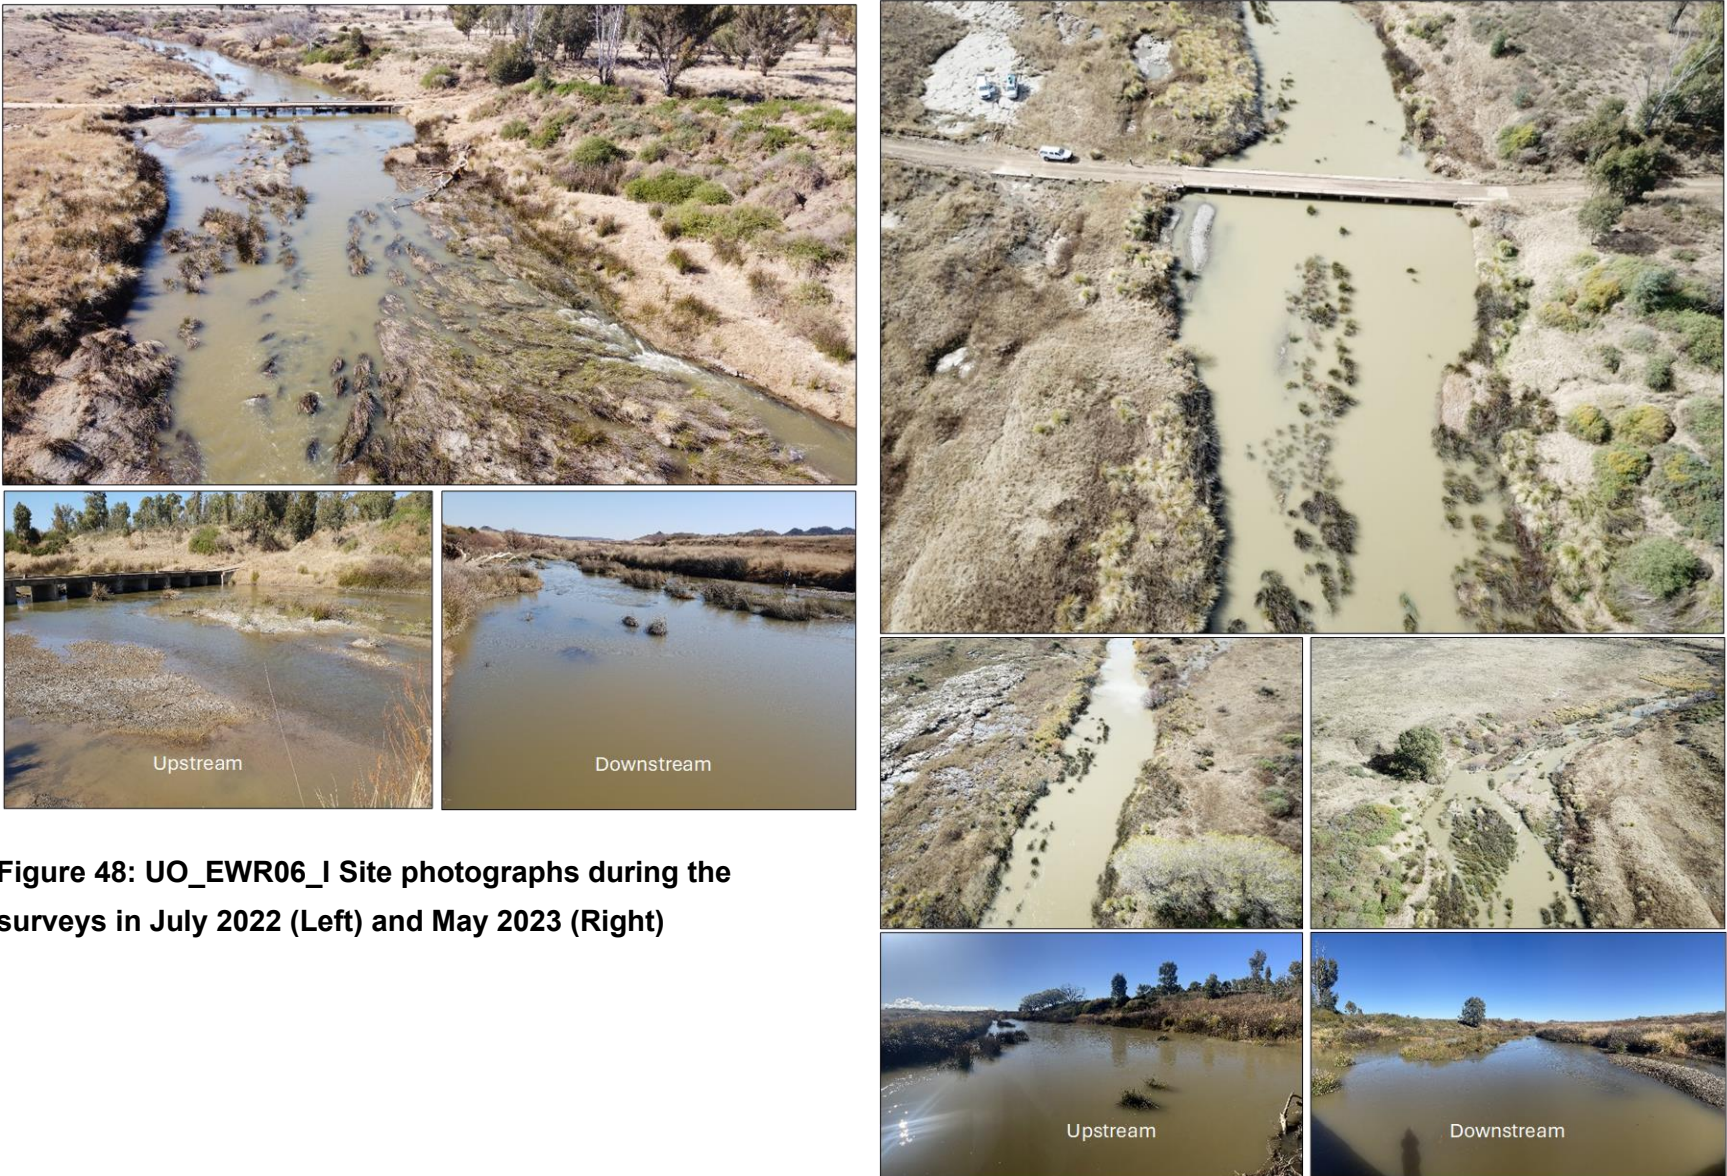
Figure 48: UO_EWR06_I Site photographs during the surveys in July 2022 (Left) and May 2023 (Right)

Figure 48 shows site photographs during the surveys in July 2022 and May 2023. The reach is largely unconfined, with the macro channel incised into the gently sloping hillslopes. The river has a straight to sinuous macro channel pattern, with a braided low flow channel pattern. Bedrock, boulder, gravel and silt sediment types at the site. Upstream of this site is the DWS REMP site and previous JBS3 site C5RIET-IFR03 and 26_10 respectively. The Riet River is a main tributary of the Vaal River and flows in a western direction. The site is located just downstream of a low water cross-over bridge, where log jams have occurred upstream of the bridge, impeding the hydraulics of the river, as well as inundation of the system upstream.

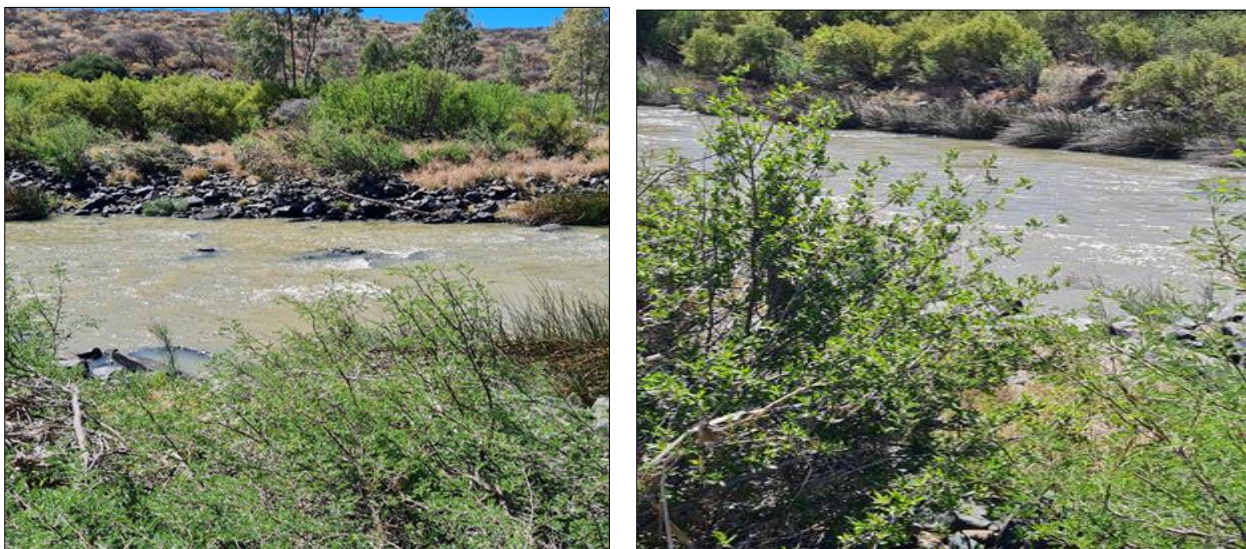
Figure 52: UO_EWR09_I Site photographs of the Lower Riet EWR site
