**DEPARTMENT OF WATER AND SANITATION  
REPUBLIC OF SOUTH AFRICA**

**NGQAMAKAWE REGIONAL SUPPLY SCHEME PHASE 5**

**BUTTERWORTH EMERGENCY SUPPLY SCHEME**

**VOLUME 4: SITE INFORMATION**

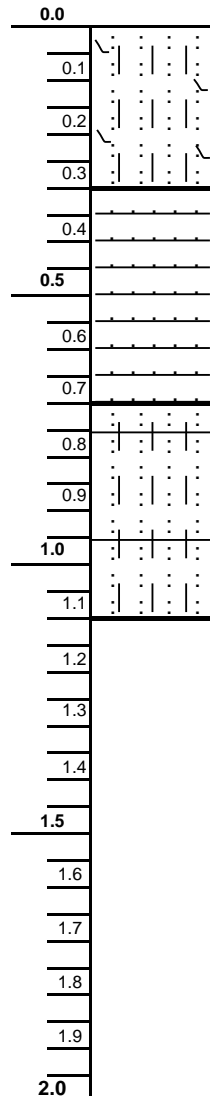
**Position:****AR Trial Hole 5**  
**S 32°02'50.7"**  
**E 27°50'38.3"**

**SAMPLES TAKEN: 3384, 3385**  
No ground water.  
Refusal @ 1000mm on Sandstone

Moist, light Brown, soft, intact,  
silty sand + Roots + Sandstone gravel.  
Transported:

Moist, light Red Brown, hard, micro-  
shattered, highly weathered Sandstone.  
Residual:

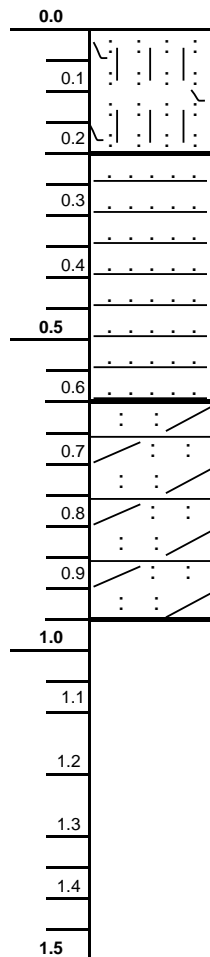
**Position:****PS 2 Trial Hole 5****S 32°03'22.5"****E 27°52'39.2"**

**NO SAMPLE TAKEN:**  
No ground water.  
Refusal @ 300mm on Sandstone Plate

Moist, light Brown, soft, intact,  
silty sand + Roots + Sandstone gravel.  
Transported:

Slightly moist, light Red Brown, soft to  
hard, micro-shattered, weathered  
Sandstone.

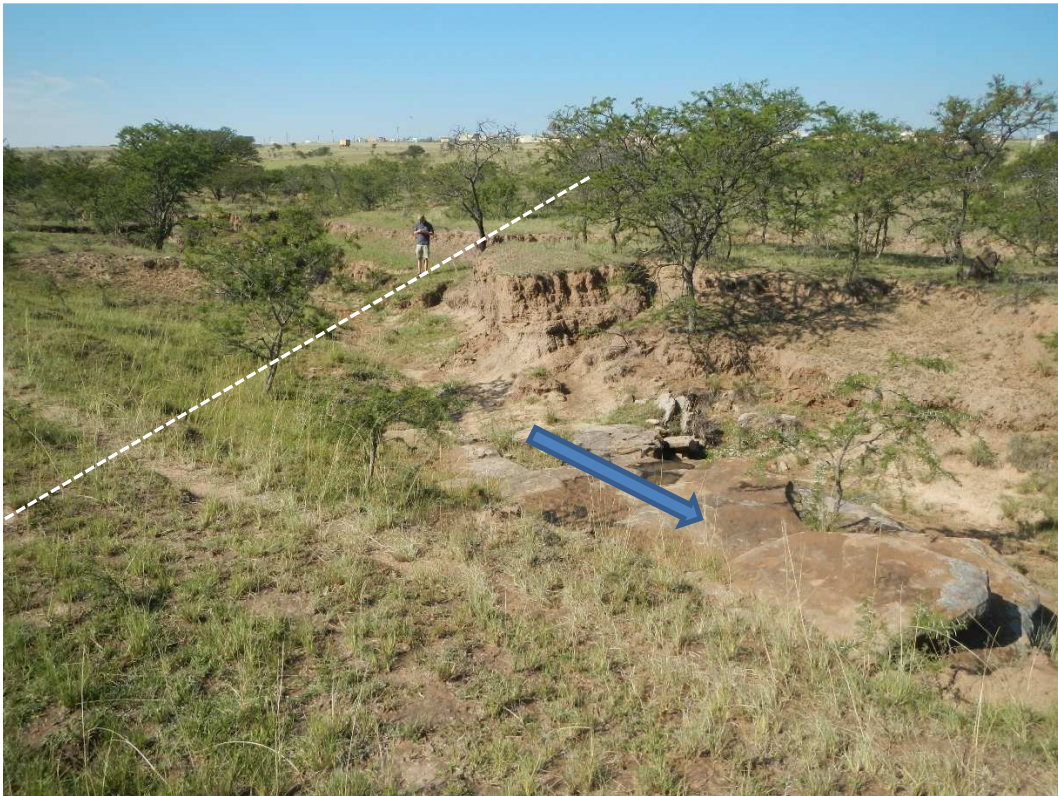
**Plate 1.** Proposed pipeline route (dotted white line) at preferred crossing location of Watercourse A, as seen from the right bank of the watercourse (dry donga).

As can be seen in Figure 1 and Plate 1, Watercourse A is a highly disturbed ephemeral stream consisting of badly eroded channels with banks from 1m to 3.5m high. The main existing impacts are associated with serious overgrazing and trampling by domestic stock (goats and cattle) and removal of riparian vegetation.

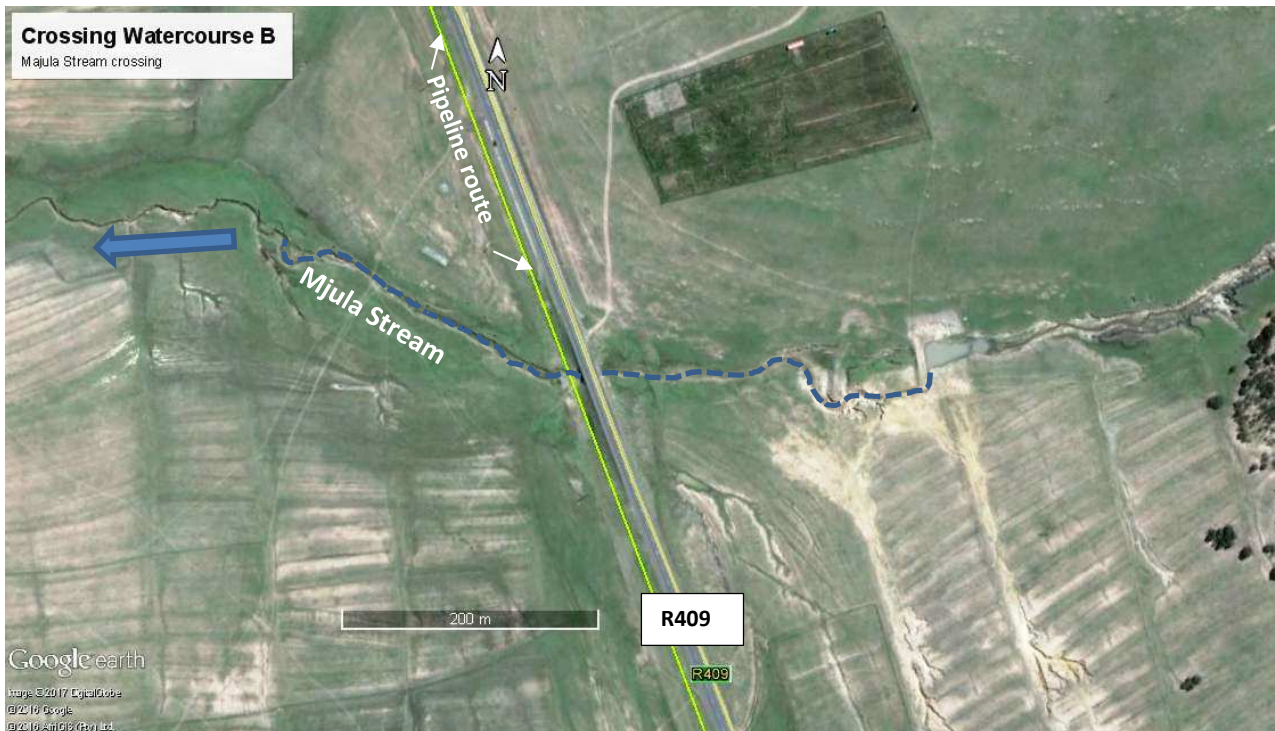
**Figure 3.** Google Earth image of pipeline crossing of Watercours B (Mjula Stream) parallel to the R409.

As seen in Figure 3 and Plates 3 to 5, the recommended release point is into an eroded gully about 10m downstream of an existing earth stock-watering dam. As pointed out by Dr B. van der Waal (pers. comm. 9 May 2017), this gully has already eroded down to bedrock and is considered wide enough to carry the released water without significant bank erosion.

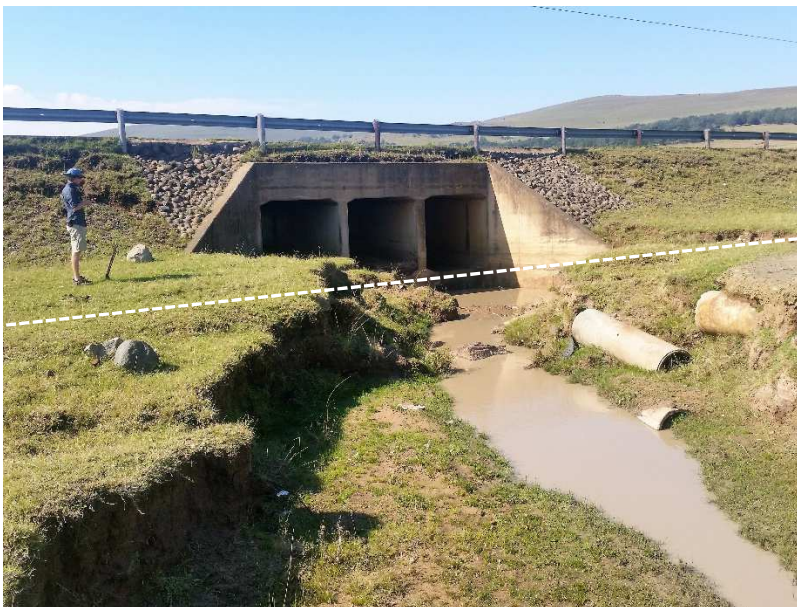
**Plate 2.** Pipeline crossing of Watercourse B (Mjula Stream) next to (west of) the R409.

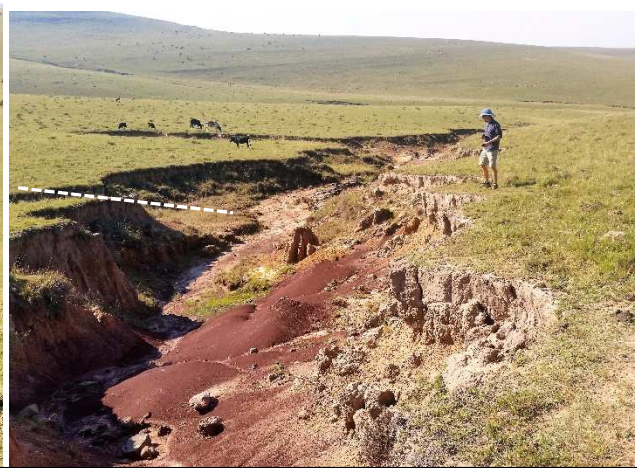
**Plate 4.** Eroded donga downstream of earth dam at proposed release point.

The tributary or gulley recommended to receive the released water (see Figure 4 and Plates 3, 4 & 5) already has a largely modified PES and is eroded down to bedrock in most areas. As this eroded gulley already has a relatively wide channel, the elevated flow should not cause further significant erosion. In addition, any sediment produced should be trapped by the large wetland about 5.5 km downstream.

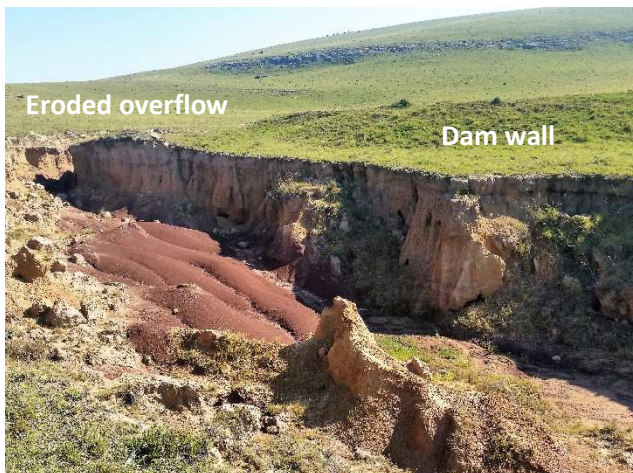
**Plate 5.** Eroded dam wall upstream of proposed water release point, looking upstream.

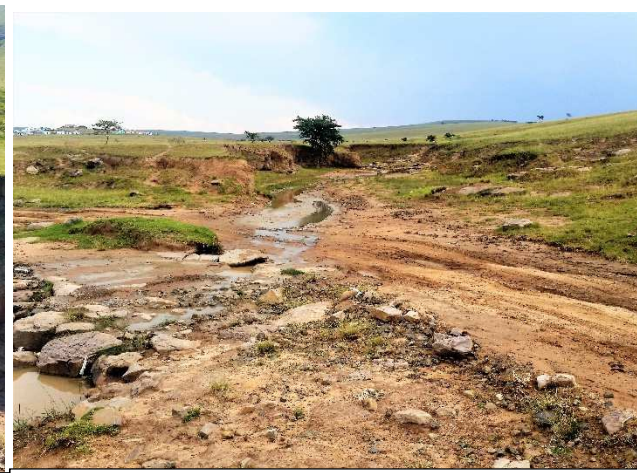
**Plate 6.** Problematic road crossing some 5 km downstream of release point (looking upstream).

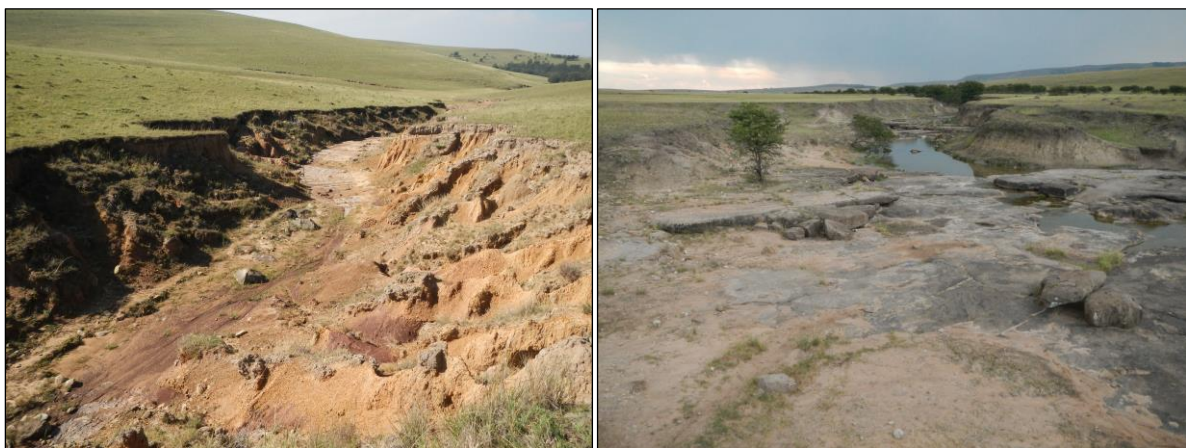
*Figure 1: Images of the Toboyi River incised to bedrock along its upper (left) and middle reaches (right).*

The Toboyi River drains to the east and is a tributary of the Xilinx River and the larger Kei River basin. These rivers are indicated on the 1:50 000 topographical maps as perennial rivers. The Toboyi and Xilinx Rivers are extensively incised into the landscape from the headwaters to the inlet at the Xilinx Dam (Figure 1 and 2). The upper 500m of the Toboyi River is underlain by resistant dolerite, whereas the rest of the Toboyi and Xilinx Rivers are underlain by erodible mudstones. Soil erodibility is moderate on the dolerite and high on the mudstones, especially where dispersive duplex soils are present (Schulze, 2007). Stream banks and gully sidewalls are mostly fine grained mudstone subsoils that are possibly dispersive due to high sodium concentration associated with mudstones (Hardie, 2009; Beckedahl and De Villiers, 2000). The incision has cut down to bedrock along most of the river course, with short sections where deposition occurs in the form of floodouts or unchanneled valley bottom wetlands (Figure 2). Fine sand, silt and clay is deposited on these floodouts. These floodouts are unchanneled and act as an important buffer for water and sediment in the landscape (Figure 3). Upstream of the floodouts the incised channel has partly filled with sediment and is indicated as 'incised in alluvium' in Figure 2. These floodouts or depositional zones are the most sensitive to degradation or incision through gully. Headcuts are present within the depositional zones, cutting a channel or gully into the deposited sediment (Figure 4 and 5). These headcuts are active and will advance during times when water is falling into the base of the headcut, eroding the supporting subsurface layer, leading to the collapse of the upper more stable layer. This upstream headcut propagation is a natural cut-and-fill process that reworks and redistributes sediment (Temme et al., 2008). This process can be accelerated by changes to flow, especially increased flow associated with the proposed activity.

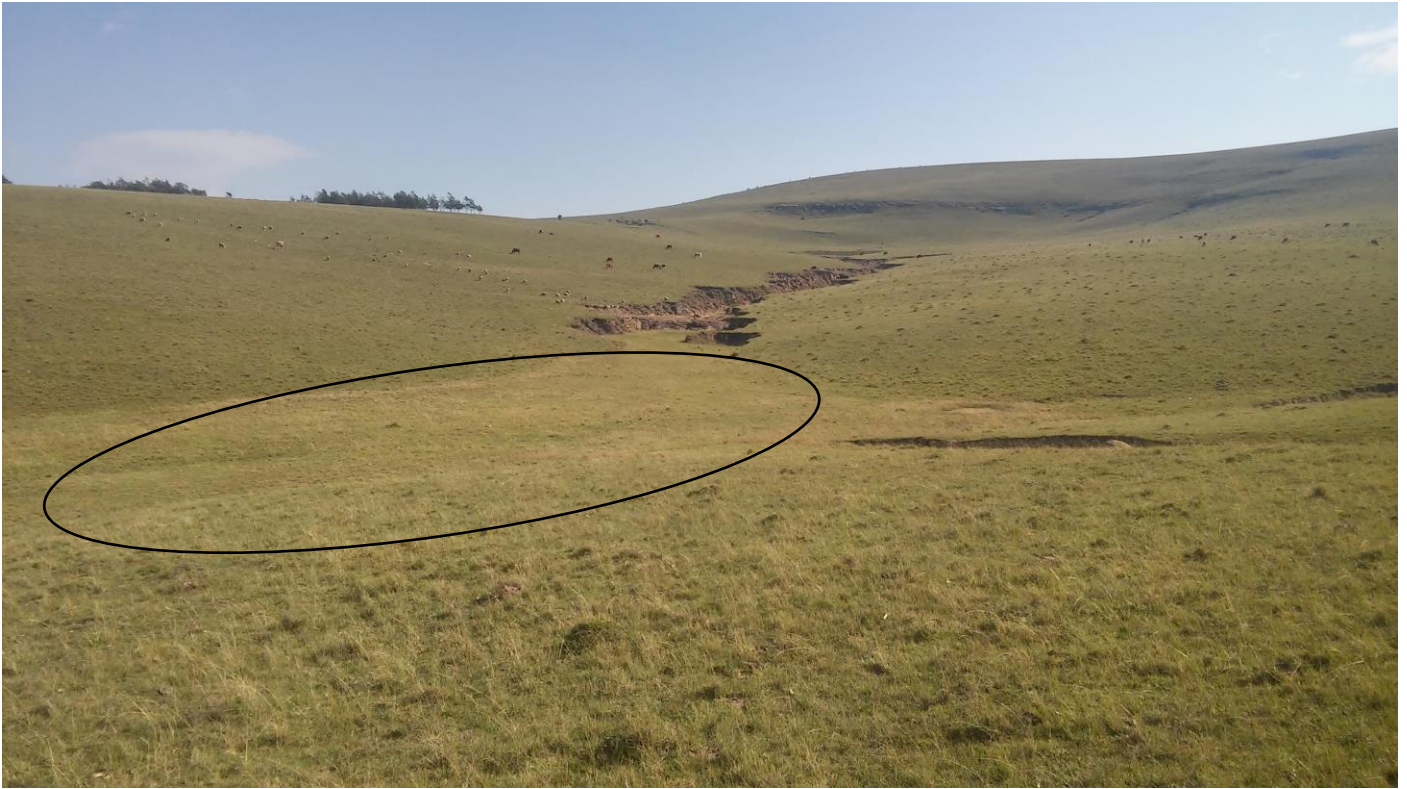
*Figure 3: Image of a floodout or sediment deposition area (circled in black) in the upper Toboyi River catchment.*

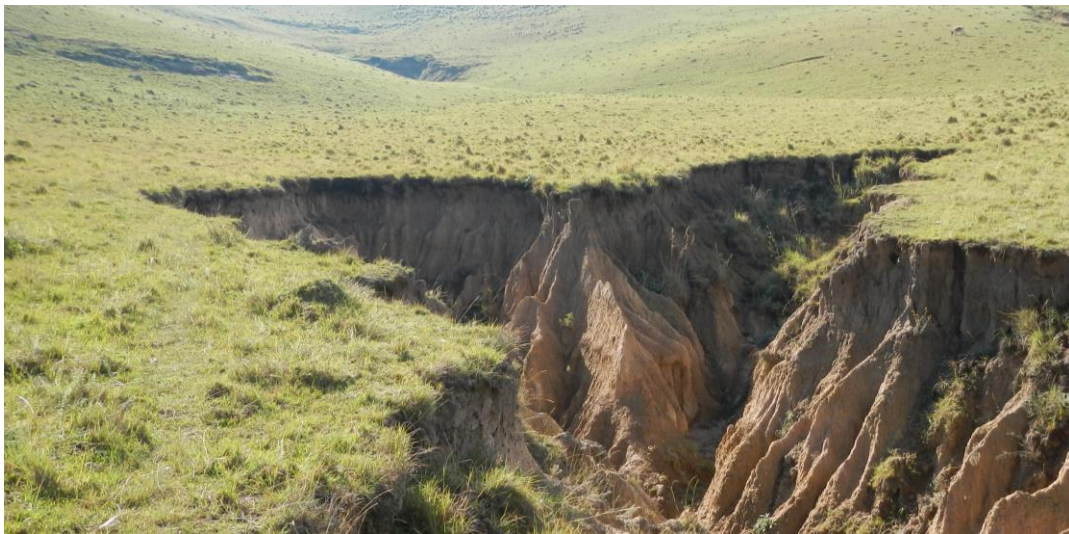
*Figure 4: Image of an active headcut in the upper Toboyi River catchment. Note the slumping of grassed topsoil where erosion is taking place.*

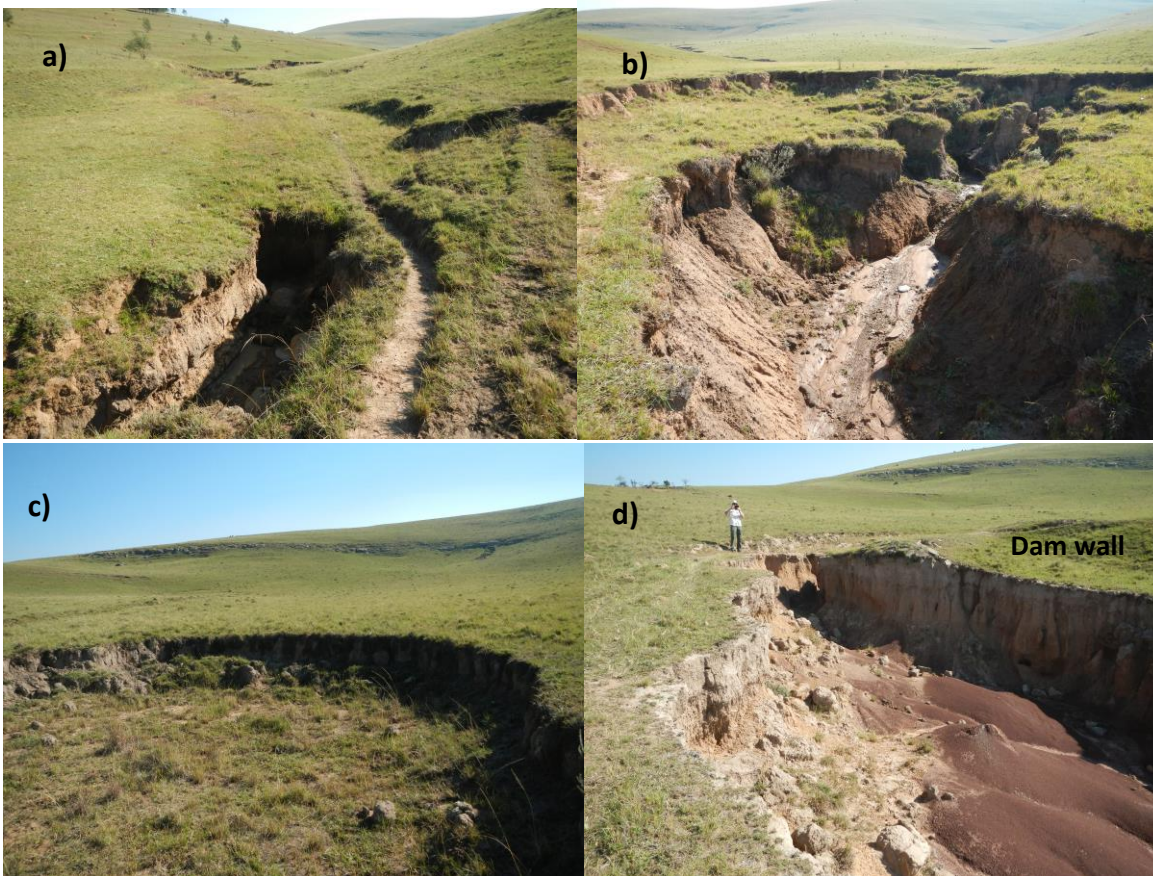
Figure 8: Images of a) the headcut (at *i* in Figure 7), b) the headcut (at *ii* in Figure 7), c) the headcut at dam spillway (at *iii* in Figure 7) and d) headcut upstream of the dam.

Pipe outlet B is likely to be of lower sediment erosion risk compared to A, as the channel network has four active headcuts and can possibly erode 450m of unchanneled drainage pathway (Table 2; Figure 8). One of these headcuts is approaching a small-dam spillway and might cause community upset if this feature is lost (important drinking point

for livestock)(Figure 8). The first 100m below the pipe outlet is steep grassed hillslope (30% slope) and will be susceptible to erosion due to its gradient. Livestock are likely to trample these wet areas along the flow path, further increasing the risk of soil erosion.

Pipe outlet C would pose the lowest threat to erosion of steep grassed hillslopes and unchanneled sections of the drainage pathway as this site has two headcuts along 166m of unchanneled sediment deposit (Table 2; Figure 8).

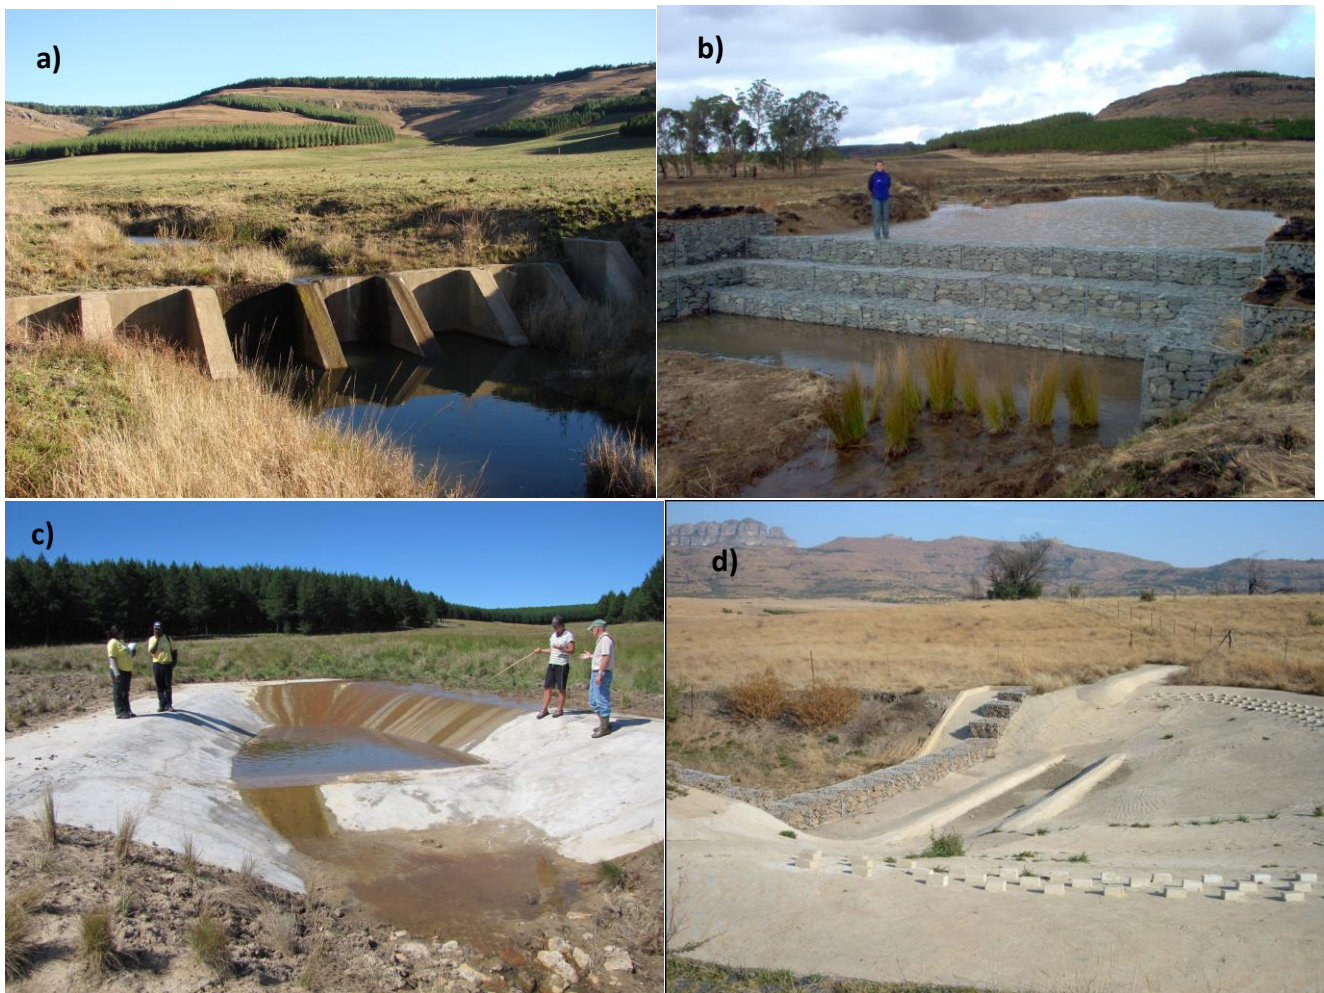
*Figure 9: Examples of headcut control structures: a) weir, b) gabion, c) and d) chute (photos by J Buckle).*

Gabions are not preferred as they are easily vandalised, are prone to rust, need frequent maintenance and are often undermined by tunnel erosion (Pers. Comm. J. Buckle). All of these options are high risk as the soils are relatively unstable and likely to be dispersive along the Toboyi River, thus easily undermined by tunnel erosion. To reduce the risk of structure failure, the structures should be well keyed into the banks and frequently monitored. Soils used for backfilling should be treated with hydrated lime, alum or polyacrylamides and compacted to  $9.3\text{kg/cm}^2$  if the soils are dispersive (Hardie, 2009).

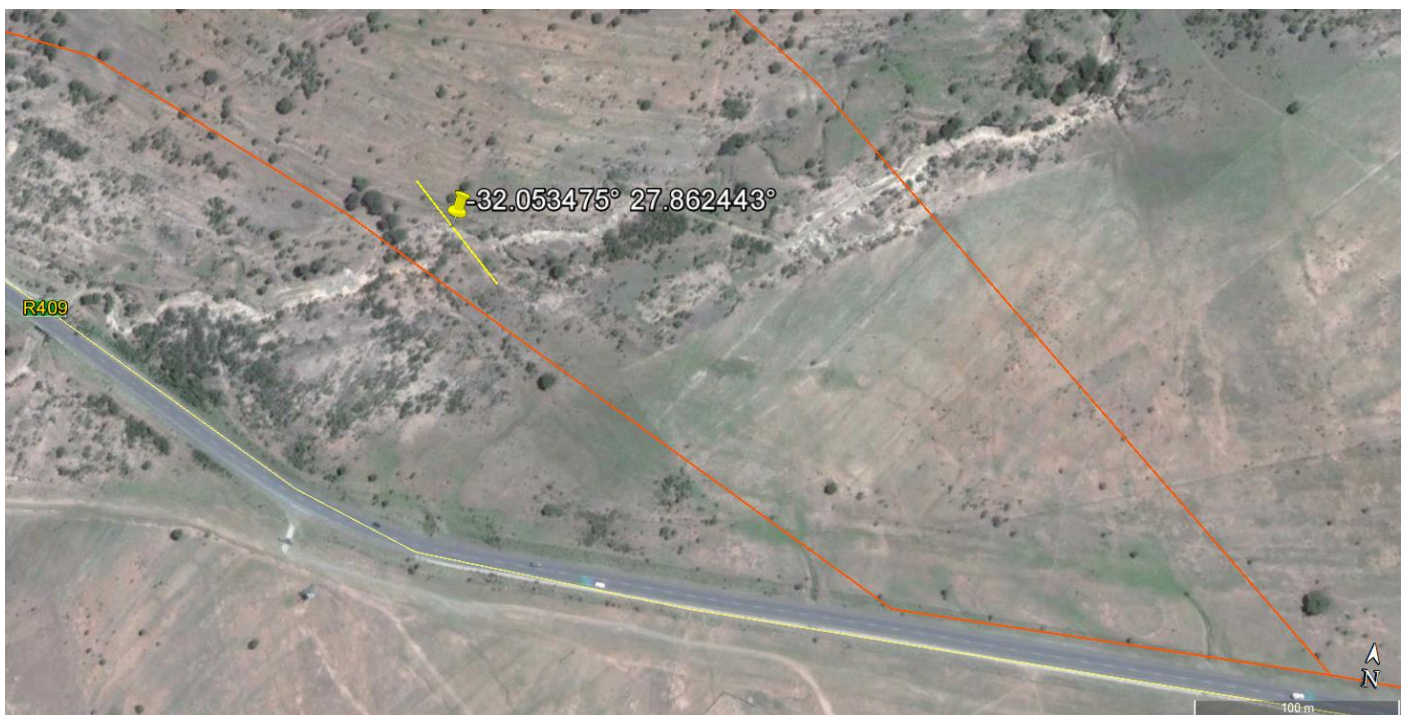
Figure 10: Proposed drainage line crossings of the pipeline (orange line) along the R409 (Google Earth image). The yellow line indicates the best geomorphic location for crossing the stream.

- An alternative option is suggested along the yellow line in Figure 10 (crossing point at -32.053475°; 27.862443°). The pipe will cross the stream where the stream is most confined (no floodplain or secondary channels/gullies) and has banks that are ~2m high. The floor is sandstone and should be resistant to rapid erosion. Best would be to place the pipe below the surface of the bedrock so as not to dam water in the channel (banks could be/are dispersive and can cause tunnelling around the structure). The banks are likely to be dispersive soils, so erosion of backfilled soil will be an ongoing issue unless treated chemically with hydrated lime, alum or polyacrylamides and compacted to 9.3kg/cm<sup>2</sup> (Hardie, 2009).

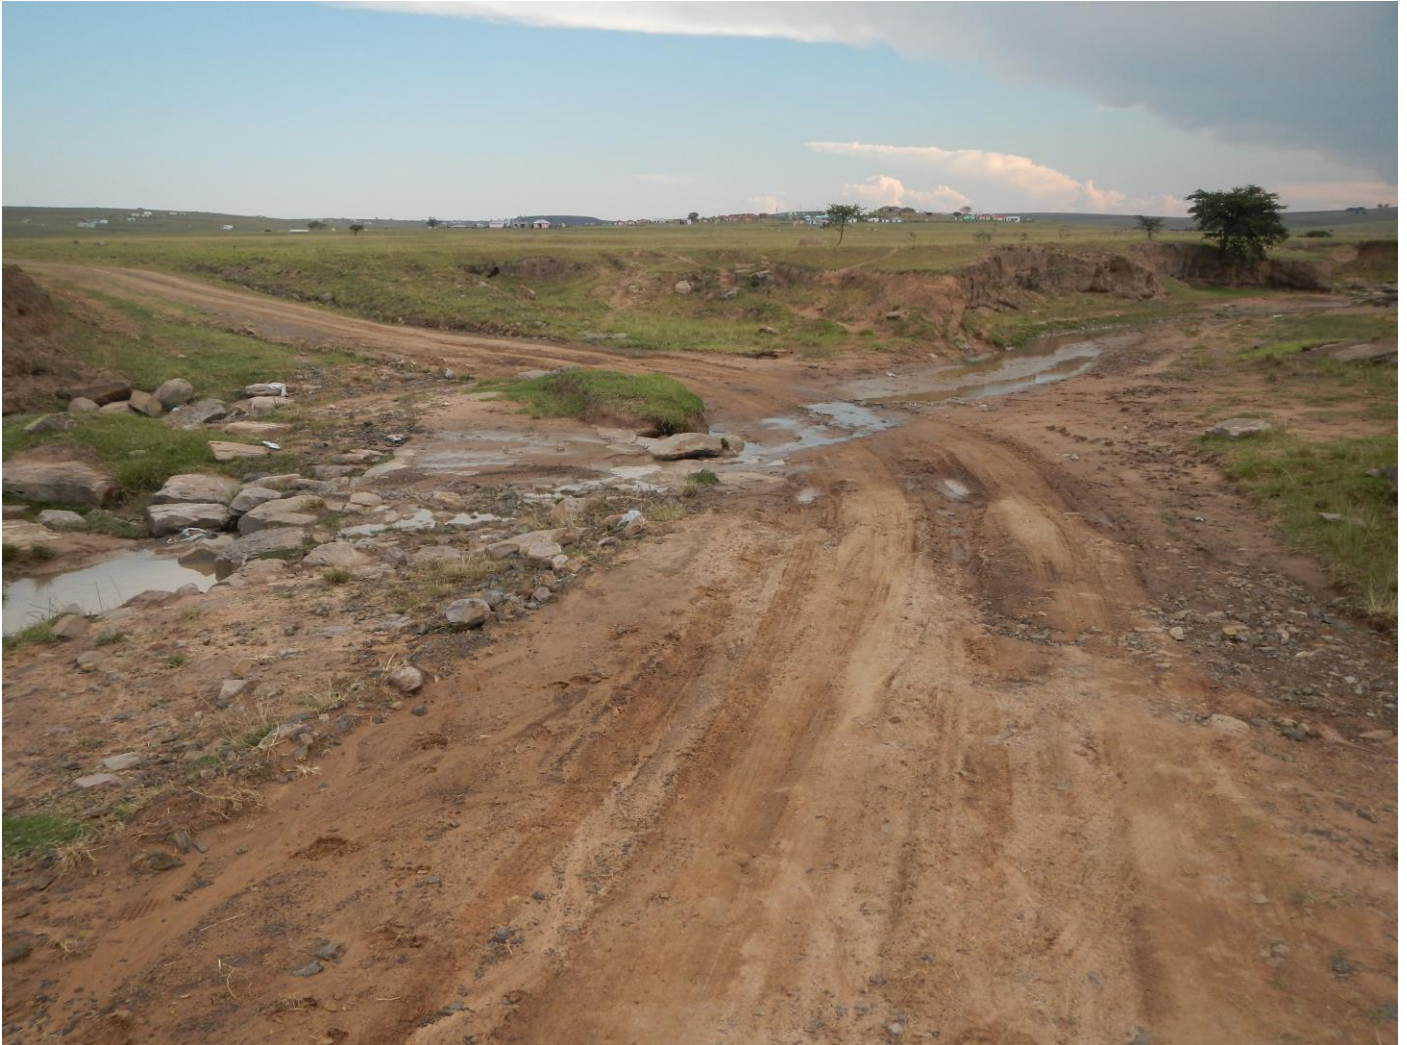
*Figure 11: Image of the main drift crossing the Toboyi River.*

There are several vehicle crossing points along the Toboyi River channel. These crossing points can only be safely used during low flow as there is no bridge or culvert at any of the crossings. Only one of the crossings was used frequently and serves as the main access route to Kunene Village (Figure 11). This crossing ( $-32.103200^\circ$ ;  $27.984985^\circ$ ) could benefit from bridge infrastructure to allow access to the village during higher flow events. However, the peak release flow of  $0.27\text{m}^3.\text{s}^{-1}$  will result in a flow depth of  $<10\text{cm}$  deep and should not pose a threat to pedestrians or vehicles. A syphon could be installed with a capacity large enough to convey the released flow below the bed of the crossing point. Care should be taken when using this crossing during times of high runoff, as is currently the case.
