**DETERMINATION OF WATER RESOURCE CLASSES, RESERVE AND  
RESOURCE QUALITY OBJECTIVES STUDY FOR SECONDARY  
CATCHMENTS A5 – A9 WITHIN THE LIMPOPO WATER MANAGEMENT  
AREA (WMA 1) AND SECONDARY CATCHMENT B9 IN THE OLIFANTS  
WATER MANAGEMENT AREA (WMA 2)**

**EWR REPORT: RIVER ASSESSMENT**

**VOLUME 1 – ECOCATEGORISATION REPORT**

**JANUARY 2024**

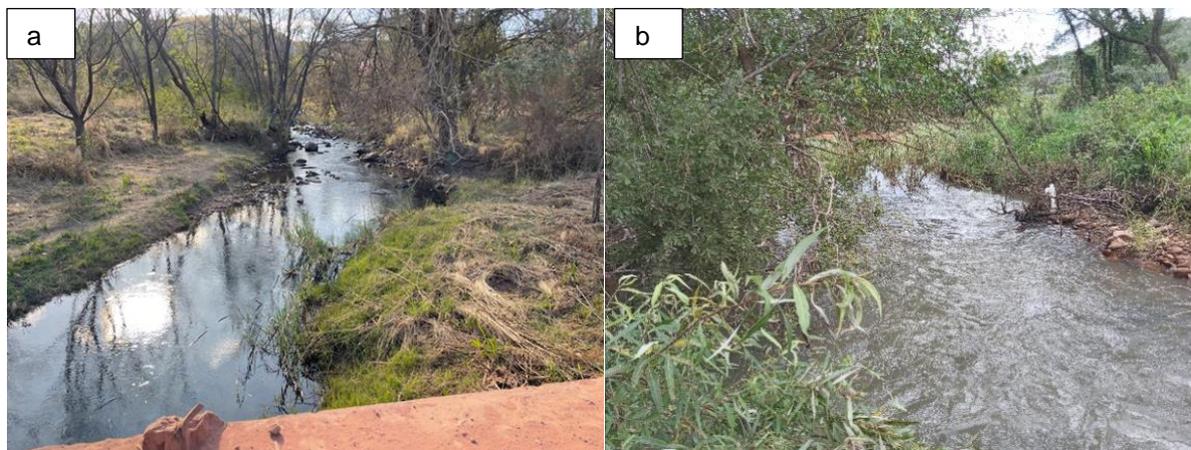
**Figure 4.3 3\_Olifantspruit, Ri1, Upper Nyl Sterk IUA, a=low flow conditions, b=high flow conditions**

This EWR site is on an inflowing tributary to the Nylsvley. It is one of the REMP sites and in good ecological condition. The site at low flow and high flow conditions is shown in Figure 4.3.

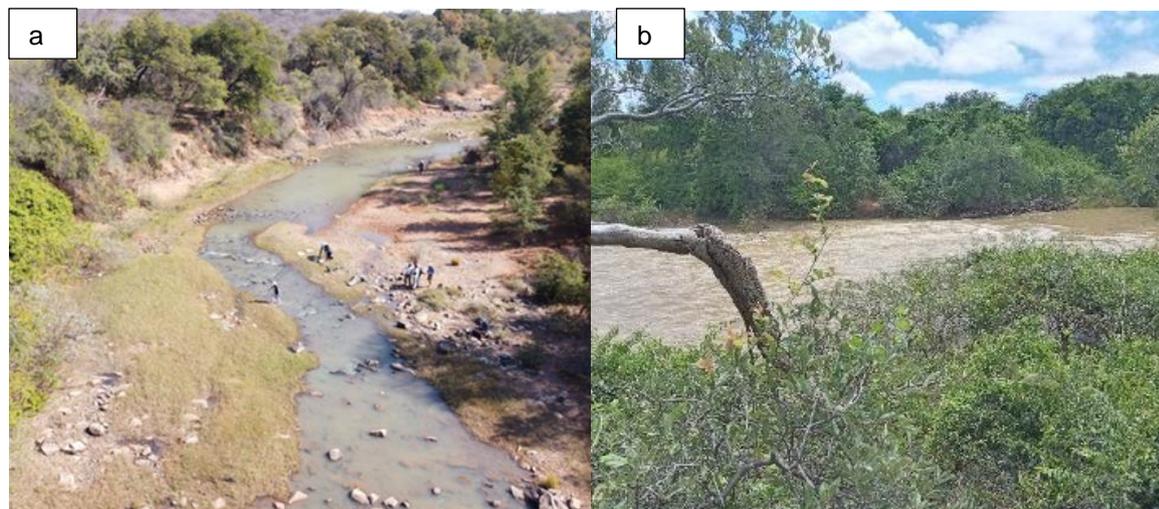
**Figure 4.5 5\_Mogalakwena2, Ri14, Mogalakwena IUA, a=low flow conditions, b=high flow conditions**

This site is one of the REMP sites and it is strategically important because it is downstream of Glen Alpine Dam. The site is good ecologically because the riparian vegetation is in relatively good condition, despite there being some exotic plants, and the channel has a nice range of aquatic habitat for invertebrates and fish (Figure 4.5).

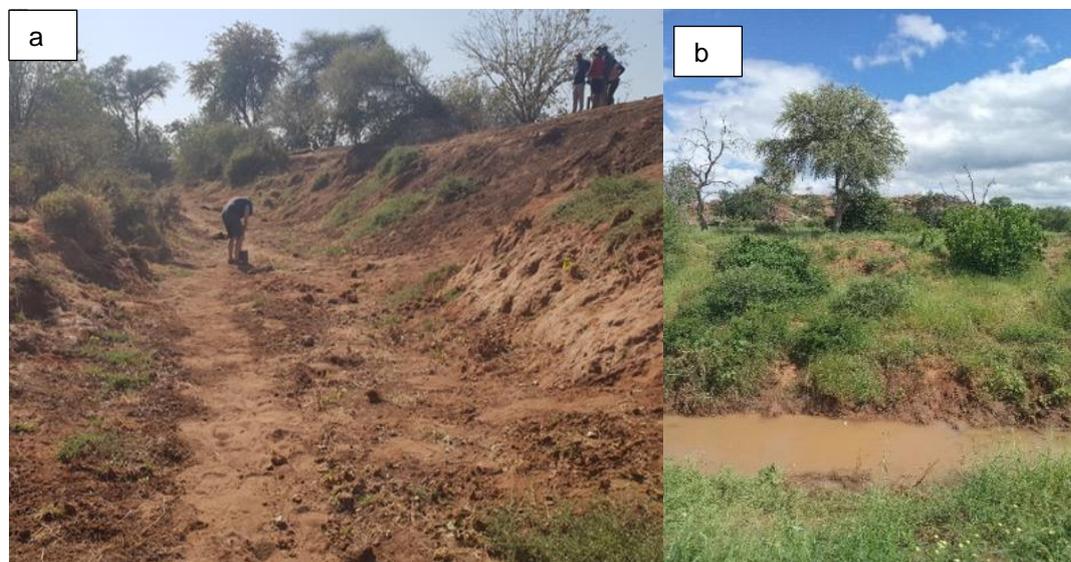
**Figure 4.6 6\_Kolope, Riv32, Mogalakwena IUA, a=dry season, b=wet season**

This site is on a non-perennial river on the largest of three rivers in this IUA. It is located in the Mapungubwe National Park. Figure 4.6 shows the distinct change in river during the dry and wet season.

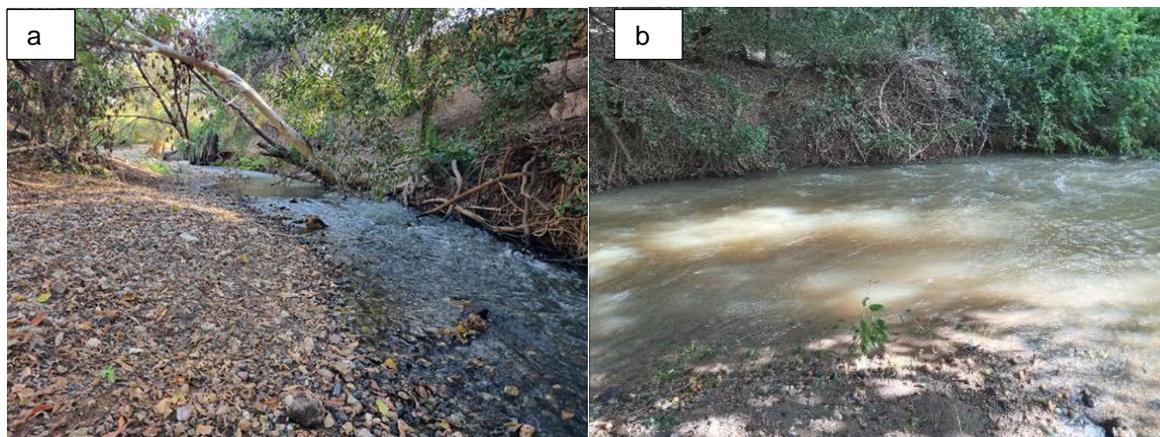
**Figure 4.9 9\_Ñwaneḡi, R28, Nzhelele/Ñwaneḡi IUA, a=low flow conditions, b=high flow conditions**

This site is one of the REMP sites in the lower reaches of the basin downstream of Cross Dam and upstream of the Vhembe Biosphere Reserve. Figure 4.9 illustrates the EWR site at low flow and high flow conditions.

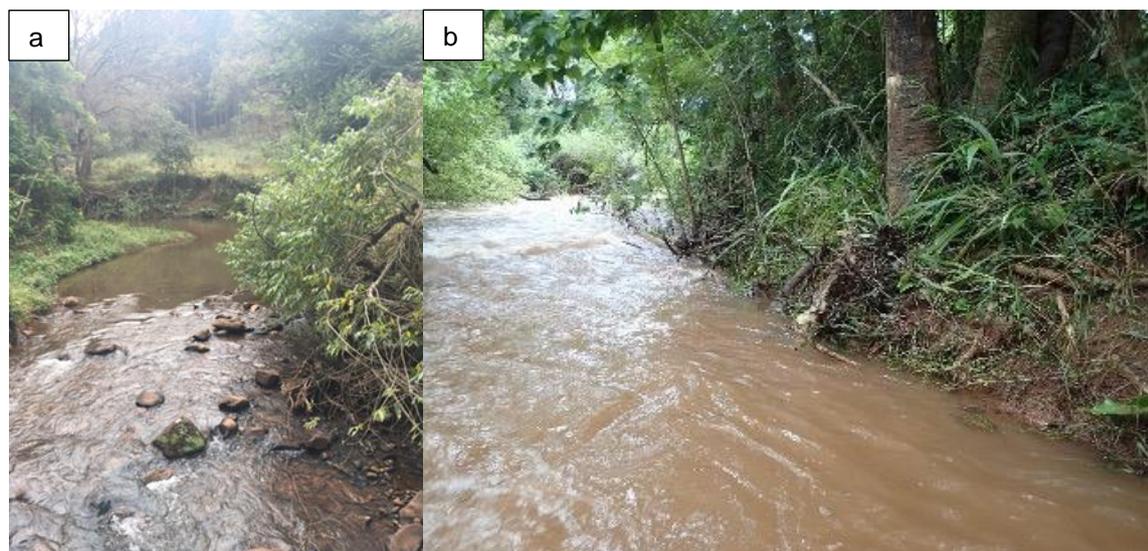
**Figure 4.10 10\_Latonyanda, Riii6, Upper Luvuvhu IUA, a=low flow conditions, b=high flow conditions**

This site is one of the REMP sites. It is one of the three main tributaries of the Luvuvhu River and is situated upstream of intensive dryland and irrigated agriculture, so acts as a good pre-disturbance reference point. The river is also in good condition because despite there being a few exotic plants, the water quality and habitat for invertebrates and fish are good (Figure 4.10).

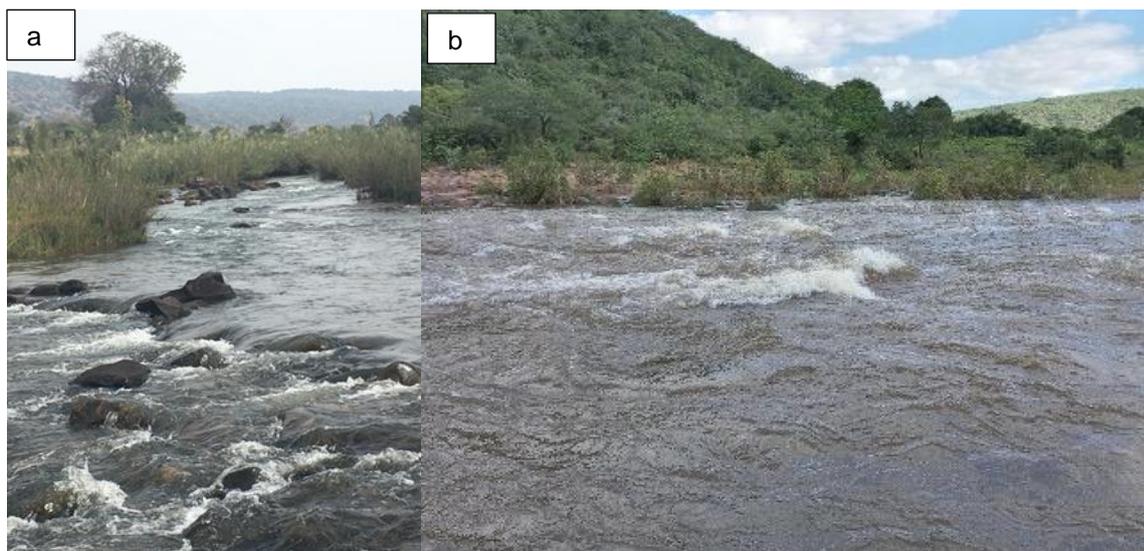
Figure 4.13 13\_Mutale1, Riv11, Lower Luvuvhu/Mutale IUA, a=low flow conditions, b=high flow conditions

This site is one of the REMP sites and it is strategically important because there are plans to dam the Mutale River upstream, to provide water for the planned SEZ. This site is also useful because it is situated just upstream of the gorge, it captures all the incremental activities upstream before this important geographical feature. Ecologically it is important because it is a FEPA that is in very good ecological condition; with good riparian vegetation, habitat for invertebrates and fish, and good quality water (Figure 4.13). It is also interesting because of the groundwater upwelling onto the floodplain.

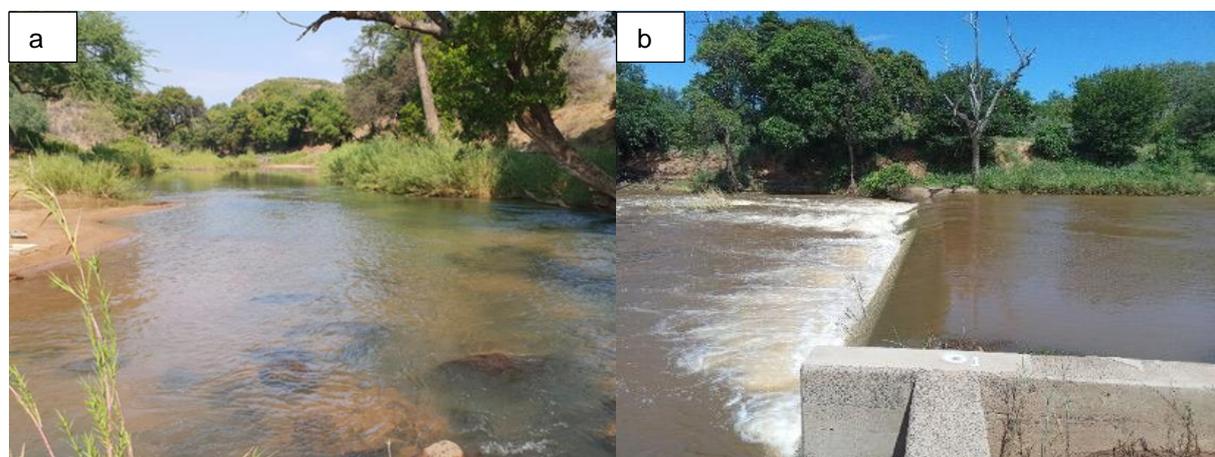
**Figure 4.14 14\_Mutale2, Ri34, Lower Luvuvhu/Mutale IUA, a=low flow conditions, b=high flow conditions**

This site is situated in a conservation area just upstream of the confluence with the Luvuvhu, so it represents the lowermost flows and consequences of upstream activities on the Mutale River. It is a very beautiful river in good ecological condition despite there being some exotic plants on the left bank. The in-channel habitats and therefore conditions for invertebrates and fish are good (Figure 4.14).
