Department:
Water Affairs and Forestry
REPUBLIC OF SOUTH AFRICA

DIRECTORATE: RESOURCE DIRECTED MEASURES

**LETABA CATCHMENT
RESERVE DETERMINATION STUDY –
RESOURCE UNITS REPORT**

FEBRUARY 2006

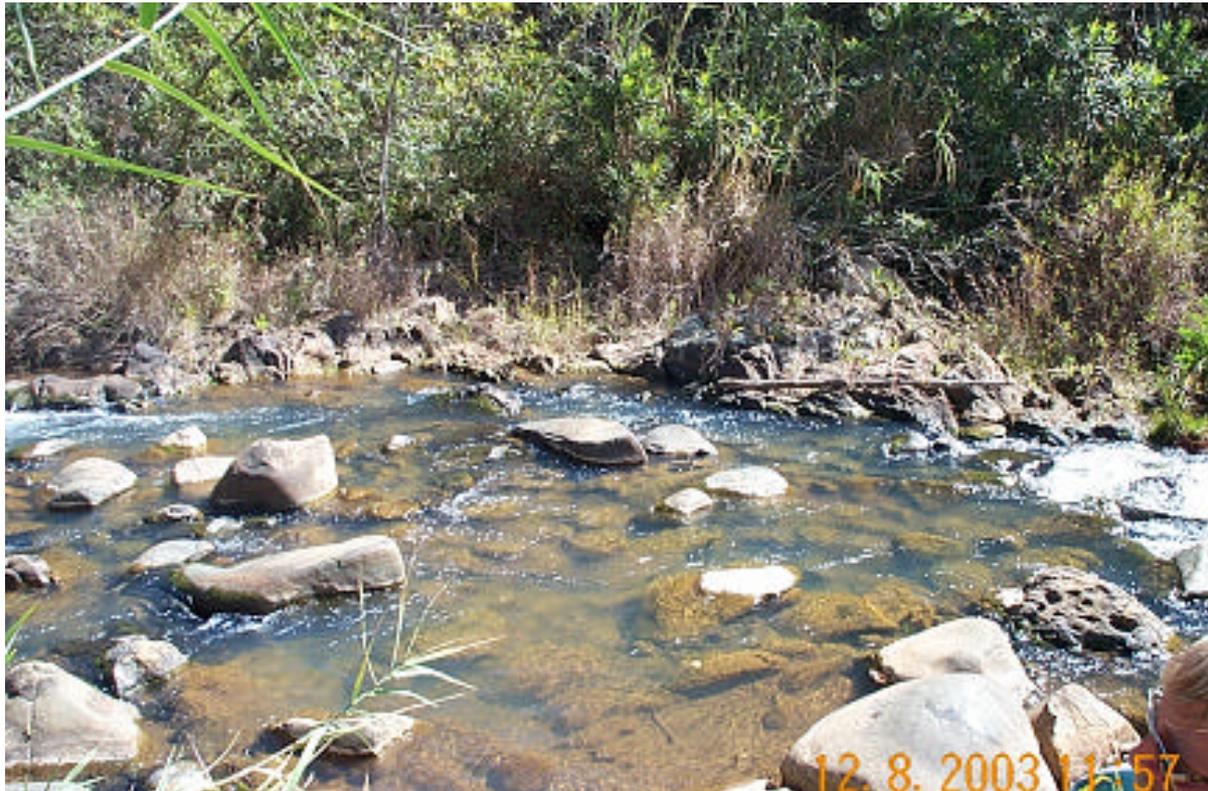
Plate 10.1: EWR 1 – Appel Groot Letaba Cross section ($Q=0.264 \text{ m}^3/\text{s}$)

Geomorphology	3	Excellent site for habitat modelling as all habitat types present. The site is characterised by a pool rapid channel type with floodplain terraces on the right bank.	The active channel has narrowed considerably through the historic photographic record, but the channel pattern is stable. Flow regulation from Ebenezer Dam and instream weirs
Hydraulics	2	One single channel.	Channel geometry that determines the local hydraulic consists of large boulders that complicate low flow modelling, and due to turbulence at low flows makes it difficult to survey accurate water stage. Dense vegetation on both banks influences overall flow resistance at high flows.
Water quality	3	Few urban rural settlements, one water quality sampling point near EWR site	Potential water quality impacts due to cultivated agriculture (bananas and citrus) and afforestation

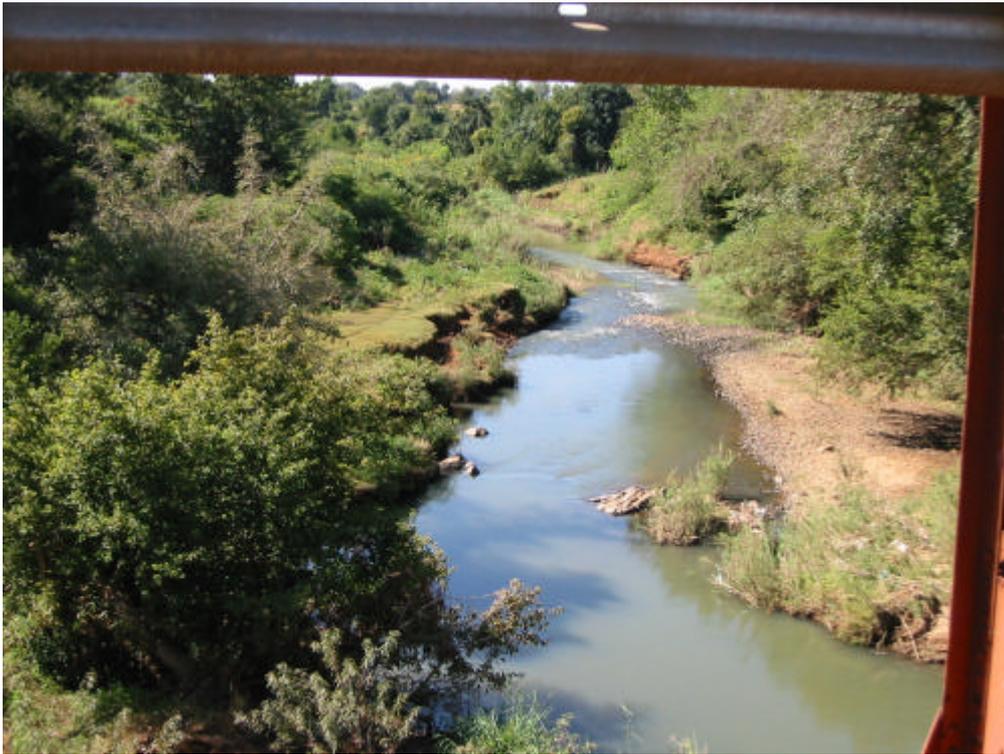
Plate 10.2: EWR 2 Letsitele Tank view, $Q=0.85 \text{ m}^3/\text{s}$

The river channel at this site is largely degraded due to erosion and local sources of water quality pollution. The site is in a highly disturbed area and extends below a railway bridge. A DWAF gauging weir occurs just upstream which allows accurate measurement of flow. The site has changed following floods in both 1996 and 2000.

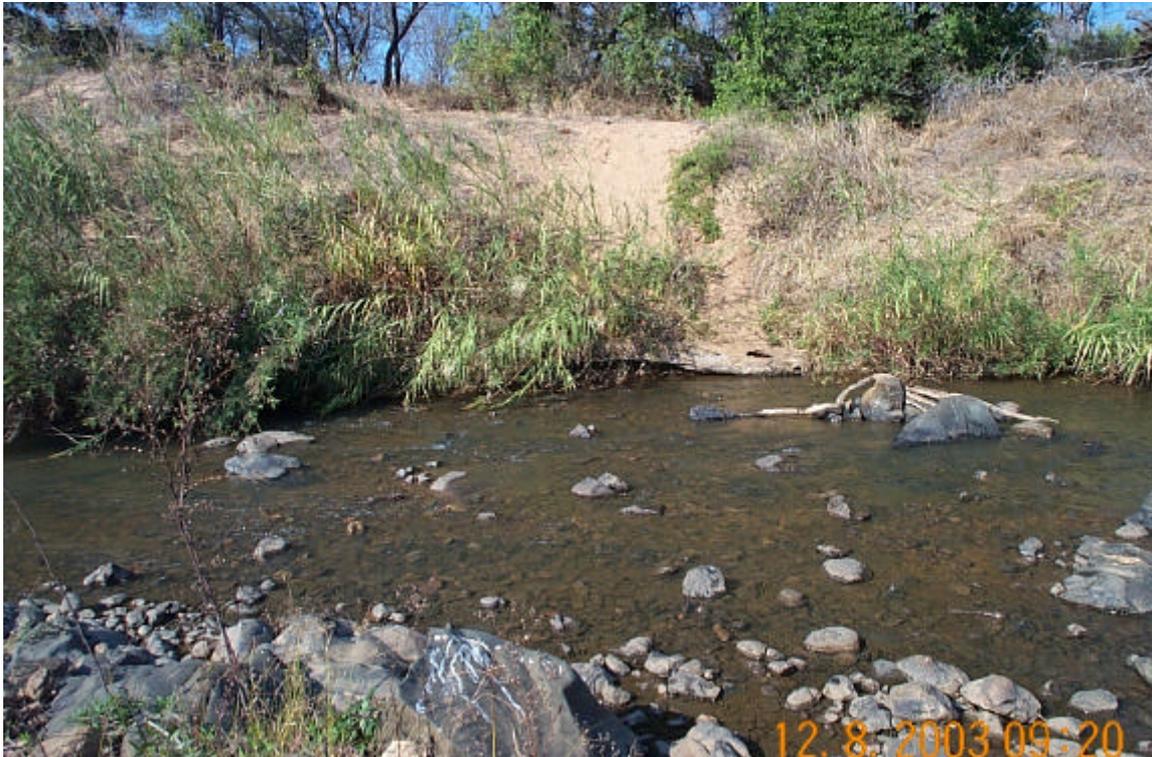
Plate 10.3: EWR 3 – Hans Marensky Cross Section, $Q=0.237 \text{ m}^3/\text{s}$

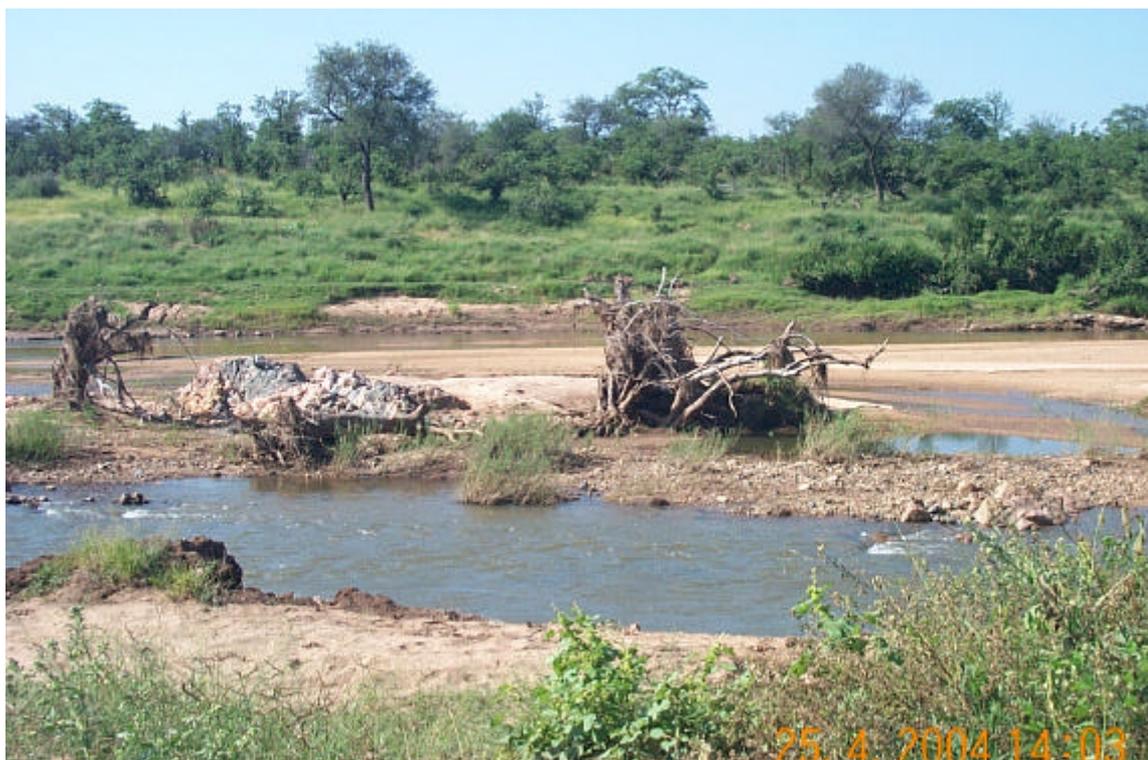
Plate 10.4: EWR 4 Letaba Ranch Cross-Section, $Q=3.72 \text{ m}^3/\text{s}$

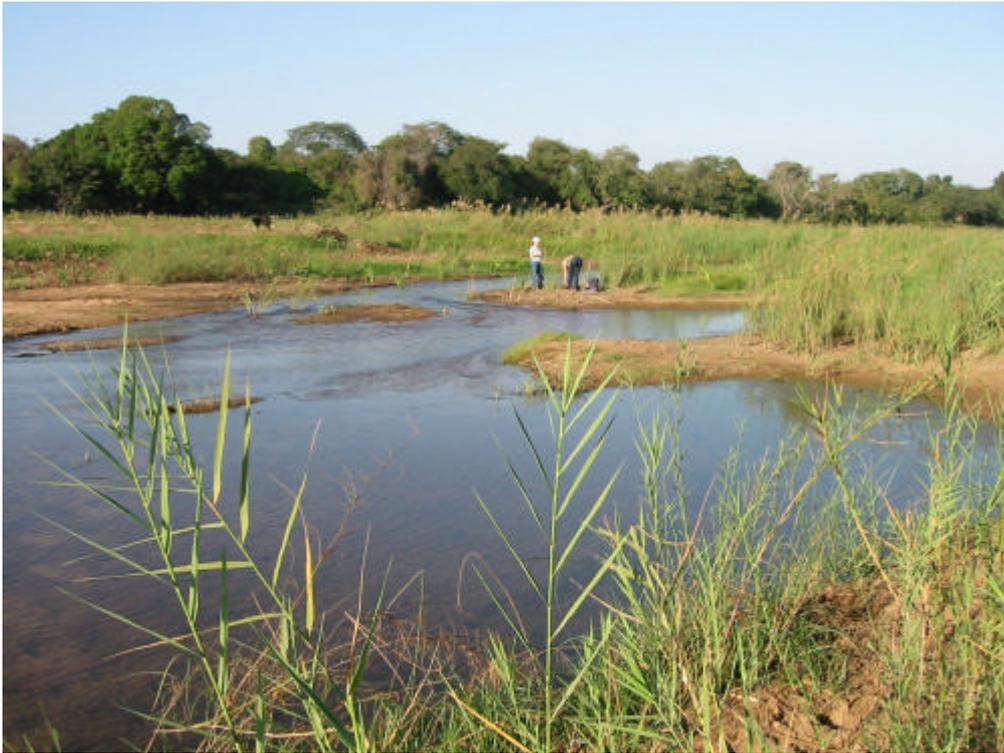
Plate 10.5: EWR 5 Klein Letaba Down Stream View, $Q=0.27 \text{ m}^3/\text{s}$

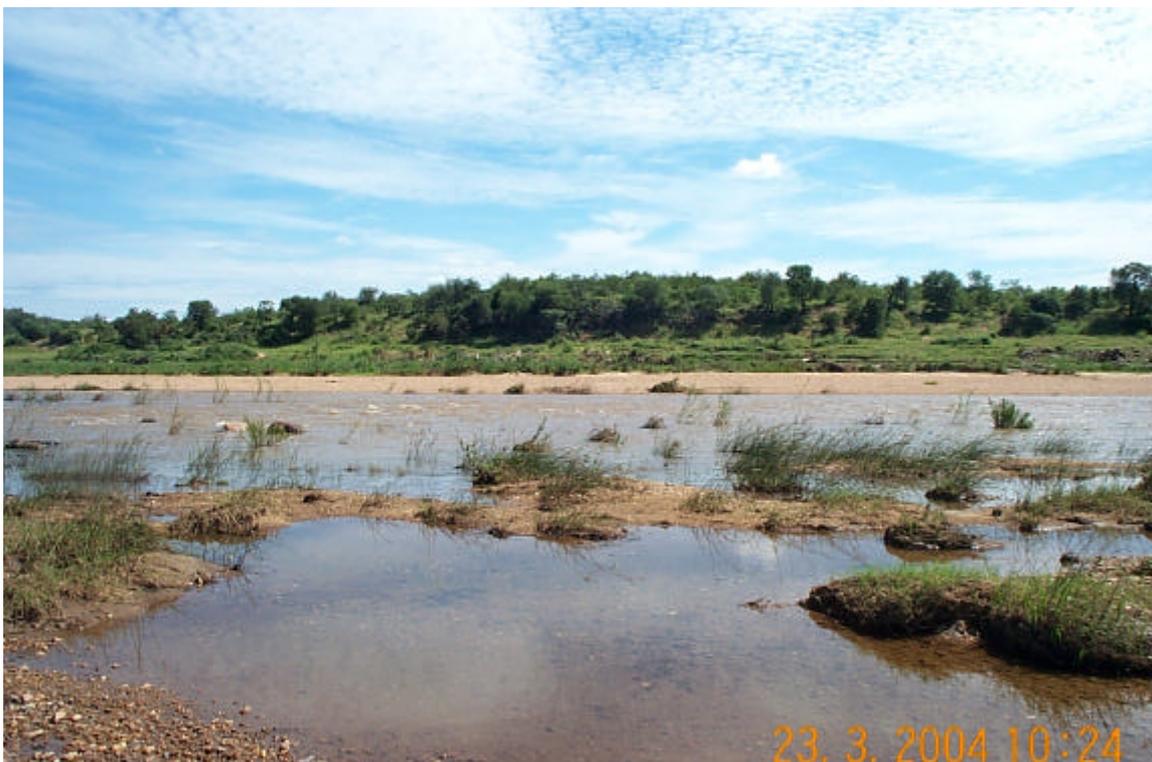
Plate 10.6: EWR 6 Lonely Bull – Groot Letaba River Cross-Section, $Q=85 \text{ m}^3/\text{s}$

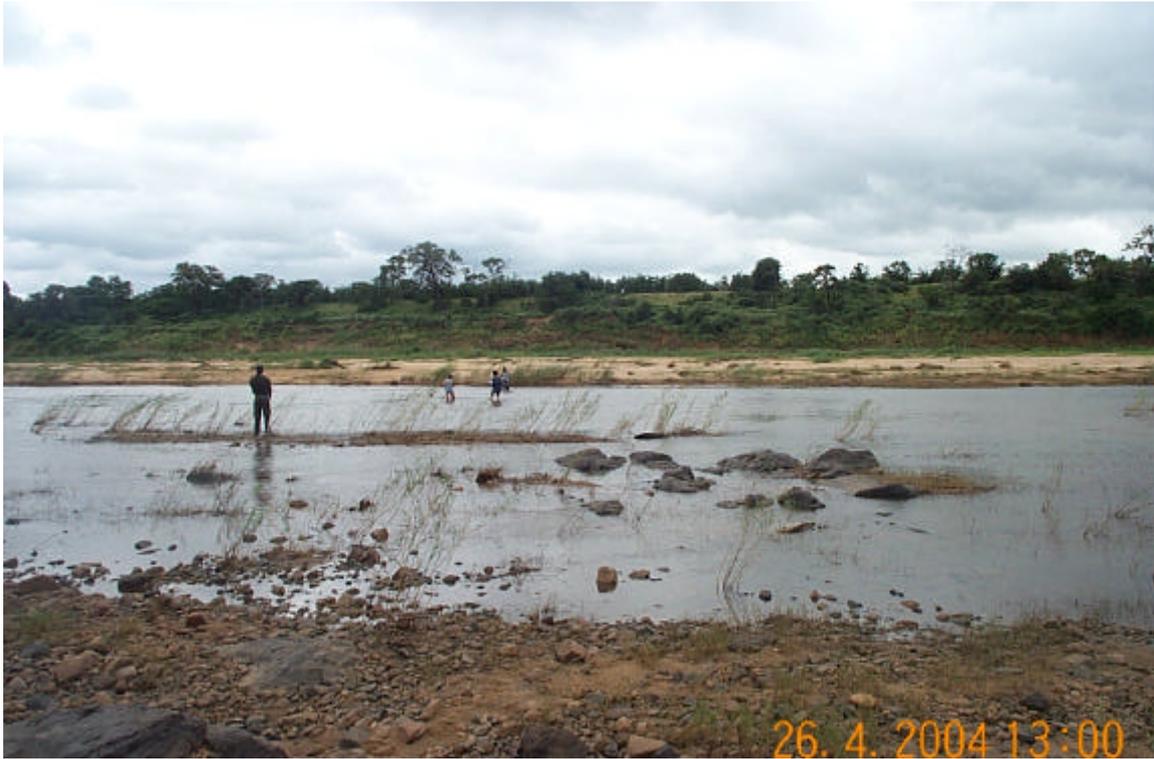
Plate 10.7: EWR 7 Letaba Bridge – Groot Letaba River - Cross-Section, $Q= 6.8 \text{ m}^3/\text{s}$

Hydraulics	3	Uniform flow conditions over a wide range of discharges. Bed composed predominantly of sand and gravels with imbedded larger material (cobbles), resulting in reasonably uniform flow resistance as a function of stage.	Mobile bed material results in changes to the channel morphology over time. Difficult to measure medium to high flows using manual flow gauging due to the wide channel. A small riffle feature (containing gravels) is a temporary feature and becomes drowned-out at low flows.
Water quality	3	No major impacts in water quality in the KNP	Limited historical water quality data
