# DEPARTMENT OF WATER AND SANITATION

## Determination of Water Resource Classes, Reserve and the Resource Quality Objectives in the Keiskamma and Fish to Tsitsikamma Catchments

### WP11354 Wetland Eco-Categorisation Report

REPORT NO.:  
WEM/WMA7/00/CON/RDM/1223

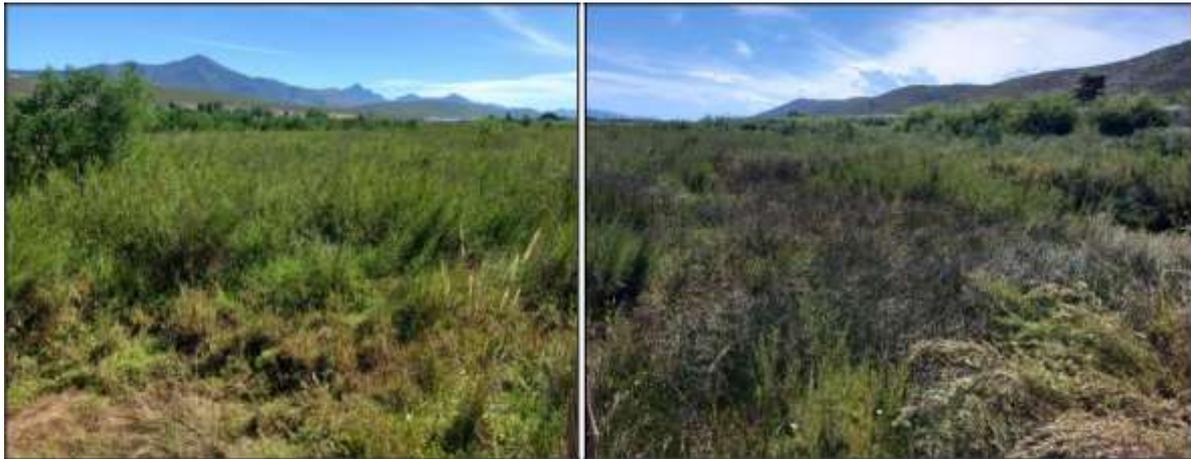
**Figure 4-4** Mixed restio/sedge/grass/shrub vegetation in Krakeel portion of the wetland, with a clump of young black wattle trees visible to the extreme left

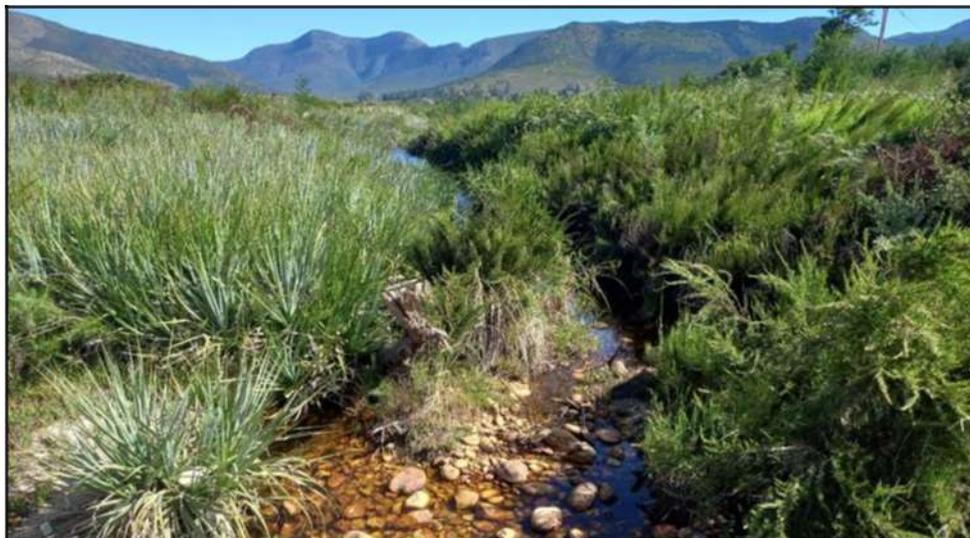
**Figure 4-5** The Wabooms River with flanking palmiet (left) and mixed shrub/restio vegetation (right)

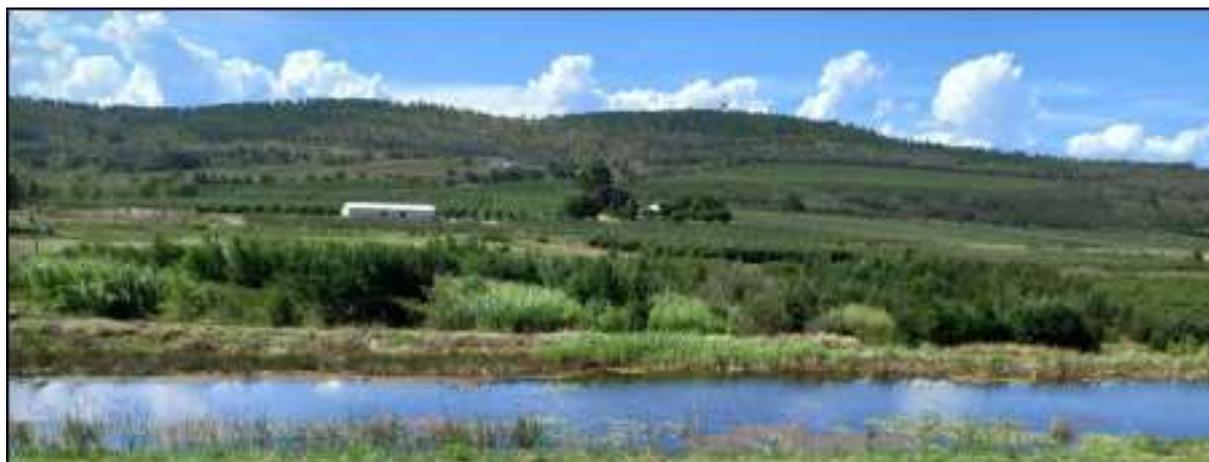
**Figure 4-6** The wetland in the upper reaches of the Krakeel River visible in the foreground comprising a mosaic of orchards, dams and semi-natural wetland (with large clumps of the invasive alien Spanish reed, *Arundo donax*, while extensive orchards adjacent to the wetland can be seen in the middle ground and an area of natural vegetation in the catchment infested with IAPs.

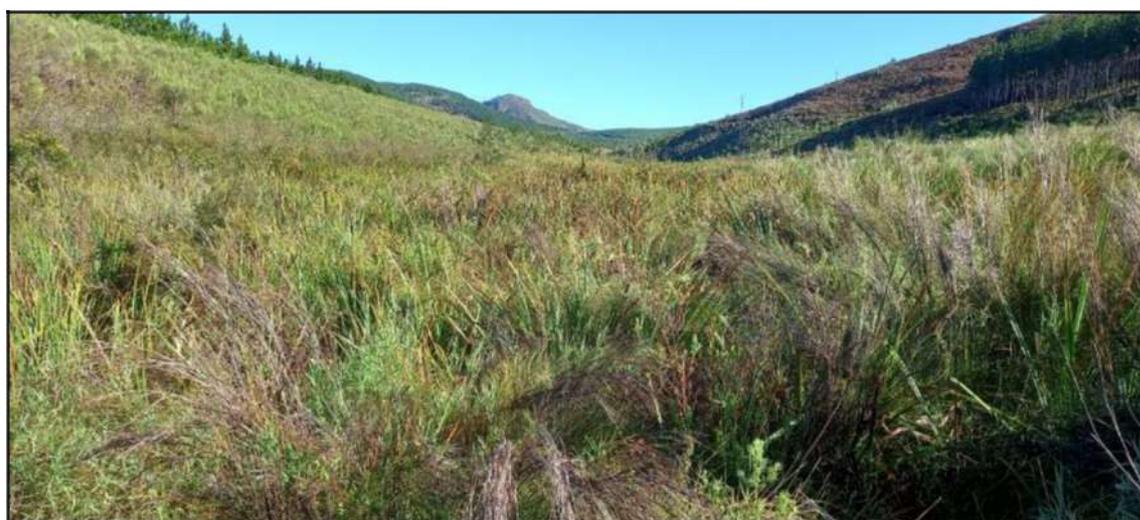
Figure 4-8 A valley bottom area with intact natural vegetation comprising a mix of restios (*Platycaulos callistachyus*), sedges (*Carpha glomerata*) and the grass-like shrub (*Cliffortia graminea*), and almost entirely free of IAP.

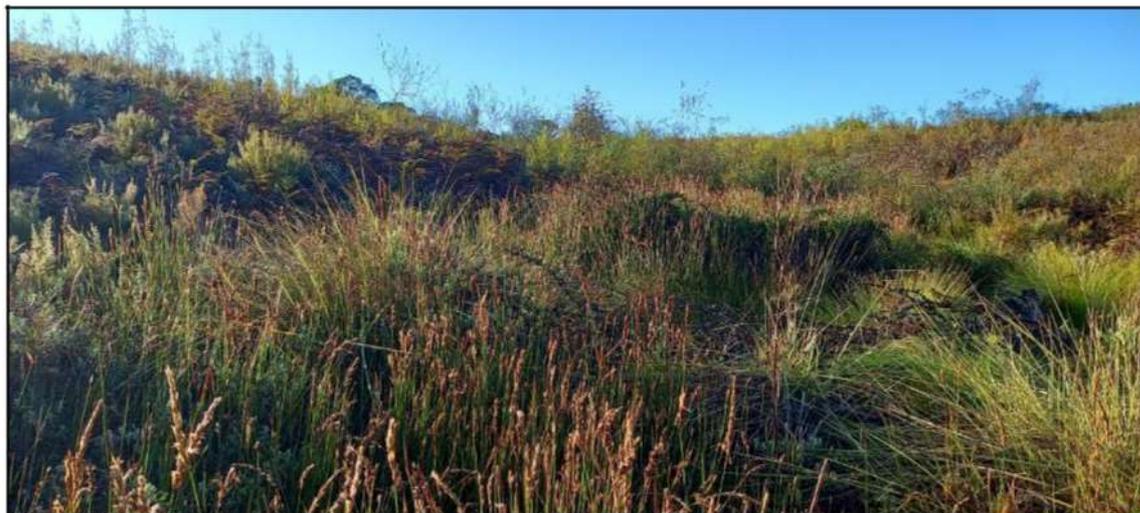
**Figure 4-9** A hillslope seep area with intact natural vegetation comprising a diverse mix of shrubs (*Erica* spp., *Psoralia* spp. and the vlei boegoe, *Empleurum uncapulare*), restios (*Elegia fistulosa*) and grass (*Miscanthus capensis*) and also almost entirely free of IAP.

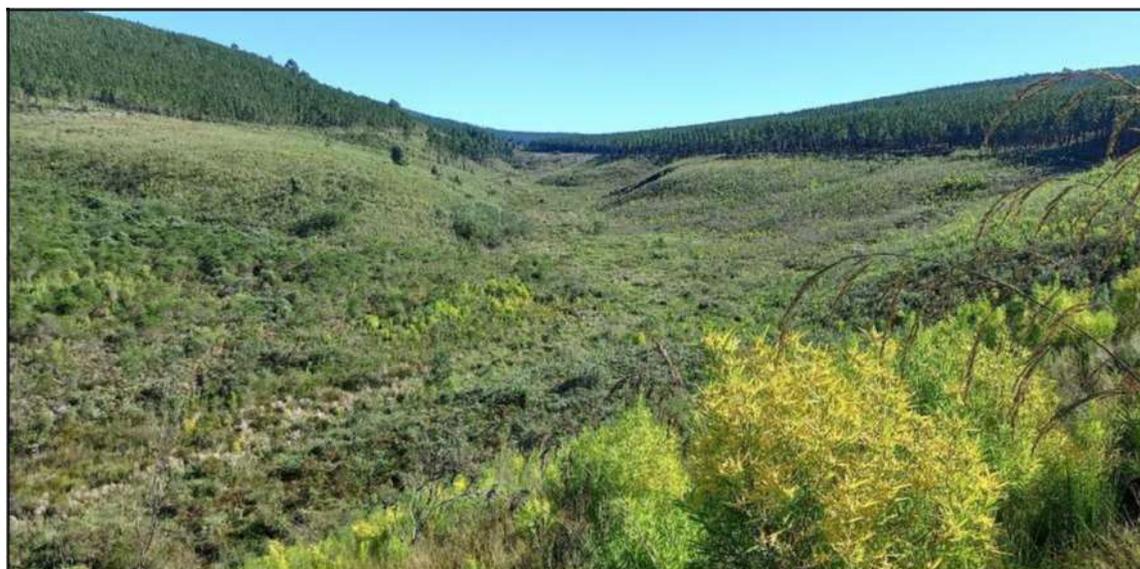
**Figure 4-10** A valley bottom wetland comprising intact natural vegetation with a low density of IAP and a relatively generous wetland buffer, which is mostly clear of IAP, especially to the right. The buffer was expanded greatly to its current position after the major fire of 2005 and when the tall pine trees in the buffer on the left are harvested they will not be replanted.

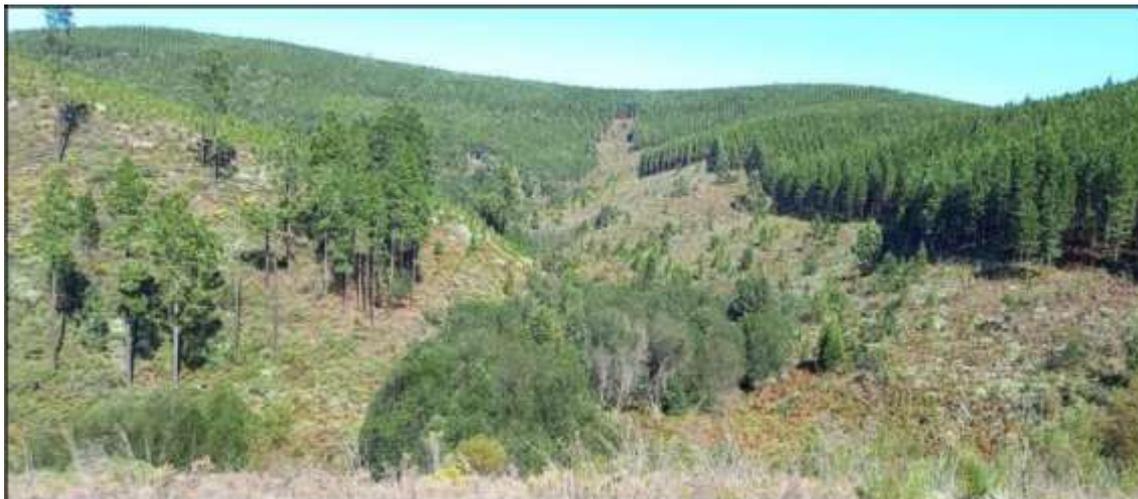
**Figure 4-11** A narrow wetland area in a steep-sided valley. In the wetland buffer to the left are some mature pine trees (also visible in the previous photo) and in the wetland is a dense clump of the indigenous forest-pioneer tree the Keurboom (*Virgilia divaricata*), both of which escaped the 2017 fire. In the buffer to the right are scattered pine trees established after the 2017 fire.

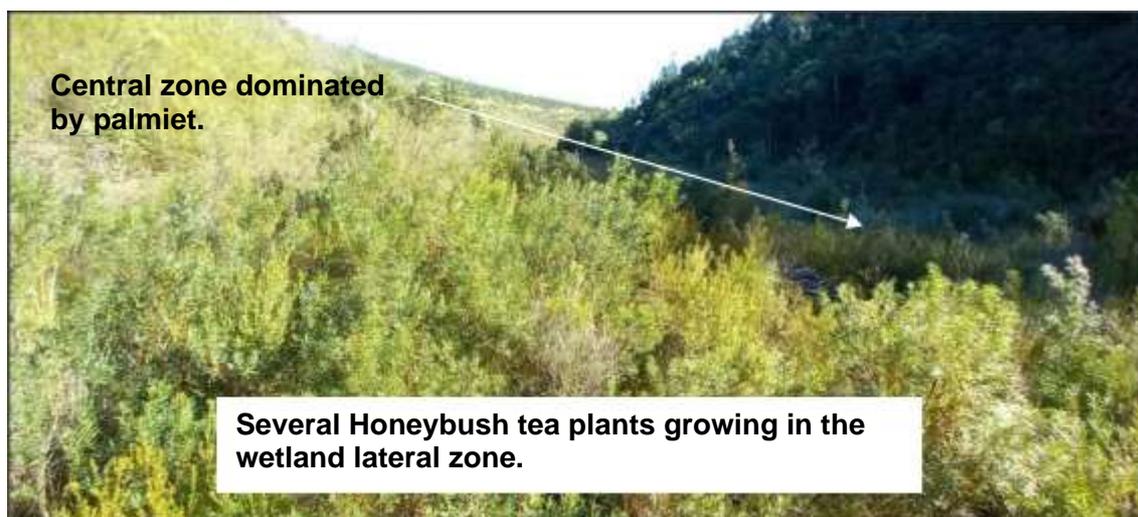
**Figure 4-12** The lowermost valley bottom portion of the wetland, with the wettest, central zone dominated by palmiet (*Prionium serratum*) and the margins supporting the largest known sub-population of the critically endangered Vanstadensberg honeybush tea, *Cyclopia longifolia*

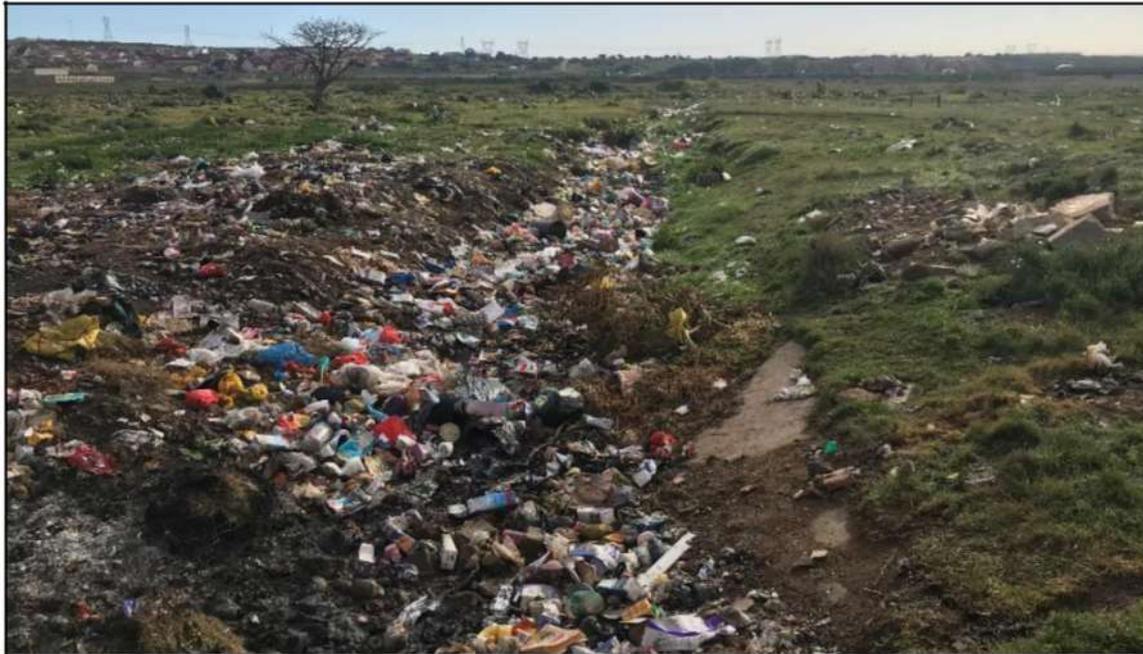
**Figure 4-15** One of the many stormwater canals that conveys stormflows into the Chatty River Wetlands. Many of these canals have been totally blocked by the litter and debris, causing them to overflow into inhabited areas, potentially posing a health risk to those living nearby. In addition, the canalised stormwater conduits that are not blocked were observed to, in some cases, have resulted in erosion and scour of the downstream wetland.

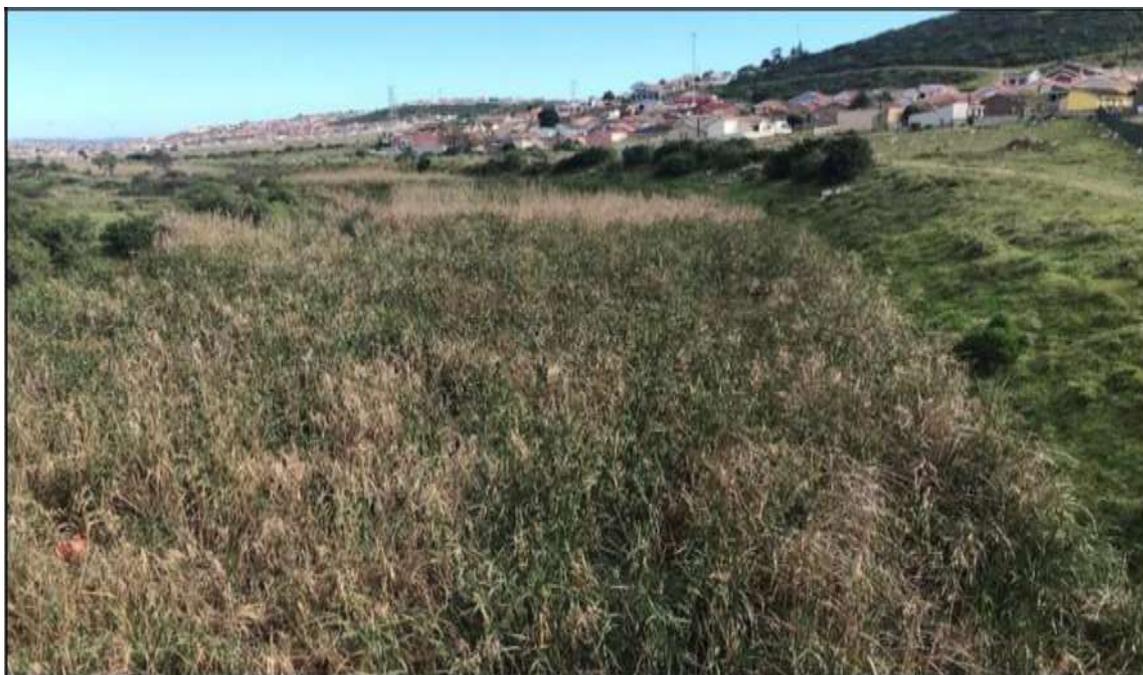
**Figure 4-16** Photograph captured from one of the bridges crossing the CVB 1 wetland – with evidence of large scale canalisation of the channel as indicated by the large bank on the right hand-side of the photograph.

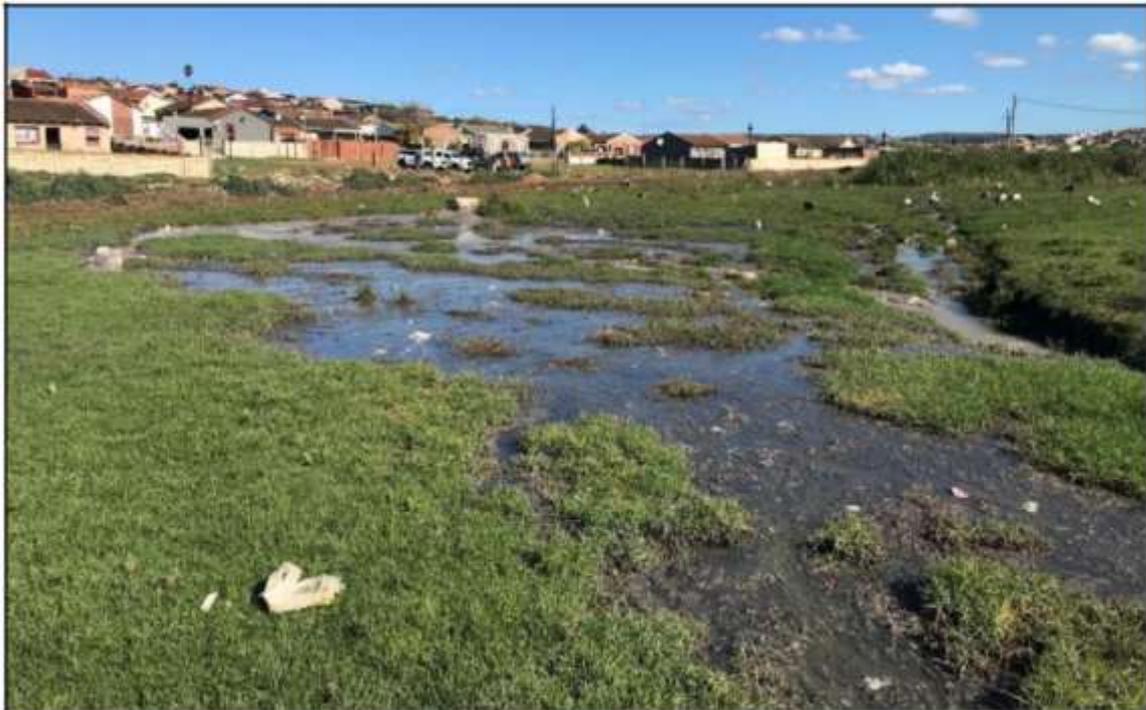
**Figure 4-17** A surcharging sewer manhole pictured centrally, and a newly incising channel pictured to the right located in CVB 3. The lateral tongues of the incising channel (heading towards the manhole) and the proximity of the point of incision to this surcharging manhole indicate that this manhole has been a large causal factor in the incision of this channel.

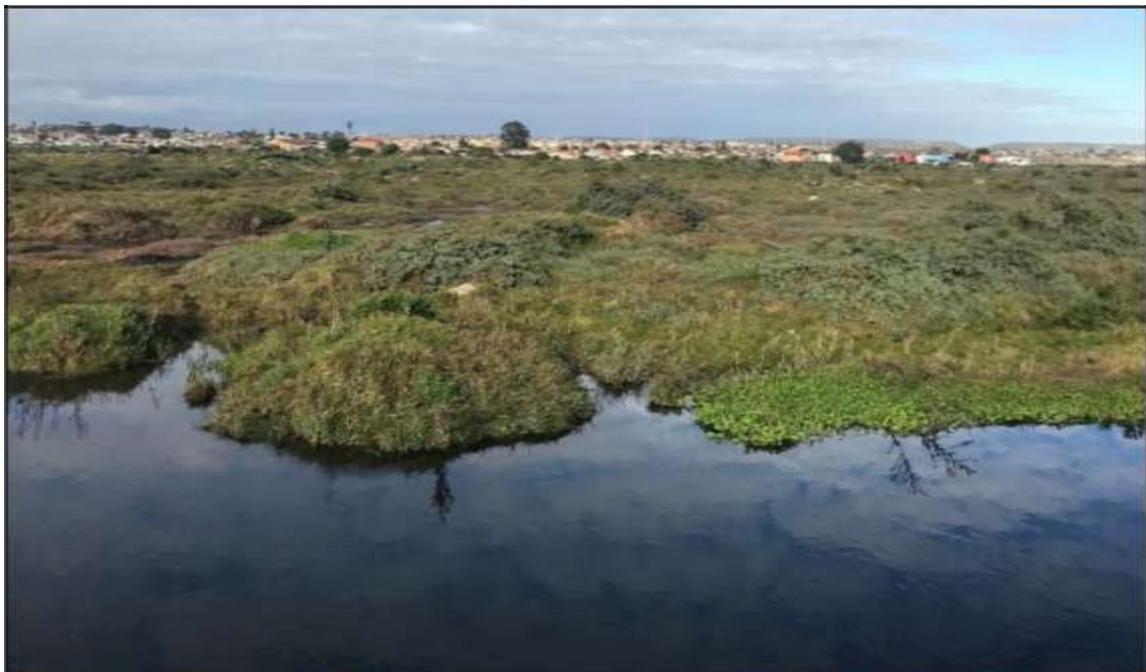
**Figure 4-18** Relatively clear and non-odourous water flowing through the toe of the wetland. In addition, this lower section of the system coincided with the most intact vegetation observed across the entire site.

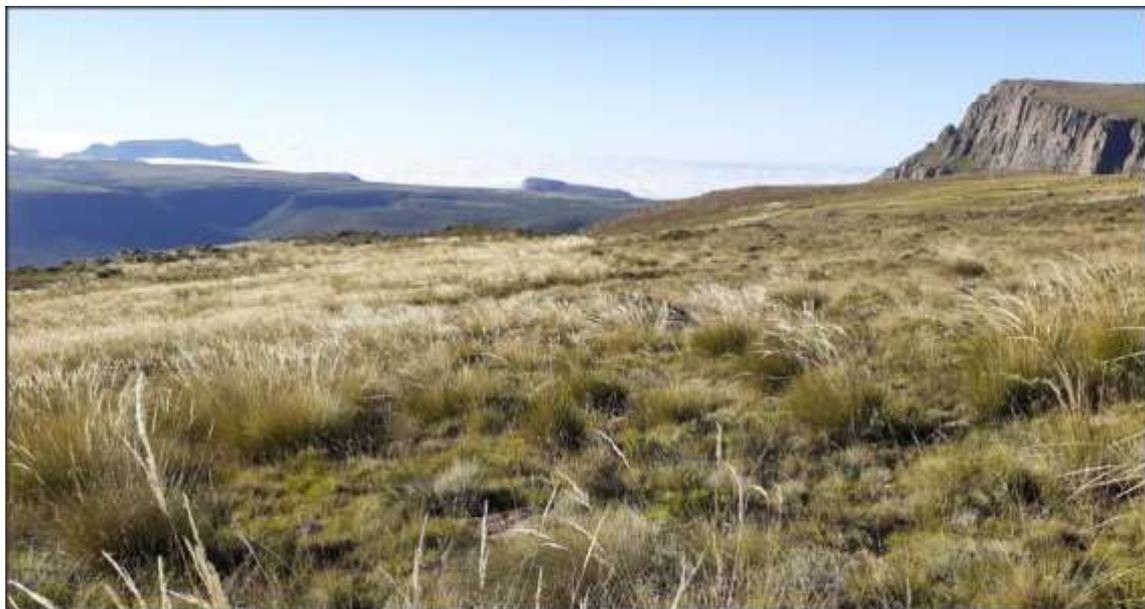
Figure 4-20 An extensive high altitude (1834-1933 m) seep wetland on the southern slopes of the Toorberg mountain, largely temporarily saturated and dominated by tall, robust grass *Merxmuellera macowanii*

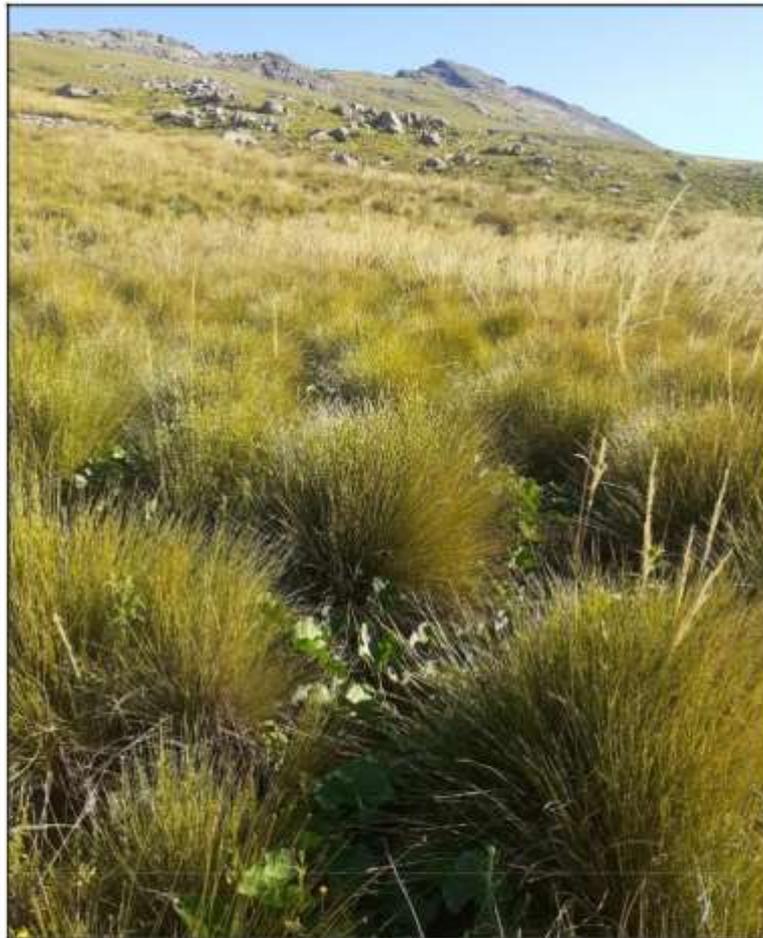
**Figure 4-21** A very localized area of the seep, seasonally to semi-permanently saturated area and with the River pumpkin (*Gunnera perpensa*)

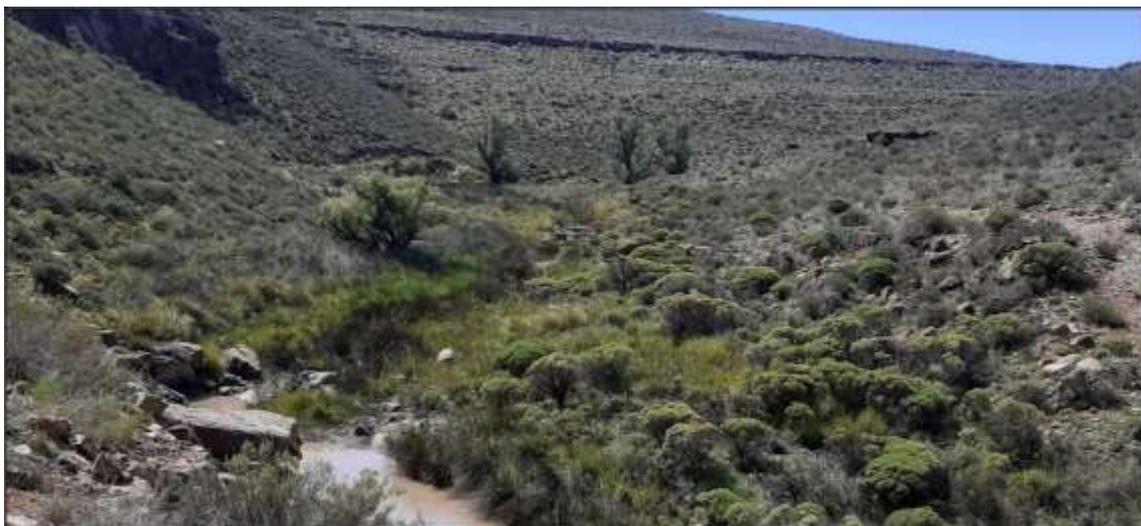
**Figure 4-22** A very narrow channeled valley-bottom wetland in a confined section of the valley in the Sneeuwberg foothills, dominated by the sedge *Pseudoschoenus inanus*, and the tall grass *Miscanthus capensis*, with scattered trees of the invasive alien crack willow, *Salix fragilis*

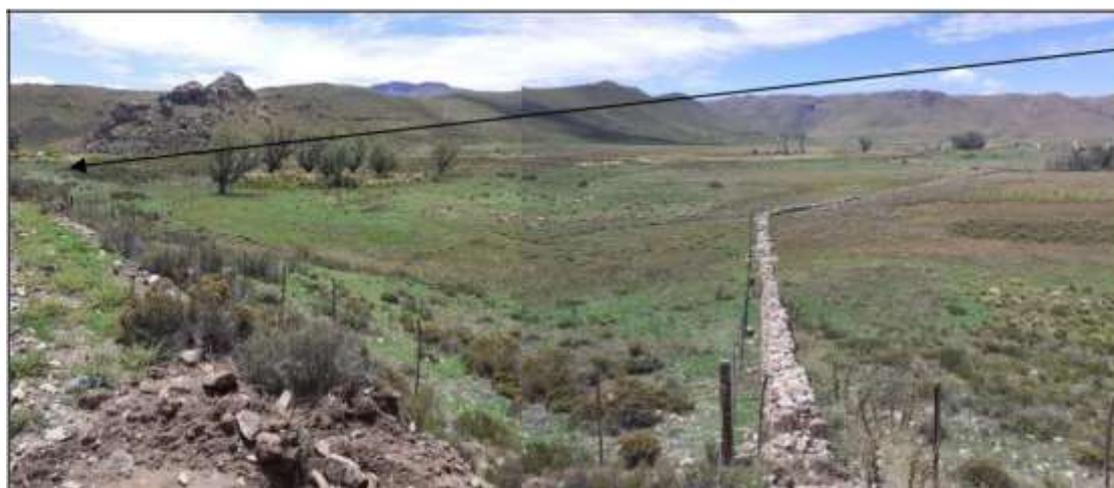
The “poort”, likely resulting from a dolerite dyke, where the wetland narrows considerably at its outlet, and which appears to act as a strong hydro geomorphologic al control on the extensive upstream wetland.

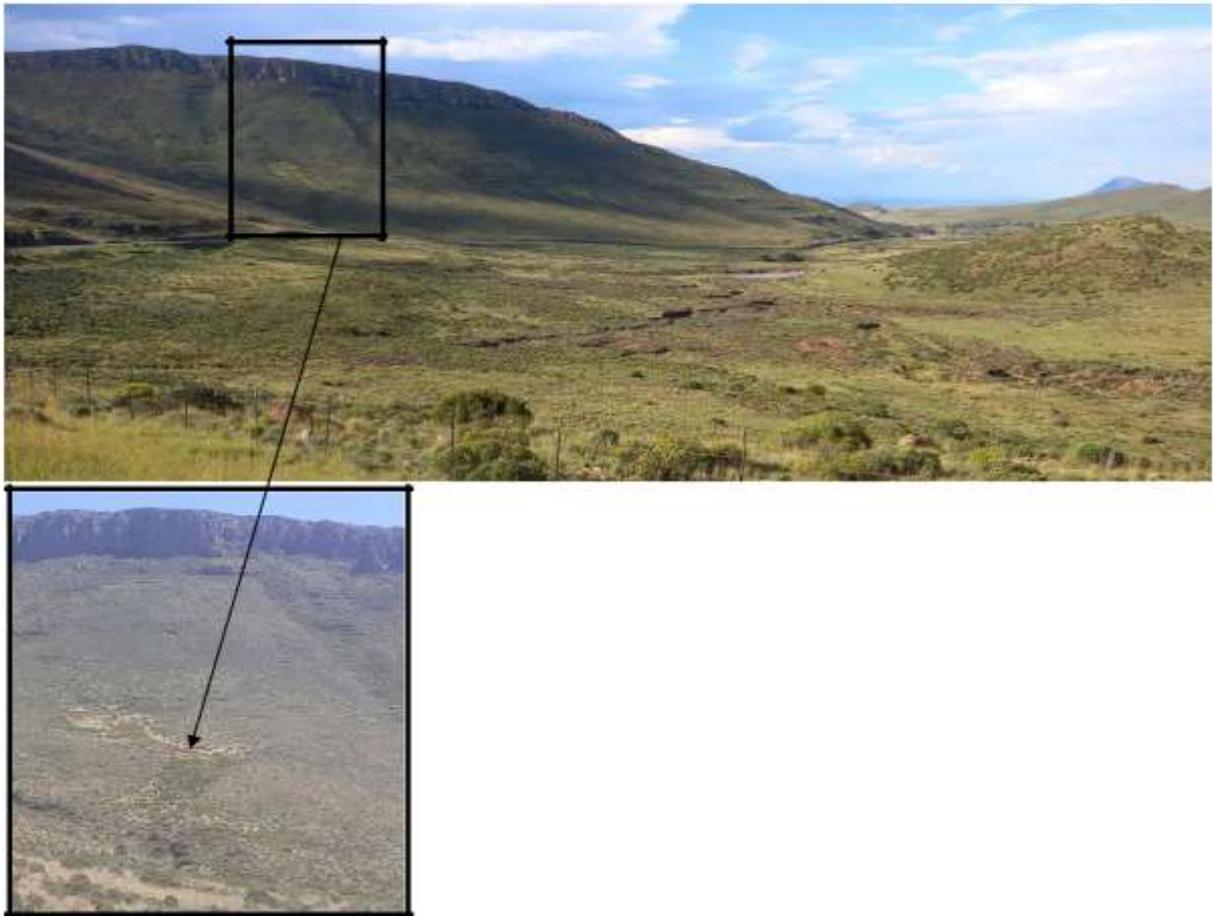
**Figure 4-25** The Loodsberg wetland RU, showing some of the eroded upper portions of the valley bottom area and cluster of seep wetlands on the lower south-facing slopes of the adjacent mountain, with one of the seep wetlands shown in the insert

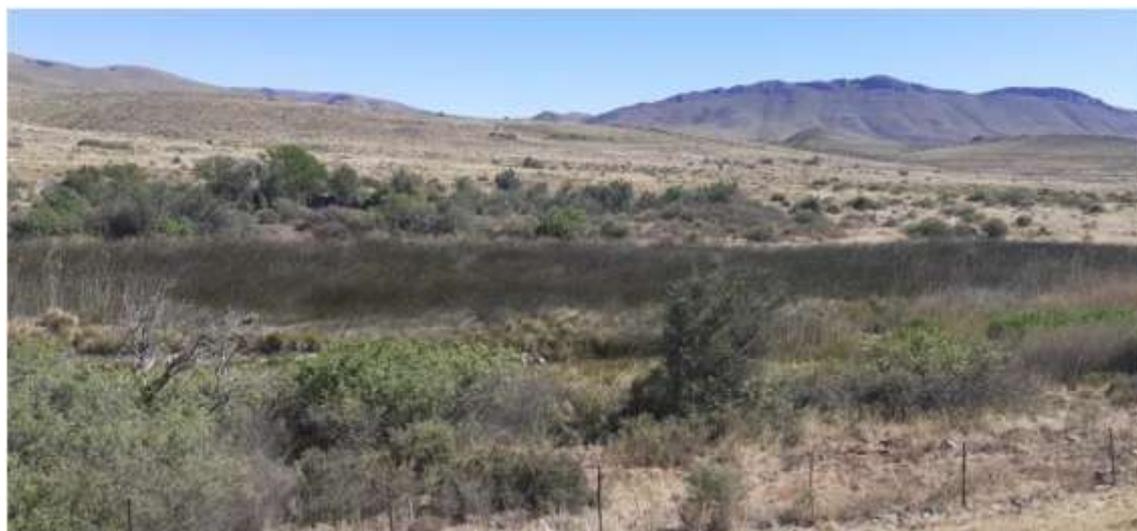
Almost all of the seep wetland areas remain under natural vegetation, while in the valley bottom wetland areas 65% of the area remains under natural vegetation (although much of it moderately degraded) (**Figure 4-26**) and 18% is eroded/severely degraded (**Figure 4-25**). **Table 4-47** provides a summary of the landcover for the two wetland types. For both the seeps and valley bottoms, the catchment remains predominantly natural vegetation, but with some degradation.

**Figure 4-26** The lower portions of the valley bottom wetland, still largely intact and dominated by the sedge *Pseudoschoenus inanus*, visible as the dark reed-like vegetation in the middle of the wetland.

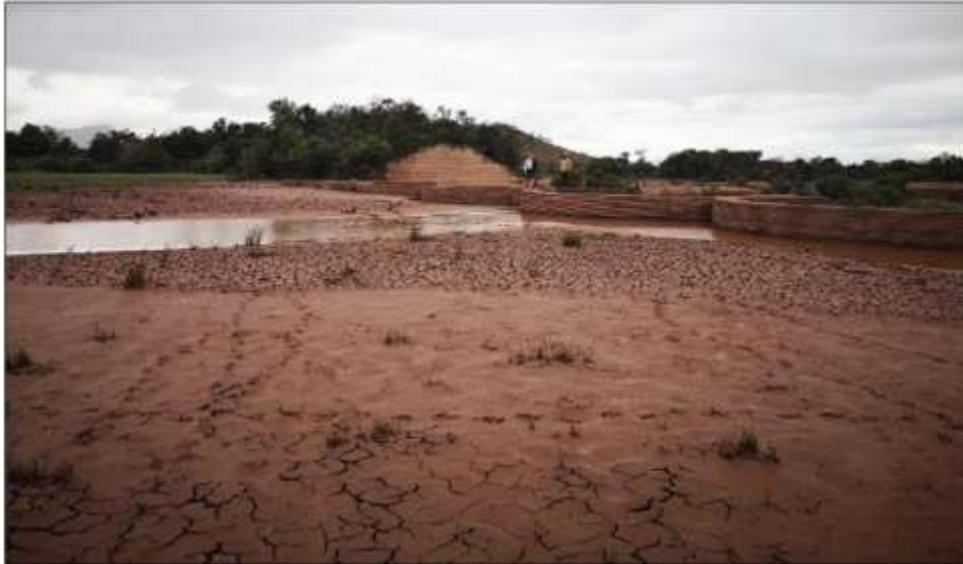
**Figure 4-28** Views of the sediment directly upstream of an intervention and the remaining open water

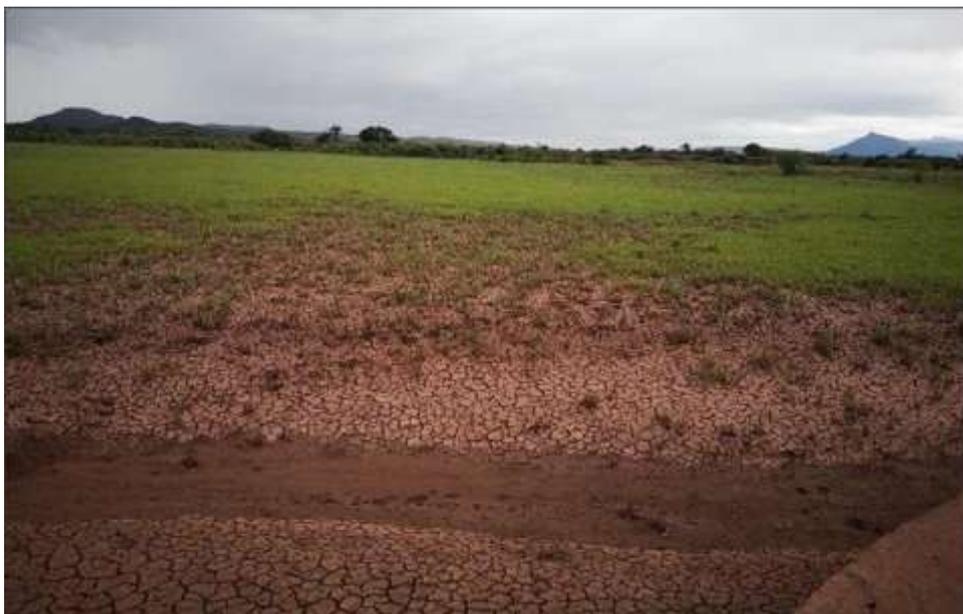
Although these systems are not considered to be true wetland habitat, they provide important ecosystem services within the landscape, including additional grazing lands and/or sources of water. **Figure 4-28** to **Figure 4-31** are photos of one of the artificial wetland systems that has formed as a result of an agricultural intervention. Additionally, the interventions have ensured that there has not been a mass export of sediment out of the greater catchment area, which would have otherwise been the case. Without intervention, the gully associated with the Vlekpoort River would have most likely been much larger in extent with further loss of the adjacent landscape to erosion. Overall, the greater river system has been classified as a D-category system (Nel *et al.* 2011) and is largely modified, which can be attributed to the interventions within the river and the degraded state of the system's catchment. However, the maintenance and management of these interventions and associated wetland systems are crucial in sustaining the habitat within the landscape and should one of the interventions fail, especially within the upper reaches, it can be assumed that the mass export of sediment may lead to the failure of the downstream interventions and as such loss of habitat within the landscape, and the formation of a large gully, similar to those present in the systems catchment. Additionally, all the mobilised sediment would accumulate in the Kommandodrif dam, which is utilised for irrigation purposes.

**Figure 4-29** View of the accumulated sediment upstream of the weir and heavily grazed grassland

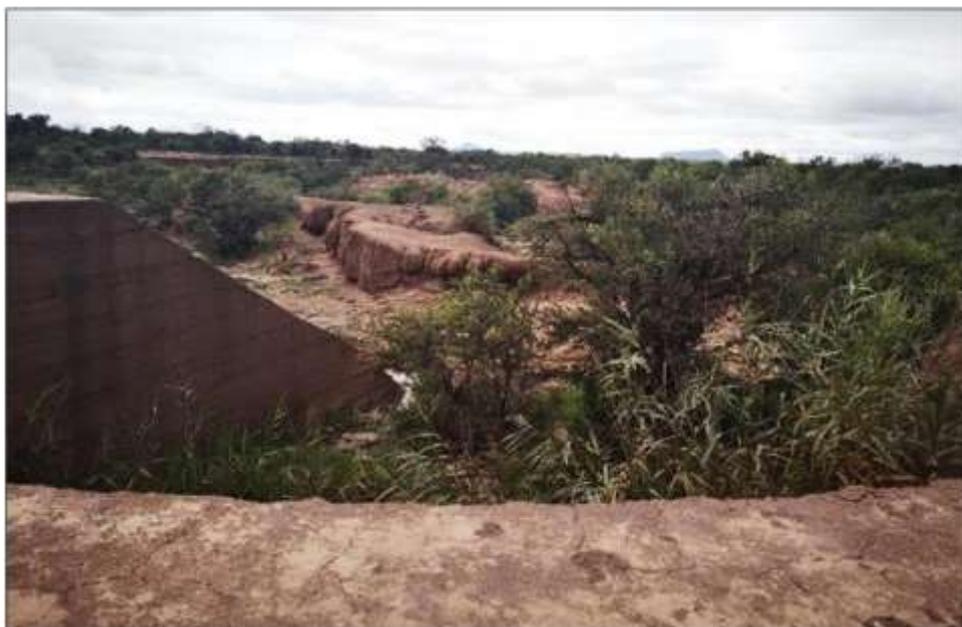
**Figure 4-30** View of the erosion gully downstream of a weir

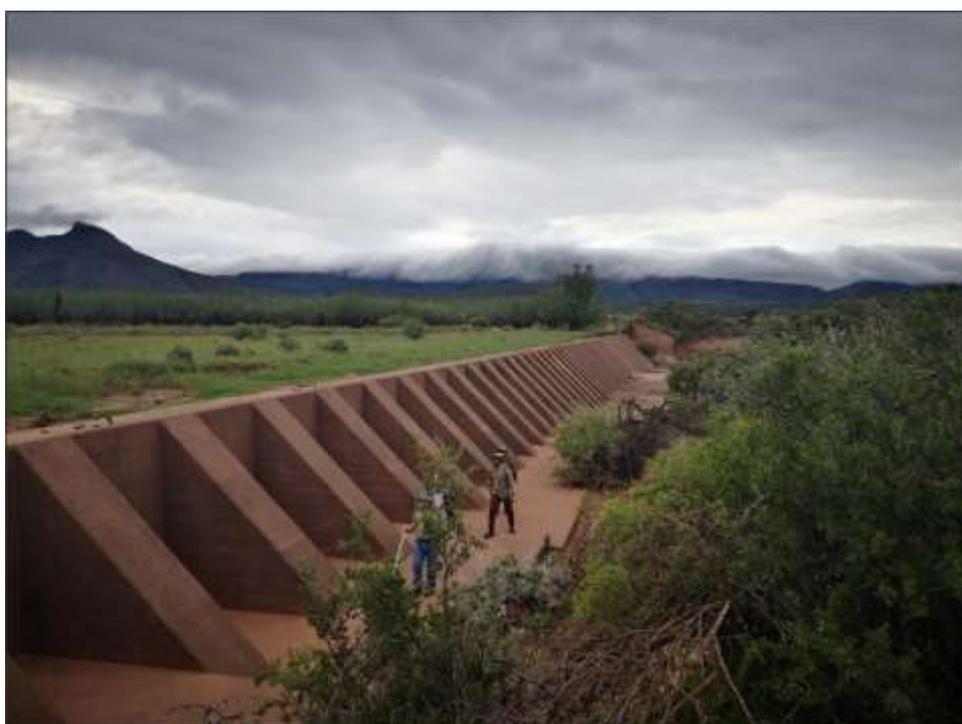
**Figure 4-31** View of a buttress weir and the upstream wetland and grazing areas

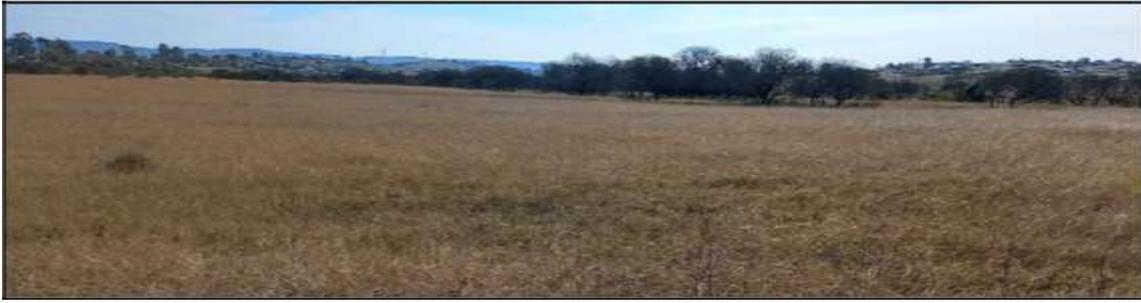
**Figure 4-33** A historically-cultivated area in the eastern arm of the upper floodplain, with *Vachellia karroo* trees (visible in the background) dominating the stream channel.

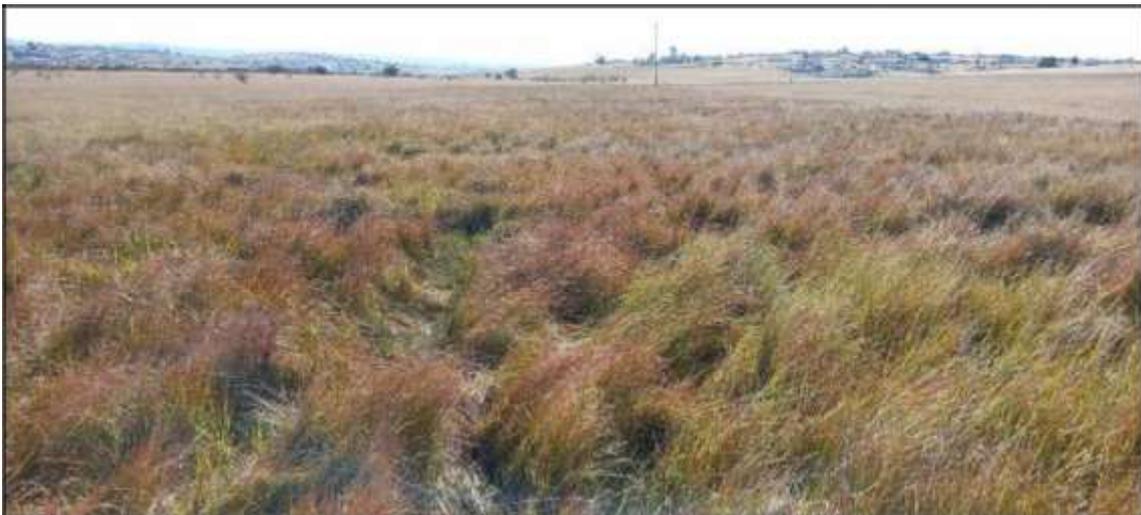
**Figure 4-34** One of the most extensive seasonally-saturated wetland areas in the floodplain, located in the eastern arm of the upper floodplain.

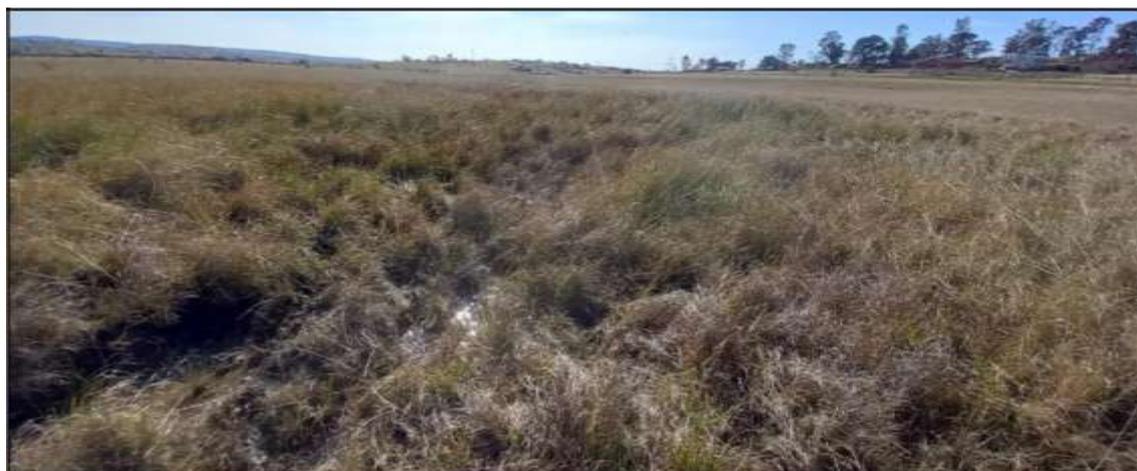
**Figure 4-35** A minor headcut erosional feature currently subject to moderate levels of livestock trampling. Although currently the level of activity of the erosion is moderately low, it could potentially increase and threatens to advance into one of the naturally wettest portions of the wetland (shown in the previous photo) which, in turn, will likely have a significant draining effect on this area of the floodplain.

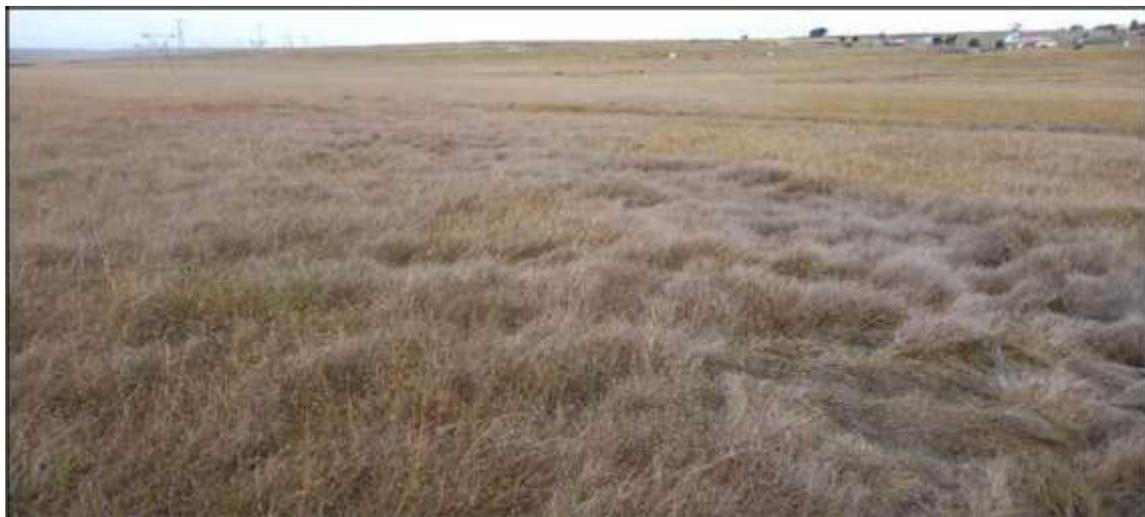
Figure 4-37 A hillslope seep dominated by the sedge *Fuirena pubescence* near the western inflow to the wetland, located in an area which is fenced off and, recently at least, appears to have been more leniently grazed than the central and eastern portions of the wetland.

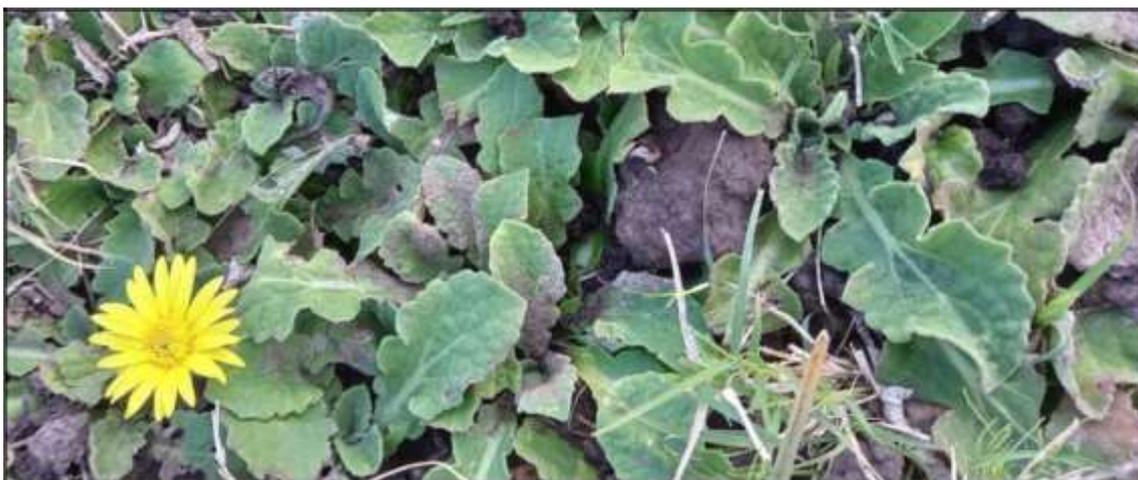
**Figure 4-38** *Arctotis debensis* growing in a kommetjievlaakte area of the wetland amongst abundant earthworm casts. This is a vulnerable species known from only eight locations in a limited geographical area between Qonce and Perie Forest, and which appears well adapted to the extensive earthworm-mediated soil turnover characteristic of Kommetjievlaakte (Dold *et al.* 2021).

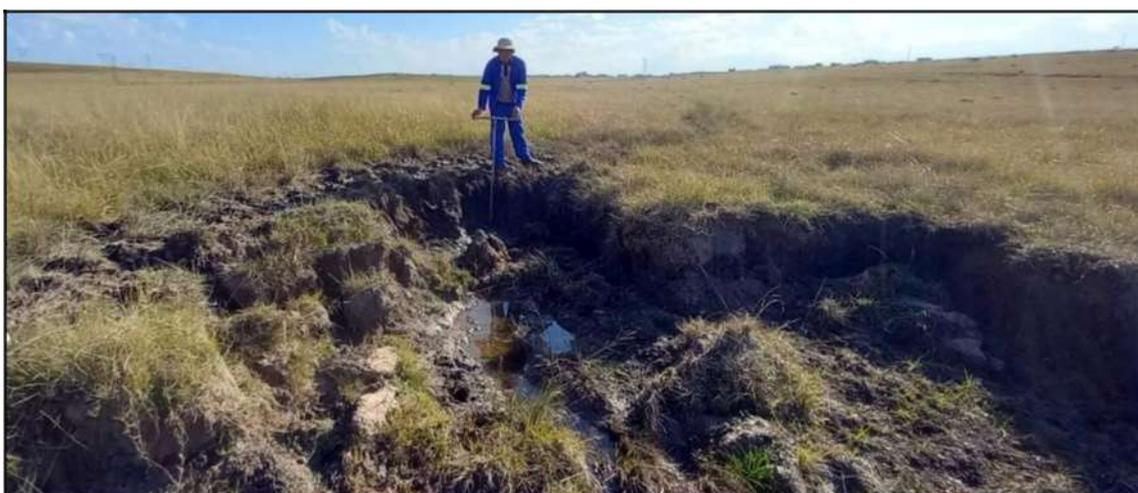
**Figure 4-39** The primary headcut at the head of the main gully (see the following four photos) which has advanced through an extensive area of unchannelled valley bottom and threatens a further large area of unchannelled valley bottom upstream. An active cattle path immediately upstream of the headcut can be seen, which is likely weakening the area under immediate threat of erosion.

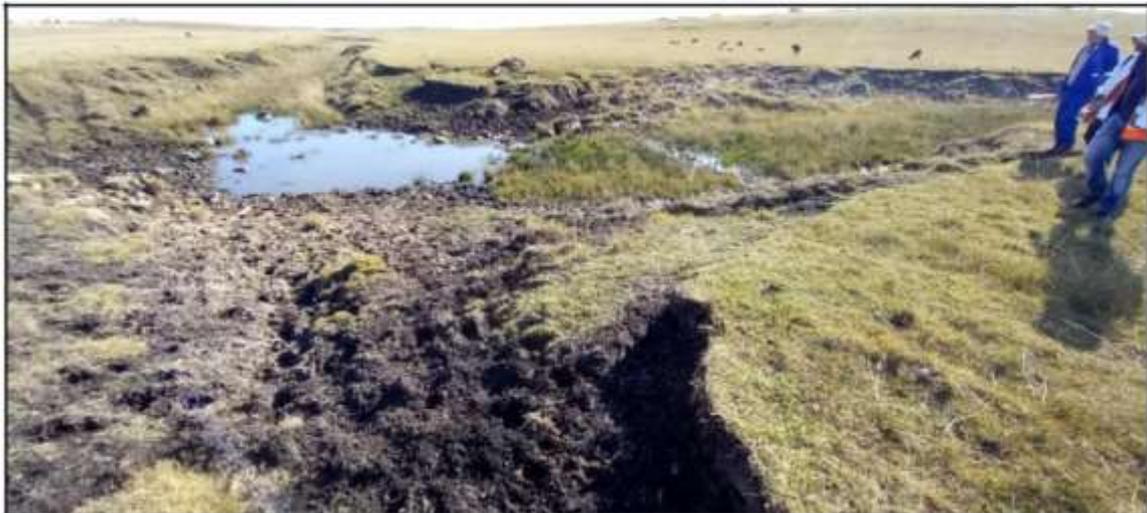
**Figure 4-40** The primary livestock crossing point through the main erosion gully in the wetland, subject to intense localized trampling.

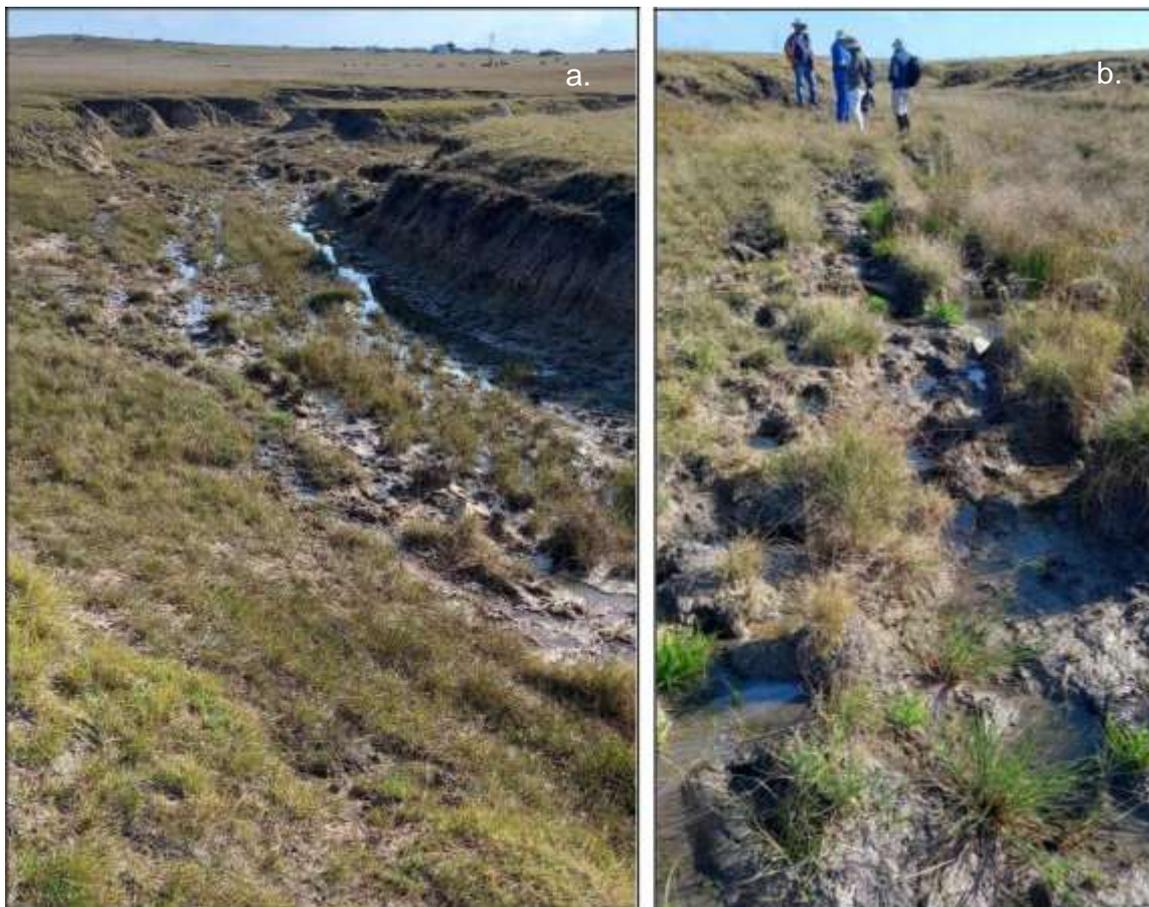
**Figure 4-41** The main erosion gully in the wetland (downstream of the headcut shown in the previous photo) with (a.) located shortly downstream with incomplete vegetation cover and (b.) somewhat further downstream where vegetation cover is generally higher and more sediment has accumulated than above
