# DEPARTMENT OF WATER AND SANITATION

## Determination of Water Resource Classes, Reserve and the Resource Quality Objectives in the Keiskamma and Fish to Tsitsikamma Catchments

### WP11354 Wetland Eco-Categorisation Report

REPORT NO.:  
WEM/WMA7/00/CON/RDM/1223

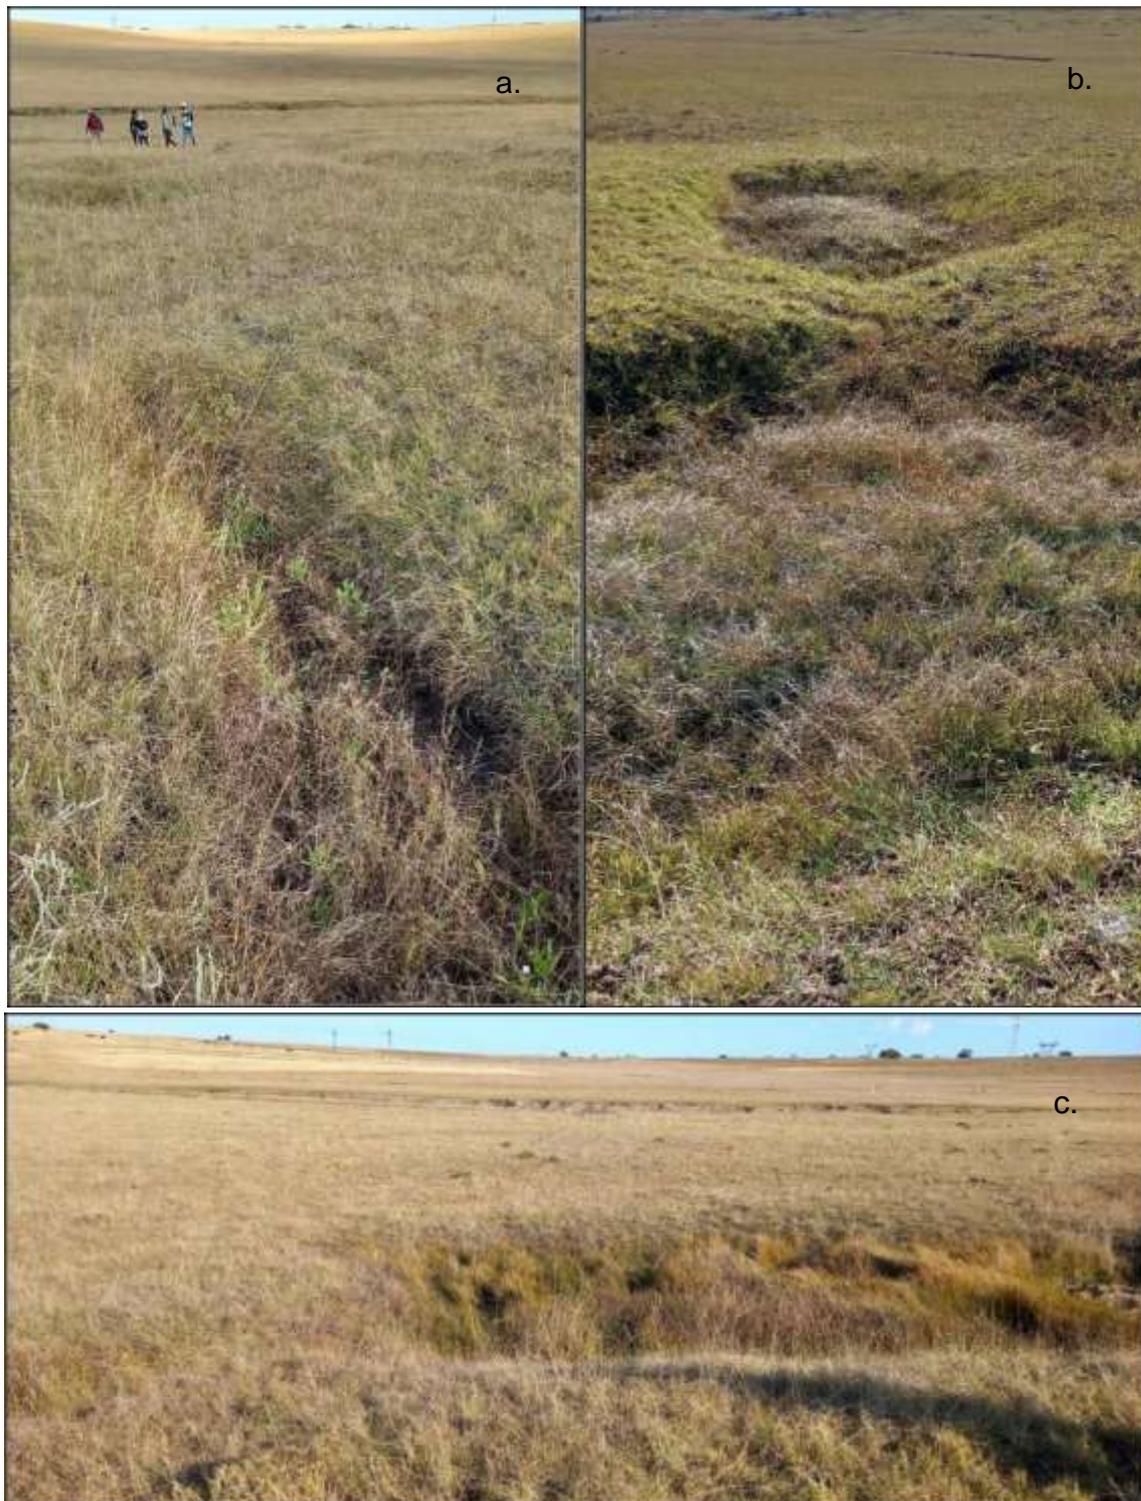
**Figure 4-42** Three different locations where the hillslope component of KwaMasele wetland extends into adjacent Kommetjievlaakte terrain, with (a.) on a mid-slope and the wetland areas confined to only a few of the deepest hollows such as that shown in the foreground; (b.) also on a footslope and

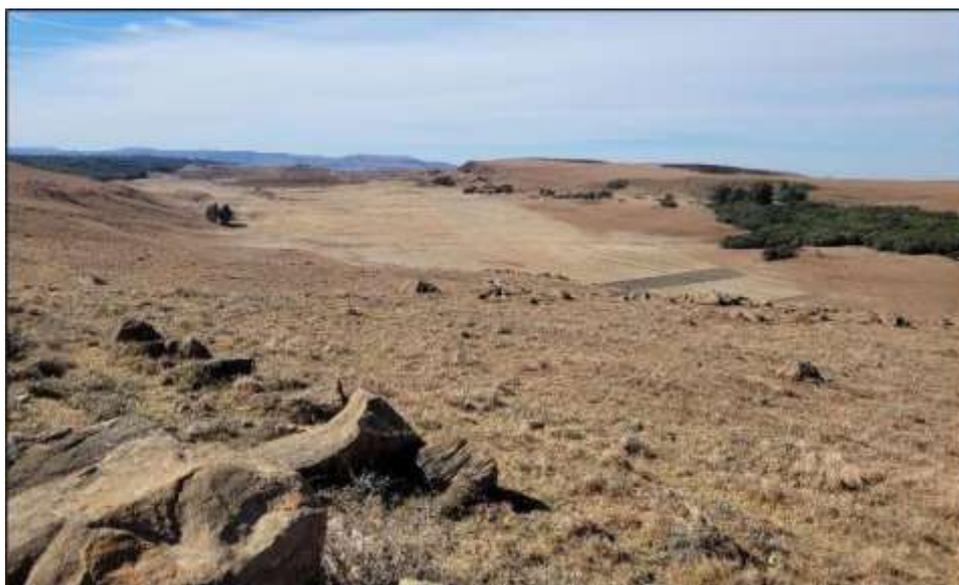
**Figure 4-44 View of the Cala wetland from the upper catchment area**

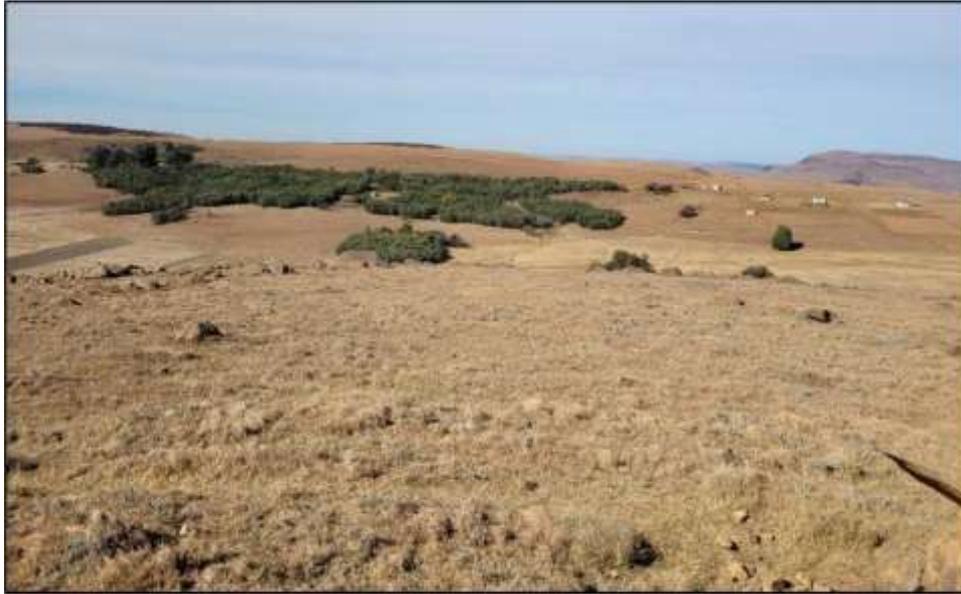
**Figure 4-45** View of the scrub wattle within a portion of the wetland's catchment

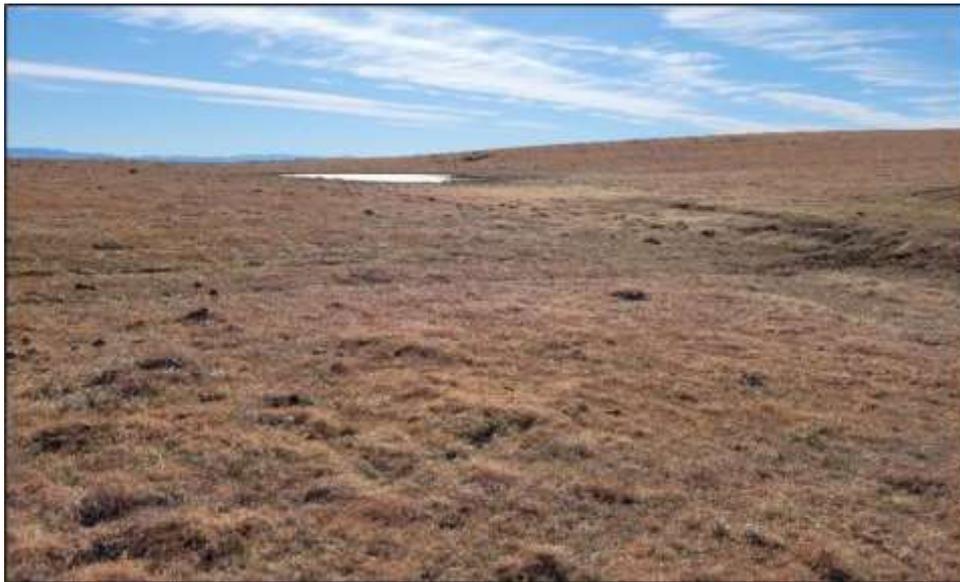
**Figure 4-46** View of the depression wetland within the catchment of the system

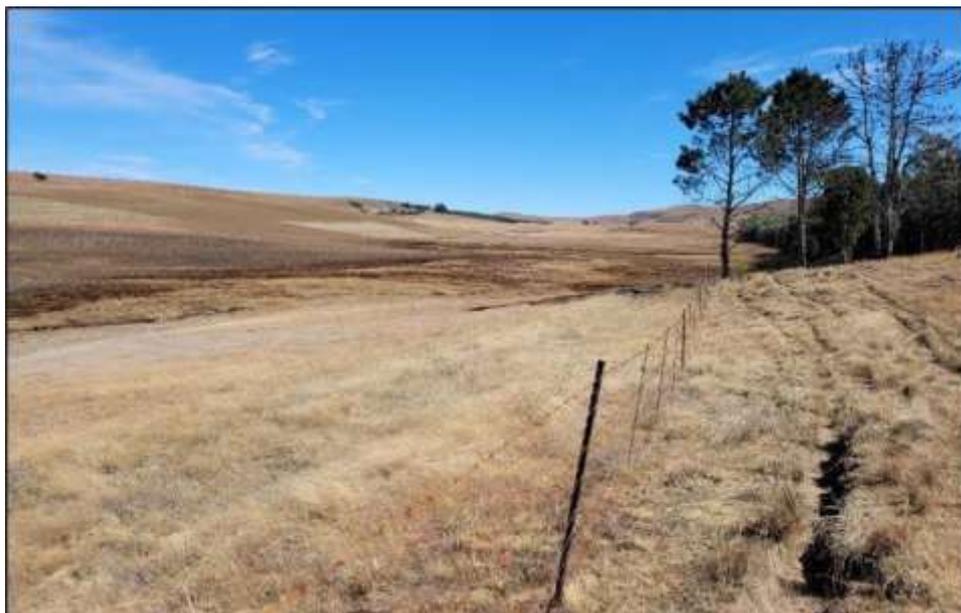
**Figure 4-47** View of the downstream portion of the valley-bottom wetland, which is characterised by permanent wetness. Note the plantation forestry along the right hand boundary of the system.

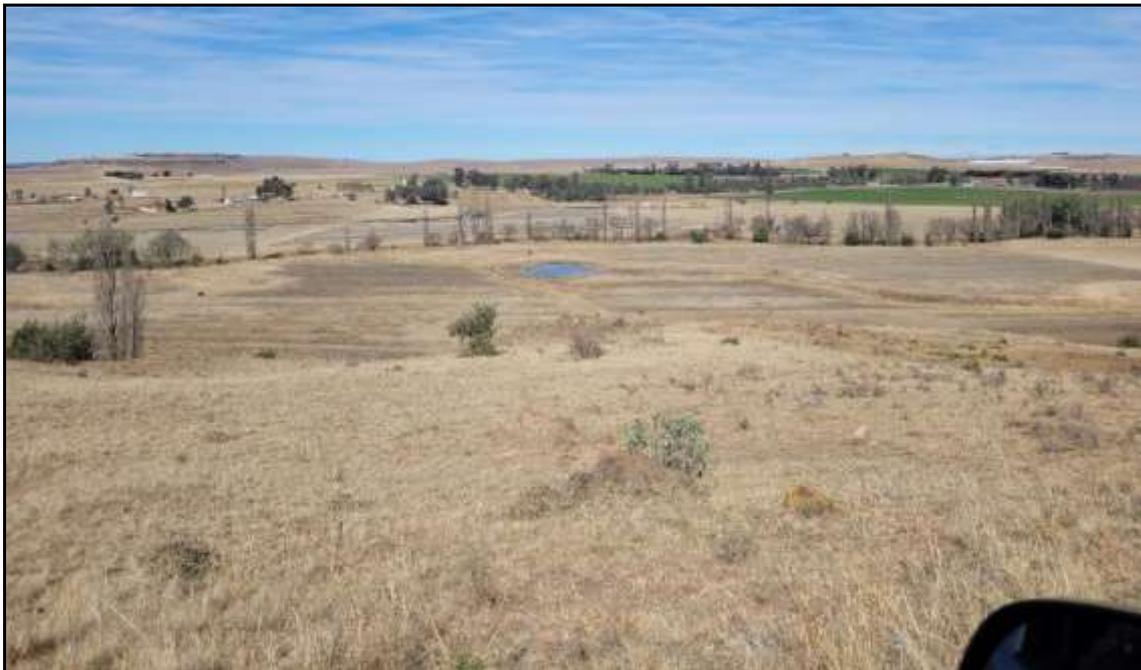
**Figure 4-49** View of a portion of the floodplain and the small artificially impounded areas on the adjacent floodplain terrace, and agricultural activities

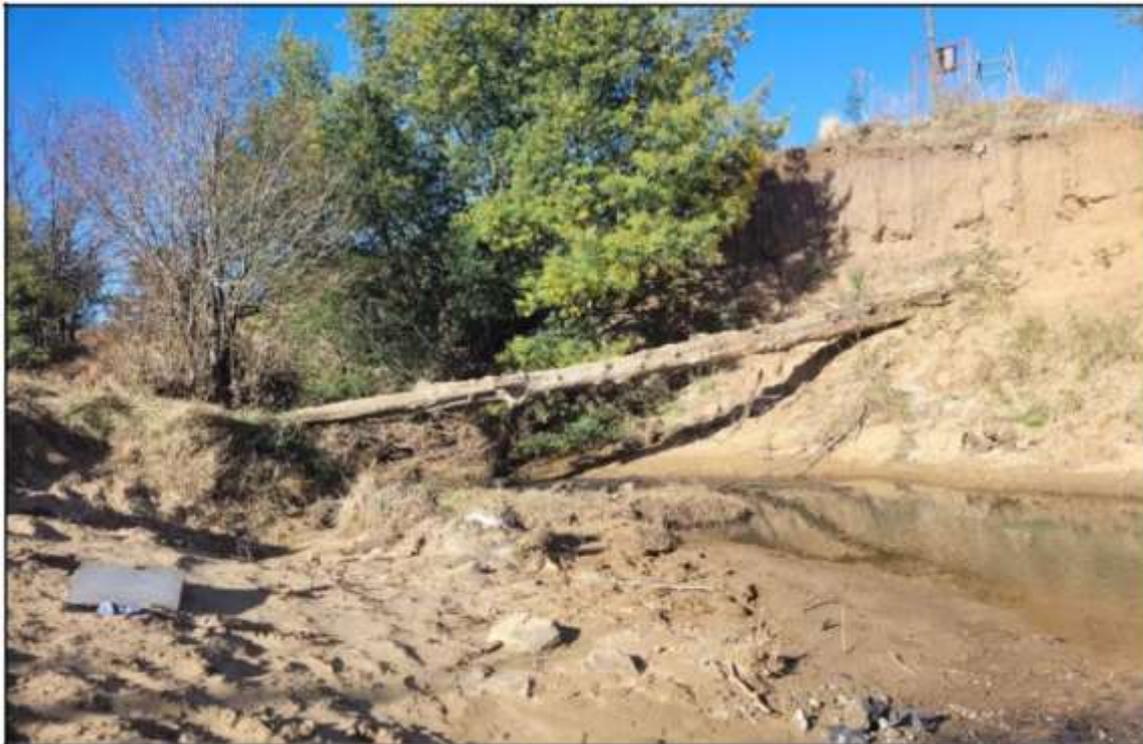
**Figure 4-50** Incised river channel within the floodplain, with the discharge point from the waste ponds slightly upstream from this point.

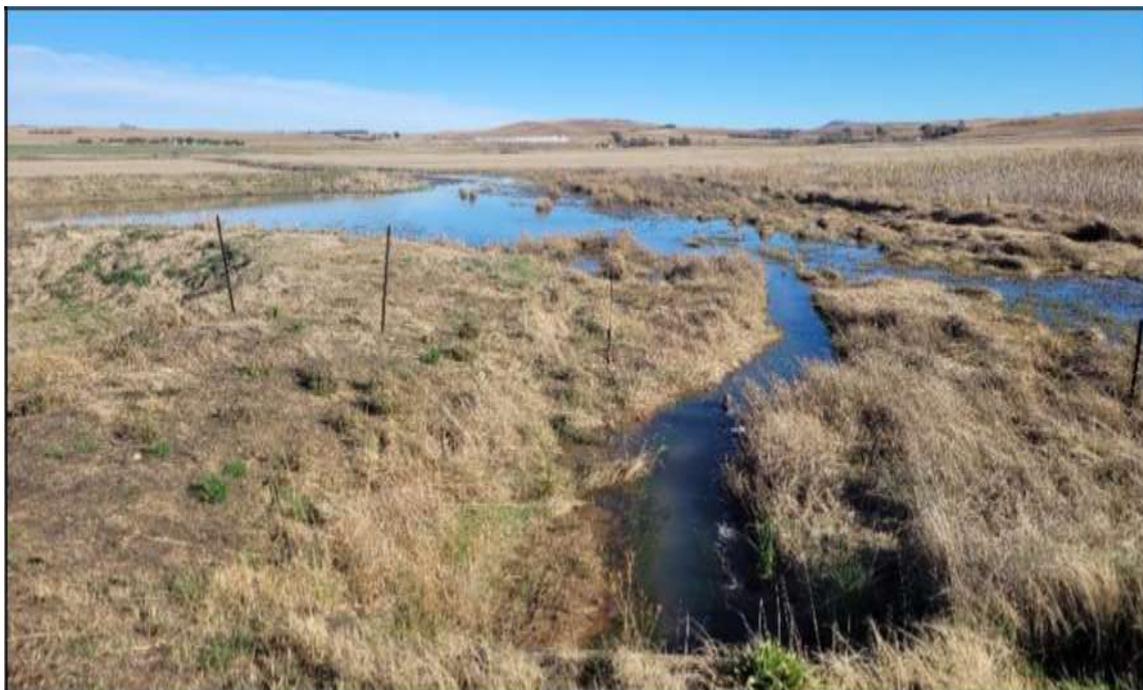
**Figure 4-51** View of the flows along the diversion canal supplying the off-channel dam.

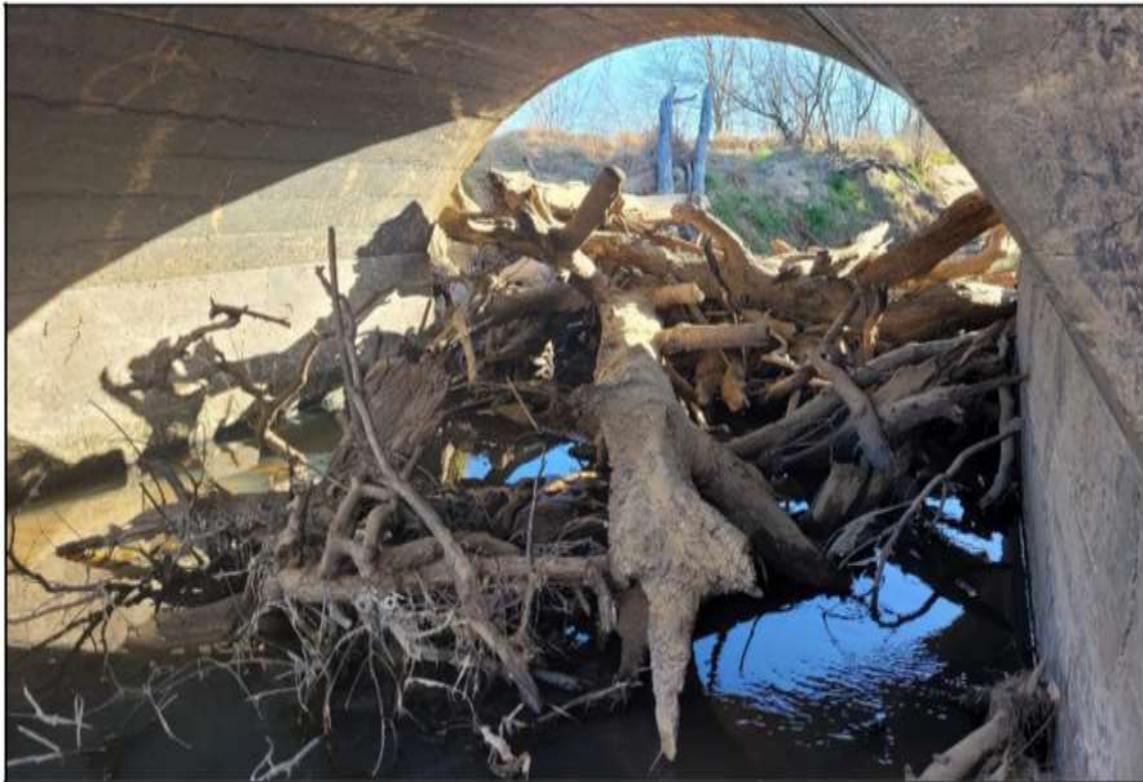
**Figure 4-52** Debris below a large road culvert across the incised portion of the floodplain.

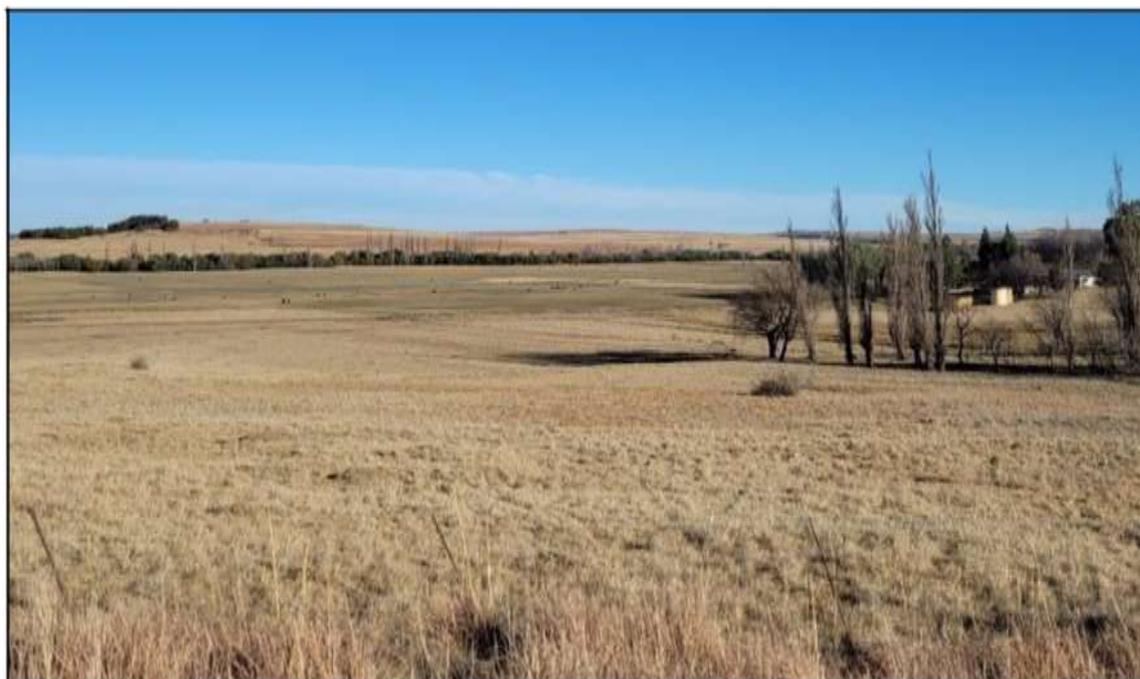
**Figure 4-54** Grazing lands within the lower portion of the floodplain system

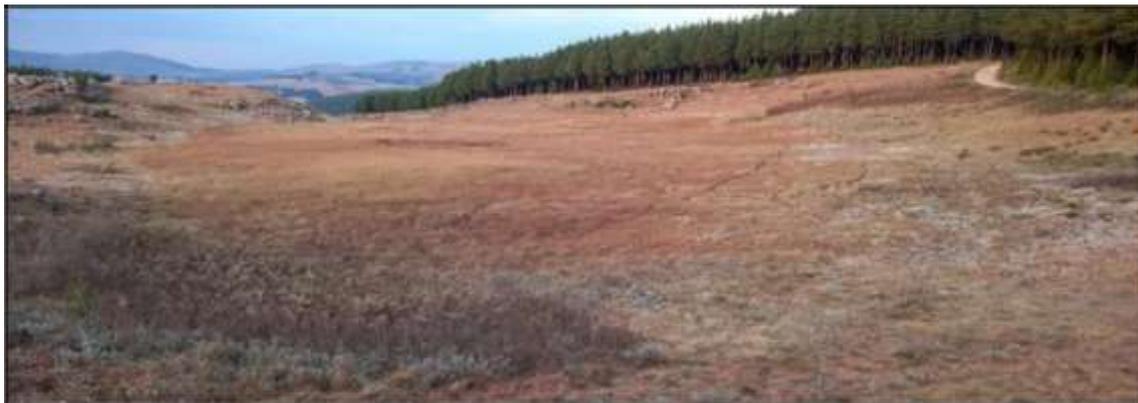
**Figure 4-58** A well-buffered wetland seep on the Gaika road, supporting a diversity of grasses (notably *Festuca caprina*) and sedge (e.g. *Pyreus* sp.) and with its wettest core dominated by the rush *Juncus pectorius*.

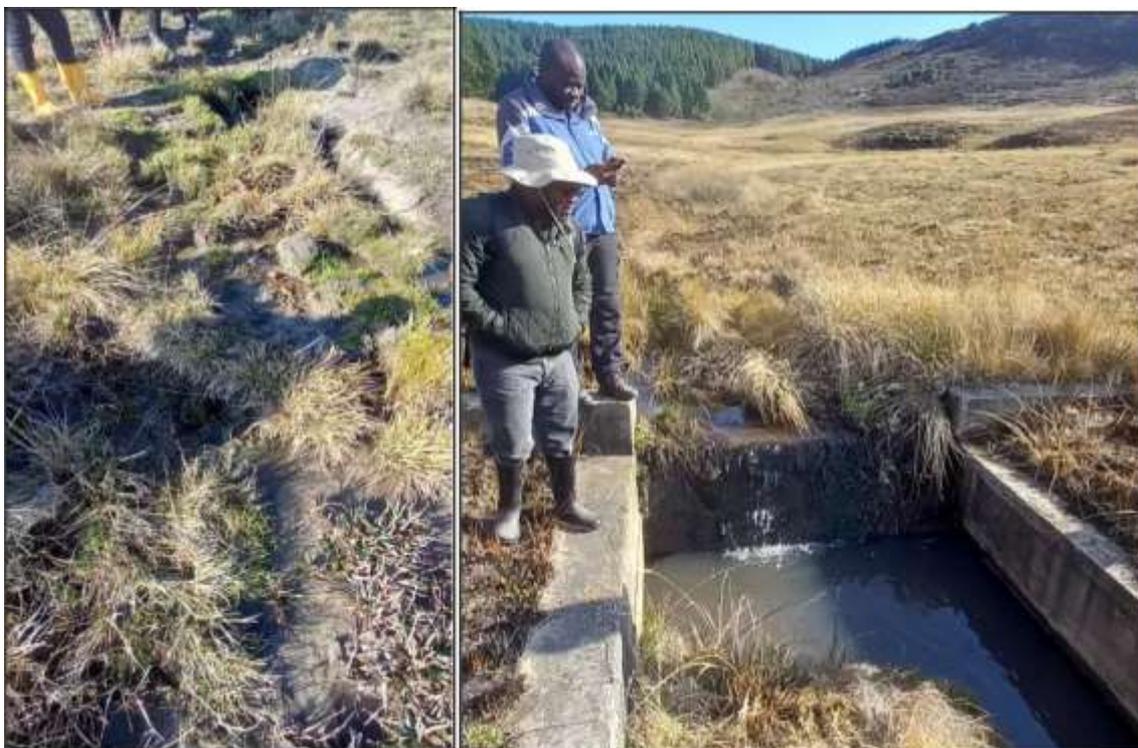
**Figure 4-59** Left: A wetland seep heavily used by livestock. Right: One of Working for Wetlands rehabilitation interventions in a channelled valley bottom which was identified as incised.

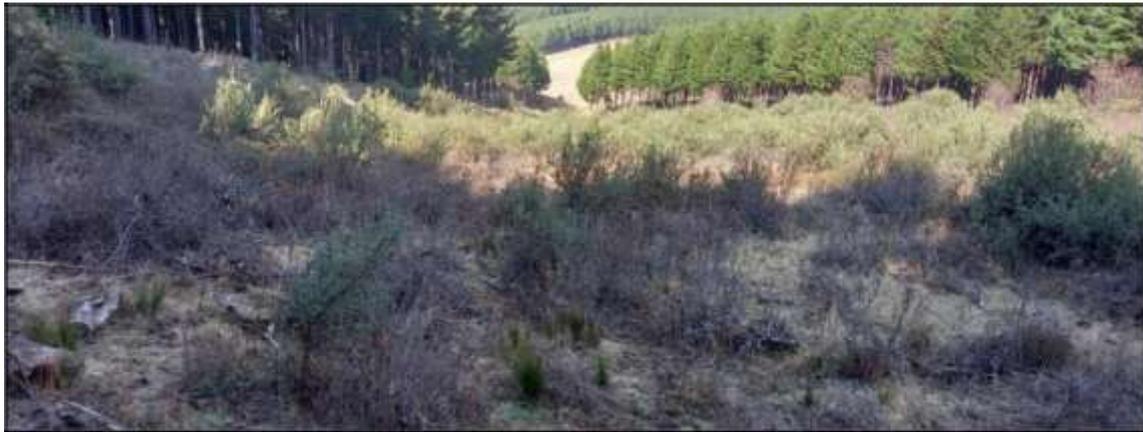
Figure 4-60 A wetland seep area with extensive *Leucosidea sericea* trees, which are favoured by an absence/infrequency of fires.

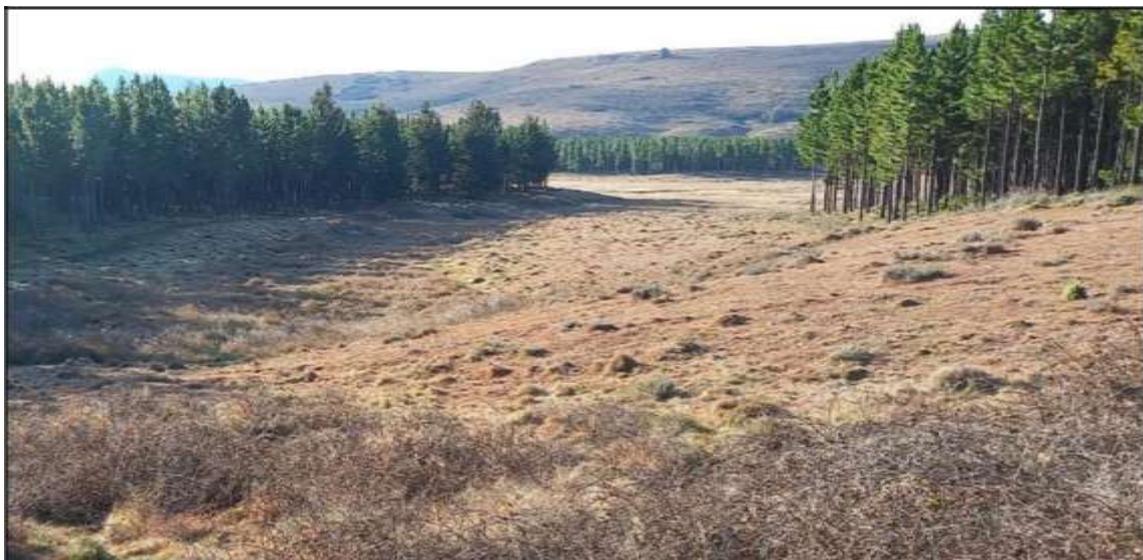
Figure 4-61 A wetland seep area infested with American bramble.

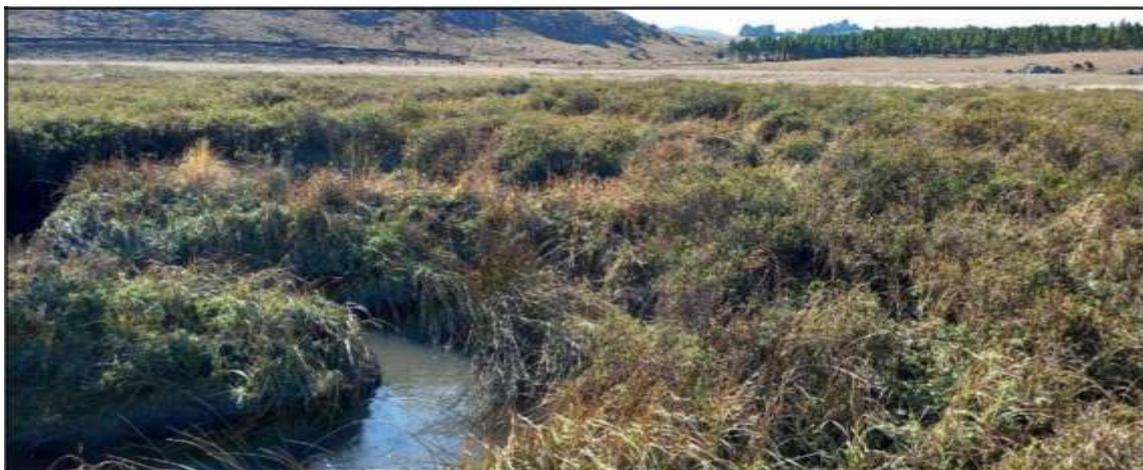
Figure 4-62 A floodplain wetland, showing the sinuous main stream channel and vigorous vegetation including the sedge *Carex acutiformis* and the short shrub *Clutia* sp.

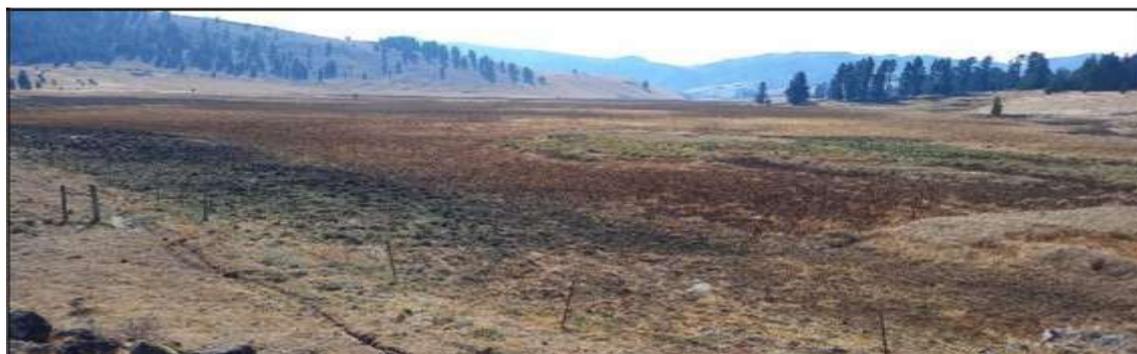
**Figure 4-63** The most extensive unchannelled valley bottom in the Hogsback area, dominated mainly by, the lesse pond sedge (*Carex acutiformis*) and seen here after a recent fire.

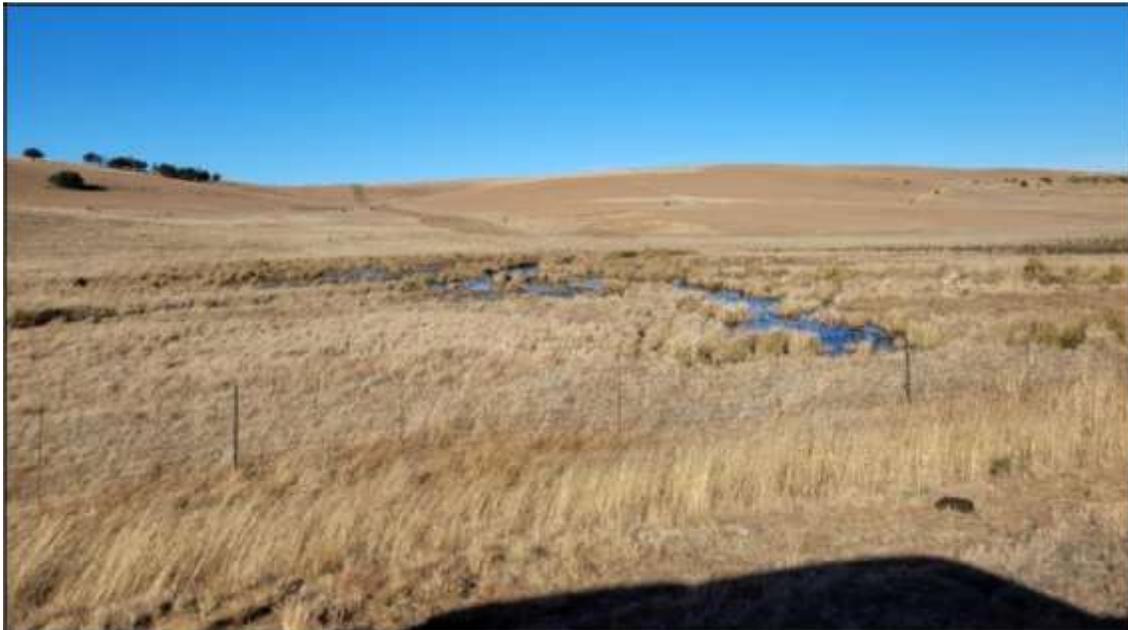
**Figure 4-66** View of an intact portion of the channelled valley-bottom wetland associated with the floodplain wetland.

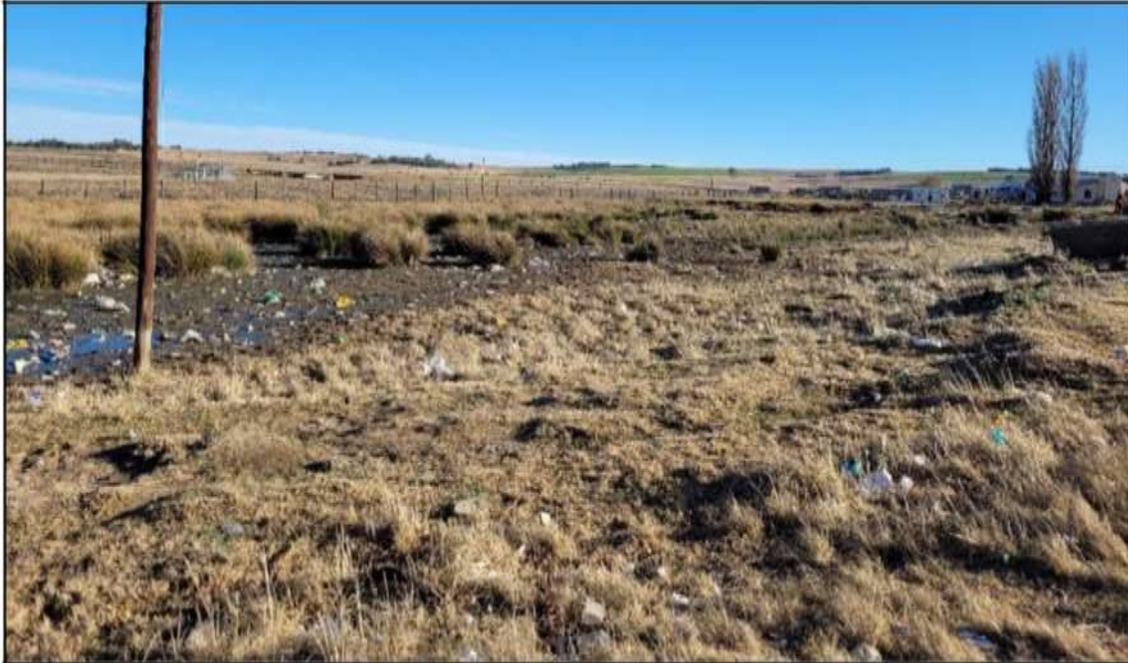
**Figure 4-67** Solid waste and die - back of wetland vegetation due to sewage contamination.

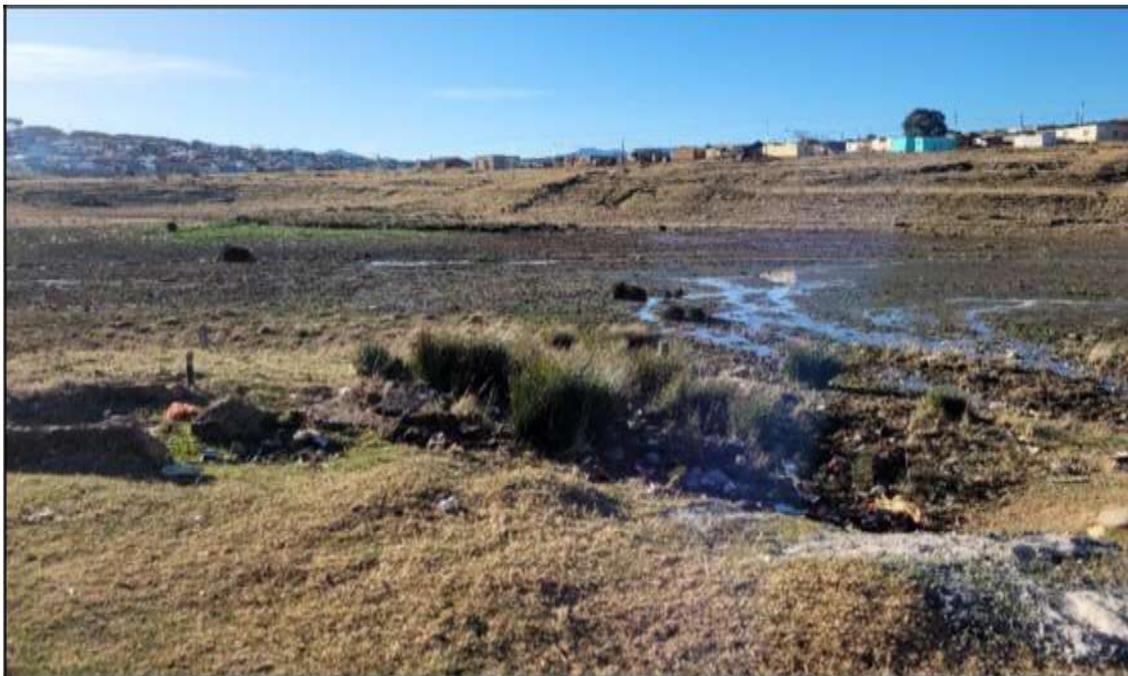
**Figure 4-68** View of the die - back of vegetation due to the accumulation of sewage within the wetland as a result of the surcharging sewerage infrastructure.

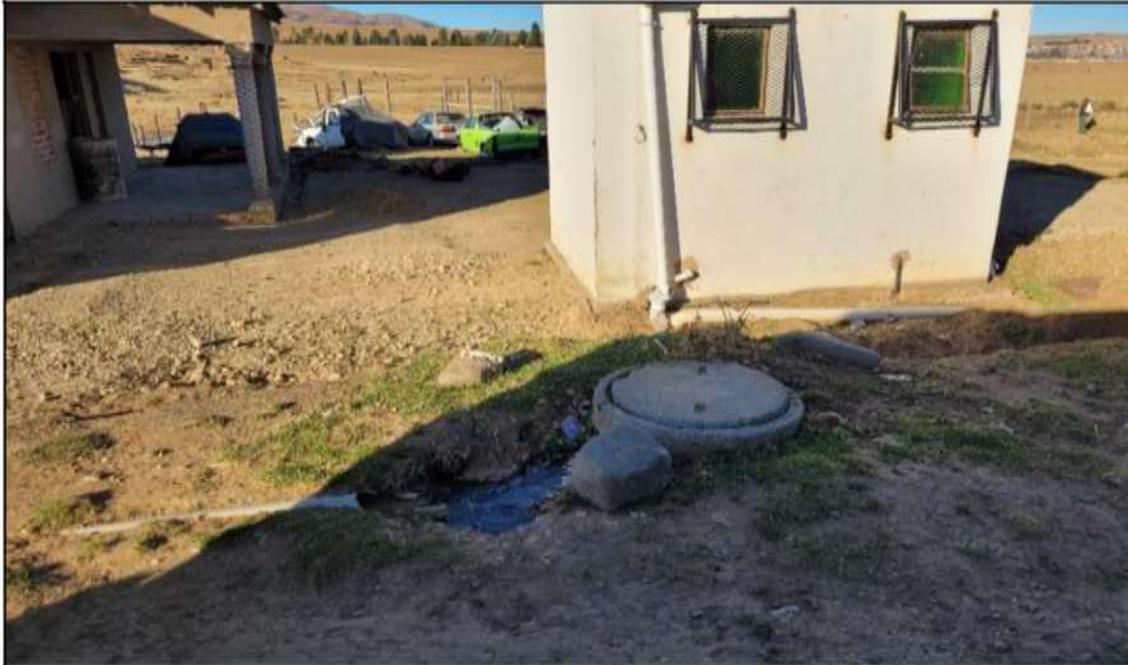
**Figure 4-69** Surcharging manhole with the sewage being directed towards the wetland.

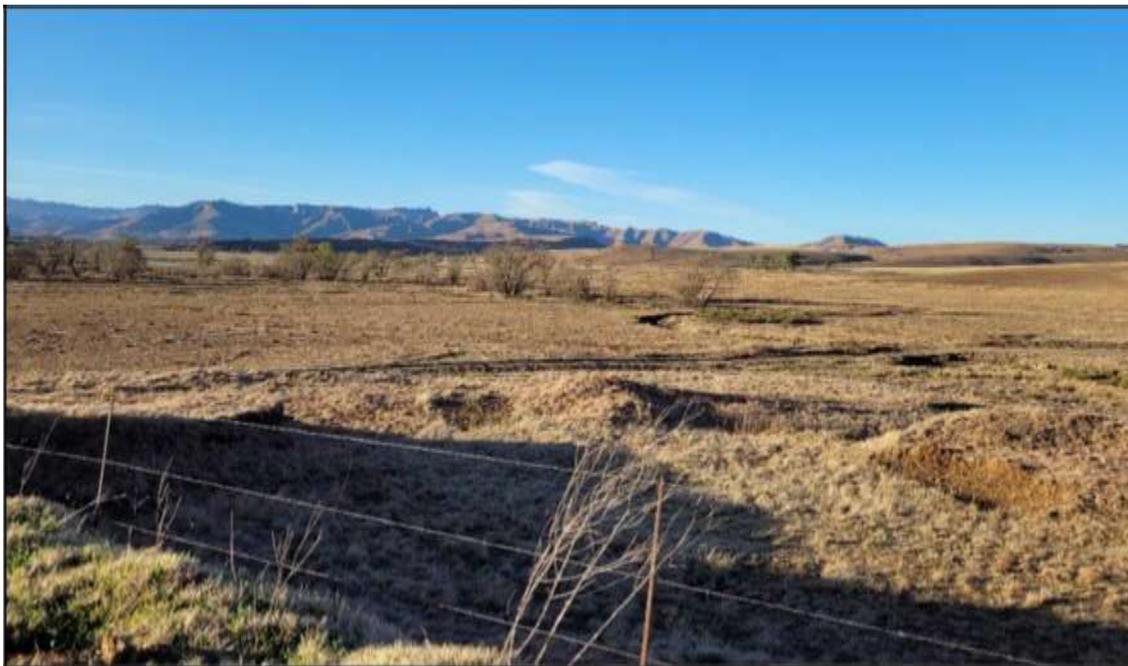
**Figure 4-70** Downstream portion of the floodplain, which is directly upstream of the geological control. This portion of the wetland resembles the most intact portion of the system and is also home to breeding cranes

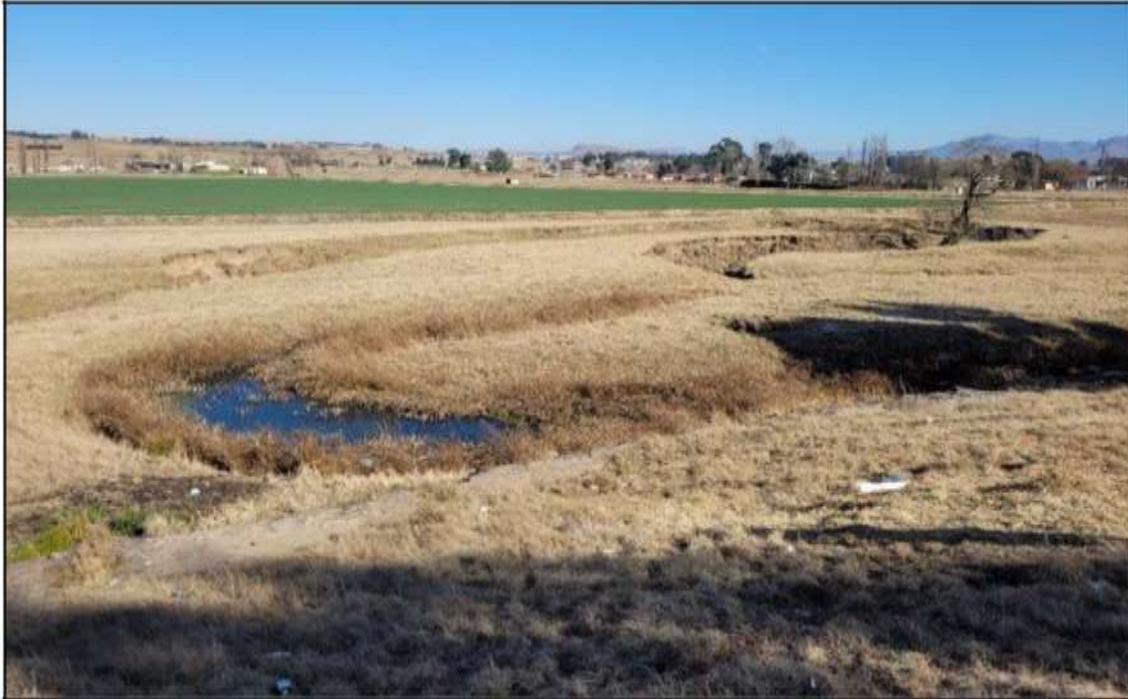
**Figure 4-71** Incised floodplain channel (in the background), which has been restricted in its movements due to a geological control along its northern boundary and a flood protection berm along its southern boundary.

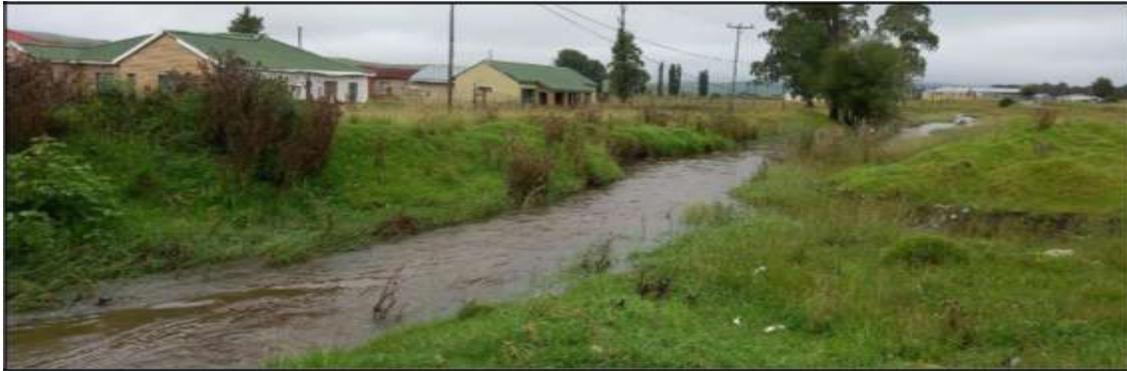
**Figure 4-73** Flood-prone houses situated adjacent to the enlarged and straightened channel shown in the previous photo.

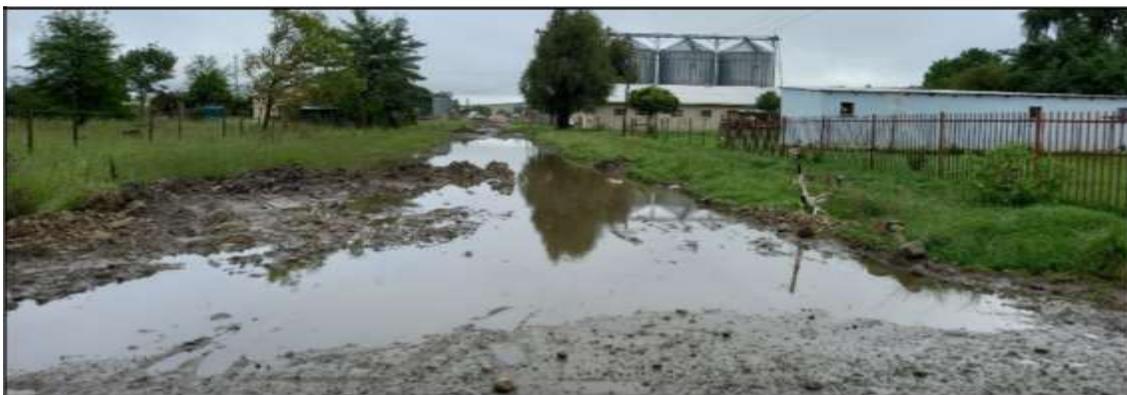
**Figure 4-74** A low-lying flood-prone area of Elliot/Khowa town located within the wetland complex.

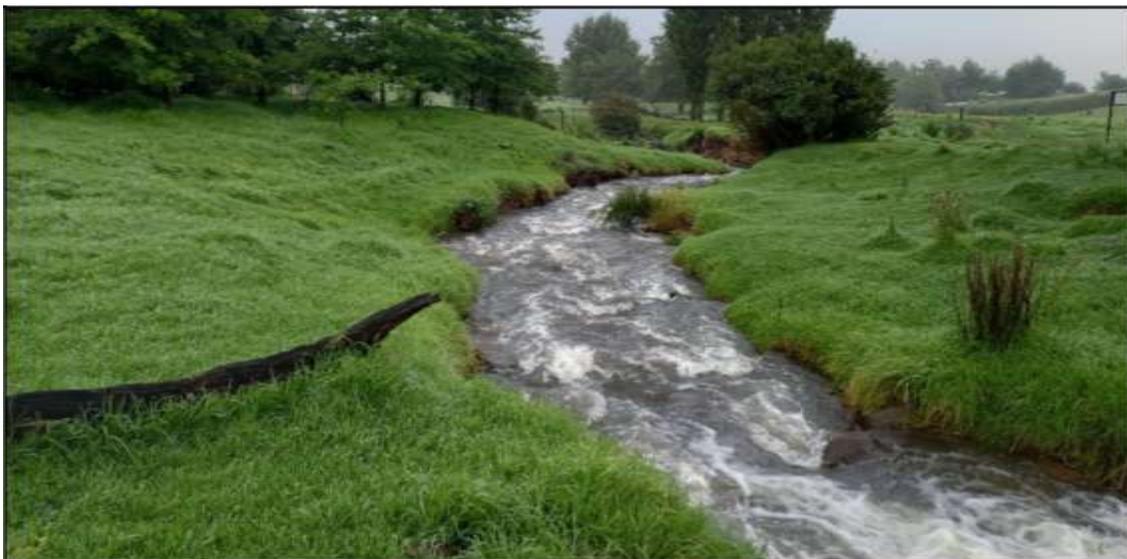
**Figure 4-75** The Slang River at the inflow to the upper portions of the Elliot/Khowa floodplain, showing the vegetation dominated by kikuyu (*Pennisetum clandestinum*) an alien pasture grass species.

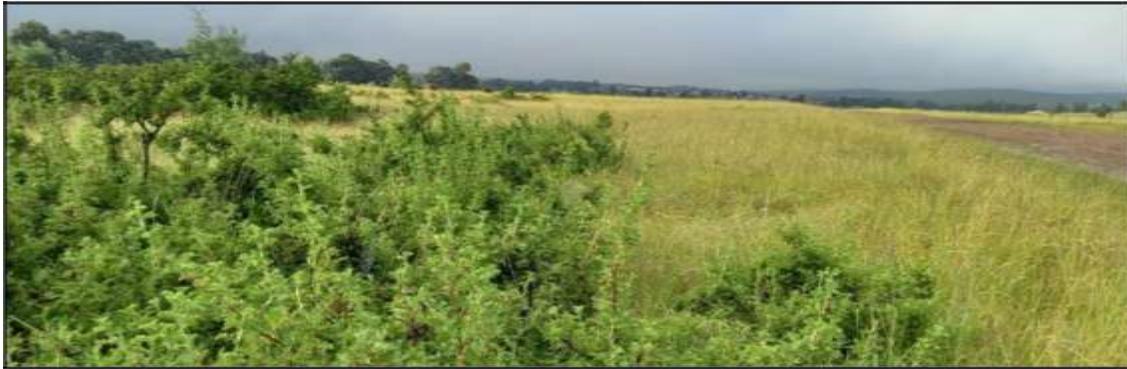
**Figure 4-76** Some of the upper portions of the Elliot/Khowa floodplain, with the indigenous shrub *Leucosidea sericea* and predominantly indigenous pioneer grasses, including *Eragrostis* and *Sporobolus* spp.

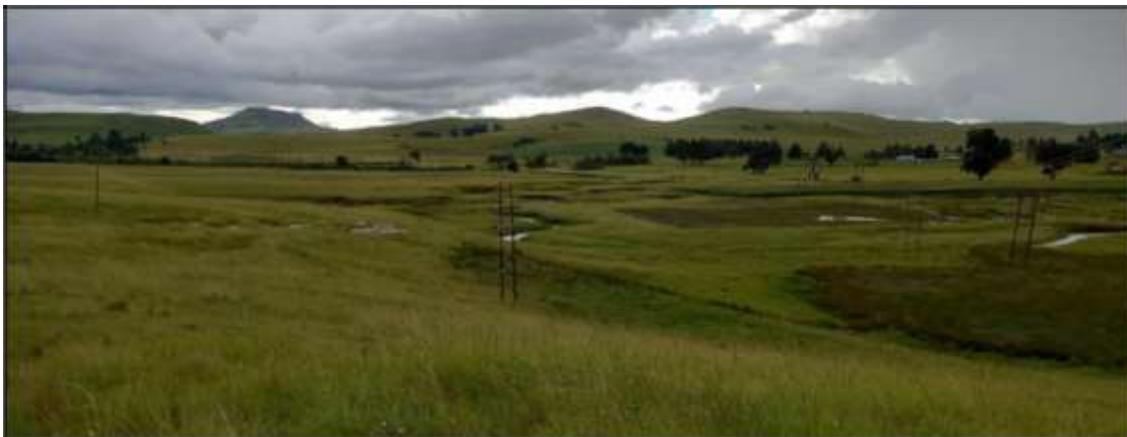
**Figure 4-77** Some of the upper portion of the Elliot/Khowa floodplain, with the higher-lying areas dominated by grasses and the lower-lying areas by sedges.

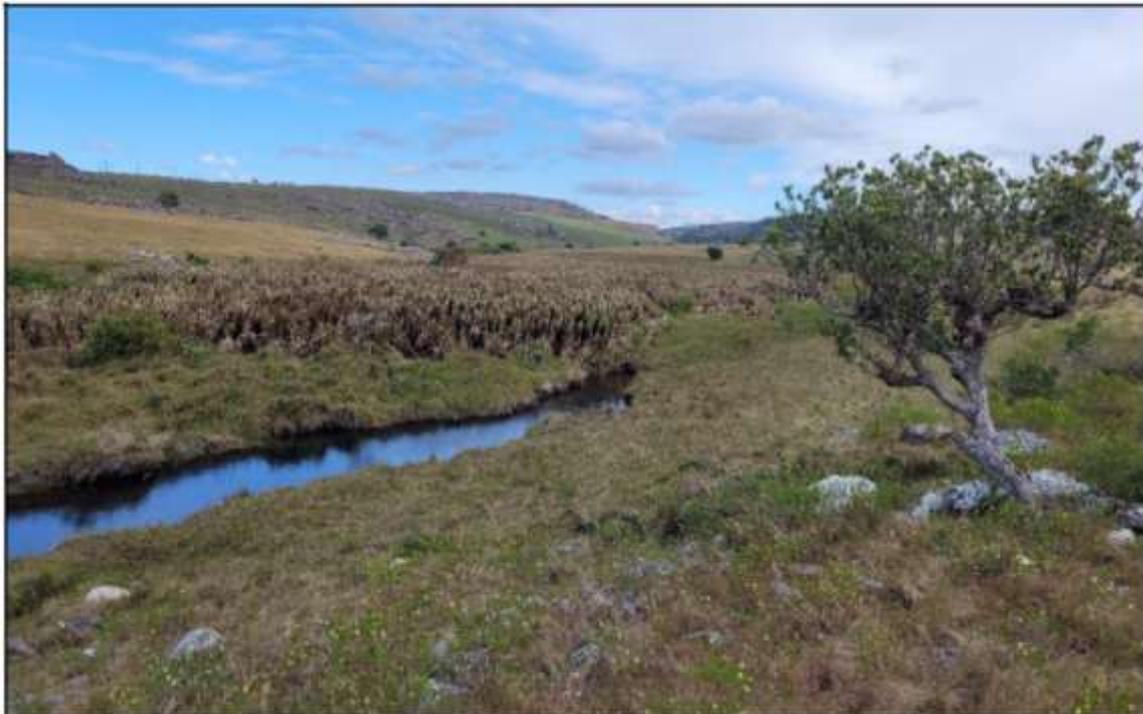
**Figure 4-79** Sikombe wetland: View of the upstream habitat of one of the major tributaries, which has been recently burnt

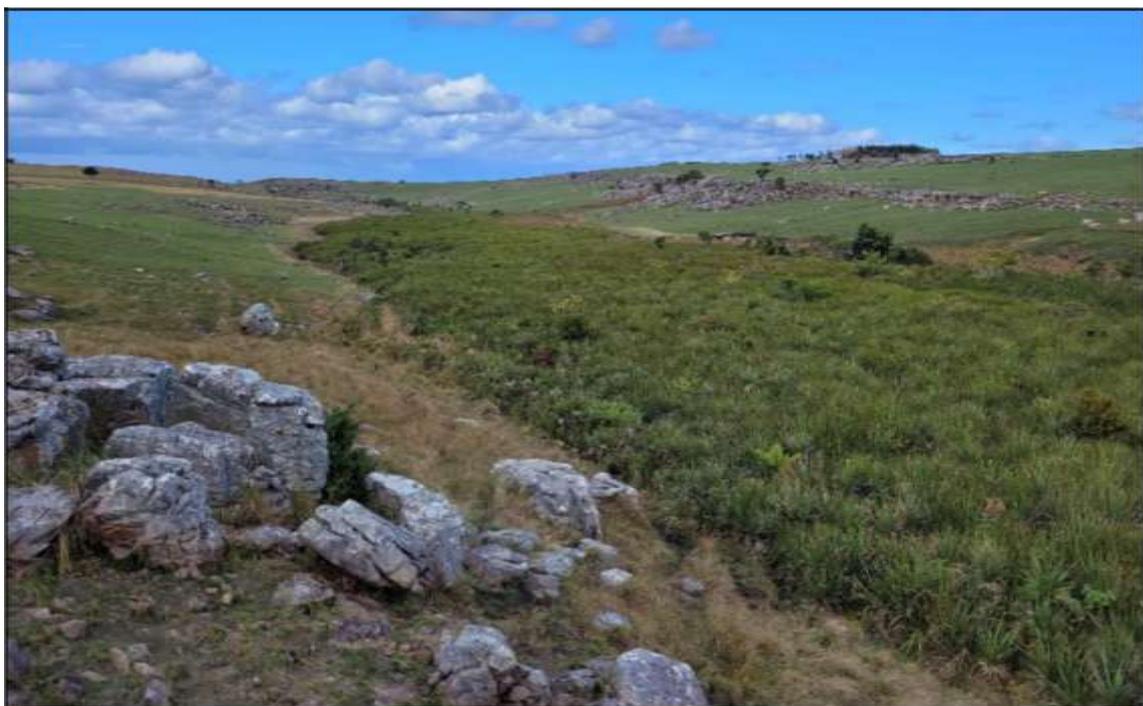
**Figure 4-80** Sikombe wetland: View of the Palmiet wetland and the establishment of some woody species within the drier portions of the system

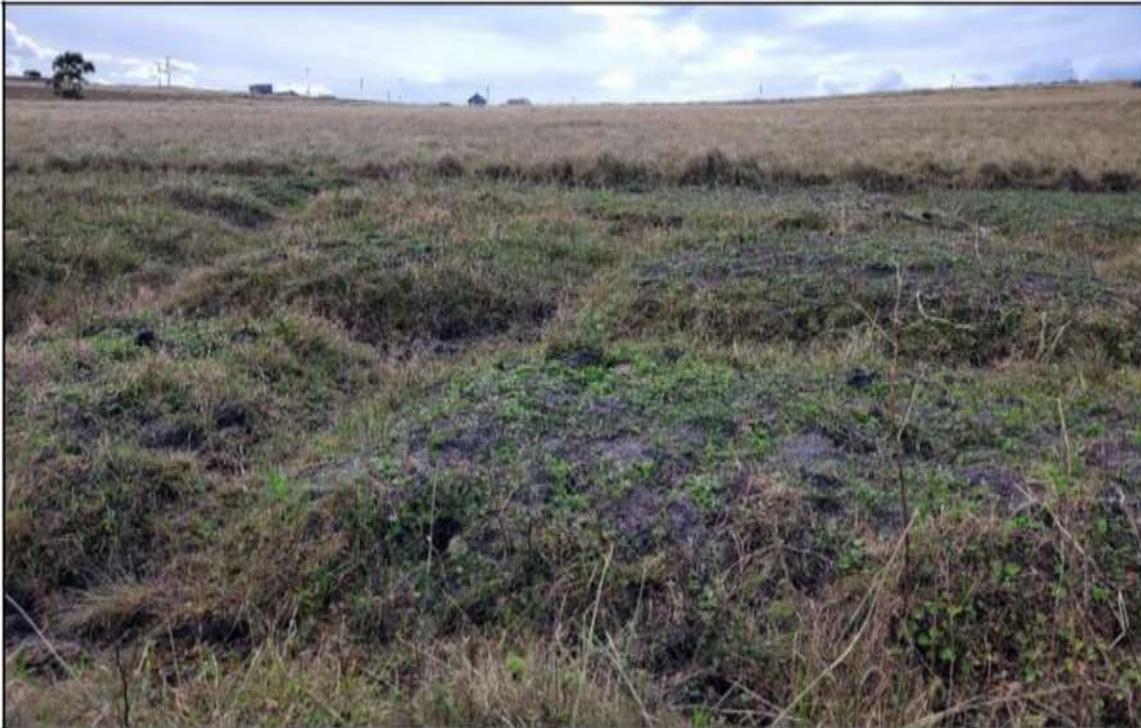
**Figure 4-81** Sikombe wetland: Rotational madumbe/taro crop field adjacent to the valley bottom wetland in the seepage zones.

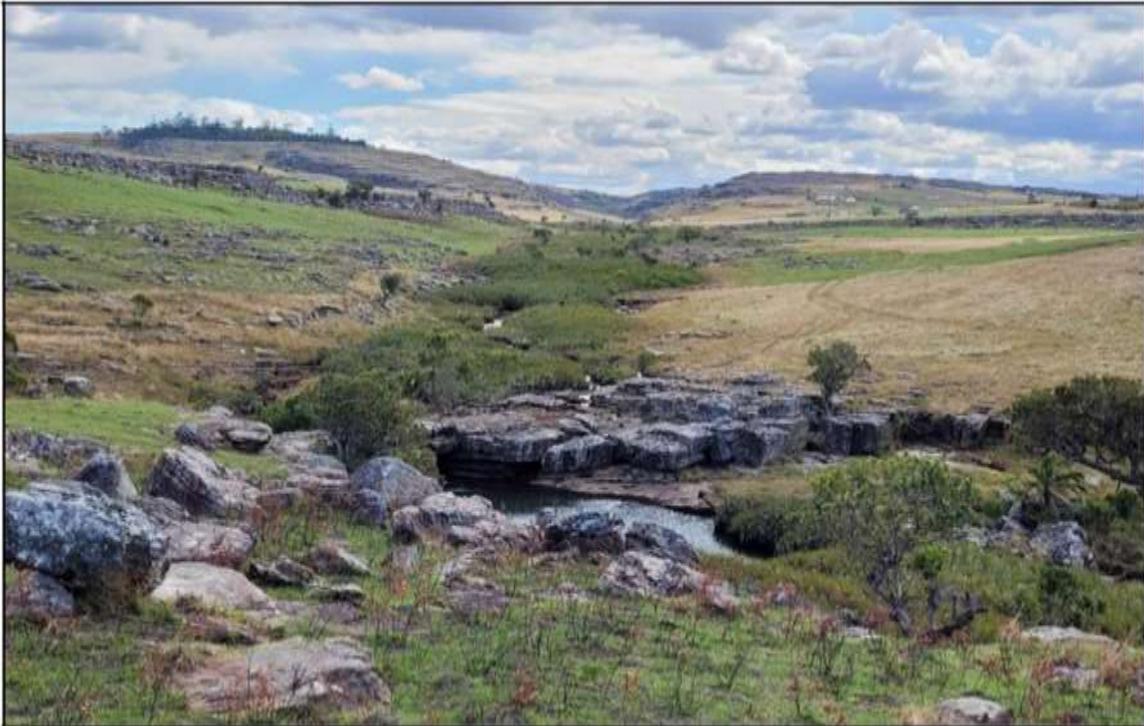
**Figure 4-83** Sikombe wetland: View of the geological control at the base of the palmiet wetland
