# DEPARTMENT OF WATER AND SANITATION

## Determination of Water Resource Classes, Reserve and the Resource Quality Objectives in the Keiskamma and Fish to Tsitsikamma Catchments

### WP11354 Wetland Eco-Categorisation Report

REPORT NO.:  
WEM/WMA7/00/CON/RDM/1223

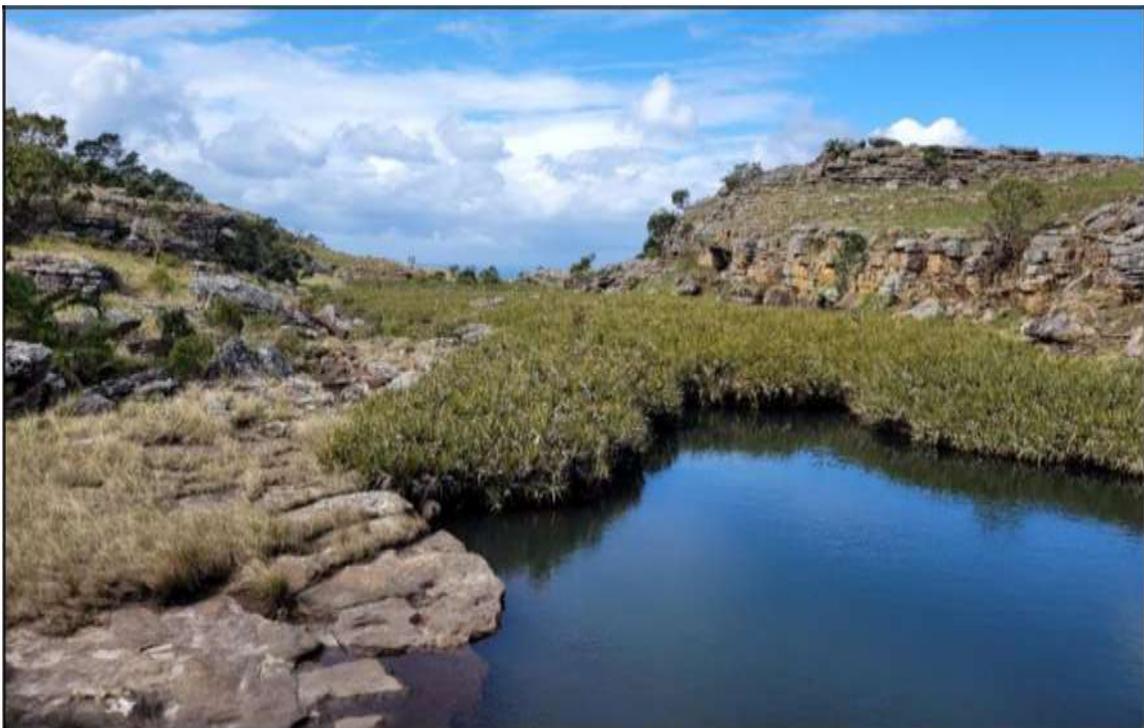
**Figure 4-84** Sikombe wetland: Palmiet wetland below the geological control

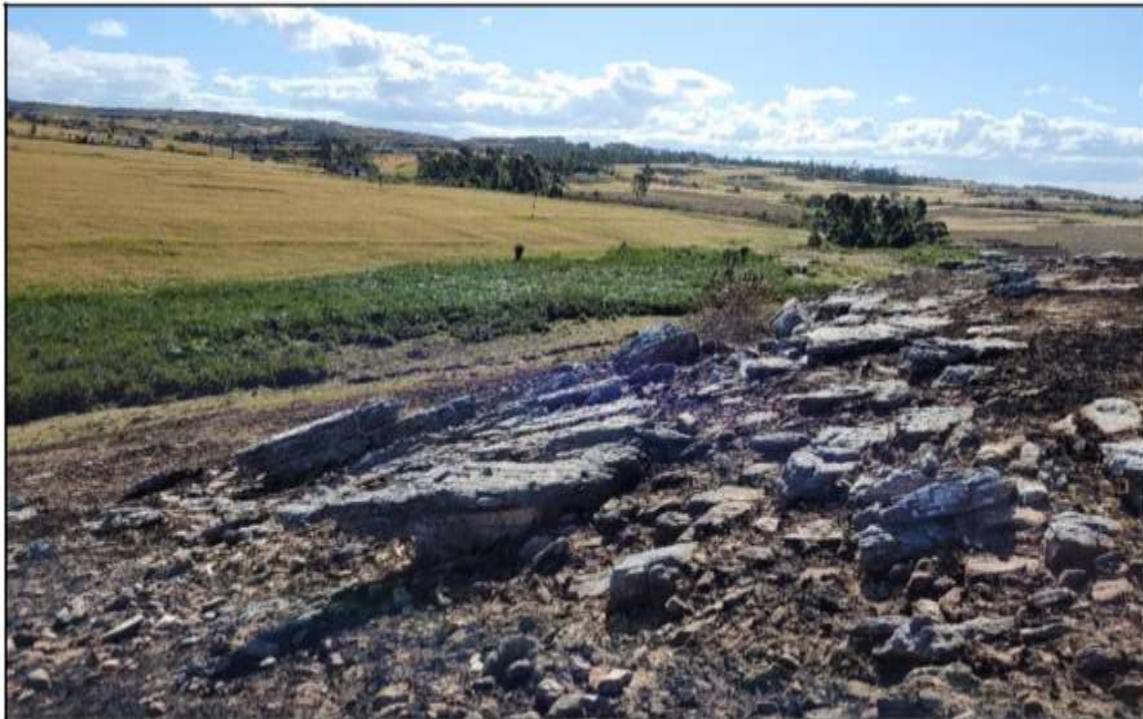
**Figure 4-85** Xolobeni wetland: View of the upstream portion of the palmiet wetland and the woodlots within the wetland habitat

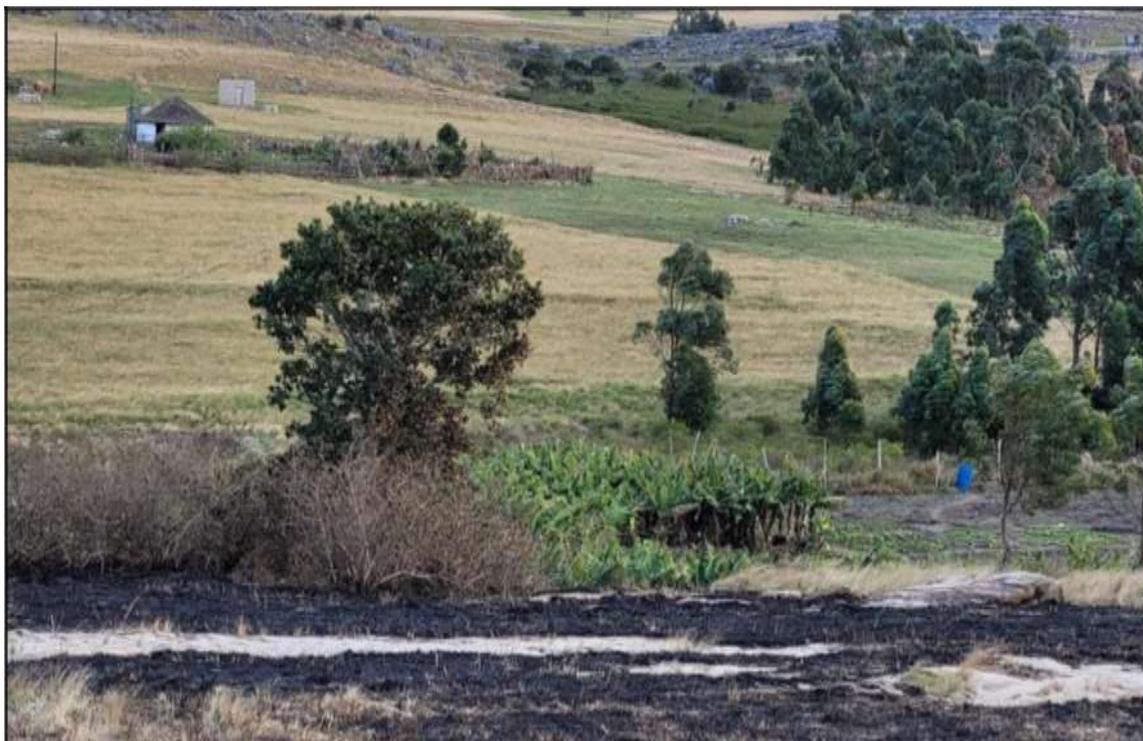
**Figure 4-86** Xolobeni wetland: cultivation within the temporary zones of wetness associated with the seepage zones adjacent to the valley bottom wetland habitat

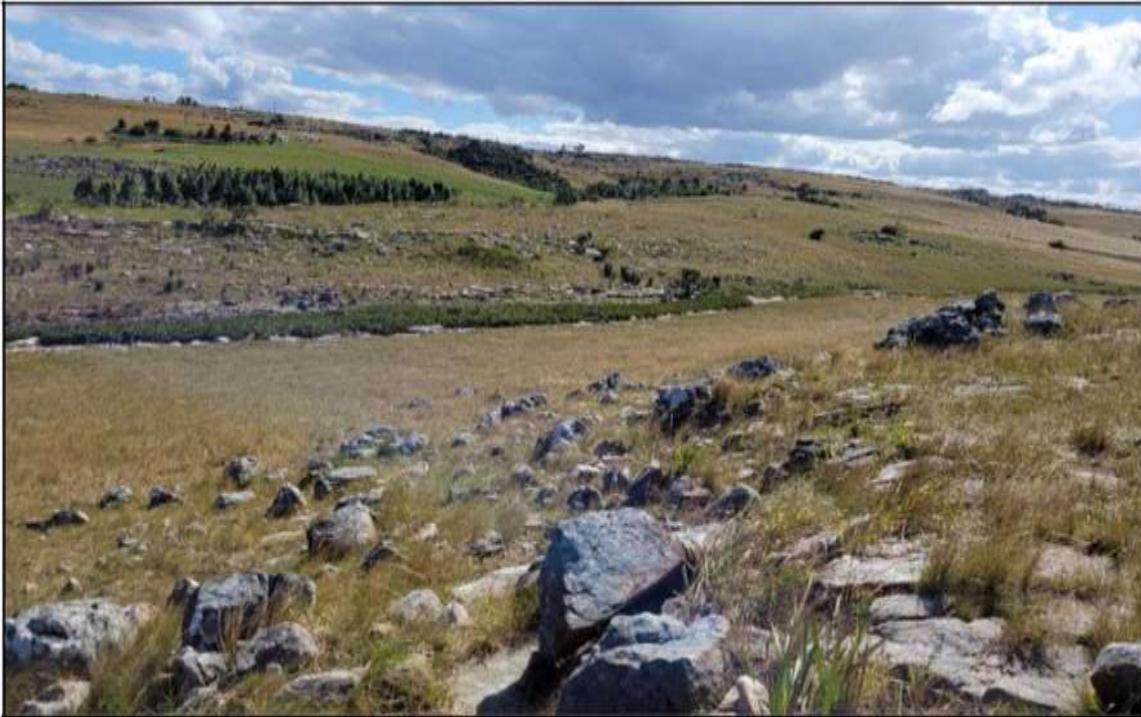
**Figure 4-87** Xolobeni wetland: View of some of the catchment impacts, and the channel which has eroded onto bedrock (lighter areas)

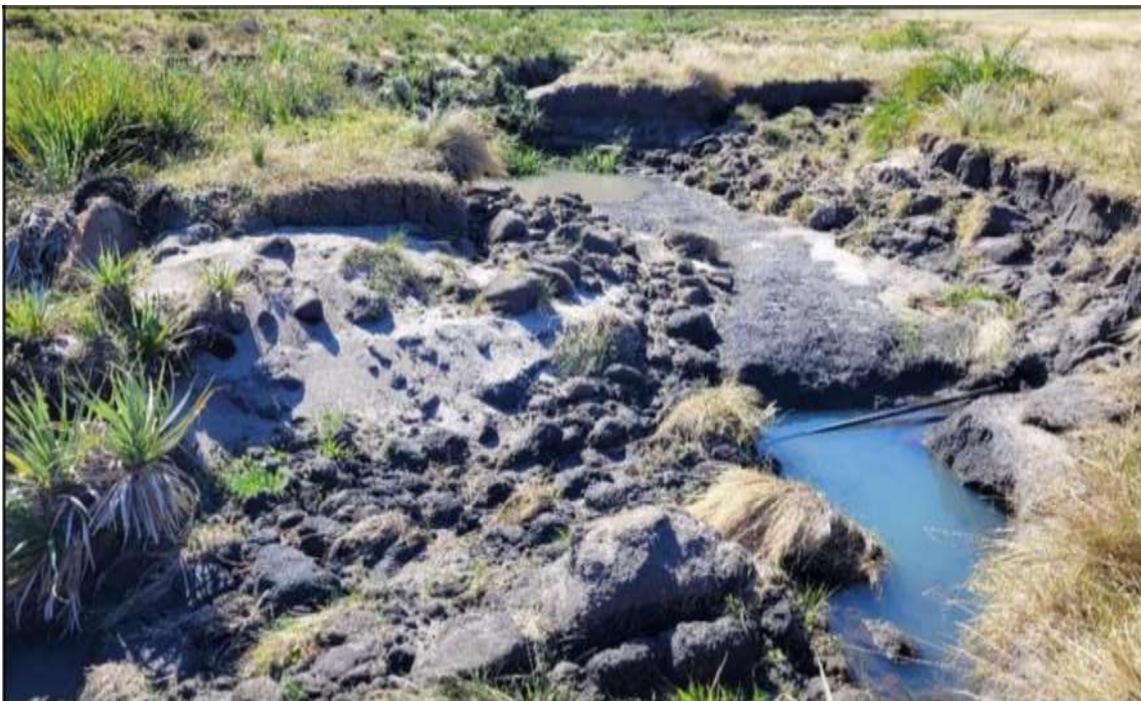
**Figure 4-88** Xolobeni wetland: Headcut erosion upstream of the water abstraction point

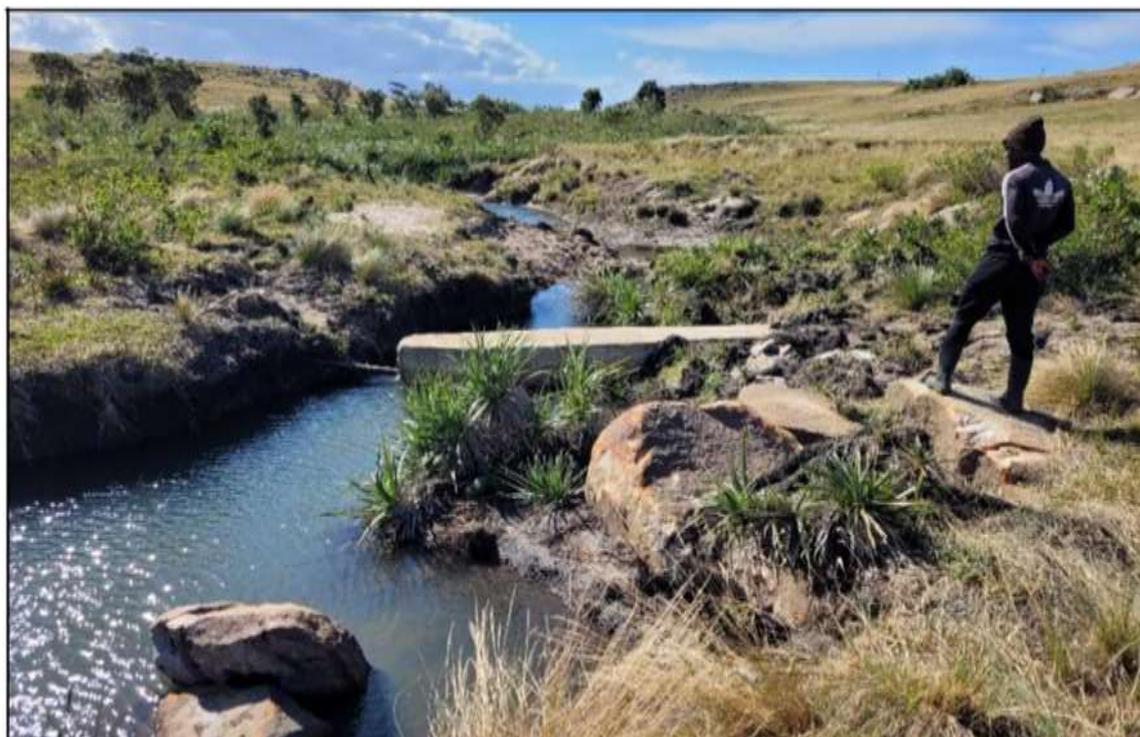
**Figure 4-89** Xolobeni wetland: Eroded palmiet wetland upstream of the water supply pipeline crossing point. Portions of the pipeline has been encased in concrete, however the channel has bypassed the concrete and has exposed portions of the pipeline

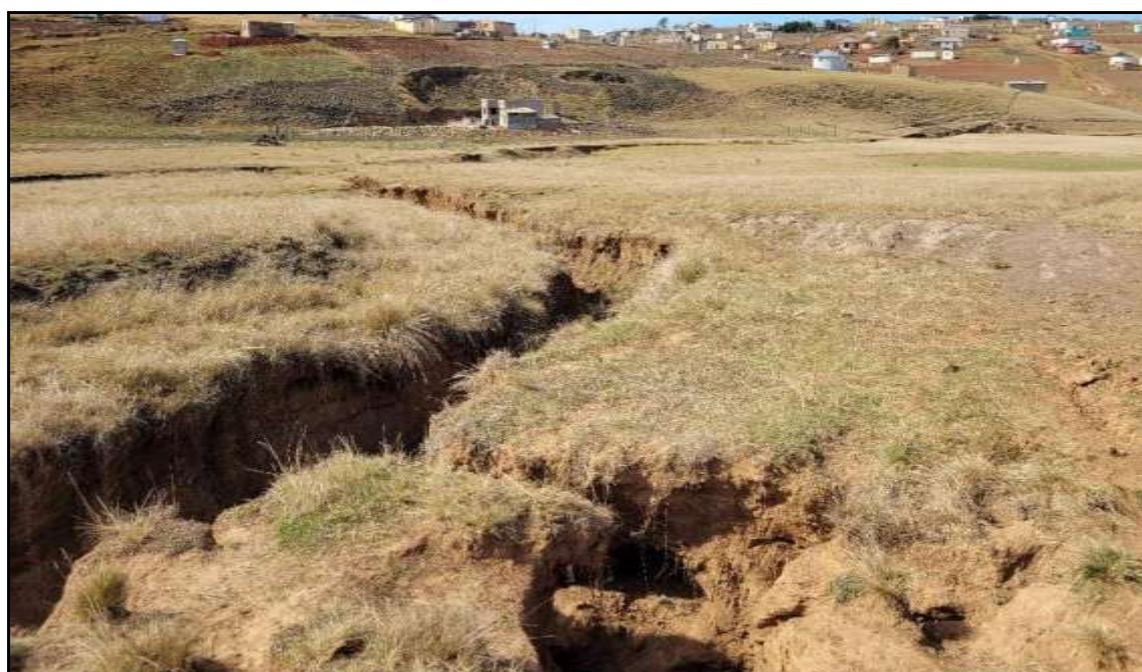
**Figure 4-91 Eroded main channel with the seepage wetland maintained on the adjacent valley bottom terrace. The seepage wetland is entirely independent of the valley-bottom system and is still considered to provide some ecosystem services within the modified landscape.**

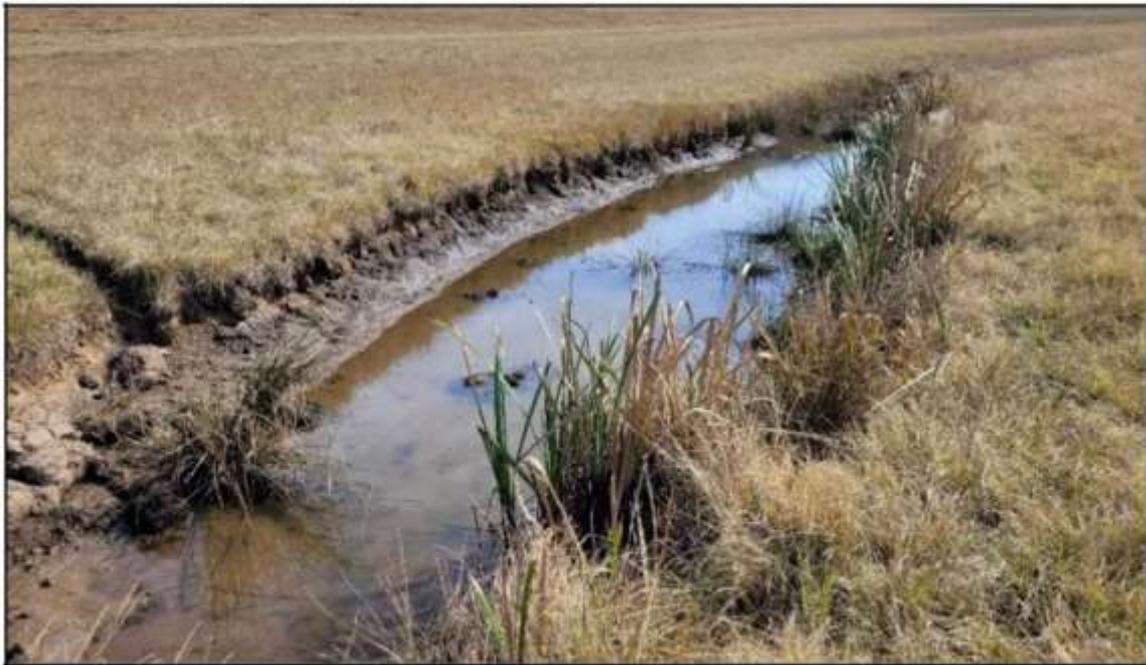
**Figure 4-92** An old flood channel associated with the valley-bottom wetland. A drain has been excavated from this pool of water towards the main channel, assisting with the desiccation of this feature and thereby, making the adjacent habitat more easily accessible for grazing purposes.

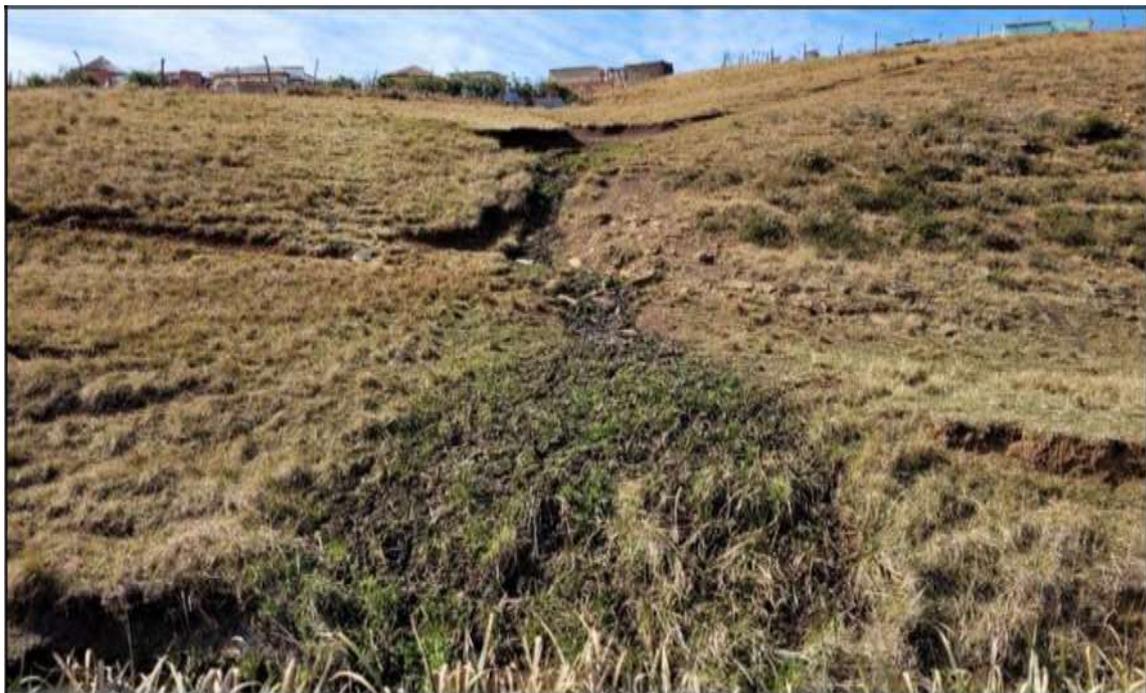
**Figure 4-93** Seepage wetland adjacent to the valley-bottom wetland, however, erosional features are present upstream thereof, threatening the integrity of the seepage wetland.

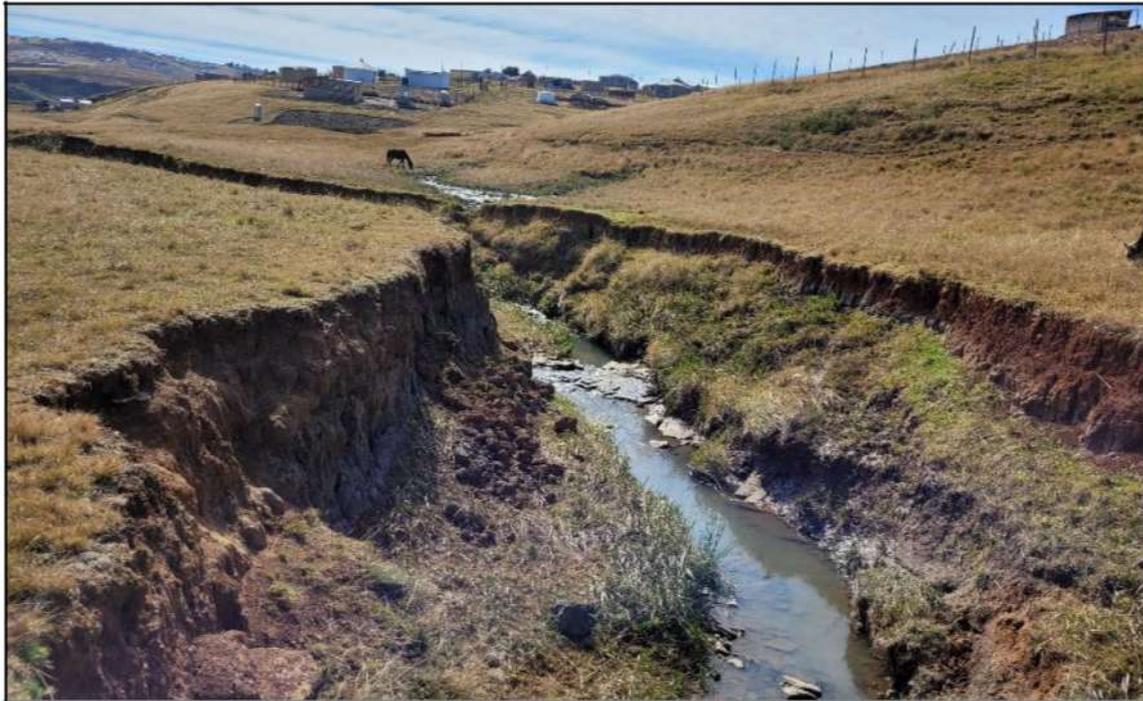
**Figure 4-94** Incised channel associated with the main valley-bottom wetland.

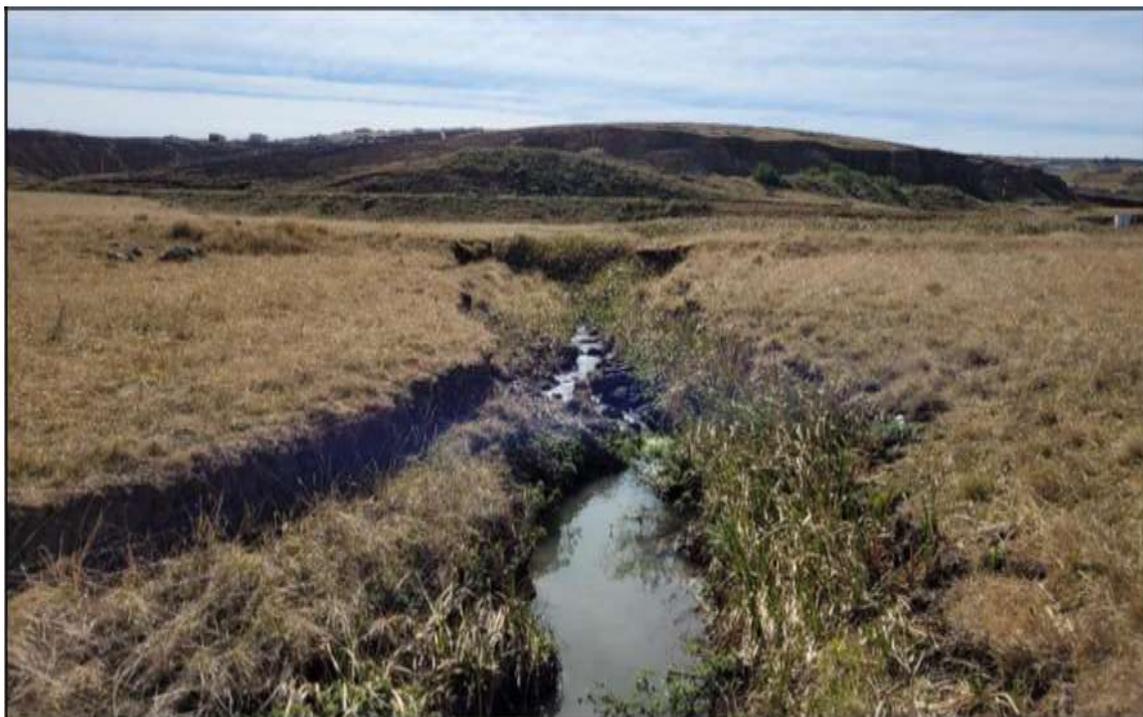
**Figure 4-95** Breached dam wall within the valley-bottom wetland. The breach is most likely as a result of the advancing head cut erosional feature.

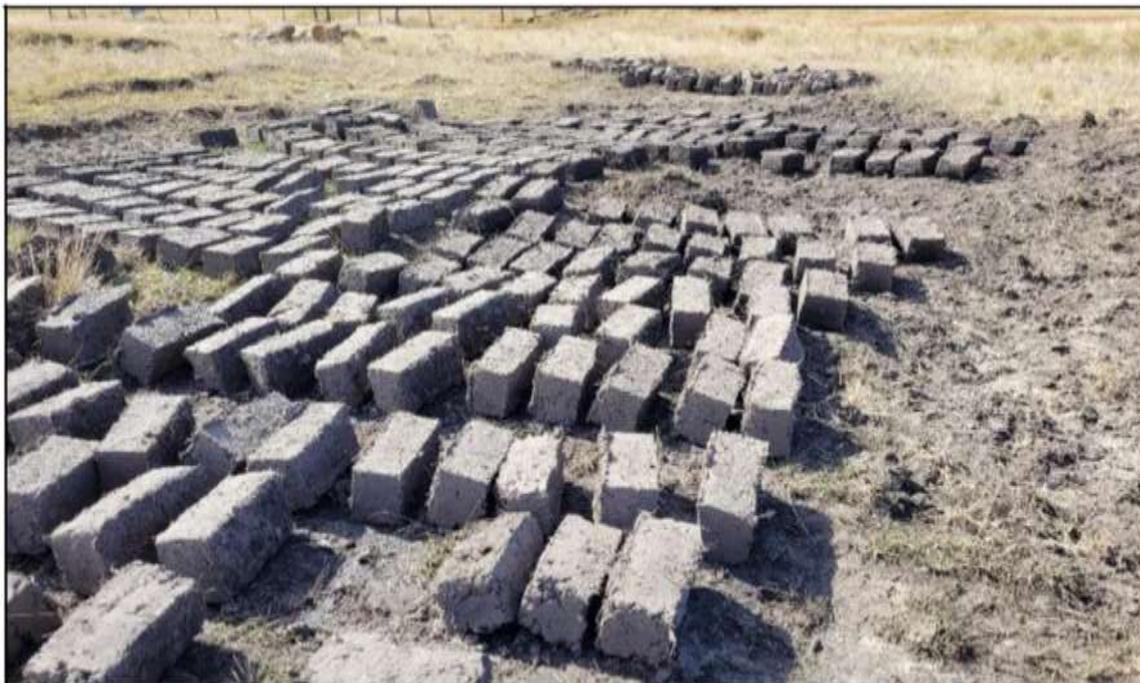
**Figure 4-96** Evidence of brick making along the main portion of the Ludeke Halt wetland.

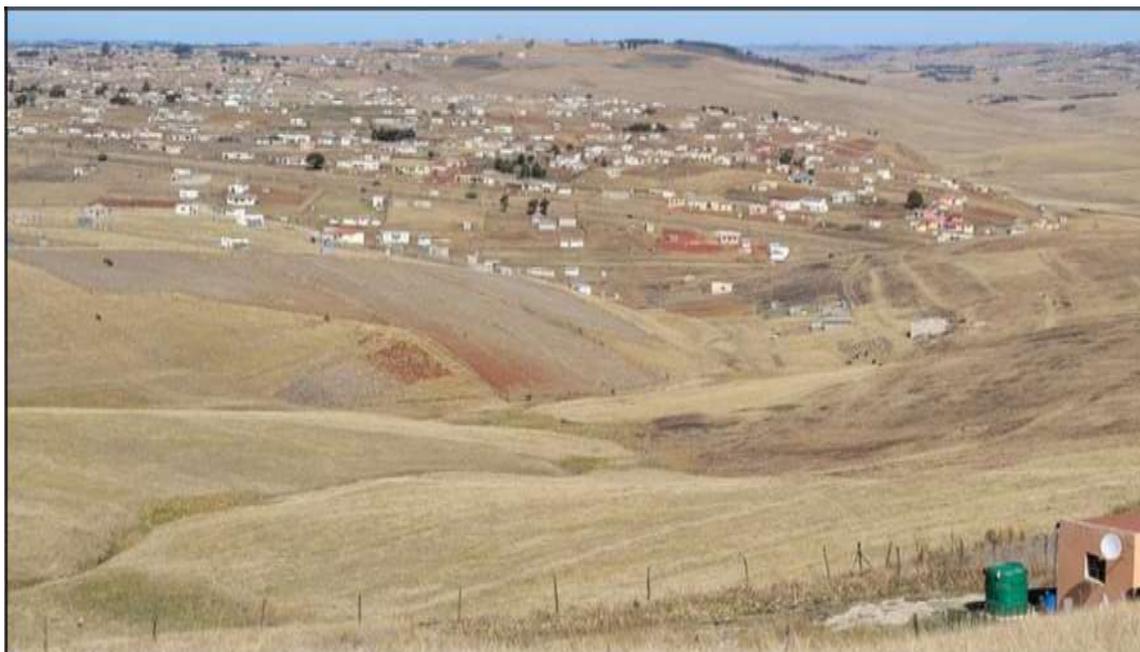
**Figure 4-97** This tributary is more heavily impacted than some of the adjacent tributaries. The density of houses and anthropogenic impacts on the wetlands are greater than the areas of the wetland. The seepage wetlands have in some instances been transformed to croplands. Additional impacts include grazing by livestock and over utilisation of the system resulting in the formation of head cut erosional features.

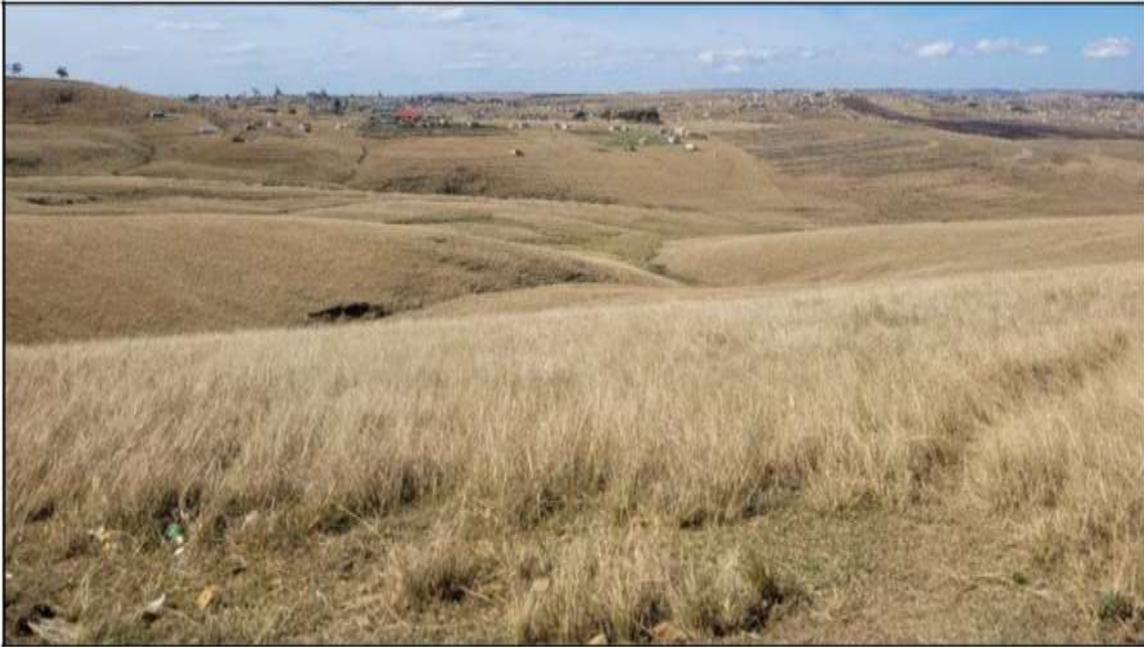
**Figure 4-98** This tributary of the Ludeke Halt wetland is considered to be relatively intact with limited catchment and in-system impacts. The major impact on the system is associated with grazing by livestock, however, the limited number of livestock seen in the catchment area were not posing a threat to the seepage and valley-bottom wetland habitat

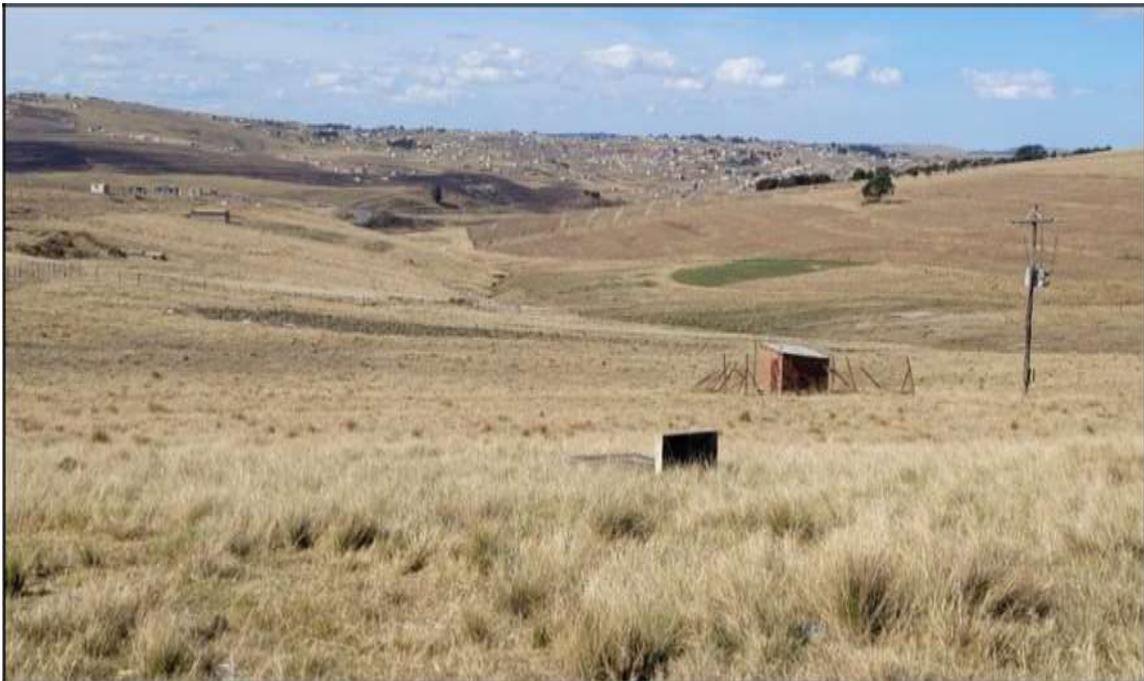
**Figure 4-99** A tributary of the Ludeke Halt wetland, which has been encroached into agricultural fields. Soils are also being harvested for brick making. Within the downstream portion of the tributary there is evidence of an old drain, which served as a cut-off drain along the edge of the system

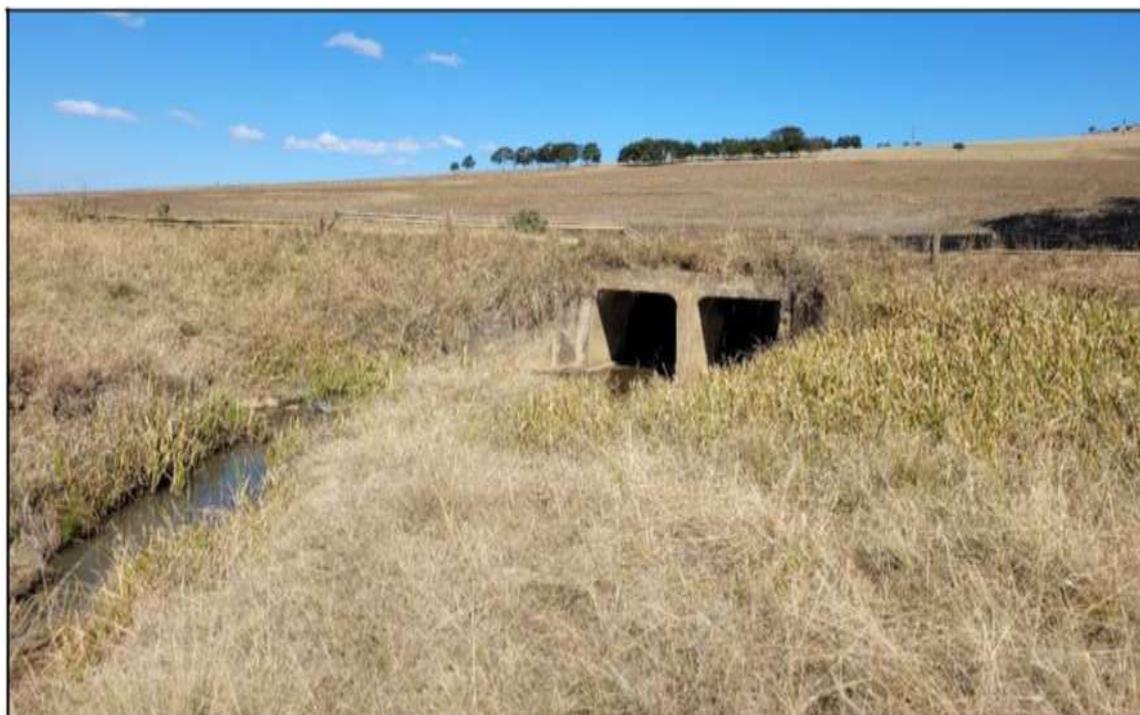
**Figure 4-100** View of the road culvert associated with the R61 which has led to the formation of a small headcut erosional feature upstream of the culvert. The headcut has not progressed too far due to the shallow bedrock layer within the system.
