Classification of Significant Water Resources and Determination of Resource Quality Objectives for Water Resources in the Usutu to Mhlathuze Catchments

RIVER SPECIALIST MEETING REPORT

September 2022

PROJECT NUMBER: WP 11387

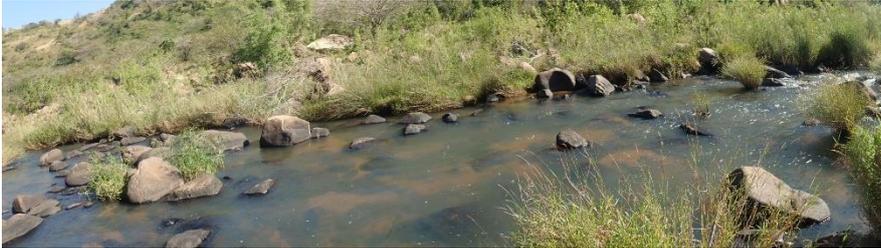
EWR MA1: Matigulu River

Co-ordinates	S29.02010 E31.47040
	SQ code	W11A-03612
	RU	RU W11-2
	IUA	IUA W11
	Level 2 EcoRegion	17.01
	Geomorph Zone	Upper foothills
EWR NS1: Nseleni River

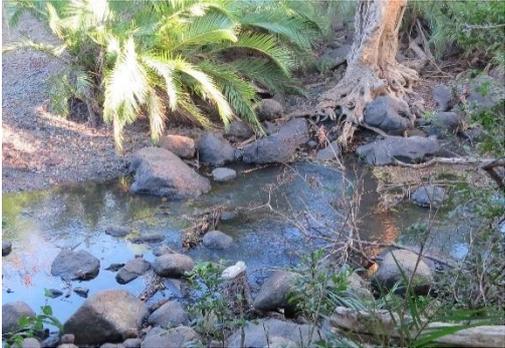
Co-ordinates	S28.63410 E31.92517
	SQ code	W12G-03229
	RU	RU W12-8
	IUA	IUA W12-b
	Level 2 EcoRegion	13.03
	Geomorph Zone	Lower foothills
EWR WM1: White Mfolozi River

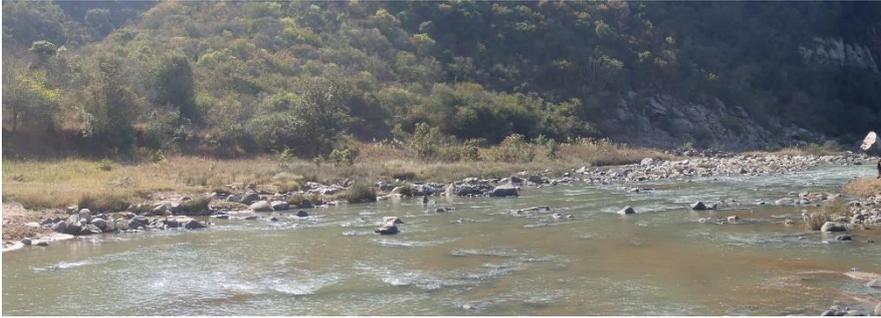
Co-ordinates	S28.23146 E31.18666
	SQ code	W21H-02897
	RU	RU W21-5
	IUA	IUA W21
	Level 2 EcoRegion	14.05
	Geomorph Zone	Lower foothills
EWR BM1: Black Mfolozi River

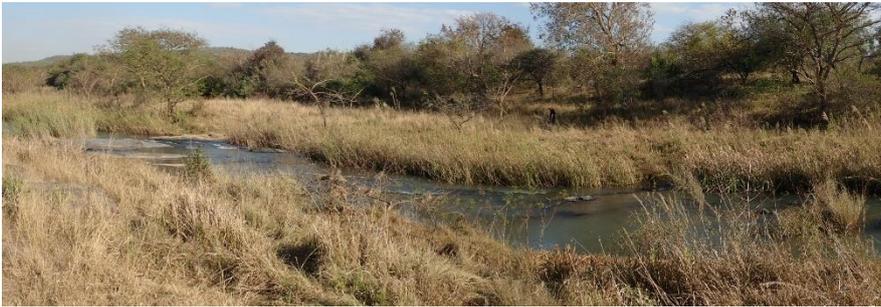
Co-ordinates	S27.93890 E31.21030
	SQ code	W22A-02610
	RU	RU W22-1
	IUA	IUA W22
	Level 2 EcoRegion	3.1
	Geomorph Zone	Upper foothills
EWR MK1: Mkuze River

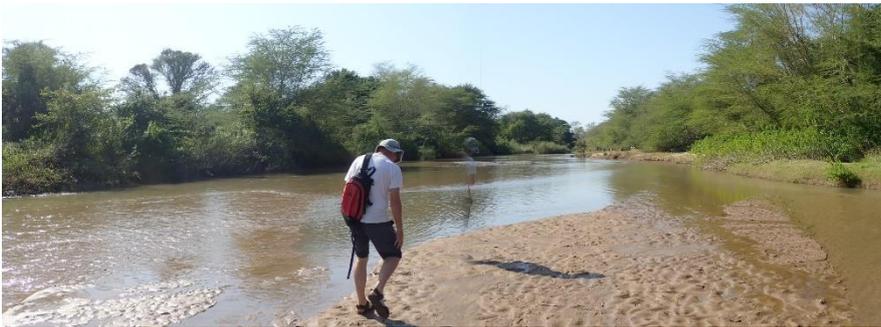
Coordinates	S27.59210 E32.21800
	SQ code	W31J-02480
	RU	RU W31-5
	IUA	IUA W31-b
	Level 2 EcoRegion	3.08
	Geomorph Zone	Lowland

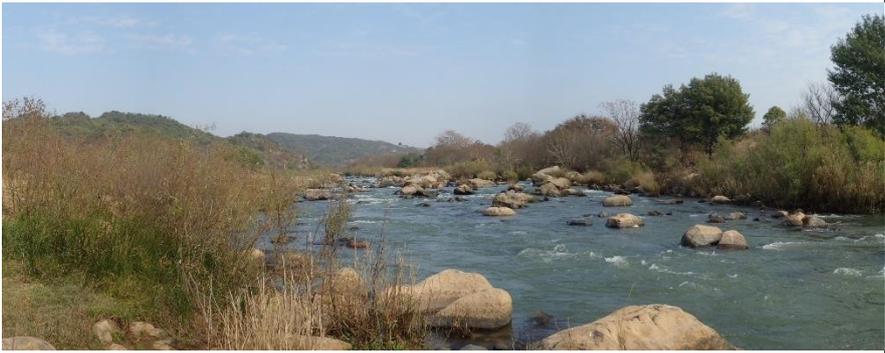
EWR UP1: Pongola River

Coordinates	S27.36413 E30.96962
	SQ code	W42E-02221
	RU	RU W42-2
	IUA	IUA W42-b
	Level 2 EcoRegion	3.1
	Geomorph Zone	lower/upper foothills
EWR AS1: Assegaai River

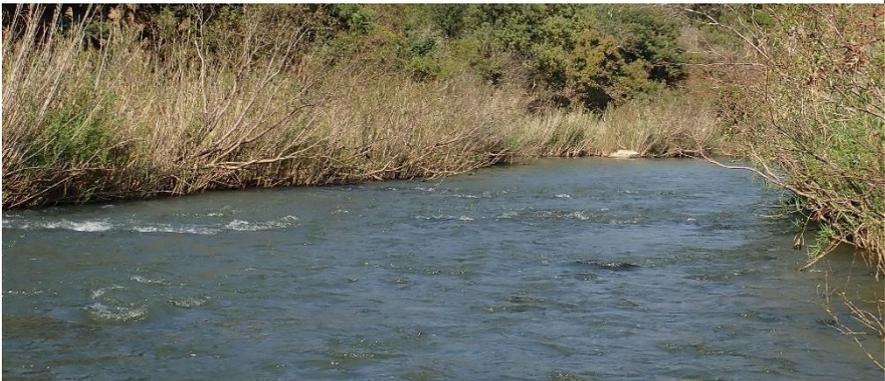
Coordinates	S27.06230 E30.98880
	SQ code	W51E-02049
	RU	RU W51-3
	IUA	IUA W52
	Level 2 EcoRegion	4.06
	Geomorph Zone	lower/upper foothills
EWR NG1: Ngwempisi River

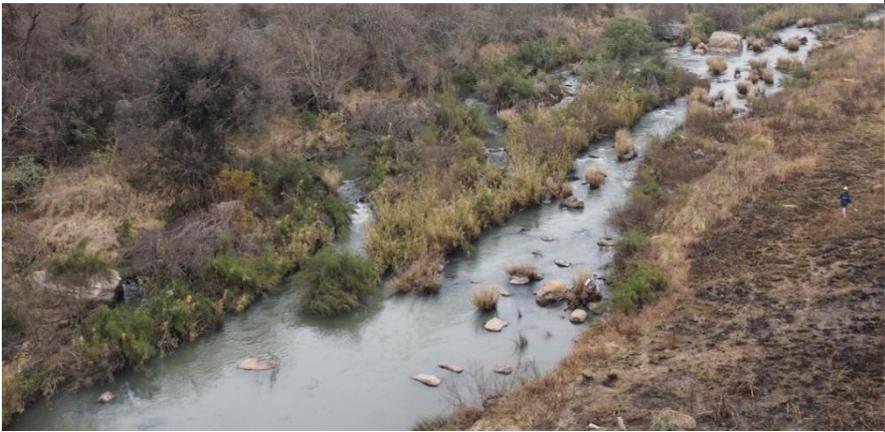
Coordinates	S26.679448 E30.70213
	SQ code	W53E-01790

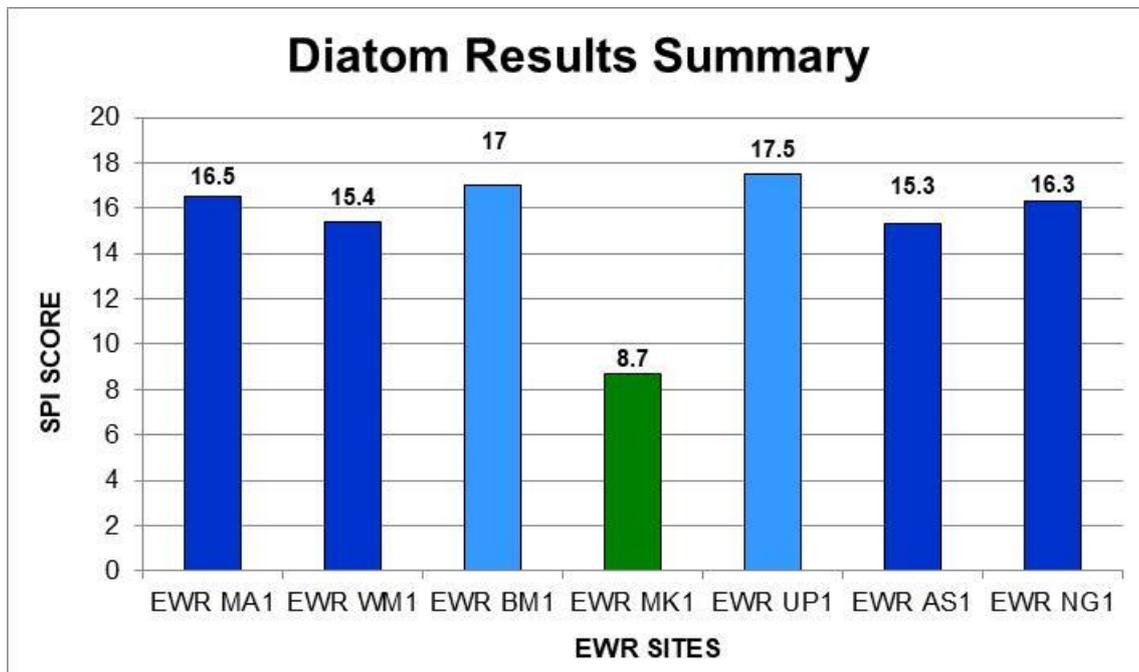
Figure B1 Diatom results obtained at the various EWR sites in June 2022

A summary of the diatom results obtained at the various EWR sites during the June 2022 EWR site visit is provided in **Figure B1**.

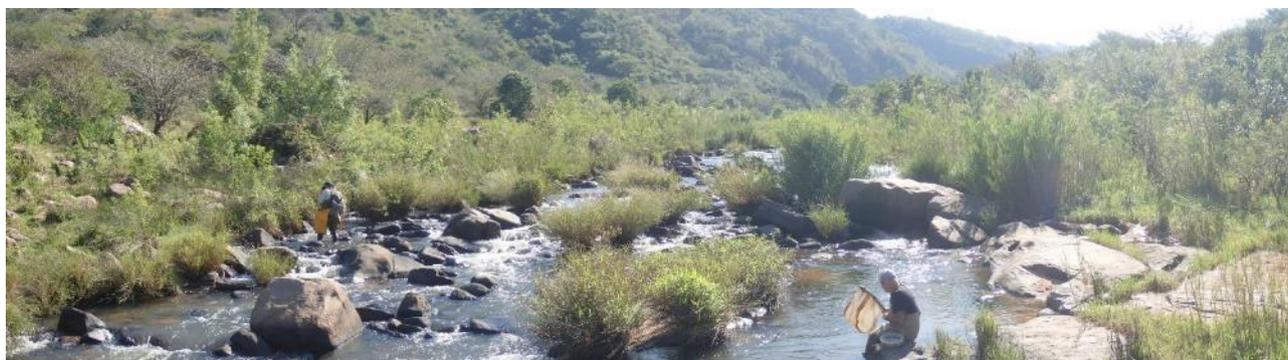
Figure E1 EWR MA1: Upstream and across

Photographs of the EWR site reflecting fish habitats (July 2022) are illustrated in **Figure E1**. The habitats available for fish at the time of the July 2022 survey is reflected as habitat cover ratings (**Table E2** and **Figure E1**).

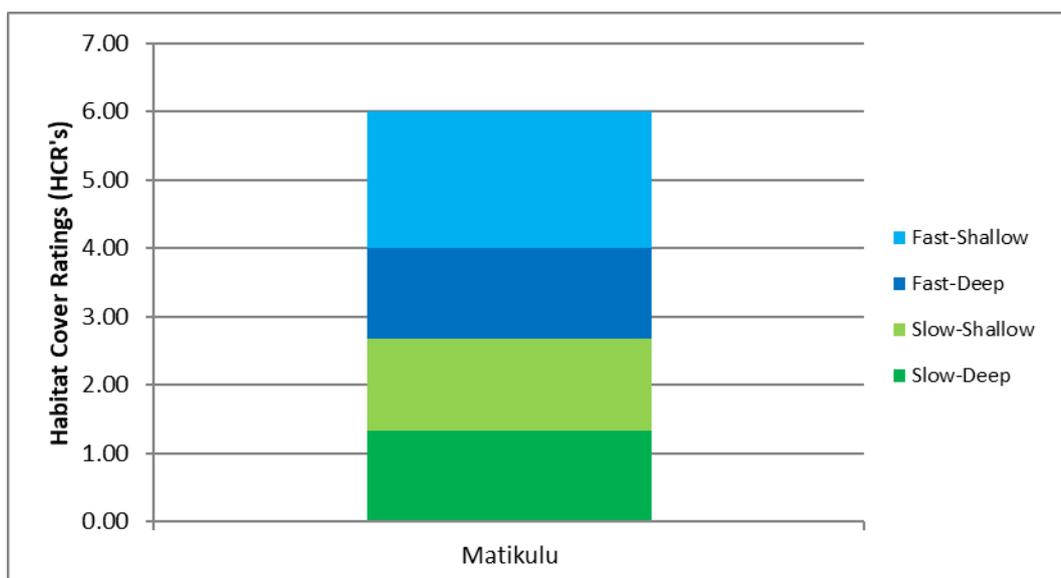
Figure E2 Fish Habitat Cover Ratings calculated for each velocity-depth category at site MA1 (July 2022 survey)

Velocity-depth class	Sites	Matigulu
SLOW-DEEP (>0.5m; <0.3m/s)	Abundance	2
	Overhanging vegetation	2
	Undercut banks and Root-wads	1
	Substrate	2
	Macrophytes	1
SLOW-SHALLOW (<0.5m; <0.3m/s)	Abundance	2
	Overhanging vegetation	2
	Undercut banks and Root-wads	0
	Substrate	3
	Macrophytes	1
FAST-DEEP (>0.3m; >0.3m/s)	Abundance	2
	Overhanging vegetation	1
	Undercut banks and Root-wads	0
	Substrate	4
	Macrophytes	1
FAST-SHALLOW (<0.3m; >0.3m/s)	Abundance	3
	Overhanging vegetation	1
	Undercut banks and Root-wads	0
	Substrate	4
	Macrophytes	1

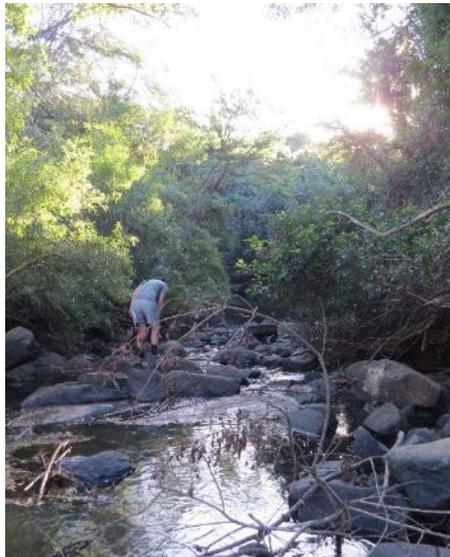
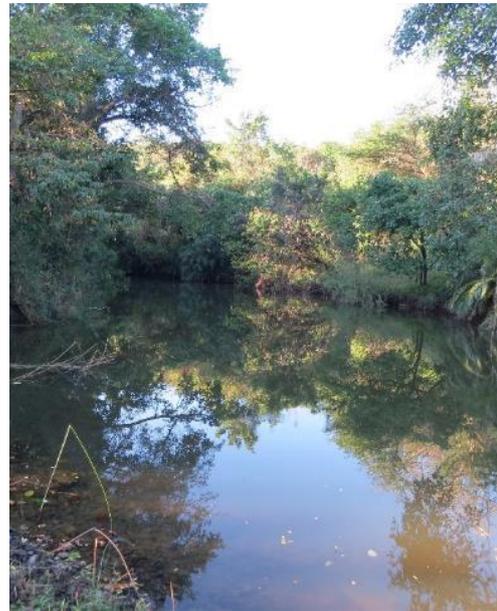
Figure E3 Photographs of the Nseleni River upstream of the EWR site

Photographs of the EWR site and river directly upstream of the EWR site reflecting fish habitats (July 2022) are illustrated in **Figure E3** and **Figure E4**.

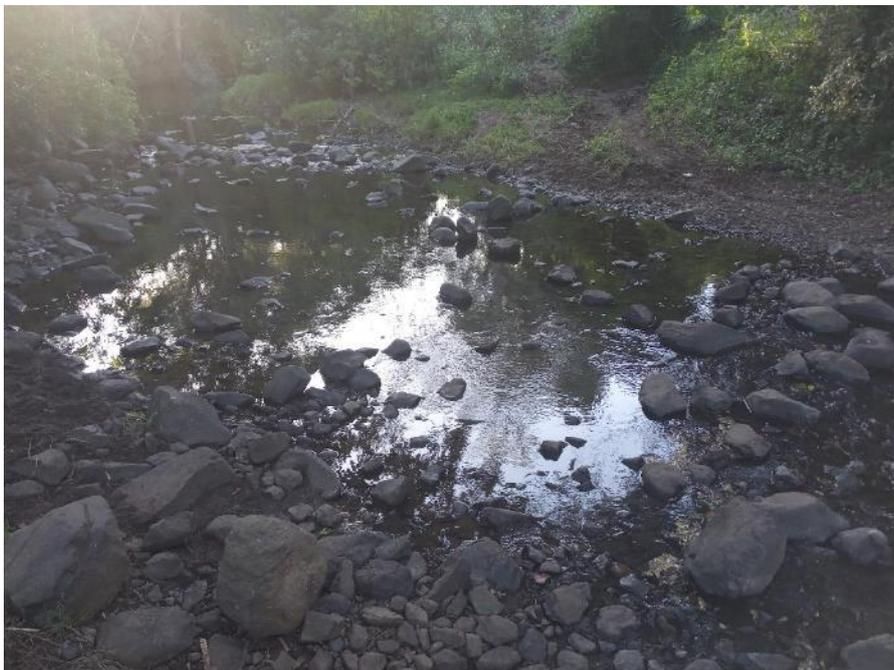
Figure E4 Photographs of the Nseleni River at the EWR site

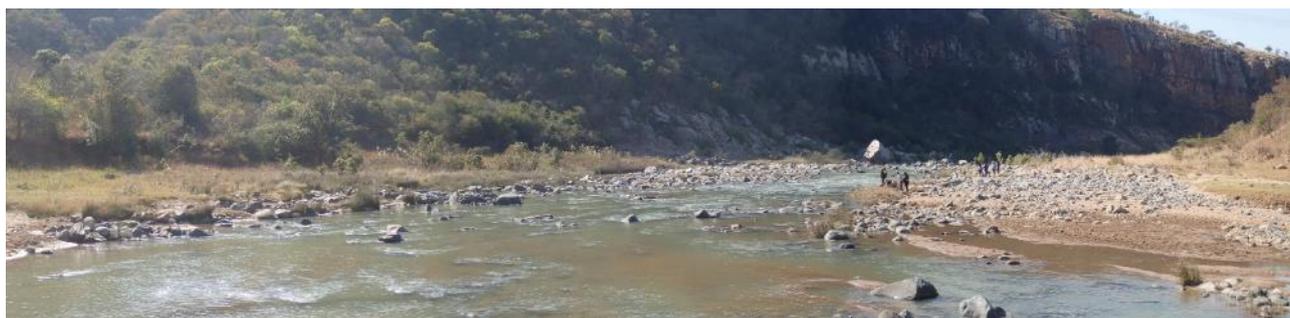
Figure E5 EWR WM1 (July 2022)

EWR WM1 is situated in the White Umfolozi River (S28.23146 E31.18666) in RU W21-5 and IUA W21 (Upper and Middle White Umfolozi). The White Umfolozi River at this site has a pool-rapid morphology dominated by boulder. An extensive point bar on the right bank is comprised of sand, cobble and boulder. Photographs of the EWR site reflecting fish habitats (July 2022) are illustrated in **Figure E5**. The habitats available for fish at the time of the July 2022 survey is reflected as habitat cover ratings (**Table E6** and **Figure E5**).

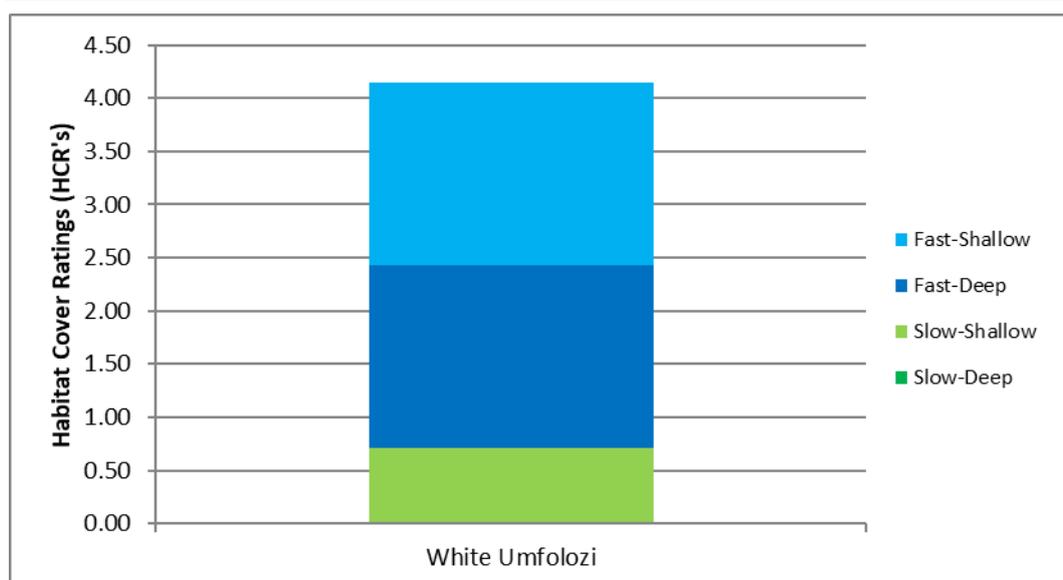
Figure E6 Fish Habitat Cover Ratings calculated for each velocity-depth category at site WM1 (July 2022 survey)

Velocity-depth class	Sites	White Umfolozi
SLOW-DEEP (>0.5m; <0.3m/s)	Abundance	0
	Overhanging vegetation	0
	Undercut banks and Root-wads	0
	Substrate	0
	Macrophytes	0
SLOW-SHALLOW (<0.5m; <0.3m/s)	Abundance	1
	Overhanging vegetation	0
	Undercut banks and Root-wads	1
	Substrate	4
	Macrophytes	0
FAST-DEEP (>0.3m; >0.3m/s)	Abundance	3
	Overhanging vegetation	0
	Undercut banks and Root-wads	0
	Substrate	4
	Macrophytes	0
FAST-SHALLOW (<0.3m; >0.3m/s)	Abundance	3
	Overhanging vegetation	0
	Undercut banks and Root-wads	0
	Substrate	4
	Macrophytes	0

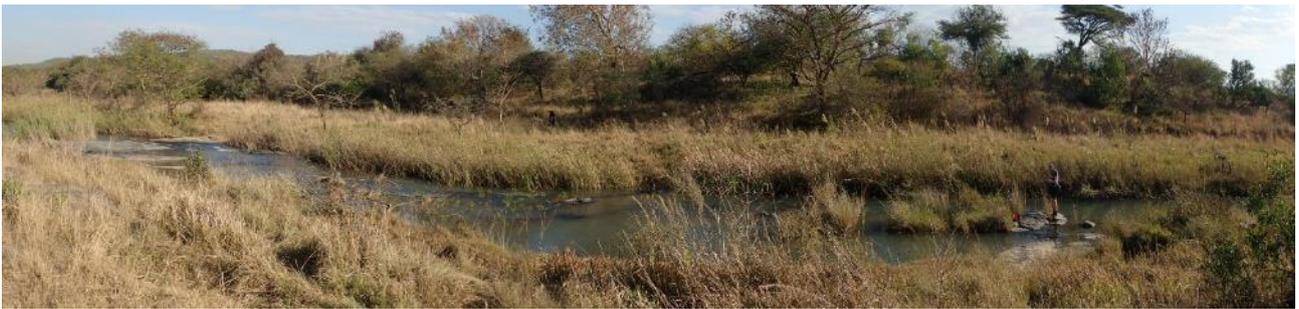
Figure E7 EWR BM1 (July 2022)

EWR BM1 is situated in the Black Umfolozi River (S27.93890 E31.21030) in RU W22-1 and IUA W22 (Upper Black Umfolozi). The Black Umfolozi at this site has a bedrock cascade morphology with flat bedrock and bedrock steps. A long pool confined by reeds occurs downstream of the site. The dominant bed material is bedrock; sand dominates the flood benches. Photographs of the EWR site reflecting fish habitats (July 2022) are illustrated in **Figure E7**. The habitats available for fish at the time of the July 2022 survey is reflected as habitat cover ratings (**Table E9** and **Figure E8**).

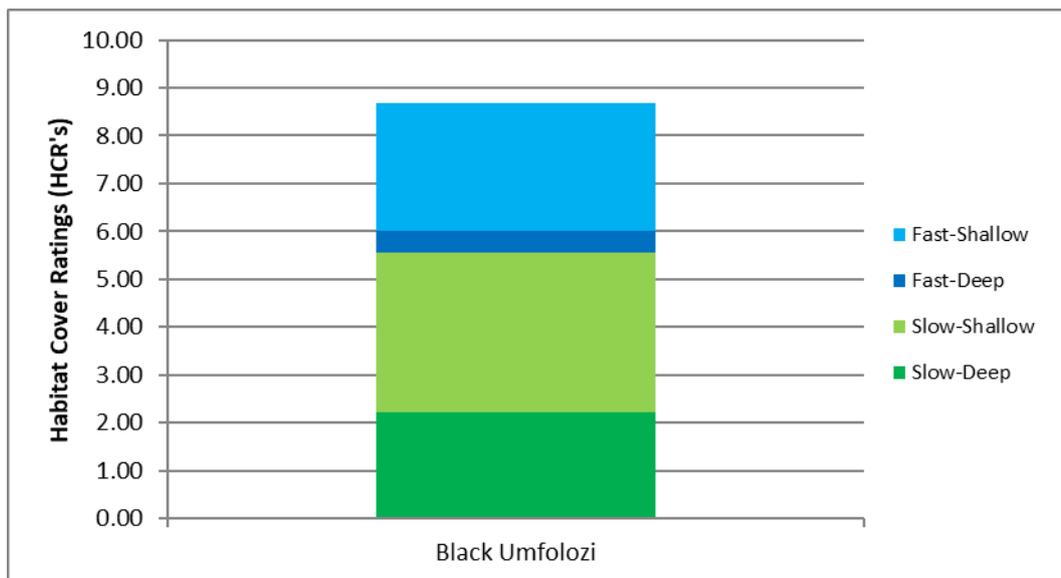
Figure E8 Fish Habitat Cover Ratings calculated for each velocity-depth category at site BM1 (July 2022 survey)

Velocity-depth class	Sites	Black Umfolozi
SLOW-DEEP (>0.5m; <0.3m/s)	Abundance	2
	Overhanging vegetation	2
	Undercut banks and Root-wads	2
	Substrate	3
	Macrophytes	3
SLOW-SHALLOW (<0.5m; <0.3m/s)	Abundance	3
	Overhanging vegetation	2
	Undercut banks and Root-wads	2
	Substrate	3
	Macrophytes	3
FAST-DEEP (>0.3m; >0.3m/s)	Abundance	1
	Overhanging vegetation	1
	Undercut banks and Root-wads	0
	Substrate	3
	Macrophytes	0
FAST-SHALLOW (<0.3m; >0.3m/s)	Abundance	3
	Overhanging vegetation	2
	Undercut banks and Root-wads	2
	Substrate	3
	Macrophytes	1

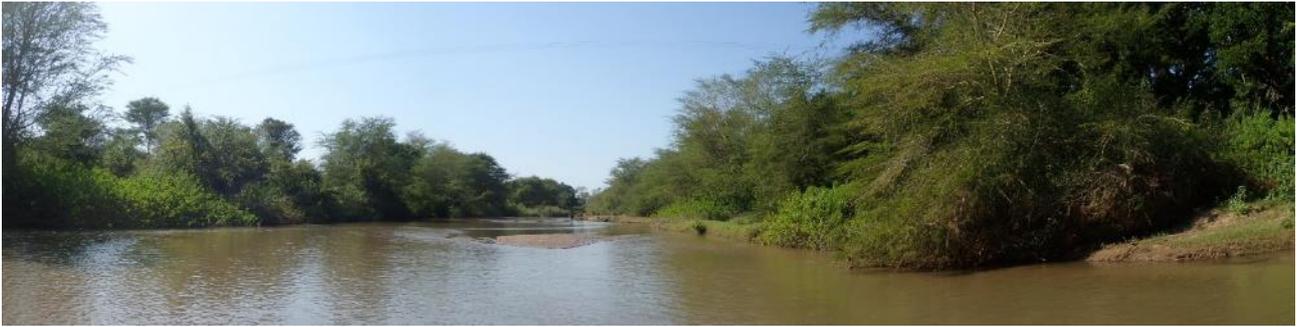
Figure E9 EWR MK1 (July 2022)

EWR MK1 is situated in the Mkuze River (S27.59210 E32.21800) in RU W31-4 and IUA W31-b (Lower Mkuze). The Mkuze River at this site is a sand-bed river with sand banks. Flood channels are characteristic of the floodplain but these are choked with shrubs and woody debris. The recently erected fence has probably resulted in an increase in forest floor and bank vegetation since 2014 due to absence of animals such as elephant and grazers. Photographs of the EWR site reflecting fish habitats (July 2022) are illustrated in **Figure E9**. The habitats available for fish at the time of the July 2022 survey is reflected as habitat cover ratings (**Table E12** and **Figure E10**).

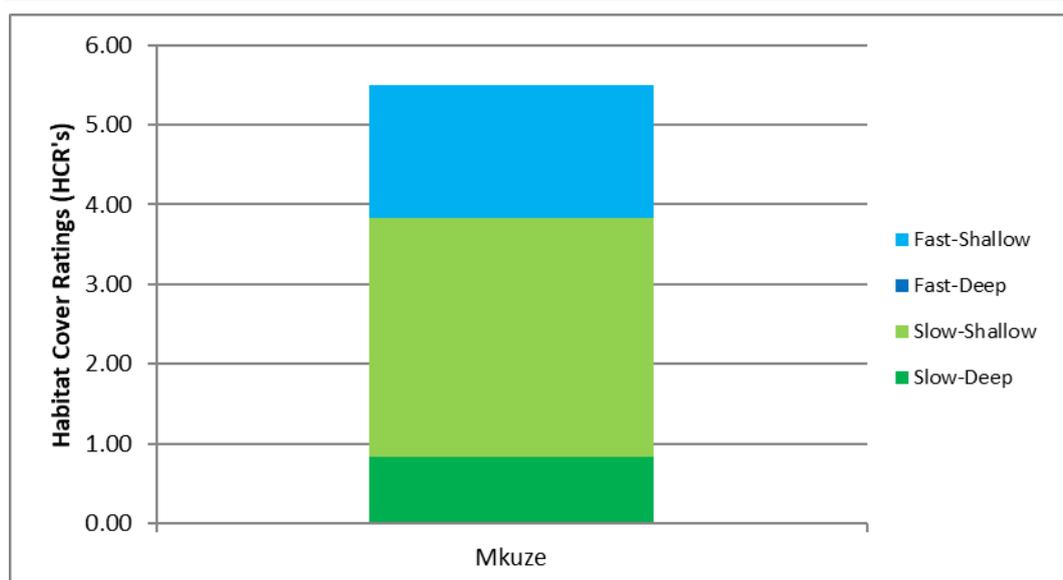
Figure E10 Fish Habitat Cover Ratings calculated for each velocity-depth category at site MK1 (July 2022 survey)

Velocity-depth class	Sites	Mkuze
SLOW-DEEP (>0.5m; <0.3m/s)	Abundance	1
	Overhanging vegetation	2
	Undercut banks and Root-wads	2
	Substrate	0
	Macrophytes	1
SLOW-SHALLOW (<0.5m; <0.3m/s)	Abundance	3
	Overhanging vegetation	3
	Undercut banks and Root-wads	2
	Substrate	0
	Macrophytes	1
FAST-DEEP (>0.3m; >0.3m/s)	Abundance	0
	Overhanging vegetation	0
	Undercut banks and Root-wads	0
	Substrate	0
	Macrophytes	0
FAST-SHALLOW (<0.3m; >0.3m/s)	Abundance	2
	Overhanging vegetation	2
	Undercut banks and Root-wads	2
	Substrate	0
	Macrophytes	1

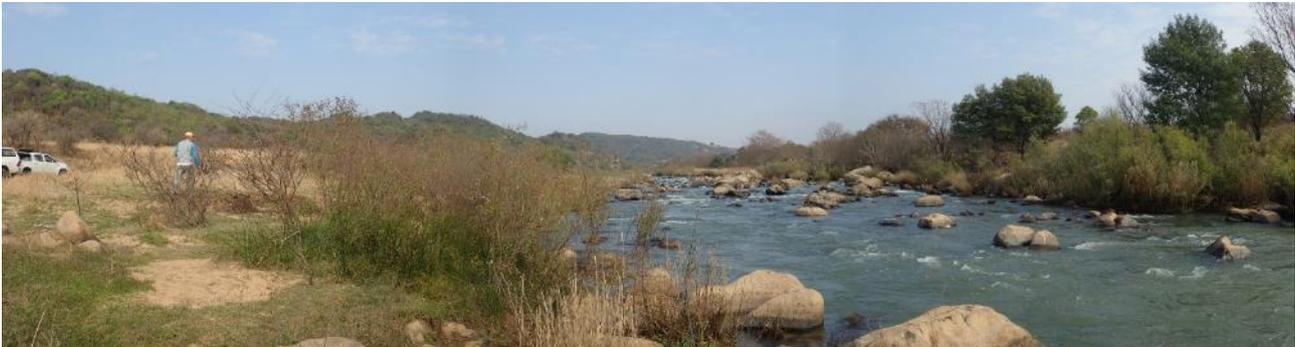
Figure E11 EWR UP1 (July 2022)

parallel to the right-hand bank provides significant low flow habitat comprised of riffle and run. Photographs of the EWR site reflecting fish habitats (July 2022) are illustrated in **Figure E11**. The habitats available for fish at the time of the July 2022 survey is reflected as habitat cover ratings (**Table E15** and **Figure E12**).

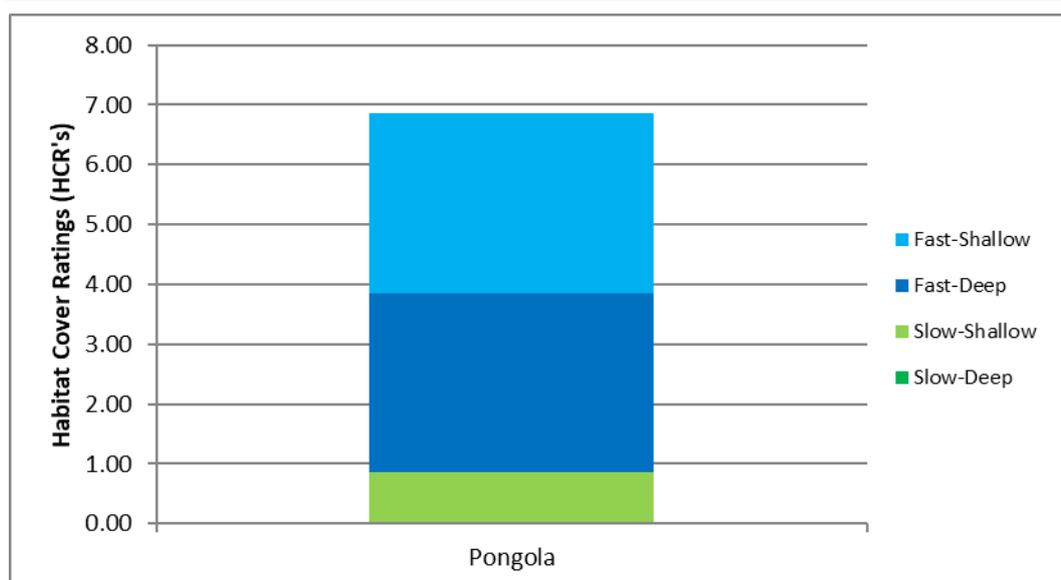
Figure E12 Fish Habitat Cover Ratings calculated for each velocity-depth category at site UP1 (July 2022 survey)

Velocity-depth class	Sites	Pongola
SLOW-DEEP (>0.5m; 0.3m/s)	Abundance	0
	Overhanging vegetation	0
	Undercut banks and Root-wads	0
	Substrate	0
	Macrophytes	0
SLOW-SHALLOW (<0.5m; <0.3m/s)	Abundance	1
	Overhanging vegetation	1
	Undercut banks and Root-wads	1
	Substrate	4
	Macrophytes	0
FAST-DEEP (>0.3m; >0.3m/s)	Abundance	3
	Overhanging vegetation	1
	Undercut banks and Root-wads	2
	Substrate	4
	Macrophytes	0
FAST-SHALLOW (<0.3m; >0.3m/s)	Abundance	3
	Overhanging vegetation	1
	Undercut banks and Root-wads	2
	Substrate	4
	Macrophytes	0

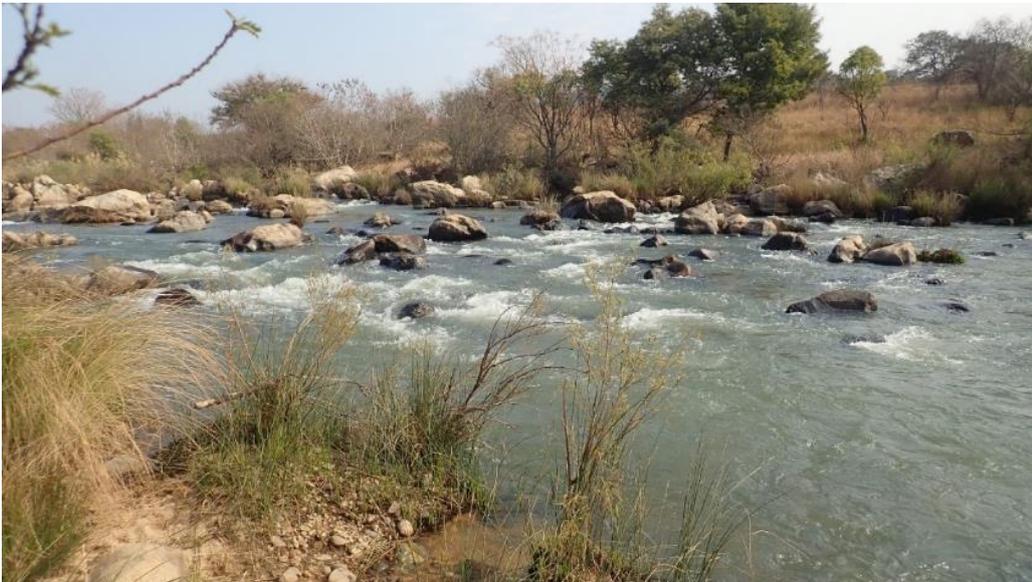
Figure E13 EWR AS1 (July 2022)

Photographs of the EWR site reflecting fish habitats (July 2022) are illustrated in **Figure E13**. The habitats available for fish at the time of the July 2022 survey is reflected as habitat cover ratings (**Table E18** and **Figure E14**).

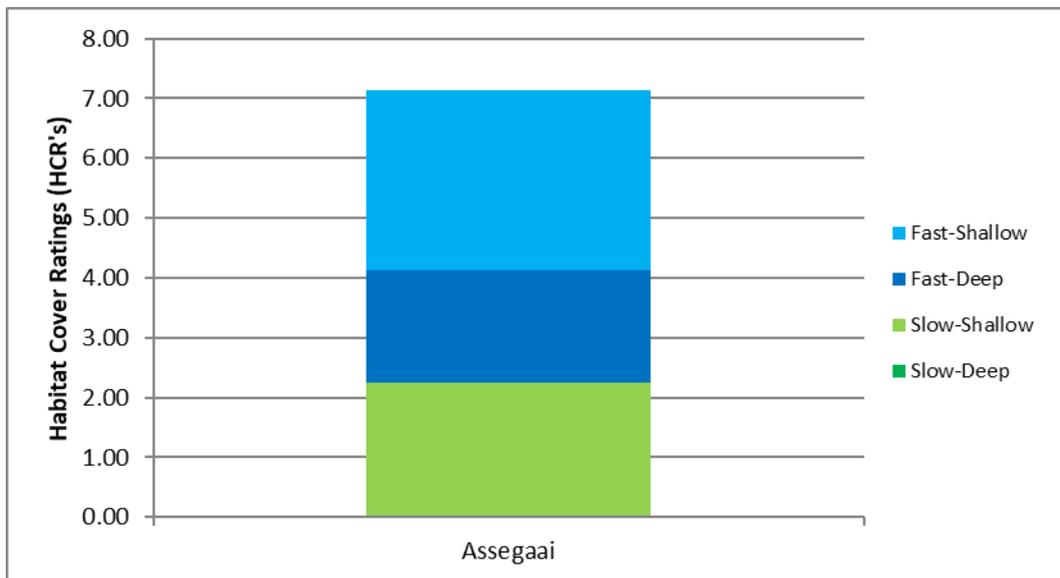
Figure E14 Fish Habitat Cover Ratings calculated for each velocity-depth category at site AS1 (July 2022 survey).

Velocity-depth class	Sites	Assegai
	Substrate	4
	Macrophytes	1

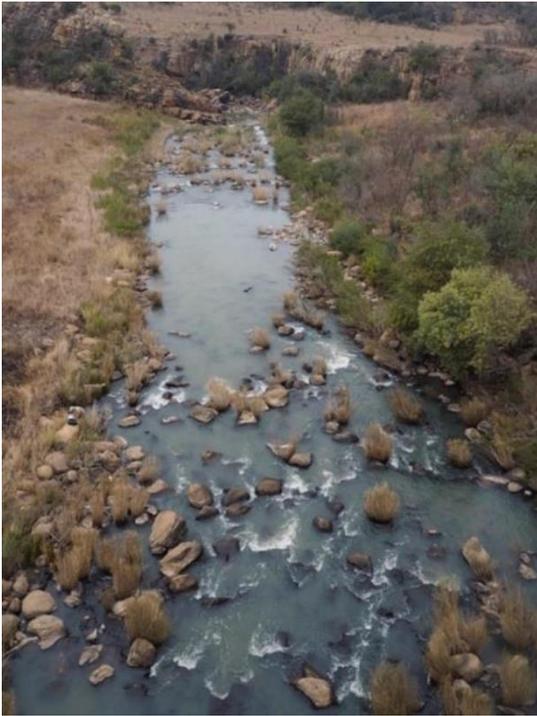
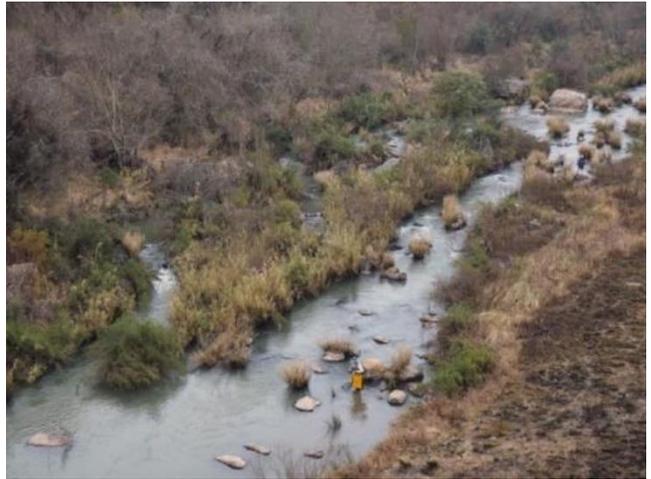
Figure E15 EWR NG1 Ngwempisi River (July 2022)

Photographs of the EWR site reflecting fish habitats (July 2022) are illustrated in **Figure E15**. The habitats available for fish at the time of the July 2022 survey is reflected as habitat cover ratings (**Table E21** and **Figure E16**).

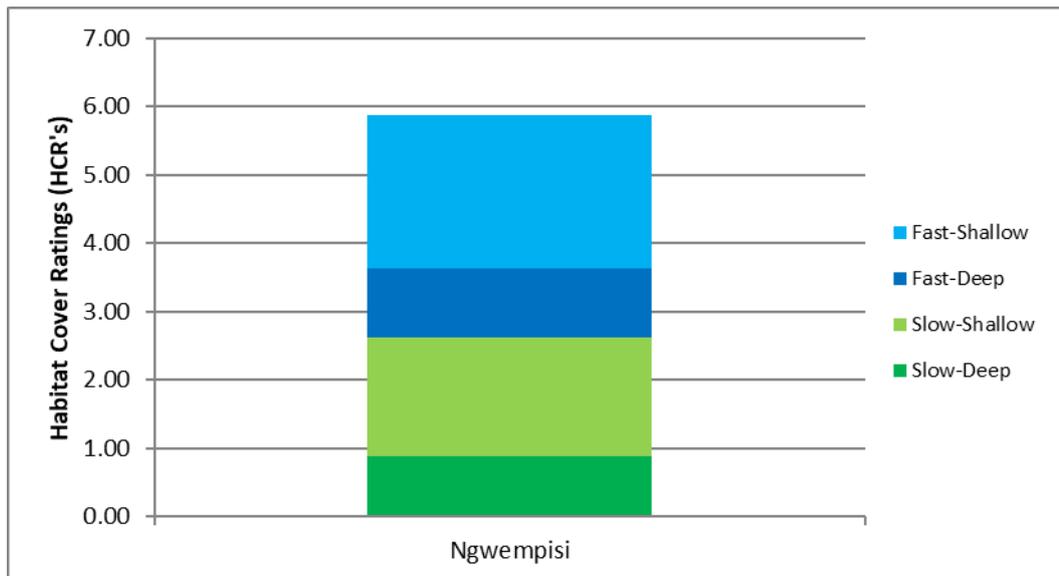
Figure E16 Fish Habitat Cover Ratings calculated for each velocity-depth category at site NG1 (July 2022 survey)

Velocity-depth class	Sites	Ngwempisi
SLOW-DEEP (>0.5m; <0.3m/s)	Abundance	1
	Overhanging vegetation	2
	Undercut banks and Root-wads	2
	Substrate	3
	Macrophytes	0
SLOW-SHALLOW (<0.5m; <0.3m/s)	Abundance	2
	Overhanging vegetation	2
	Undercut banks and Root-wads	1
	Substrate	3
	Macrophytes	1
FAST-DEEP (>0.3m; >0.3m/s)	Abundance	2
	Overhanging vegetation	0
	Undercut banks and Root-wads	0
	Substrate	4
	Macrophytes	0
FAST-SHALLOW (<0.3m; >0.3m/s)	Abundance	3
	Overhanging vegetation	1
	Undercut banks and Root-wads	1
	Substrate	4
	Macrophytes	0

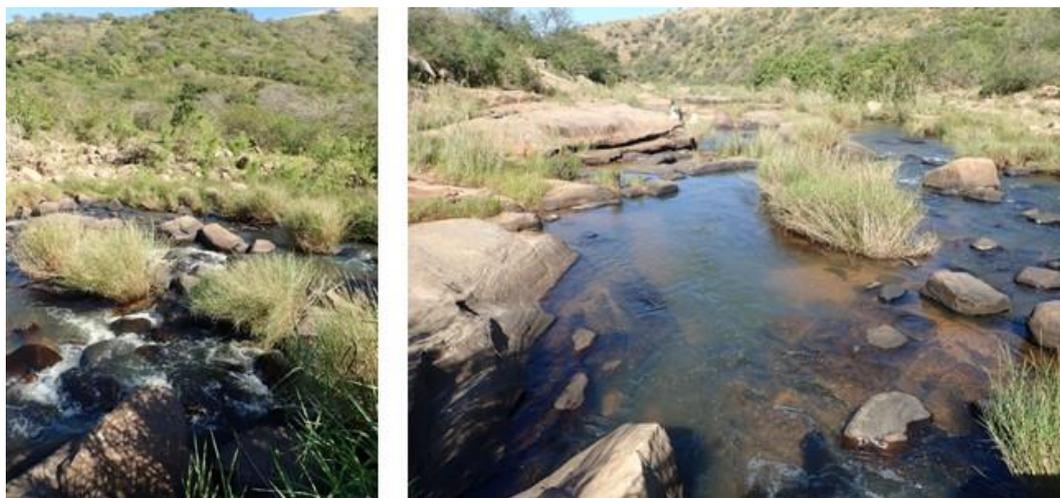
Figure F1 Riverine biotopes at EWR MA1 (July 2022)

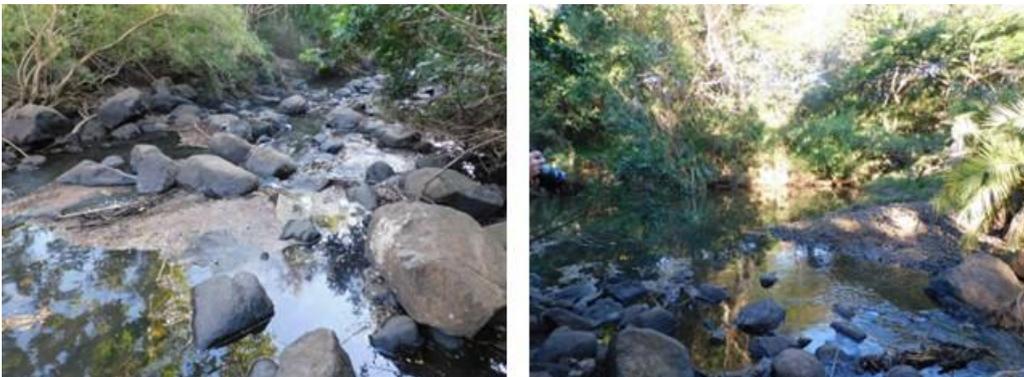
Figure F2 Riverine biotopes at EWR NS1 (July 2022)

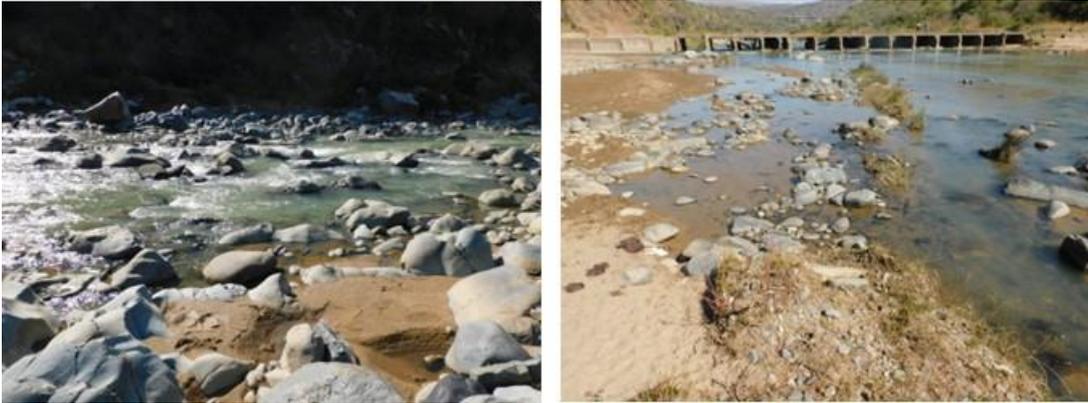
Figure F3 Riverine biotopes at EWR WM1 (July 2022)

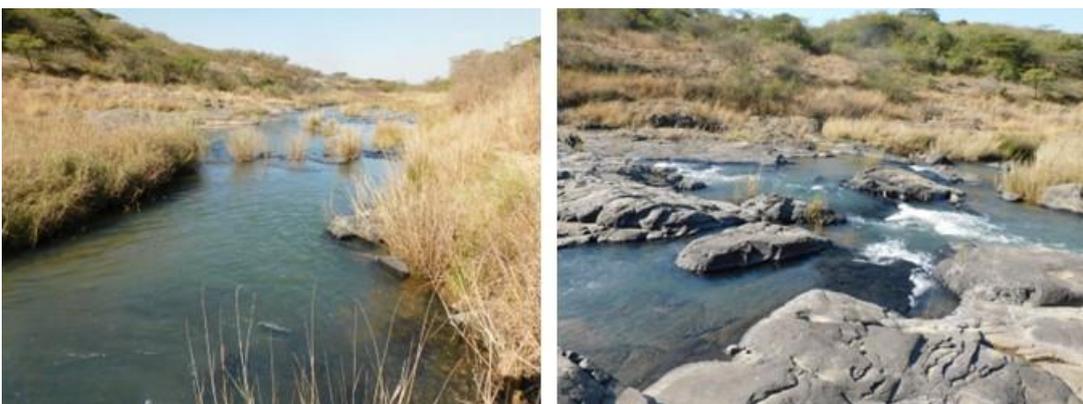
Figure F4 Riverine biotopes at EWR BM1 (July 2022)

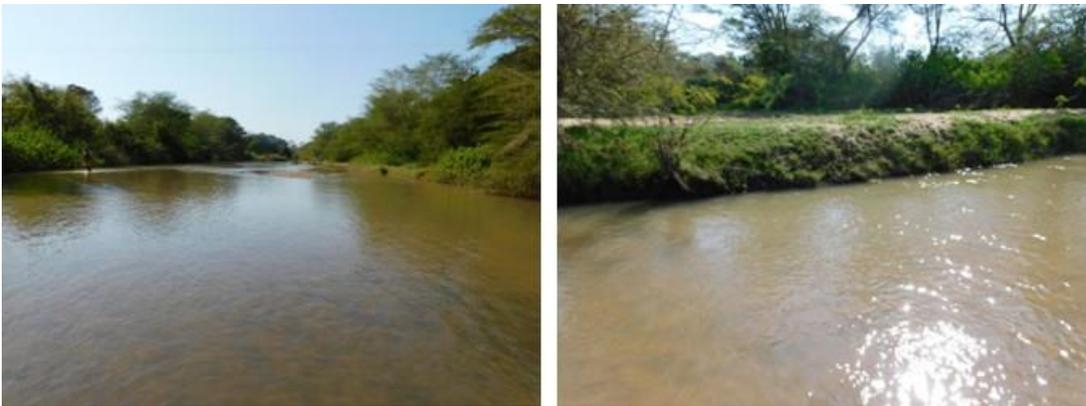
Figure F5 Riverine biotopes at EWR MK1 (July 2022)

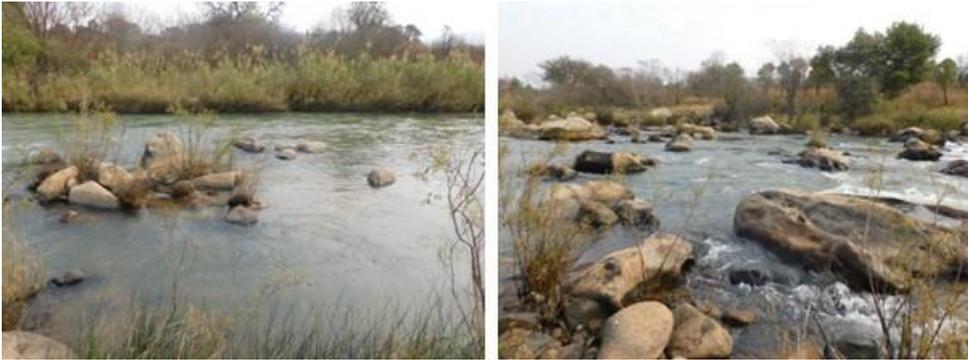
Figure F6 Riverine biotopes at EWR UP1 (July 2022)

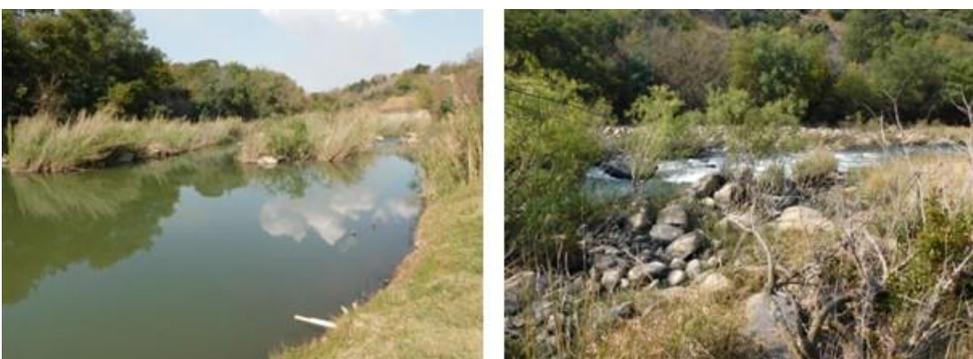
Figure F7 Riverine biotopes at EWR AS1 (July 2022)

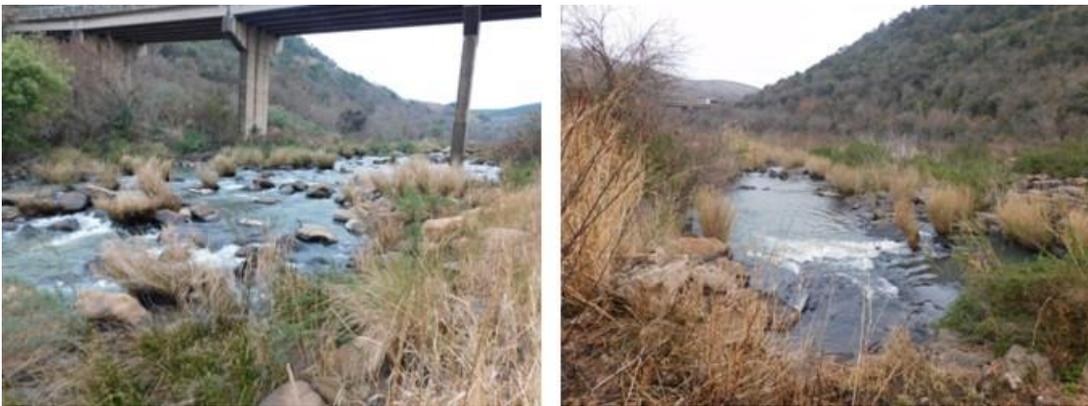
Figure F8 Riverine biotopes at EWR NG1 (July 2022)

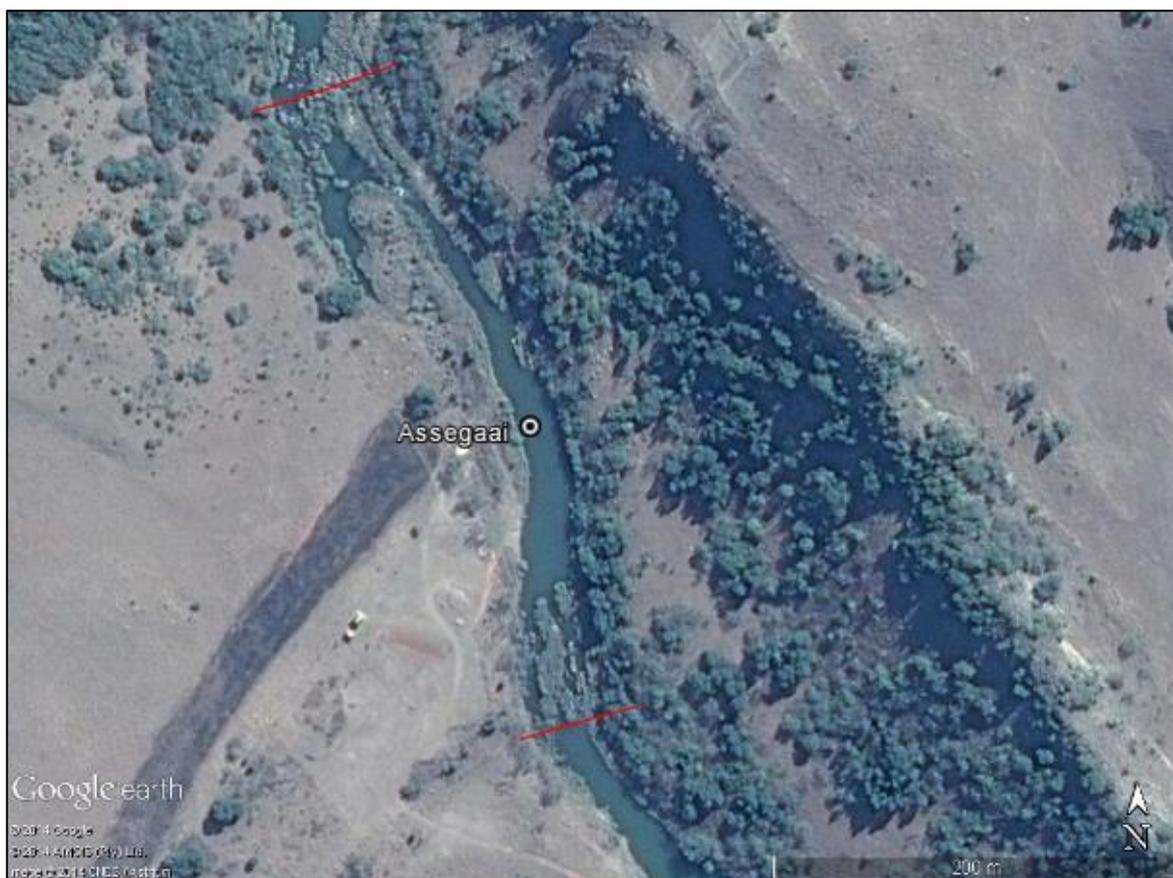
Figure G1 Satellite image from Google Earth © showing the placement and extent of the VEGRAI assessment area for the Assegaai River (upstream and downstream limits of site indicated by red lines)

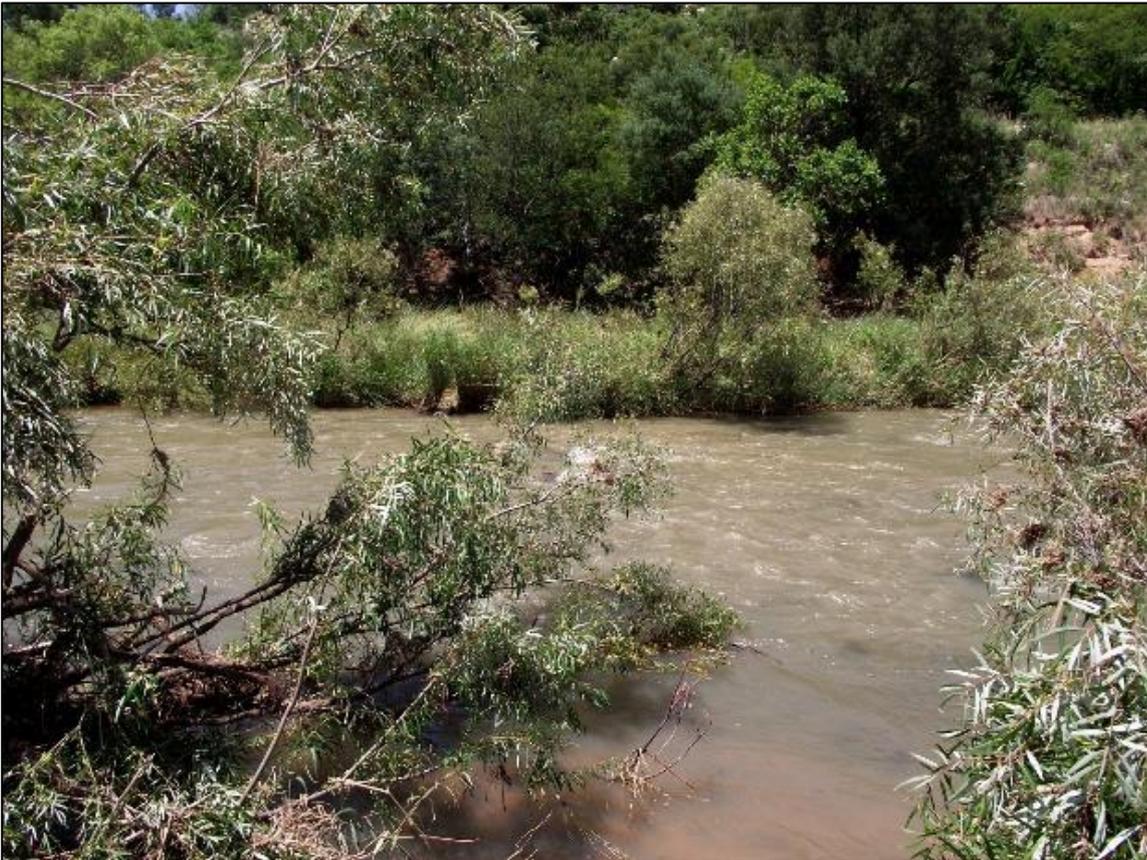
Figure G2 Typical riparian vegetation at the Assegaai River, dominated by marginal and lower zone grasses and sedges, Cape Willow and alien Australian Wattle species.

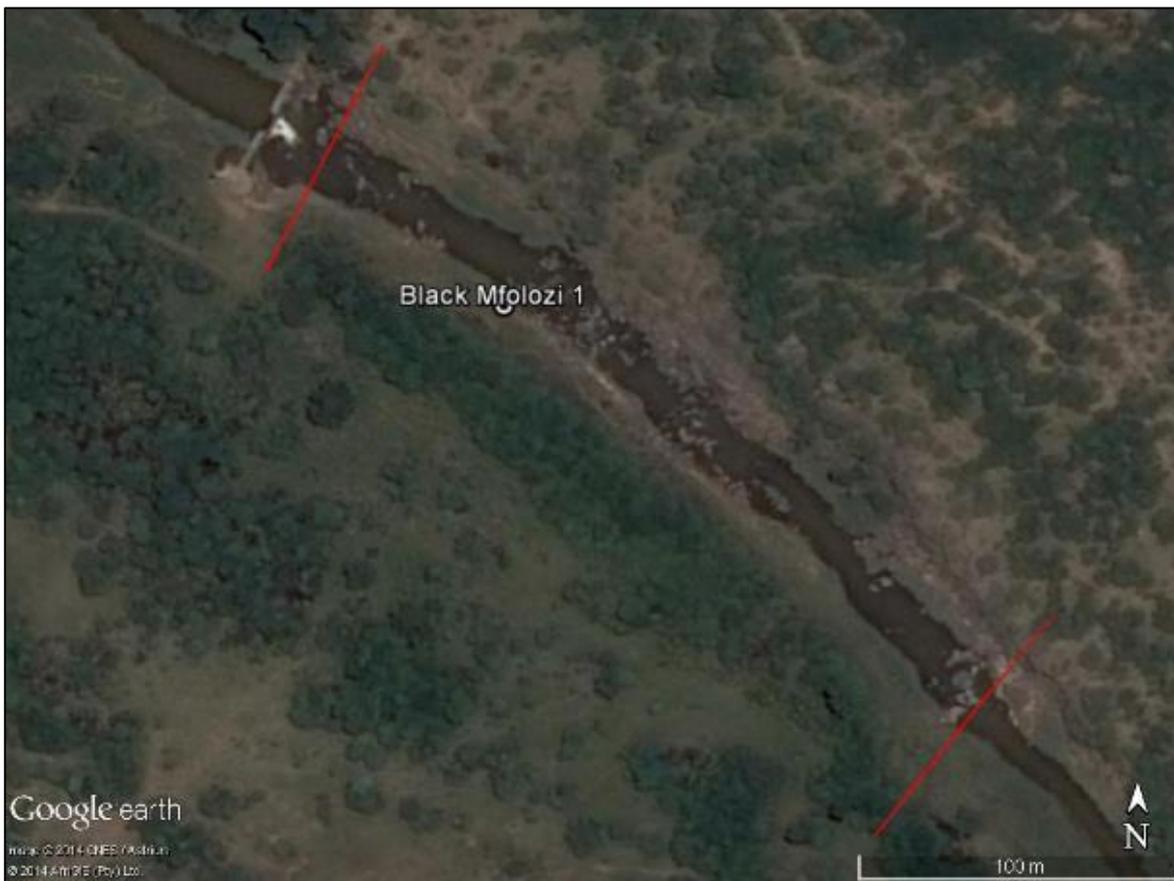
Figure G3 Satellite image from Google Earth © showing the placement and extent of the VEGRAI assessment area for the Black Mfolozi (BM1) River (upstream and downstream limits of site indicated by red lines)

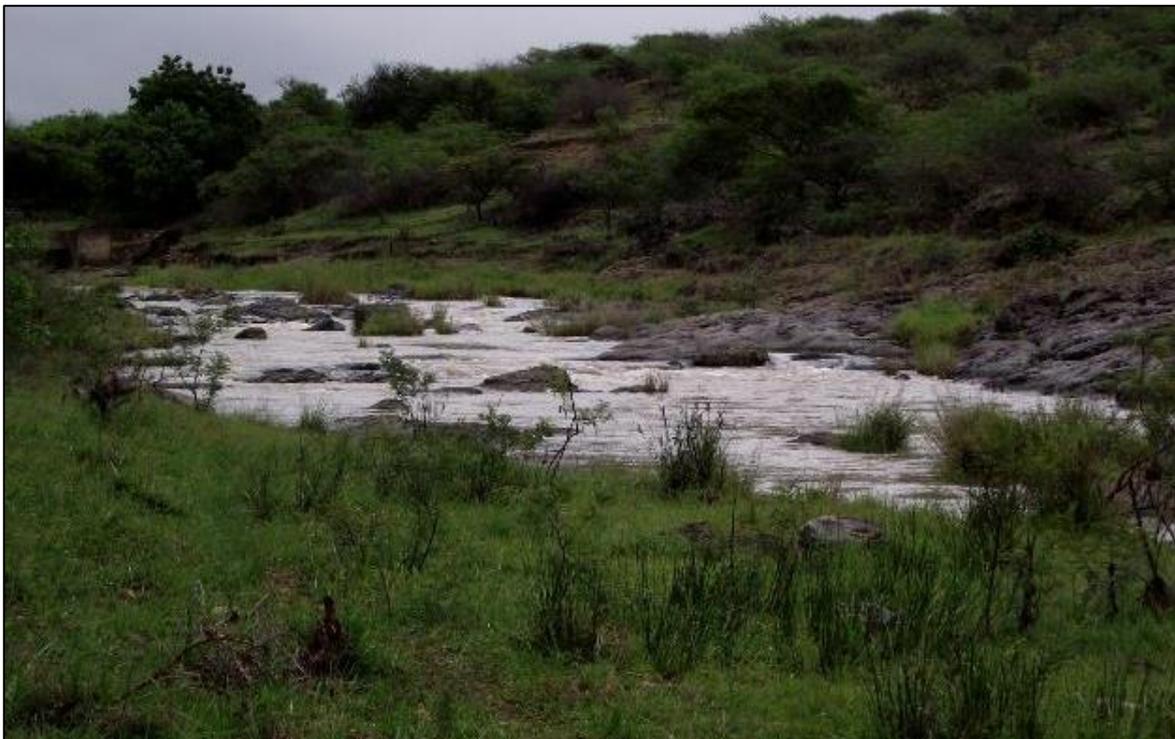
Figure G4 Typical riparian vegetation at the Black Mfolozi River (site BM1), dominated by grass, reeds and sedges along the valley floor and a woody upper zone
