Classification of Significant Water Resources and Determination of Resource Quality Objectives for Water Resources in the Usutu to Mhlathuze Catchments

RIVER SPECIALIST MEETING REPORT

September 2022

PROJECT NUMBER: WP 11387

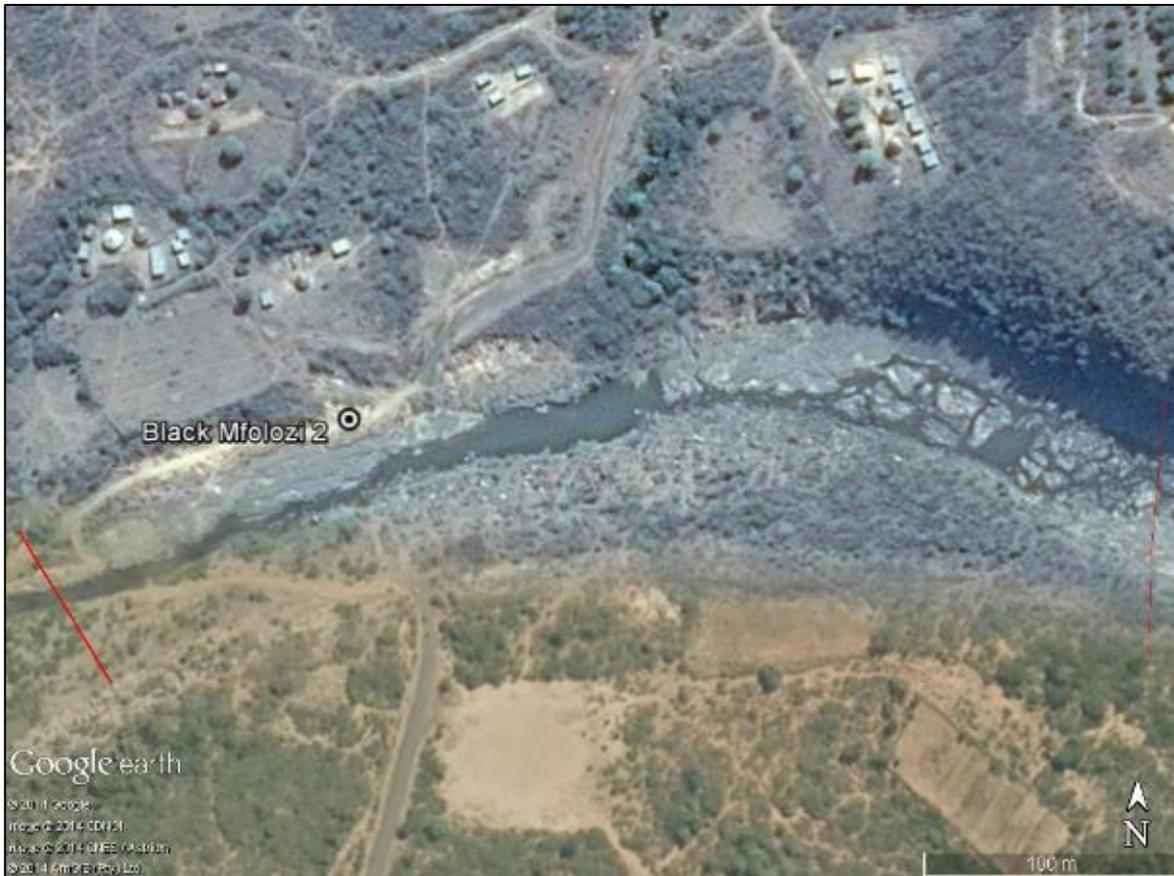
Figure G5 Satellite image from Google Earth © showing the placement and extent of the VEGRAI assessment area for the Black Mfolozi (BM2) River (upstream and downstream limits of site indicated by red lines)

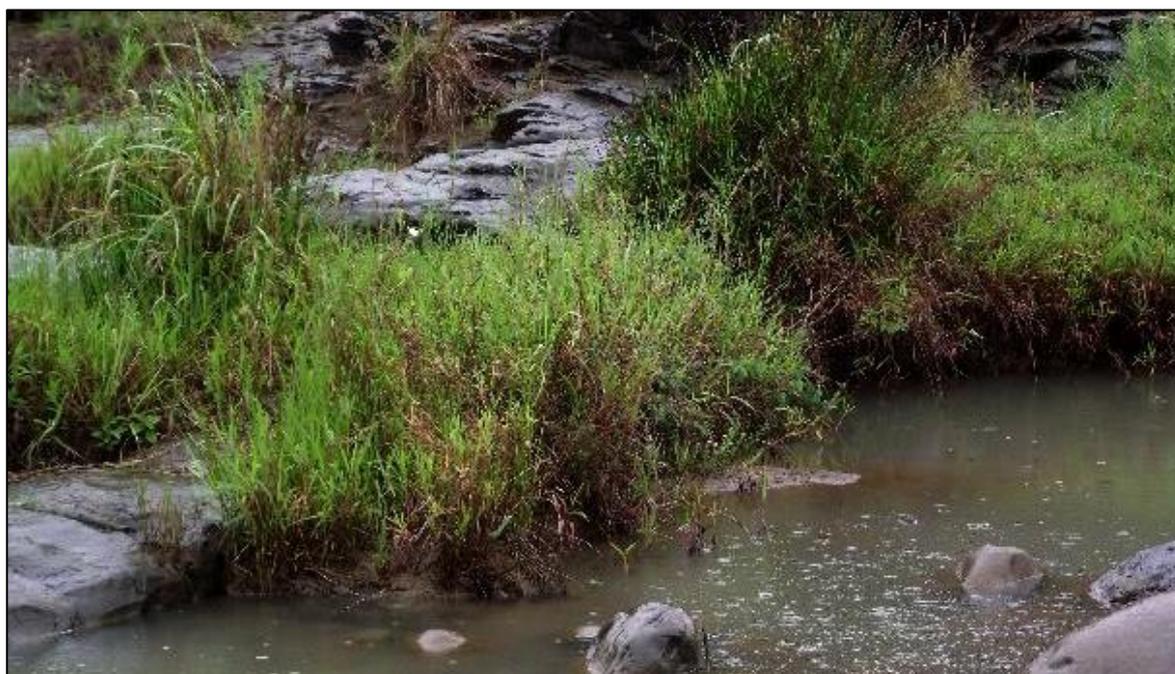
Figure G6 Typical riparian vegetation at the Black Mfolozi (Site BM2) dominated by open bedrock with patches of hydrophilic² grasses and sedges

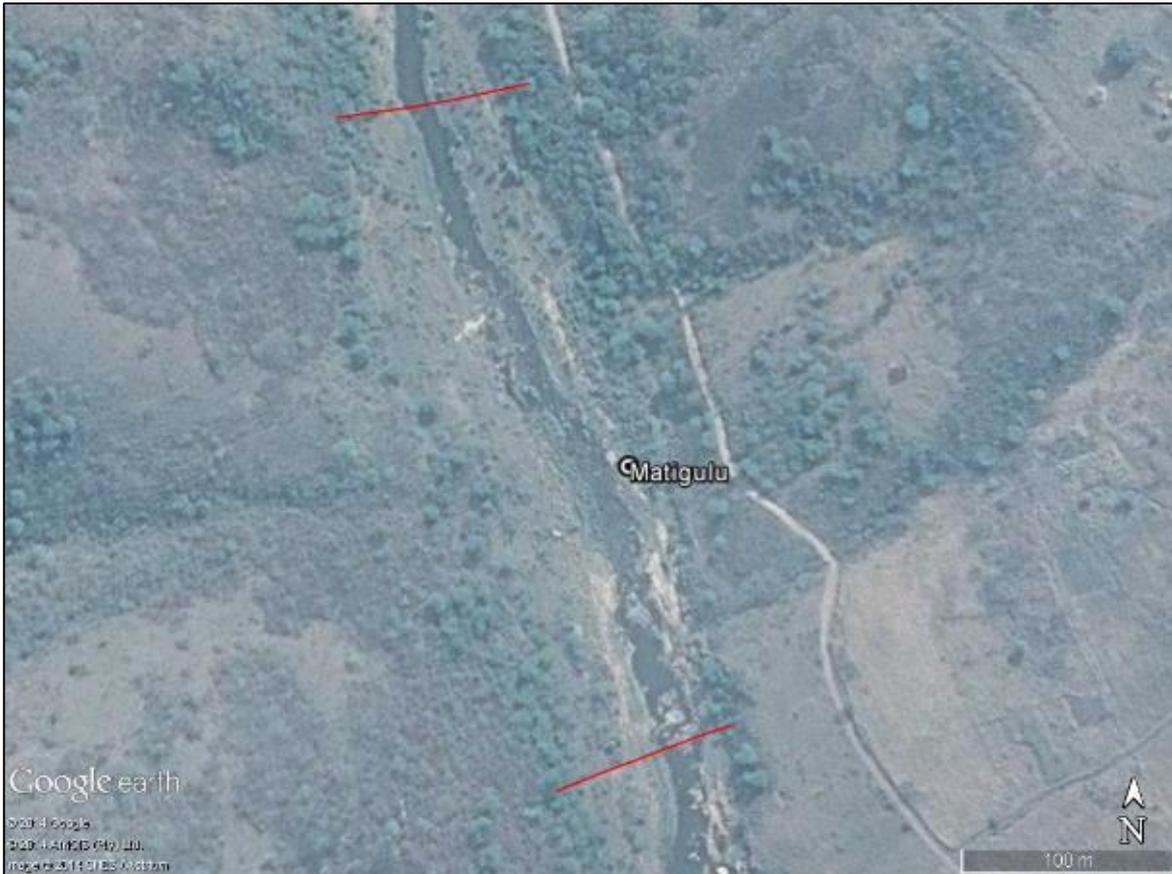
Figure G7 Satellite image from Google Earth © showing the placement and extent of the VEGRAI assessment area for the Matigulu River (upstream and downstream limits of site indicated by red lines)

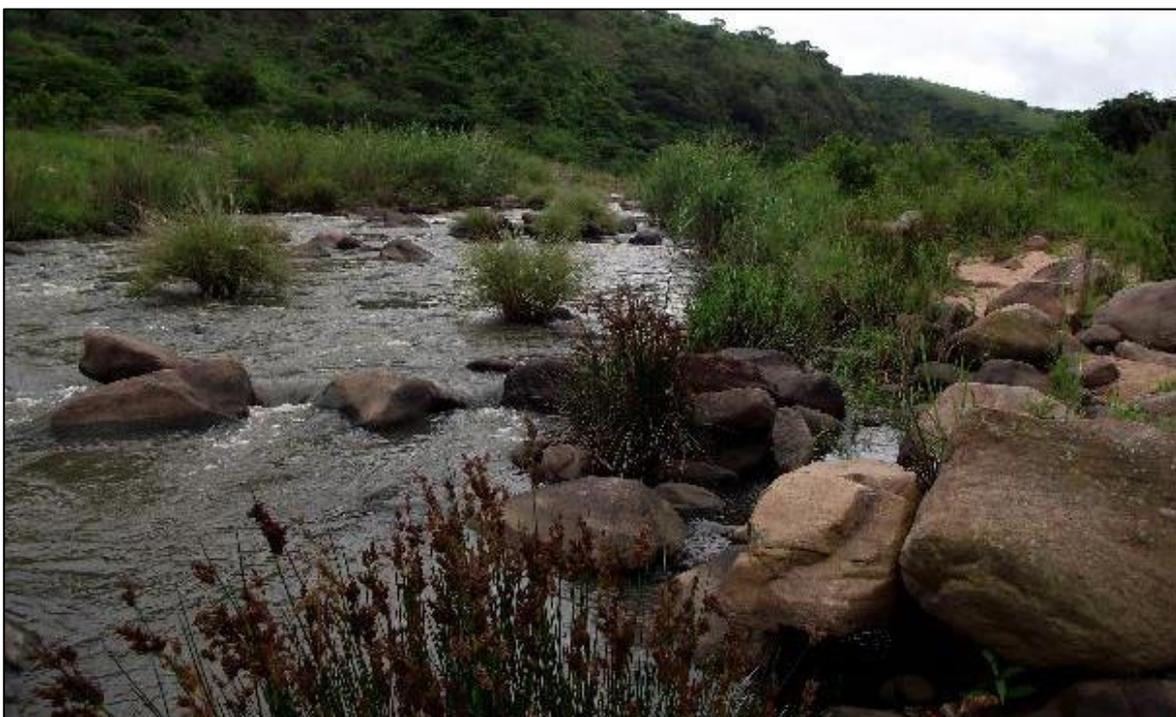
Figure G8 Typical riparian vegetation at the Matigulu River included grasses, sedges and reeds with scattered trees within the macro channel floor and more dense trees along the banks (background)

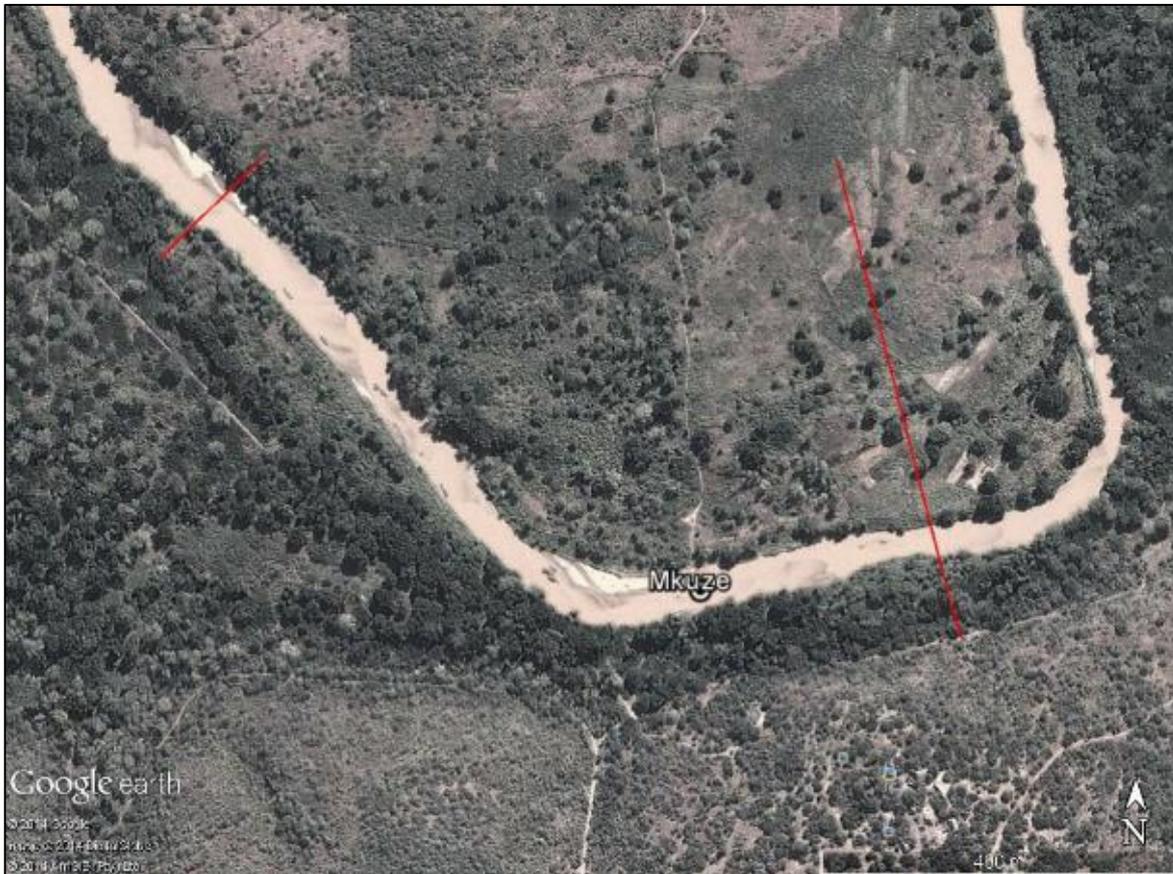
Figure G9 Satellite image from Google Earth © showing the placement and extent of the VEGRAI assessment area for the Mkuze River (upstream and downstream limits of site indicated by red lines)

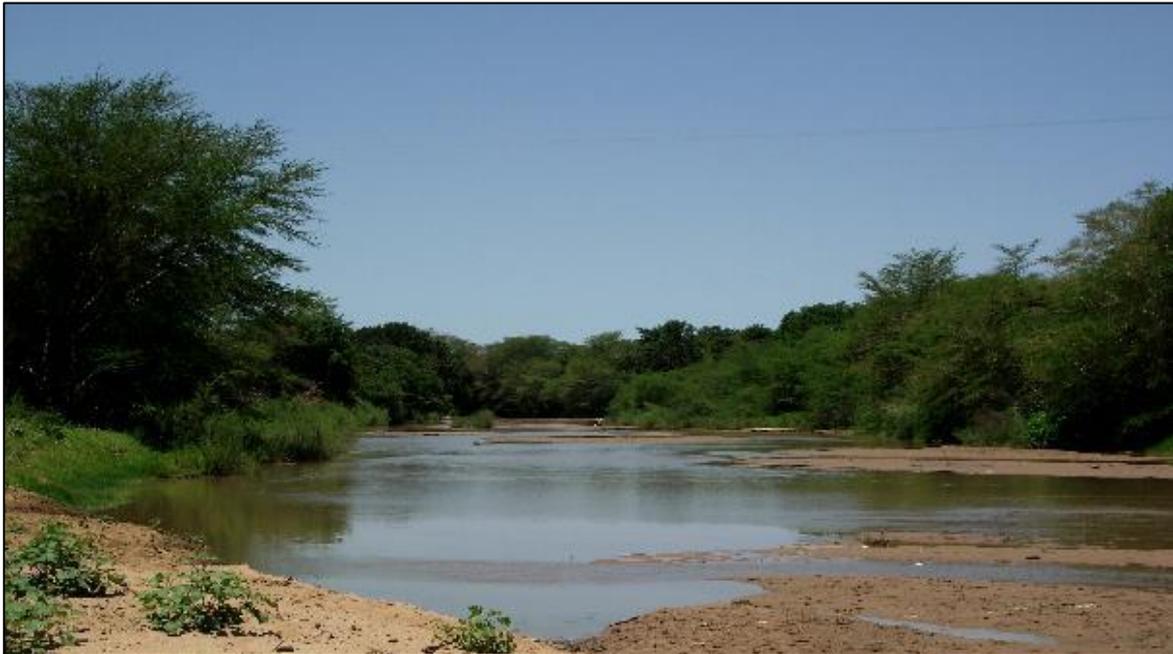
Figure G10 Typical riparian vegetation at the Mkuze River, dominated by marginal zone reeds and grasses, and tall woody species forming riparian forest, dominated by Sweet Thorn and Wild Fig amongst others, with overhanging habitats for instream fauna

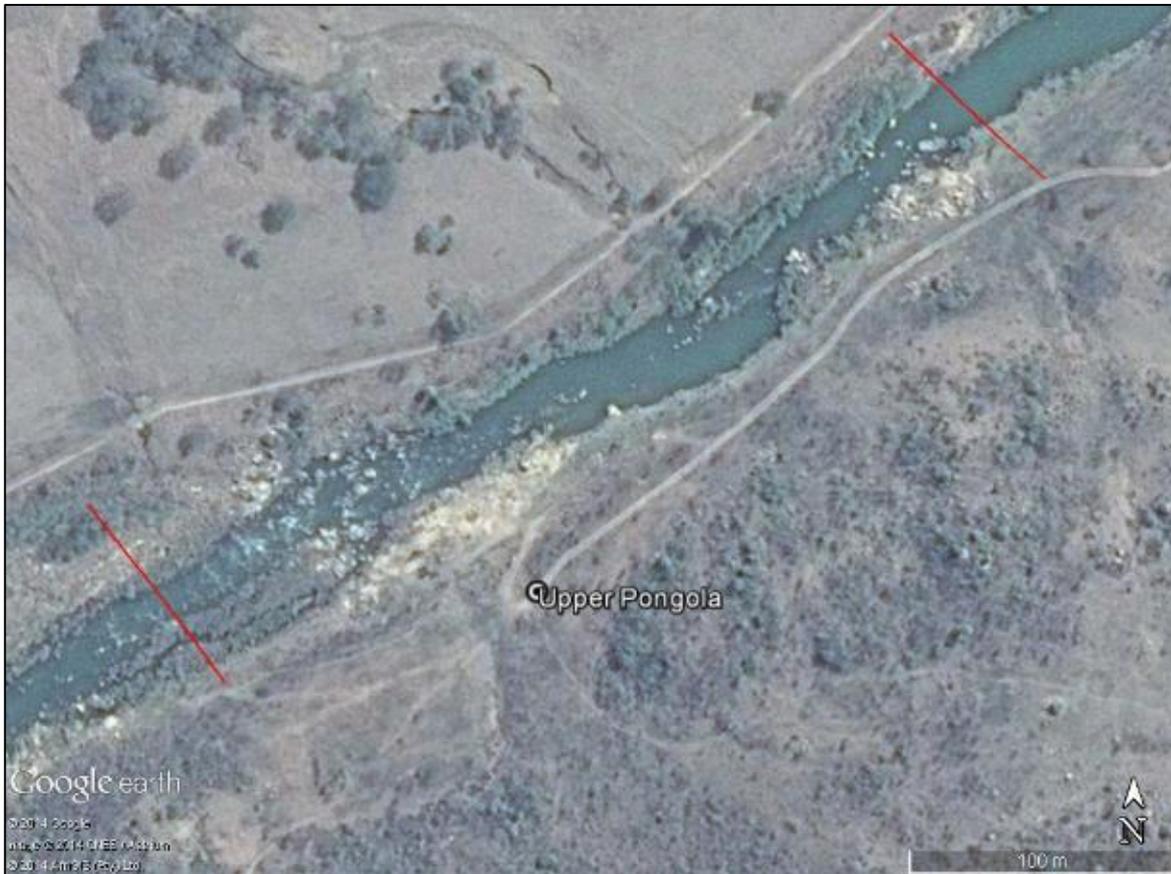
Figure G13 Satellite image from Google Earth © showing the placement and extent of the VEGRAI assessment area for the Upper Pongola River (upstream and downstream limits of site indicated by red lines)

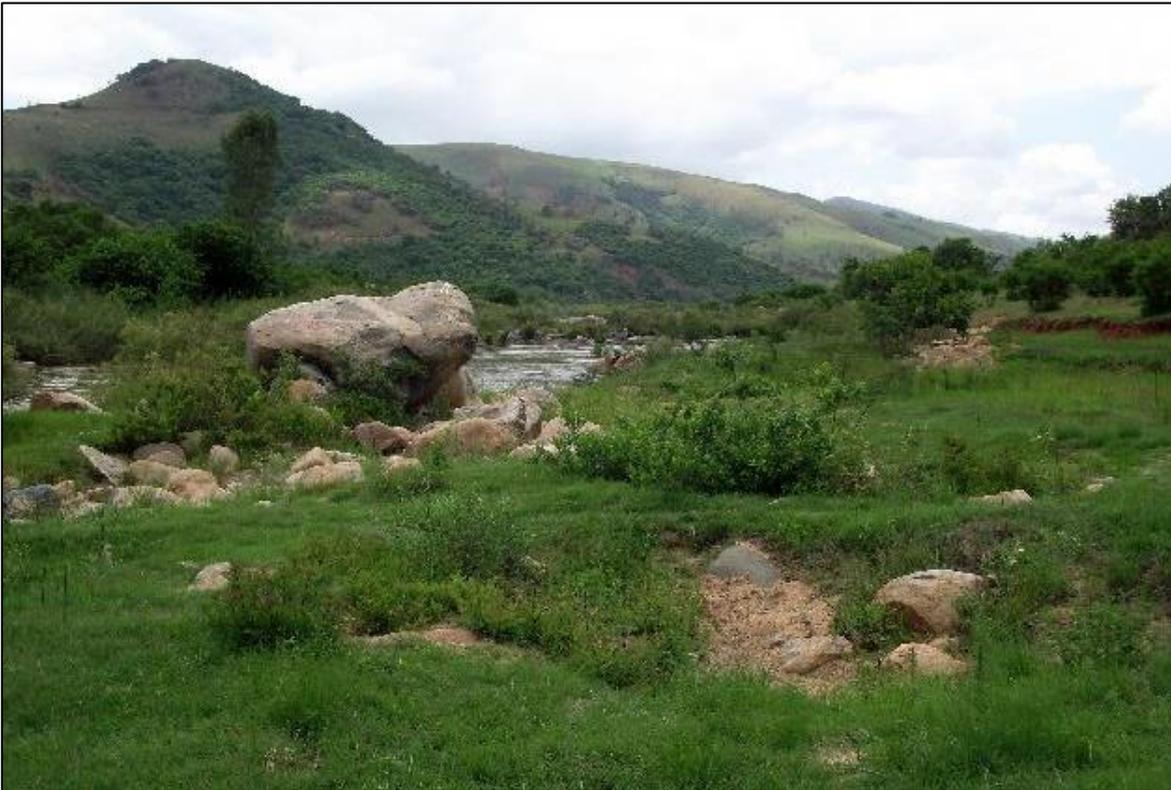
Figure G14 Typical riparian vegetation at the Upper Pongola River, dominated by marginal and lower zone grasses and reeds, Cape Willow, Wattle, Sweet Thorn and upper zone grasses and shrubs

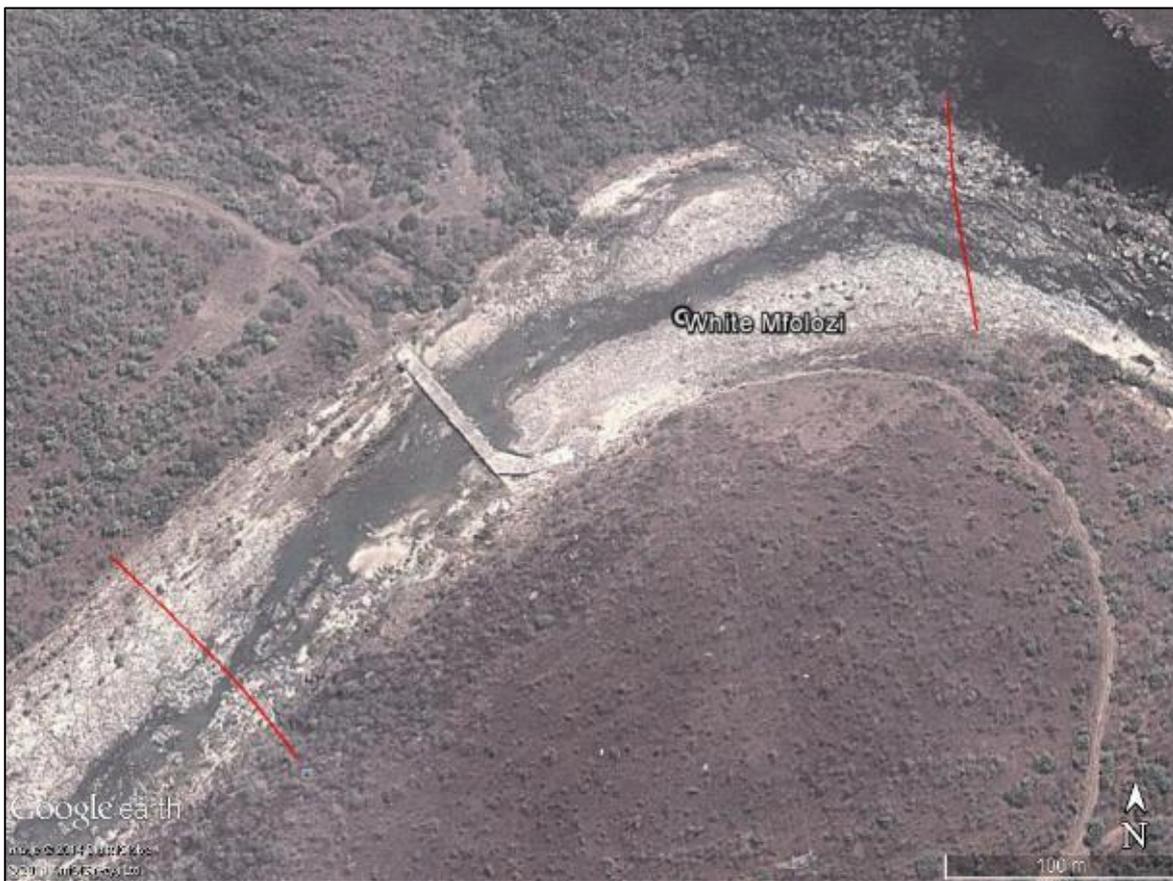
Figure G15 Satellite image from Google Earth © showing the placement and extent of the VEGRAI assessment area for the White Mfolozi River (upstream and downstream limits of site indicated by red lines)

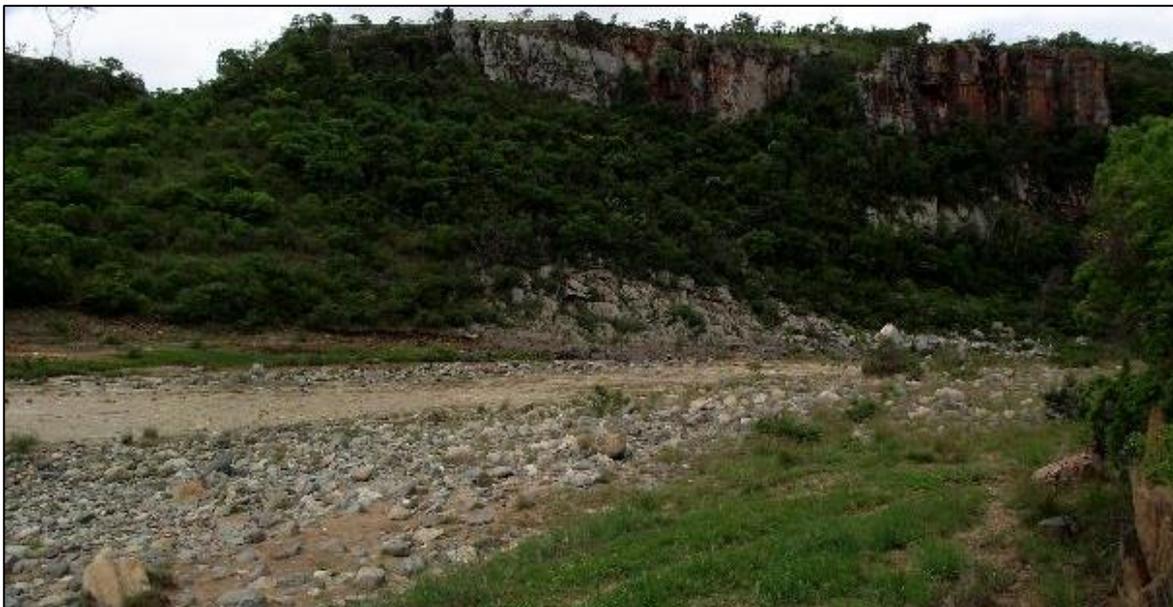
Figure G16 Typically, riparian vegetation was sparse at the White Mfolozi River with scattered grasses, sedges and a few riparian trees, mostly in shrub form

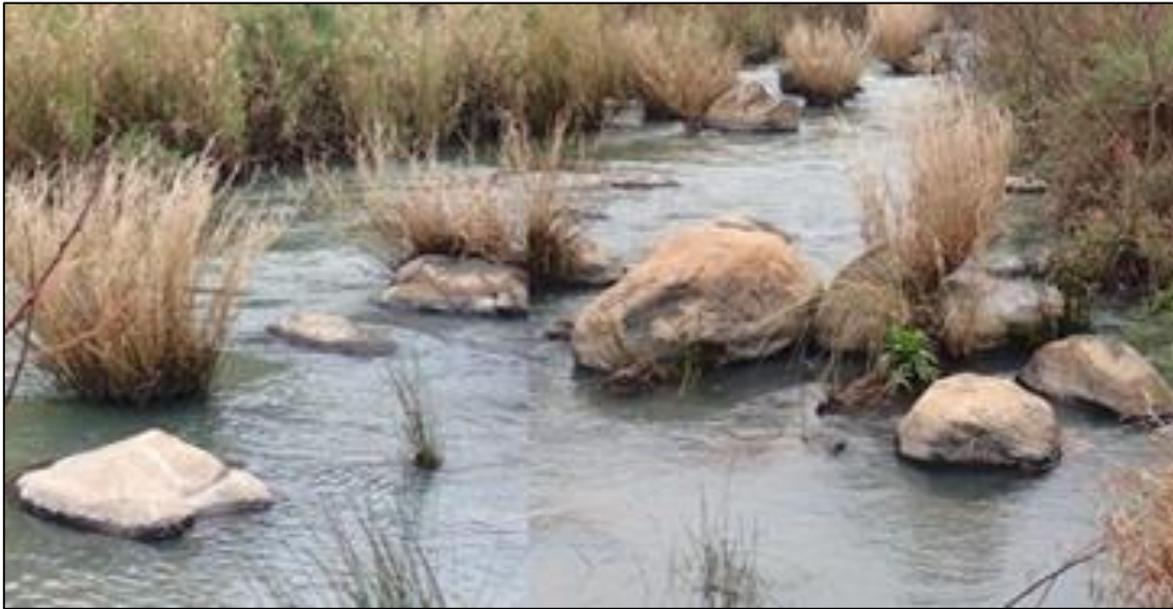
Figure G17 Typically, riparian vegetation was a good mix of woody and non-woody vegetation at the Ngwempisi River with tufted grasses, sedges and marginal zone trees and shrubs, and woody and non-woody prevalence in the non-marginal zone

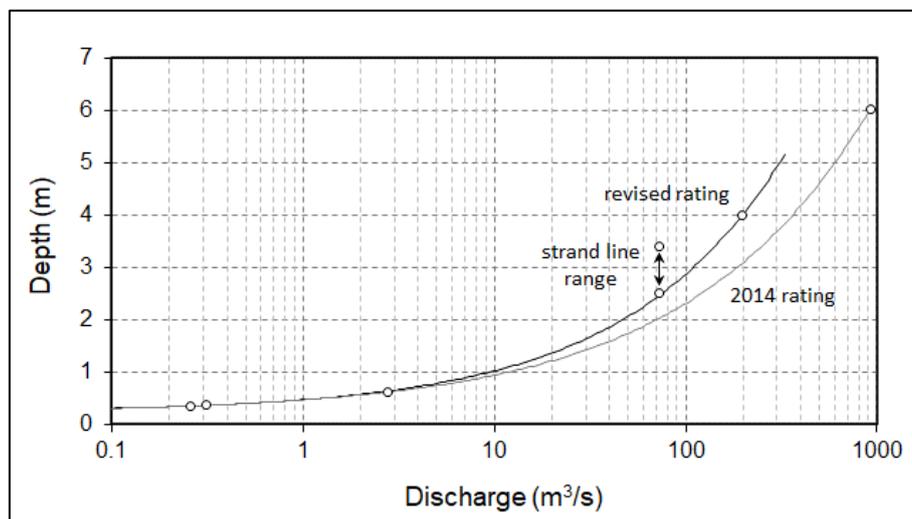
Figure H1 Revised rating relationship for EWR Site BM1 on the Black Mfolozi River

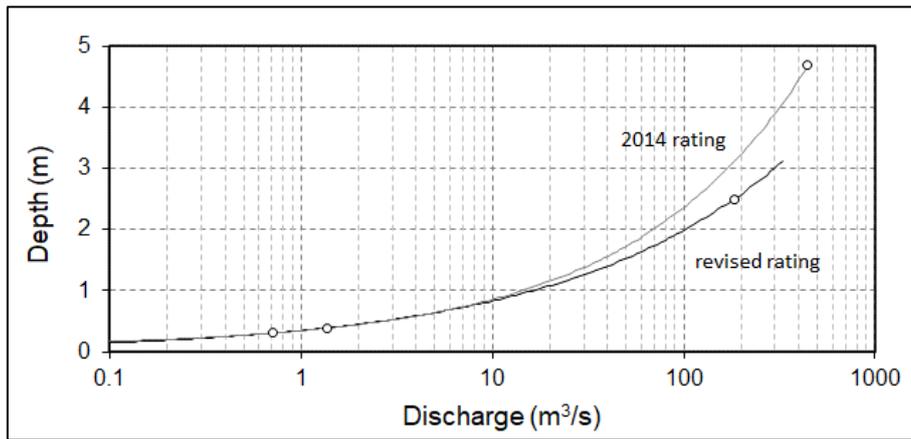
Figure H2 Revised rating relationship for EWR Sites MK1 on the Mkuze River

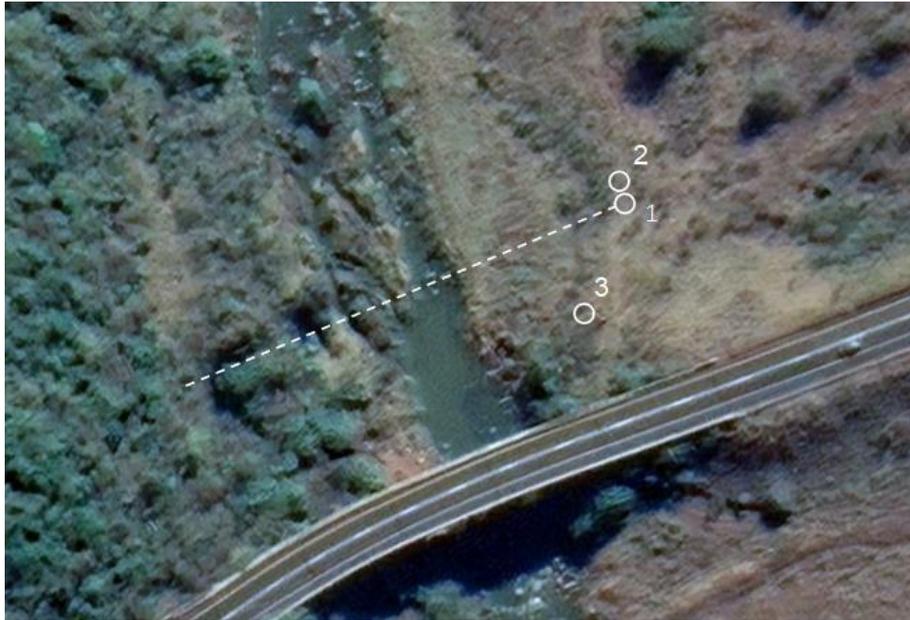
Figure H3 Location of the surveyed cross-section at the downstream end of a boulder rapid; approximate positions of bench marks/fixed stations are indicated with circular markers; flow direction is top-to-bottom

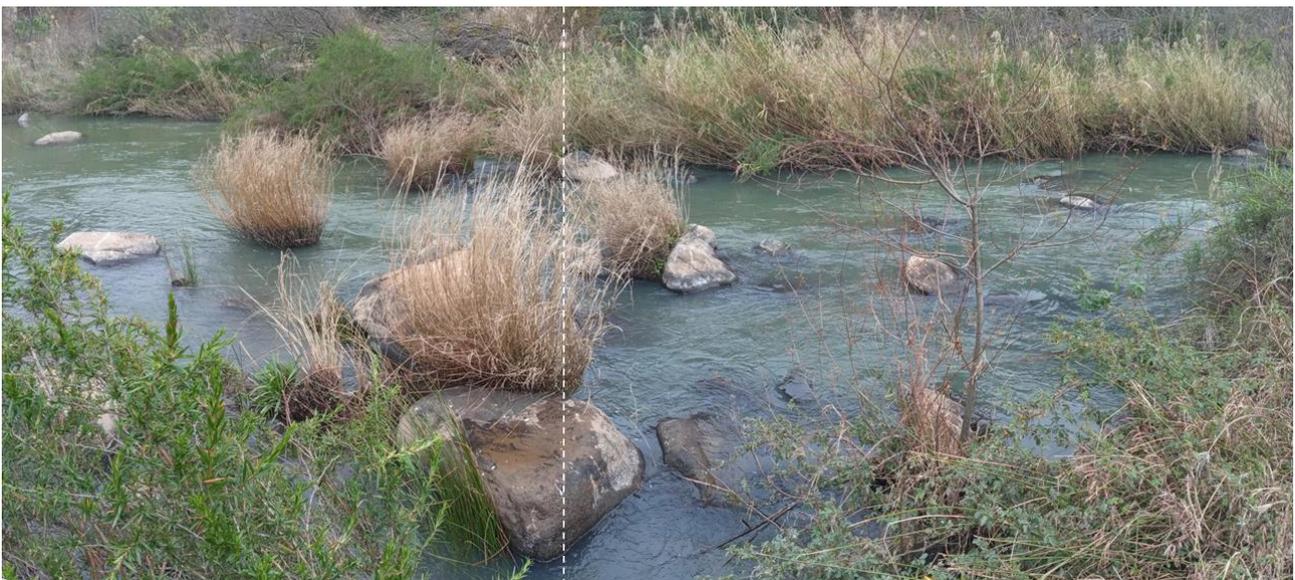
Figure H4 Position of the surveyed cross-section; flow direction is right to left; discharge of 1.69 m³/s (22/07/2022)

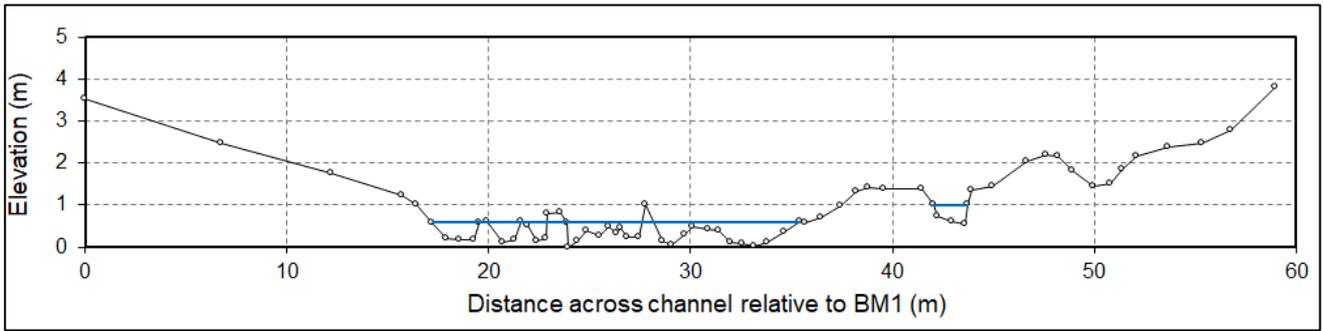
Figure H5 Surveyed cross-sectional profile across the Ngwempisi River (EWR Site NG1) relative to the position of BM1 (refer to Error! Reference source not found.); maximum depth of 0.58 m is indicated, corresponding to a discharge of 1.69 m³/s

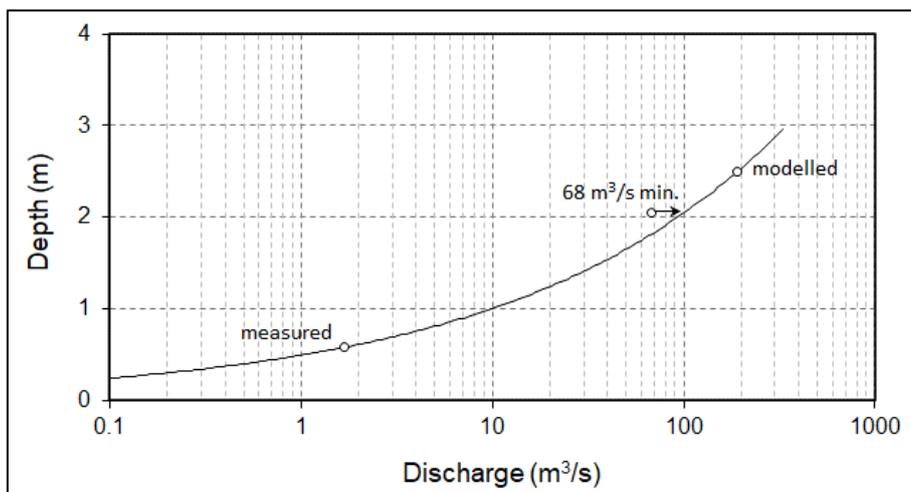
Figure H6 Measured ($y = 0.58$; $S = 0.015$; $n = 0.16$) and modelled ($y = 2.5$; $S = 0.01$; $n = 0.040$) rating points and modelled relationship for EWR Site NG1 on the Ngwempisi River; the surveyed strand line corresponds to a discharge > 68 m³/s (maximum rating of DWS Gauge W5H026)
