Classification of Significant Water Resources and Determination of Resource Quality Objectives for Water Resources in the Usutu to Mhlathuze Catchments

ESTUARY SURVEY REPORT

October 2022

PROJECT NUMBER: WP 11387

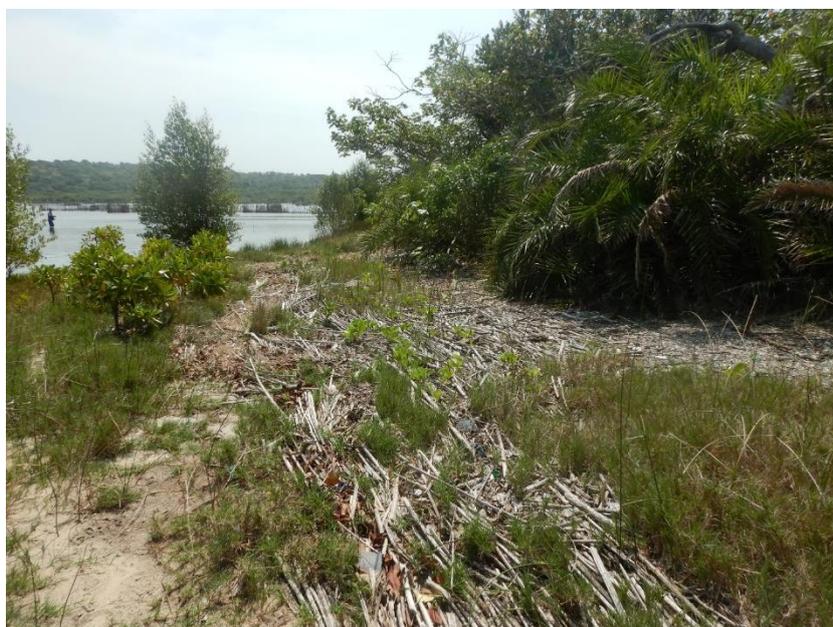
Figure 5.1 The Kosi estuarine lake is nationally important as a tropical system that supports high biodiversity. Photo of estuary habitats (Photo: J Adams, 1 October 2022)

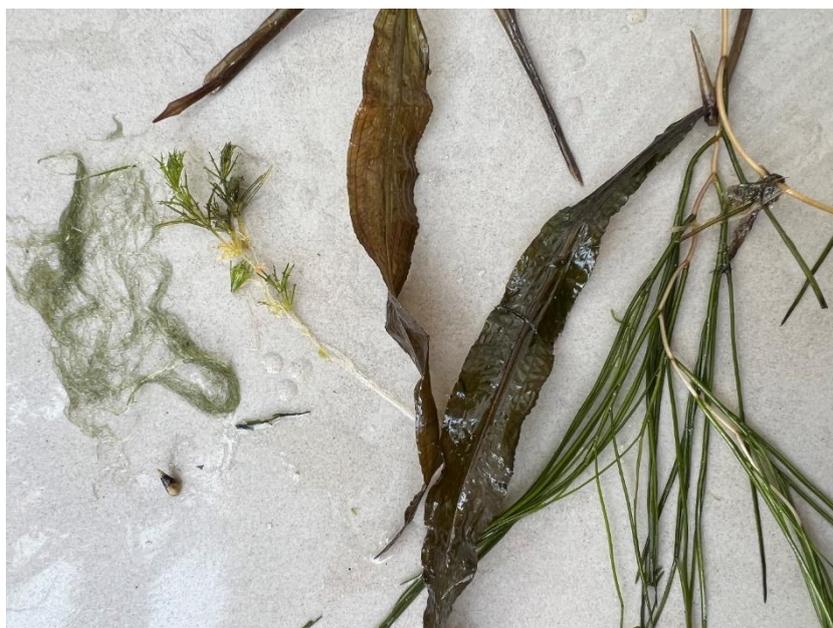
Figure 5.2 Diversity of algae and submerged macrophytes from Lake 3, Kosi Bay (left to right filamentous green algae, *Najas* sp., *Potamogeton sweinfurthii* and *Stuckenia pectinata*). (Photo: J Adams)

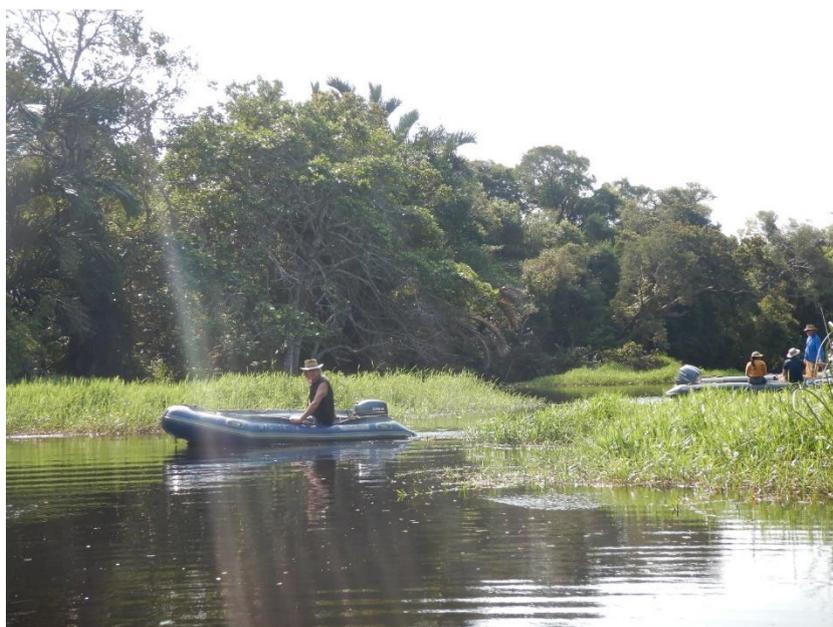
Figure 5.3 Sihadhla River flows into Lake 4 of Kosi estuarine lake; there was little water movement at the time of sampling. Grasses, reeds, sedges encroached into the water column that was filled with dense submerged vegetation (Photo: J Adams, 29 September 2022)

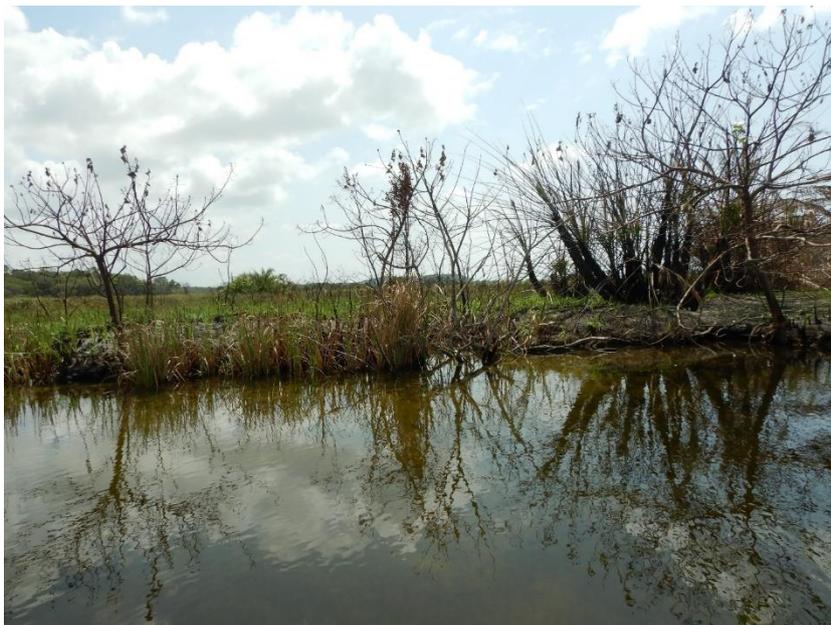
Figure 5.4 Burning of vegetation on Mtando Channel that links Lakes 3 and 2, Kosi Estuary. This activity threatens bank stability. (Photo: J Adams, 29 September 2022)

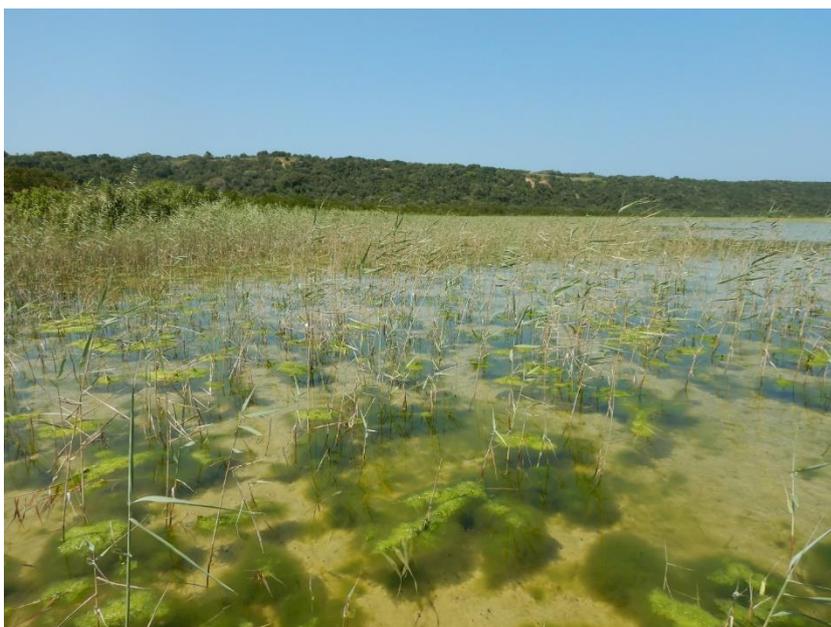
Figure 5.5 Filamentous green algae occurred amongst the reeds in Lakes 1 and 2 at Kosi Estuary (Photo: J Adams, 30 September 2022)

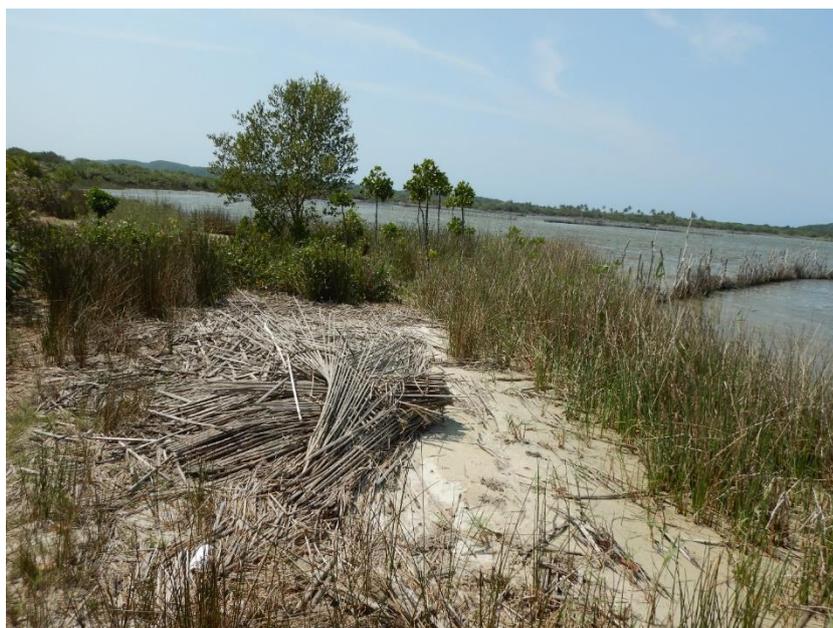
Figure 5.6 Mangrove and palm harvesting near Kosi Estuary mouth for materials to build and maintain adjacent fish traps (Photo: J Adams, 1 October 2022)

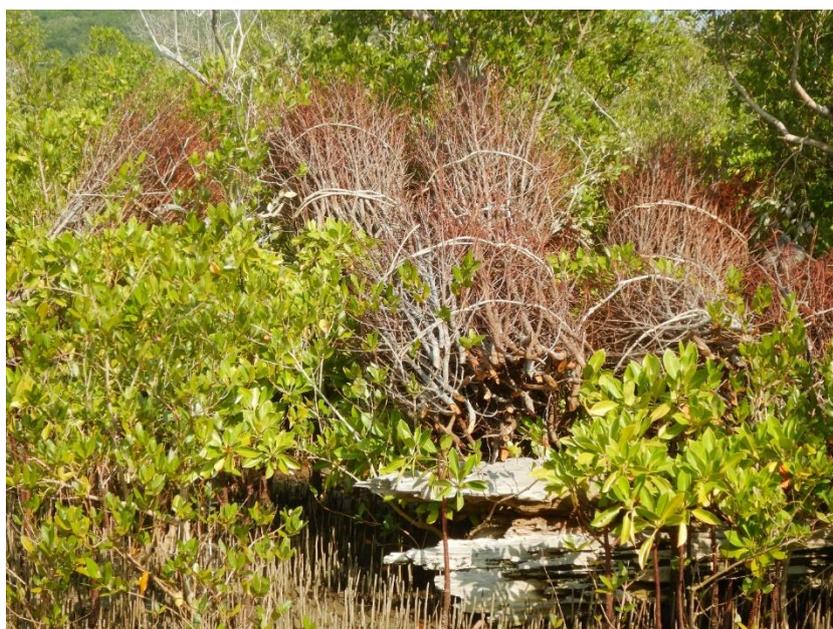
Figure 5.7 Black mangrove harvested for use in fish traps. Location: Kosi Estuary opposite mouth adjacent to steep eastern dunes. (Photo: J Adams, 1 October 2022)

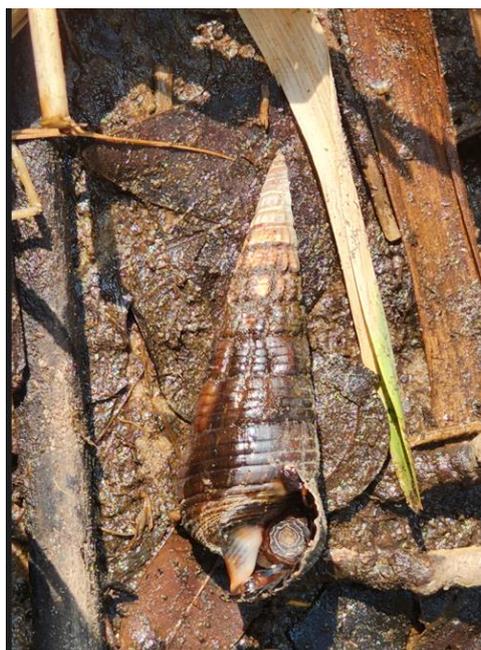
Figure 5.10 The giant mangrove whelk *Terebralia palustris* found across the Indo-west pacific, but now limited to Kosi Estuary

All samples are yet to be analysed but the impression was of a system that has an increasing salinity profile in the upper reaches. This was also evidenced by for e.g., the sand prawn (*Kraussillichirus kraussi*) which was historically prolific in Lakes Mpungwini and Makhawulani, but this survey found evidence of increased distribution into Lake Nhlangwe (Lake 3, sites NHL1, NHL3 and NHL4; **Figure 5.9**). Also notable was the spread of the invasive gastropod *Tarebia granifera* further into Lake Nhlangwe where it seems to have spread from the boat launch area initially. The giant mangrove whelk, *Terebralia palustris* (**Figure 5.10**) was fairly common at waypoint 221 and the shells of which were used by an as yet unknown species of hermit crab. The whelk has all but

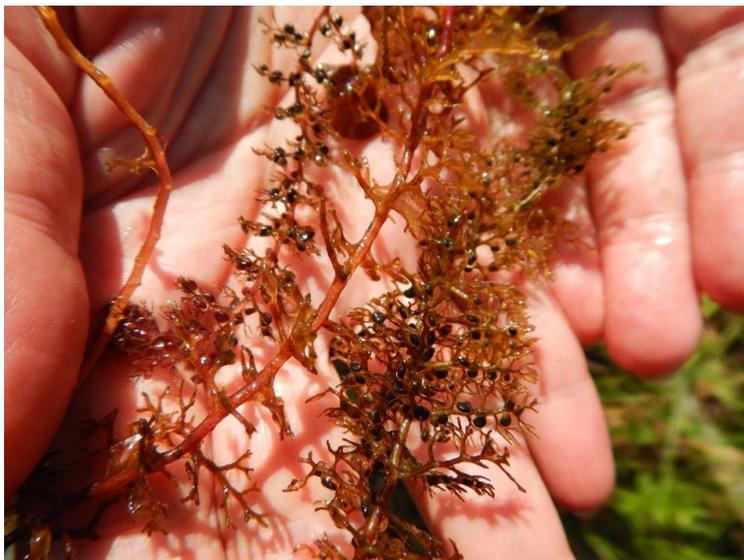
Figure 6.1 Submerged macrophyte *Urticularia* sp. from Lake uMgobezeleni. These species are carnivorous and capture small organisms by means of bladder-like traps (Photo: J Adams, 3 October 2022)

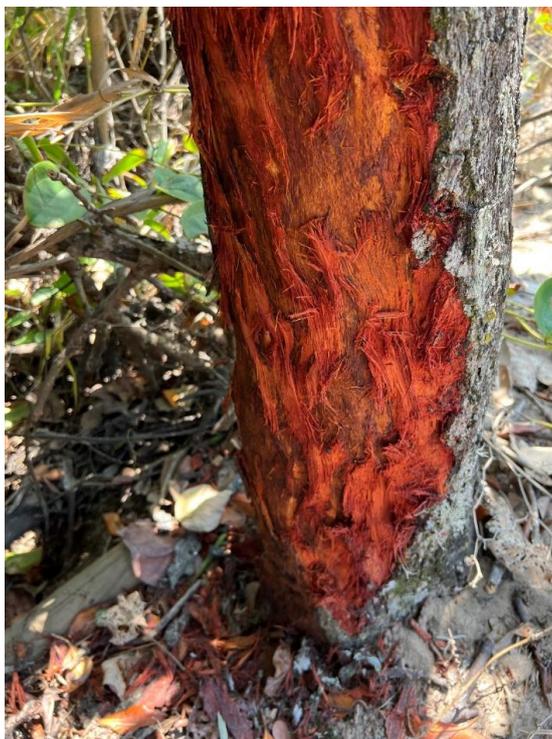
Figure 6.2 Bark harvesting of the black mangrove *Bruguiera gymnorhiza* above the road bridge at uMgobezeleni Estuary (Photo: J Adams, 3 October 2022)

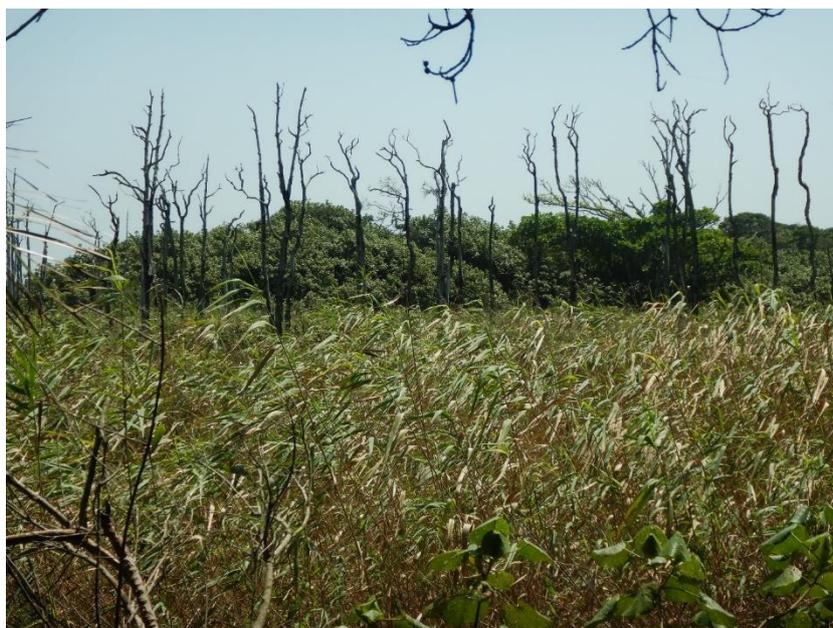
Figure 6.3 Dead black mangrove trees (*Bruguiera gymnorhiza*) occur among reeds and mangrove fern adjacent to swamp forest (*Hibiscus tiliaceus*) at uMgobezeleni Estuary (Photo: J Adams, 3 October 2022)

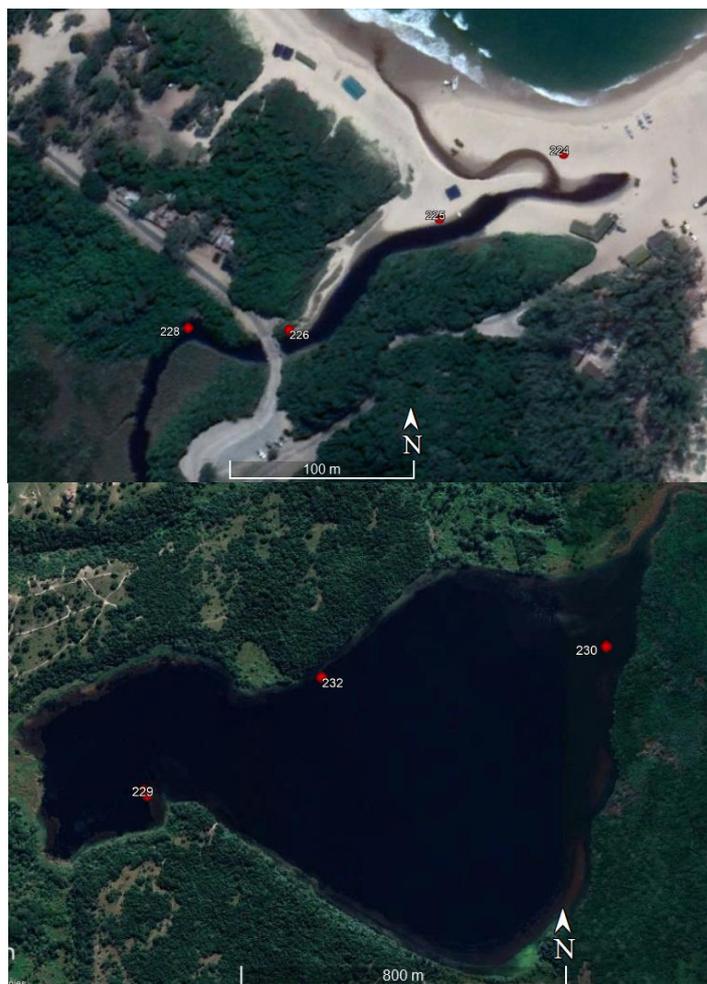
Figure 6.4 Invertebrate fauna, sediment and physico-chemical stations 3/10/2022 at uMgobezeleni Estuary and Lake (Photo: F MacKay)

All samples are yet to be analysed (**Figure 6.4** for site locations). Samples appeared more depauperate than from similar sediment habitats in Kosi and sediments had much particulate organic decaying matter (POM) which with the low oxygen levels measured would not support an abundant benthic invertebrate community. Invertebrate bycatch from fish seines were retained for identification.

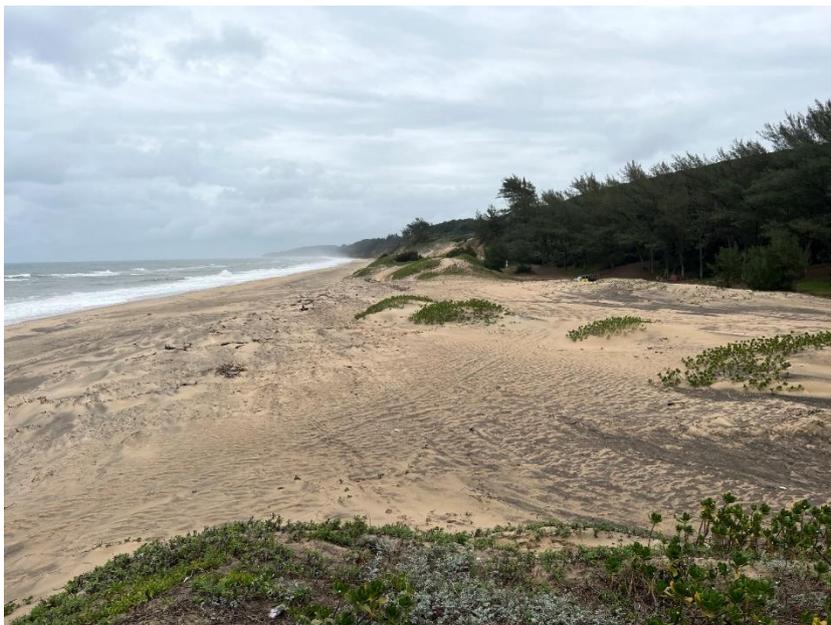
Figure 7.1 High dunes at the mouth of the iNhlabane Estuary (Photo: J Adams, 4 October 2022)

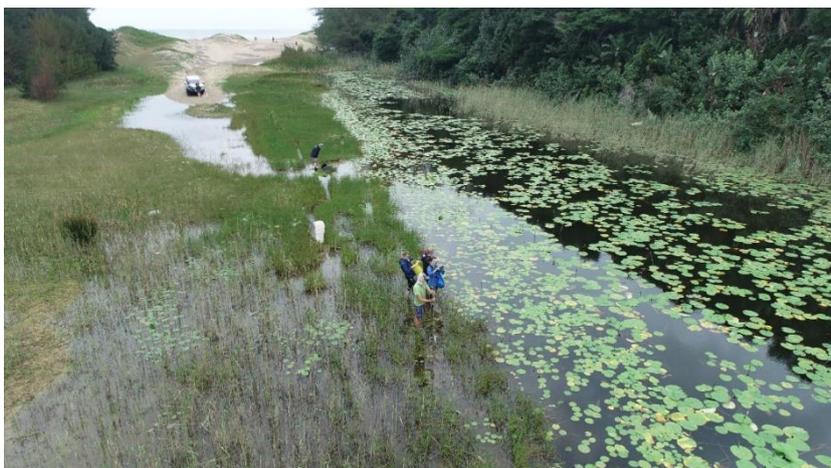
Figure 7.2 Stagnant lower reaches of iNhlabane Estuary (Photo: Riaan Weitz, 4 October 2022)

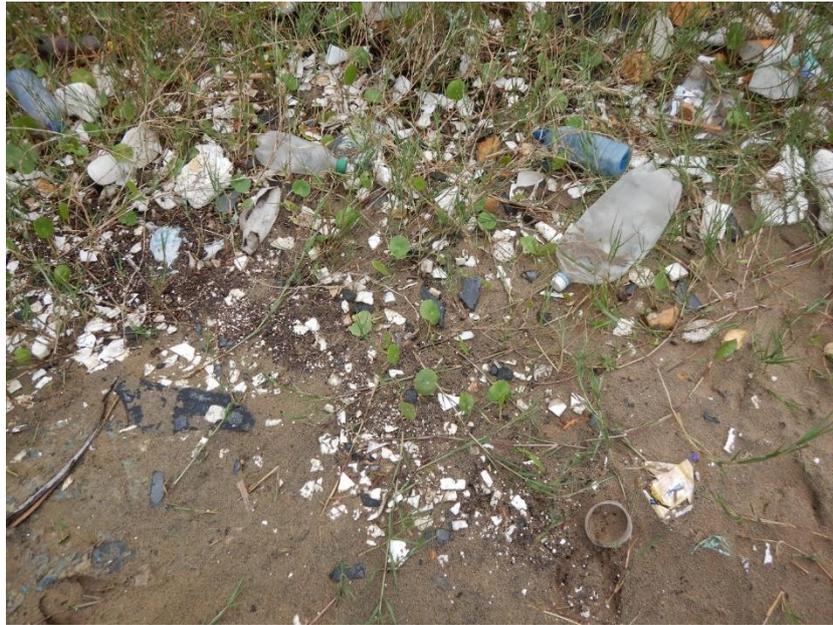
Figure 7.3 Plastic pollution at the mouth of the iNhlabane Estuary. (Photo: J Adams, 4 October 2022)

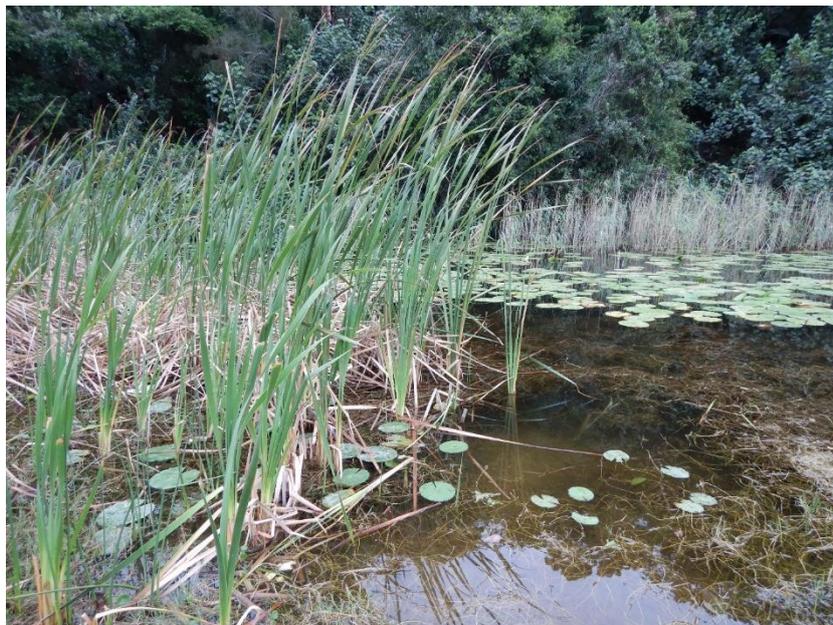
Figure 7.5 Pooled stagnant water at the mouth of the iNhlabane Estuary. Bulrush, reeds, lilies and pondweed dominant. (Photo: J Adams, 4 October 2022)

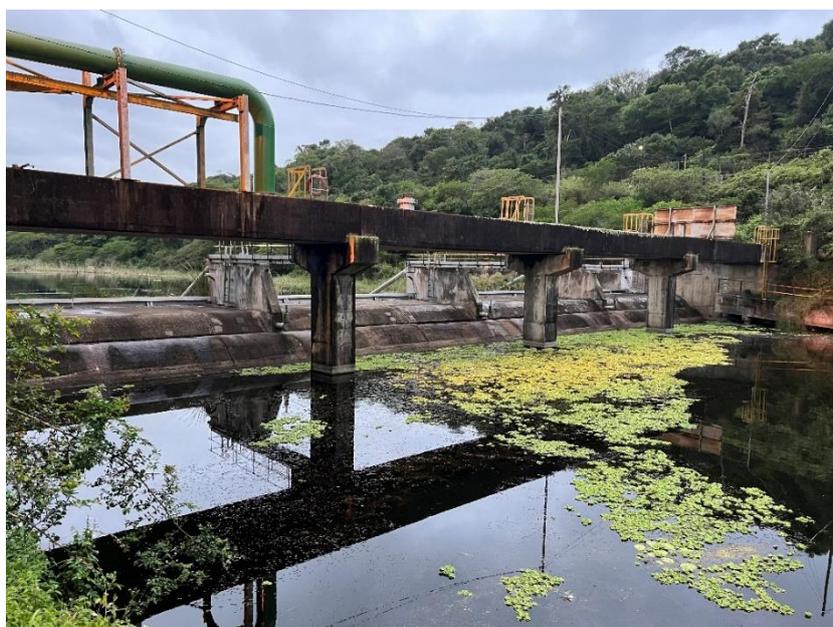
At the barrage / dam wall that separates the iNhlabane Estuary from the dam / previous estuarine lake the aquatic invasive plant *Pistia stratiotes* (water cabbage) was floating on the surface water. Also present was large submerged beds of the invasive aquatic macrophyte *Ceratophyllum demersum* that is associated with slow flowing, freshwater eutrophic habitats. Pondweed *Stuckenia pectinata* was also present as well as the floating invasive *Lemna minor* (duckweed) (Figure 7.5 - 7.7).

Figure 7.6 The barrage / dam wall that separates the iNhlabane Estuary from the dam / previous estuarine lake. Aquatic invasive plant *Pistia stratiotes* (water cabbage) floating on the surface water. (Photo: J Adams)

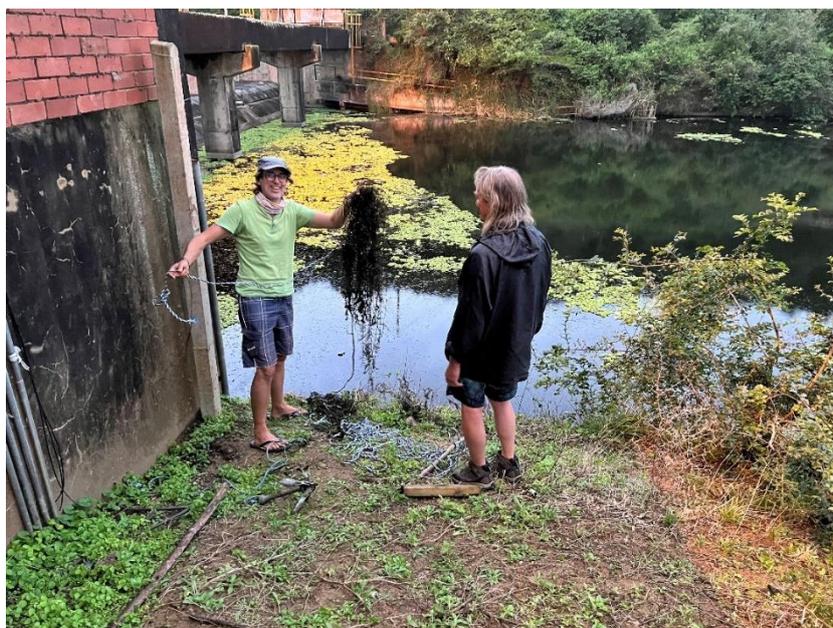
Figure 7.7 Large submerged beds of the invasive aquatic macrophyte *Ceratophyllum demersum* that is associated with slow-flowing, freshwater eutrophic habitats were present at the iNhlabane barrage (Photo: J Adams, 4 October 2022)

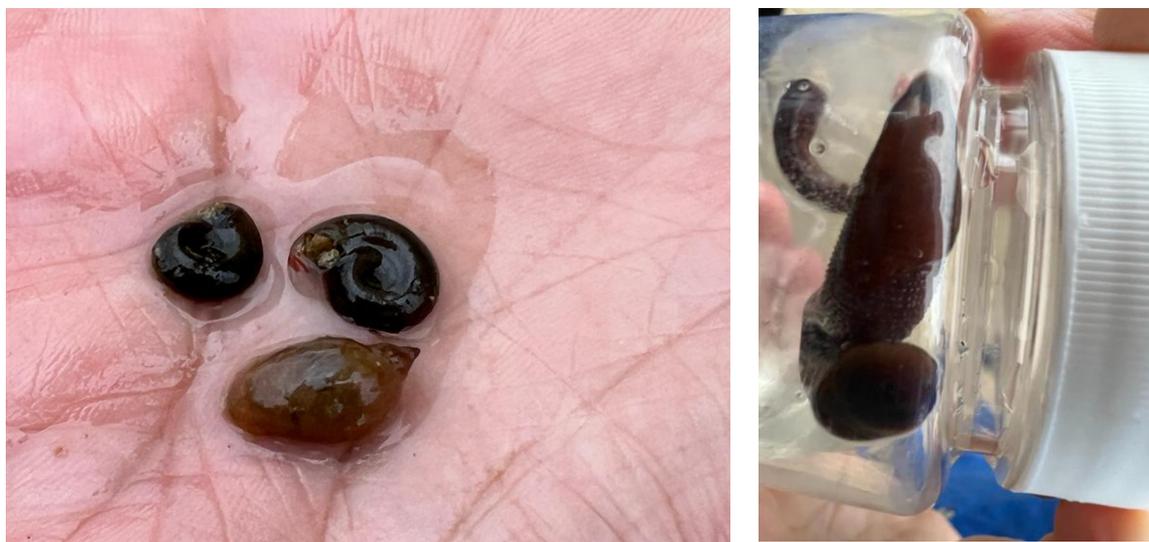
Figure 7.9 Bilharzia vectors were abundant in the lower reaches of the estuary and freshwater *Hirudinea* (Photos: J Adams, 4 October 2022)

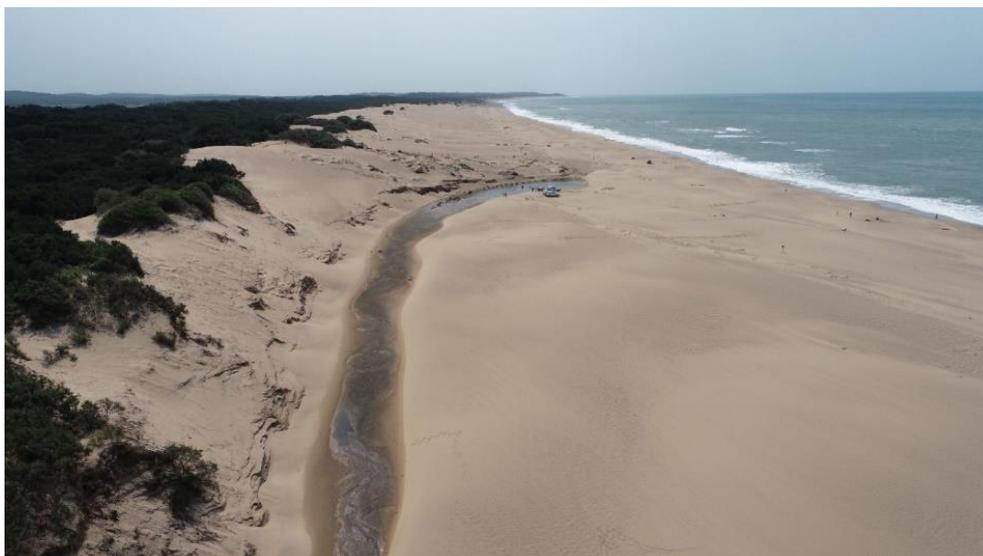
Figure 8.1 iSiyaya Estuary mouth showing the high dune buildup at mouth and low water levels (Photo: Riaan Weitz, 5 October 2022)

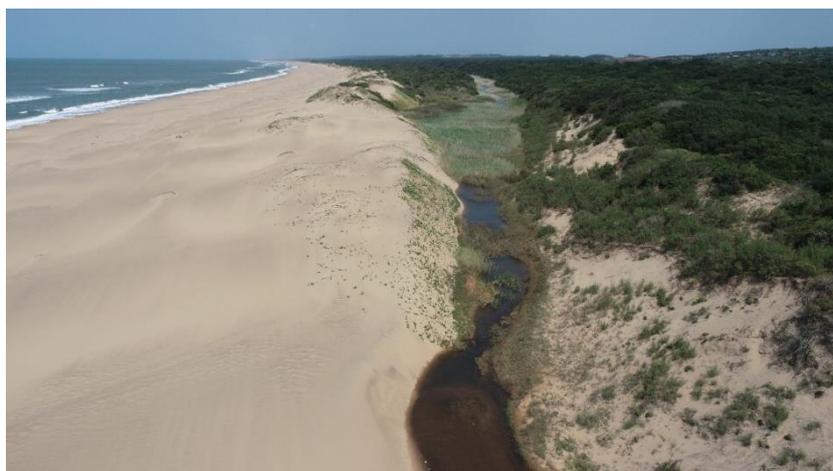
Figure 8.2 iSiyaya Estuary mouth area, start of dense reeds; little open water surface area. (Photo: Riaan Weitz, 5 October 2022)

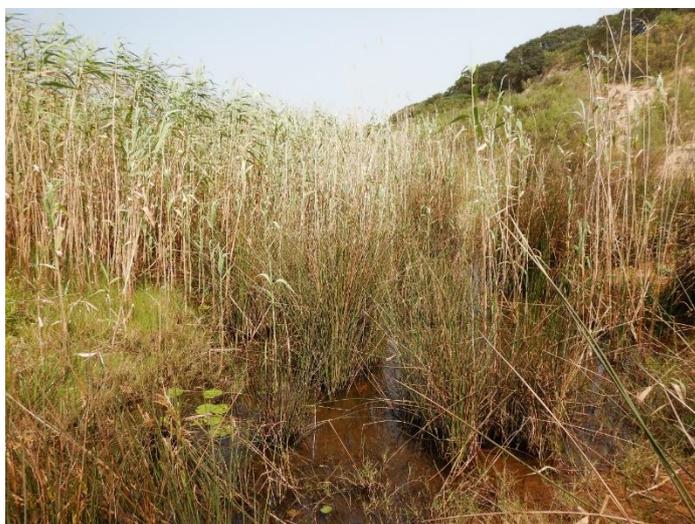
Figure 8.3 iSiyaya Estuary upstream from mouth; shallow freshwater conditions as indicated by the lilies (Photo: J Adams, 5 October 2022)

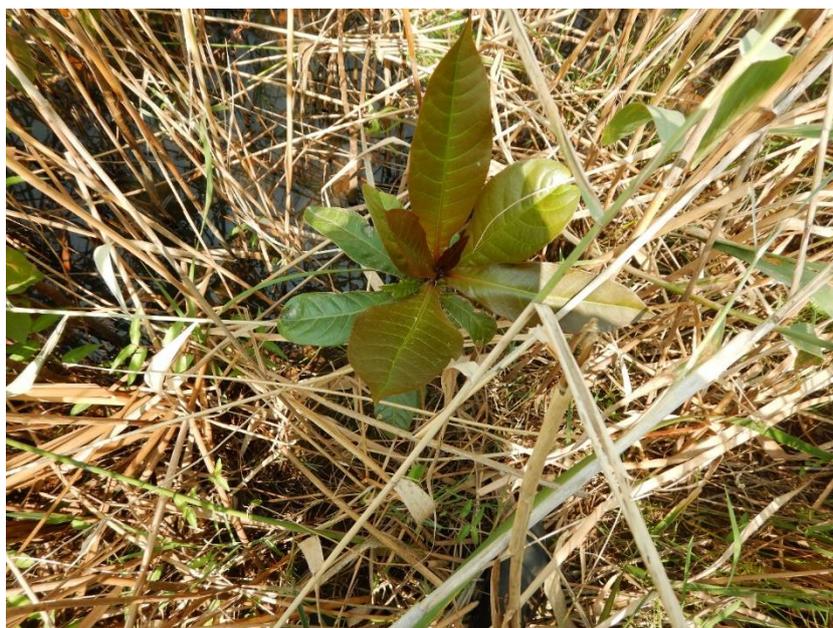
Figure 8.4 *Barringtonia racemosa* seedling competing for space and light from surrounding reeds and sedges at the iSiyaya Estuary. This is a swamp forest tree commonly known as the powderpuff tree. (Photo: J Adams, 5 October 2022)

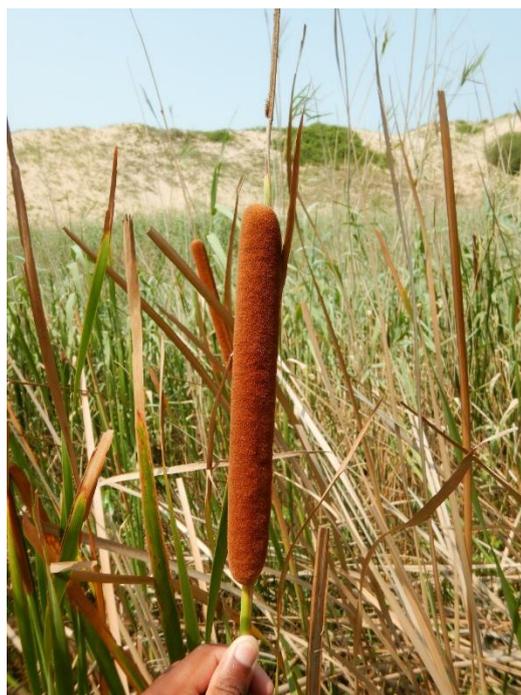
Figure 8.5 Bulrush, *Typha sp.* indicates fresh, standing or slow-flowing waters at iSiyaya Estuary (Photo: J Adams, 5 October 2022)

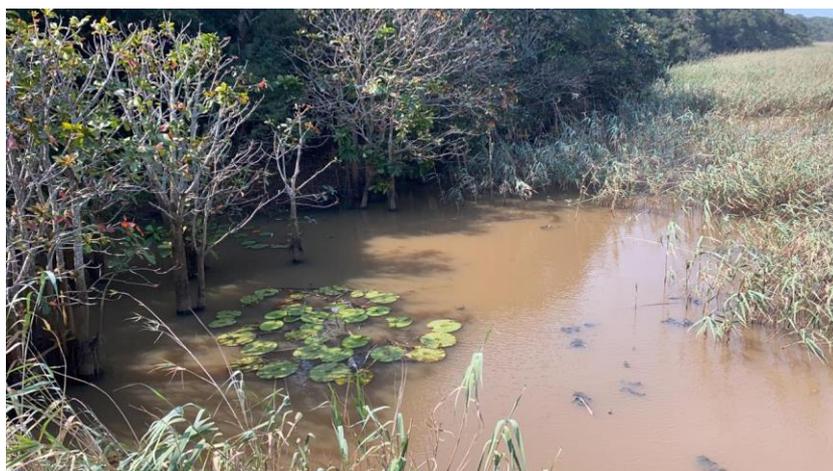
Figure 8.6 Upstream site of the iSiyaya Estuary indicating flooded and dying *Barringtonia racemosa*, swamp forest trees (Photo: J Adams, 5 October 2022)

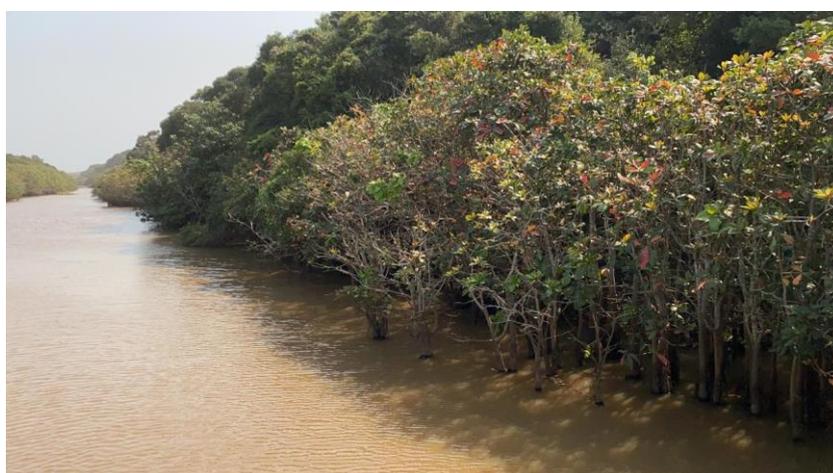
Figure 8.7 Swamp forest (*Barringtonia racemosa*) in the middle reaches of the iSiyaya Estuary (Photo: J Adams, 5 October 2022)

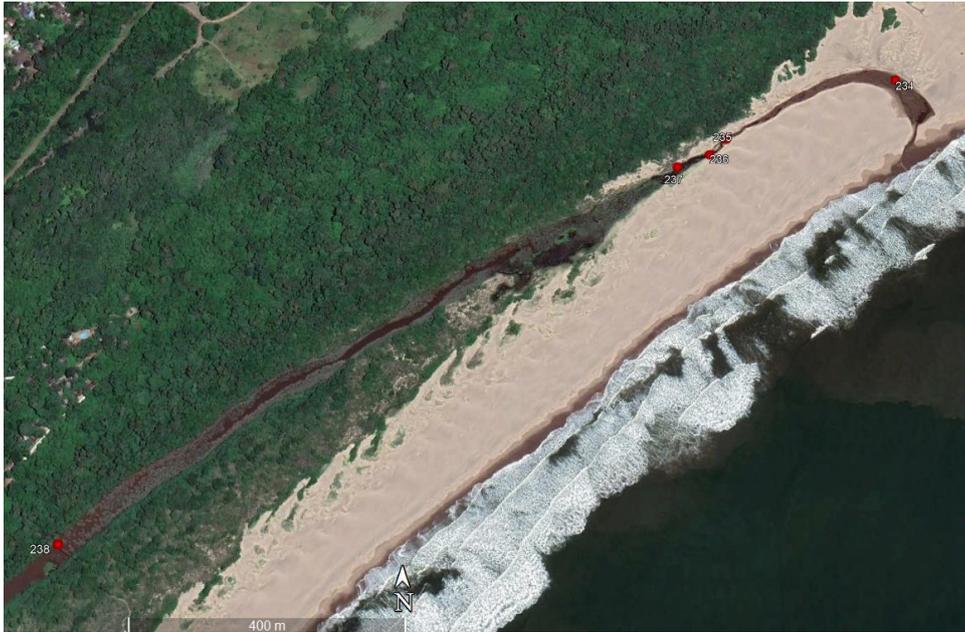
Figure 8.8 Invertebrate fauna, sediment and physico-chemical stations 4/10/2022 at iSiyaya Estuary (Photo: F MacKay)

All samples are yet to be analysed (**Figure 8.8** for site locations). Visible fauna included macrocrustaceans *Varuna litterata* (swimming crab) and *Kraussillichirus kraussi* (sand prawn) (**Figure 8.9**) which are remnant estuarine indicative, whereas all other visible aquatic invertebrates were Insecta given the brackish/fresh conditions along the system (salinity 2.39 at the closed mouth). Invertebrate bycatch from fish seines were retained for identification.

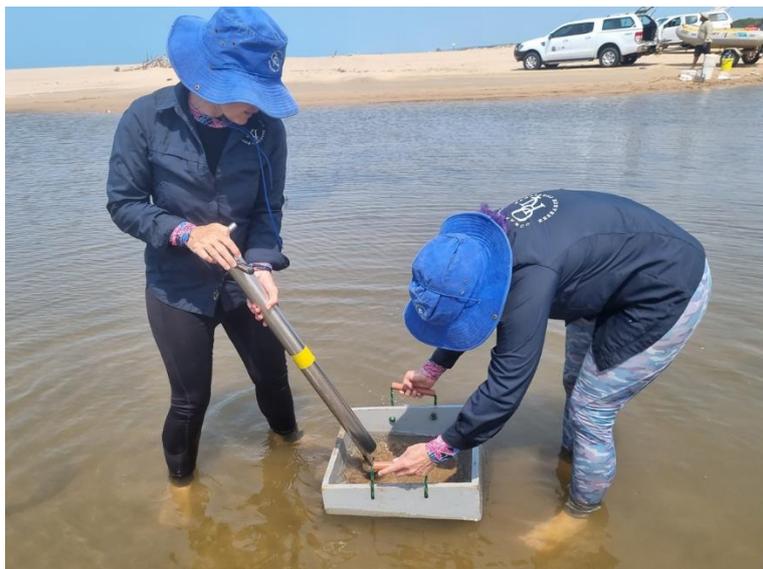
Figure 8.9 Investigating sand mounds and burrows for sand prawn *Kraussillichirus kraussi* specimens in the lower iSiyaya Estuary (Photo: S Jordaan 5 October 2022)

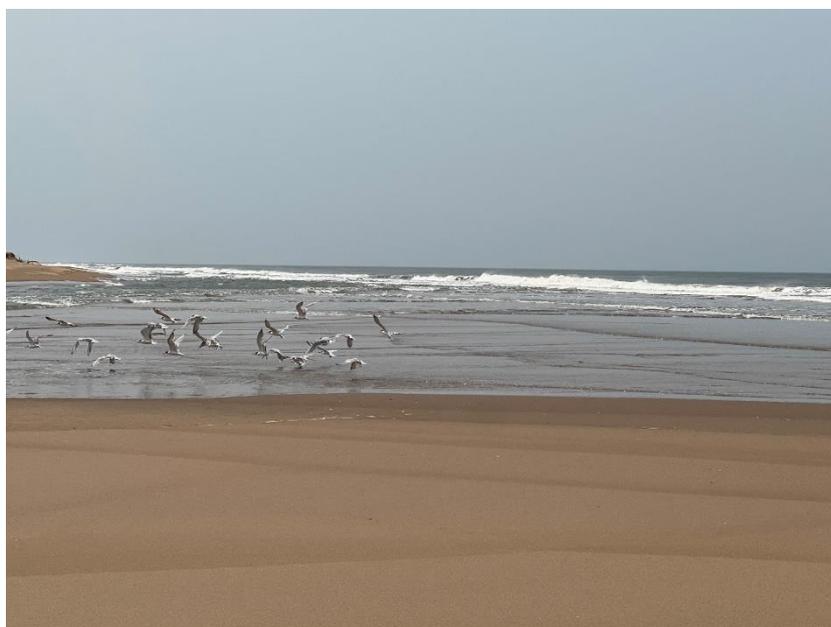
Figure 9.1 uMlalazi Estuary mouth open to the sea (Photo: J Adams, 7 October 2022)

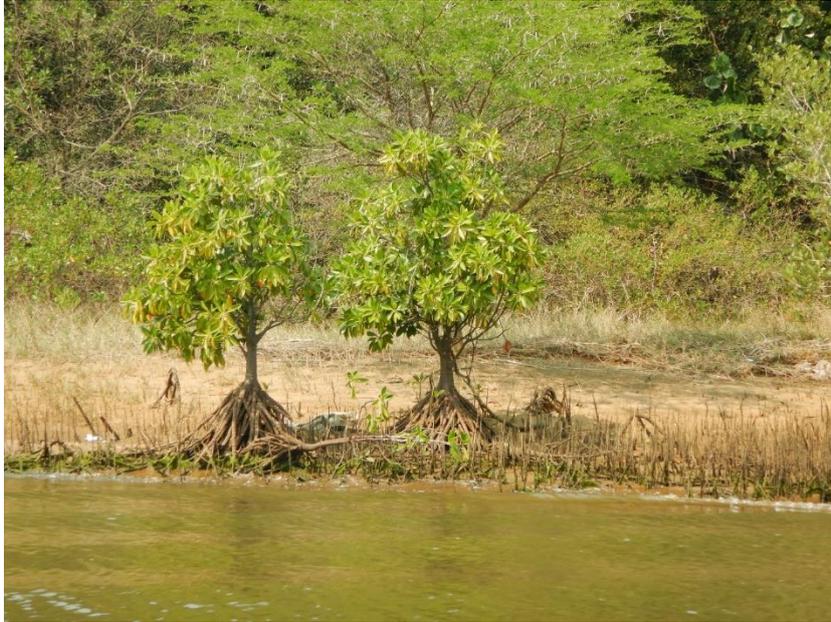
From the launch site downstream stringy filamentous green algae was abundant possibly indicating nutrient enrichment. This is a perfect site for long term monitoring of mangroves due to lack of pressures such as harvesting and cattle browsing. White mangrove and black mangrove were dominant with recruitment throughout the estuary. Stands of different age structures

indicating a regenerating forest was found in the lower, middle and upper reaches of the estuary. Mangroves were most extensive in the middle reaches where intertidal and floodplain habitat occurs. According to Taylor (2020) the mangrove extent is 40 ha. Mangroves did not occur in the estuary prior to the 1930's and artificial mouth breaching created suitable intertidal conditions for mangrove expansion. The estuary also has important salt marsh and reed and sedge habitats (**Figure 9.2 - 9.5**).

Figure 9.2 Small black mangrove trees with seedlings and filamentous green algae among the white mangrove aerial roots at the uMlalazi Estuary (Photo: J Adams, 6 October 2022)

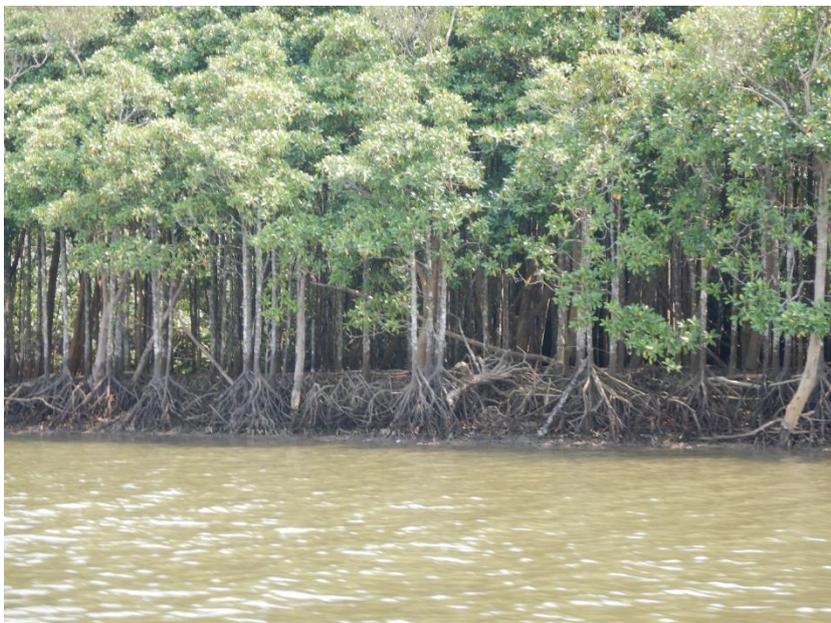
Figure 9.3 Exposed root system of black mangroves that line the uMlalazi Estuary water channel indicates some erosion (Photo: J Adams, 7 October 2022)

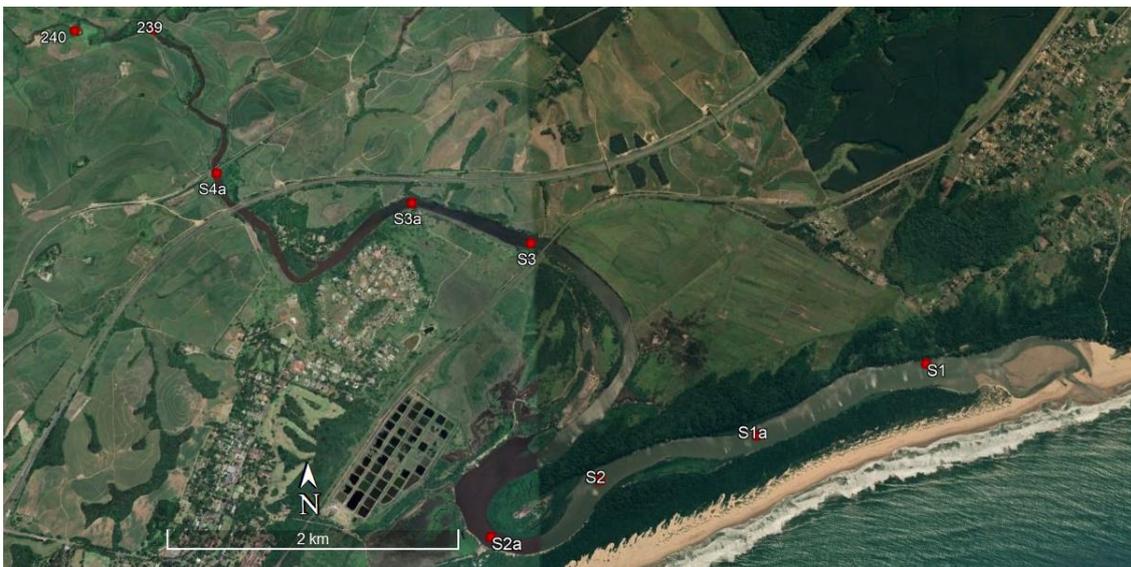
Figure 9.4 Invertebrate fauna, sediment and physico-chemical stations at uMlalazi Estuary on 6/10/2022 (Photo: F MacKay)

All samples are yet to be analysed (**Figure 9.4** for site locations). Visible fauna included macrocrustaceans *Scylla serrata* (giant mud swimming crab) (**Figure 9.5**) and *Ashtoret lunaris* (moon crab). Penaeidae prawns, *Penaeus indicus* (Indian white prawn) and *P. monodon* (Giant tiger prawn) are using the system as a nursery area. Notable in the infauna samples thus far is the burrowing ocypodid crab, *Paratyrodiplox blephariskios*. This small crab is endemic to the southeast coast of southern Africa where it forms an important component of the muddy estuaries (where it occurs). Twenty years ago, it was prolific in St Lucia but has not been noted there since then. Invertebrate bycatch from fish seines were retained for identification.

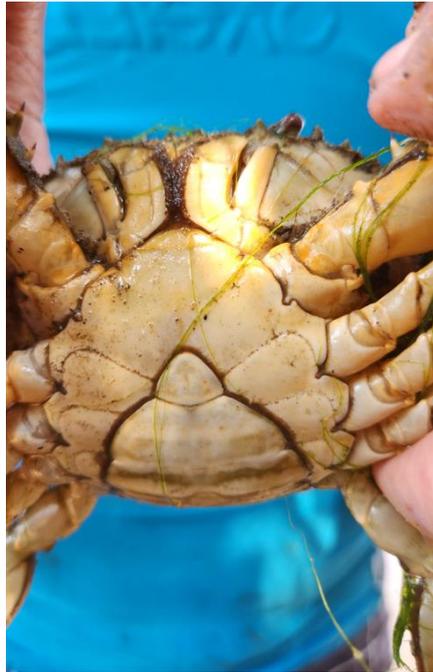
Figure 9.5 Large female mud crab *Scylla serrata* caught as invertebrate bycatch in fishing seines, lower uMlalazi Estuary (Photo: F Mackay, 6 October 2022)

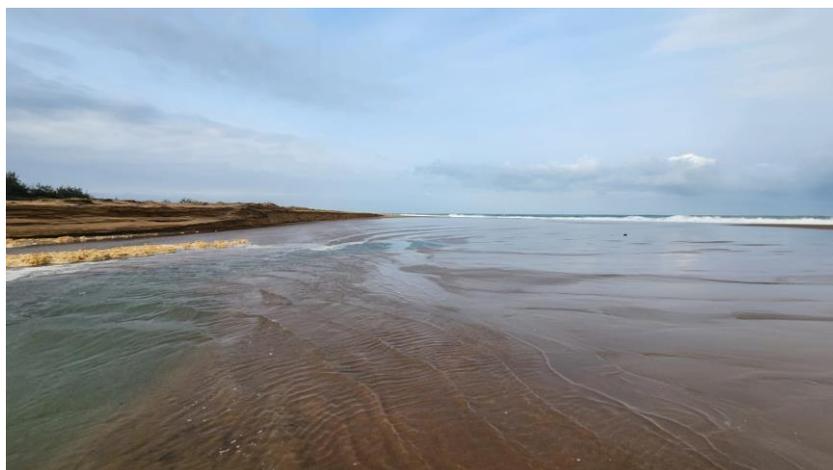
Figure 10.1 Mouth of aMatigulu/iNyoni Estuary overtopping from the sea (Photo: Fiona Mackay, 7 October 2022)

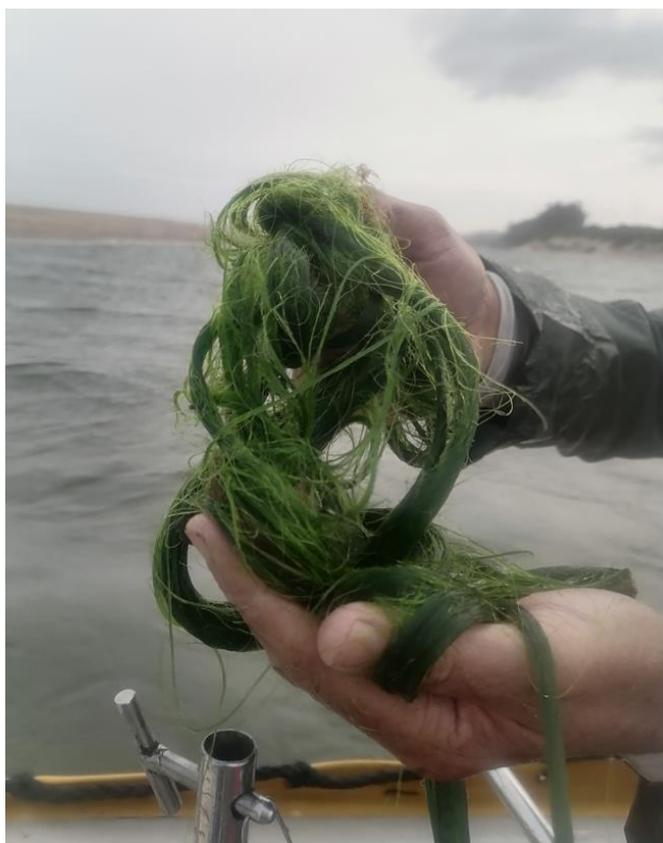
Figure 10.3 Filamentous algae growth on large areas of mid-lower subtidal sediments of the aMatigulu/iNyoni Estuary (Photo: B McKelvey, 7 October 2022)
