Determination of Water Resource Classes, Reserve and the Resource Quality Objectives in the Keiskamma and Fish to Tsitsikamma Catchments

WP11354 Wetland Field Survey Report

REPORT NO.:
WEM/WMA7/00/CON/RDM/0522

SEPTEMBER 2022

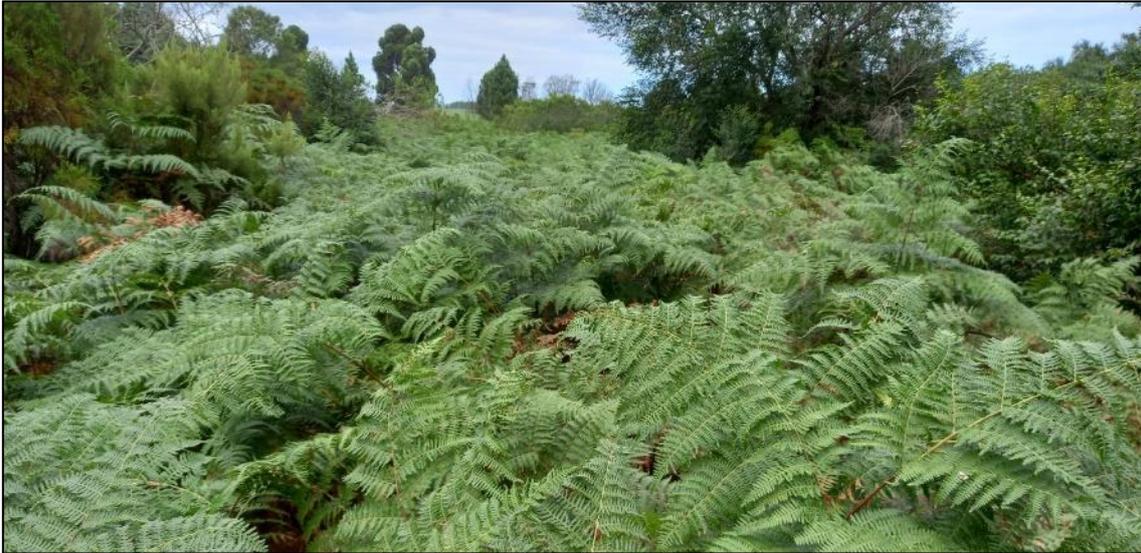
Figure 3-6 An historically disturbed and now infrequently burnt wetland area in poor ecological condition, which is dominated by bracken fern, with a few typical wetland species such as *Berzelia intermedia* as well as several *Halleria lucida* shrubs, a forest precursor species.

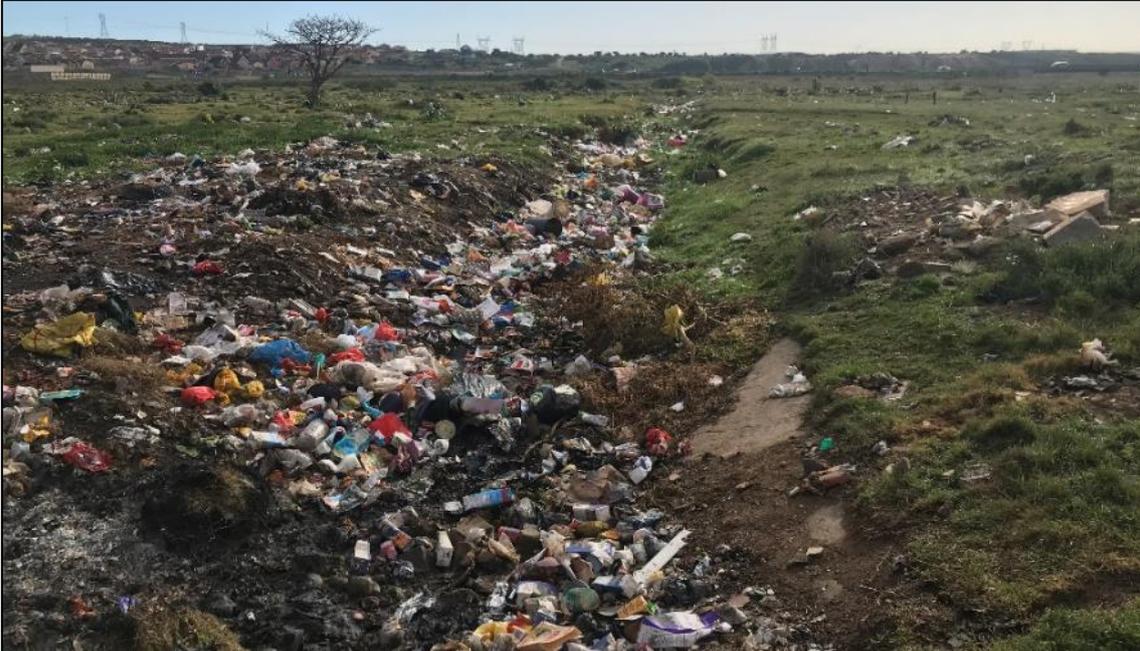
Figure 3-36 One of the many stormwater canals that conveys stormflows into the Chatty River Wetlands. Many of these canals have been totally blocked by the litter and debris, causing them to overflow into inhabited areas, potentially posing a health risk to those living nearby. In addition, the canalised stormwater conduits that are not blocked were observed to, in some cases, have resulted in erosion and scour of the downstream wetland.

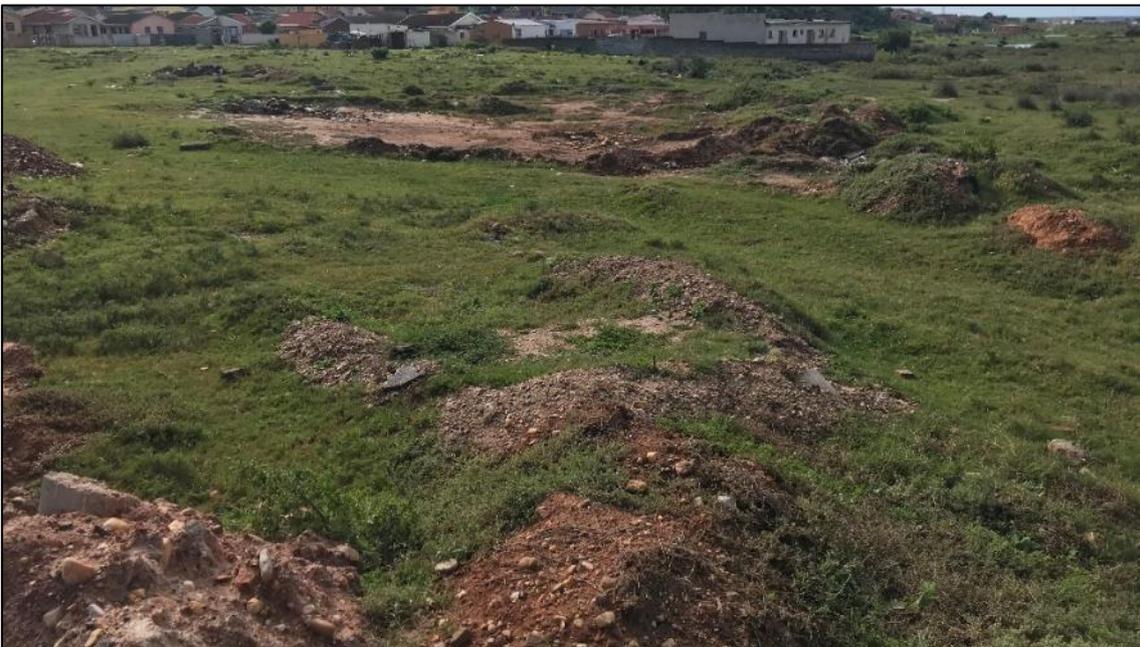
Figure 3-37 Evidence of recent infilling of rubble used for construction in CVB 1. It was noted that a homestead structure had recently been built using some of the rubble pictured here.

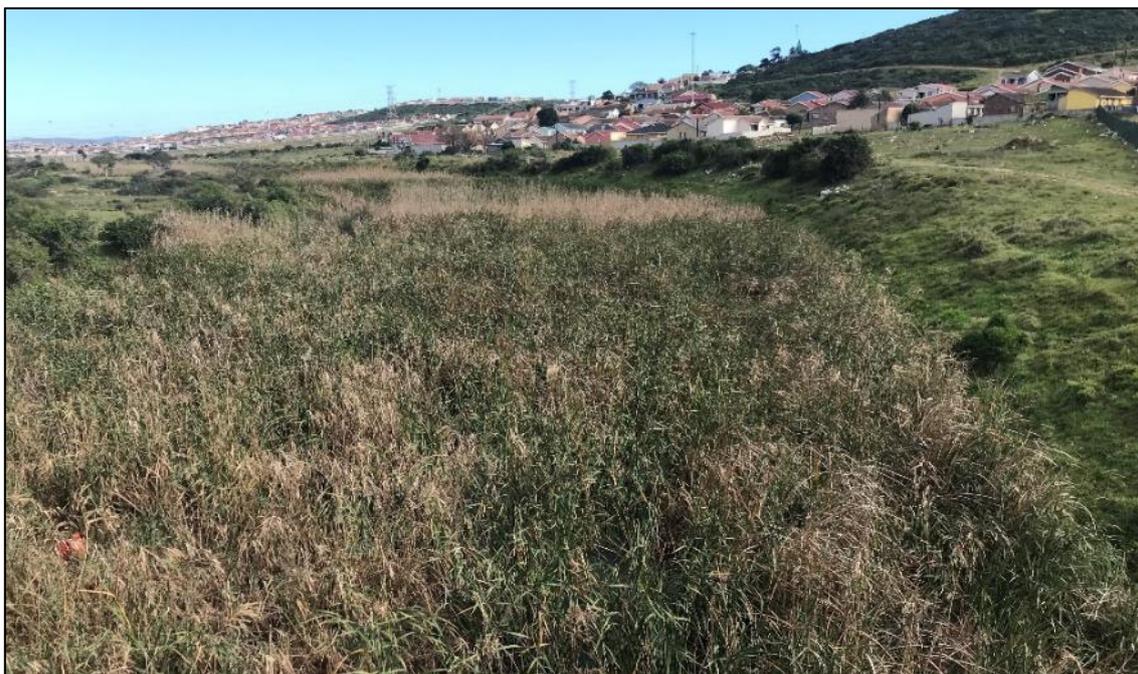
Figure 3-38 Photograph captured from one of the bridges crossing the CVB 1 wetland – with evidence of large scale canalisation of the channel as indicated by the large bank on the right hand-side of the photograph.

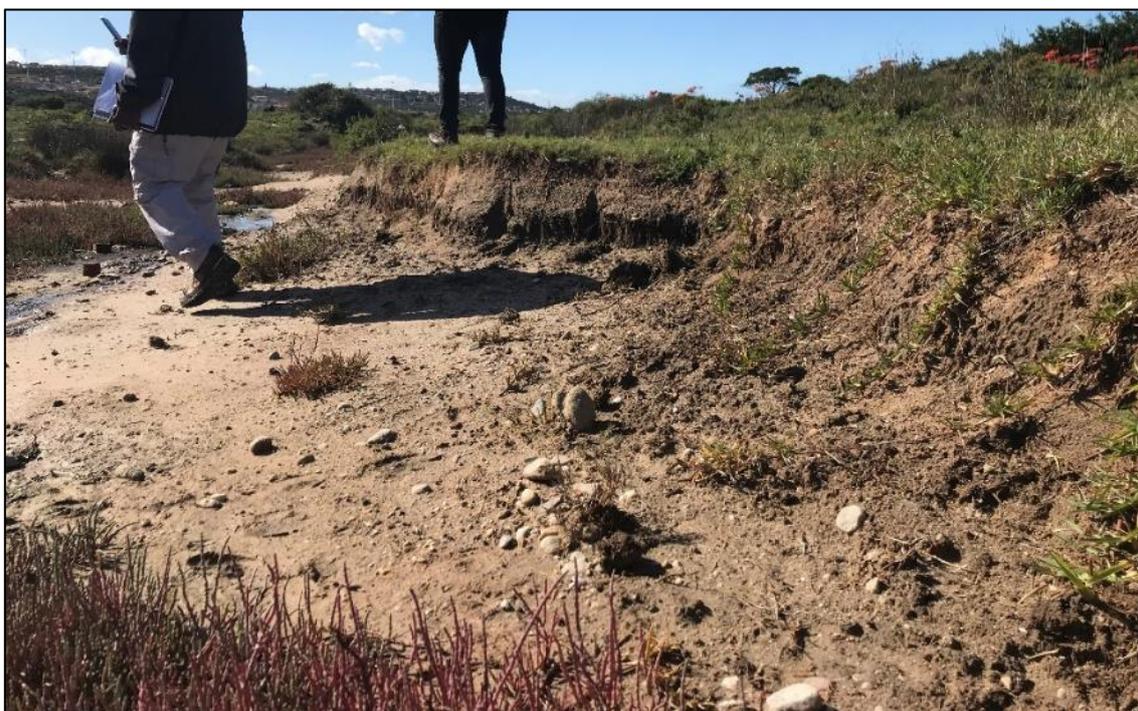
Figure 3-39 A lateral erosion gully that has been created directly downstream of one of the stormwater drains inputting water into the CVB 1 wetland. It appeared to be moderately active, with a stand of *Pennisetum clandestinum* growing across the active face of the headcut.

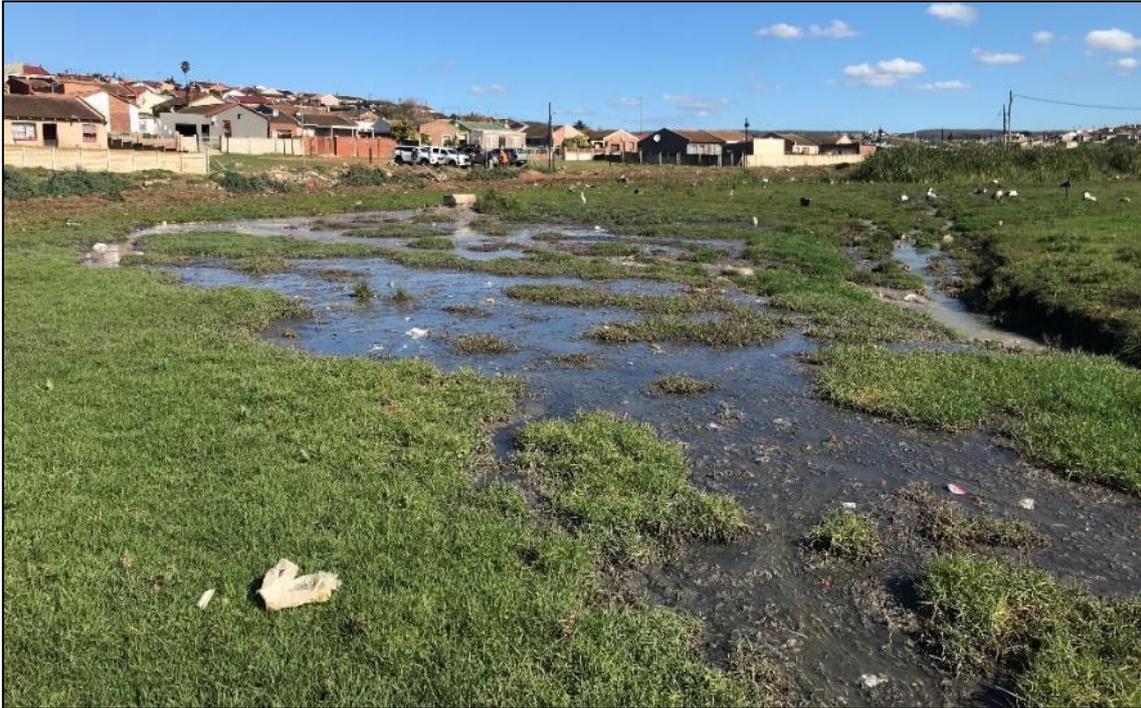
Figure 3-40 A surcharging sewer manhole pictured centrally, and a newly incising channel pictured to the right located in CVB 3. The lateral tongues of the incising channel (heading towards the manhole) and the proximity of the point of incision to this surcharging manhole indicate that this manhole has been a large causal factor in the incision of this channel

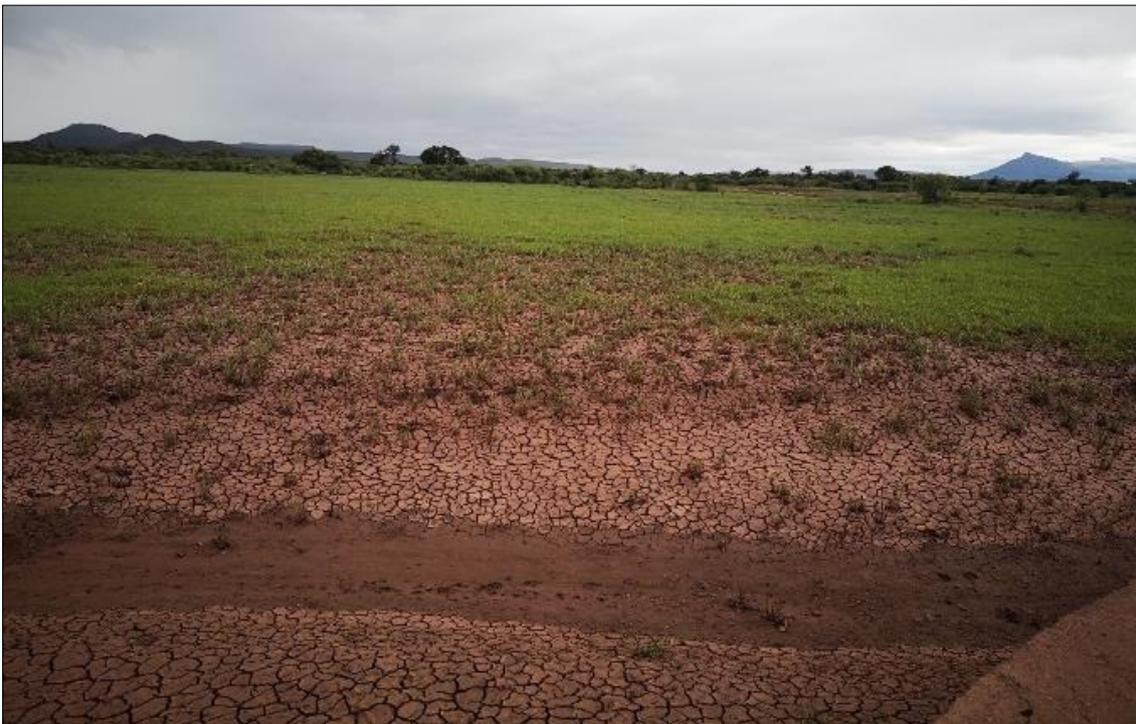
Figure 3-49 View of the accumulated sediment upstream of the weir and heavily grazed grassland

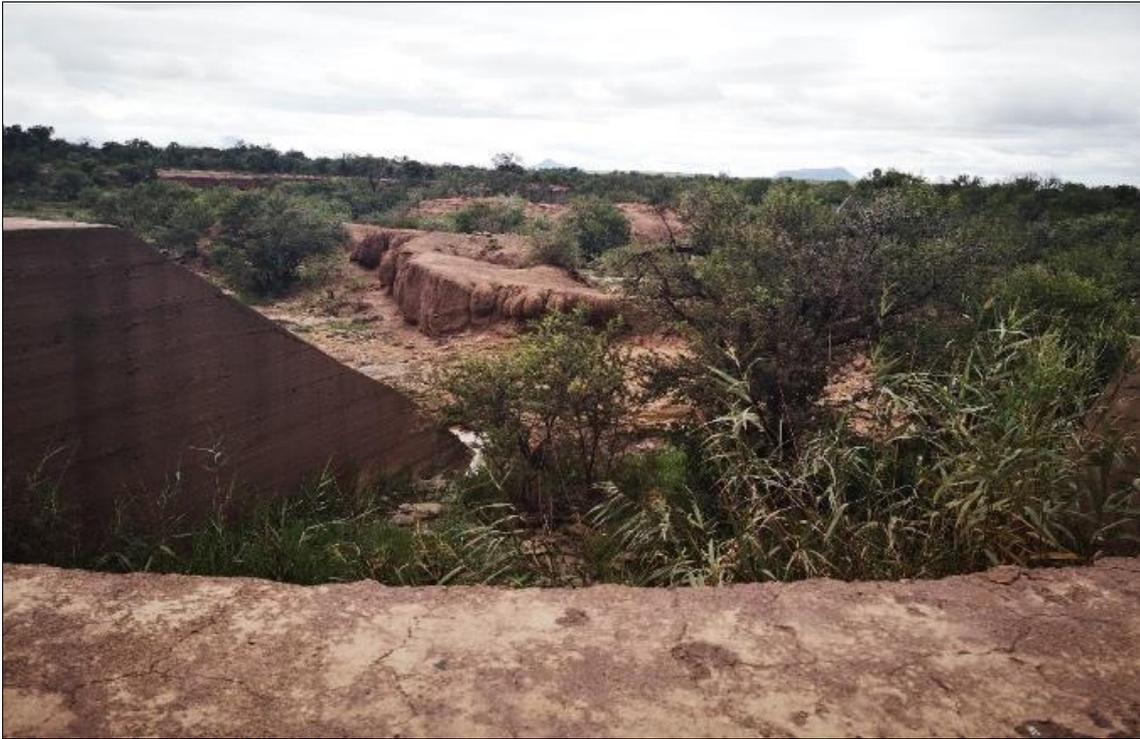
Figure 3-50 View of the erosion gully downstream of a weir

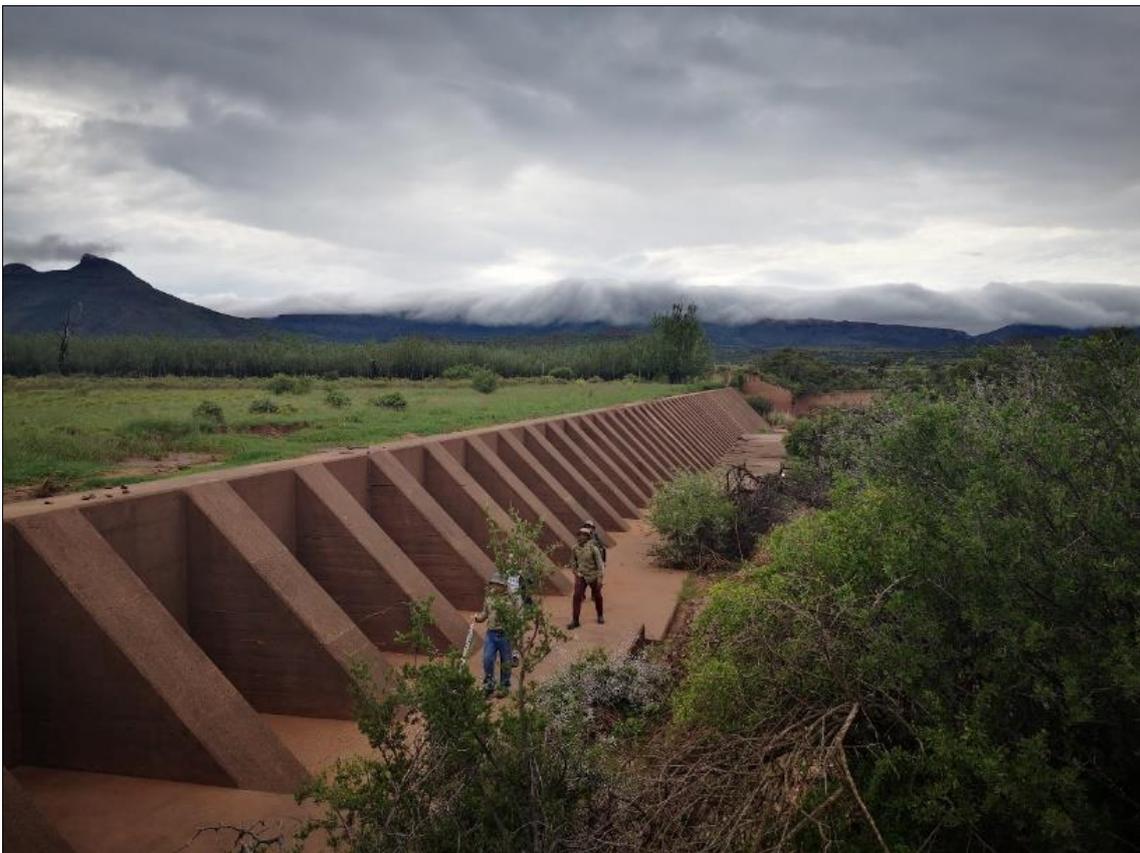
Figure 3-51 View of a buttress weir and the upstream grazing areas

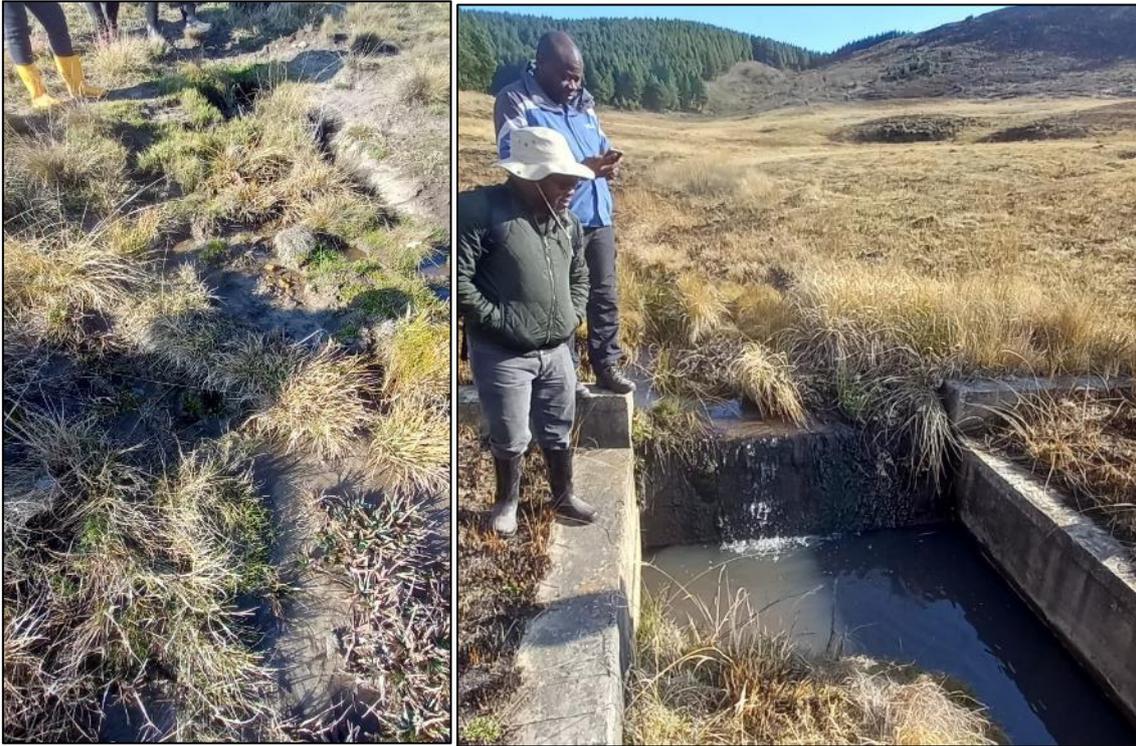
Figure 3-55 Left: A wetland seep heavily used by livestock. Right: One of Working for Wetlands rehabilitation interventions in a channelled valley bottom which was identified as incised

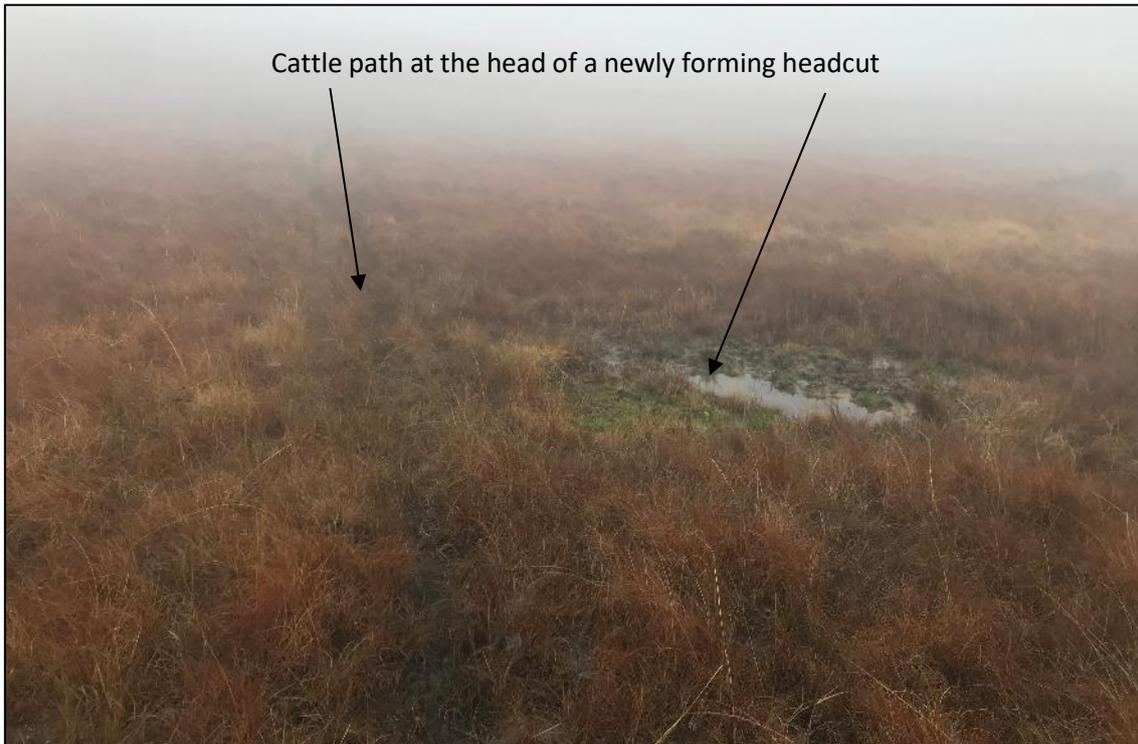
Figure 3-76 Evidence of trampling by cattle across one of the seeps. The cattle path coincides with a new headcut which is forming, possibly as a result of the cattle path which may channel water into the headcut.

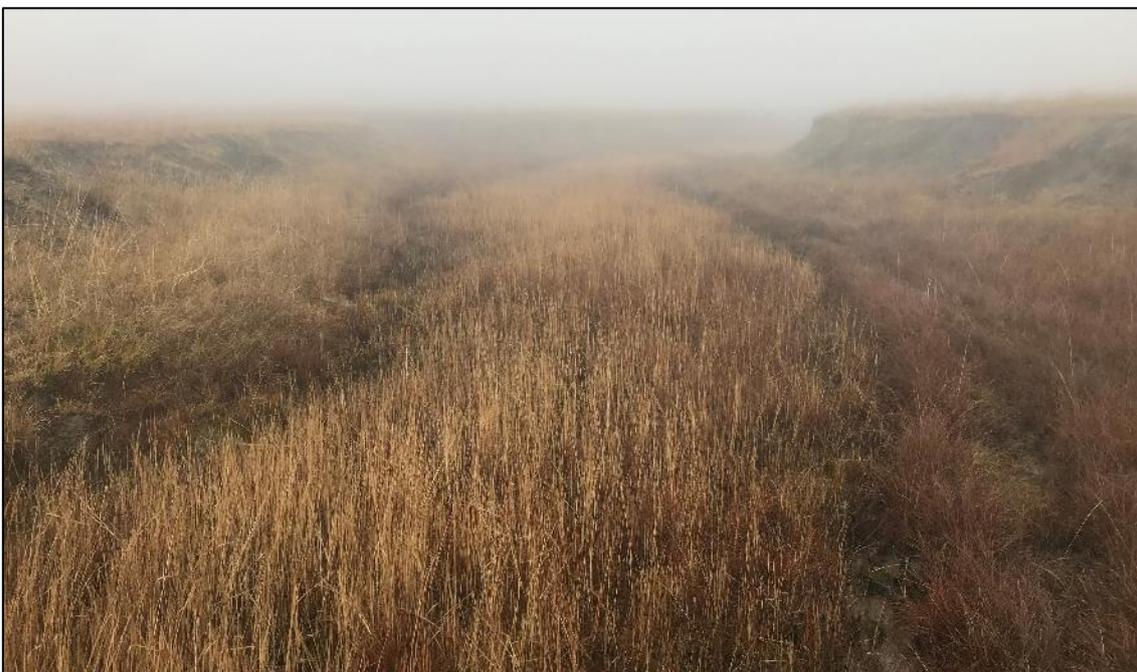
Figure 3-77 A large gully within a seepage wetland, characterised by a large depositional feature in its centre which has been colonised by *Eragrostis planiculmis* and *Fuirena pubescens*.

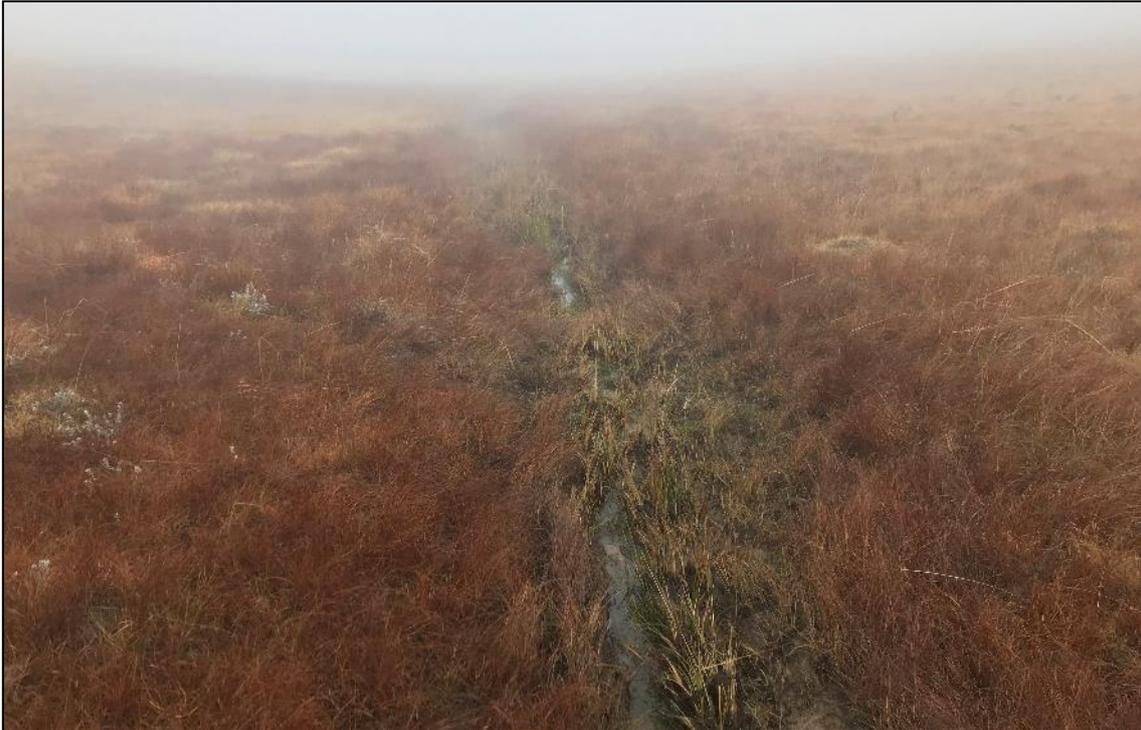
Figure 3-78 Preferential flow path in one of the seep wetlands which has been extensively trampled by cattle that now use this feature to drink water.

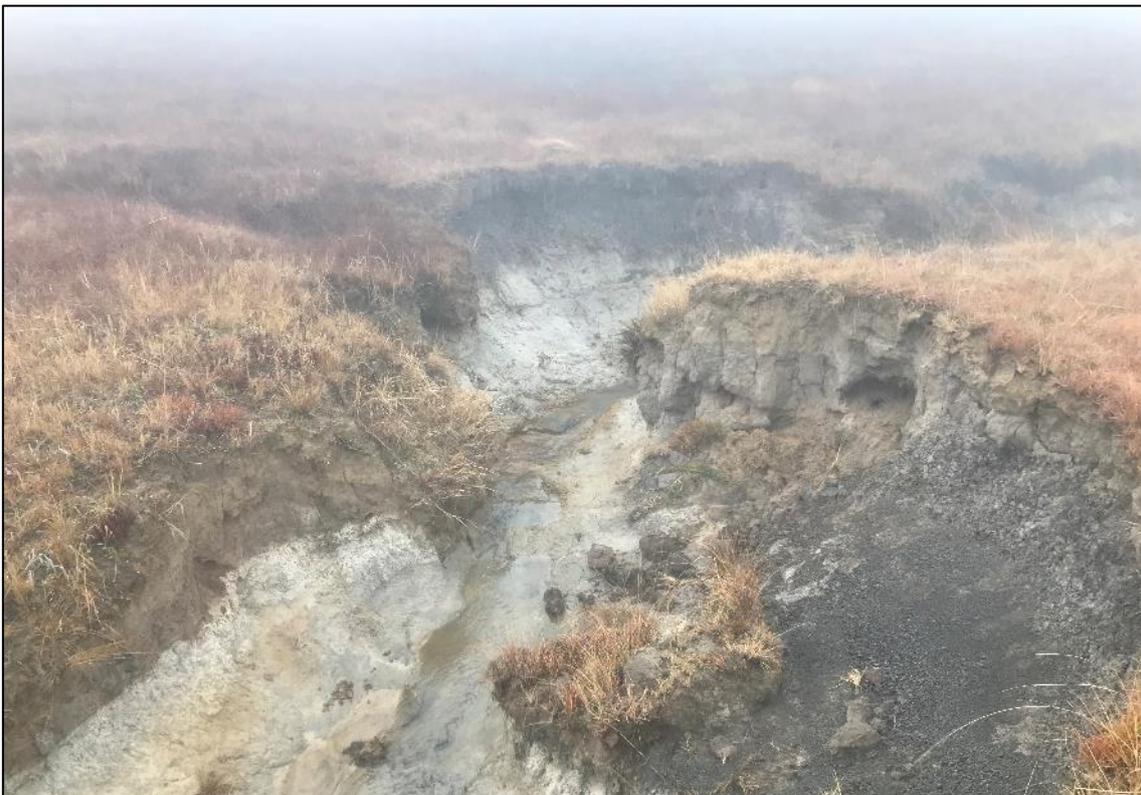
Figure 3-79 Deeply incised channel in the valley-bottom wetland – predominantly eroded down onto bedrock. This channel sets the geomorphological base level for all the seep wetlands which feed into this wetland and explains much of the erosion observed within the seep wetlands.

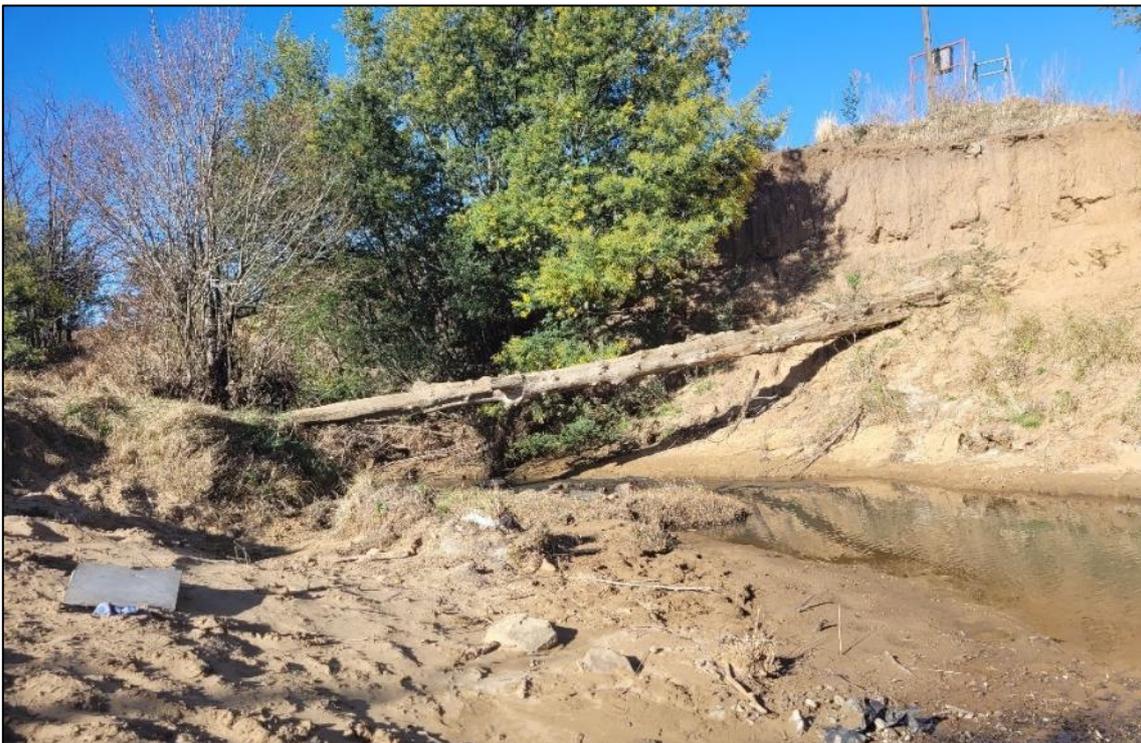
Figure 3-82 Incised river channel within the floodplain, with the discharge point from the waste ponds slightly upstream from this point.

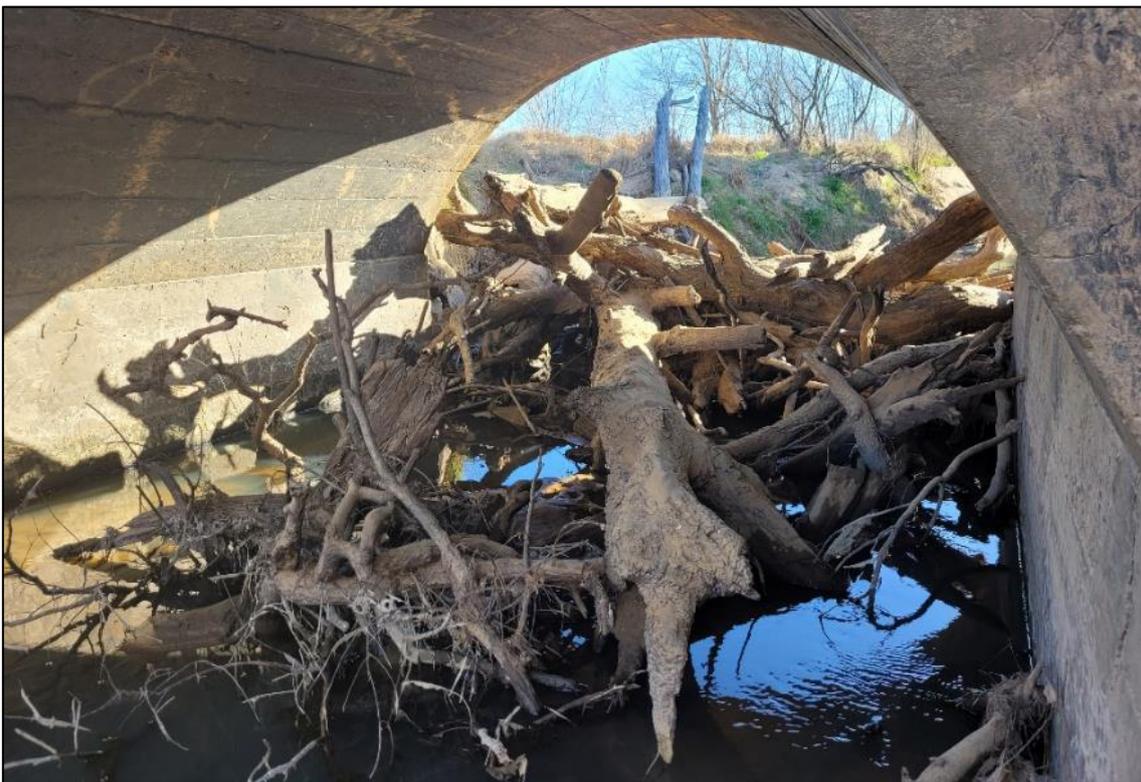
Figure 3-84 Debris below a large road culvert across the incised portion of the floodplain.

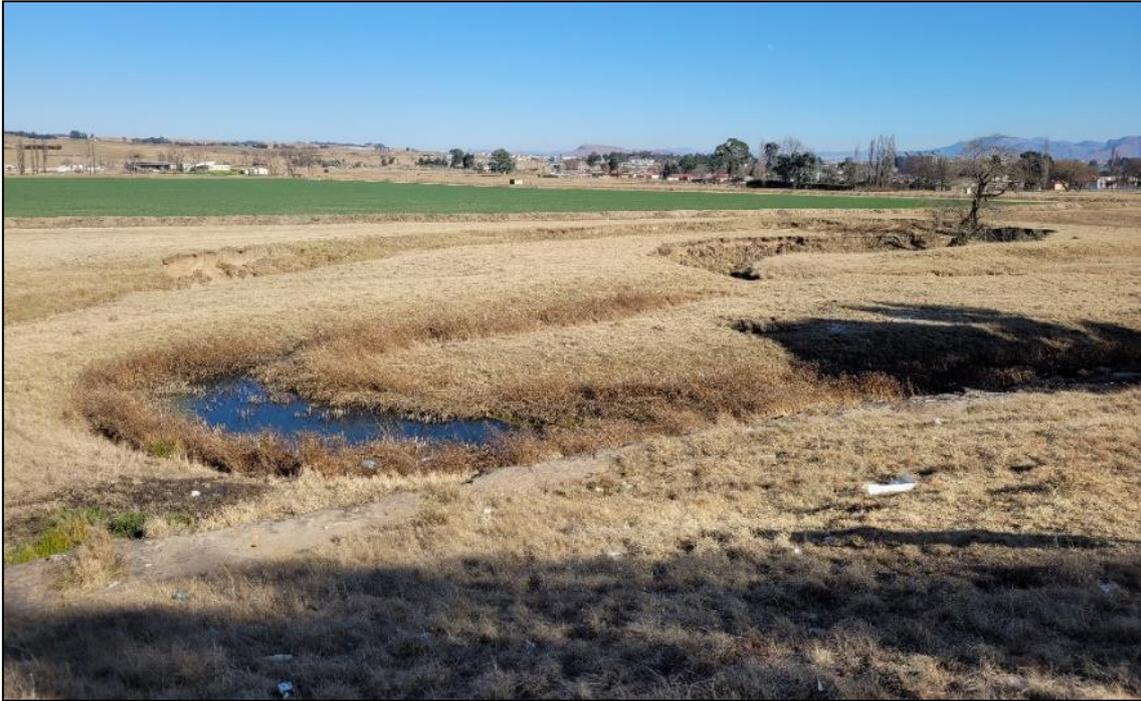
Figure 3-94 Incised floodplain channel (in the background), which has been restricted in its movements due to a geological control along its northern boundary and a flood protection berm along its southern boundary.

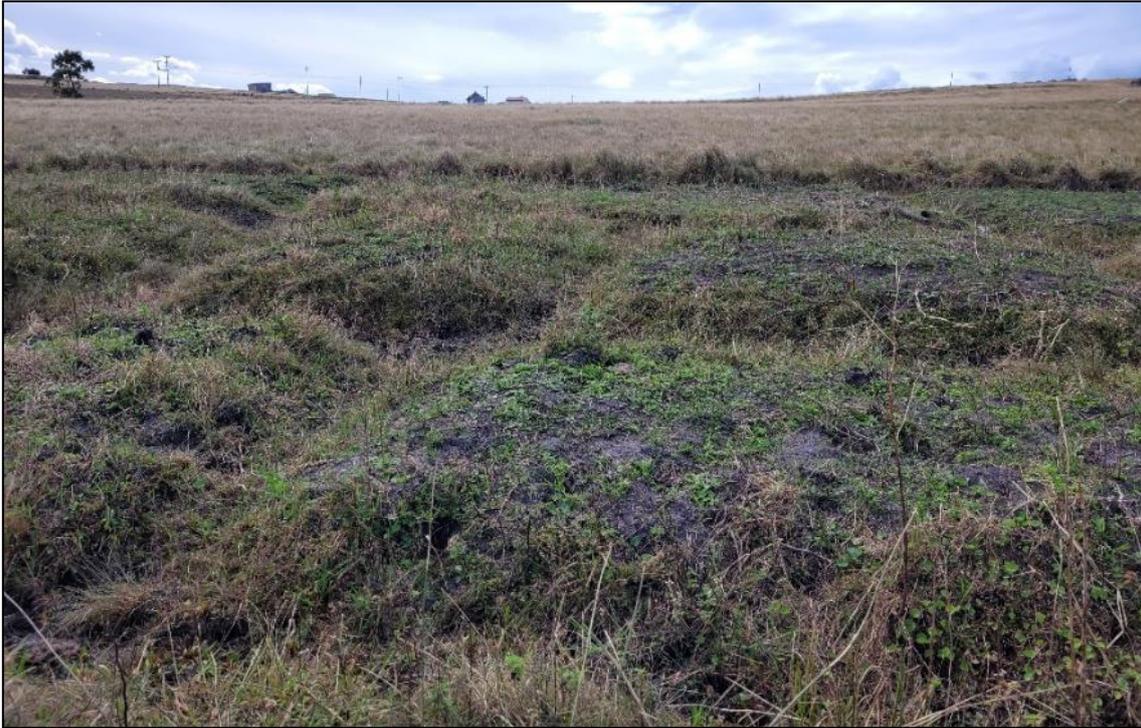
Figure 3-107 Sikombe wetland: Rotational madumbe/taro crop field adjacent to the valley bottom wetland in the seepage zones.

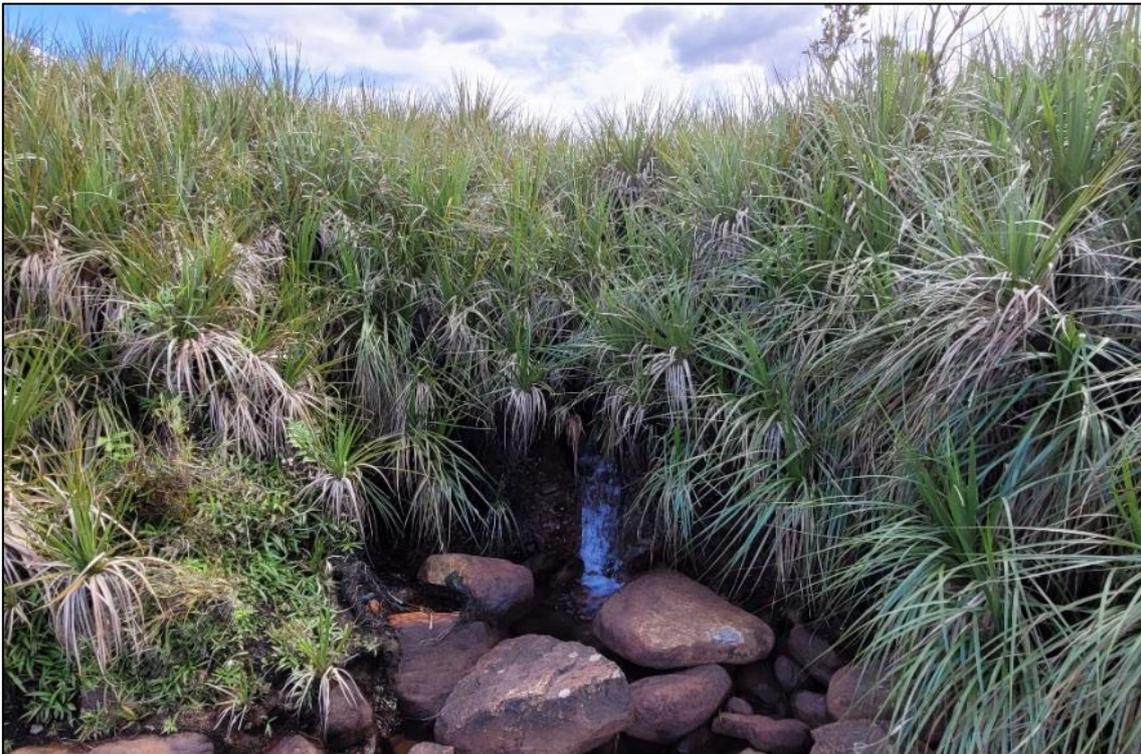
Figure 3-108 Sikombe wetland: Headcut erosion within the lower portion of the system.

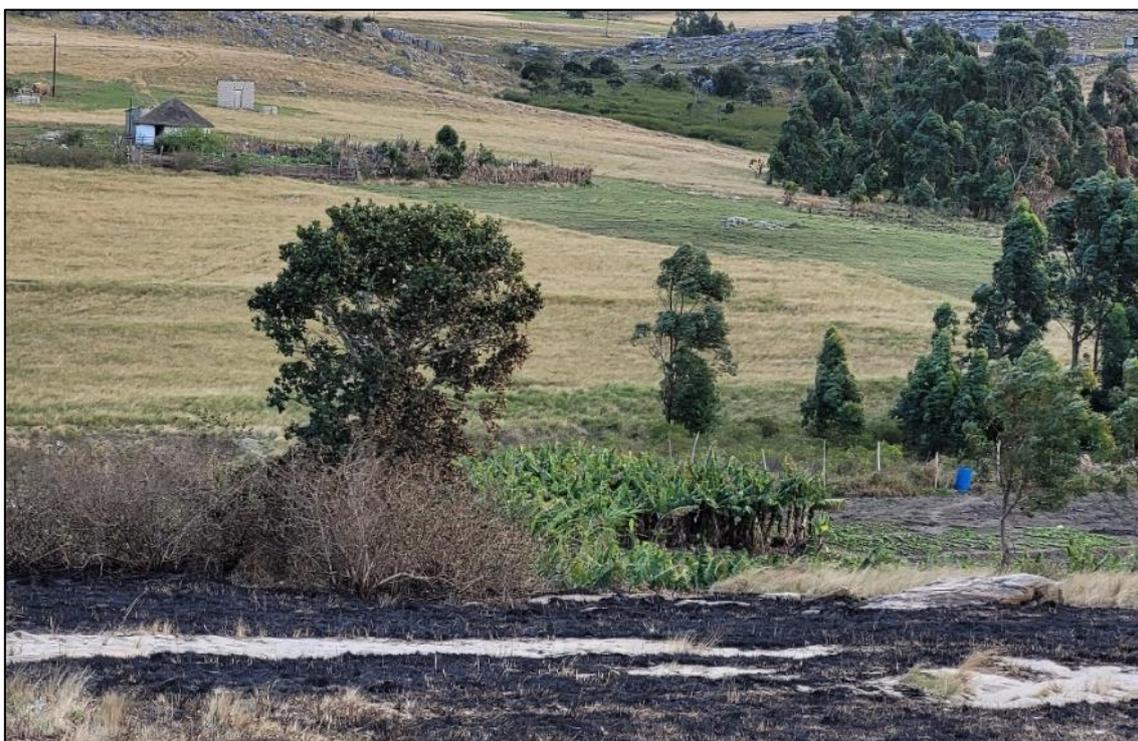
Figure 3-112 Xolobeni wetland: cultivation within the temporary zones of wetness associated with the seepage zones adjacent to the valley bottom wetland habitat

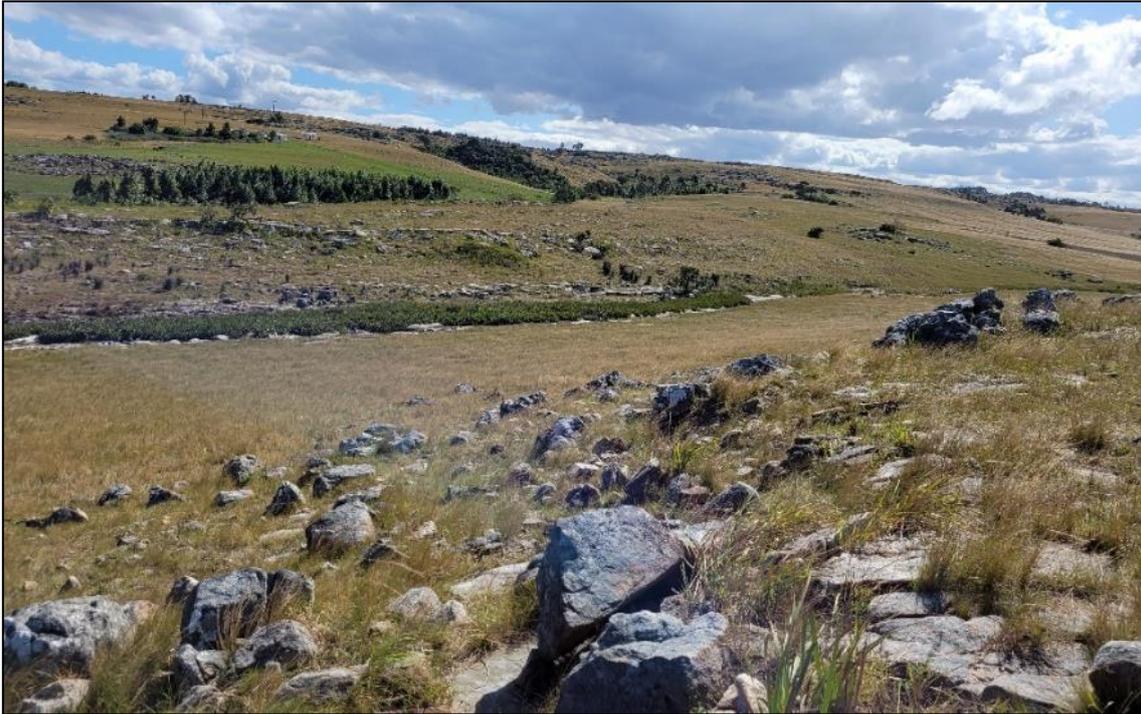
Figure 3-113 Xolobeni wetland: View of some of the catchment impacts, and the channel which has eroded onto bedrock (lighter areas)

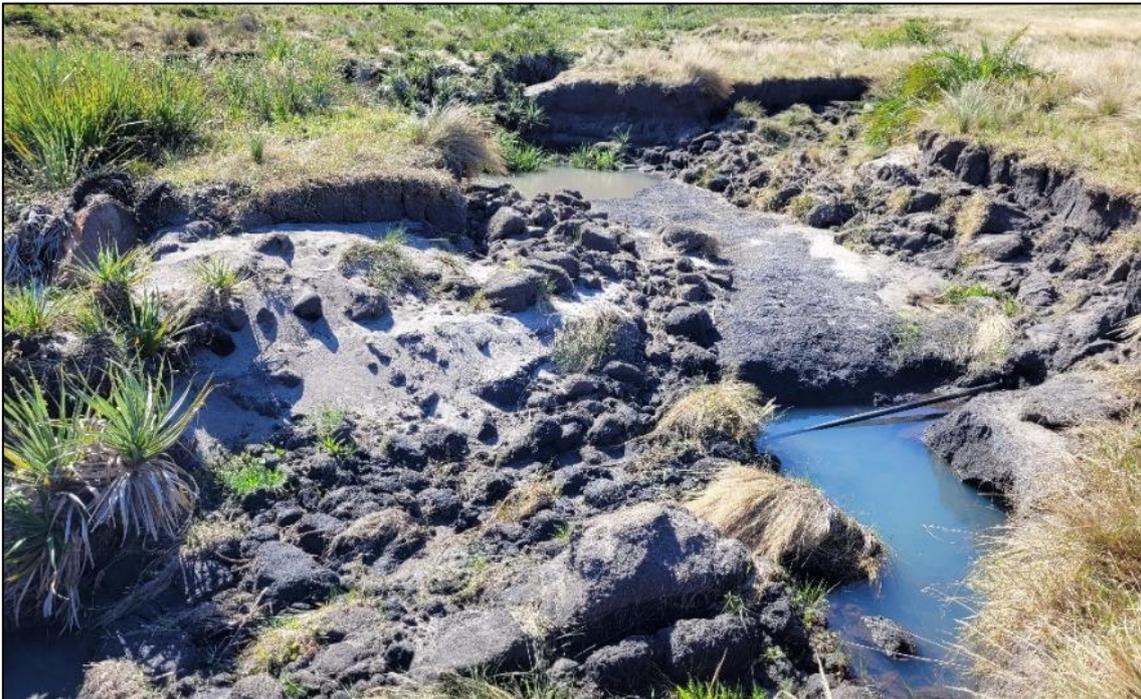
Figure 3-114 Xolobeni wetland: Headcut erosion upstream of the water abstraction point

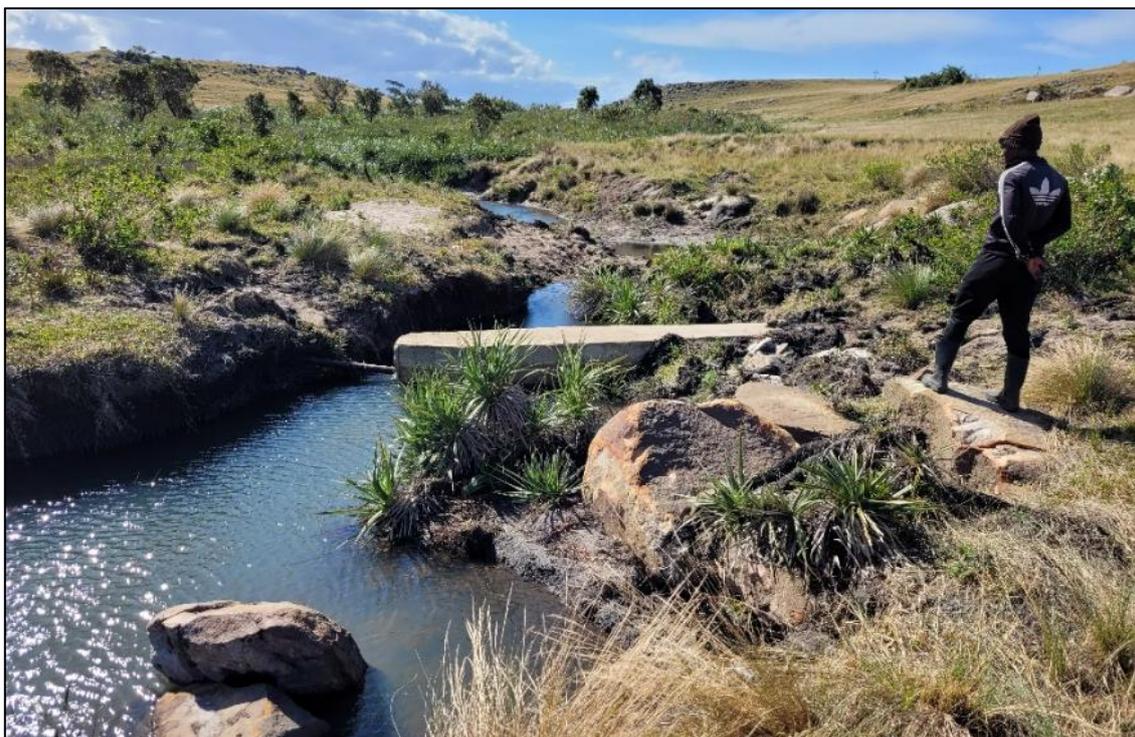
Figure 3-115 Xolobeni wetland: Eroded palmiet wetland upstream of the water supply pipeline crossing point. Portions of the pipeline has been encased in concrete, however the channel has bypassed the concrete and has exposed portions of the pipeline

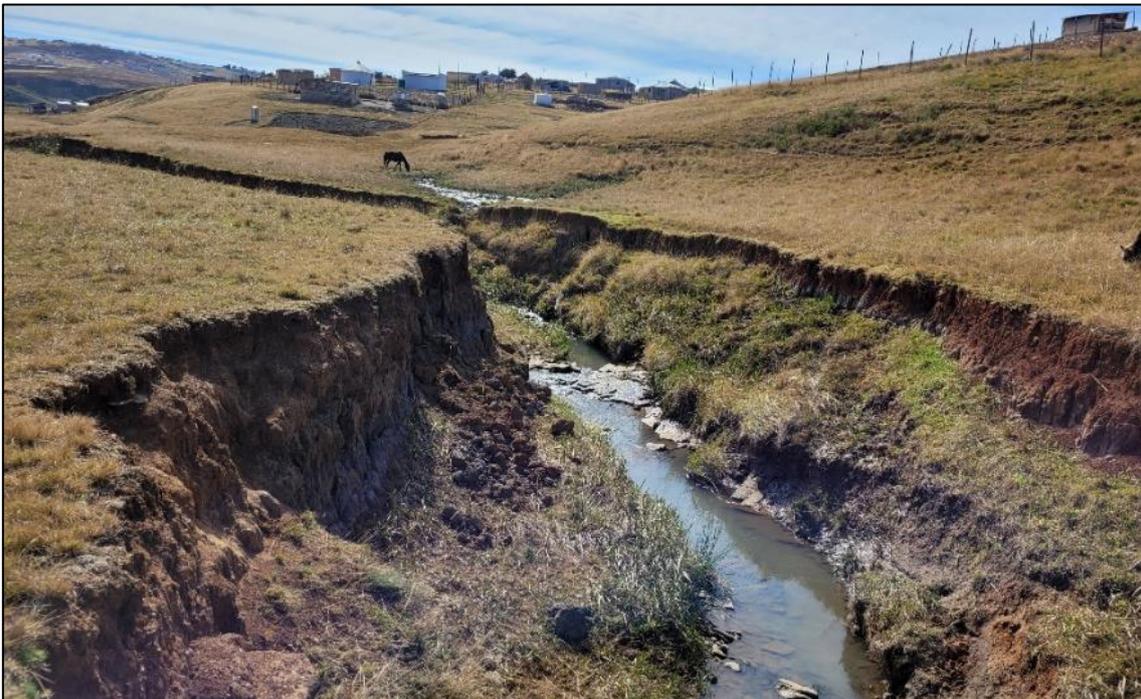
Figure 3-120 Incised channel associated with the main valley-bottom wetland.

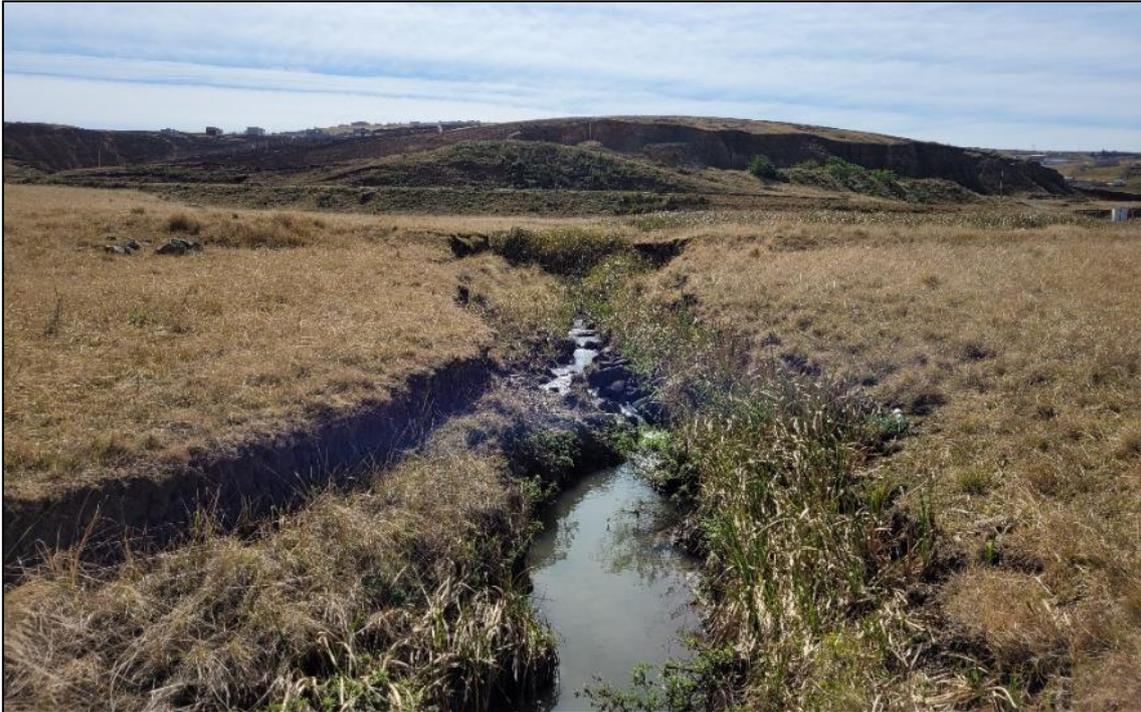
Figure 3-121 Breached dam wall within the valley-bottom wetland. The breach is most likely as a result of the advancing headcut erosional feature.

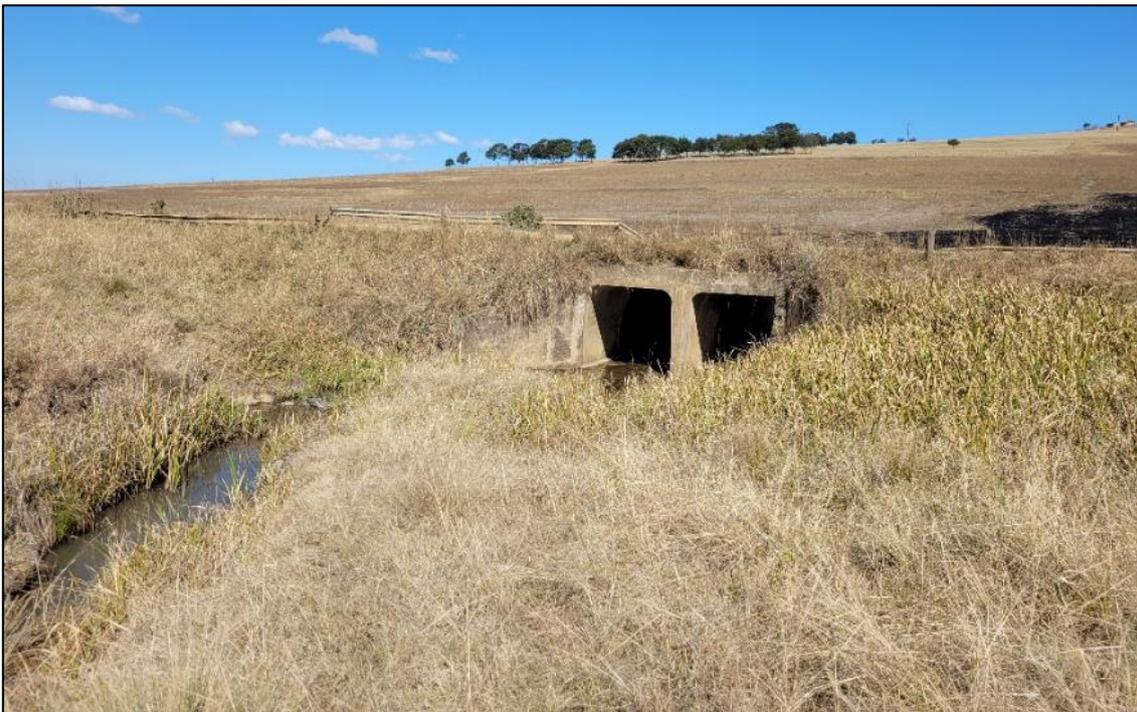
Figure 3-126 View of the road culvert associated with the R61 which has led to the formation of a small headcut erosional feature upstream of the culvert. The headcut has not progressed too far due to the shallow bedrock layer within the system
