Determination of Water Resource Classes, Reserve and the Resource Quality Objectives in the Keiskamma and Fish to Tsitsikamma Catchments

WP11354 Wetland Field Survey Report

REPORT NO.:
WEM/WMA7/00/CON/RDM/0522

SEPTEMBER 2022

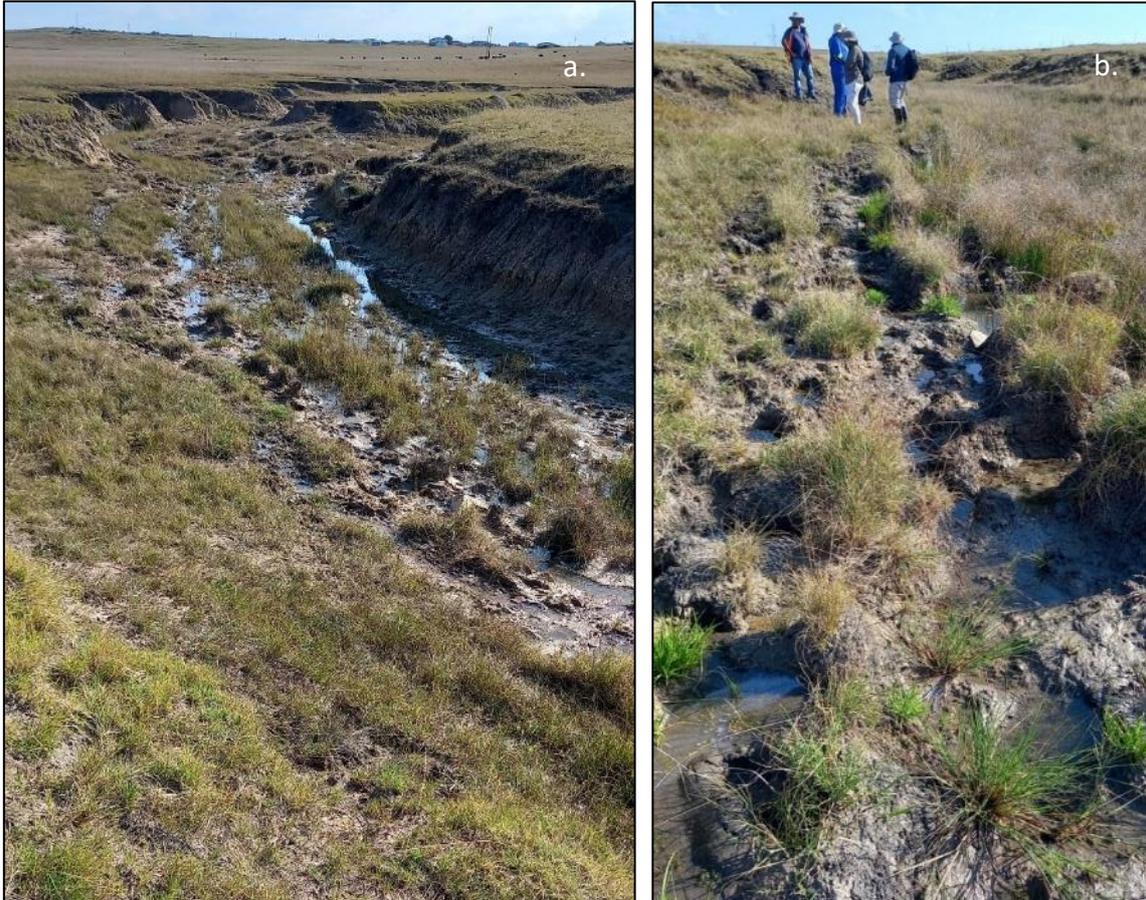
Figure 3-132 The main erosion gully in the wetland (downstream of the headcut shown in the previous photo) with (a.) located shortly downstream with incomplete vegetation cover and (b.) somewhat further downstream where vegetation cover is generally higher and more sediment has accumulated than above but a cattle path has provided a focal point for localized incision and remobilization of some of the deposited sediment
