DETERMINATION, REVIEW AND IMPLEMENTATION
OF THE RESERVE IN THE OLIFANTS/LETABA SYSTEM

FIELD SURVEY REPORT

Golder Associates Africa

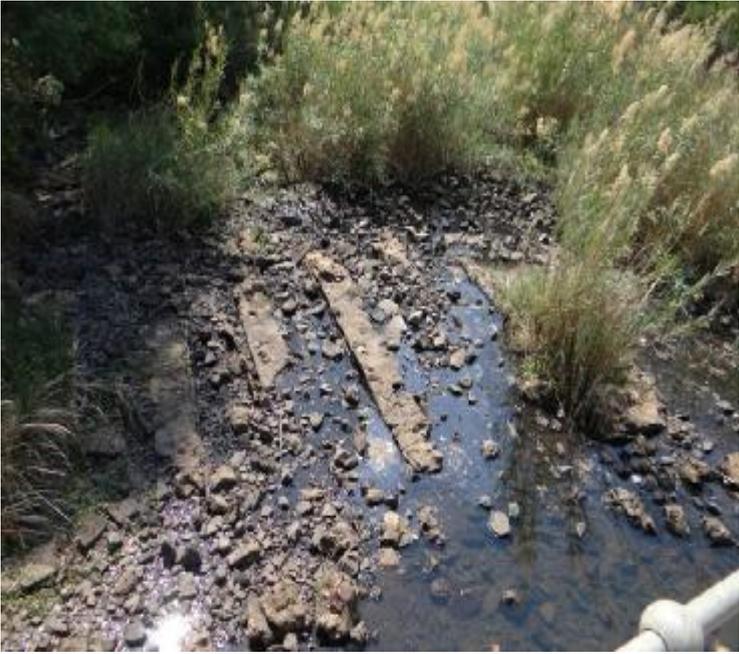
Table 2: Details and Characteristics of Site S1

<i>River</i>	Elands River	
<i>Quaternary Catchment</i>	B31C	
<i>Co-ordinates</i>	-25,303074; 28,46311	
<i>IUA</i>	4	
<i>SQ Reach</i>	B31C-00770	
<i>IEI Rating</i>	3	
<i>WRUI Rating</i>	2	
<i>Survey Type</i>	Rapid III	
<i>PES</i>	C	
COMMENTS/OBSERVATIONS	<p>High organic material content observed. This can be attributed largely to leaves from canopy. Some algae and siltation present. Good site for biological surveys in future.</p> <p>Discharge: 0.0085 m³/s</p> <p>Water Quality: pH 8.7; EC 16.0 mS/m; DO 5.03 mg/l</p> <p>ASPT: 6.45</p> <p>Fish Habitat: Good</p>

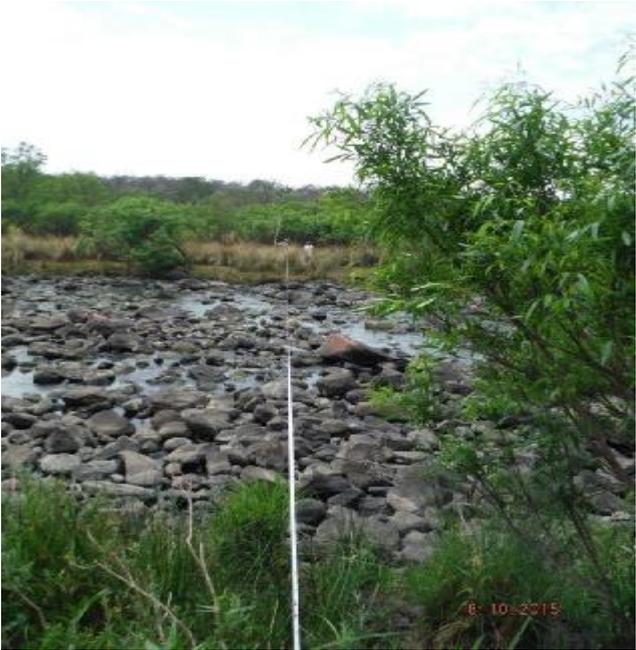
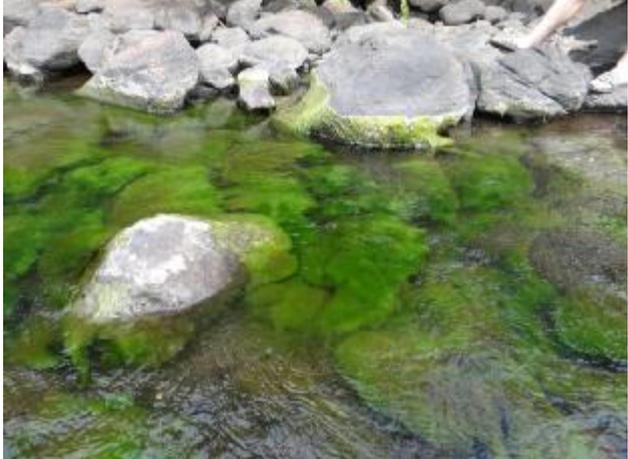
Table 3: Details and Characteristics of Site S2

<i>River</i>	Lower Wilge River	
<i>Quaternary Catchment</i>	B20J	
<i>Co-ordinates</i>	-25.619625; 28,999047	
<i>IUA</i>	2	
<i>SQ Reach</i>	B20J-00998	
<i>IEI Rating</i>	3	
<i>WRUI Rating</i>	2	
<i>Survey Type</i>	Rapid III	
<i>PES</i>	C

COMMENTS/OBSERVATIONS		<p>Flow velocity was very low. Dense algae and fine sediments were observed. Green algae dominate in fast flowing water.</p> <p>Sediments noted out of channel and as a result less green algae. Fish: 10 - 380 mm, 40 min.</p> <p>Discharge: 0.124 m³/s</p> <p>Water Quality: pH 8.7; EC 54.0 mS/m; 7.38 mg/l</p> <p>ASPT: 6.62</p> <p>Fish Habitat: Fair</p>

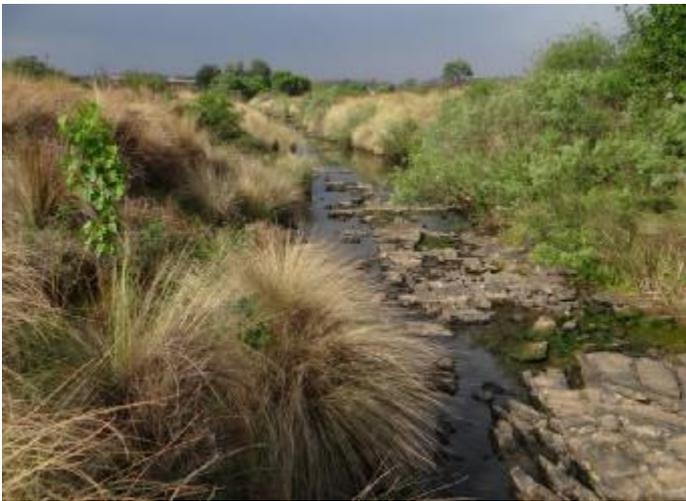
Table 4: Details and Characteristics of Site S3

River	Wilge River	
Quaternary Catchment	B20F	
Co-ordinates	-25,843984; 28,871978	
IUA	2	
SQ Reach	B20F-01150	
IEI Rating	3	
WRUI Rating	3	
Survey Type	Rapid III and biological	
PES	C	
COMMENTS/OBSERVATIONS		<p>Deeply incised banks that are collapsing. Lots of algae and silt. Bedrock, cobbles and boulders present. Some embedment. Low flow is restricted by undercut and root wads. Depth of 25 – 350 mm for fish, 25 min.</p> <p>Discharge: 0.0035 m³/s</p> <p>Water Quality: pH 8.6; EC 44.0 mS/m; DO 4.85 mg/l</p> <p>ASPT: 5.42</p> <p>Fish Habitat: Fair</p>

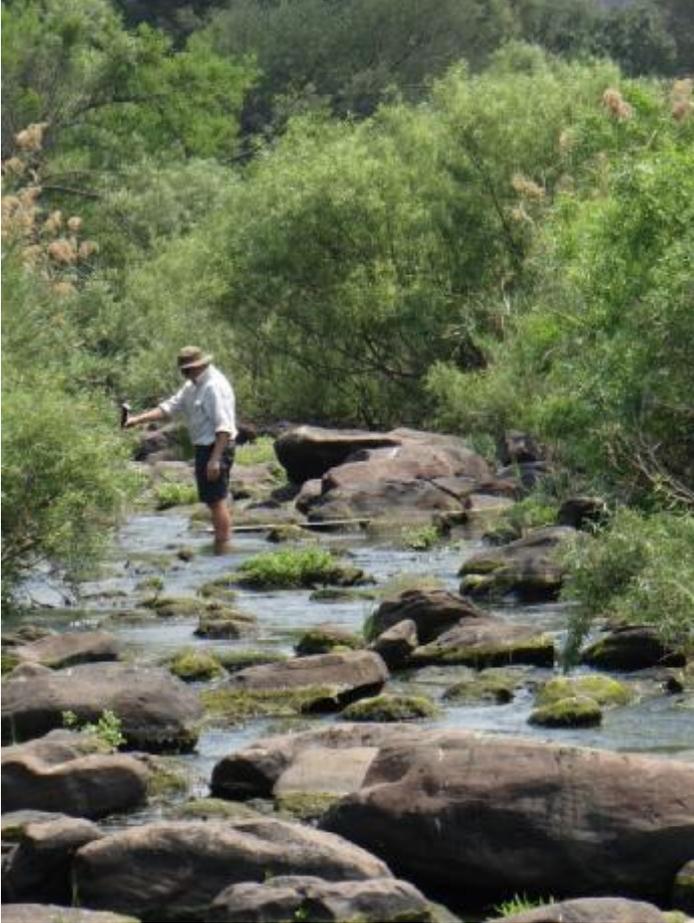
Table 6: Details and Characteristics of Site S5

River	Olifants	
Quaternary Catchment	B11J	
Co-ordinates	B11J-01086	
IUA	1	
SQ Reach	-25,759183; 29,309564	
IEI Rating	2	
WRUI Rating	4	
Survey type	Rapid III	
PES	B	
COMMENTS/OBSERVATIONS		<p>Algae is dense, some silt present. Flow is very low flow. Water has a chemical smell.</p> <p>Macro channel = 95 m, Active = 50 m, wet = 12 m</p> <p>Land owner says CCAR, MSAL, OMOS, BMAR caught in large pools.</p> <p>Discharge: 0.163 m³/s</p> <p>Water Quality: pH 8.6; EC 100 mS/m; DO 5.02 mg/l</p> <p>ASPT: 5.37</p> <p>Fish Habitat: Good</p>

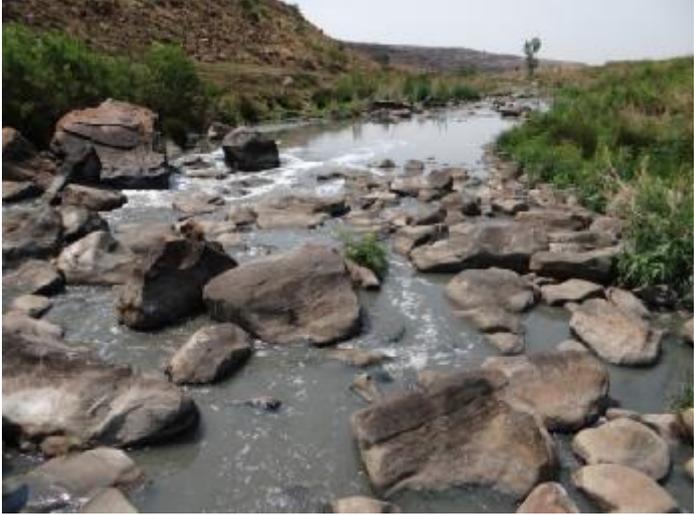
Table 7: Details and Characteristics of Site S6

River	Klein Olifants	
Quaternary Catchment	B12D	
Co-ordinates	-25,748872; 29,458649	
IUA	1	
SQ Reach	B12D-01118	
IEI Rating	2	
WRUI Rating	4	
Survey type	Rapid III	
PES	D	
COMMENTS/OBSERVATIONS		<p>Algae present. Flow was low. Solid waste was observed in the river channel. Invasive plants (riparian) present.</p> <p>Discharge: 0.391 m³/s</p> <p>Water Quality: pH 8.9; EC 74 mS/m; DO 6.07 mg/l</p> <p>ASPT: 4.29</p> <p>Fish Habitat: Fair</p>

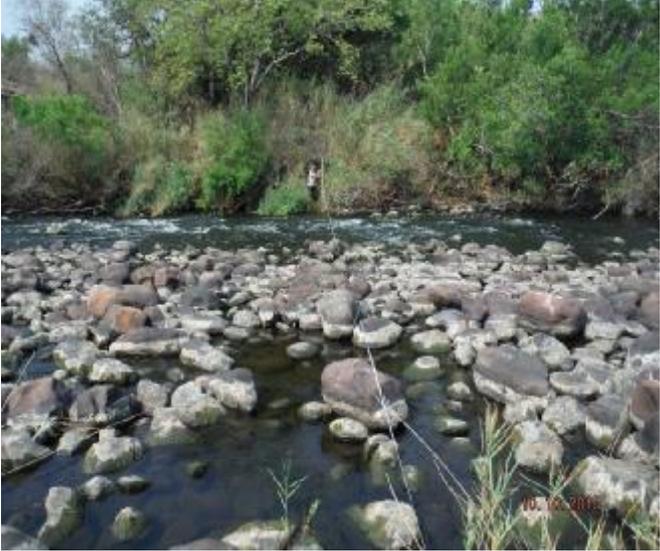
Table 8: Details and Characteristics of Site S7

River	Olifants	
Quaternary Catchment	B32A	
Co-ordinates	-25,496324; 29,254597	
IUA	3	
SQ Reach	B32A-00937	
IEI Rating	3	
WRUI Rating	3	
Survey Type	Rapid III	
PES	B	
COMMENTS/OBSERVATIONS		<p>Cobbles and boulder habitat present. High algae. Very low flow. Limited marginal vegetation present.</p> <p>Discharge: 1.452 m³/s</p> <p>Water Quality: pH 8.8; EC 81 mS/m; DO 6.75 mg/l</p> <p>ASPT: 5.59</p> <p>Fish Habitat: Good</p>

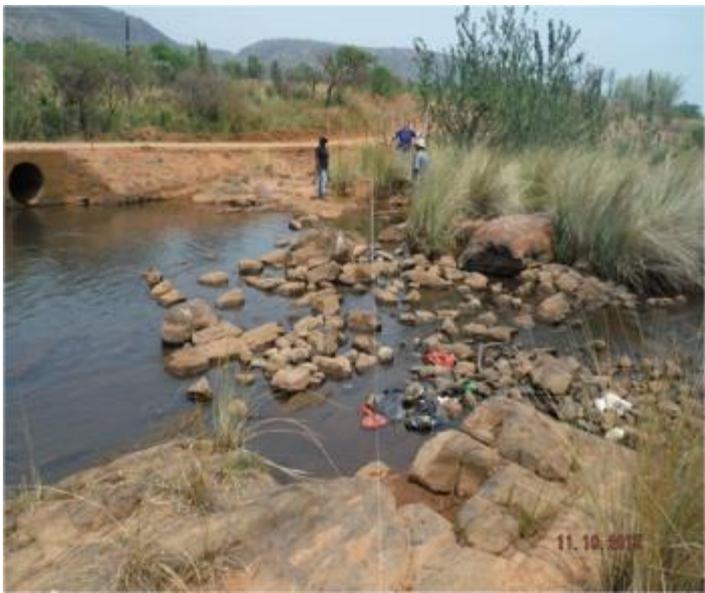
Table 9: Details and Characteristics of Site S8

River	Kranspoortspruit	
Quaternary Catchment	B32A	
Co-ordinates	-25,437714; 29,475619	
IUA	3	
SQ Reach	B32A-00950	
IEI Rating	3	
WRUI Rating	2	
Survey type	Rapid III	
PES	C	
COMMENTS/OBSERVATIONS		<p>Water was discoloured. Algae and silt was observed covering cobbles. Habitat bedrock and boulder/cobbles with some sand and gravel. In stream vegetation was limited. When inundated there will be good overhanging vegetation and undercut banks.</p> <p>Discharge: 0.013 m³/s</p> <p>Water Quality: pH 8.6; EC 9.0 mS/m; 6.86 mg/l</p> <p>ASPT: 6.55</p> <p>Fish Habitat: Fair</p>

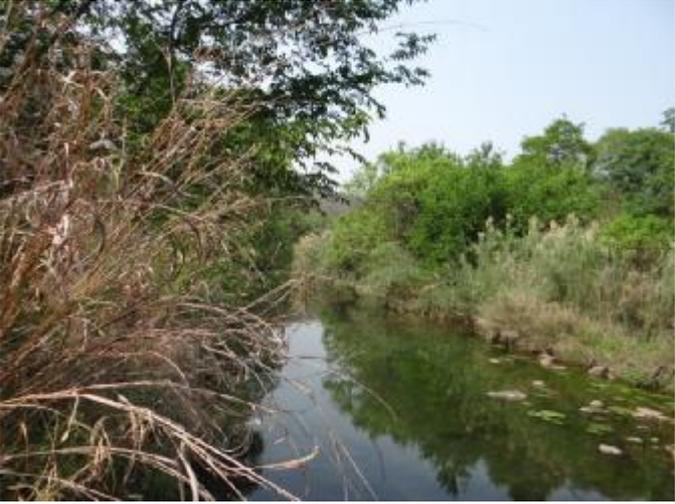
Table 10: Details and Characteristics of Site S9

River	Selons	
Quaternary Catchment	B32C	
Co-ordinates	-25,379969; 29,435557	
IUA	3	
SQ Reach	B32C-00936	
IEI Rating	3	
WRUI Rating	4	
Survey type	Rapid III	
PES	C	
COMMENTS/OBSERVATIONS		<p>Very low flow observed. Cobble and boulders present. Riffles with limited algae. Pool had dense green algae bloom. Some vegetation observed, mainly root wads. Parasites observed on BPAU</p> <p>Discharge: 0.038 m³/s</p> <p>Water Quality: pH 8.8; EC 27.0 mS/m; DO 6.11 mg/l</p> <p>ASPT: 5.94</p> <p>Fish Habitat: Good</p>

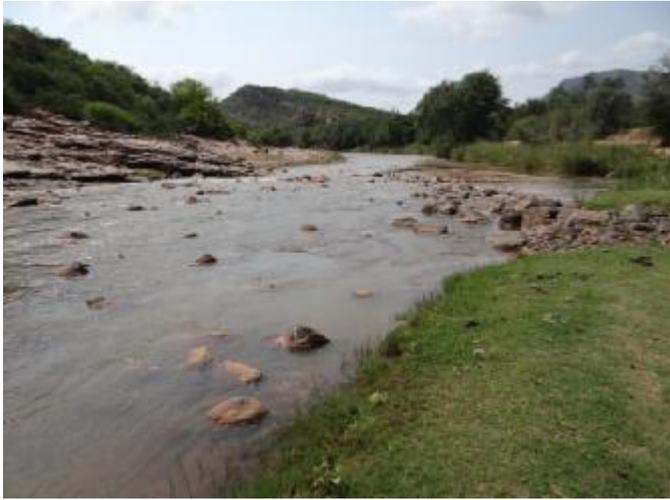
Table 11: Details and Characteristics of Site S10

River	Olifants	
Quaternary Catchment	B71D	
Co-ordinates	-24.239917; 30.082457	
IUA	10	
SQ Reach	B71D-00412	
IEI Rating	2	
WRUI Rating	4	
Survey type	Rapid III	
PES	D	
COMMENTS/OBSERVATIONS		<p>Very low flow present. Pool, cobbles, boulders and sand observed. Silt deposition. Vegetation and undercut banks limited due to low water level.</p> <p>Discharge: 2.343 m³/s</p> <p>Water Quality: pH 8.8; EC 63 mS/m; DO 7.6 mg/l</p> <p>ASPT: 6.25</p> <p>Fish Habitat: Fair</p>

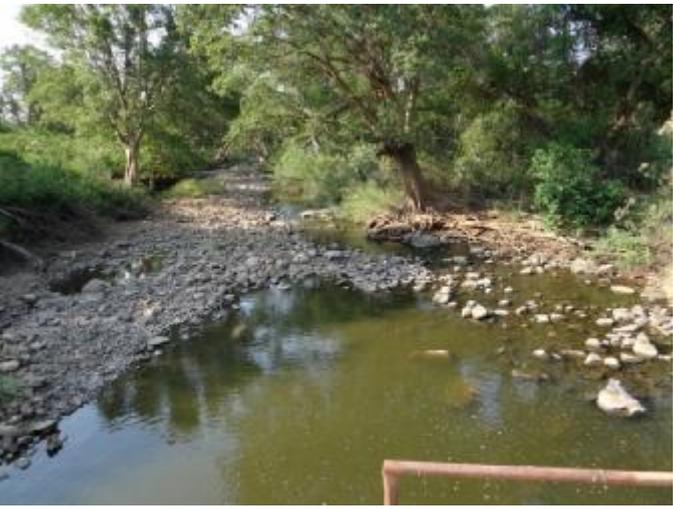
Table 12: Details and Characteristics of Site S11

River	Spekboom	
Quaternary Catchment	B42H	
Co-ordinates	-24,694155; 30,361267	
IUA	8	
SQ Reach	B42H-00553	
IEI Rating	3	
WRUI Rating	3	
Survey type	Rapid III	
PES	C	
COMMENTS/OBSERVATIONS		<p>Pool, cobbles, boulders present. Very low flow observed. Water discoloured green with some silt present. Good root wads present.</p> <p>Discharge: 0.028 m³/s</p> <p>Water Quality: pH 9.1; EC 61 mS/m; DO 7.29 mg/l</p> <p>ASPT: 7.55</p> <p>Fish Habitat: Fair</p>

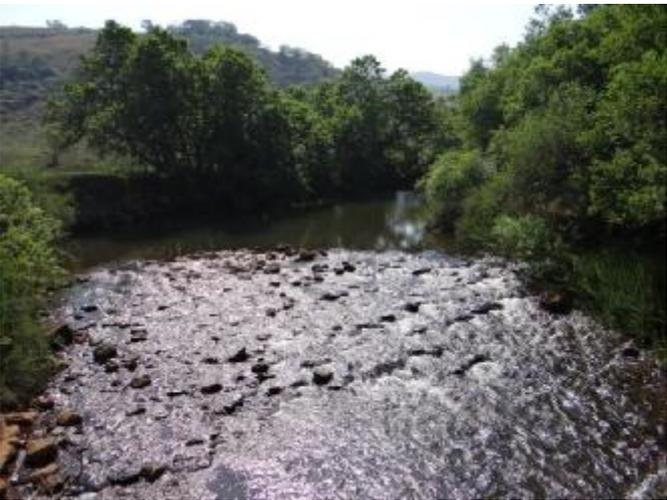
Table 13: Details and Characteristics of Site S12

River	Upper Blyde	
Quaternary Catchment	B60B	
Co-ordinates	-24,734412; 30,778321	
IUA	13	
SQ Reach	B60B-00566	
IEI Rating	4	
WRUI Rating	1	
Survey type	Rapid III	
PES	B	
COMMENTS/OBSERVATIONS	<p>Pool, cobbles, boulders observed. Snag trees under bridge provided habitat. High silt loads observed. Limited overhanging vegetation.</p> <p>Discharge: 2.039 m³/s</p> <p>Water Quality: pH 8.4; EC 19.0 mS/m; DO 11.95 mg/l</p> <p>ASPT: 6.5</p> <p>Fish Habitat: Good</p>

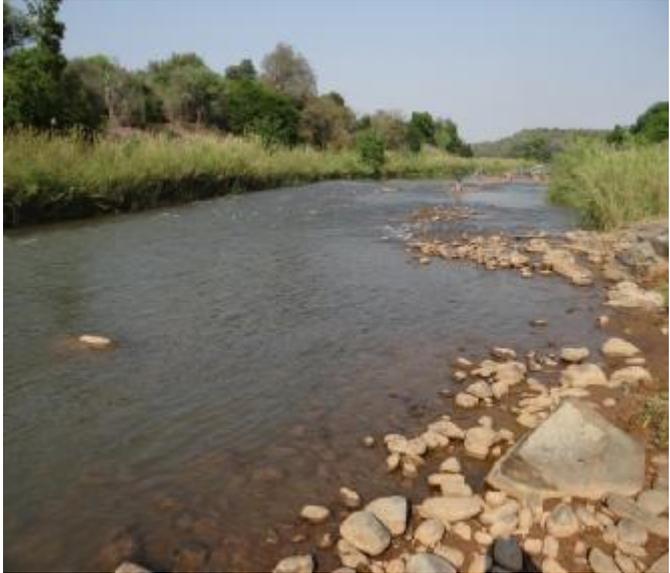
Table 14: Details and Characteristics of Site S13

River	Olifants	
Quaternary Catchment	B71J	
Co-ordinates	-24,307563; 30,785695	
IUA	10	
SQ Reach	B71G-00428	
IEI Rating	3	
WRUI Rating	4	
Survey type	Rapid III	
PES	C	
COMMENTS/OBSERVATIONS		<p>Water was silty and substrate was smothered in fine silt. Cobbles were embedded. Little boulders and bedrock were present. Vegetation limited but under higher flow undercut banks and root wads will be present.</p> <p>Discharge: 4.051 m³/s</p> <p>Water Quality: pH 9.0; EC 55 mS/m; DO 11.63 mg/l</p> <p>ASPT: 6..48</p> <p>Fish Habitat: Fair</p>

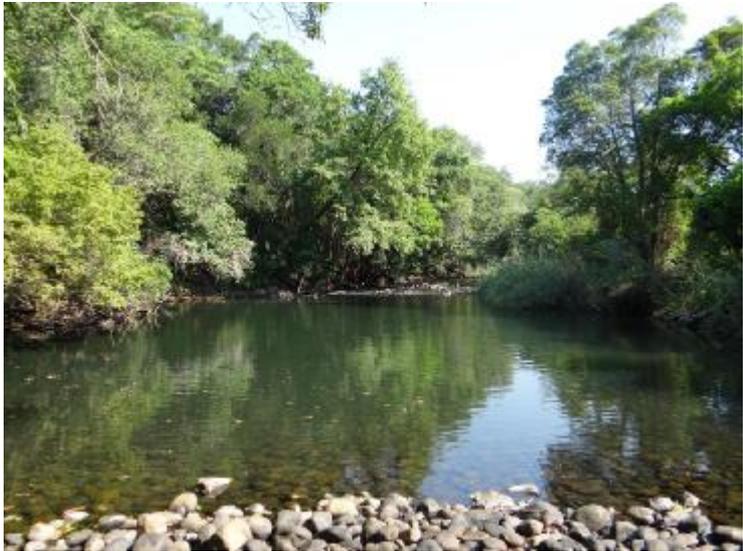
Table 15: Details and Characteristics of Site S14

River	Lower Blyde	
Quaternary Catchment	B60J	
Co-ordinates	-24,407481; 30,827404	
IUA	10	
SQ Reach	B60J-00444	
IEI Rating	3	
WRUI Rating	3	
Survey type	Rapid III	
PES	C	
COMMENTS/OBSERVATIONS		<p>Low flow observed. Habitat consisted of cobbles with snags and root wads. Overhanging vegetation and some undercut banks present. Silt and algae present. Deep pools.</p> <p>Discharge: 0.653 m³/s</p> <p>Water Quality: pH 8.6; EC 20 mS/m; DO 10.92 mg/l</p> <p>ASPT: 5.59</p> <p>Fish Habitat: Fair</p>

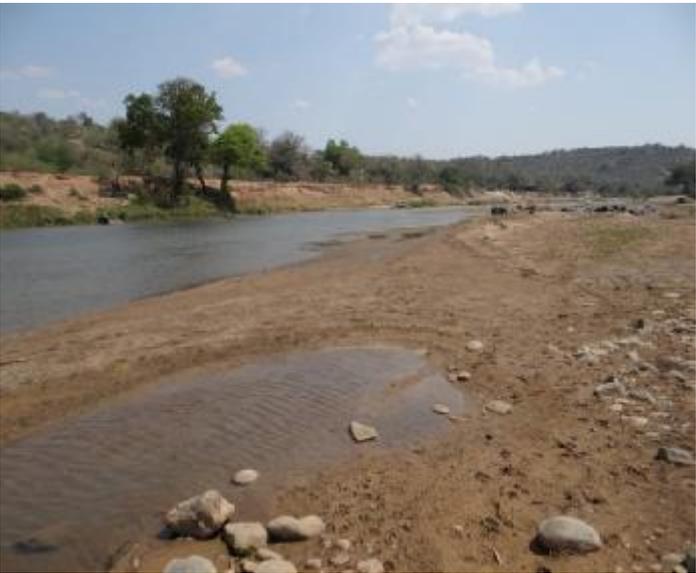
Table 16: Details and Characteristics of Site S15

River	Olifants	
Quaternary Catchment	B72D	
Co-ordinates	-24,12843; 31,01457	
IUA	12	
SQ Reach	B72D-00326	
IEI Rating	2	
WRUI Rating	4	
Survey type	Rapid III	
PES	C	
COMMENTS/OBSERVATIONS		<p>Low flow observed. Some silt. Low algae growth. Sand with limited cobbles. Limited root wads and undercut banks.</p> <p>Discharge: Gauging weir</p> <p>Water Quality: pH 8.8; EC 56 mS/m; DO 10.68 mg/l</p> <p>ASPT: 5.84</p> <p>Fish Habitat: Poor</p>

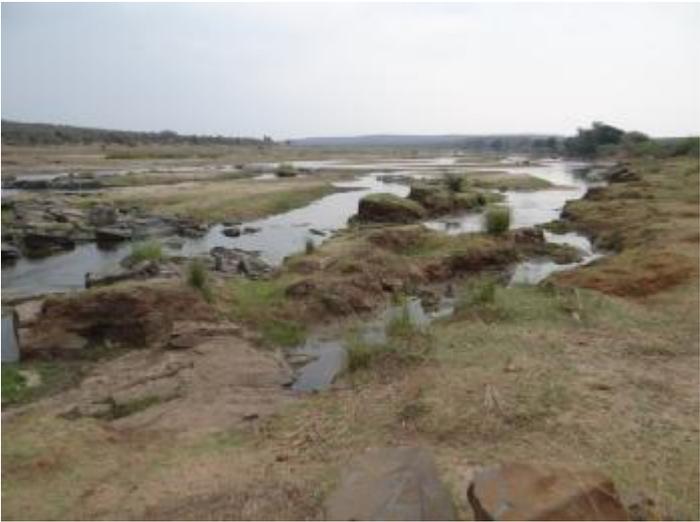
Table 17: Details and Characteristics of Site S16

River	Olifants	
Quaternary Catchment	B73H	
Co-ordinates	-24,049426; 31,731751	
IUA	12	
SQ Reach	B73H-00311	
IEI Rating	3	
WRUI Rating	4	
Survey type	Rapid III	
PES	C	
COMMENTS/OBSERVATIONS		<p>Sand and bedrock habitat. Very low flow present. Some stringy algae observed at site.</p> <p>Discharge: Gauging weir</p> <p>Water Quality: pH 8.9; EC 65 mS/m; DO 12.55 mg/l</p> <p>ASPT: 5.84</p> <p>Fish Habitat: Fair</p>

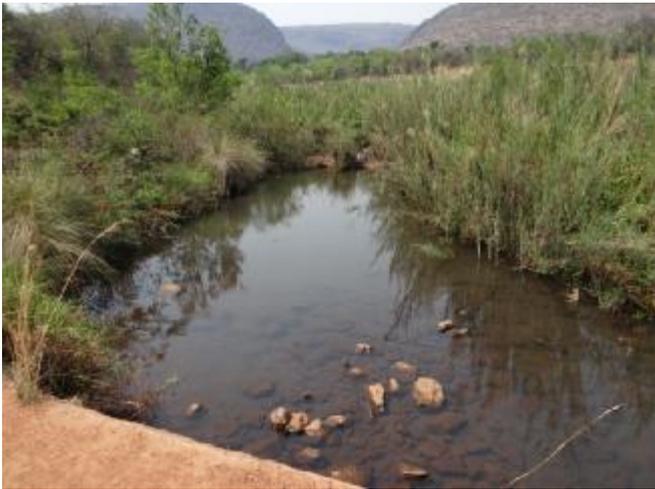
Table 18: Details and Characteristics of Site B1

River	Steenkoolspruit	
Quaternary Catchment	B11E	
Co-ordinates	-26,0824.61; 29,1608.27	
IUA	1	
SQ Reach	B11E-01297	
IEI Rating	2	
WRUI Rating	4	
Survey type	Biological	
PES	D	
COMMENTS/OBSERVATIONS		<p>Flow velocity very low. Azolla (red fern) abundant. High sediment and algae observed on substrate. Site had some bedrock with overhanging vegetation. Depth 50 – 650 mm for fish, 20 min.</p> <p>Water Quality: pH 8.0; EC 48 mS/m; DO 5.64 mg/l ASPT: 3.43</p> <p>Fish Habitat: Poor</p>

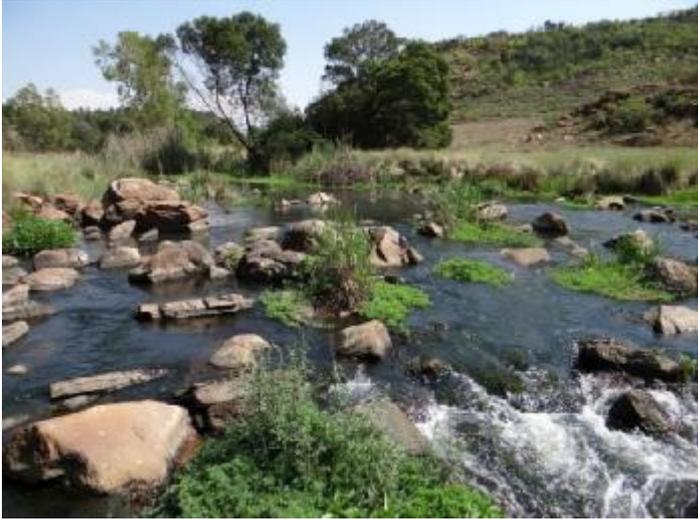
Table 19: Details and Characteristics of Site B2

River	Bronkhorspruit	
Quaternary Catchment	B20D	
Co-ordinates	-25,5304.5; 28,4325.7	
IUA	2	
SQ Reach	B20D-01146	
IEI Rating	3	
WRUI Rating	4	
Survey type	Biological	
PES	C	
COMMENTS/OBSERVATIONS		<p>Floating debris, sedimentation and organics observed. Moderate flow was a result of release from the dam. Lots of algae and diatoms present (long stringy algae). Clear water. Floating Macrophytes. High parasite on observed fish.</p> <p>Water Quality: pH 8.1; EC 37 mS/m; DO 7.52 mg/l ASPT: 3.92 Fish Habitat: Good</p>

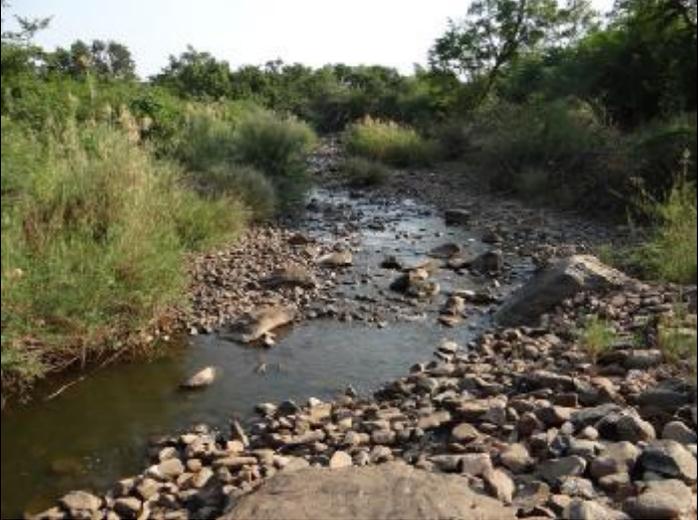
Table 20: Details and Characteristics of Site E5

River	Masala	
Quaternary Catchment	B41C	
Co-ordinates	-25,0827.6; 29,5459.4	
IUA	6	
SQ Reach	B41C-00766	
IEI Rating	2	
WRUI Rating	3	
Survey type	Biological	
PES	C	
COMMENTS/OBSERVATIONS		<p>Low flow, limited roots, cobbles (mostly bedrock) observed. Some marginal vegetation. MSAL introduced at site. (Confusion on river name Hoofstadsrivier, Masala, Mapochs)</p> <p>Water Quality: pH 8.72; DO 5.91 mg/l</p> <p>ASPT: 5.67</p> <p>Fish Habitat: Good</p>

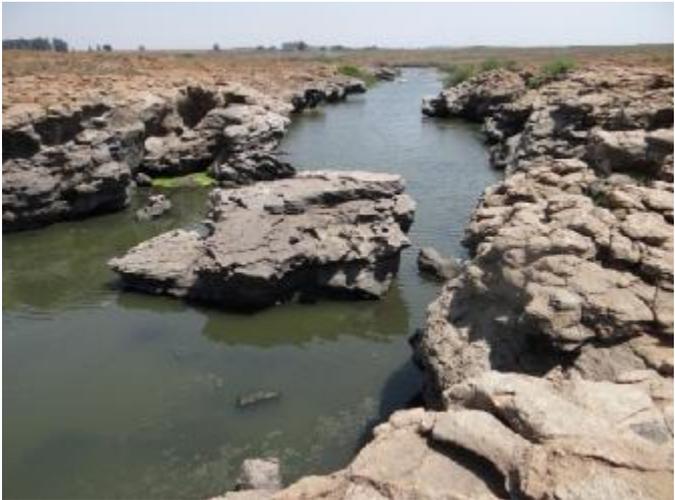
Table 21: Details and Characteristics of Site E7

River	Klip	
Quaternary Catchment	B41F	
Co-ordinates	-24,5904.58; 29,5919.70	
IUA	6	
SQ Reach	B41F-00699	
IEI Rating	4	
WRUI Rating	2	
Survey type	Biological	
PES	B	
COMMENTS/OBSERVATIONS		<p>Low flow, silt higher than expected, some algae, detritus. Cobble/boulders and bedrock with pool observed. Sand in stream with no marginal vegetation. According to local information the DWS noted severe pollution from the mines during construction of Lake De Hoop. Off channel dams to pump and purify were constructed but not active after closure of the Mapochs Mine.</p> <p>Water Quality: pH 8.4; DO 6.08 mg/l ASPT: 6.58 Fish Habitat: Good</p>

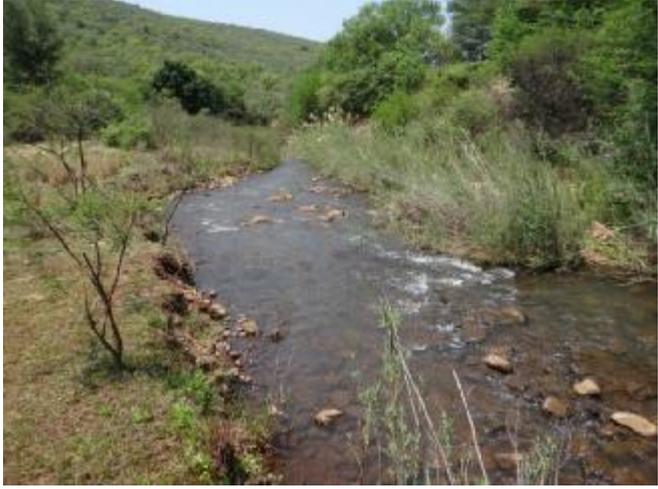
Table 22: Details and Characteristics of Site H7

<i>River</i>	Dwars	
<i>Quaternary Catchment</i>	B41H	
<i>Co-ordinates</i>	-24,5038.33; 30,0530.24	
<i>IUA</i>	6	
<i>SQ Reach</i>	B41H-00640	
<i>IEI Rating</i>	2	
<i>WRUI Rating</i>	4	
<i>Survey type</i>	Biological	
<i>PES</i>	D	
COMMENTS/OBSERVATIONS		<p>Low flow, some silt and limited algae observed. Impacts from grazing, wood harvesting (wood crafters) and mining.</p> <p>Water Quality: pH 8.4; DO 8.49 mg/l</p> <p>ASPT: 6.48</p>

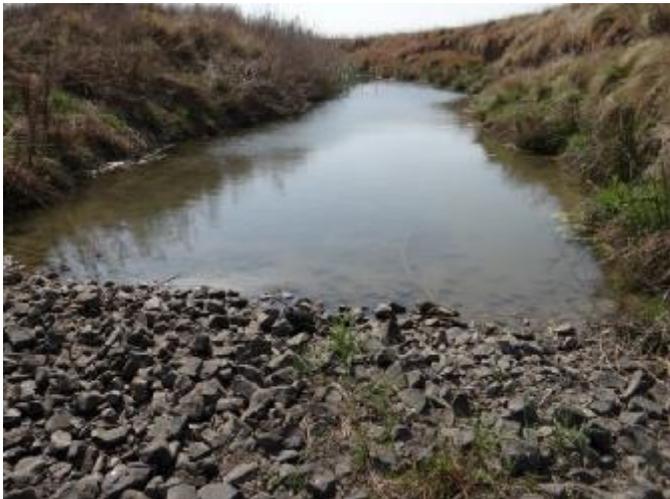
Table 23: Details and Characteristics of Site X1

<i>River</i>	Steenkoolspruit	
<i>Quaternary Catchment</i>	B11C	
<i>Co-ordinates</i>	-26,1928.78; 29,1827.39	
<i>IUA</i>	1	
<i>SQ Reach</i>	B11C-01449	
<i>IEI Rating</i>	2	
<i>WRUI Rating</i>	2	
<i>Survey type</i>	Biological	
<i>PES</i>	C	
COMMENTS/OBSERVATIONS		<p>Water was clear. High silt and algae observed. Impacts are associated with mining, cultivation, trampling by cattle and erosion. Lots of exotic invasive trees observed. Low gradient, deeply incised homogenous system. Limited instream macrophytes, little overhanging vegetation. No flow, only pool that was silted and algae over substrate. Depth 10 mm – 500 mm for fish, 10 min.</p> <p>Water Quality: pH 8.4; EC 89 mS/m; DO 5.63 mg/l</p> <p>ASPT: 4.45</p> <p>Fish Habitat: Poor</p>

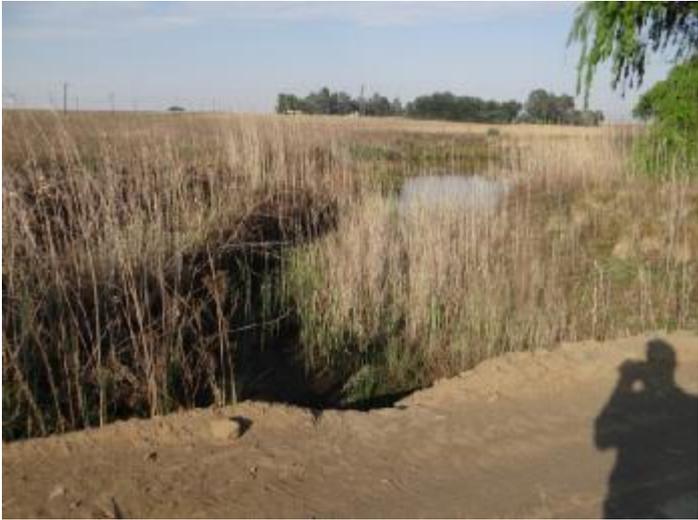
Table 24: Details and Characteristics of Site X2

River	Dwars-in-die-wegspruit	
Quaternary Catchment	B11D	
Co-ordinates	-26,2040.27; 29,1244.90	
IUA	1	
SQ Reach	B11D-01467	
IEI Rating	2	
WRUI Rating	2	
Survey type	Biological	
PES	C	
COMMENTS/OBSERVATIONS	<p>Water discoloured with organic sheen on surface. No flow, standing pool. Deeply incised channel. Some stones in current if there is flow downstream of bridge. Dumping of solid waste (household) observed. Steep banks could be dangerous for sampling in high flow. Deep pool may be as a result of excavation. Cultivation, cattle, trampling, erosion, mining and two power stations are located in close proximity (6 km – 10 km).</p> <p>Water Quality: pH 8.2; EC 85 mS/m; DO 5.49 mg/l</p>

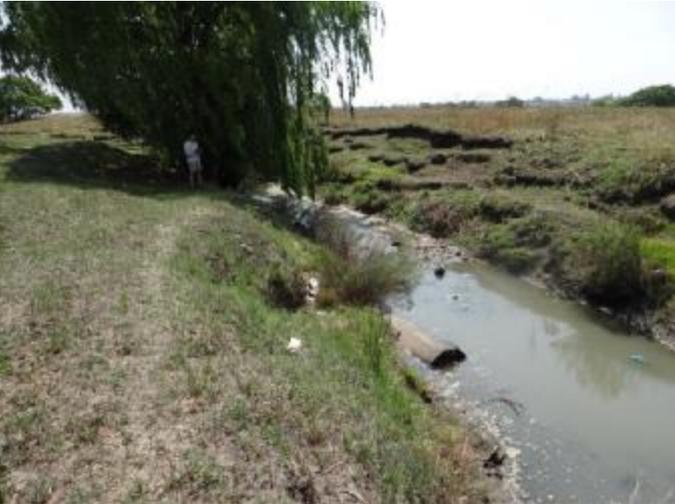
Table 25: Details and Characteristics of Site X3

River	Steenkoolspruit	
Quaternary Catchment	B11D	
Co-ordinates	-26,1608.94; 29,1417.73	
IUA	1	
SQ Reach	B11D-01366	
IEI Rating	2	
WRUI Rating	4	
Survey type	Biological	
PES	D	
COMMENTS/OBSERVATIONS		<p>Mining, cattle and cultivation impacts noted. Site is located close to Kriel Power station. Informal settlement near site. Solid waste and faecal matter present.</p> <p>Erosion, incised channel observed.</p> <p>Water Quality: pH 8.7; EC 35 mS/m; DO 6.56 mg/l</p> <p>Fish Habitat: Poor</p>

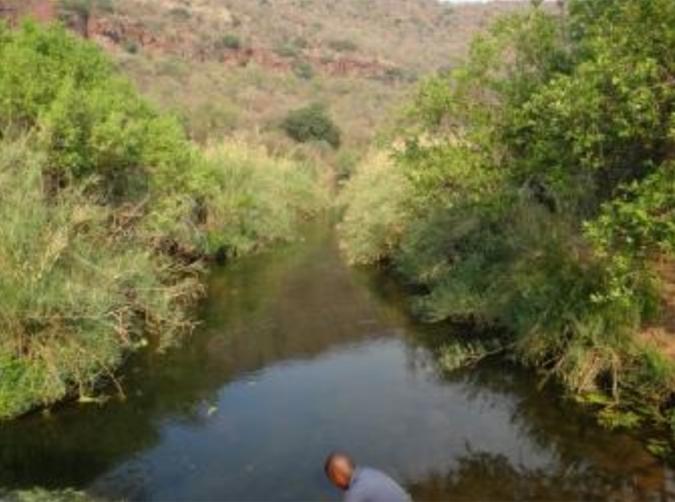
Table 26: Details and Characteristics of Site X5

River	Olifants	
Quaternary Catchment	B11L	
Co-ordinates	-25,3550.23; 29,1227.42	
IUA	1	
SQ Reach	B11L-01024	
IEI Rating	3	
WRUI Rating	3	
Survey type	Biological	
PES	C	
COMMENTS/OBSERVATIONS		<p>High algae observed. Encroachment of alien vegetation on bank and in water (macrophytes). Organic odour present. Sediments resulted in embededness of cobbles. Depth of 50 mm – 600 mm for fish, 20 min.</p> <p>Water Quality: pH 8.9; EC 87 mS/m; DO 7.85 mg/l</p> <p>ASPT: 5.07</p> <p>Fish Habitat: Fair</p>

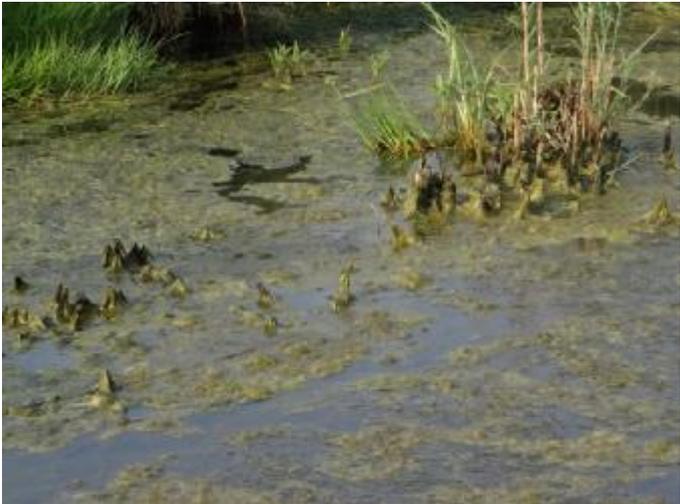
Table 27: Details and Characteristics of Site X6

River	Klein Olifants	
Quaternary Catchment	B12B	
Co-ordinates	-25,5305.62; 29,3758.39	
IUA	1	
SQ Reach	B12B-01192	
IEI Rating	2	
WRUI Rating	4	
Survey type	Biological	
PES	D	
COMMENTS/OBSERVATIONS	<p>Algae high and sediment observed. River had strong odour and faecal smell. Informal settlements located in close proximity of site. Cultivation centre pivots in area and cattle grazing and trampling observed. Two pump houses for extraction are observed close to site.</p> <p>Water Quality: pH 8.9; EC 260 mS/m; DO 6.63 mg/l</p> <p>ASPT: 4.72</p> <p>Fish Habitat: Poor</p>

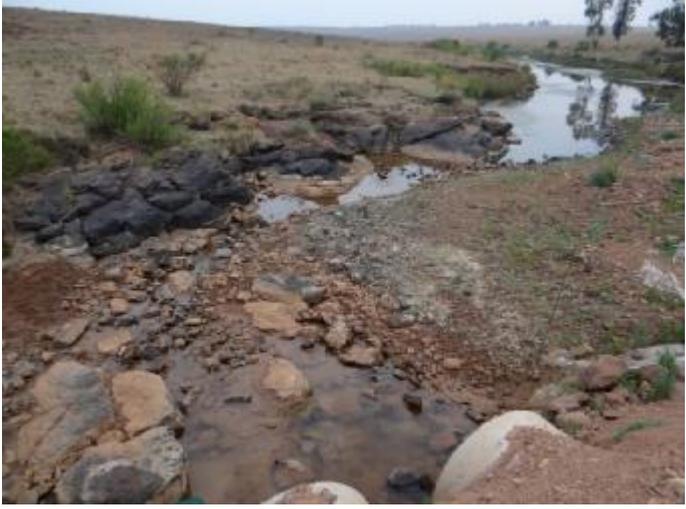
Table 28: Details and Characteristics of Site X7

River	Klein Olifants	
Quaternary Catchment	B12C	
Co-ordinates	-25,4903.25; 29,3525.98	
IUA	1	
SQ Reach	B12C-01153	
IEI Rating	2	
WRUI Rating	4	
Survey type	Biological	
PES	C	
COMMENTS/OBSERVATIONS		<p>River reach was dry. Water quality impacts noted (diatoms). Bridge construction nearby. Impacts include grazing cultivation and solid waste.</p> <p>Water Quality: pH 8.8; EC 240 mS/m; DO 5.70 mg/l</p> <p>Fish Habitat: Dry</p>

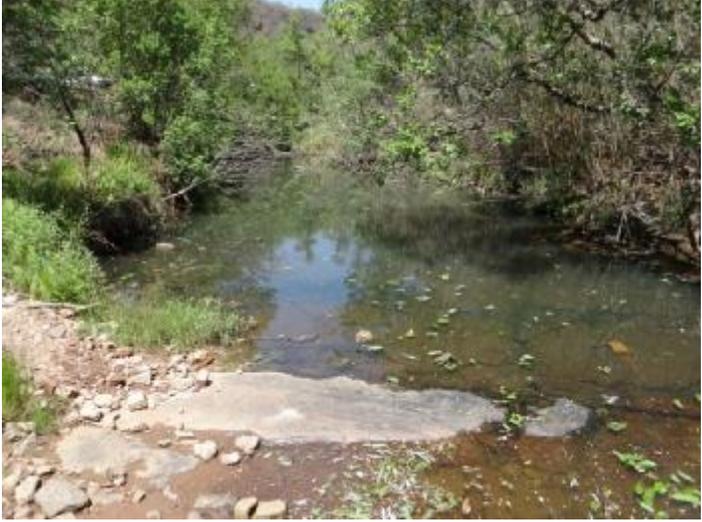
Table 29: Details and Characteristics of SiteX10

River	Elands	
Quaternary Catchment	B31A	
Co-ordinates	-25,3430.04; 28,3435.79	
IUA	4	
SQ Reach	B31A-00963	
IEI Rating	3	
WRUI Rating	3	
Survey type	Biological	
PES	C	
COMMENTS/OBSERVATIONS		<p>Very low flow, riffles limited, substrate has fine silt. Detritus build up noted. Linked to canopy cover. Upstream flow modifications, abstraction and weirs present.</p> <p>Water Quality: pH 8.6; EC 25 mS/m; DO 6.85 mg/l</p> <p>Fish Habitat: Good</p>

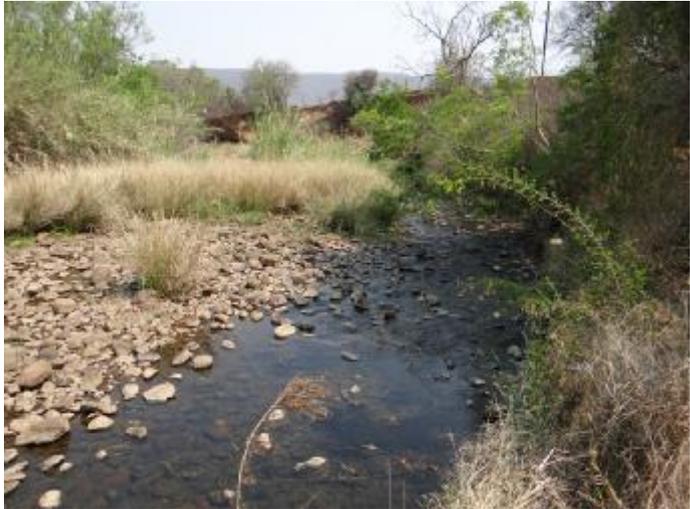
Table 30: Details and Characteristics of Site X17

River	Groot Dwars	
Quaternary Catchment	B41G	
Co-ordinates	-25,0539.99; 30,0720.72	
IUA	6	
SQ Reach	B41G-00721	
IEI Rating	3	
WRUI Rating	2	
Survey type	Biological	
PES	C	
COMMENTS/OBSERVATIONS		<p>Cobble, boulders and pool observed. Water low flow but clear. Some silt noted. No fish present. Possible impacts from mine.</p> <p>Water Quality: pH 8.4; DO 6.52 mg/l</p> <p>ASPT: 6.21</p> <p>Habitat: Good</p>

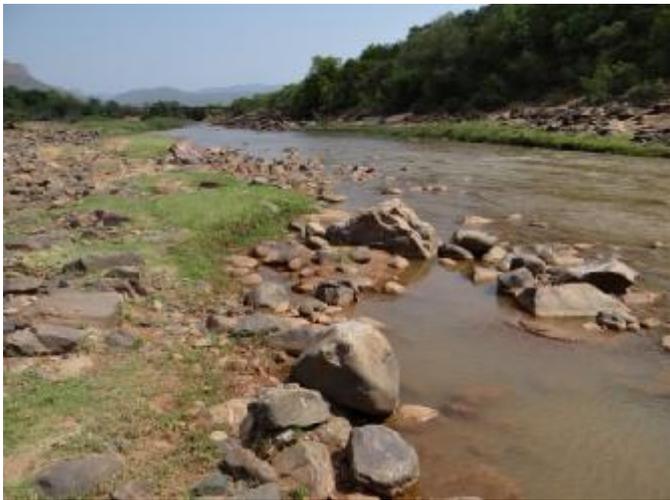
Table 31: Details and Characteristics of Site X18 and H3

River	Steelpoort	
Quaternary Catchment	B41H	
Co-ordinates	-24,5339.71; 30,0101.67	
IUA	6	
SQ Reach	B41H-00610	
IEI Rating	2	
WRUI Rating	3	
Survey type	Biological	
PES	D	
COMMENTS/OBSERVATIONS		<p>Low/moderate flow present. Releases are made from De Hoop. Water abstraction present (use by construction vehicles and local communities for drinking)</p> <p>Water Quality: pH 8.4; DO 8.93 mg/l</p> <p>ASPT: 5.74</p>

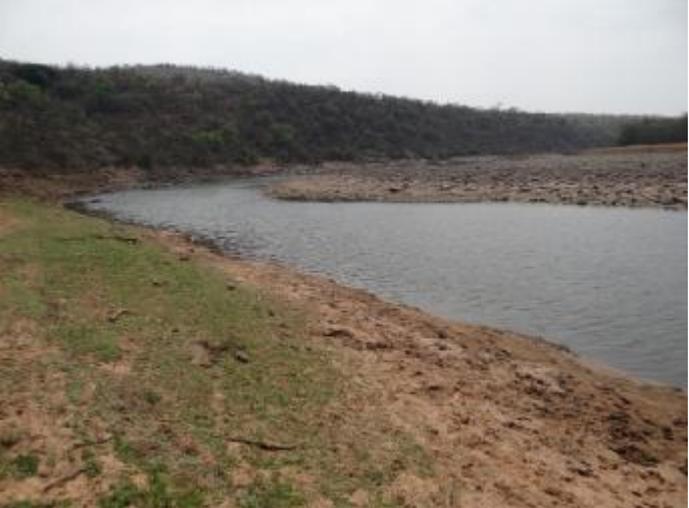
Table 32: Details and Characteristics of Site X19

River	Mohlapiitse	
Quaternary Catchment	B71C	
Co-ordinates	-24,0613.01; 30.0706.47	
IUA	10	
SQ Reach	B71C-00292	
IEI Rating	4	
WRUI Rating	2	
Survey type	Biological	
PES	B	
COMMENTS/OBSERVATIONS		<p>Low flow with high silt noted after rain (water – brown colour). Pooled SASS sample however difficult to see biotopes.</p> <p>Water Quality: pH 8.4; DO 5.79 mg/l</p> <p>ASPT: 7.33</p> <p>Fish Habitat: Poor</p>

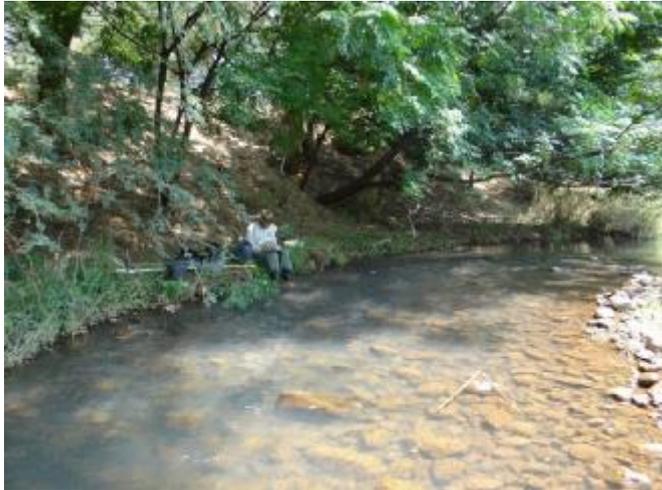
Table 33: Details and Characteristics of Site X20

River	Olifants	
Quaternary Catchment	B71B	
Co-ordinates	-24,1413.08; 30,0435.75	
IUA	10	
SQ Reach	B71B-00335	
IEI Rating	2	
WRUI Rating	4	
Survey type	Biological	
PES	C	
COMMENTS/OBSERVATIONS		<p>Low flow observed. Invasive vegetation noted in riparian zone. High sedimentation. Water had a blue soapy feel and look to it.</p> <p>Water Quality: pH 8.6; EC 34 mS/m; DO 8.42 mg/l</p> <p>ASPT: 5.96</p> <p>Fish Habitat: Good</p>

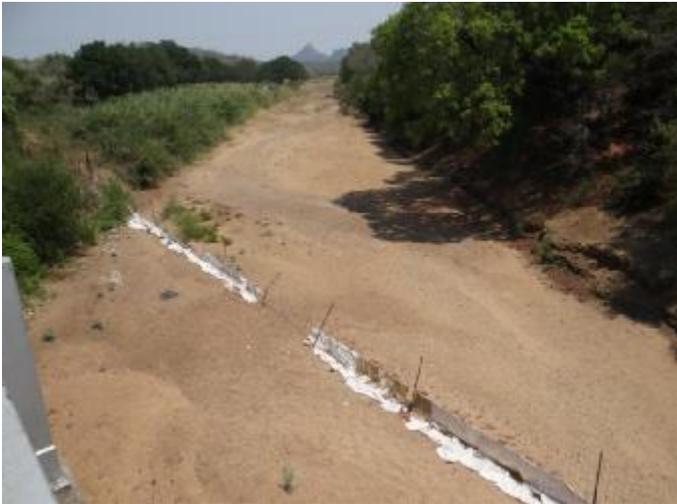
Table 34: Details and Characteristics of Site X21

River	Motse	
Quaternary Catchment	B71E	
Co-ordinates	-24,1852.46; 30,1023.34	
IUA	10	
SQ Reach	B71E-00429	
IEI Rating	1	
WRUI Rating	4	
Survey type	Biological	
PES	E	
COMMENTS/OBSERVATIONS	<p>No fish. Very little water - mostly ephemeral. Some water observed, from rain earlier in week. Little cobble present, mostly sand and no marginal vegetation.</p> <p>Water Quality: pH 8.5; DO 5.84 mg/l</p> <p>ASPT: 6.00</p> <p>Fish Habitat: Poor</p>
