A High Confidence Reserve Determination Study for Surface Water, Groundwater, and Wetlands in the Upper Orange

WP11343 River Survey Report 2

REPORT NO.:
RDM/WMA13/00/CON/COMP/1223

Title: River Survey Report 2

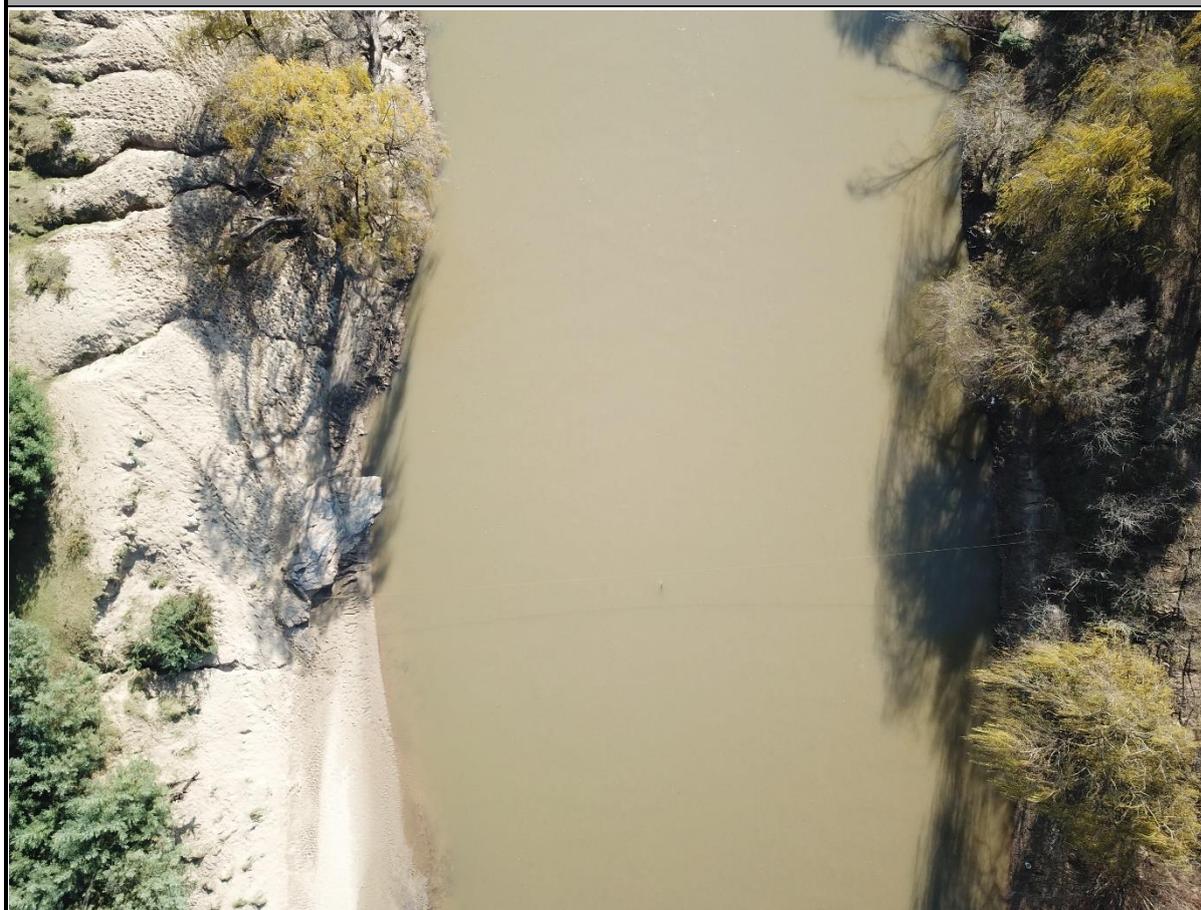
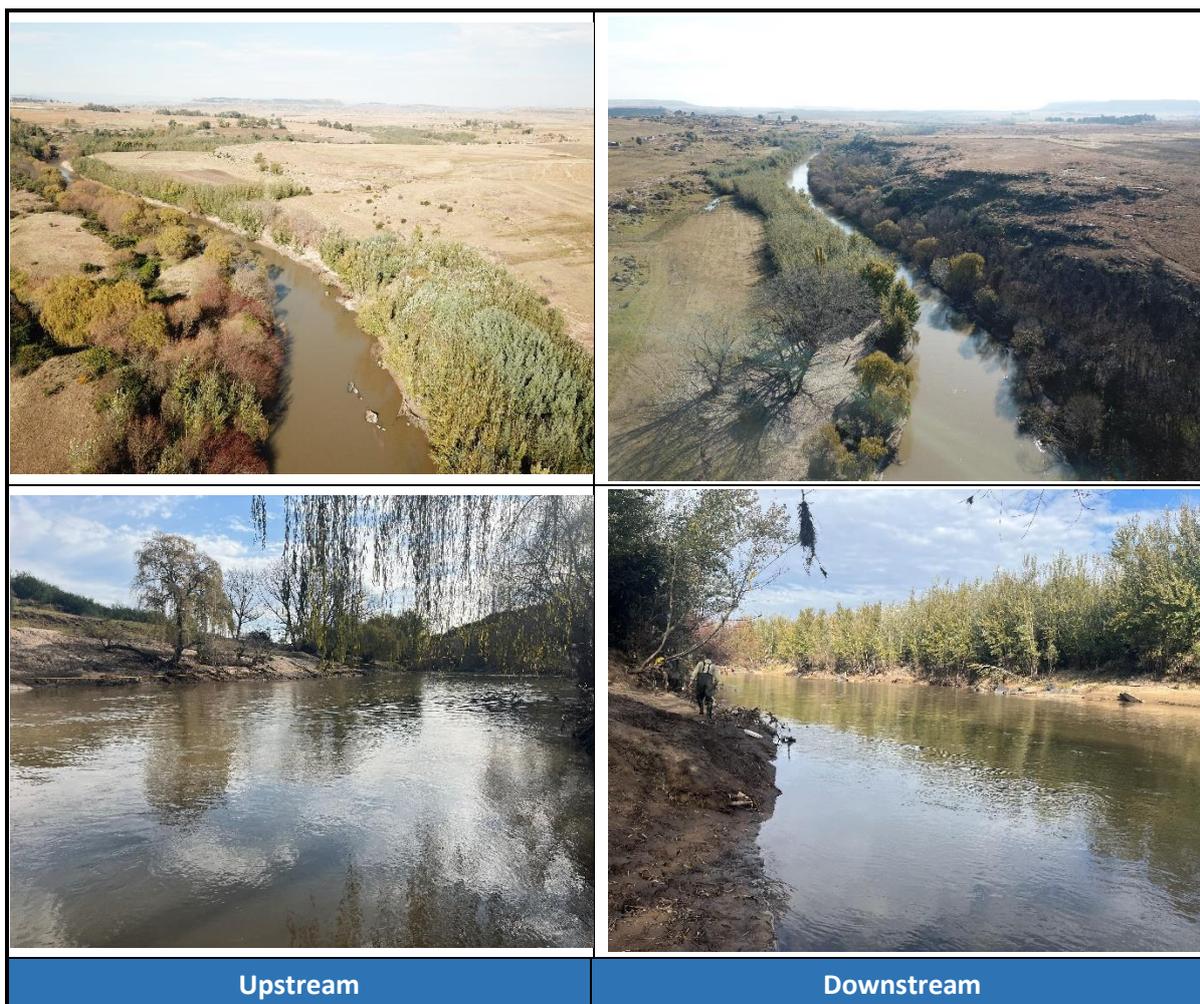
Site Photographs: Survey 2 (May 2023)

Upstream **Downstream**

The reach is partly confined with a deeply incised channel. The width is approximately 50m, homogenous with some inundated sandbars along the channel. The riverbed is very muddy and both banks are sandy, steep and highly erodible. Habitat availability for biota is poor and the water very turbid. The surrounding area is a mix of settlements, grazing areas and small-scale croplands. The Lesotho side is heavily overgrazed and eroded contributing to the already high fine sediment load and evidence of sediment deposition.

The riparian zone is defined by a deeply incised channel with steep banks that are infested by invasive alien trees (IAPs), notably Black Locust (*Robinia pseudoacacia*) on the right bank and Poplar (*Populus candescens*) and Wattle (*Acacia deacurrens*) on the left bank, interspersed by Weeping Willow (*Salix babylonica*). The marginal zone is inundated by high baseflows, and the

lower banks are devoid of vegetation. The riparian vegetation is also heavily impacted by bank erosion, footpaths and livestock trampling, and litter snagged in vegetation and scattered along the banks highlights a solid waste problem upstream.

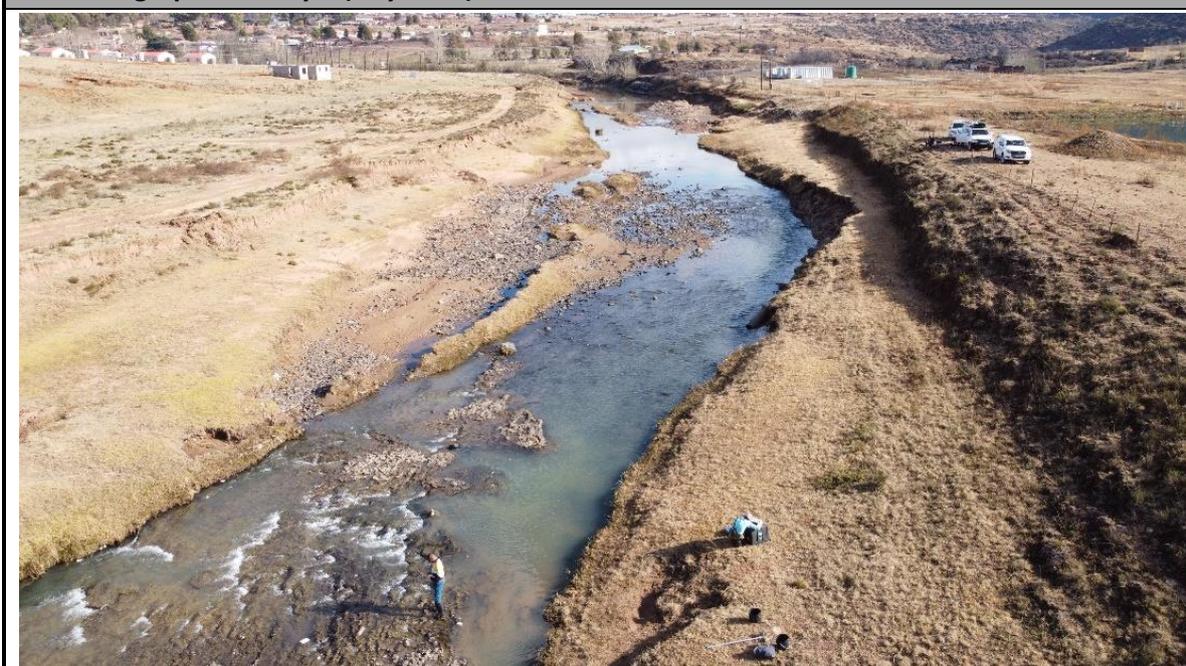
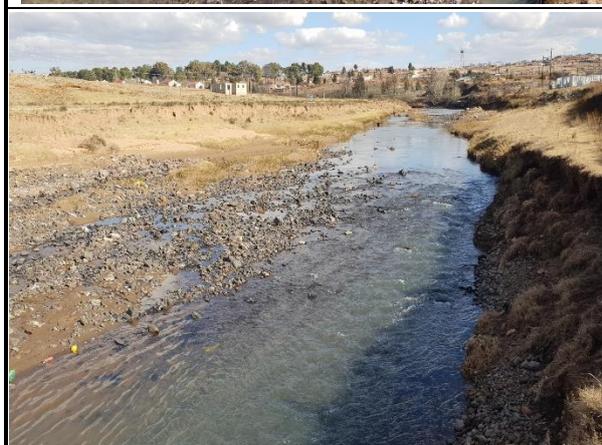
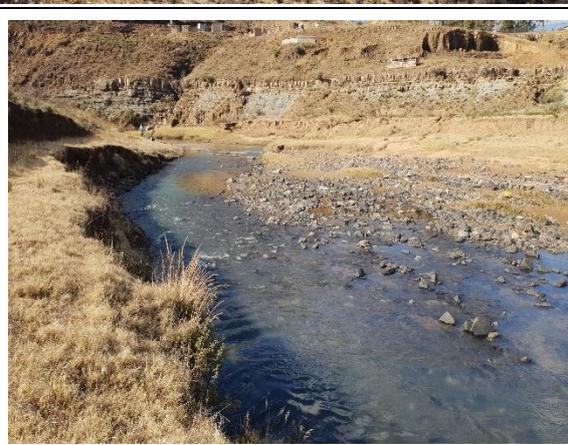
Site Photographs: Survey 1 (July 2022)

The site is located downstream from the town of Sterkspruit and Hershell, but just upstream of the Sterkspruit sewage maturation pond (see inlet and overflow into the Sterkspruit in the above image). The valley setting is confined, with cobbles, boulder and bedrock forming riffles and pools. The river is ~5m to 10m wide (macro channel 30m wide) with some bed and channel modifications, erosion on both banks, and cattle trampling and grazing. Biotopes available for macroinvertebrates included SIC, SOOC and slated/fractured bedrock, along with Gravel, Sand, Mud (GSM) and limited marginal vegetation, owing to undercut banks and vegetation die-back during both surveys. For fish there was Slow-Deep (SD), Slow-Shallow (SS) and FS. Various sections of riffles and runs present. Moderate algae content and very high macroplastics in-stream, including domestic plastic (nappies).

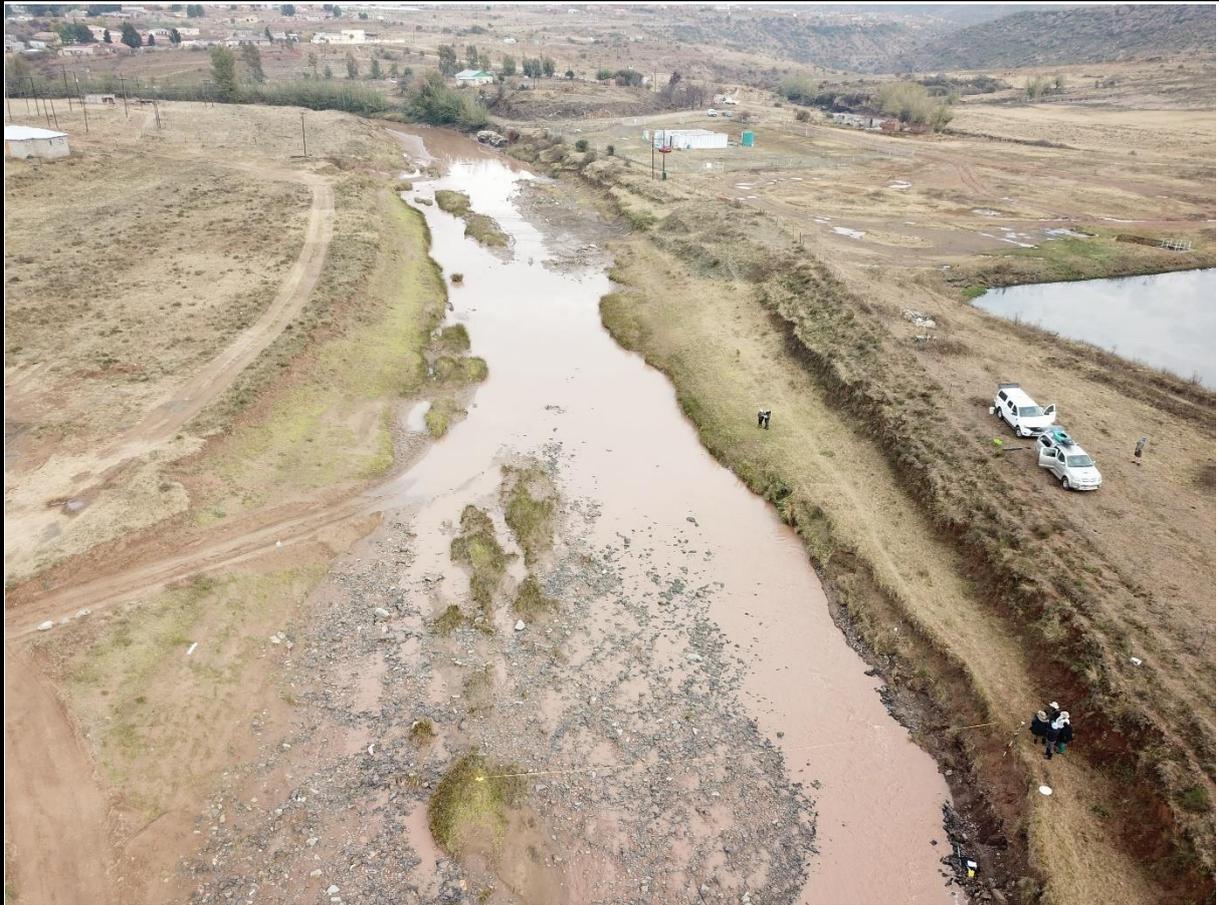
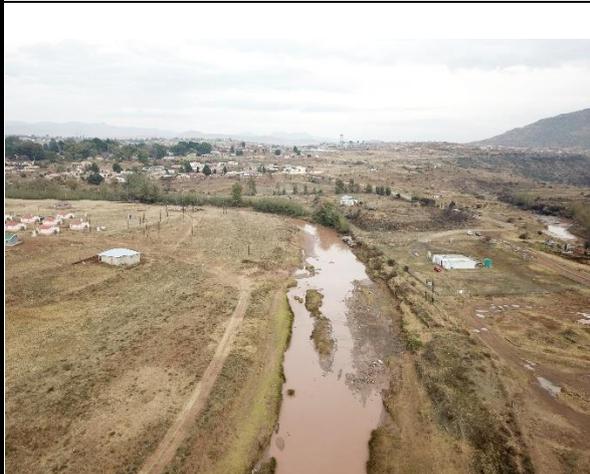
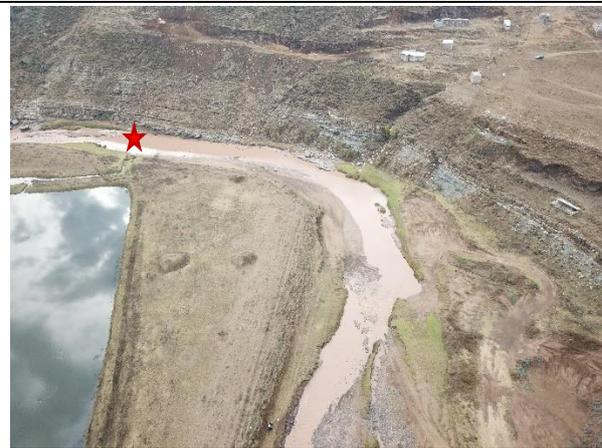
Site Photographs: Survey 2 (May 2023)

During the May 2023 survey, the water was considerably turbid, likely owing to recent rainfall events resulting in sediment loading downstream. Furthermore, there is much sand mining taking place, particularly at the EWR site itself, in-channel (Figure 1), and just above the site, mountain cutting activities are taking place to clear foundations for settlements (Figure 2). All having a detrimental impact on the functioning of this ecosystem.

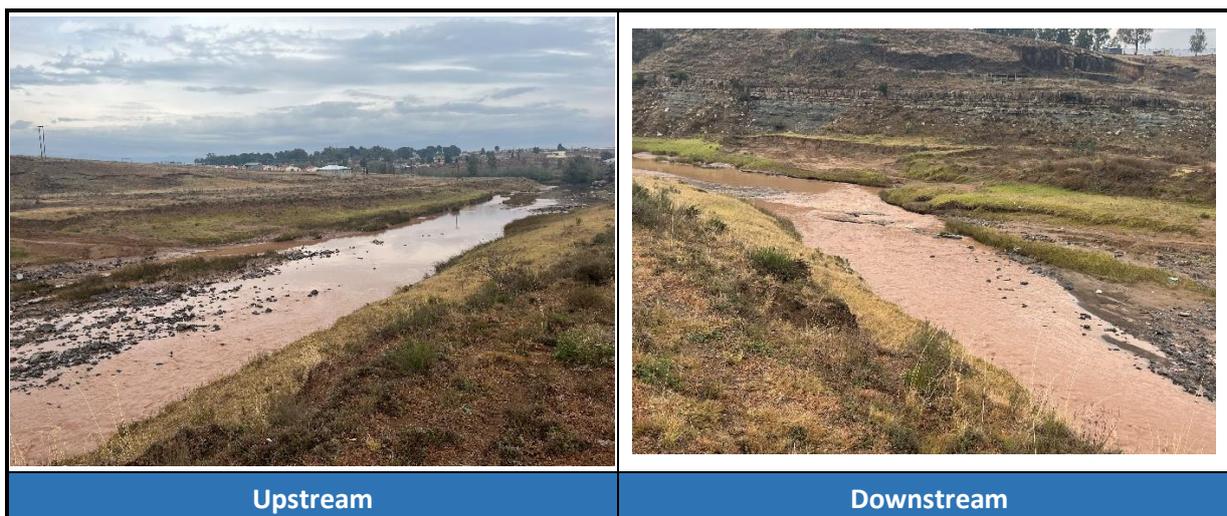
★ Inlet into the Sterkspruit from the adjacent maturation pond

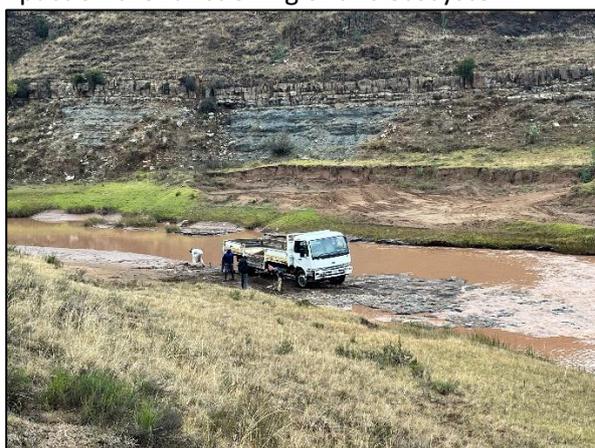
Figure 1: Sand mining at the EWR site in-channel

Both marginal and non-marginal zones have been severely impacted by sand mining operations at various points across the site, with additional impacts from rubbish dumping, livestock grazing/trampling, invasive alien plants (IAPs), bank erosion/collapse and sediment deposition. Nevertheless, the site retains reasonable riparian vegetation with some encroachment from terrestrial plant species. Areas not directly impacted by sand mining support good marginal vegetation dominated by *Cyperus marginatus*. The non-marginal zone is dominated by the grass

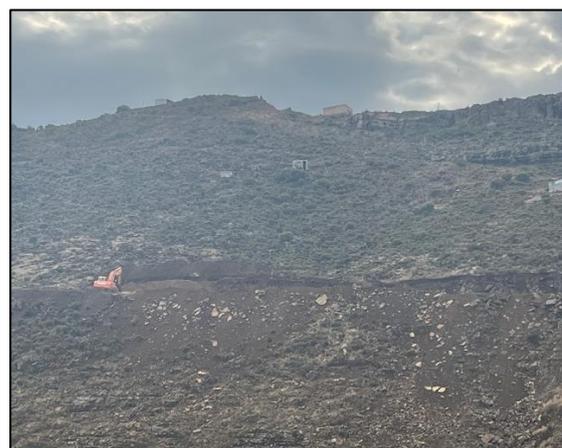
Figure 2: Mountain cutting to create foundations for settlements

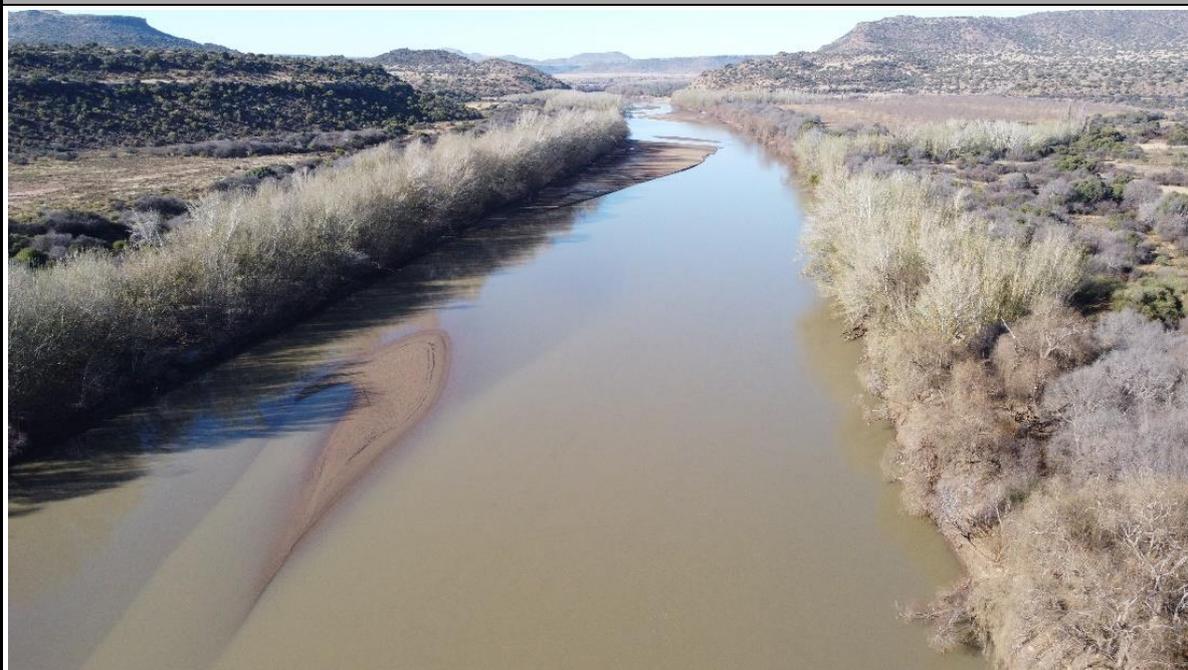
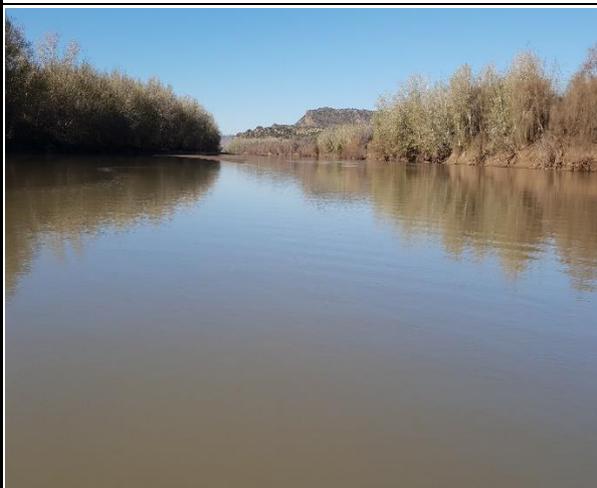
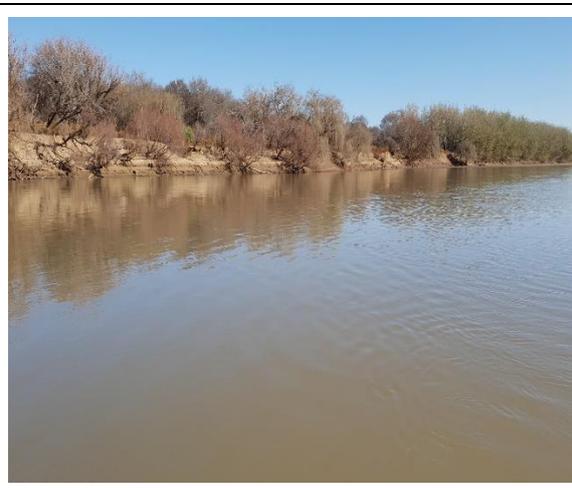
Site Photographs: Survey 1 (July 2022)

The site is located along a partly confined valley setting with terraces and narrow flood benches along both banks with an incised channel. The river is ~120m wide and homogenous sand bed channel with limited habitat diversity and exposed sand bars along the right bank. The site is located ~8 km upstream from the confluence of the Kraai River. The surrounding area is mostly agriculture with small-scale croplands and grazing areas. Intense in-stream sand mining both downstream and upstream of the site. The macrochannel is sandy and the steep fine sand and silt banks prove to be highly erodible. Both banks show recent erosion along the lower margins,

removing inset benches. Thickets of heavy infestation of *Salix sp.* and *Populus sp.* on both sides of the riverbanks. However, it is likely these trees are aiding in stabilising the macro channel banks to limit lateral migration. The water is turbid, and the riverbed is dominated by a featureless sand bed.

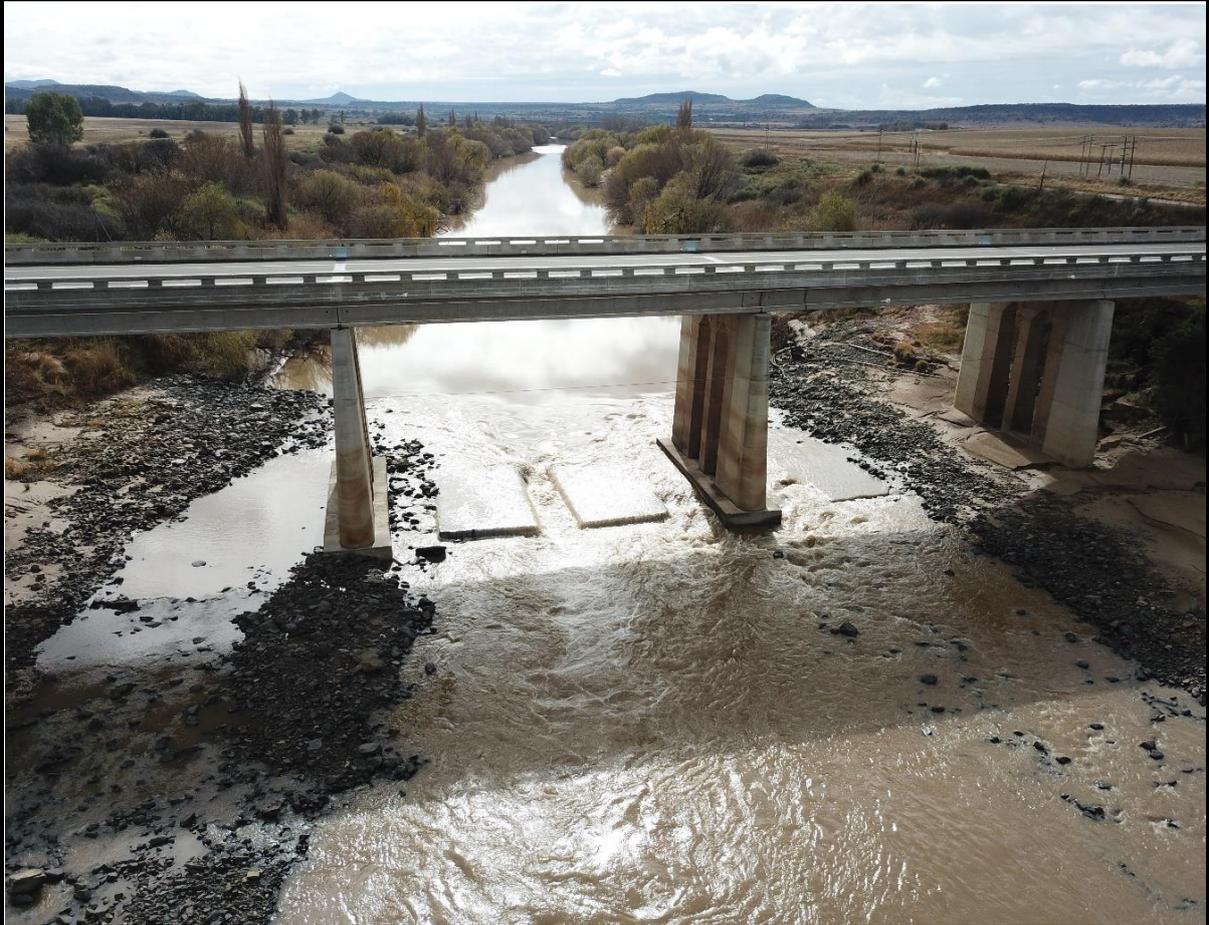
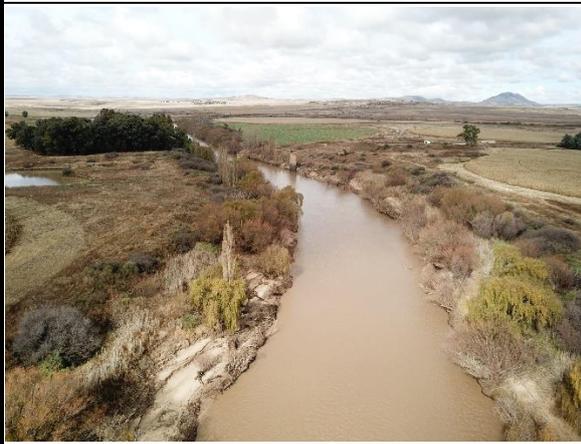
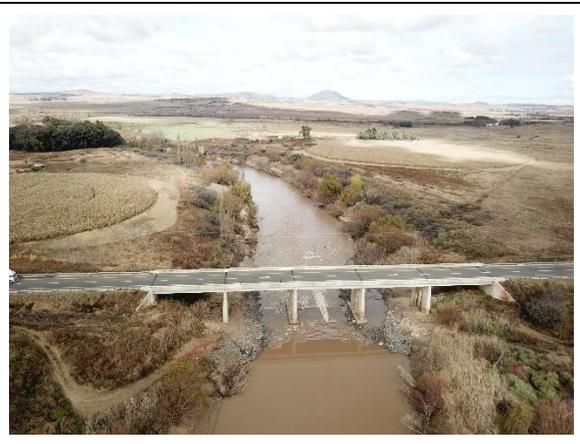
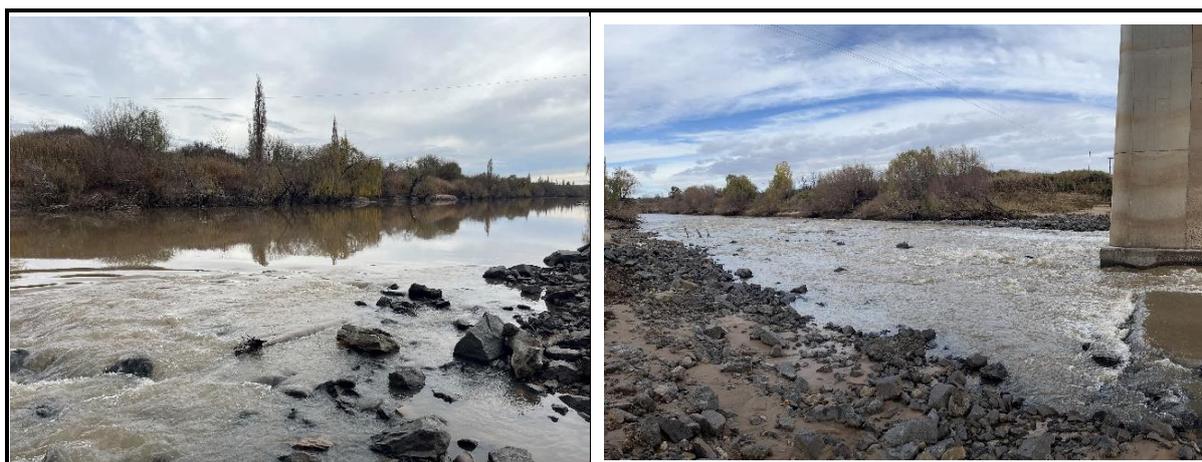
Site Photographs: Survey 2 (May 2023)

Just downstream of the N6 road bridge between Rouxville and Smithfield. The water transfer from the Caledon River to the Knellpoort Dam and the Welbedacht Dam are ~100km upstream. The surrounding land use is extensive sheep farming with localised irrigation of lucerne from the Caledon River. High silt loads in this river, abstracted for irrigation, are causing significant problems for local farmers with “fines” clogging the soil pores and preventing water penetration. The site is located along an unconfined low gradient reach. The channel is relatively straight, incised into the surrounding landscape with narrow flood features. The banks are steep and lined with invasive trees and annuals. Salix and Populus trees dot the riverbanks from the waterline to ~10 m from the water. The river at this site is ~50-70m wide and defined by a couple of strong basaltic intrusions diagonally across the river defining a narrow (~5m wide) resistant bedrock shelf and providing the key geomorphic structure to this reach of the river. Coarse material (boulder and cobble sized) has been introduced for the bridge construction. This has created a series of concrete shelves under the bridge and boulder and cobble shoots, runs and riffles directly downstream of the bridge. At the reach scale the system is dominated by the finer alluvial sands and silts from active upstream erosional processes. These sediments are regularly and extensively deposited onto the riverbanks and under lower flows defines a fine sediment dominated bed and braided main channel.

The marginal riparian zones are bare with emergent Salix mucronata trees (including some that are dead). This pattern extends into the lower portion of the lower zone. Beneath the bridge there is a broad area of exposed rocks and sand with very little vegetation cover. There is an abrupt increase in vegetation cover higher up the non-marginal zone which exists as a mosaic of woody and non-woody vegetation. A number of IAPs were recorded, namely *Cyperus eragrostis*, *Bidens pilosa*, *Gleditsia triacanthos*, *Persicaria lapathifolia*, *Populus nigra*, *Salix babylonica* and *Tagetes minuta*.

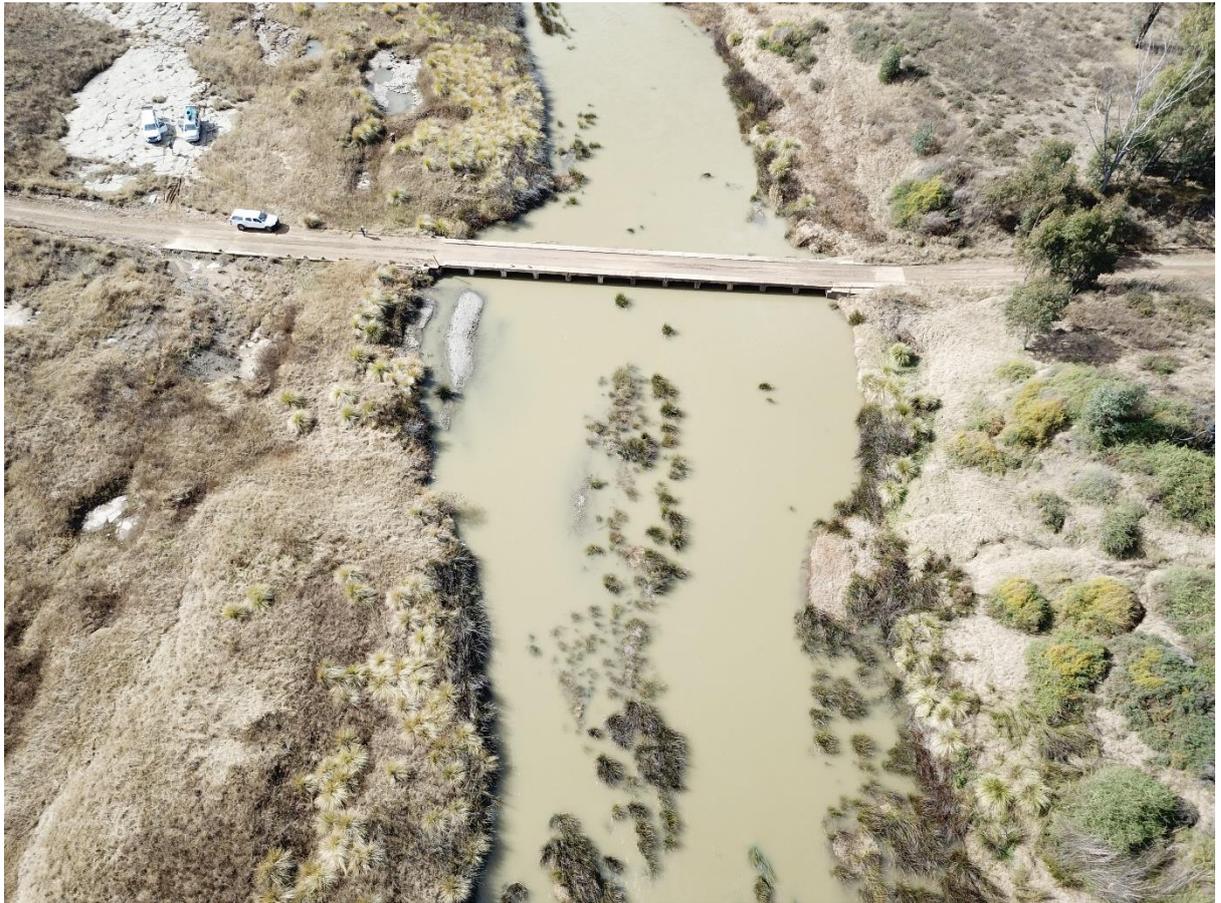
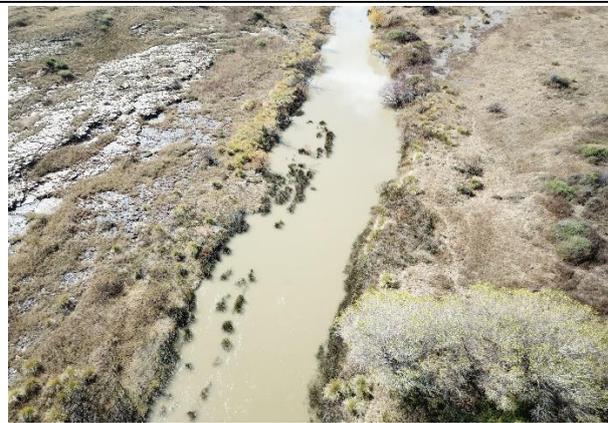
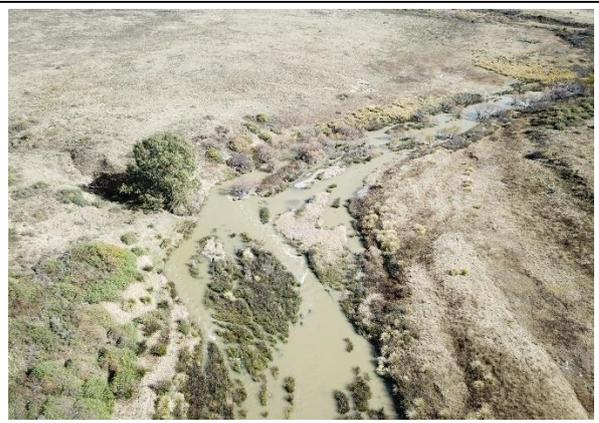
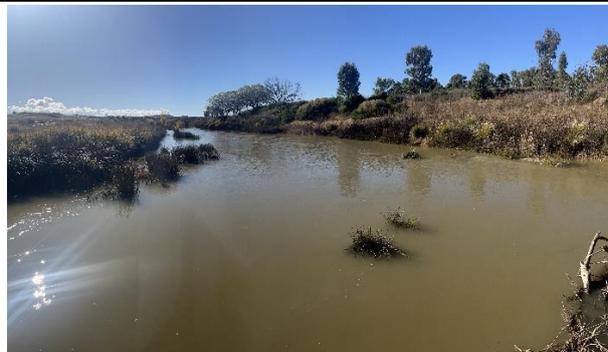
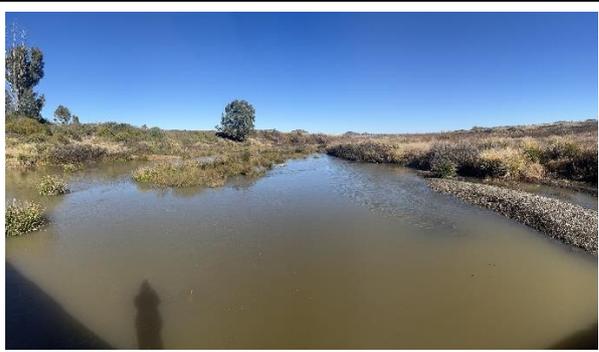
Site Photographs: Survey 2 (May 2023)

The reach is largely unconfined, with the macro channel incised into the gently sloping hillslopes. The river has a straight to sinuous macro channel pattern, with a braided low flow channel pattern. Bedrock, boulder, gravel and silt common sediment types at the site. This site is located in the upper reaches of the Riet River, upstream of the Kalkfontein Dam Nature Reserve and ~20km upstream of the confluence of the Kromellenboog. Upstream of this site is the DWS REMP site and previous JBS3 site C5RIET-IFR03 and 26_10 respectively. The Riet River is a main tributary of the Vaal River and flows in a western direction. The site is located just downstream of a low water cross-over bridge, where log jams have occurred upstream of the bridge, impeding the hydraulics of the river, as well as inundation of the system upstream.

The turbid channel is ~40m wide and braided downstream of the bridge owing to in-stream vegetated and gravel islands. The substrate at the site is dominated by gravel and cobbles, a section of bedrock along the left side of the channel. The forming braids have resulted in small streams running through the instream island with rocky habitat for macroinvertebrates and fish, sections of SOOC and mud forming allowing for instream vegetation. Small pools have formed as back eddies from the vegetated sedimentation which has formed. The increased flows have allowed aquatic grass to establish in the deep runs. Marginal vegetation was abundant and comprised reeds, grasses and sedges. Bank erosion from cattle trampling was evident, more so along the right bank, along with undercut banks.

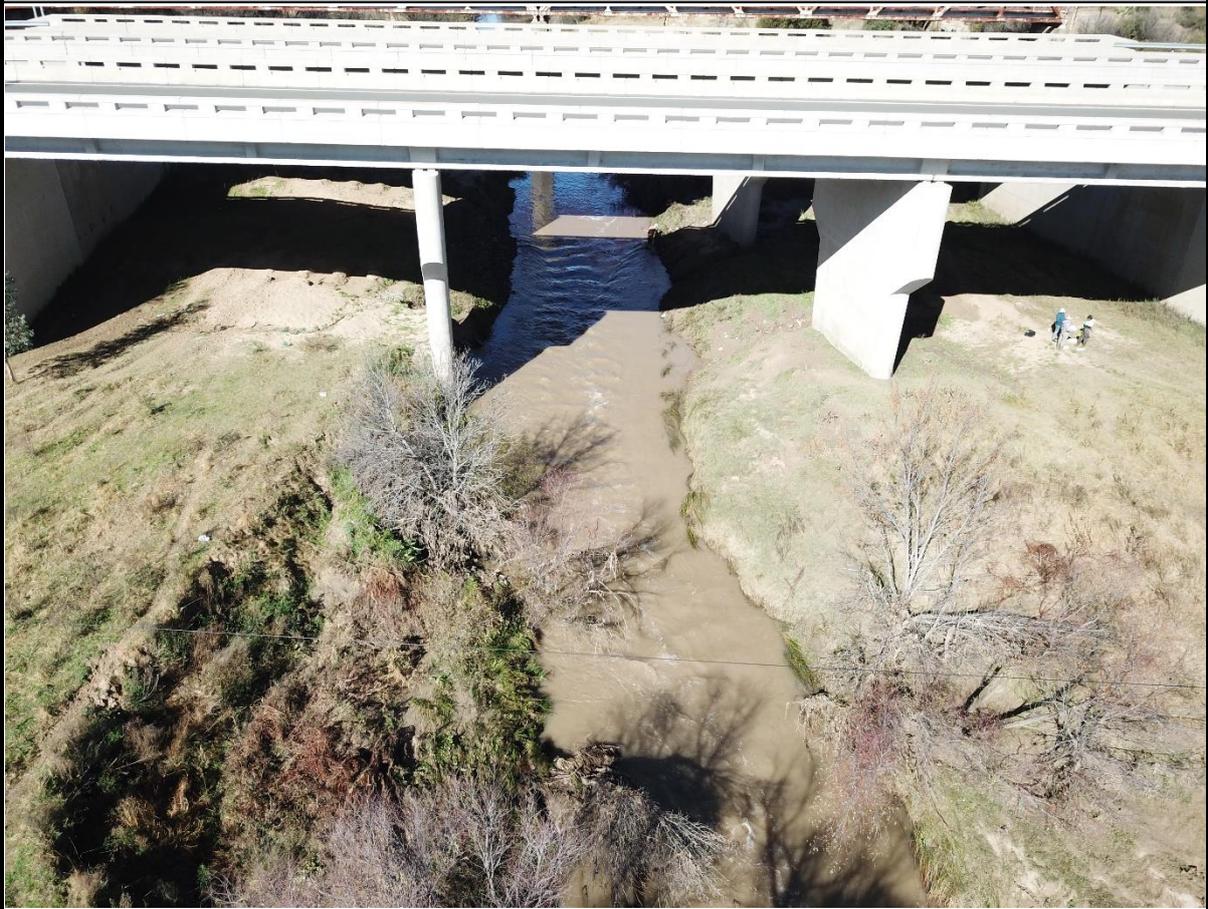
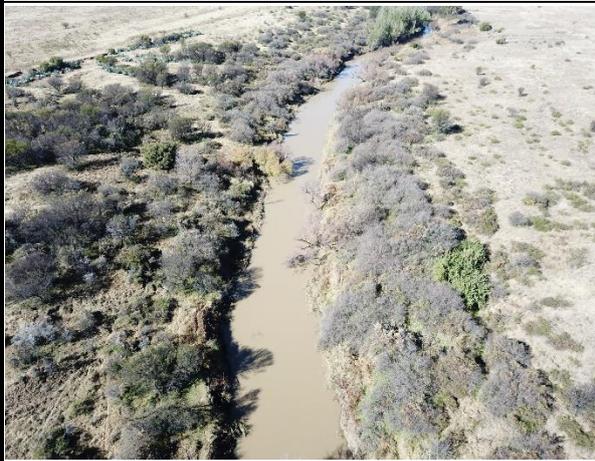
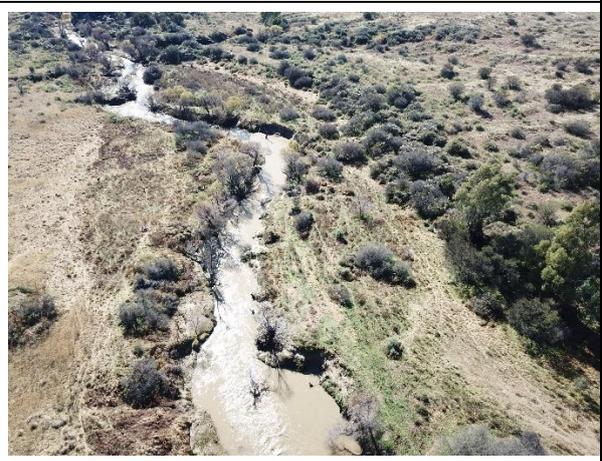
Site Photographs: Survey 2 (May 2023)

The reach is largely unconfined, with gently sloping hillslopes and an incised channel with narrow flood features. The site is bedrock controlled with silty banks and introduced coarser bed material. Gravel and sand bars are present downstream of the site. The site along the upper reaches of the Modder River is located ~30km east of Bloemfontein off the N8, with its confluence downstream with the Riet River near the town of Ritchie. The site is situated approximately 13 km downstream of Rustfontein Dam. It is impeded by two (2) railway crossings and a large bridge. Furthermore, a gauging weir is located just upstream of the site. The river width varies from 3 m to 15 m in places with inundation taking place just upstream of the weir. Owing to these influences and impediments, much of the instream substrate, downstream of the weir comprises riffles with artificial loose SIC, and some SOOC. However, bedrock is the dominant substrate from the bridge and further downstream. There is relatively good GSM, but marginal vegetation, being grasses and sedges, was limited owing to undercut banks and vegetation die back (representative of the season). Sedimentation is present downstream of the weir forming a back eddie along the sandbank with algae on the rocks at the river's edge. Overall, considerable channel and bed modification is present at this site. Both banks are heavily eroded owing to recent flooding, flow modifications and cattle trampling.

The riparian zone has been affected by altered flows as a result of Rustfontein Dam located upstream, with localised impact caused by the bridge structures associated with the N8 and the railway line, as well as the gauging wier. The right bank, upstream of the wier has a dense stand of exotic Populus trees (*Populus canescens*). There has been an increase in woody vegetation, inclusive of IAPs and encroachment of terrestrial species such as *Vachellia karroo* and *Searsia lancea*. Erosion along the banks is exacerbated by runoff from the N8, as well as concentration of flows under the bridge. Various signs of impacts from cattle were also noted throughout the site.

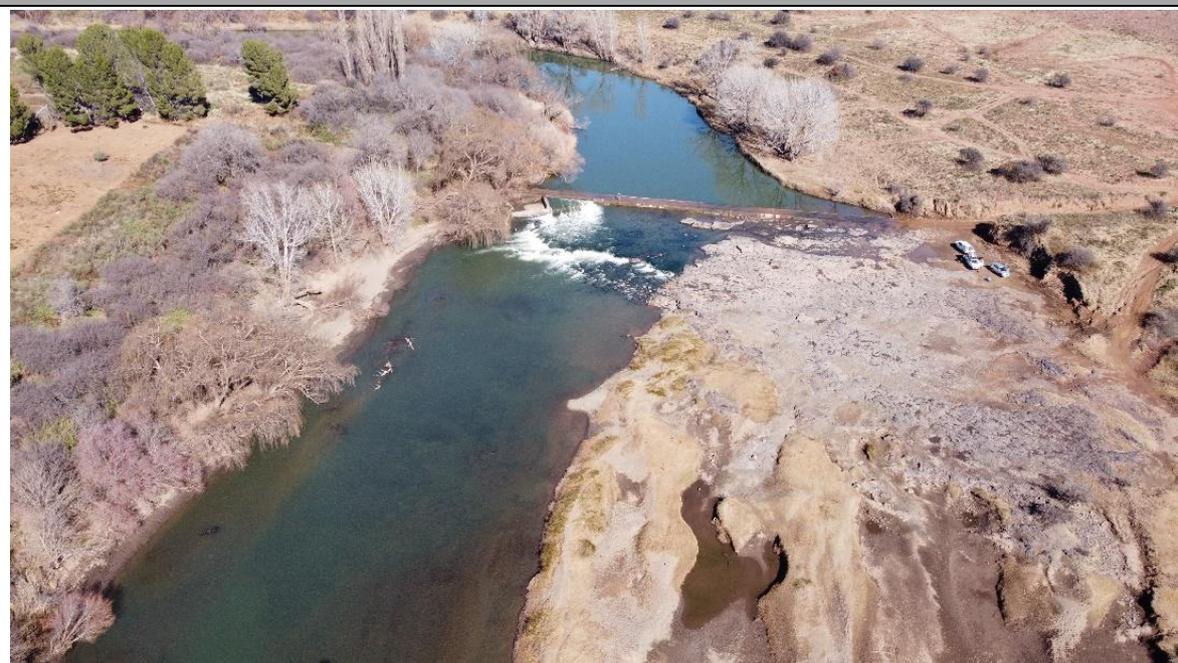
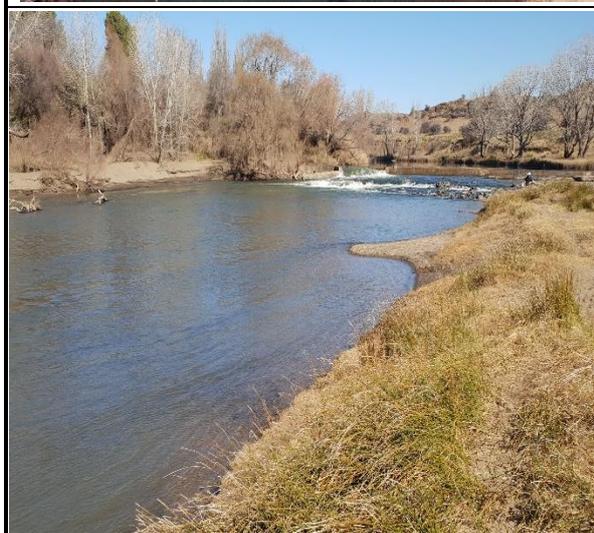
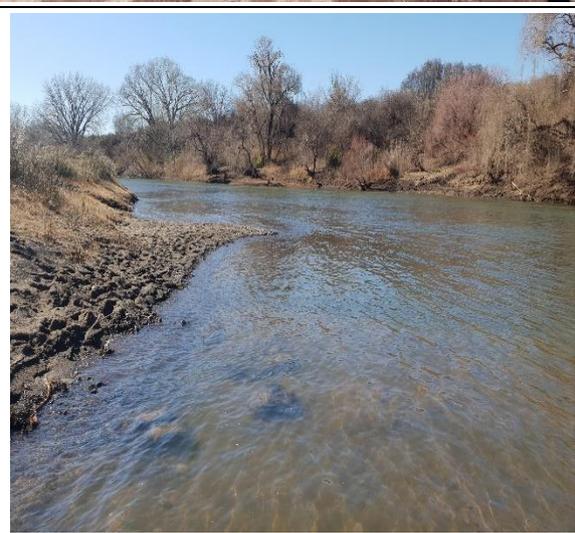
Site Photographs: Survey 1 (July 2022)

This site is ORASECOM JBS3 site (26_11) and the DWS REMP site D1KRAA-ALIWA. The reach has a partly confined valley setting, straight to wandering channel form and pool-riffle sequences. The channel is incised with narrow flood features. The site is immediately downstream of a causeway/bridge which is frequently used by farmers. There is a sluice gate on the right end of the bridge – which can be closed in times of drought or should the Orange River dry up. This functions in pooling up the river upstream of the bridge for Basic Human Needs support. This river is a free flowing river, ~30 m wide and has a range of biotopes. There is a solid igneous bedrock base with riffles and runs below the causeway. Much filamentous algae coverage over the SIC biotopes. Most of the river in the area has deeper, slow flowing pools. The river comprises various sections of riffles and pools downstream of the bridge, providing a range of habitats. All biotopes for the macroinvertebrates are present, SIC, SOOC, GSM, although vegetation is limiting owing to undercut banks and vegetation die back/erosion. For fish, there are FD, SD, SS and FS habitats. During both the July and May 2022 survey, the baseflows were higher than expected for the time of year as a result of the high rainfall during the latter part of summer.

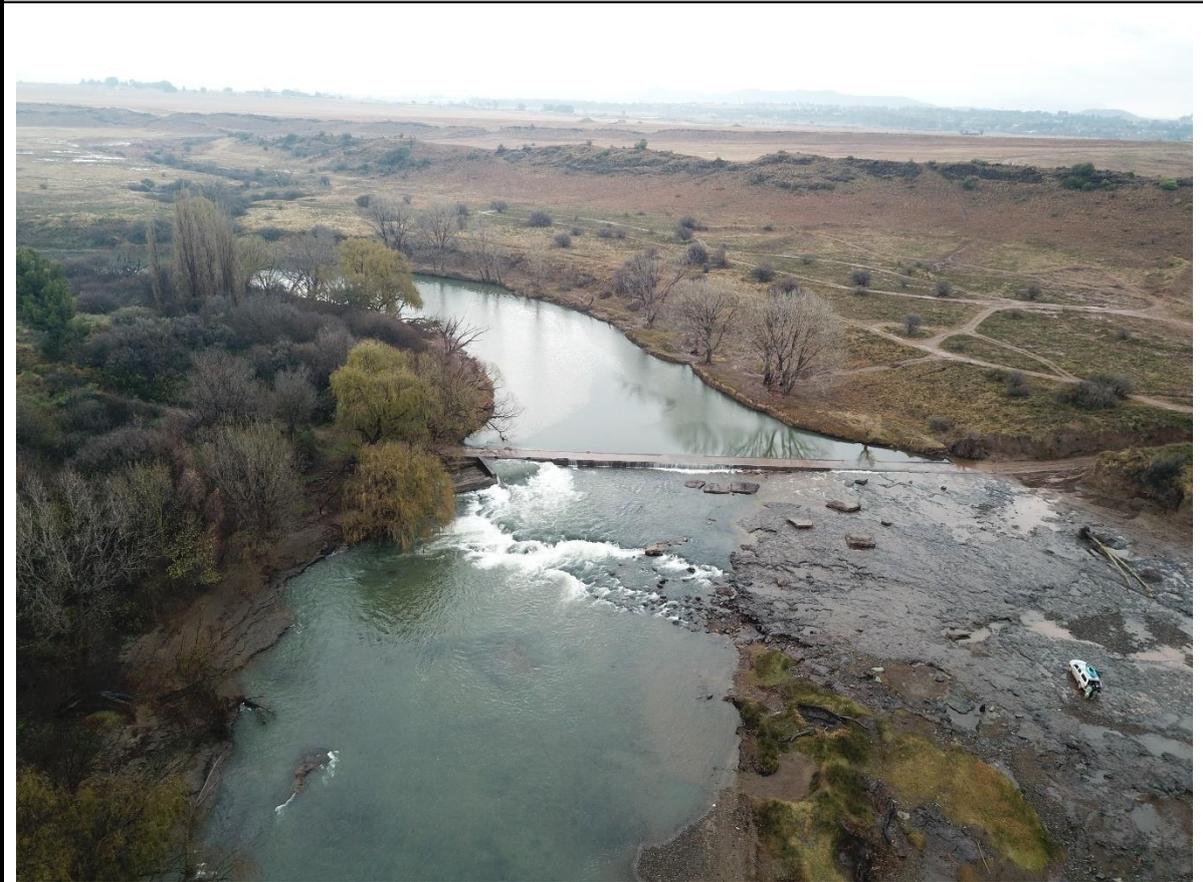
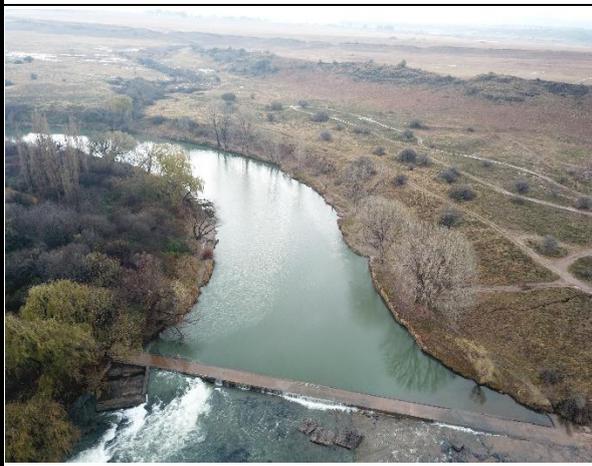
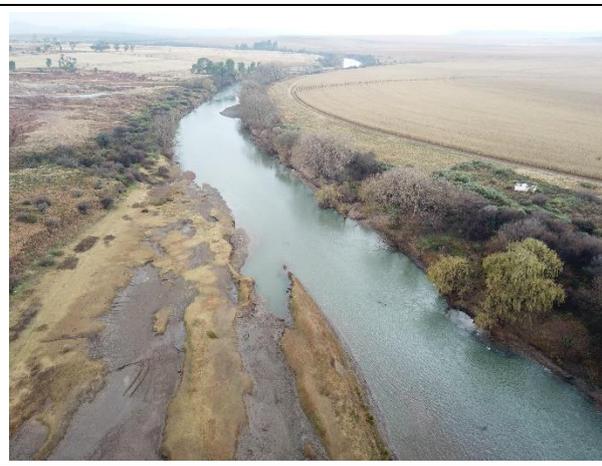
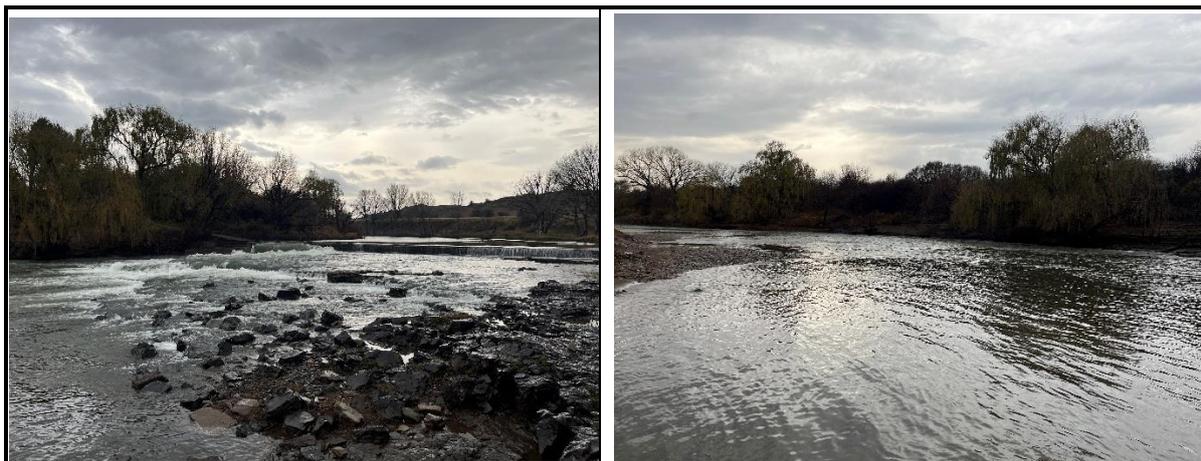
Site Photographs: Survey 2 (May 2023)

Left bank is dominated by non-woody vegetation, with several, large Poplar trees (*Populus canescens*) growing along the lower banks upstream of the weir. The site is spilt by the weir/causeway, which results in marginal zone being inundated. Downstream of the weir is a broad, flat bench of mostly bare/exposed alluvium with patches of raised alluvial mounds covered with *Cynodon dactylon* and a narrow strip of dense *Cyperus marginatus* growing along the marginal zone. The outer edge of the riparian is marked by a steep bank leading up into the terrestrial zone. The right bank has dense wooded vegetation comprising a mix of indigenous (e.g. *Celtis africana*, *Diospyros lyciodes*, *Lycium sp.*, *Salix mucronata* and *Searsia pyroides*) and IAPs (e.g. *Populus canescens* and *Salix babylonica*) which are sheltered from high velocities during flood events. There is a steep bank between the lower and upper zones. The riparian vegetation is mainly affected by vegetation removal due to roads, 4x4 tracks, footpaths, cultivation (right banks), as well as shading by IAPs. There is also serious erosion leading from the terrestrial areas into the riparian areas, especially on the left bank, as well as bank collapse and scour erosion.
