A High Confidence Reserve Determination Study for Surface Water, Groundwater, and Wetlands in the Upper Orange

WP11343 River Survey Report 2

REPORT NO.:
RDM/WMA13/00/CON/COMP/1223

Title: River Survey Report 2

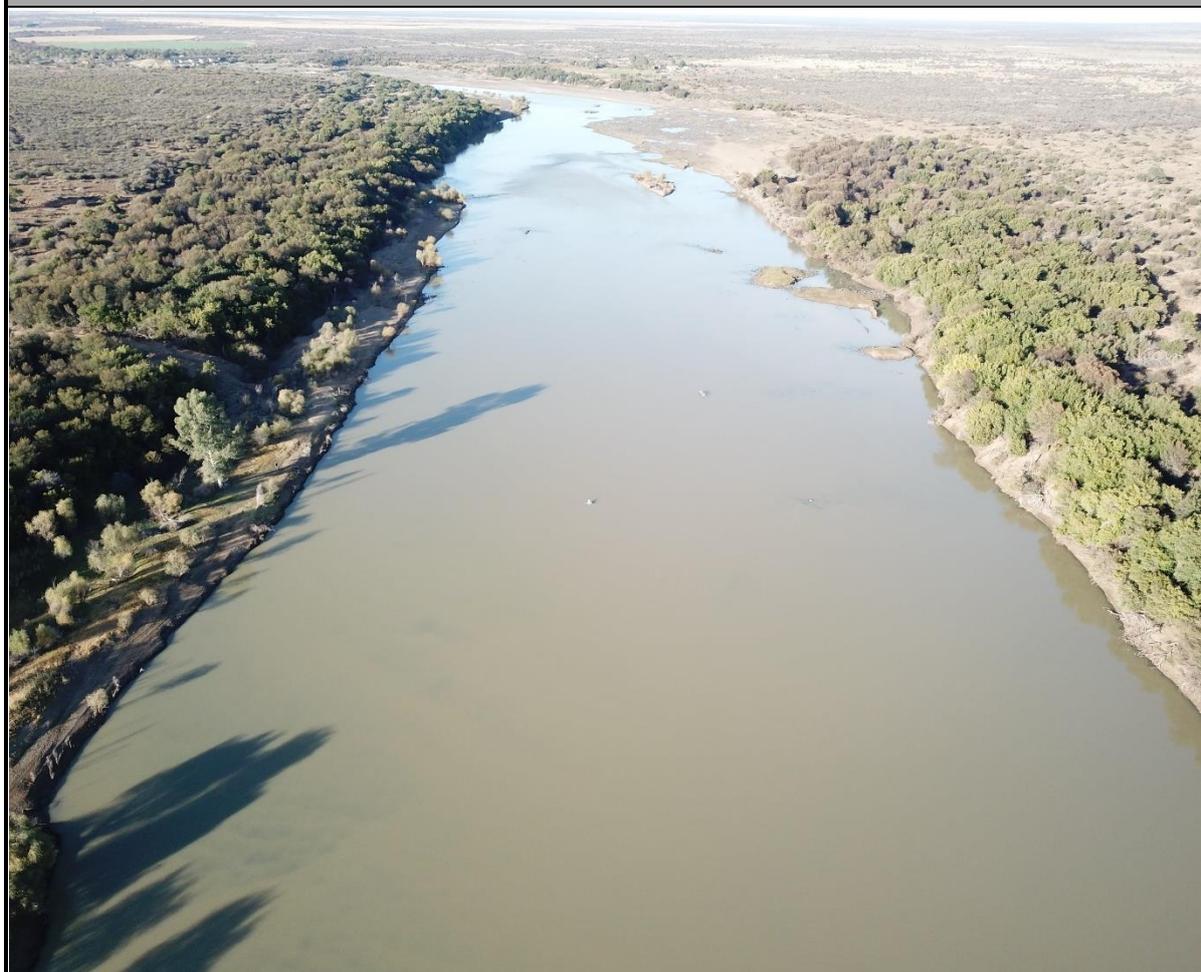
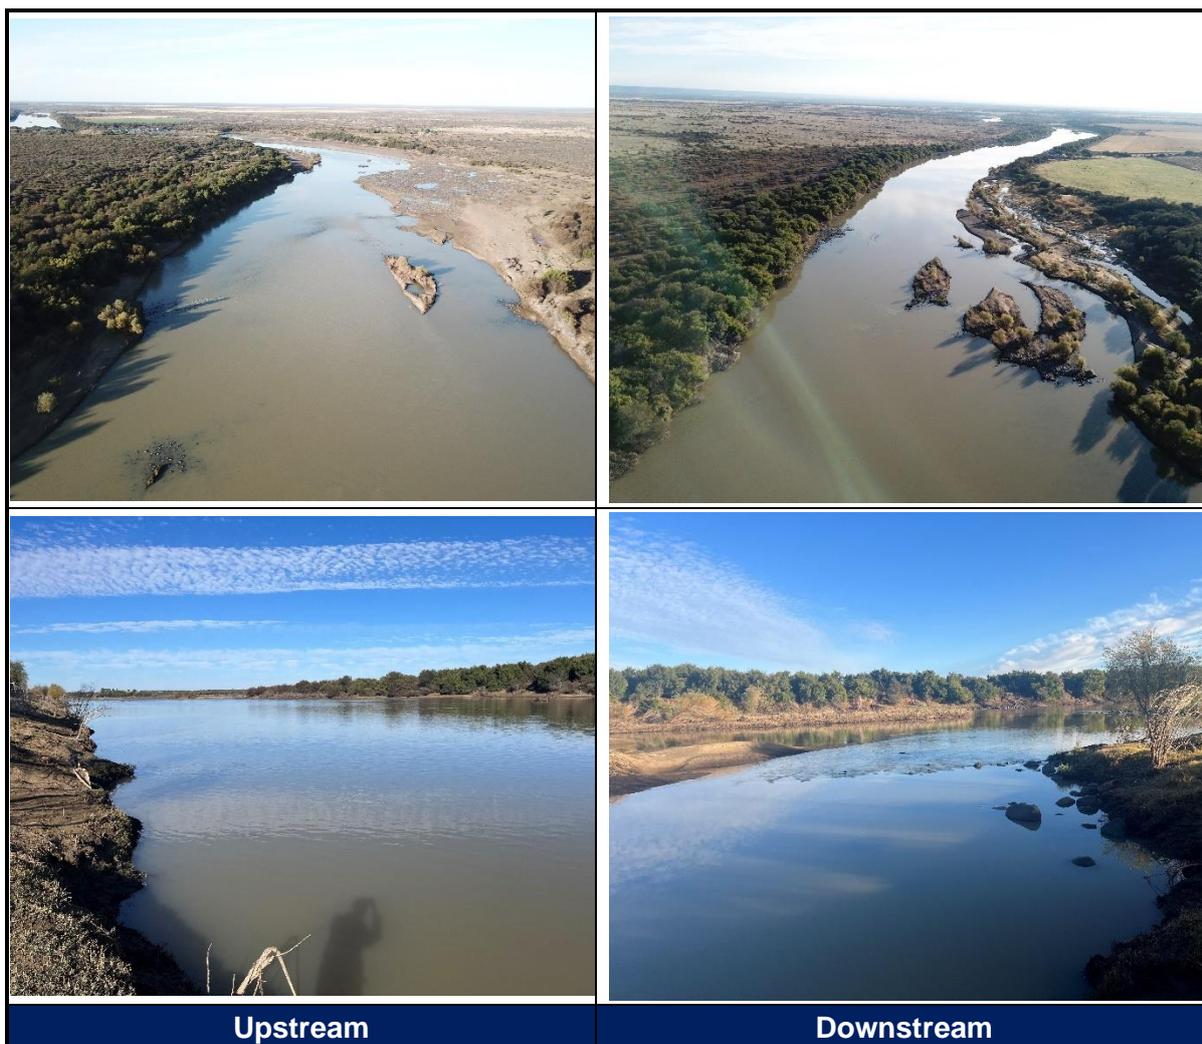
Site Photographs: Survey 2 (May 2023)

Upstream **Downstream**
