# DEPARTMENT OF WATER AND SANITATION

## A High Confidence Reserve Determination Study for Surface Water, Groundwater, and Wetlands in the Upper Orange

### WP11343 Final Wetland Fieldwork Report

REPORT NO.:  
RDM/WMA13/00/CON/COMP/0522

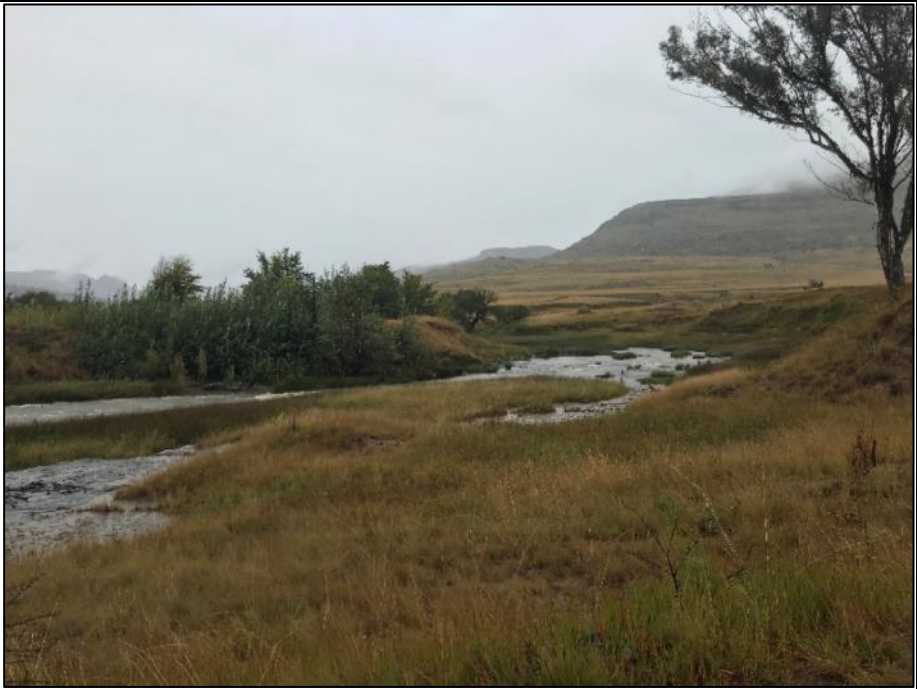
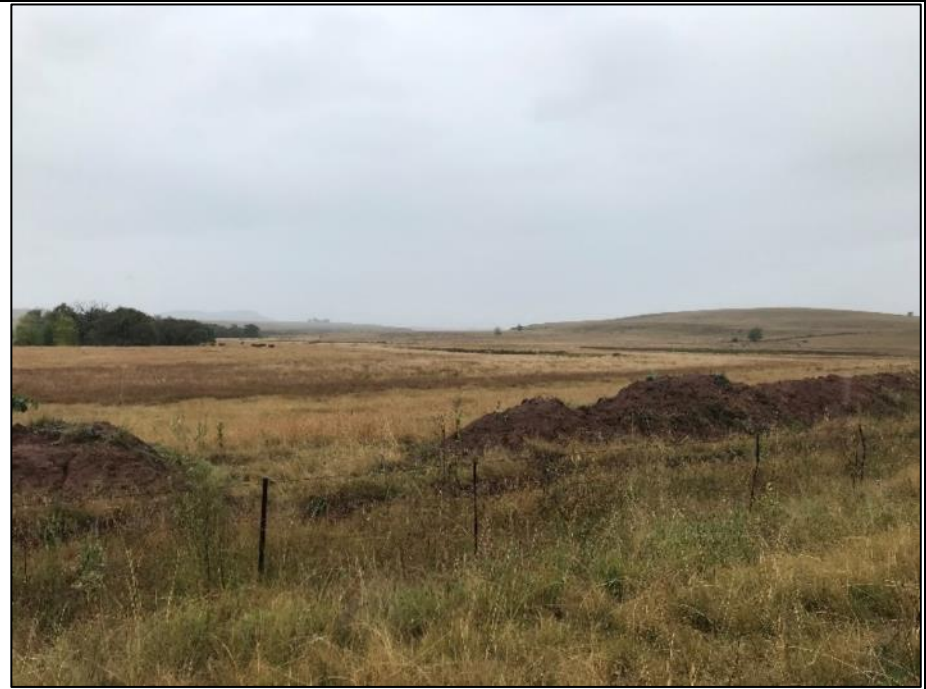
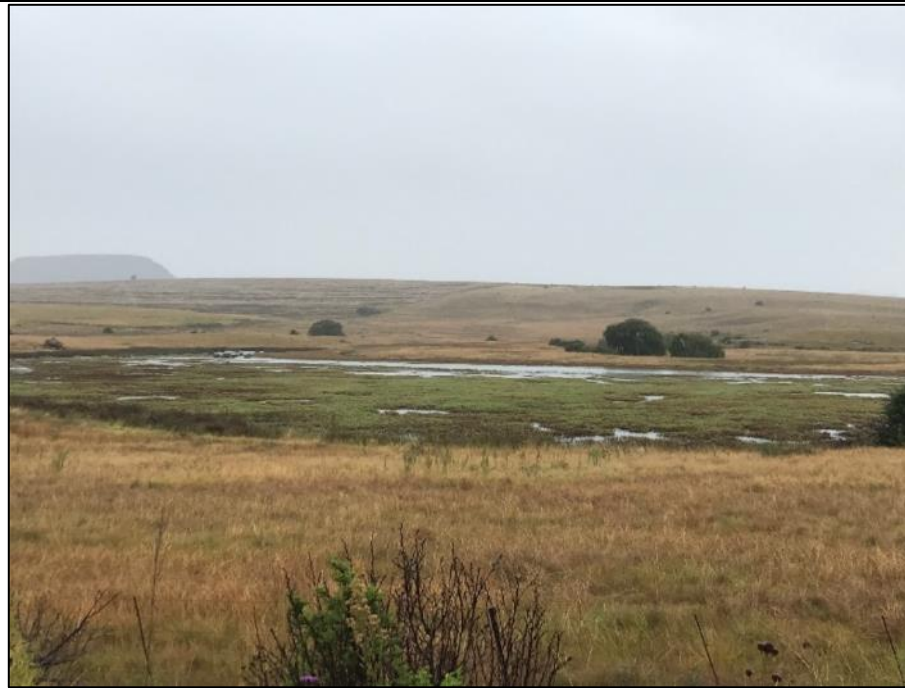
**Site Name: WRU02**

Top Left: Deeply incised and widened channel of the Brandwater River as it flows out of the southern portion of the WRU02 wetland.

Top Right: Floodplain features still maintained by lateral processes as indicated by darker patches of vegetation in the central and right-hand side of the photograph.

Bottom: Oxbow lake located in the northern portion of the floodplain wetland.

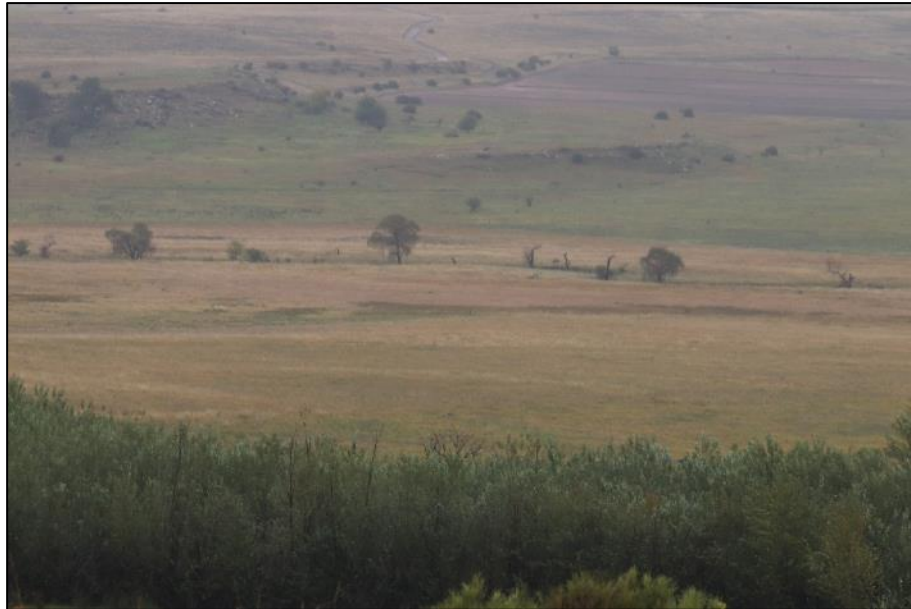
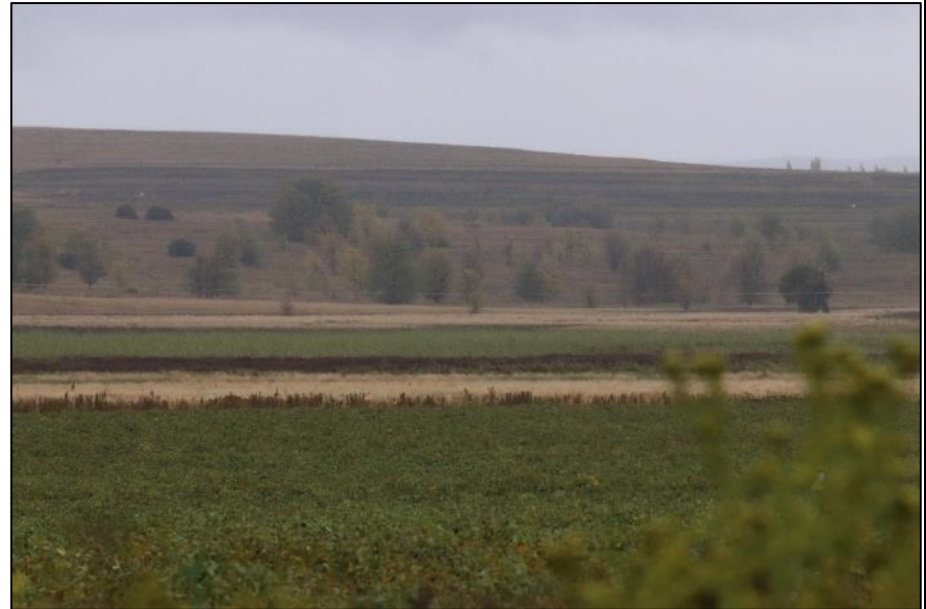
**Site Name: WRU13**

Left: Middle section of the floodplain wetland before it loses confinement. Dark patches adjacent to the channel indicate wetland vegetation and lateral seep processes that support wetland habitat.

Right: Picture taken from the toe of the wetland looking upstream. Green fields in the foreground are cultivated and green band in the middle of the picture is the extensive unchannelled valley-bottom and reedbed.

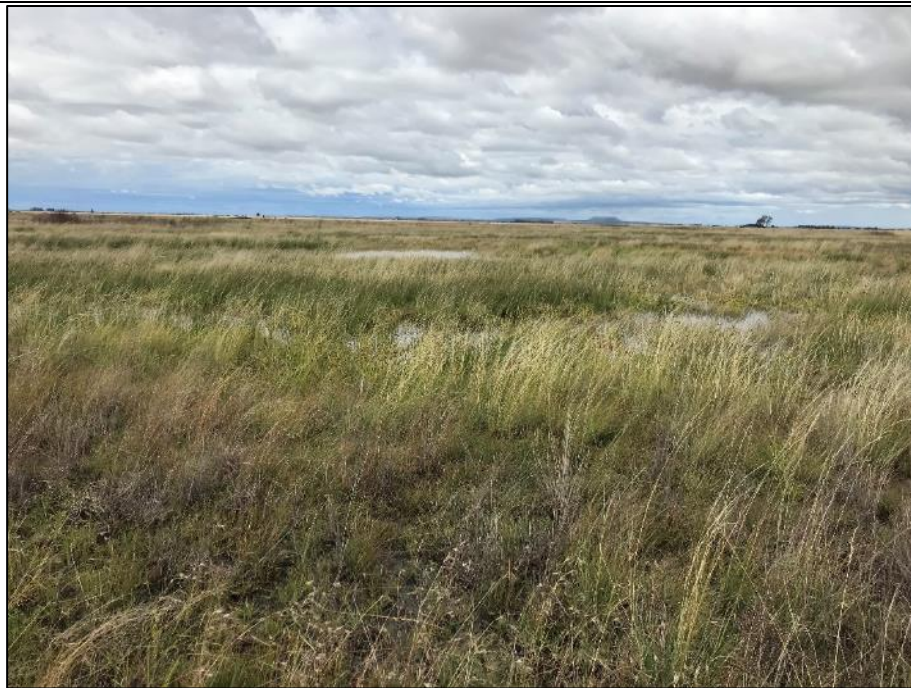
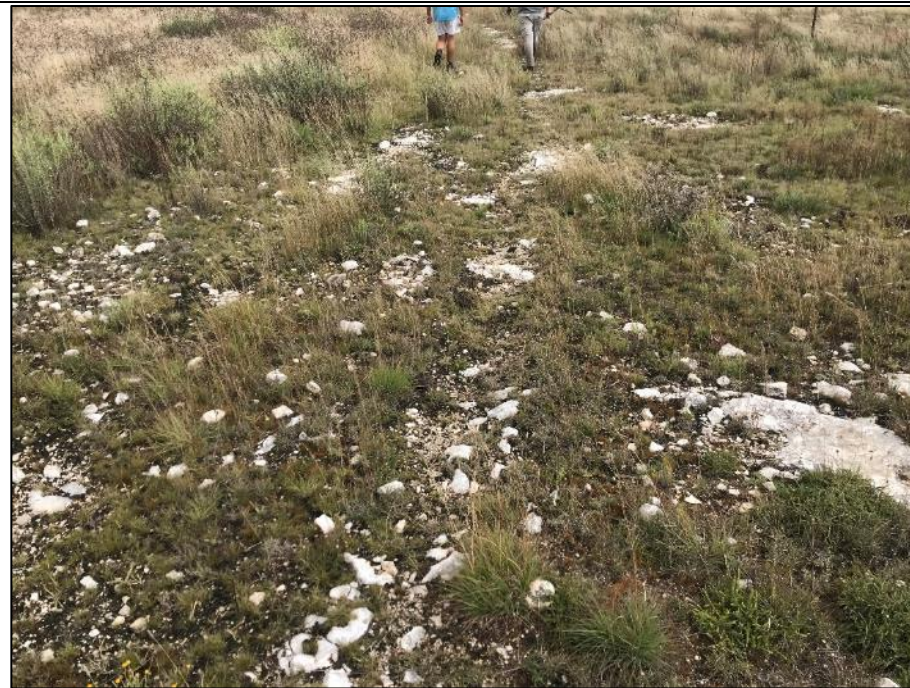
**Site Name: WRU12**

Left: Middle section of the large wetland flat looking upstream. Extremely flat topography with extensive areas of standing water due to recent heavy rains in the region.

Right: Evidence of very shallow soils in areas of the wetland. Picture depicts area of non-wetland, but similar outcrops were encountered frequently when augering within the wetland boundary itself.

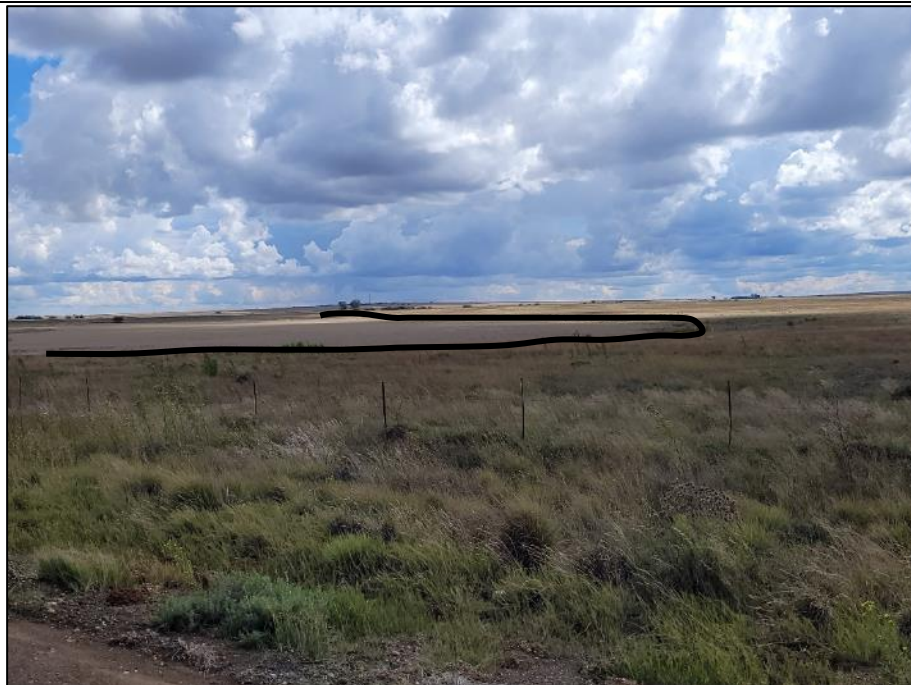
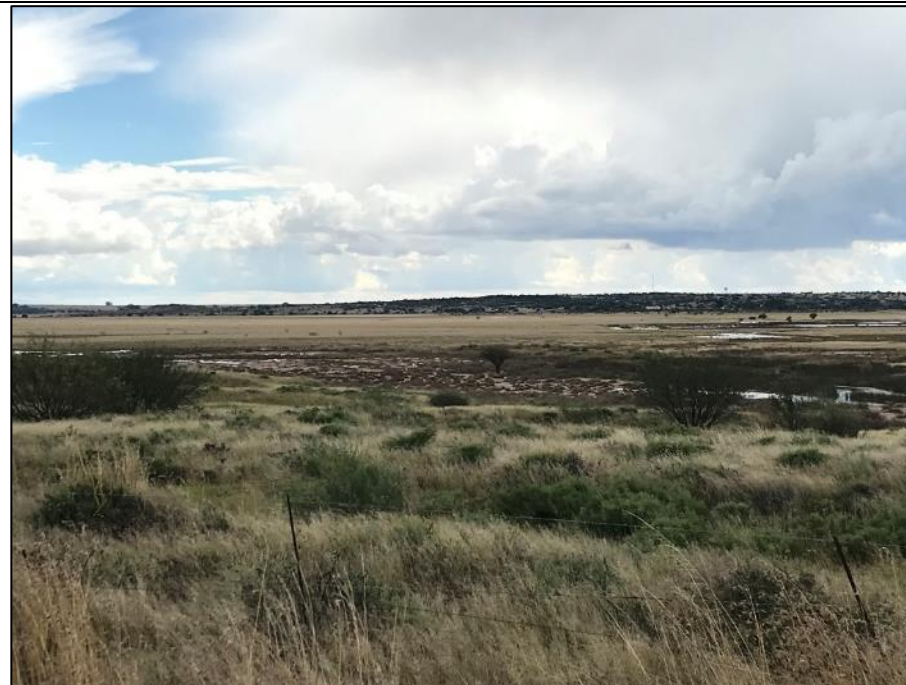
**Site Name: WRU03**

Left: Large depression wetland forming a part of WRU03. Grassed depression wetland is depicted within the black line in the photograph.

Right: Picture of Soutpan with evidence of vegetation clearing in the foreground in preparation to set up a salt mining operation, and an active salt mining operation located to the right of the photograph.

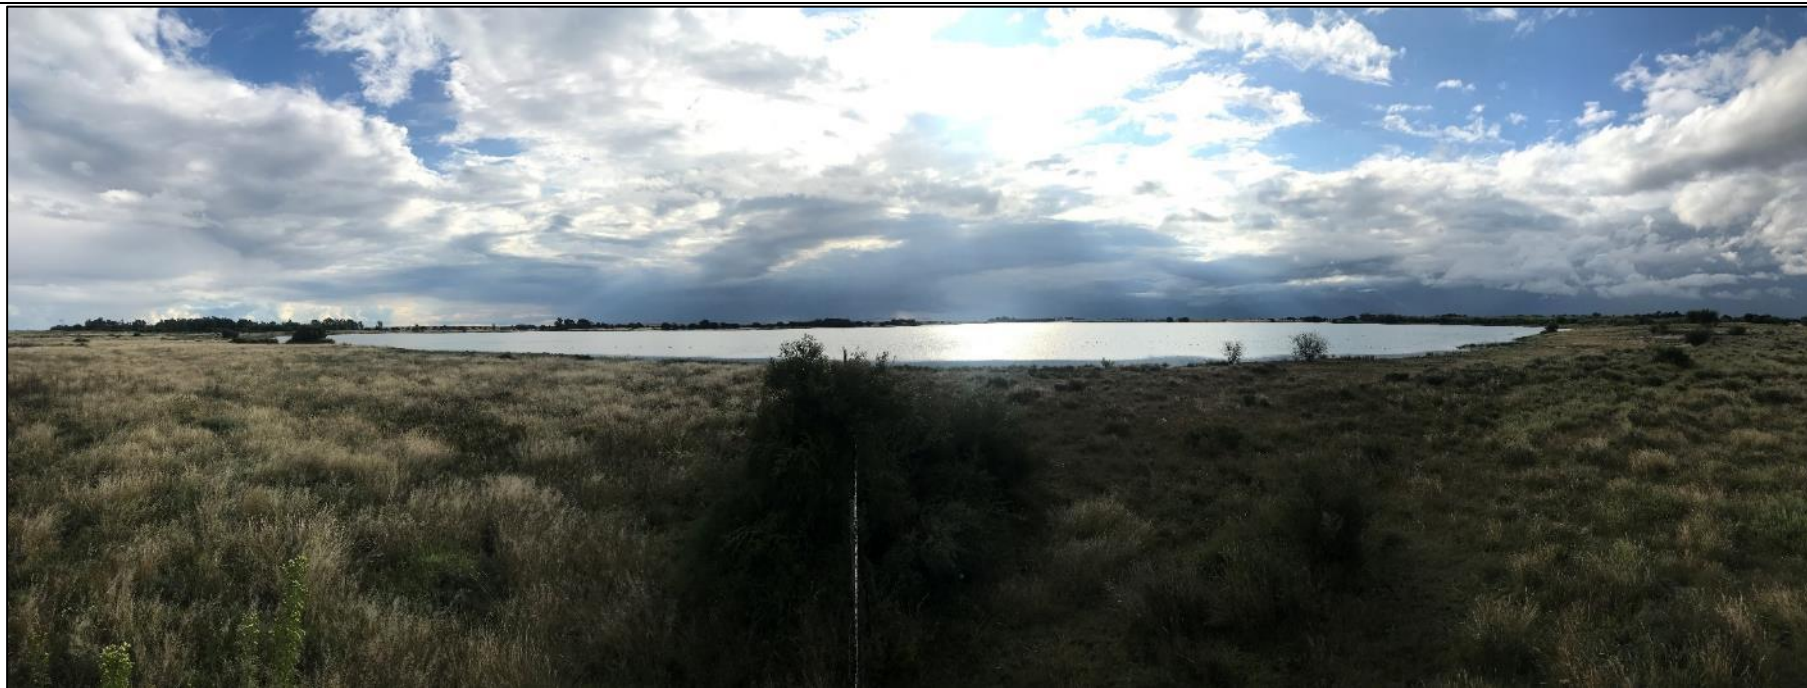
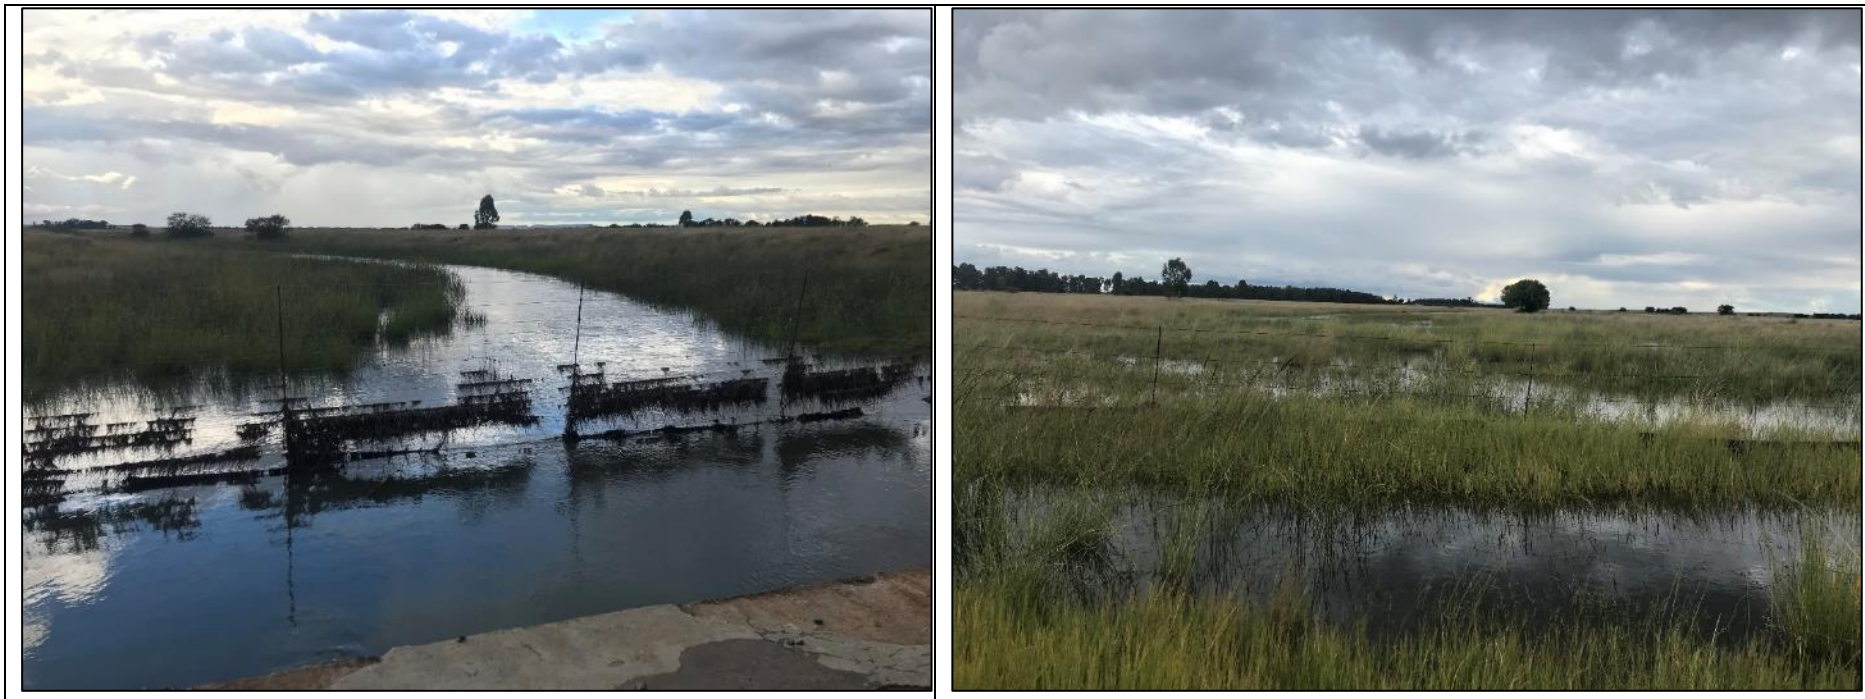
**Site Name: WRU11**

Top: Large depression wetland forming a part of WRU11. This depression wetland is unique in that it receives water from the main valley-bottom wetland at its head and feeds water back into the valley-bottom wetland at its toe.

Bottom Left: Channelled section of wetland towards the north of the mainstem valley-bottom wetland.

Bottom Right: Discontinuously channelled valley-bottom section in the wide central portion of the mainstem wetland.

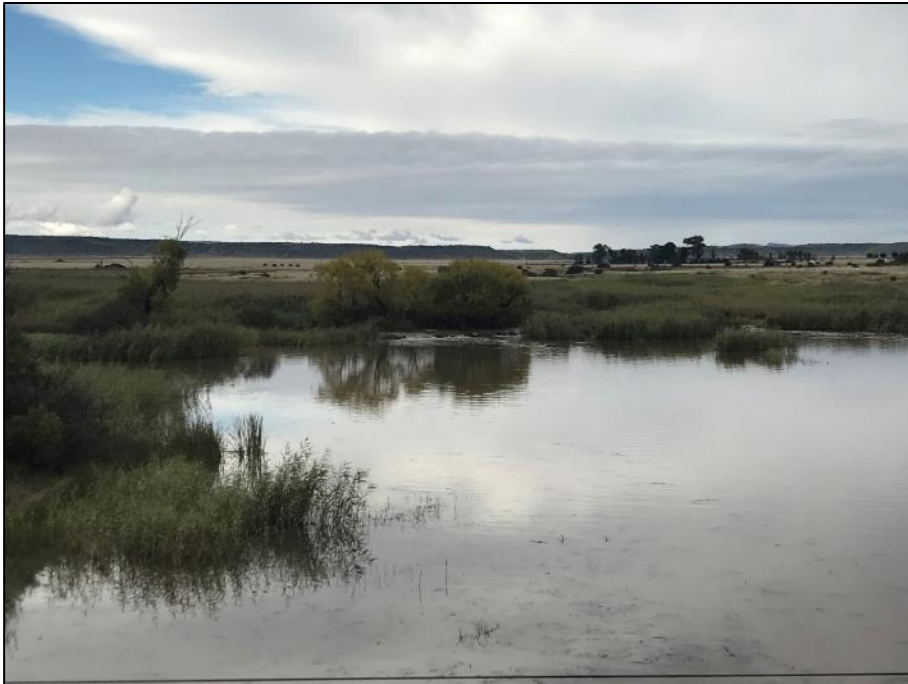
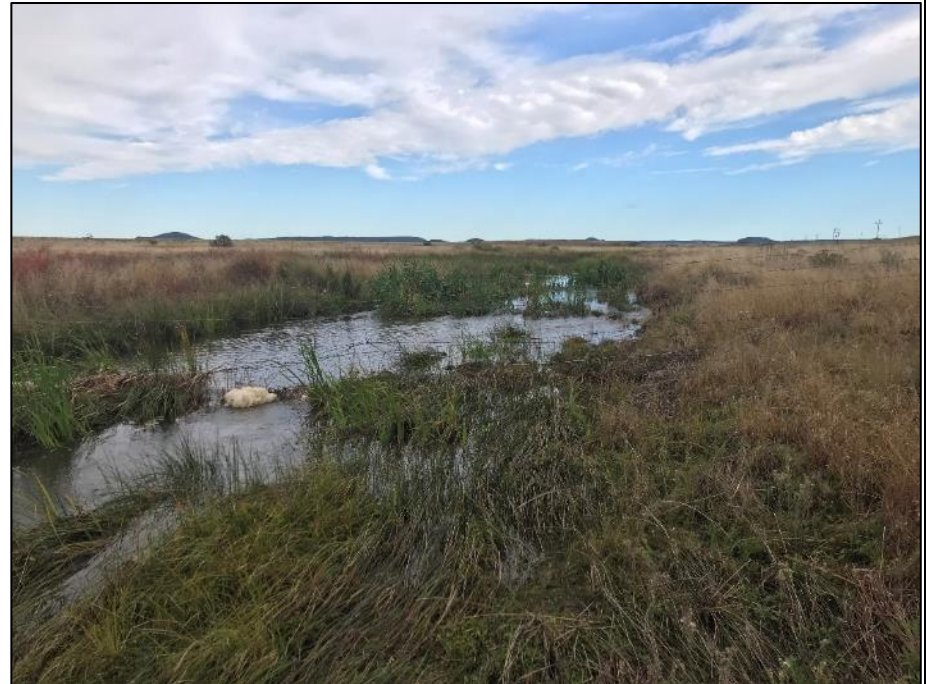
**Site Name: WRU15**

Left: Large reedbed at the confluence of the four valley-bottom wetlands.

Right: Photograph of the northern-most wetland arm with foam and signs of pollution evident within the channel

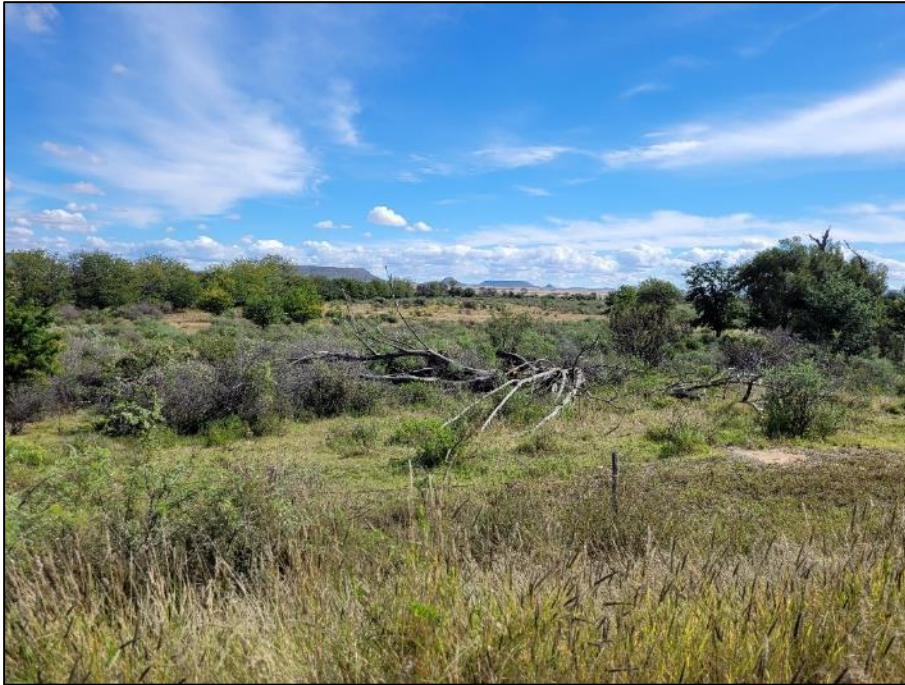
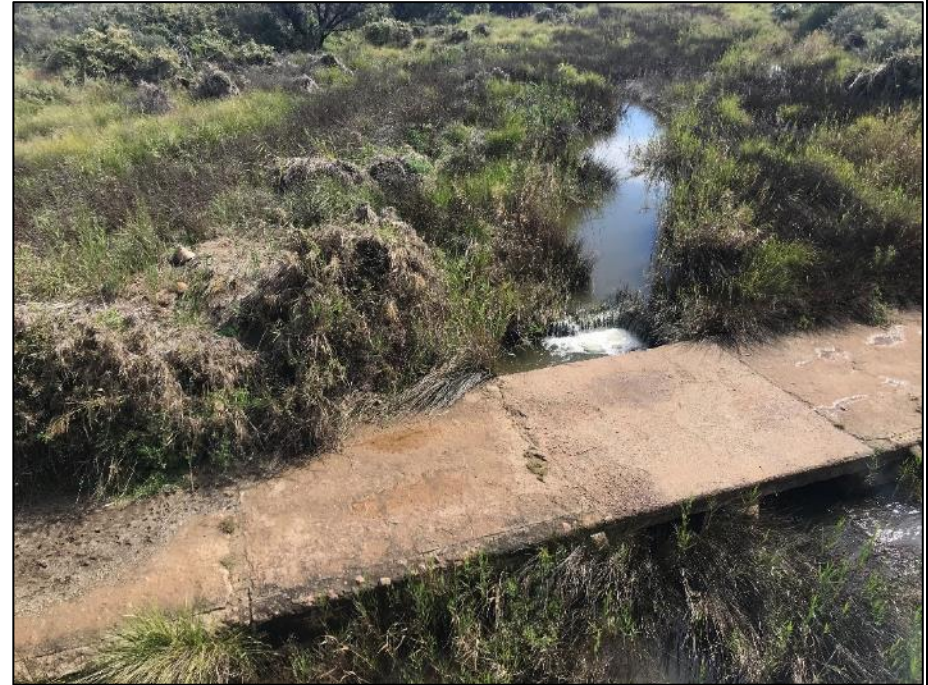
**Site Name: WRU09**

| Site Name | Site Coordinates | | Level of Survey | Comments / brief description |
|---|---|---|---|---|
| <b>WRU09</b> | 30°12'03.82"S | 24°41'54.63"E | Tier 1 | WRU09 is predominantly a fluvial system that has wetland indicators which have formed in the flood back of a dam along the Hondeblaf River before it flows into the Vanderkloof Dam. Its close link to the Vanderkloof Dam was the primary reason for its inclusion as a WRU. However, upon visiting the WRU it was decided to exclude it from any further assessment as the wetland area is in fact artificial in nature and is significantly smaller than initially expected based on the desktop assessment of the system. |

Left: Little evidence of wetland vegetation with extensive bush encroachment into the area where the WRU had been mapped.

Right: Predominantly fluvial and riparian habitat at the toe of the WRU. Some wetland vegetation was present but limited to the confines of the channel.

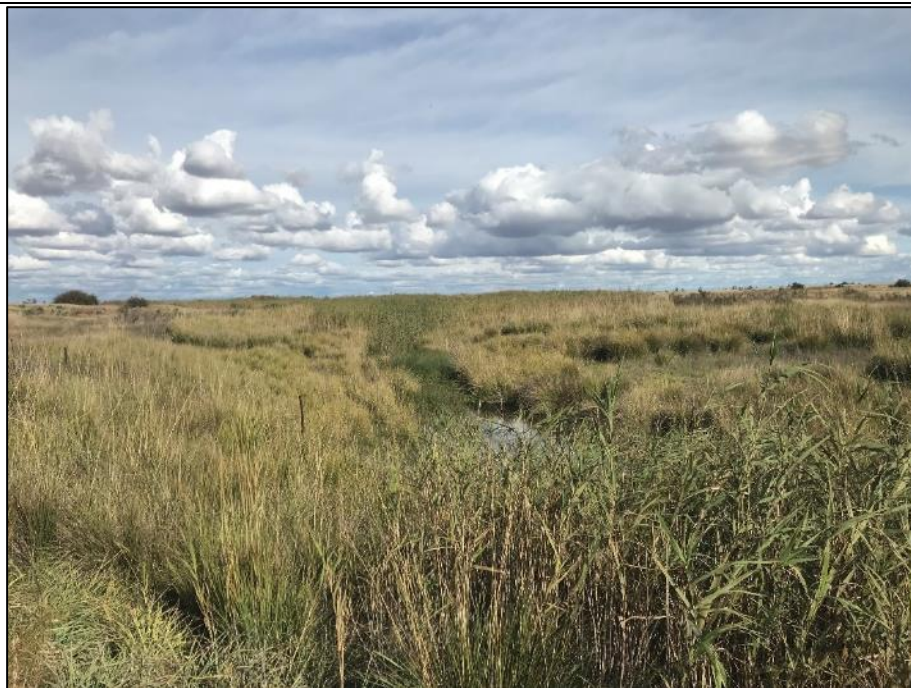
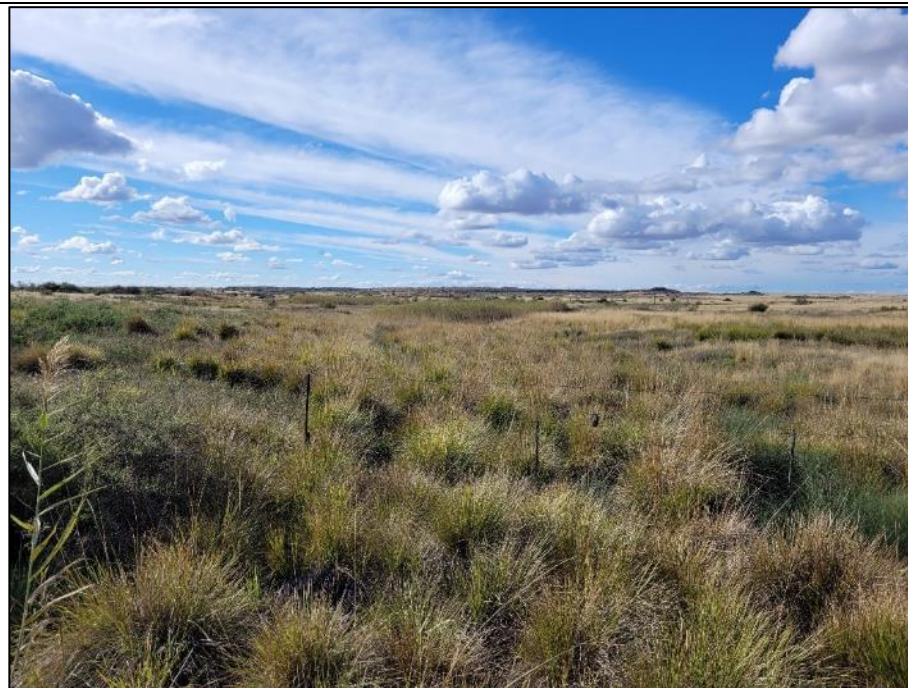
**Site Name: WRU04**

Left: Extensive *Phragmites australis* reedbed located upstream of gradient change in wetland.

Right: Extensive *Phragmites australis* reedbed located downstream of road crossing with extensive stands of *Miscanthus capensis* along the valley-bottom wetland.

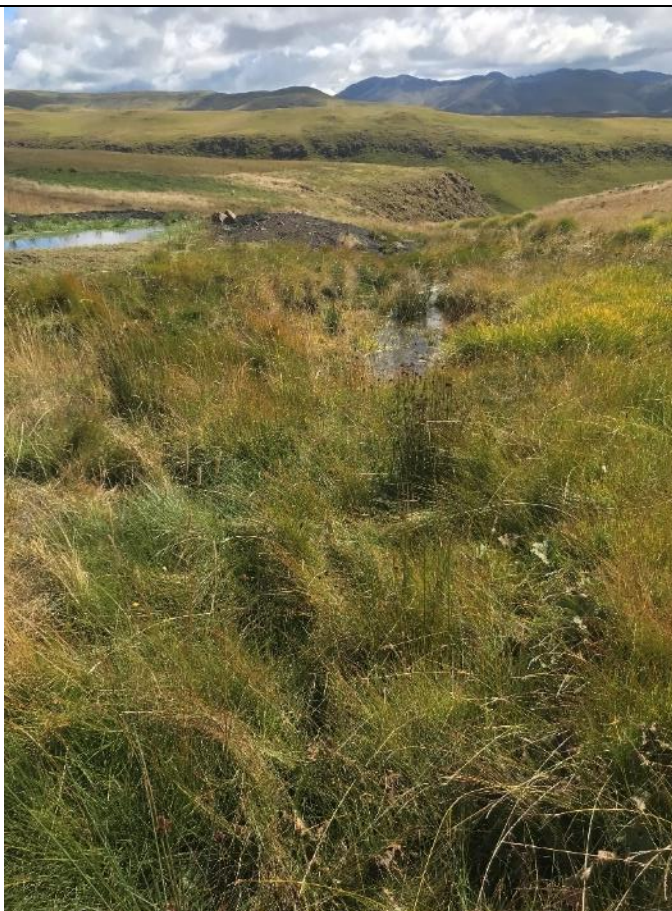
**Site Name: WRU16**

Centre: A small hillslope seep downstream of WRU16 which would be indicative of the hillslope seep habitat in WRU16 – the vegetation dominated by *Merxmüllera disticha*.

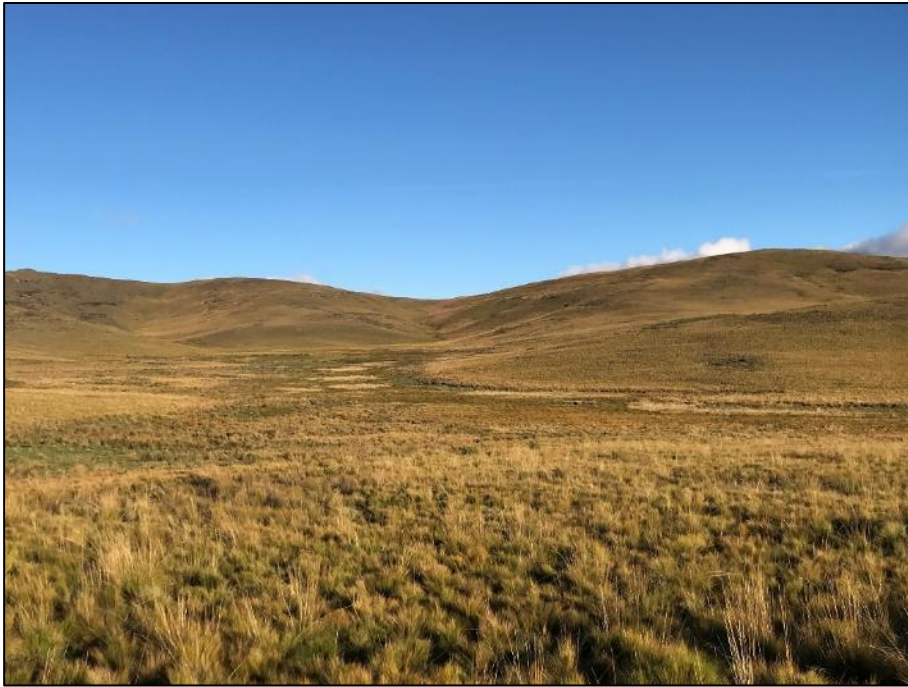
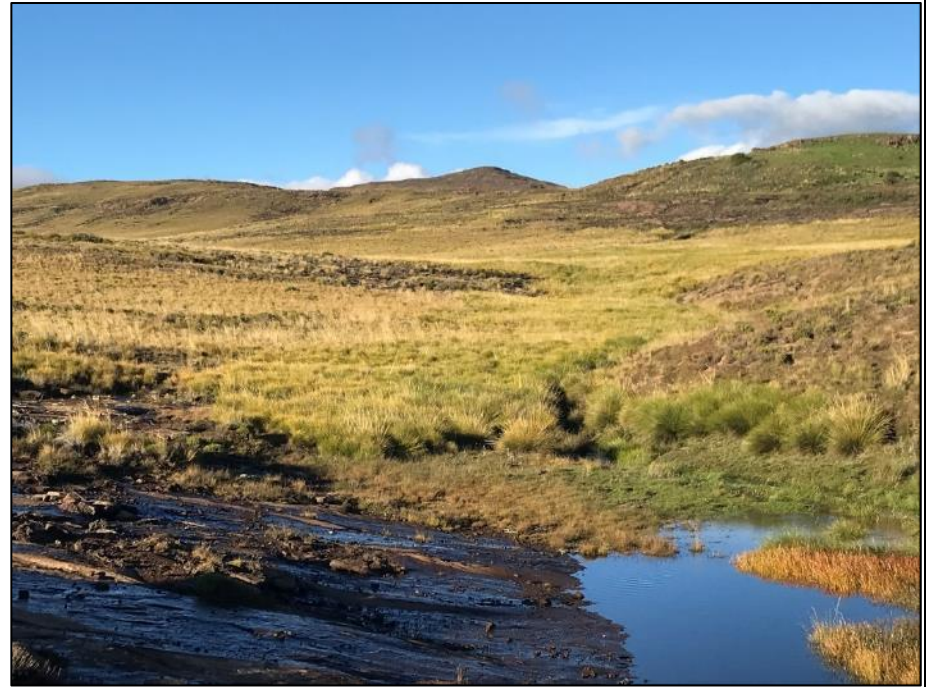
**Site Name: WRU17**

Left: Broad valley-bottom wetland with a number of seeps feeding into it. The darker colour in the landscape indicates the approximate valley-bottom wetland extent.

Right: An example of an intact hillslope seep wetland dominated by *Merxmuellera disticha*.
